May 14, 2021

RE: Foundation Inspection  
Job #19679

# 4403 Sarong Drive

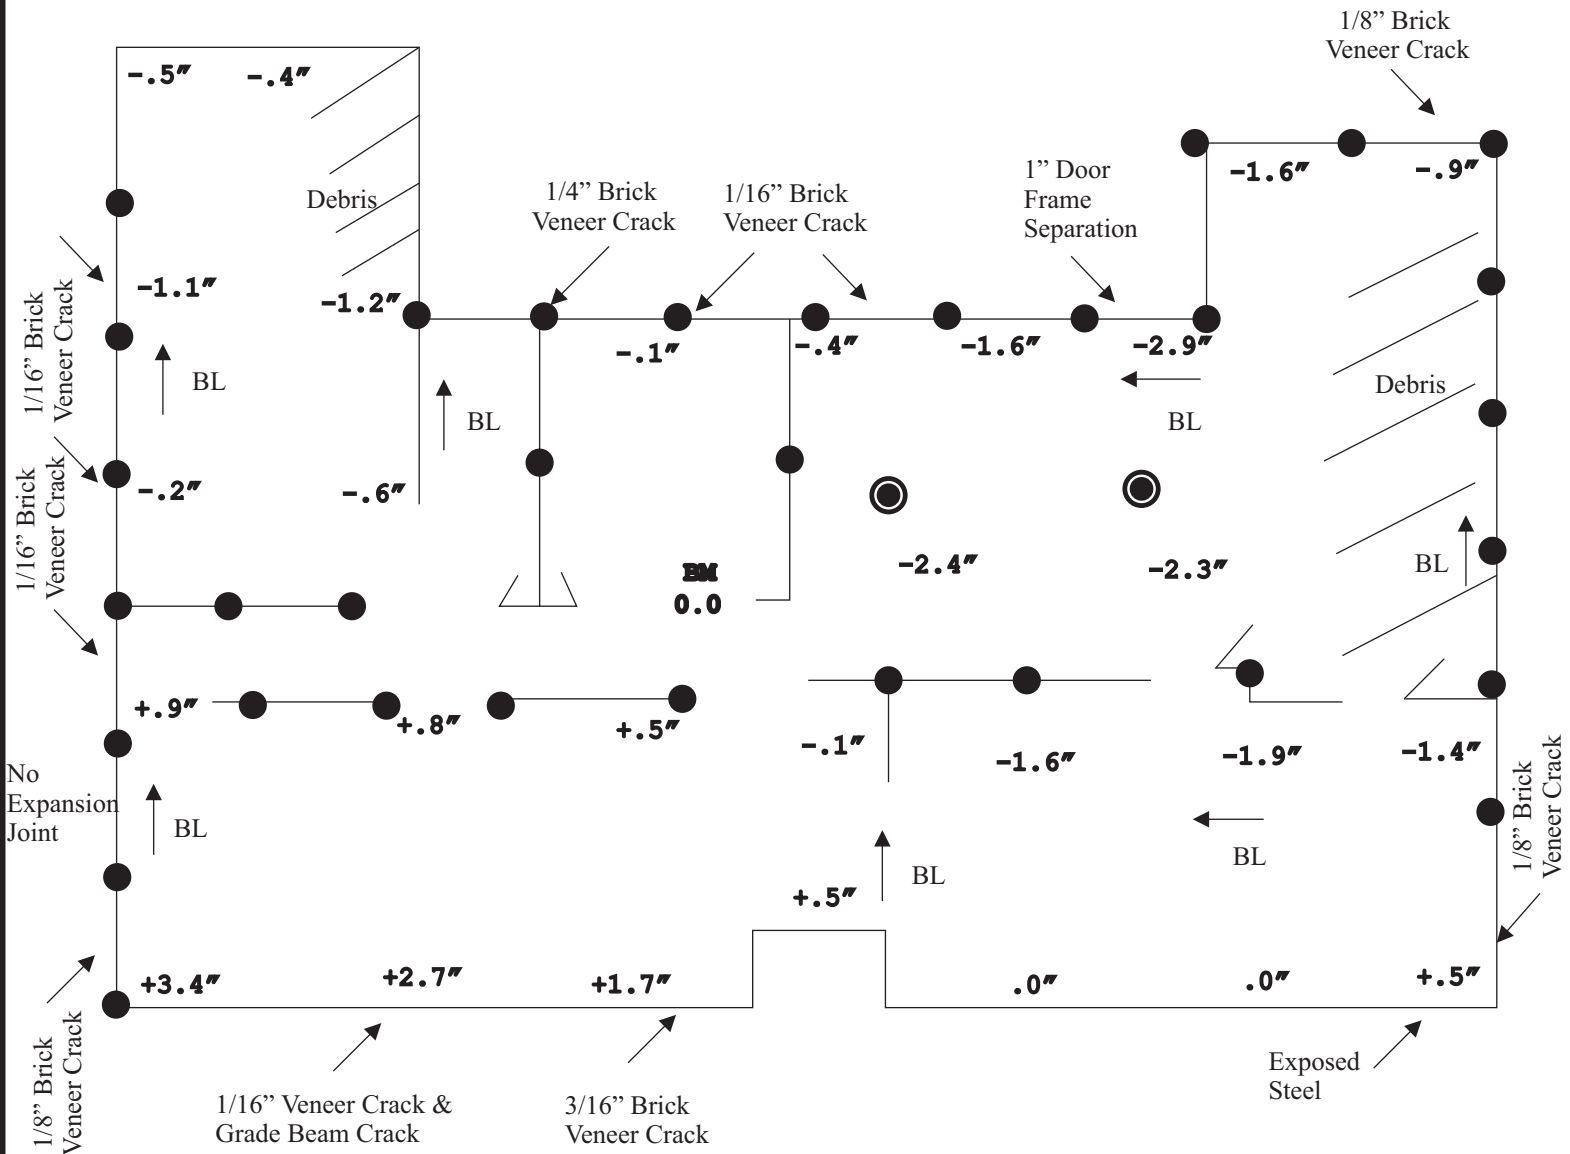
**The foundation inspection did reveal the existence of a non-functioning slab, as evidenced by sloping floors, elevation differentials, door frame separation, sheetrock cracks everywhere, bubble levels and numerous brick veneer cracks.**

**Foundation movement was documented by measuring the surface of the floor coverings (compensating for covering as necessary). Movement whether it be settlement or heaving is documented with the elevations on the floor-plan attached. Spreadsheet calculations were performed utilizing the FPA (Foundation Performance Association's SC-13-1 Calculation Spreadsheet) resulting in a deflection ratio of L/209 which is excessive and will require foundation repair with piers. Tilt ratio of 0.90% which is just within the 1% tolerance. This spreadsheet and report were reviewed and this engineer has taken into consideration the recommendations and guidelines of the TBPE (Texas Board of Professional Engineers), ASCE (American Society of Civil Engineers), ACI (American Concrete Institute), and TRCC (Texas Residential Construction Commission).**

Elevation Differential 6.3"  
Instrument Repeatability Error 0.2"

Approximately 22 exterior piers and 14 interior piers need to be installed with steel I-beams will need to be installed, as depicted on the attached diagram the reasonable placement is based on the opinions and engineering judgment of this engineer. The pier placements are approximate and can be altered as necessary to be placed exactly under interior bearing walls and under interior slab beams.
