HEDDERMAN ENGINEERING, INC.

REF: CONDITION OF PROPERTY SURVEY

At your request, a visual survey of the townhouse/condo located at 3010 Holly Hall Street Unit 3010, Houston, Texas, was made by Mr. Ruben Martinez and Mr. Tim Hedderman.

3010 Holly Hall Street Unit 3010

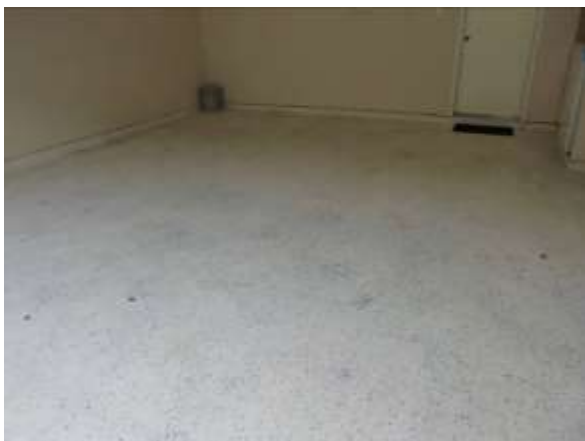
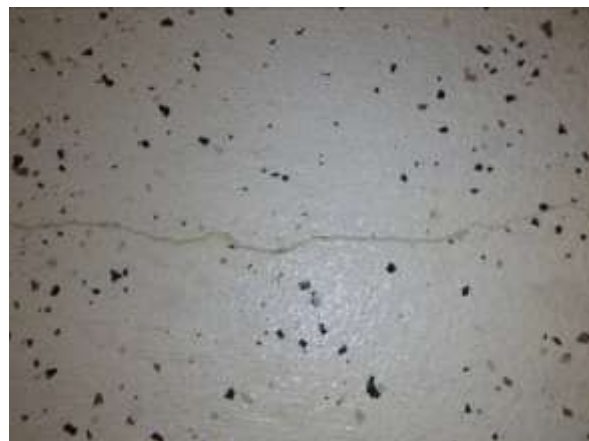
Cracking of the foundation concrete exists in virtually all foundations. It is pointed out that cracking is a normal property of concrete and other brittle materials, and Hedderman Engineering, Inc. assumes no responsibility should cracks be found that are not mentioned in this report. Some cracking was observed in this concrete foundation, including at the garage floor.

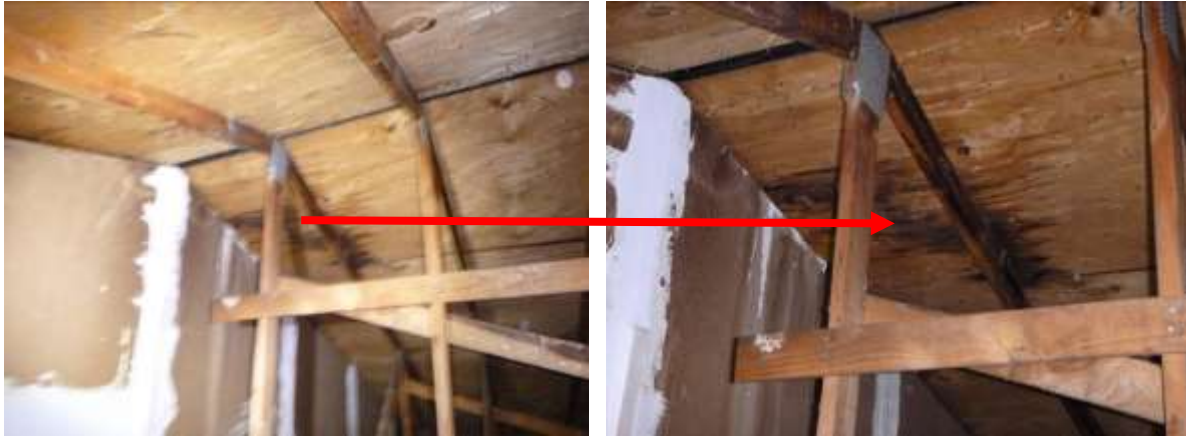
After observing the interior of the structure, evidences of current roof leaks were not visible. The absence of evidences of roof leaks does not guarantee that roof leaks were not present; rather, that no evidences of leaking were visible at the time of the inspection. Some stains were visible in the attic, but the stains appeared to be related to previous roof leaks. It is recommended that you check with the owner and/or a service company concerning the stains.

Locations included: attic at the south above the master bedroom

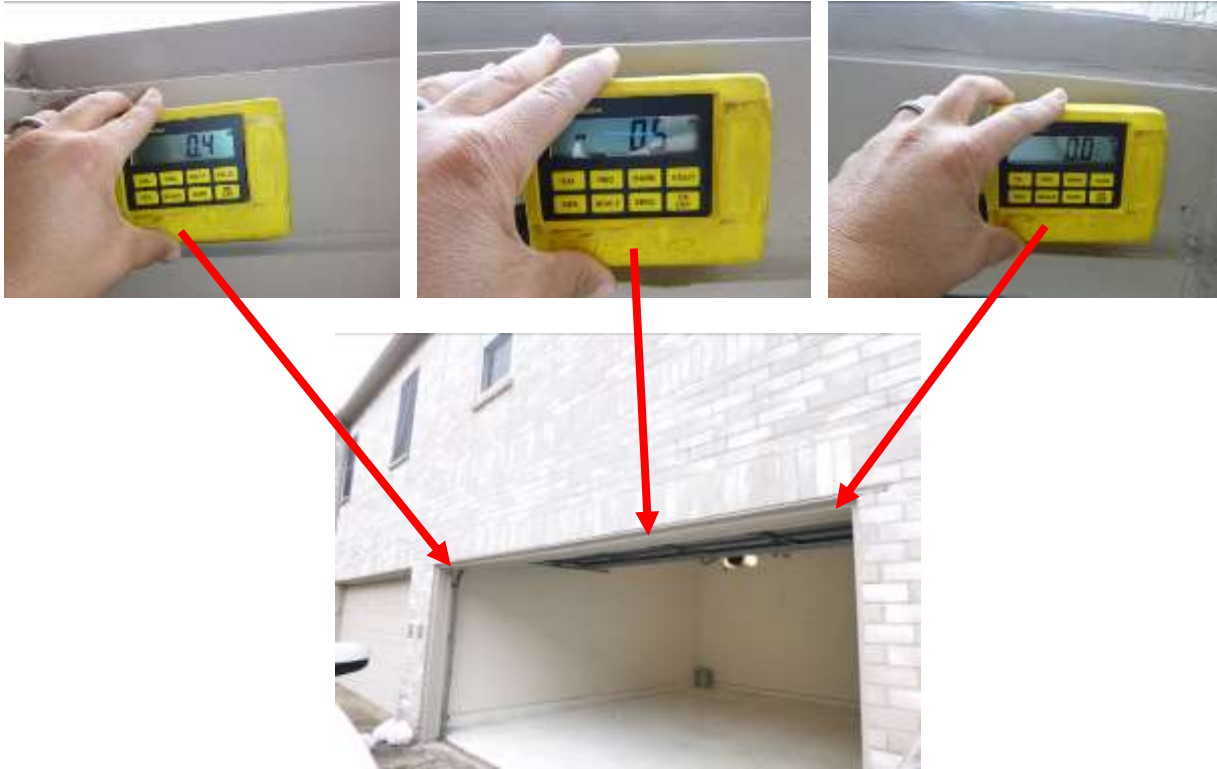
The header over the garage door was deflected slightly (less than one inch deflection in a 30-foot horizontal distance ($L/\Delta = 360$ per the building code)). The degree of the deflection was not such that the header was not performing its intended function and, therefore, no repairs are recommended at this time.

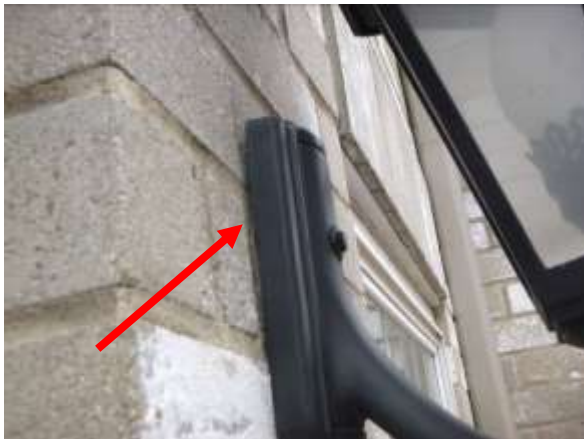
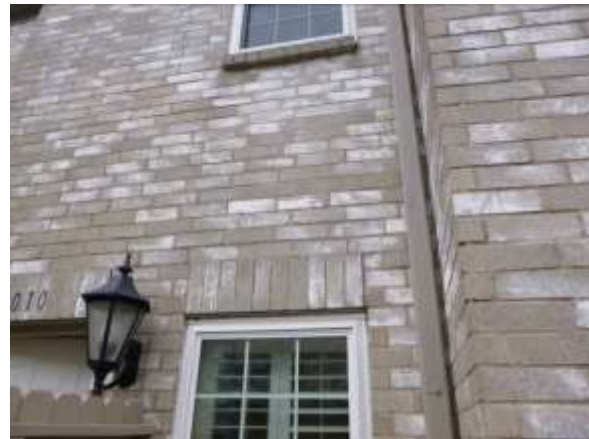
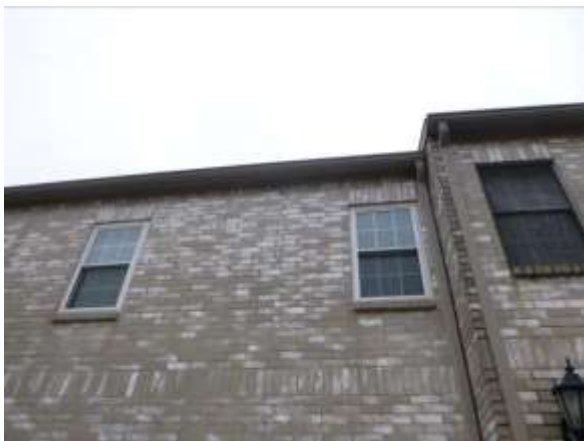
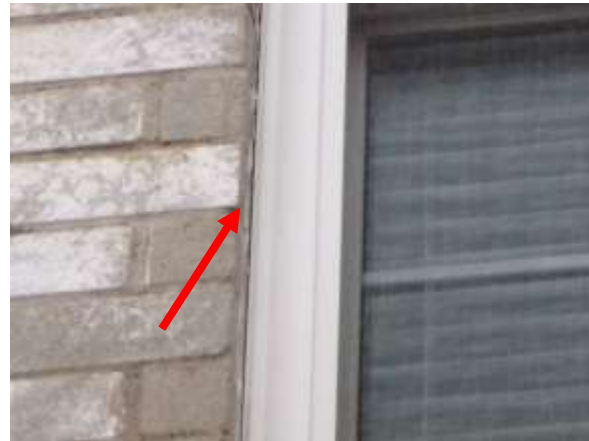
A substantial vulnerability to water penetration was observed at penetrations/openings through the exterior building envelope, and it is recommended that all penetrations/openings be sealed against water penetration. Typical examples on a structure may include light fixtures, air conditioning refrigerant lines, water piping, gas piping, vent caps, windows, doors, expansion joints, etc. Below is a representative sample of locations and/or photographs showing some, but not necessarily all, locations where there is a vulnerability to water penetration. Have a contractor provide a cost estimate to seal all vulnerable areas on the exterior building envelope against water penetration.

- The exterior light fixtures have not been caulked.
- Windows where the caulking was cracked or missing, and/or had gaps in the caulking.

Obtain Cost Estimate

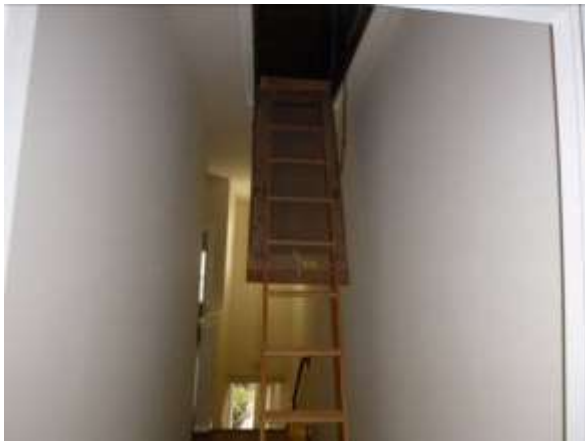
The access ladder was not labeled to indicate the rated capacity of the ladder.

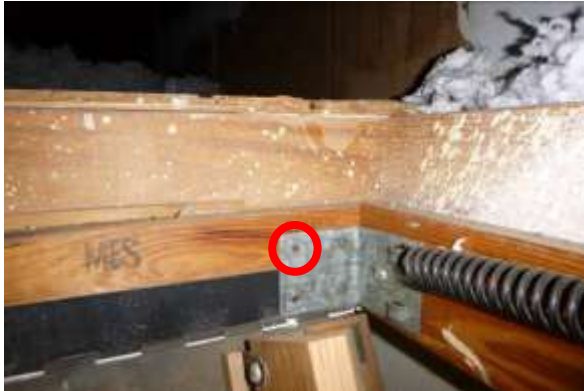
The stair assembly was not properly installed or secured to the framing members, and repair is needed for safety purposes. The condition(s) can be a safety hazard, and repair is needed, as an improperly installed stair assembly can possibly collapse.

- The nails used to secure the ladder assembly to the attic framing were not installed through the holes in the corner brackets at the top of the stairs.

Obtain Cost Estimate

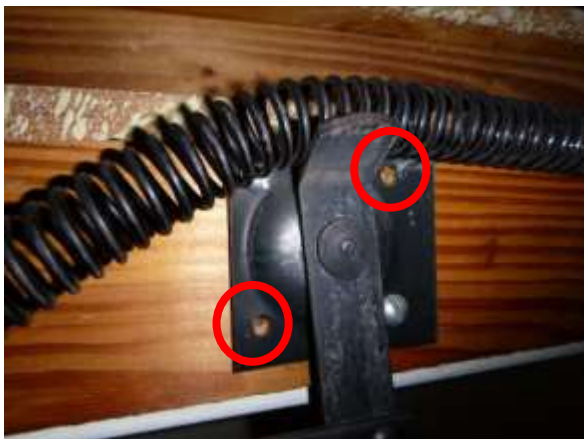
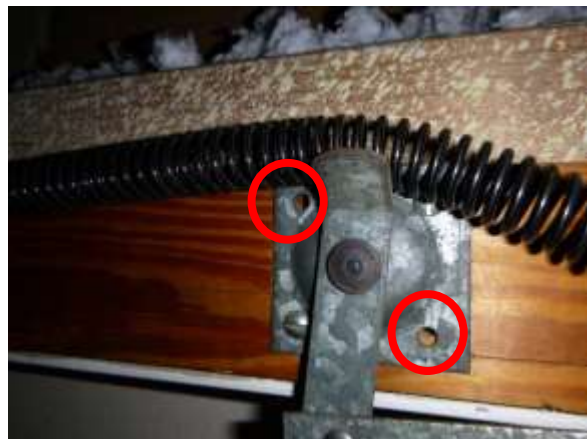
- The nails used to secure the ladder assembly to the attic framing were not installed through the holes in the spring arm pivot plates on the sides of the access ladder.

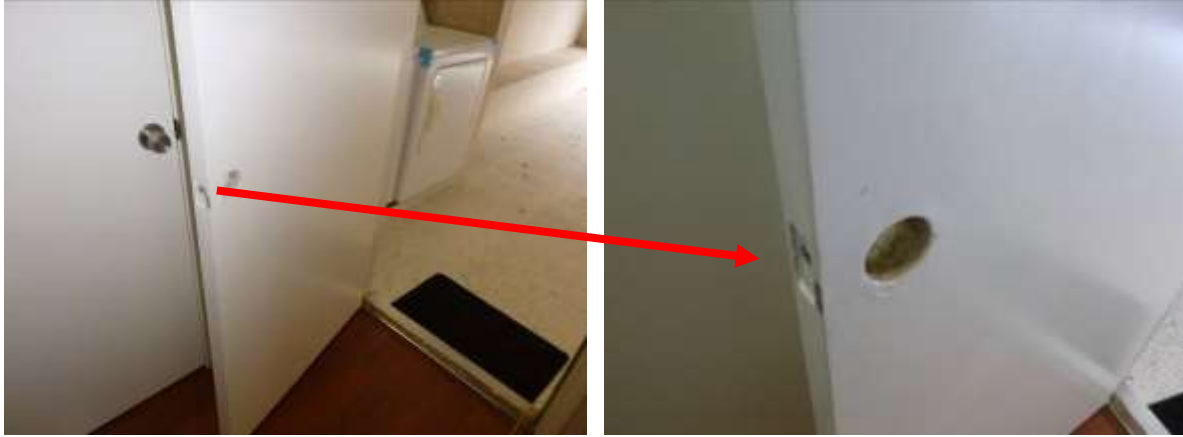
Doors had missing hardware that needs to be replaced.

Locations included: garage pedestrian door

Obtain Cost Estimate

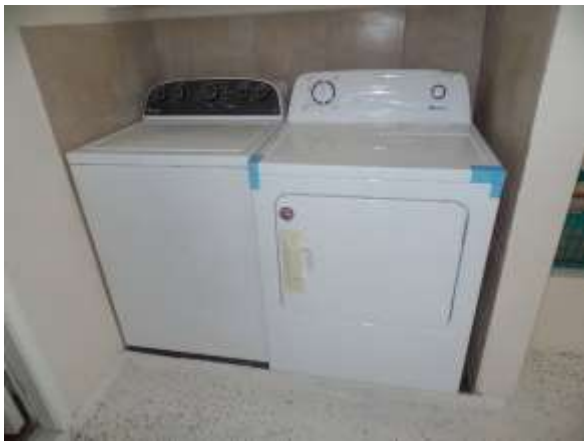
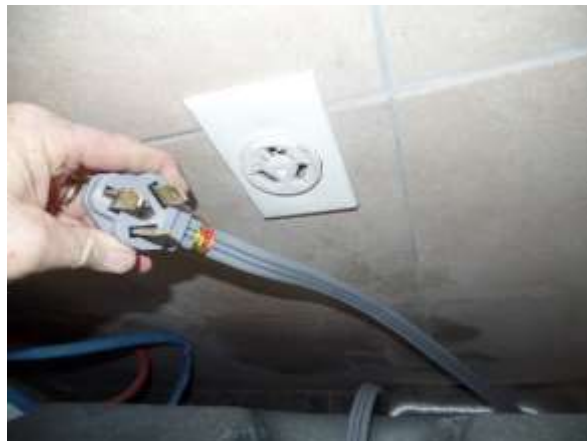
The 240-volt outlet for an electric dryer was the old style 3-prong outlet, rather than the new style 4-prong outlet.

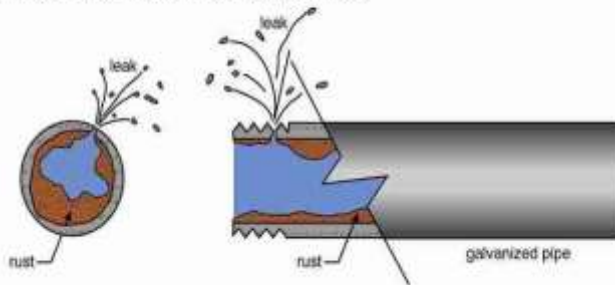
The water supply piping inside the house was observed to be galvanized steel.

rusting of galvanized pipe can greatly reduce water pressure and will eventually cause leaks as rust creates holes in the pipe walls

problems are likely to occur soonest on pipes carrying hot water, horizontal pipes and at threaded (thinner) sections

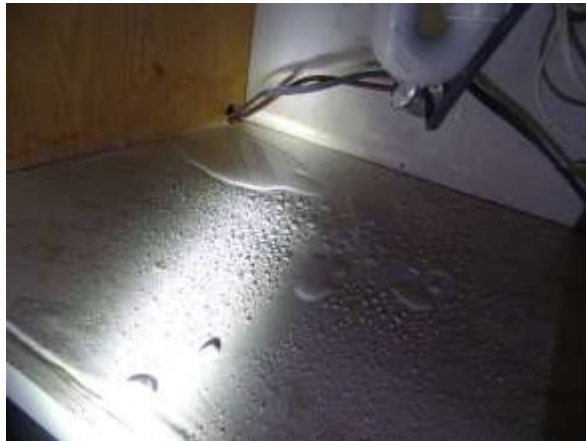
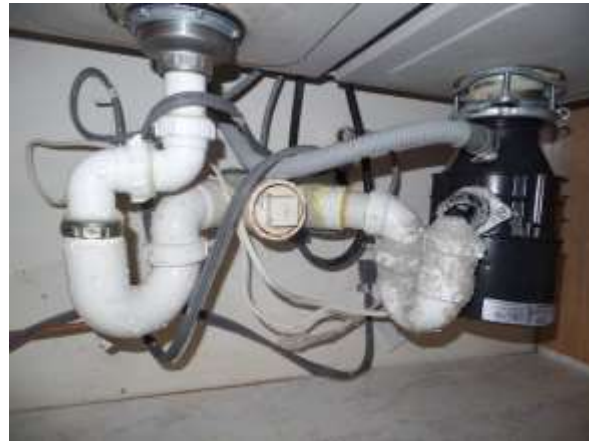
The drain line was leaking under the sink when the sink was filled with water and allowed to drain. Also, the drain line was heavily puttied, indicating previous leaks. Locations included: the kitchen sink

Obtain Cost Estimate

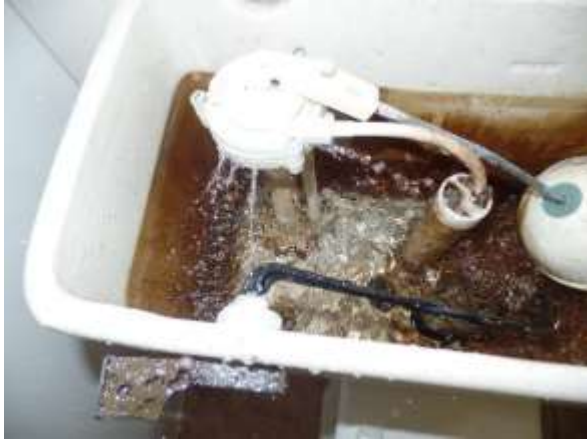
The toilet fill valve(s) was leaking inside the toilet tank and is in need of replacement
Locations included: upstairs secondary toilet

Obtain Cost Estimate each

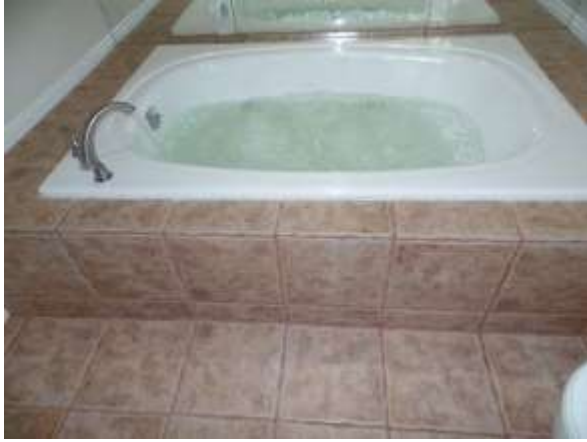
No items requiring repair were observed in the operation of the whirlpool tub. The recirculation pump and aerators, were functioning properly. However, the GFCI was missing and needs to be installed for safety purposes.

Locations included: the master bathroom

Obtain Cost Estimate

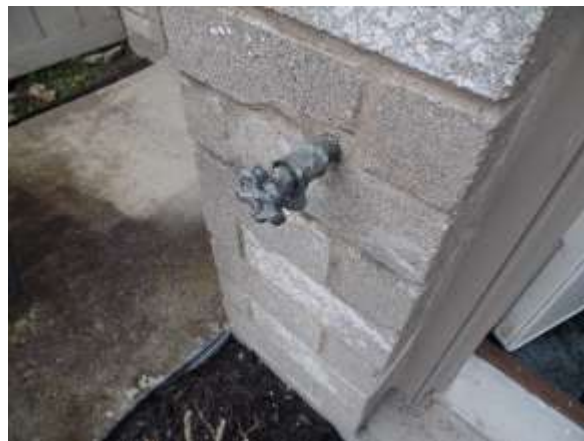
The atmospheric vacuum breaker devices were missing at one or more of the hose bibbs, and it is recommended that they be installed to prevent cross connections, which can allow contaminated water to enter the potable water supply.

Obtain Cost Estimate

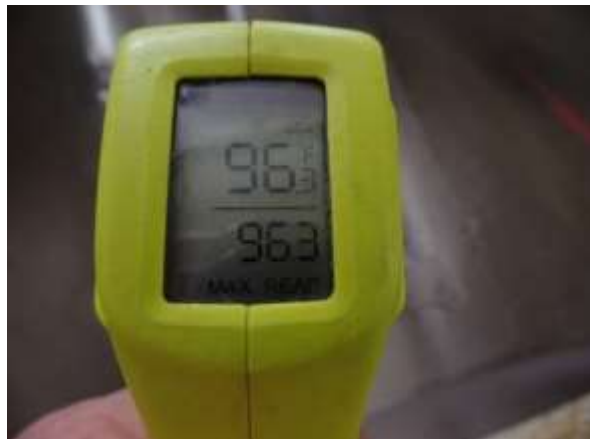
The temperature of the hot water at the kitchen sink was measured to be 96 degrees at the time of the inspection. Normally, we see 120 degrees, so further investigation with the Homeowners Association is recommended.

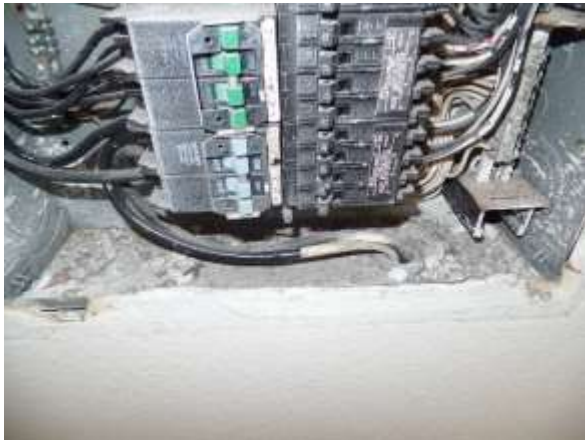
Foreign matter was observed in the panel box, which can be a safety hazard, and it is recommended that the panel be cleaned

Obtain Cost Estimate
