PRELIMINARY FOUNDATION INSPECTION REPORT: JOB NO. 21-F220

LOCATION: 1623 West 7th
Freeport, TX

DATE OF INSPECTION: August 10, 2021

Firm Reg. # F-15269 This document is the property of G A Brooks Engineering LLC, and the information contained within is confidential and privileged. It may not be copied or distributed without written consent from G A Brooks Engineering LLC.		G A Brooks ENGINEERING LLC	
2003 Mossy Cup Lake Jackson, TX 77566 gregbrookspe@yahoo.com (979)341-9181	SIZE L	JOB NO 21-F220	DWG NO 21-F220-1
SCALE 1 in = 15 ft.	SHEET 01 of 01	REV 0	SHEET 1 OF 3
Proposed Repair Plan 1623 West 7th Freeport, TX

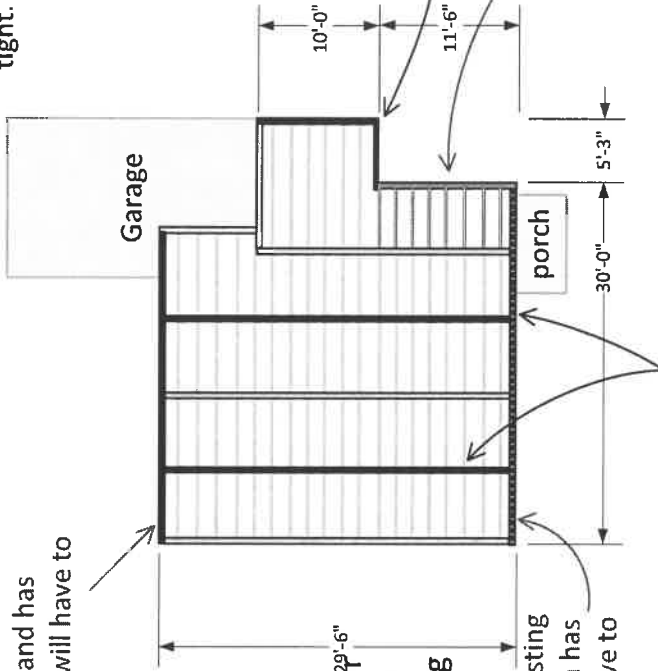
4"x6" beam and perimeter band has severe termite damage and will have to be replaced.

Termite shields missing throughout original structure, inadequate pier pads were used and have caused premature settling

4"x6" beam and perimeter band resting on top of concrete perimeter beam has severe termite damage and will have to be replaced.

Both beams have severe termite damage and will have to be replaced

Joists have severe termite damage at end that rest on top of beam. Joist will have to be sistered/replaced from perimeter to 1st interior beam.

Two interior stringer beams have been added to allow more interior weight distribution during leveling for the structure

Existing beam span in the original structure is aggressive especially to properly level the house. Two stringer beams should be added as noted on the drawing. Approximately 70' of perimeter beam has extreme termite damage and will have to be replaced. Also 50' of perimeter band has severe termite damage and will have to be replaced as well. Total beam length to be added/replaced is approx. 130'. All beams should be a minimum of 4"x6" construction. Perimeter bands should be like for like 2"x6" replacement.
