### RESIDENTIAL HOME INSPECTION

### 2110 Winged Foot Dr League City TX 77573

Charles Akers JANUARY 28, 2021

## **PROPERTY INSPECTION REPORT**

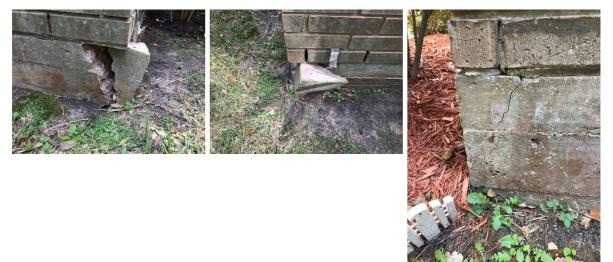
#### 1: Shear Cracks

Corners of the concrete foundation have cracked and/or "sheared" off. While this will not negatively affect the foundation performance, re-sealing of these corners is recommended.

Recommendation: Contact a handyman or DIY project

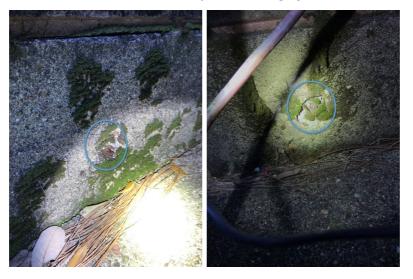
Several of the post tension cable ends were exposed and should be cleaned and covered with a concrete sealant, like an epoxy grout, to protect them from further corrosion.

Recommendation: Contact a handyman or DIY project

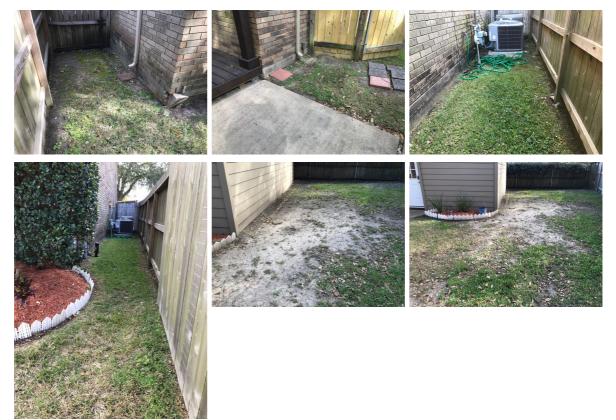
#### 2: Poor Grading Recommendation

The property had areas of inadequate/poor grading that may not completely route runoff from precipitation away from the foundation. Because the home was in an area that may contain expansive soil, re-grading these areas or ensuring a functional underground drainage system is in place is recommended to help prevent foundation issues.

Recommendation: Contact a qualified landscaping contractor

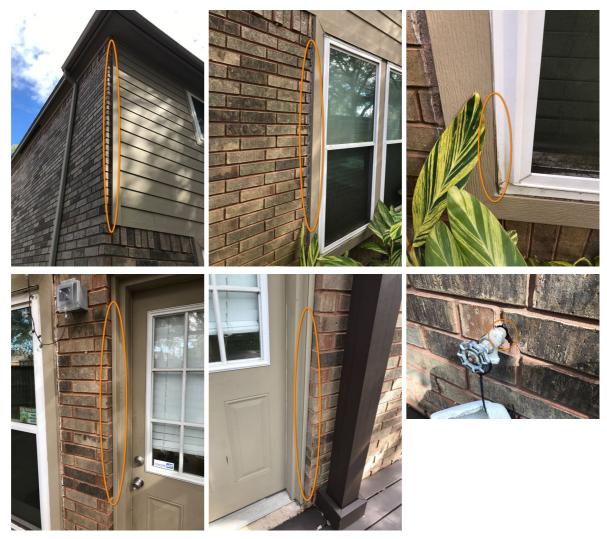
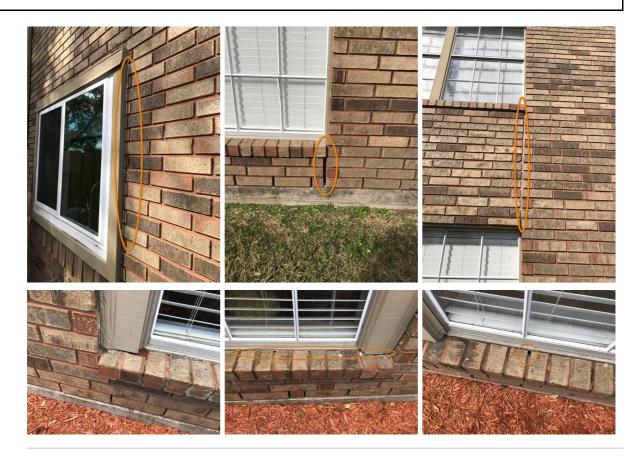
Caulking/sealing all gaps, cracks, openings and penetrations in the exterior wall is recommended. There were several areas around the house that need sealing to prevent insect and moisture intrusion.

Recommendation: Contact a handyman or DIY project

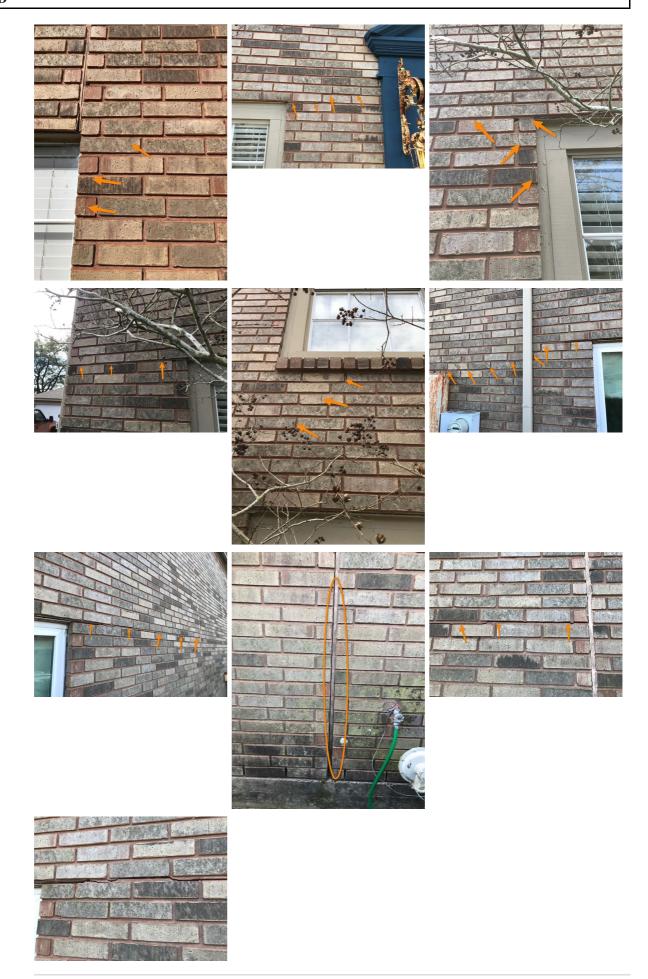
#### 2: Stress Cracks Recommendation

Brick and mortar separation (stress cracking) was noted at multiple locations at the exterior walls. These types of cracks can potentially indicate previous structural movement.

Recommendation: Contact a qualified professional.

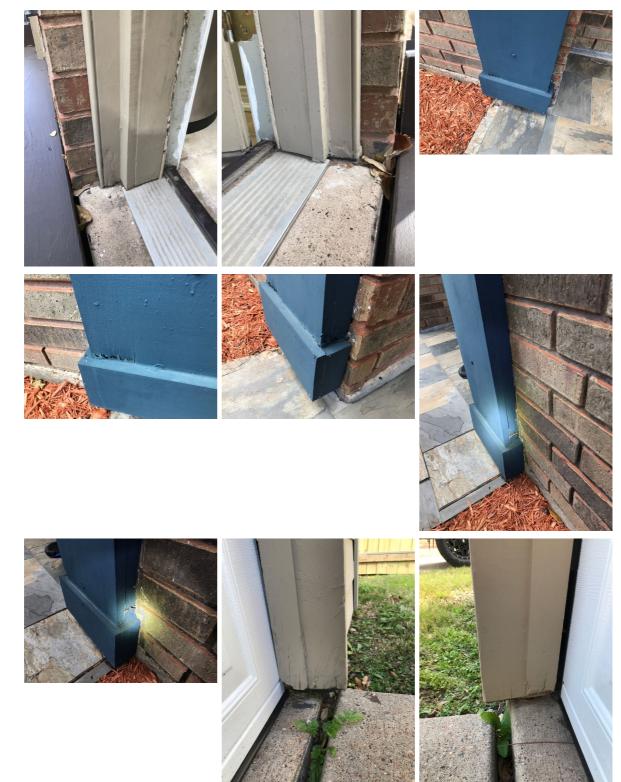
# **8: Deteriorated Trim •** Recommendation

Deterioration/rot was observed at multiple locations: localized repairs are recommended.

Recommendation: Contact a qualified siding specialist.

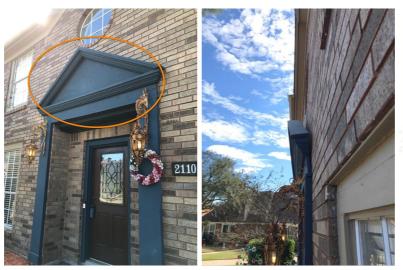
**10: Loose Trim/Facade Recommendation**

Loose trim/façade was observed. Further evaluation by a qualified contractor to determine the best method of remedy is recommended.

Recommendation: Contact a qualified professional.

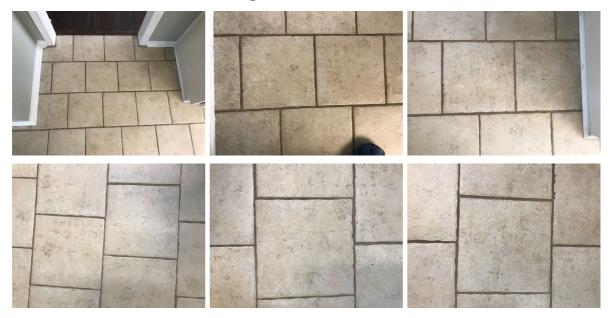
#### **3: Minor Tile Cracks**

Minor cracks/damage was observed at the tile.

Recommendation: Recommend monitoring.

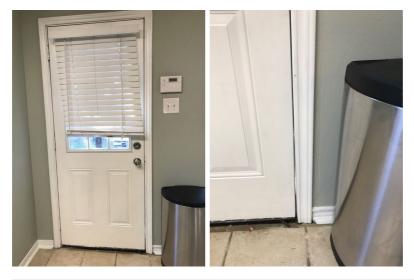
2: Poor Door Seal
Recommendation
Rear Exterior,

The exterior door did not make a proper seal: check weather stripping.

Recommendation: Contact a qualified handyman.

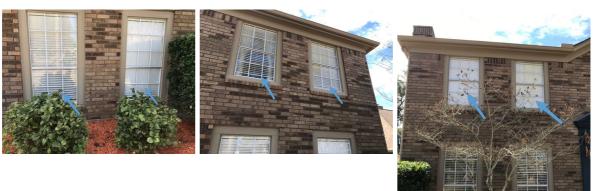
1: Missing Screens Maintenance/Note Multiple Locations

The window screen was missing.

Recommendation: Contact a qualified window repair/installation contractor.

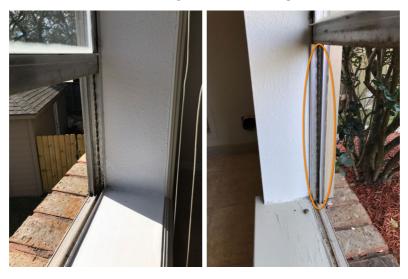
A broken/loose window balance spring was observed. Each window requires two balance springs to support its weight; these springs also help keep the window open. Replacement may become necessary for proper operation of the window.

Recommendation: Contact a qualified window repair/installation contractor.

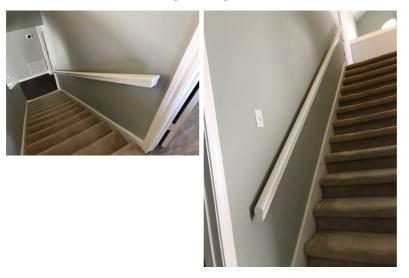
1: Loose Railing A Safety Hazard

The railing was loose and should be better secured for reasons of safety.

Recommendation: Contact a qualified professional.

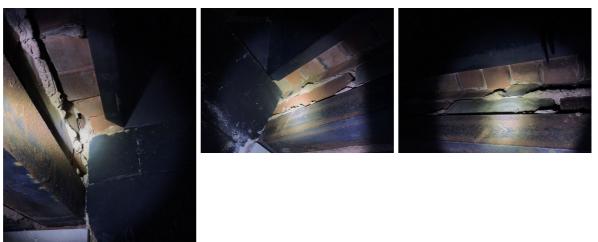
There were openings/gaps in the firebox. This condition will not provide proper protection from heat to the surrounding structure. Repairs are recommended.

Recommendation: Contact a qualified fireplace contractor.

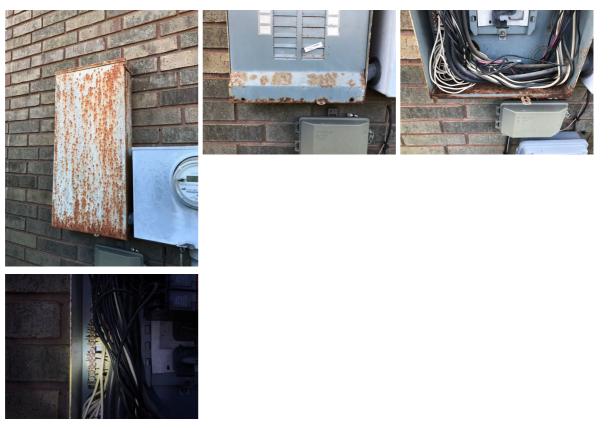
The electrical panel had excessive rust/corrosion present.

Recommendation: Contact a qualified electrical contractor.

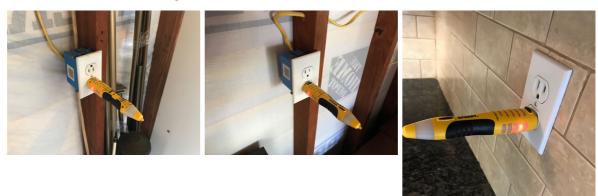
#### **3: Outlet - Un-Grounded** ▲ Safety Hazard Garage (multiple), Kitchen (multiple),

An un-grounded outlet was observed.

Recommendation: Contact a qualified electrical contractor.

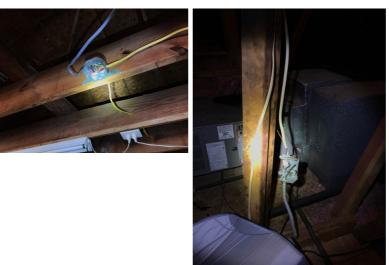
#### 8: Wiring - Exposed Splices Commendation

Garage, Kitchen, Attic,

Exposed wire splices were observed. Splices should be properly sealed in a junction box.

Recommendation: Contact a qualified electrical contractor.

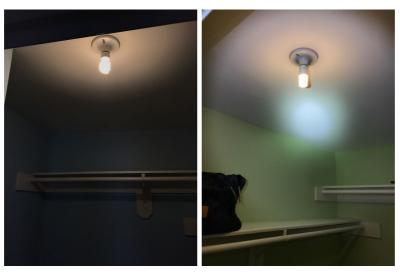
9: Light - Exposed bulb in Closet

Light fixtures with exposed bulbs are no longer allowed to be installed in closets. Updating the fixture is recommended.

Recommendation: Contact a qualified electrical contractor.

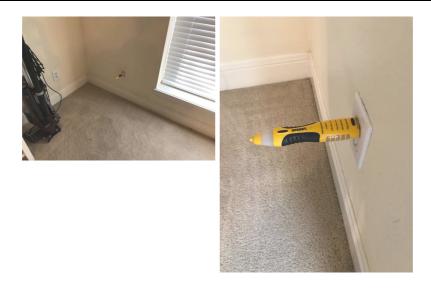
# 15: Outlet - Not Functional Recommendation Master Bedroom, A non-functional outlet was observed.

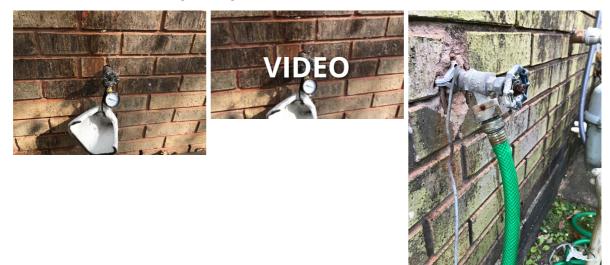
2: Hose Bibb - Leak
Maintenance/Note
Multiple Locations
The hose bibb(s) (water valve) leak while in use.

Recommendation: Contact a qualified professional.

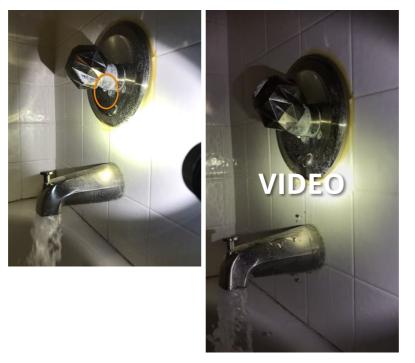
13: Tub - Leaky Faucet
Recommendation
Upstairs Bath,
The tub faucet leaked.

Recommendation: Contact a qualified plumbing contractor.

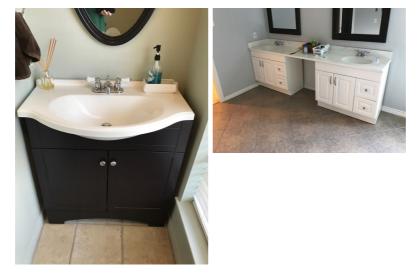
15: Vanity Loose
Recommendation
Half bath, Master Bath,
The sink/vanity was not securely installed.

Recommendation: Contact a qualified professional.

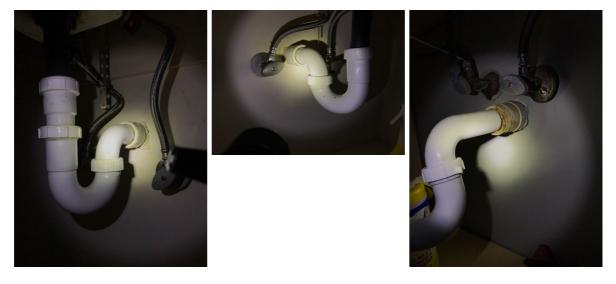
There was evidence of a previous leak below the sink. No active leaks were observed at the time of inspection.

Recommendation: Recommend monitoring.

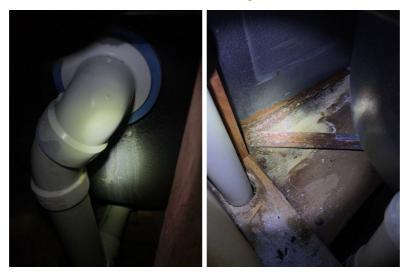
#### 2: Tub - Previous Leak

There was evidence of a previous leak below the tub. No active leaks were observed at the time of inspection.

Recommendation: Recommend monitoring.

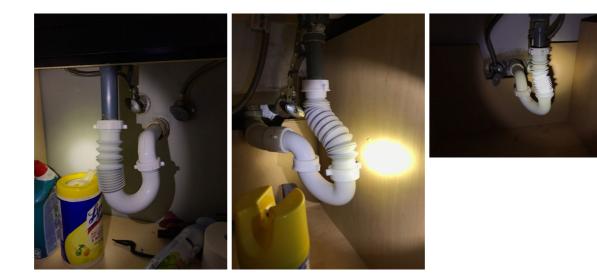
#### **3: Accordion Drains**

Flexible/accordion drain lines have been used in repairs to the plumbing drain/waste lines. These are generally indicate amateur work and are prone to drain line restrictions, especially at kitchen sinks (trap grease): replacing with smooth interior pipe is recommended.
