## PROPERTY INSPECTION REPORT

Prepared For: Paul Varello  
(Name of Client)

Concerning: 22 Hepplewhite Way, Spring, TX 77382  
(Address or Other Identification of Inspected Property)

By: Dennis Inman, Lic #20664 05/17/2021  
(Name and License Number of Inspector) (Date)

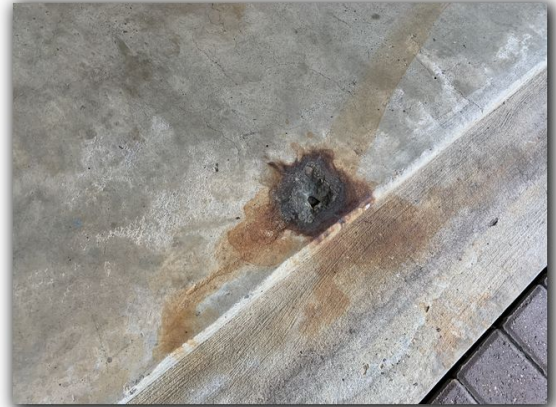
A void / damage was found at the right garage front middle portion of the floor/foundation.

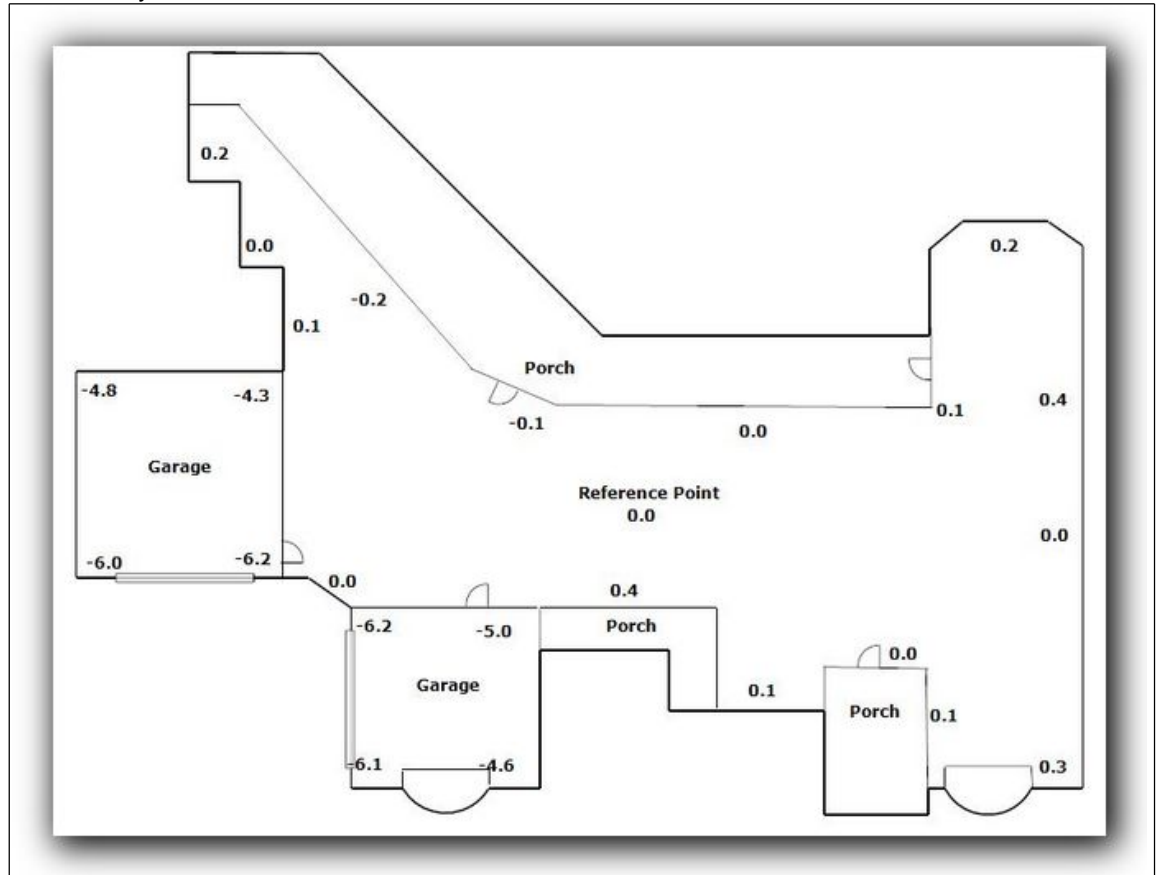
The below graph reflects measurements taken during the inspection to assist with determining the performance of the foundation. The outline / drawing is not to scale and does not accurately reflect every detail of the foundation walls.

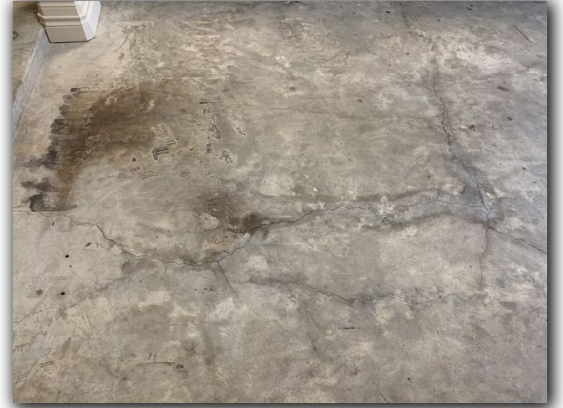
Shrinkage cracks were observed at various visible locations on the foundation / concrete floors. Cracking is a normal property of concrete as it dries and shrinks during the curing process. Additional shrinkage cracks may be present under the floor coverings in the structure.

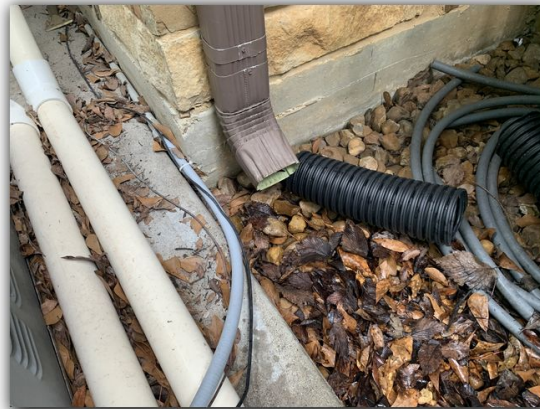
- Splash blocks not installed at the base of gutter downspouts

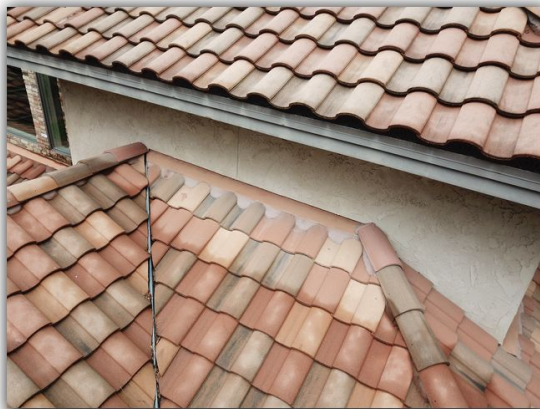
Improper clearance from the roof & veneers is present (recommend 1"). This restricts visibility of underlying flashing.

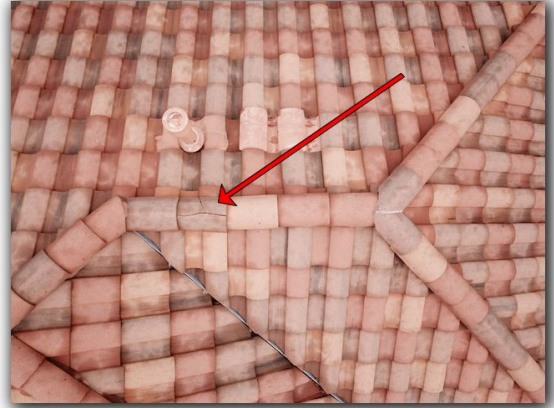
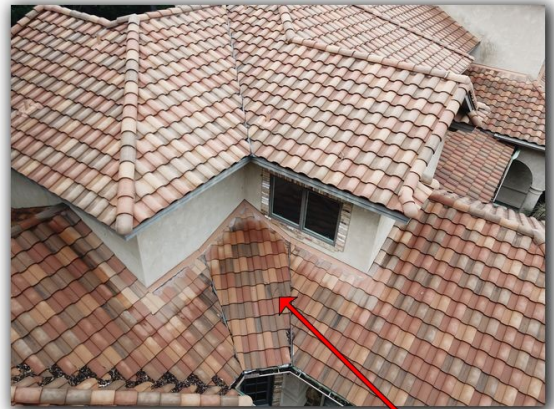
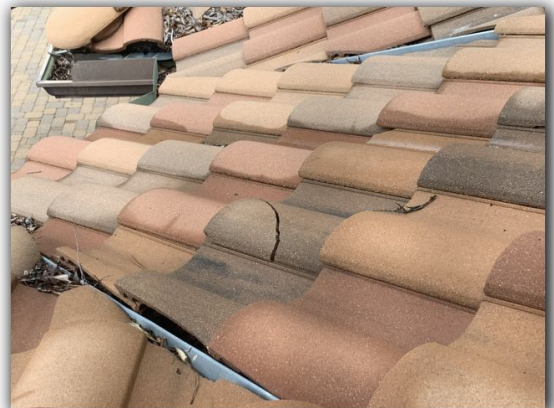
Cracked, damaged, and/or displaced roof tiles were found at multiple areas of the roof. Full evaluation and repair by a qualified roofing contractor is recommended.

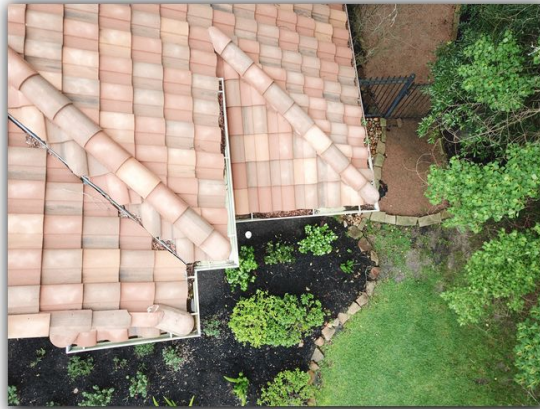
The debris should be cleaned from the gutters to allow proper drainage of rainwater from the roof covering.

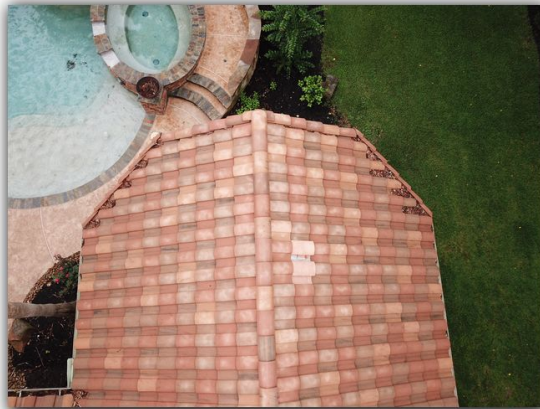
Leaves and other debris were found at sections of the roof covering. Due to the trees around the structure, this will require ongoing maintenance. The buildup of leaves will slow the flow of rainwater from the roof, making the roof vulnerable to water penetrations. Recommend removal of the debris on the roof covering.

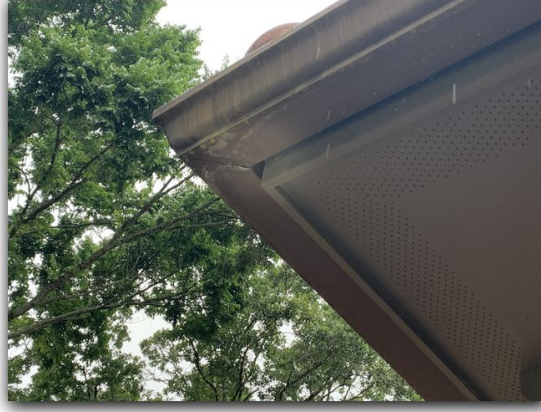
Leaky gutters were found around the perimeter of the roof covering. The leaks should be repaired along with any damage caused by the leaks. The qualified tradesman should also verify that the slope of the gutters is correct.

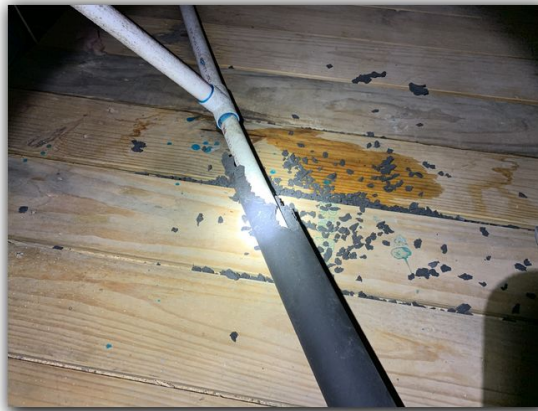
Evidence of rodent activity was noted in the attic as evident by nesting materials, holes, etc.

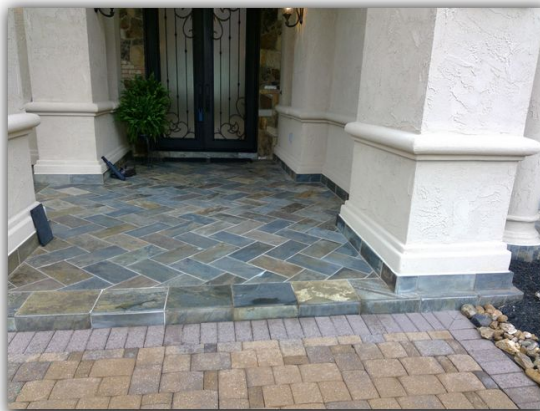
- Improper clearance of the exterior veneers from flatwork (2").

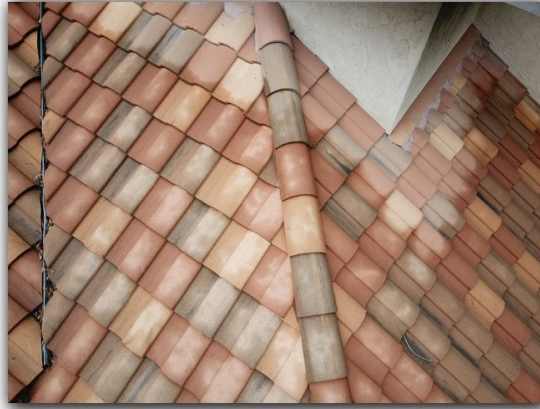
- Improper clearance of the exterior veneer from the roof.

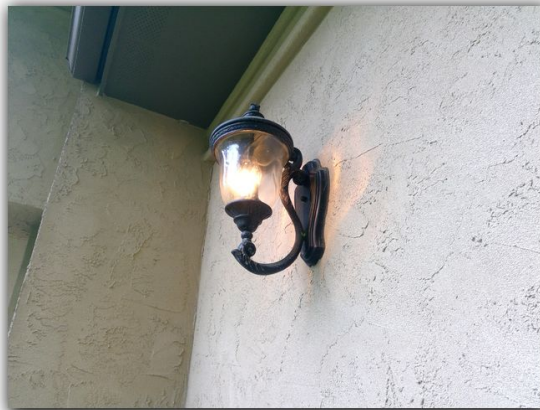
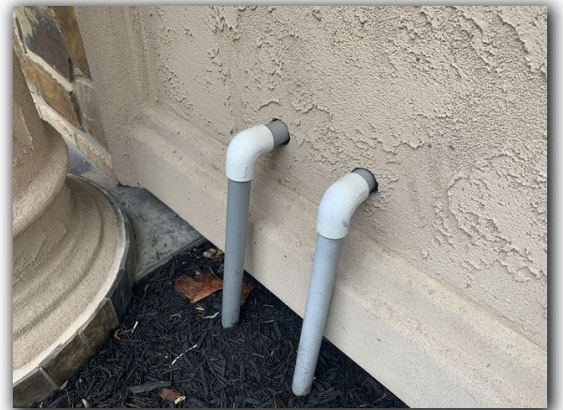
Damaged and missing sealant was found at wall penetrations. All penetrations into a stucco wall should be sealed and maintained regularly.

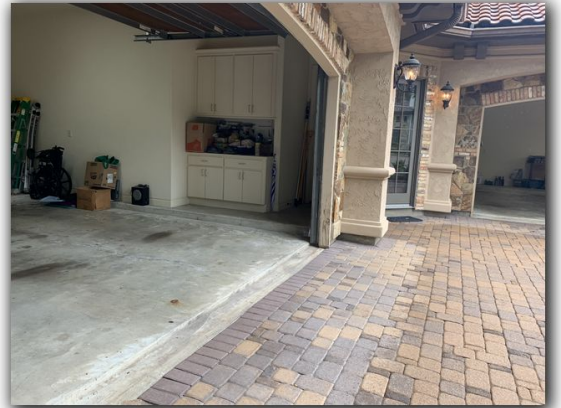
Flaking / damaged coatings were found at the garage overhead door jambs.

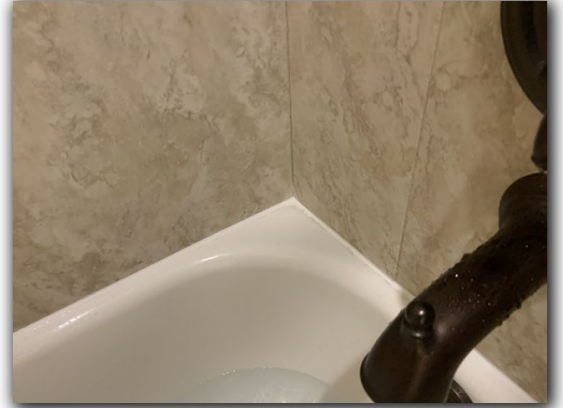
Damaged and missing grout/caulking was noted in the front left guest bathroom shower/bathtub enclosure.

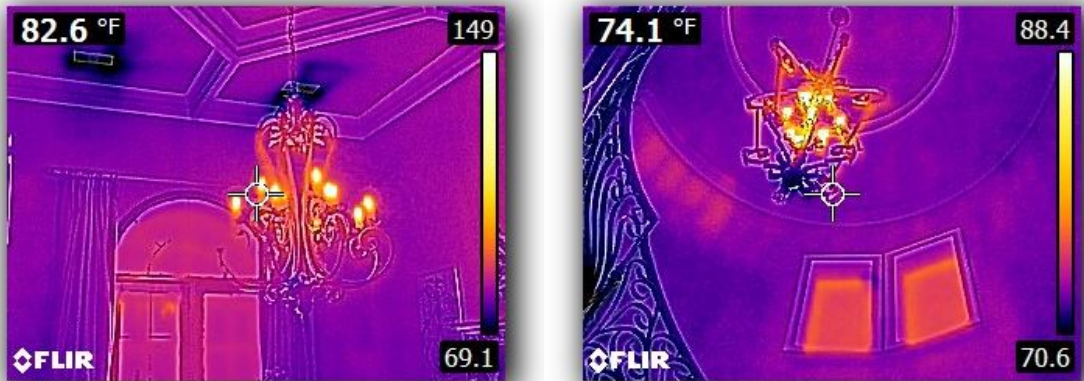
During the inspection of the walls on the interior of the structure with an infrared camera abnormalities were not noted. The picture(s) below are a sampling of some image(s) taken during the inspection.

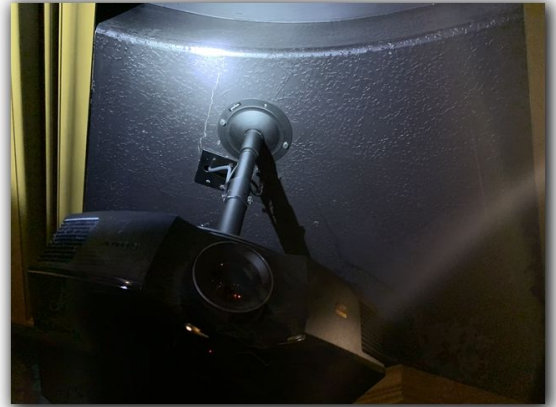
Cracking was noted on the interior ceiling of the property as evidence of settlement.

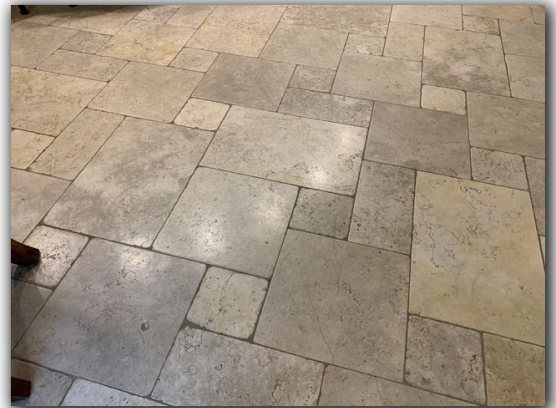
Cracked floor tiles were found in the breakfast room, kitchen, first floor left bedroom hallway, first floor guest bathroom., master bedroom hallway

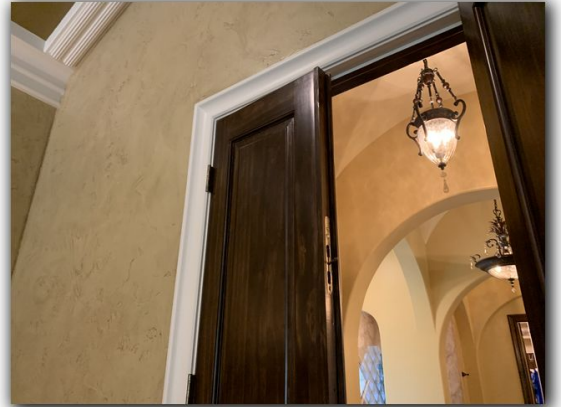
All doors at the property should be adjusted to operate properly.

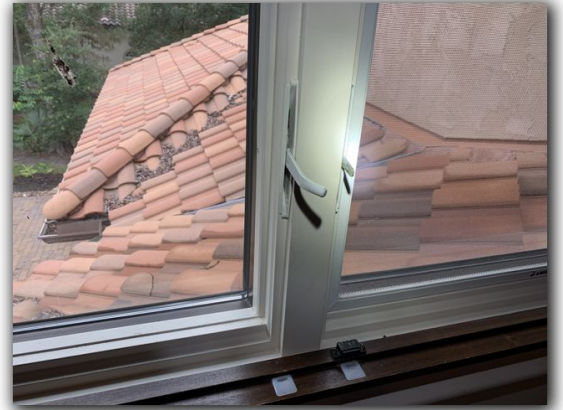
Windows in the front left guest bedroom did not easily lock and missing lock handle hardware were noted. Repair is recommended.

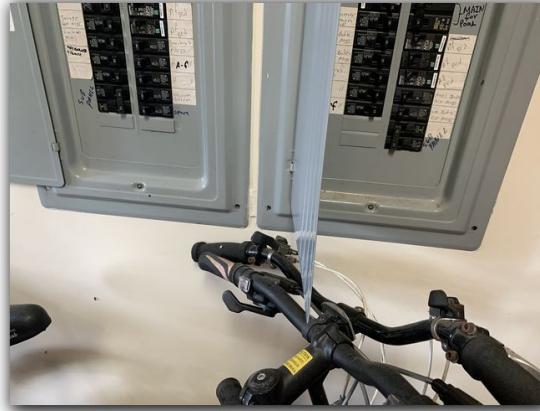
Missing screws were found at the dead front cover located at the main service panel. Approved screws should be installed at the dead front to properly secure the cover.

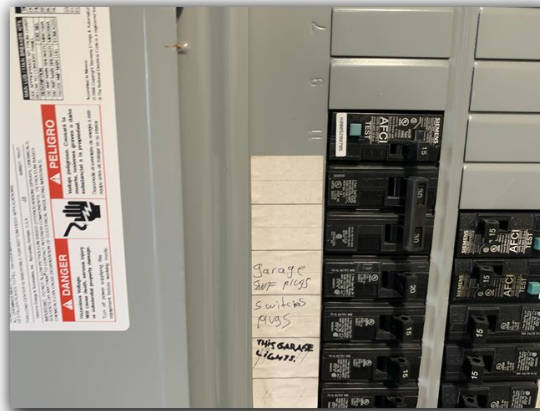
The breakers within the panel boards have not been completely labeled. All circuits should be properly labeled.

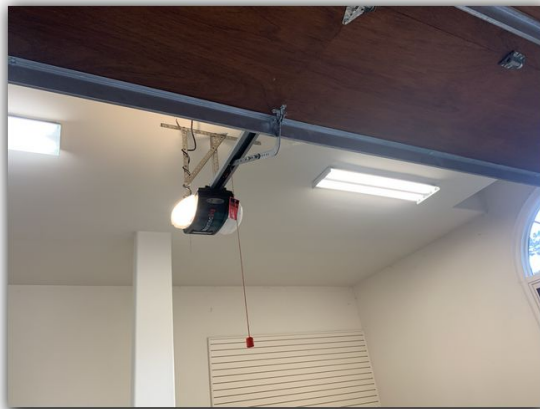
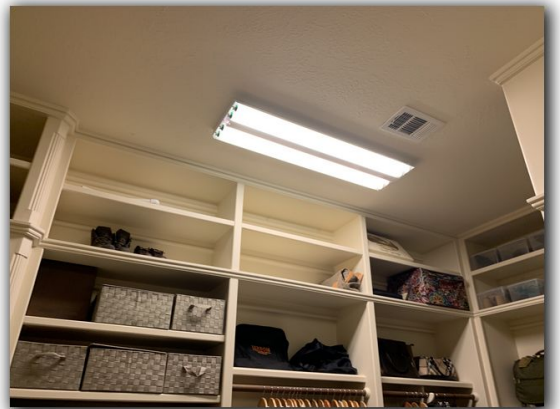
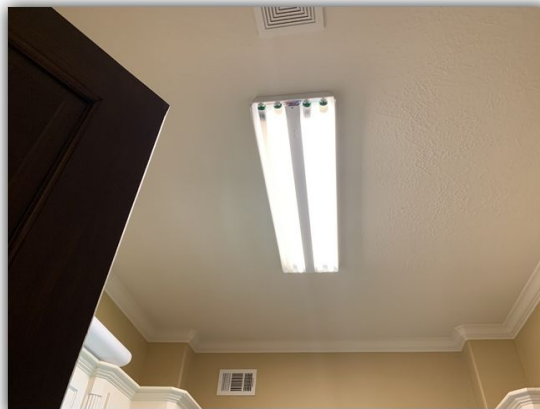
Missing fixture covers were noted in the right garage, master bathroom closet, laundry room.

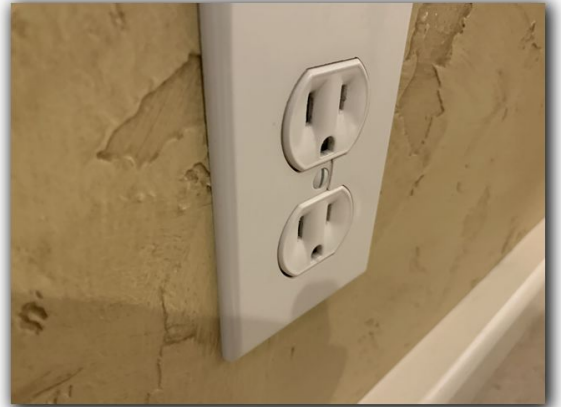
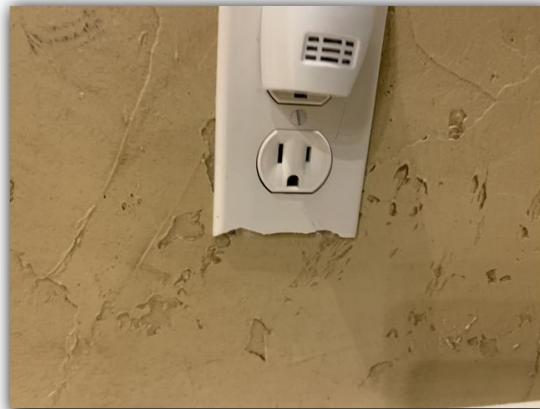
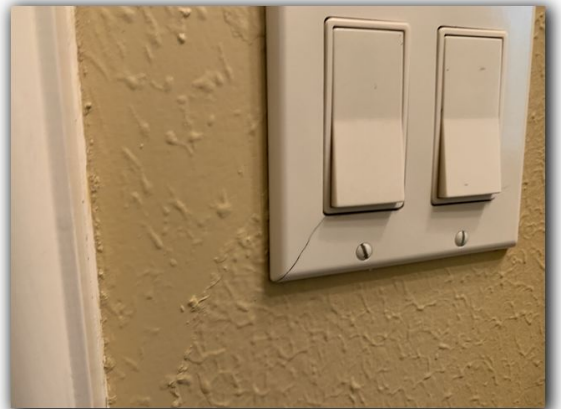
Damaged cover plates were found in many rooms in the home. Recommend replacement of the plates.

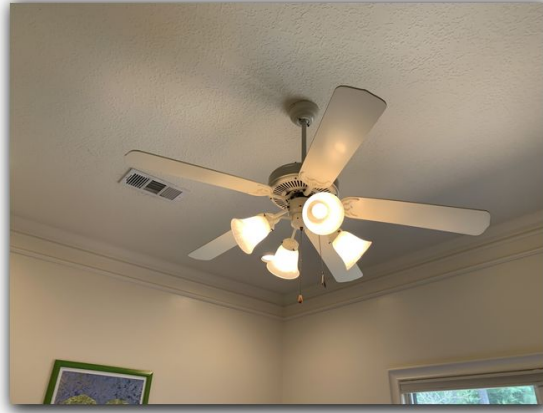
The upstairs rear left guest bedroom ceiling fan did not function during testing.

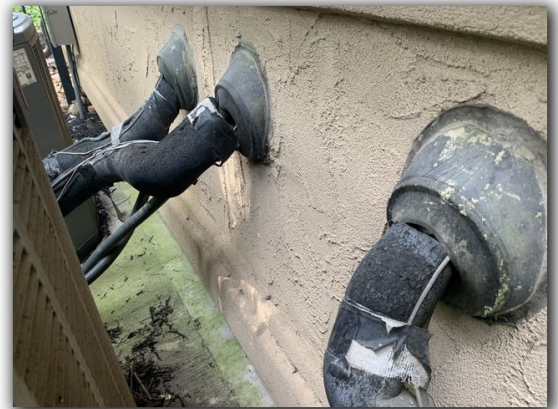
Damaged and missing insulation on the visible portions of the refrigerant lines should be repaired/replaced.

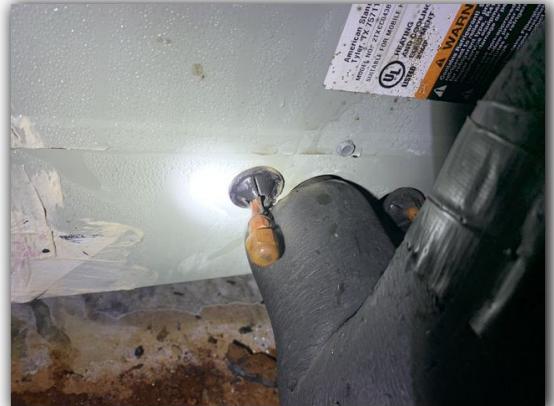
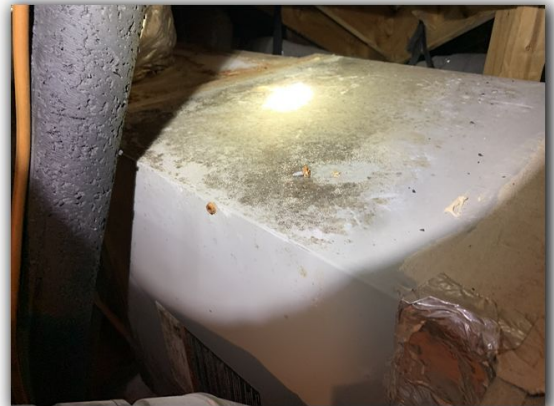
Moisture was observed at the evaporator housing of and/or pan beneath the cooling units in the attic. The moisture appears to be coming from under the evaporator or it could be a result of the refrigerant line not being properly insulated, thus allowing condensation to form on the line and drip into the housing pan. A licensed A/C technician should be consulted to inspect/repair any conditions causing the rust buildup in the pan.

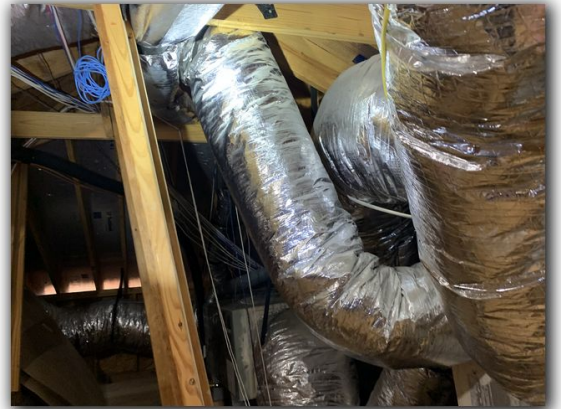
- Bends at ductwork improper

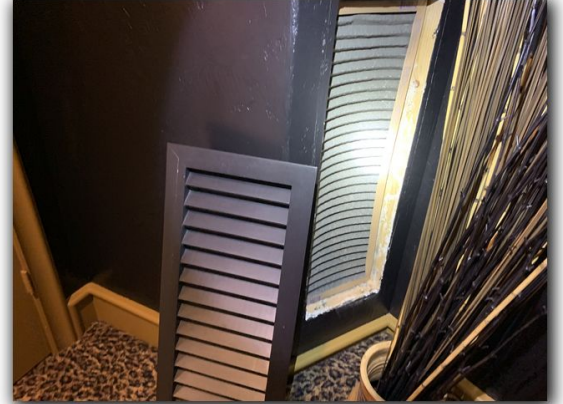
The return air filter(s) is dirty and need(s) to be changed.

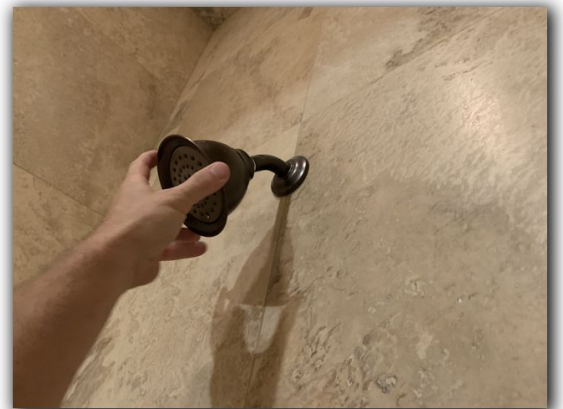
Loose supply piping was found at the shower.

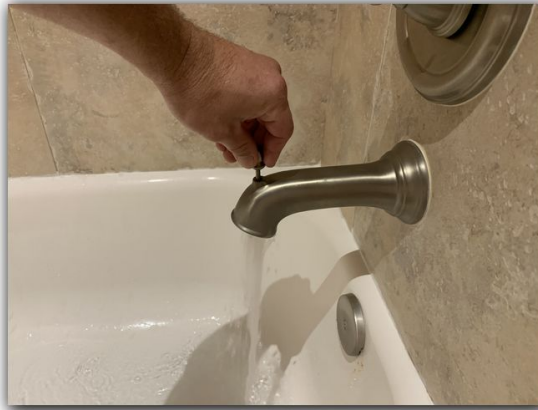
The shower/tub valve is not operating as intended. When the valve is in the shower position, the tub downspout continues to flow water resulting in low water pressure at the shower. Recommend repairs.

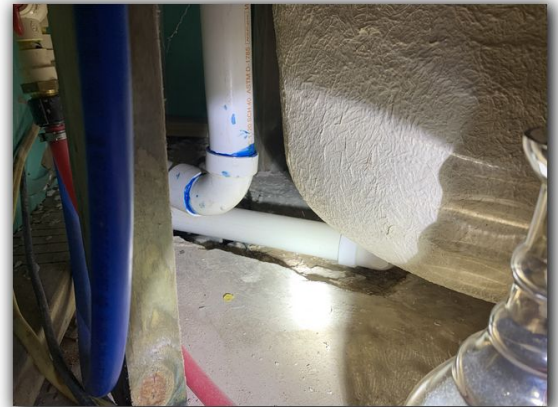
Active leaks were found at the tub. Recommend repairs of the leaks by a licensed plumber and repairs of any damage caused by the leaks.

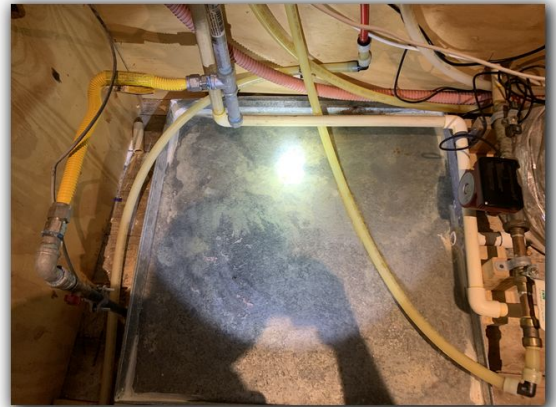
Moisture accumulation was noted at the water heater emergency drain pan. Leaks were found at condensate piping. Repair by a licensed plumber is recommended.

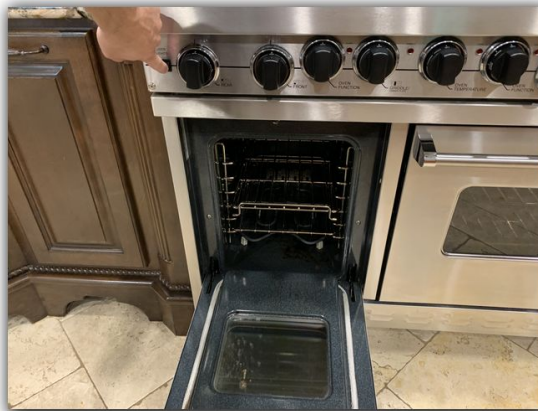
The left oven light is inoperative.

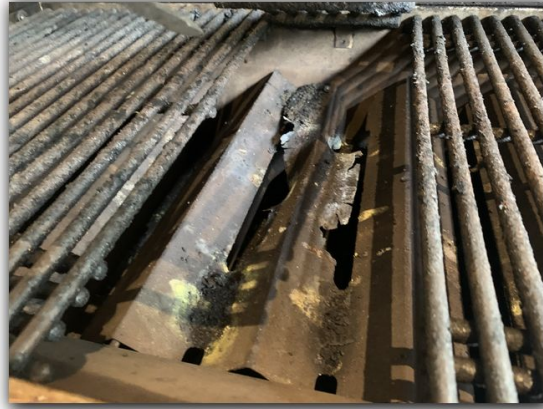
Damage was found at the outdoor grill burner deflectors.

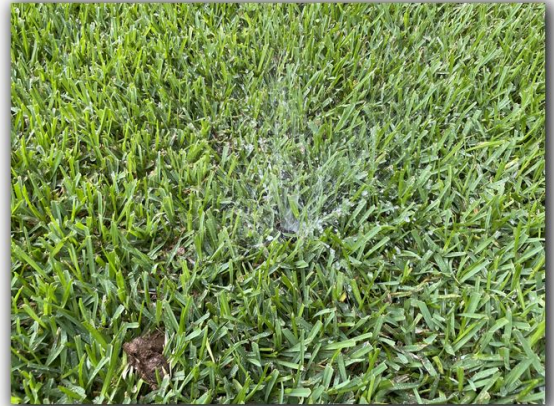
**Heads were found in zone #7,19,20 that need to be raised due to the height of the grass and other vegetation. This problem is preventing the heads from properly watering the designated area.**

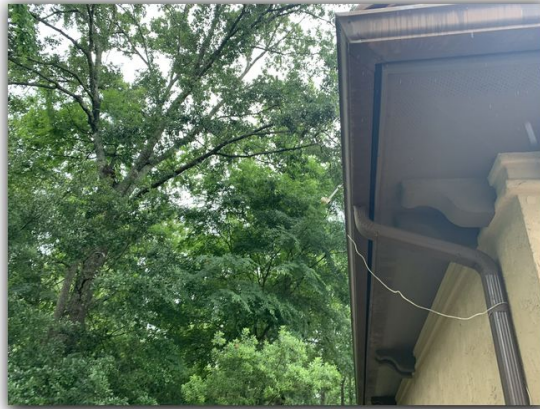
The rain sensor is loose on the Left Side of Property of the property. Recommend re-securing.

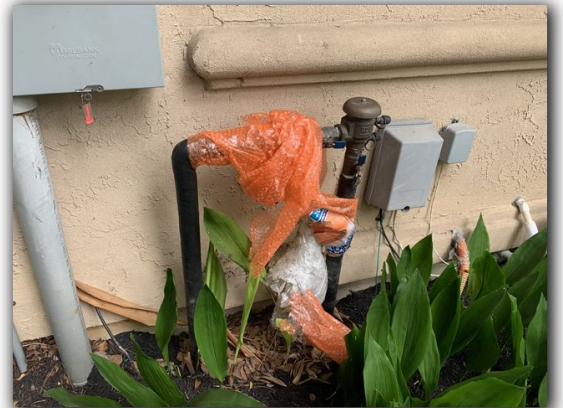
Rust and corrosion were found at the valve handles installed at the backflow prevention device. The valve handles should be repaired as the rust will eventually cause the handles to become inoperative.

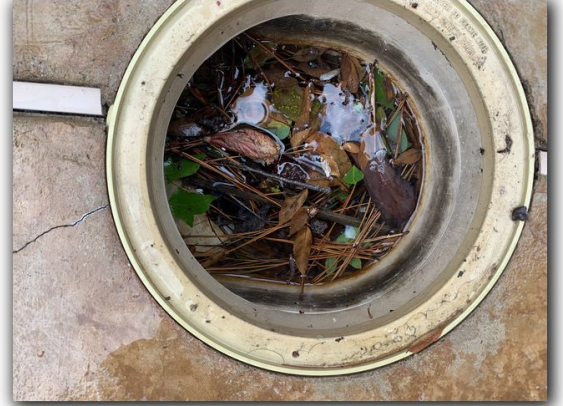
The pool baskets should be cleaned of debris.

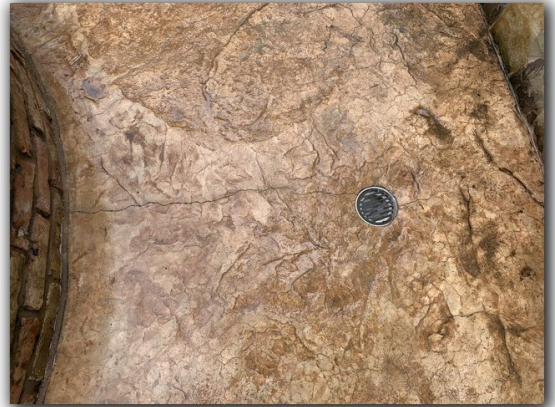
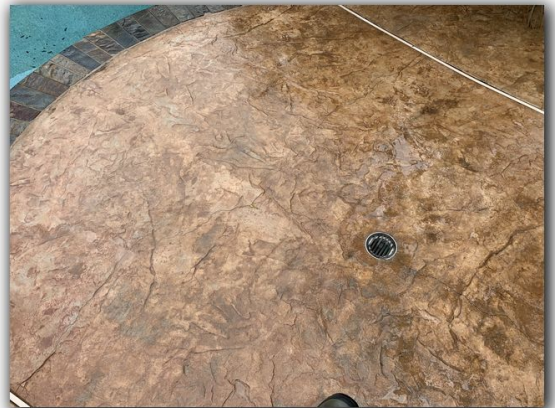
Damaged/cracked decking was found at multiple portions of the pool perimeter.

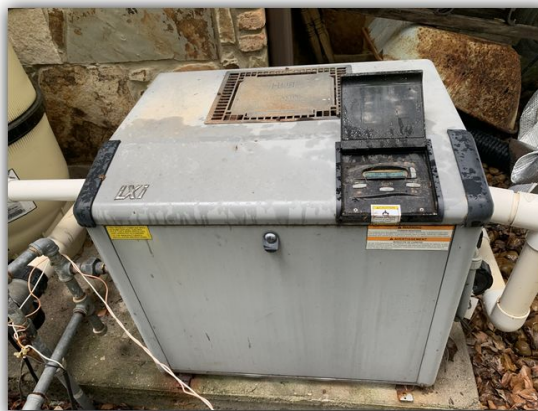
The gas heater is not functioning for the pool / spa. Recommend further investigation and repairs.

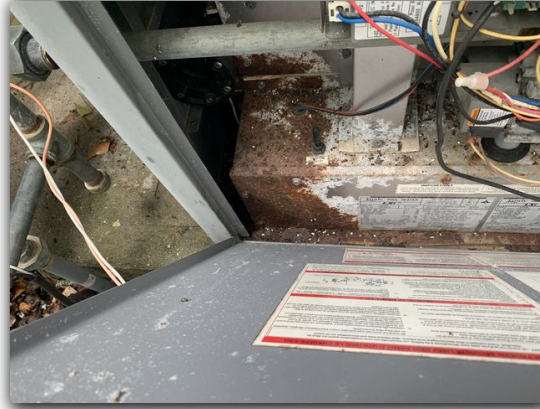
During the inspection of the pool/spa heater, rust buildup was observed at the burner compartment. A qualified tradesman should be consulted to clean and repair the heater.

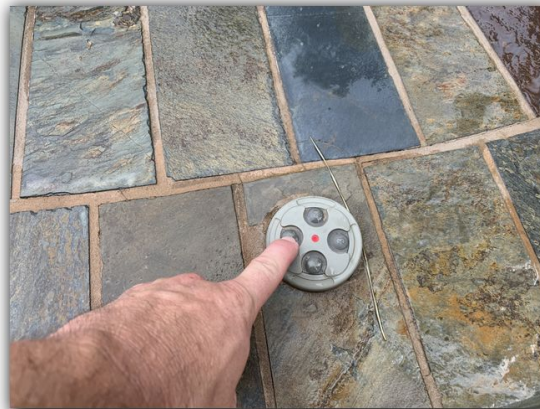
The spa-side control panel did not operate the spa blower during testing.

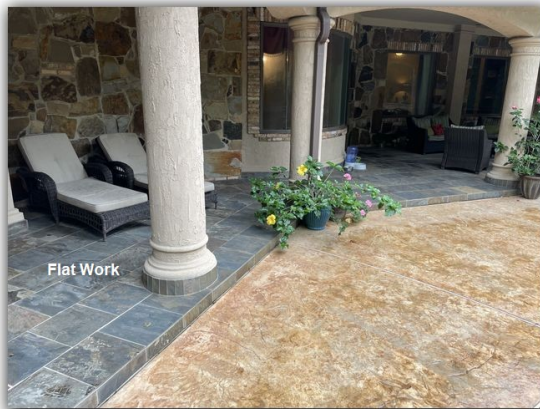
Inaccessible Areas Present: The foundation walls are not visible on porches in the front and back of the structure
