Invasive Stucco Inspection

Paul Varello
22 Hepplewhite Way
Spring, TX 77382

May 18, 2021

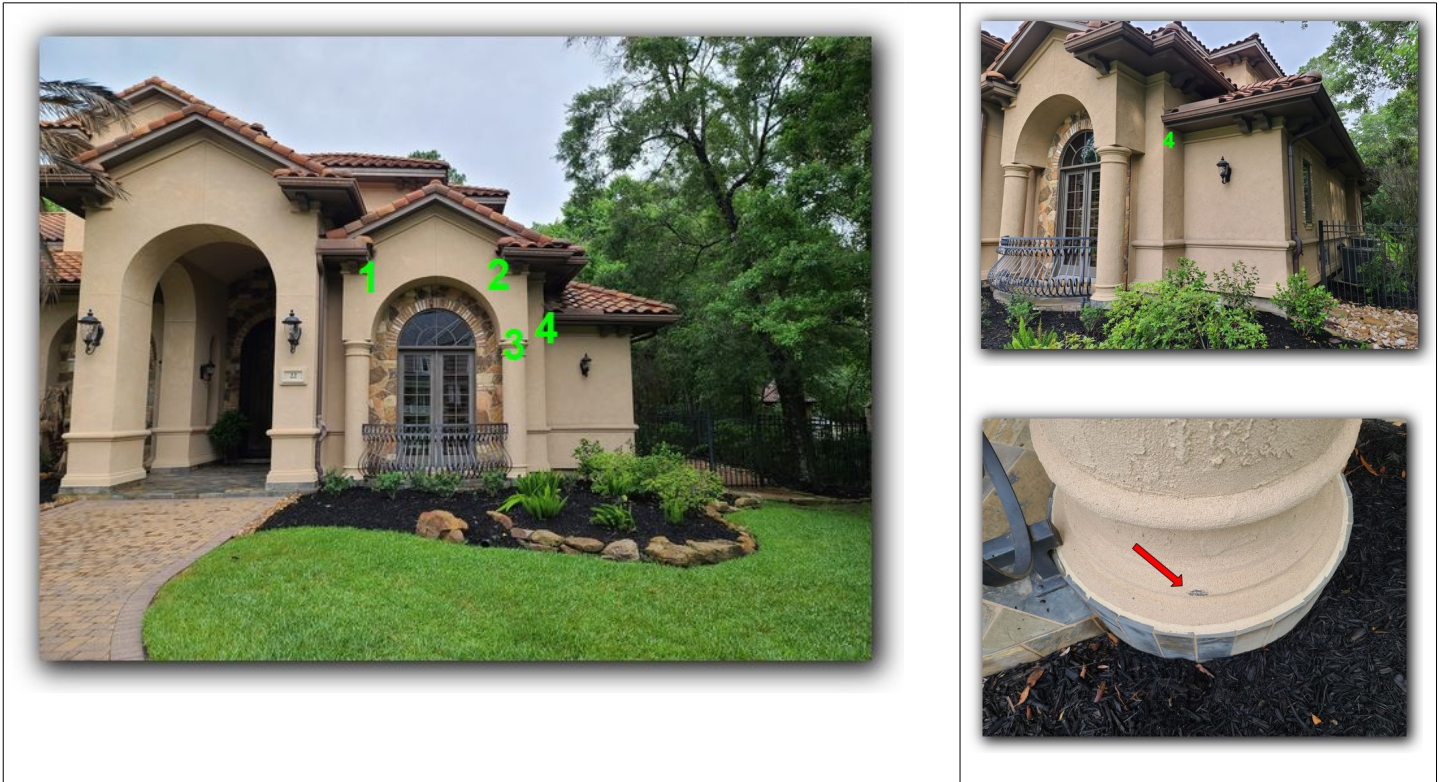
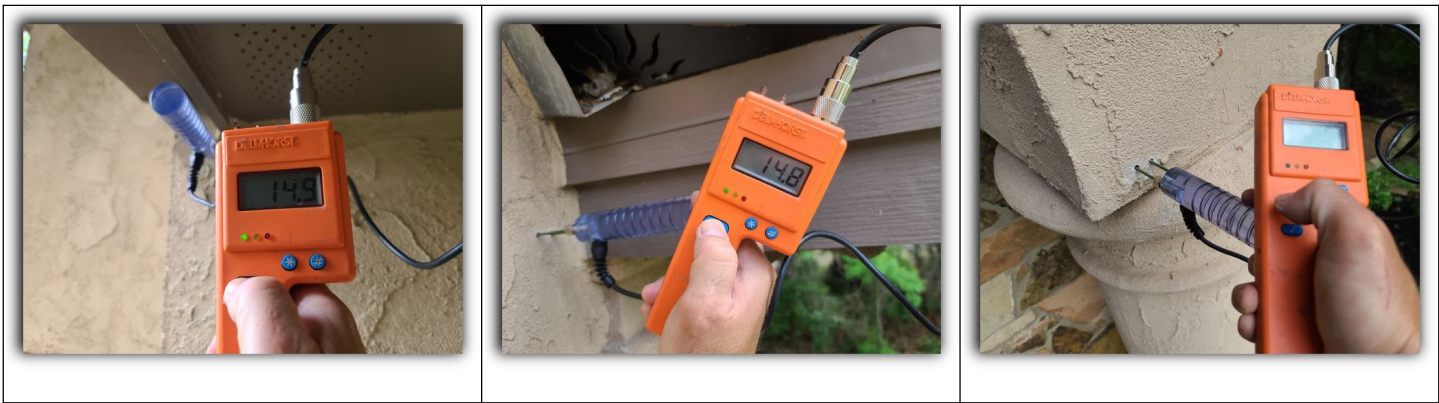
Front Elevation 1

Location	Moisture Reading	Substrate Condition	Observations / Comments
1 - 4	Low	Firm	
Red Arrow	n/a	n/a	Damaged EIFS Band

Recommend repairs of the EIFS by a contractor.

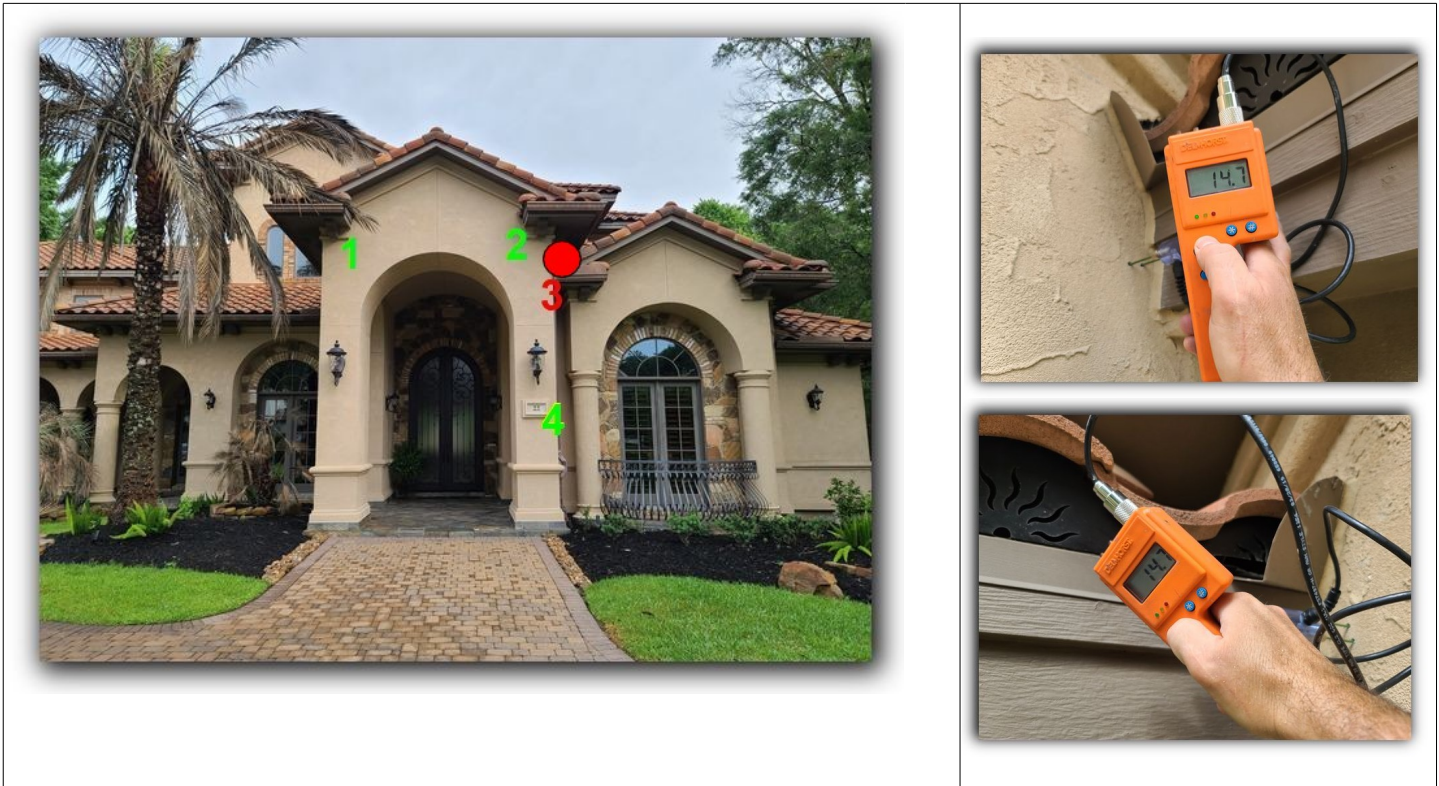
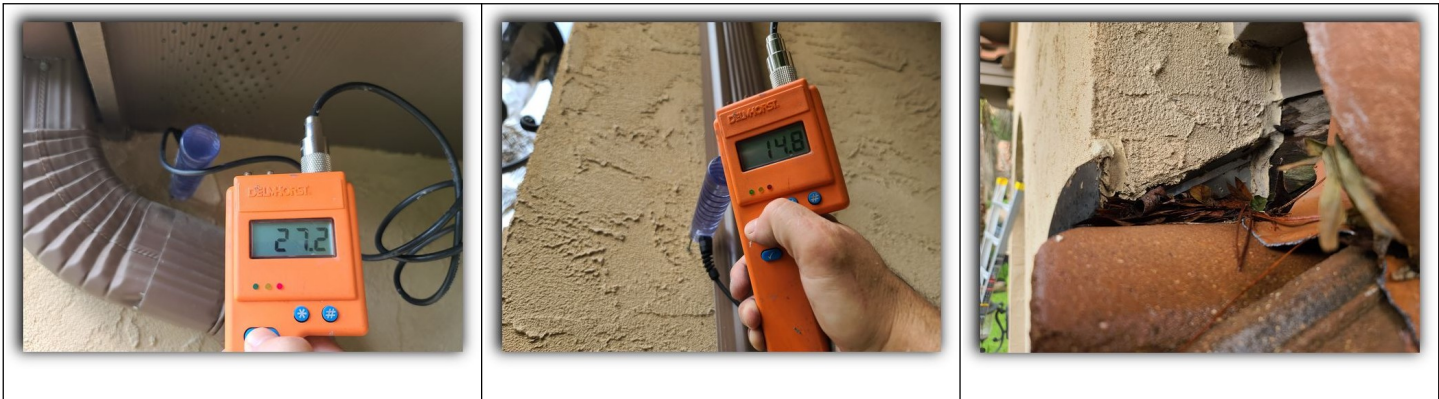
Front Elevation 2

Location	Moisture Reading	Substrate Condition	Observations / Comments
1 - 2	Low	Firm	
3	High	Firm	Below Kickout
4	Low	Firm	Mid Wall below Kickout
Red Dot	n/a	n/a	Debris built up at the wall intersection, improve

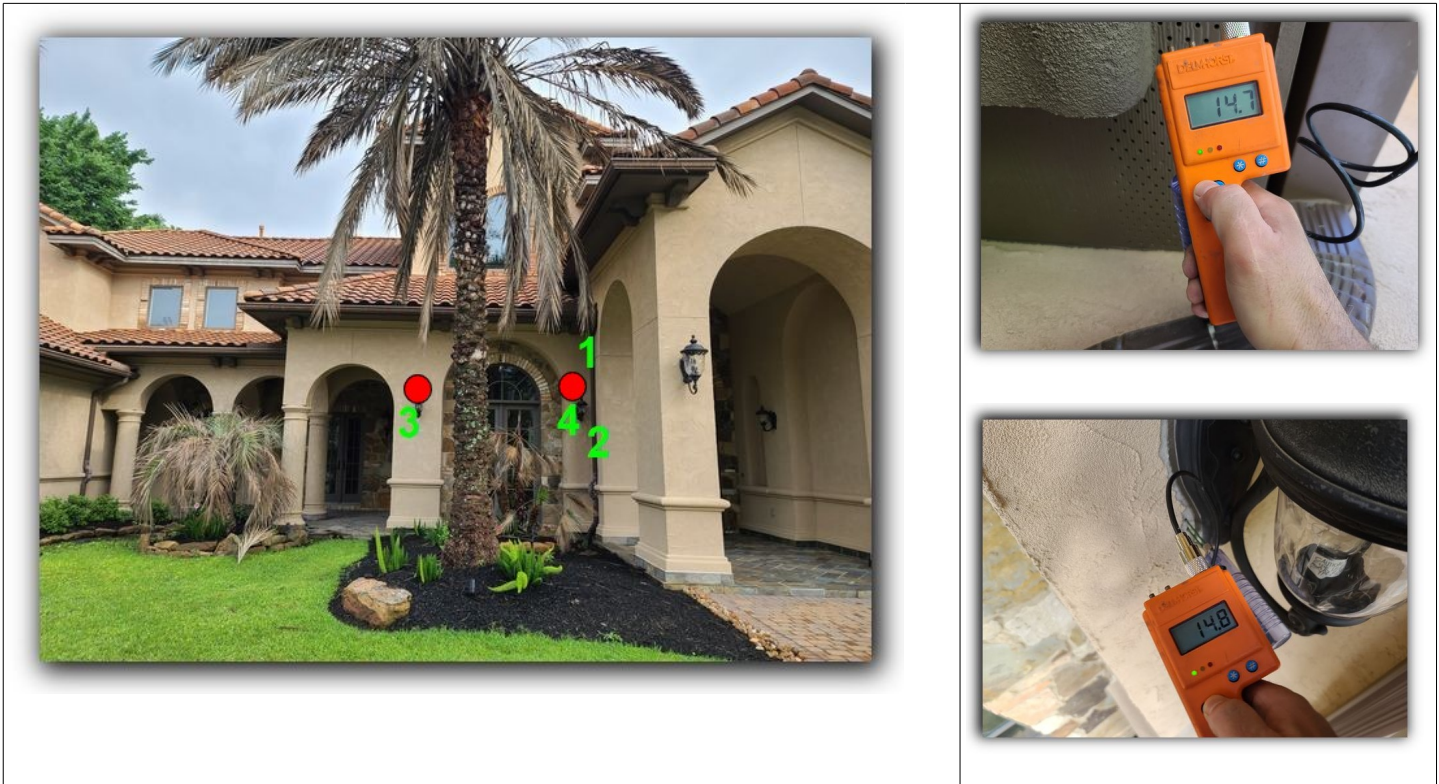
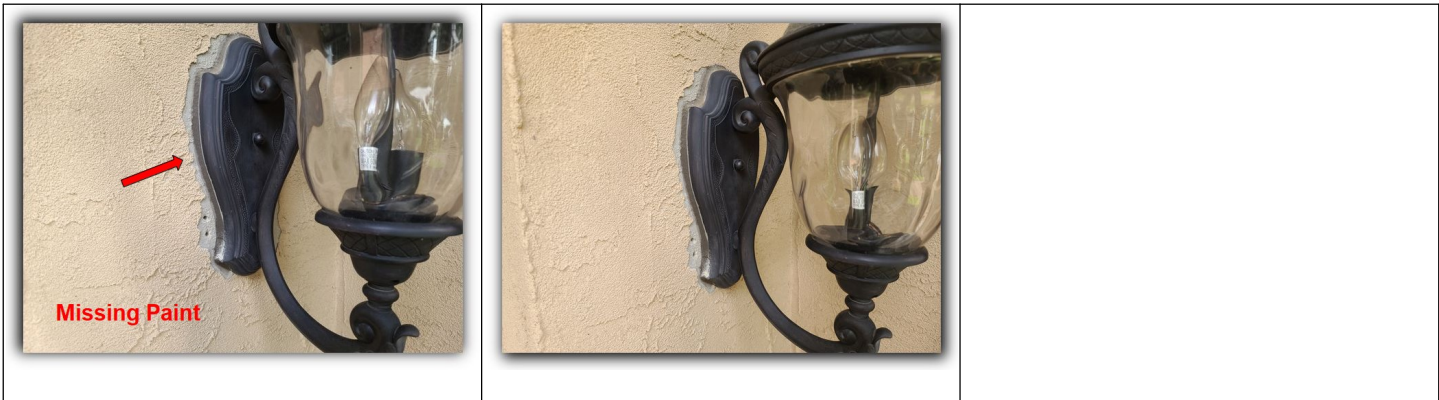
Front Elevation 3

Location	Moisture Reading	Substrate Condition	Observations / Comments
1-2	Low	Firm	Below Kickout
3 - 4	Low	Firm	Light Fixtures
Red Dots	n/a	n/a	Paint / Coating Chipped away at light fixtures / wall

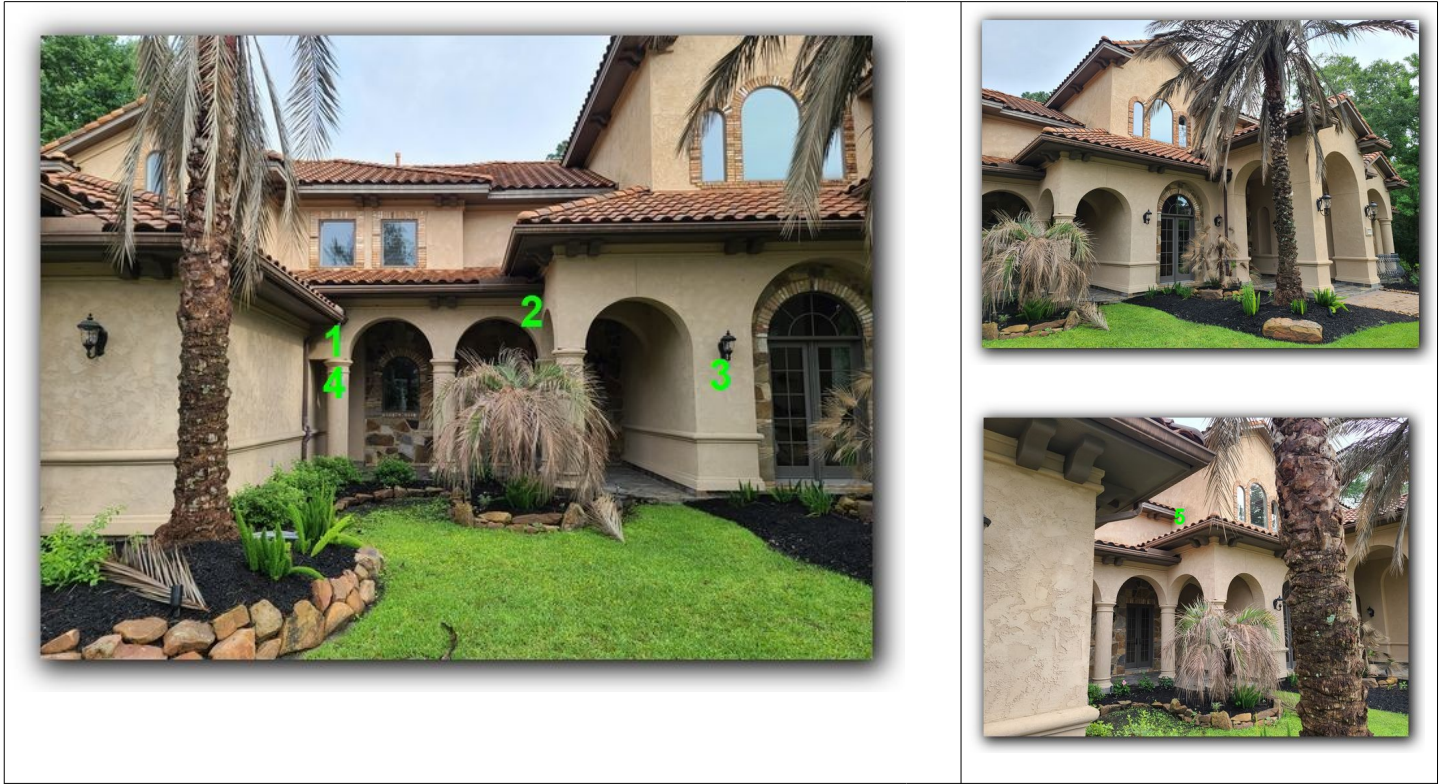
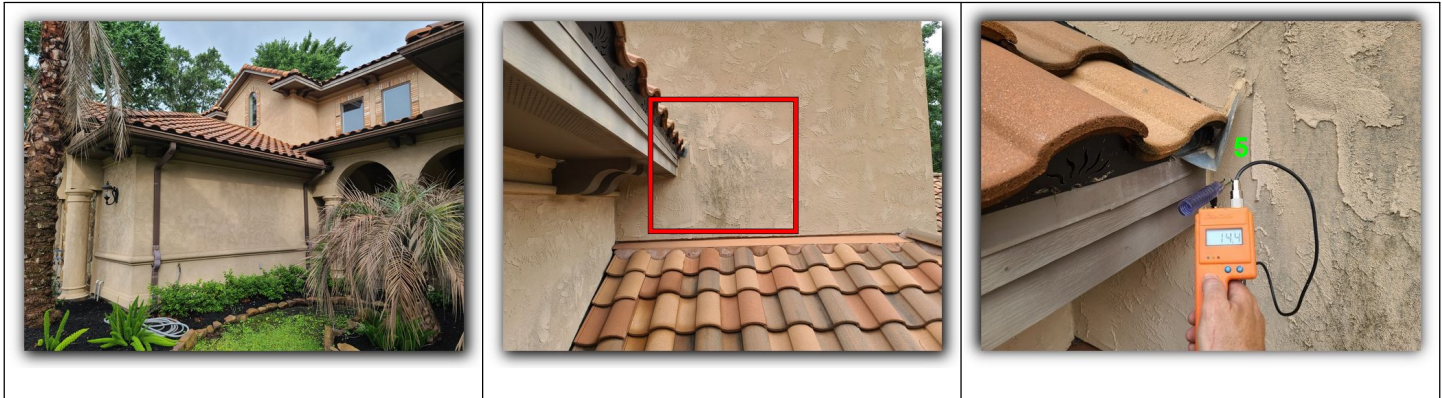
Front Elevation 4

Location	Moisture Reading	Substrate Condition	Observations / Comments
1 - 5	Low	Firm	
Red Box	Low	Firm	Discoloration on surface of wall

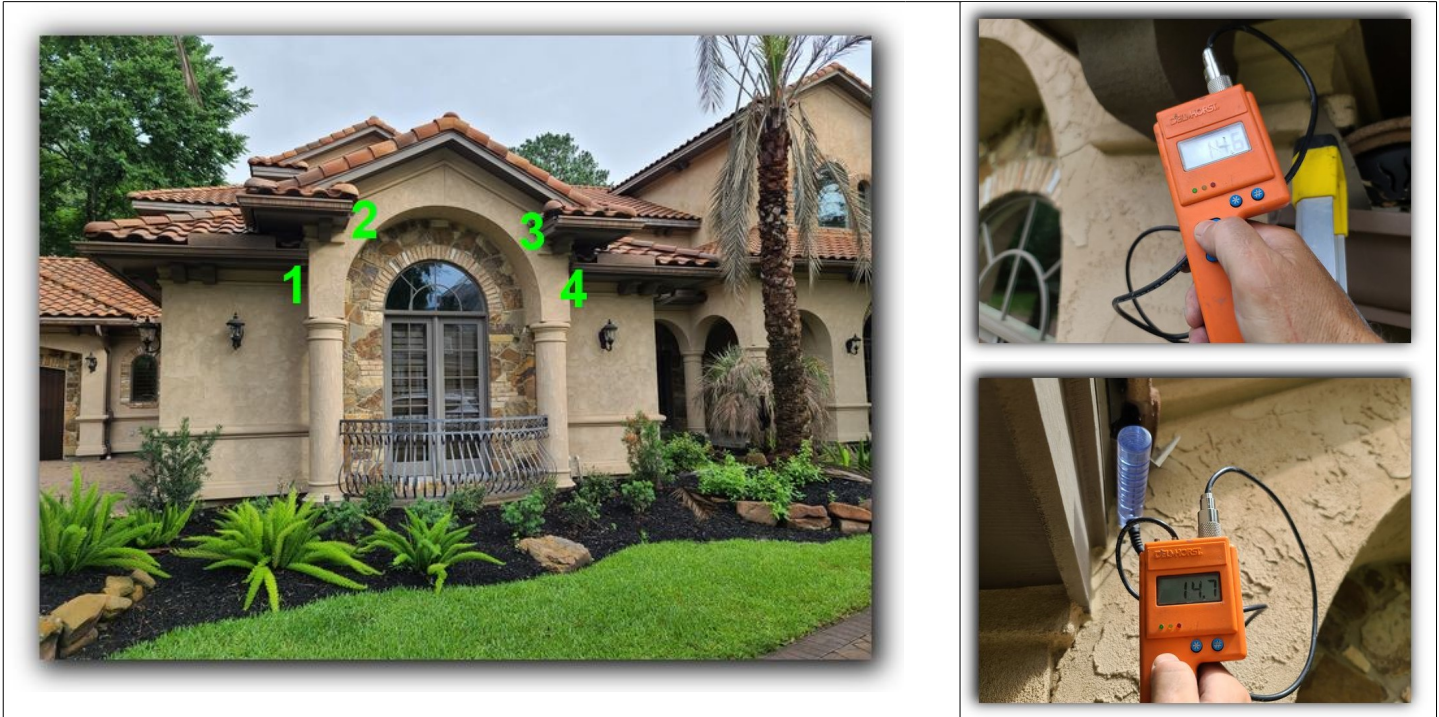
Front Elevation 5

Location	Moisture Reading	Substrate Condition	Observations / Comments
1 - 4	Low	Firm	Below Kickout Flashings

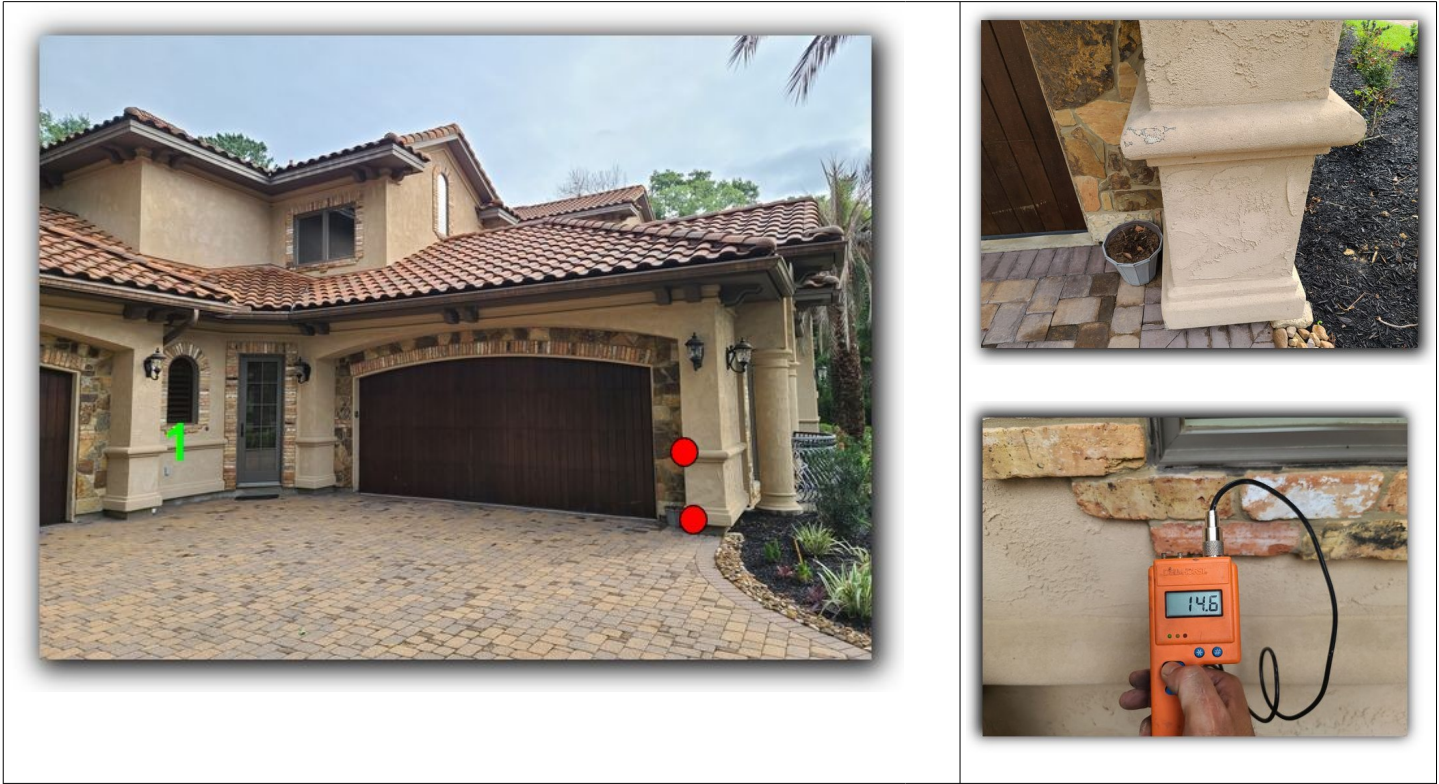
Garage Elevation 1

Location	Moisture Reading	Substrate Condition	Observations / Comments
1	Low	Firm	
Red Dot	n/a	n/a	Damaged EIFS

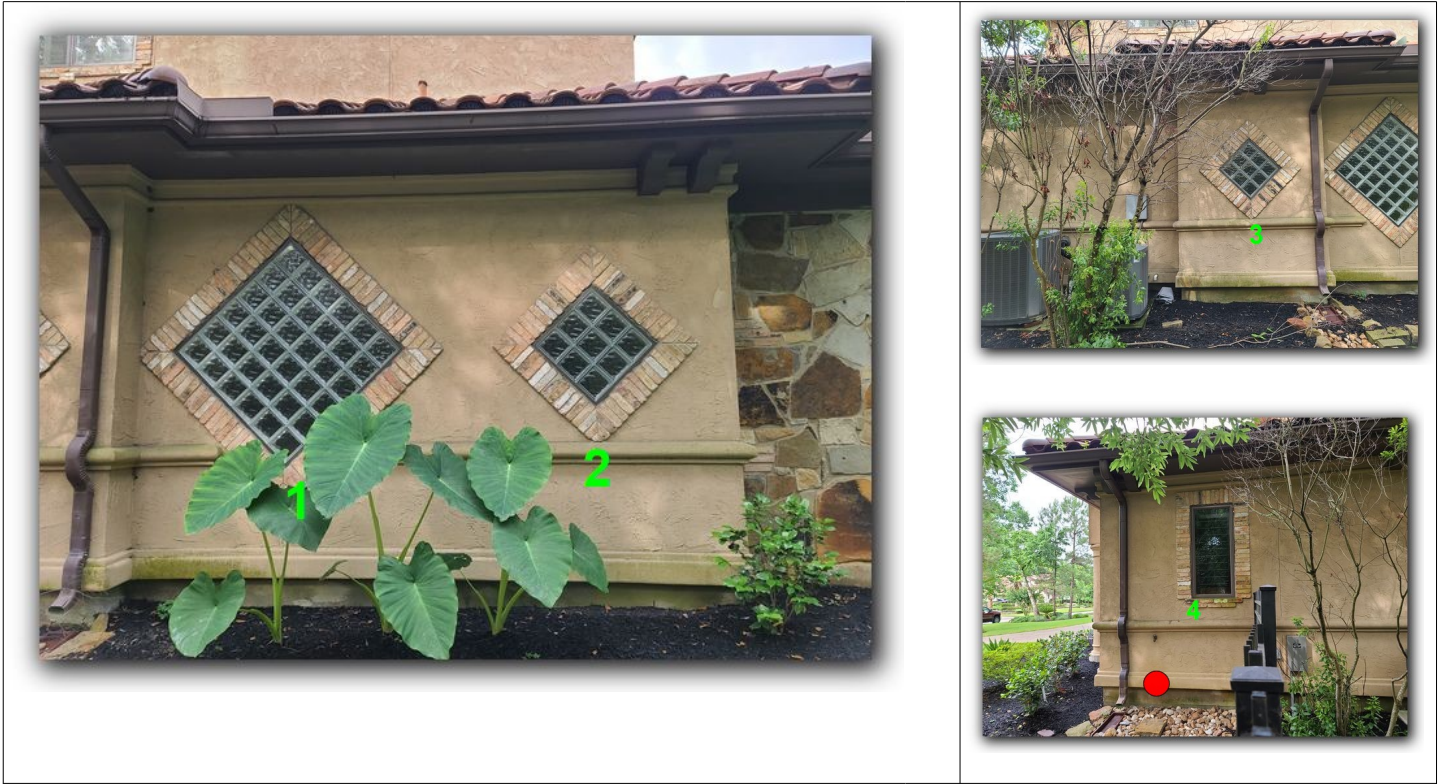
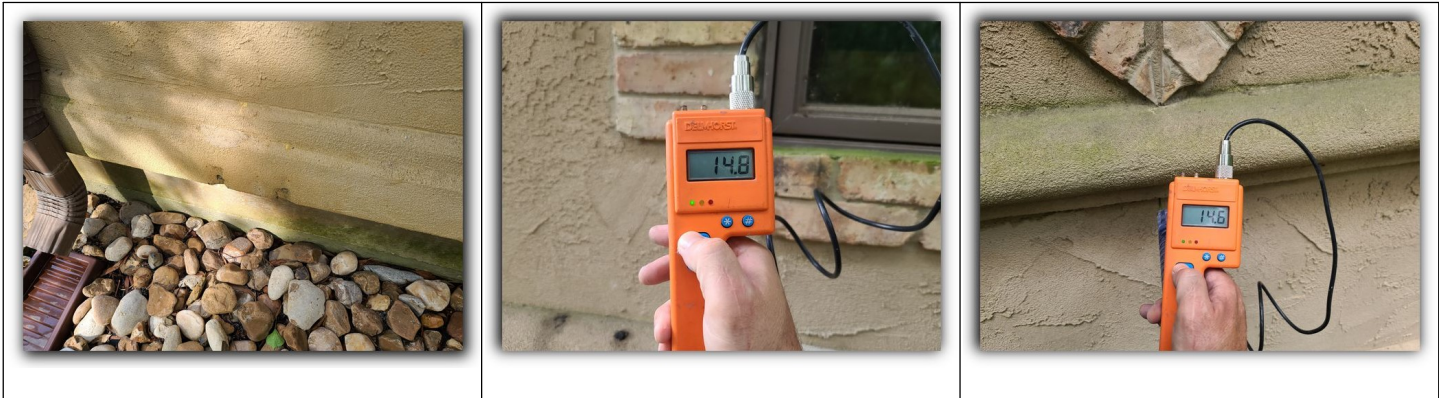
Right Elevation 1

Location	Moisture Reading	Substrate Condition	Observations / Comments
1 - 4	Low	Firm	
Red Dot	n/a	n/a	Damaged EIFS

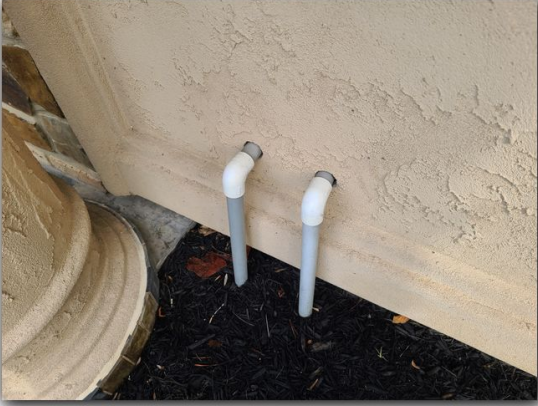
1.1

1. Damaged, missing, and improperly installed sealants were found at the openings in the stucco veneers. It is recommended that a qualified waterproofing contractor be consulted to seal all doors, windows, and penetrations as needed to reduce the likelihood of water penetrations. It is recommended that an approved sealant be applied, i.e. elastomeric, NP1, etc. using approved methods / tools.

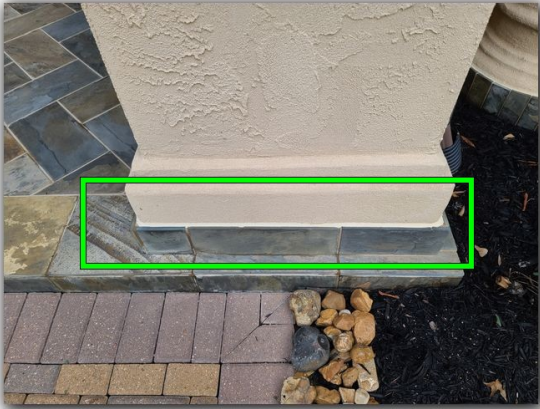
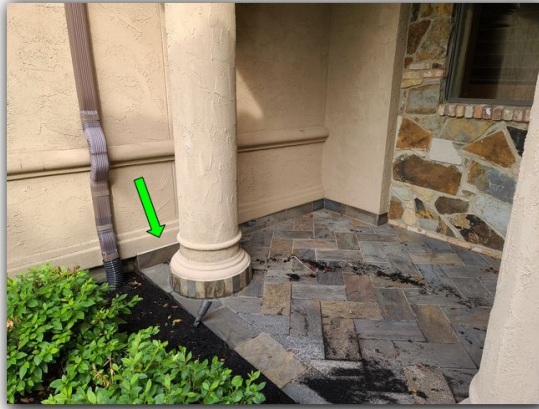
Cant beads were present at wall and flatwork intersections. These should be maintained.

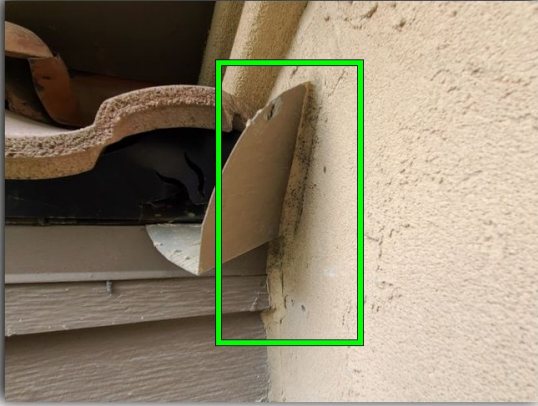
Sealant was present at the visible kickout / diverter flashings. The sealant should be maintained.
