PROPERTY INSPECTION REPORT

Concerning: 23846 Beaverwood Dr. Spring, TX 77373
(Address or Other Identification of Inspected Property):

By: Giovanni Angel, 22909 12/13/2021
(Name and License Number of Inspector) (Date)

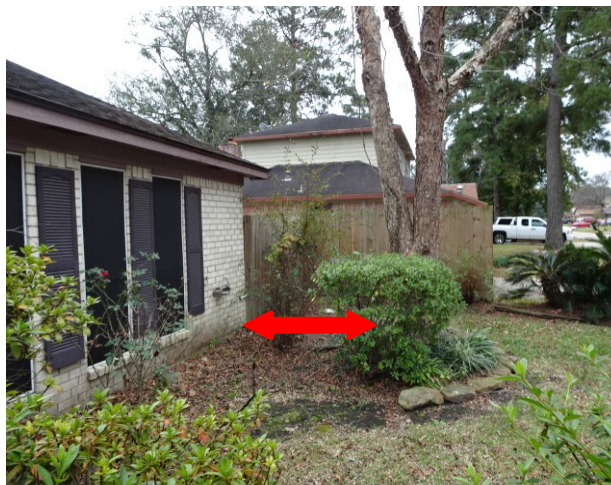
- Corner pops (spalling) on at least one corner. Note: This usually is caused by thermal expansion of the brick wall and a typical tight connection connecting the brick and concrete surface. The brick will expand in the hot weather and will put forth a force adequate to shear the corner from the foundation. This is quite common and is not to be considered a structural defect. Recommend to properly seal gaps to avoid any further damage and deter the possible entrance of termite or other bugs

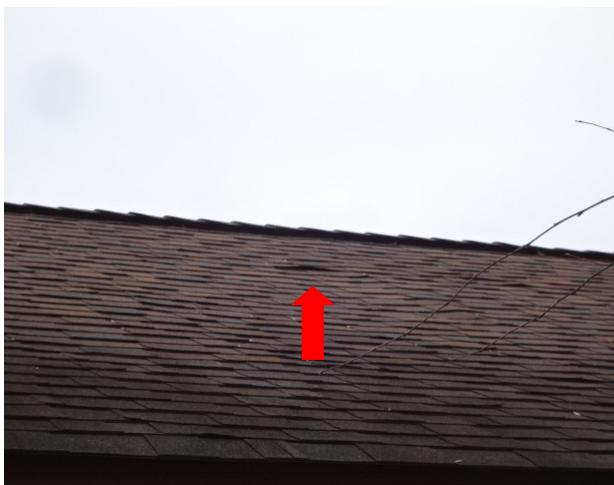
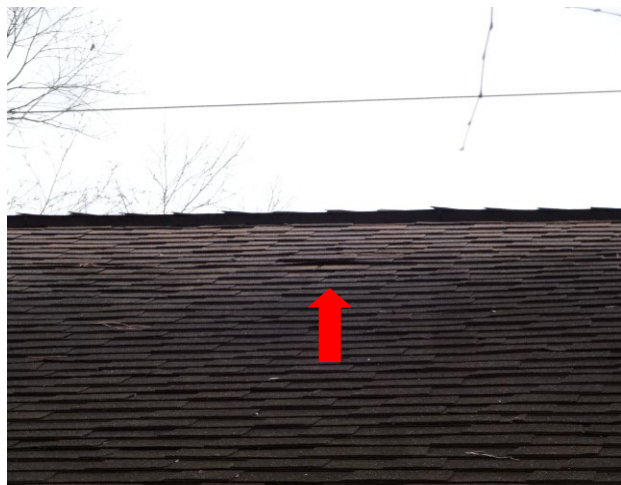
- Slightly lifting shingles on the front side of the roof. Properly repair to avoid further deterioration and possible water intrusion.

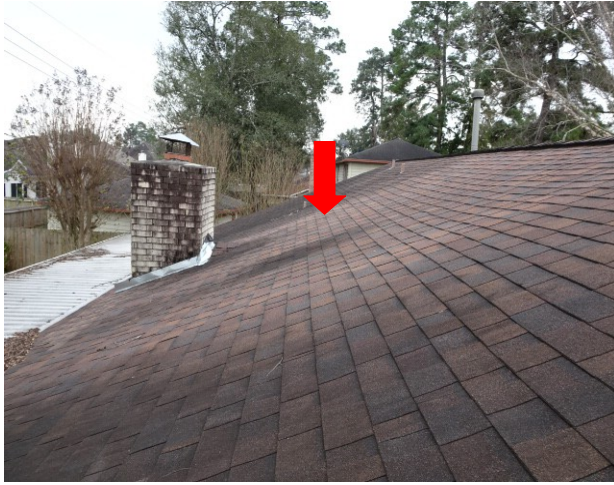
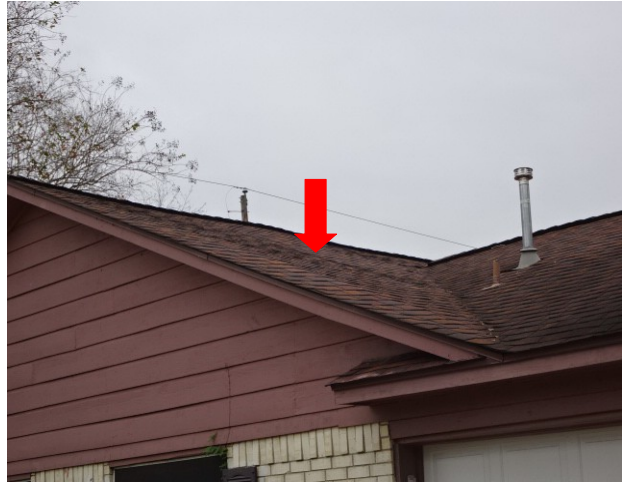
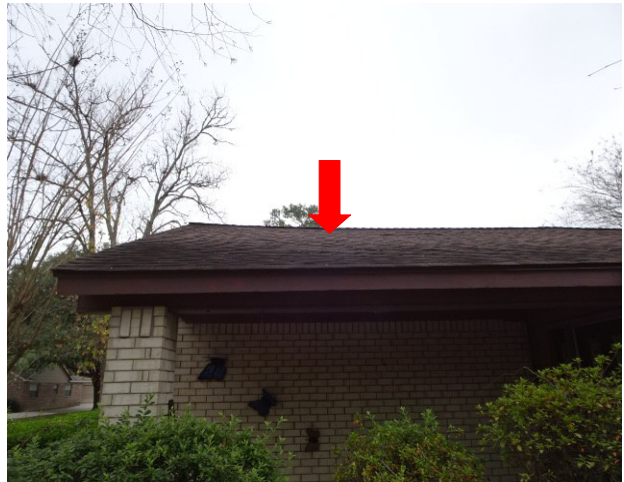
- Sags/depressions on multiple sides of the roof. This may be associated with structural movement. Recommend further evaluation and proper repair as needed by qualified contractor(s).

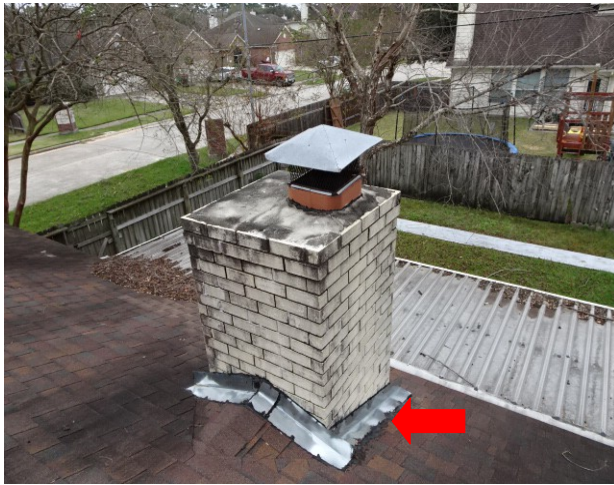
- Improperly installed chimney flashing. Repair by a qualified roofing contractor to prevent premature deterioration and possible water intrusion.

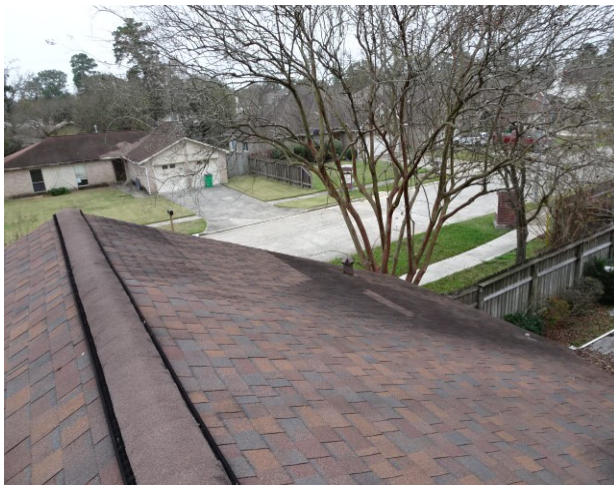
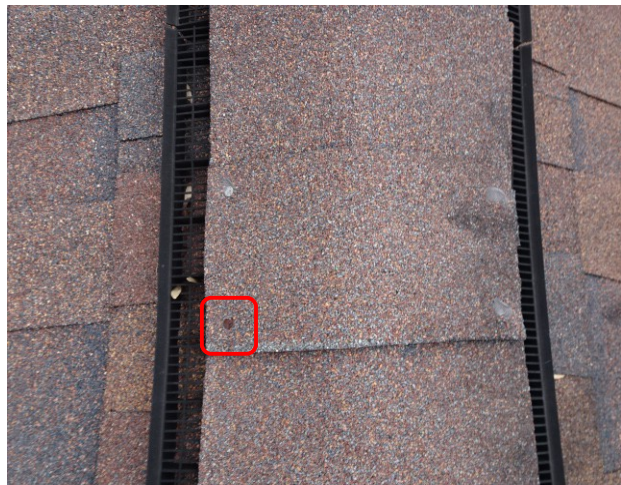
- Evidence of repair on the rear side of the roof. Further investigate root cause as needed.
- Noticed exposed nails on roof ridges. **Note:** All exposed nails should be covered with roof caulking to prevent corrosion and possible water infiltration

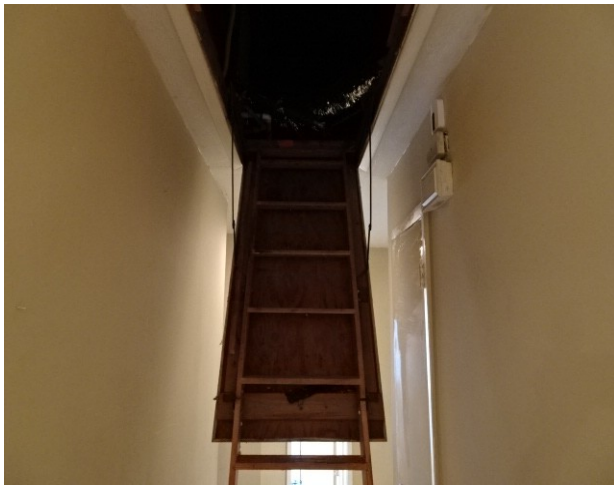
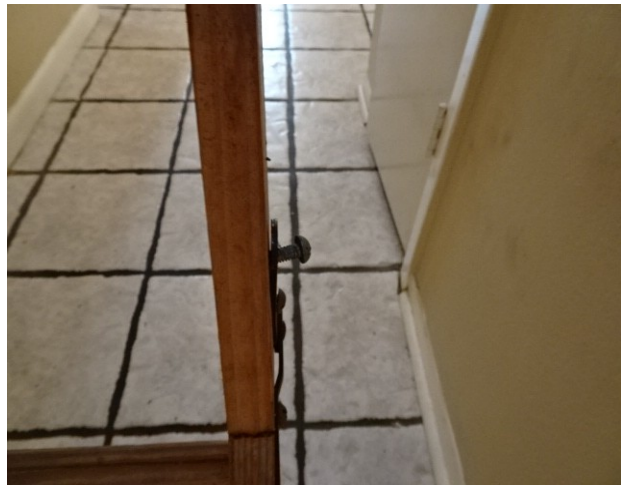
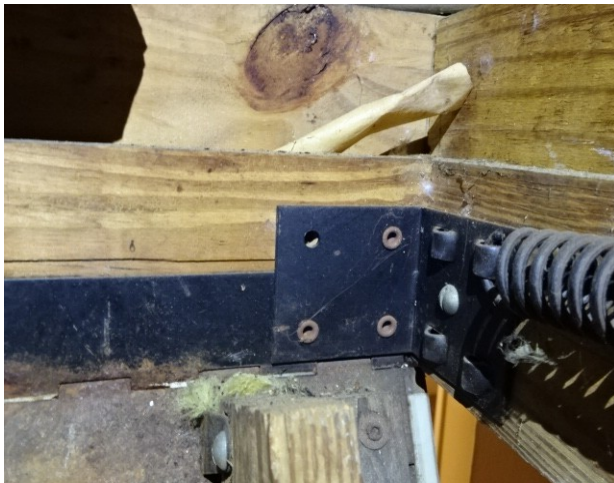
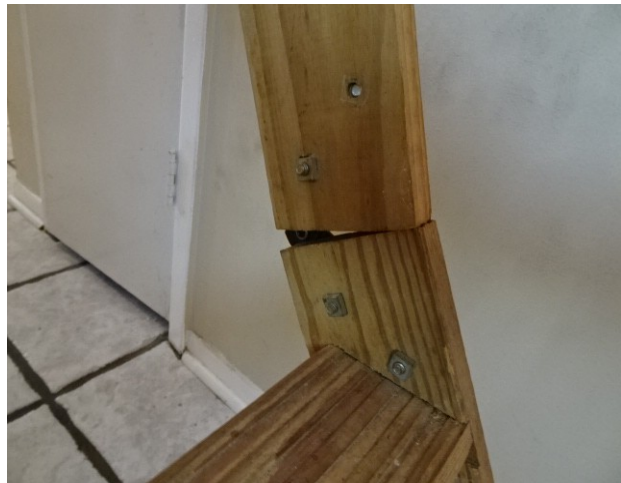
- Recommend to insulate ladder rungs and install weather stripping on attic door edges or on access frame for energy efficiency.
- Secure loose and replace missing hardware where needed.
- Ladder not cut to fit properly. There should be no gaps at section ends. In need of repair

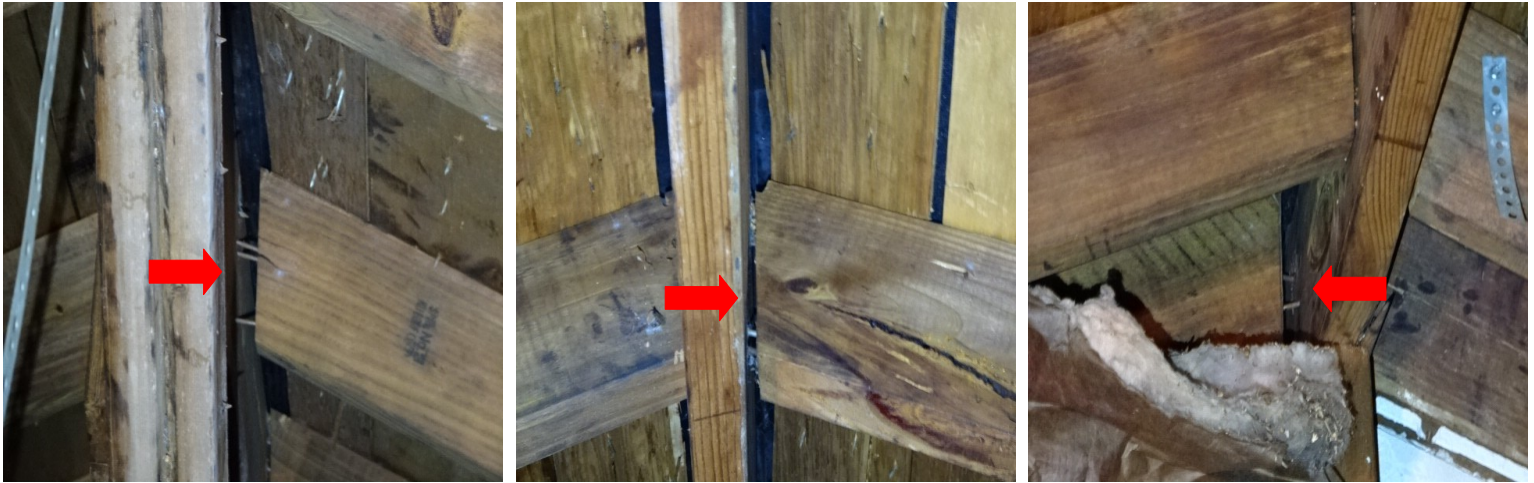
- Some rafters do not fit snugly against the ridge board, due to structural movement or inaccurate framing cuts. Rafters should be in full contact with the ridge board. Rafters that bear at the toe and not the heel are prone to splitting. Recommend repair by a qualified roofing contractor. Samples below.

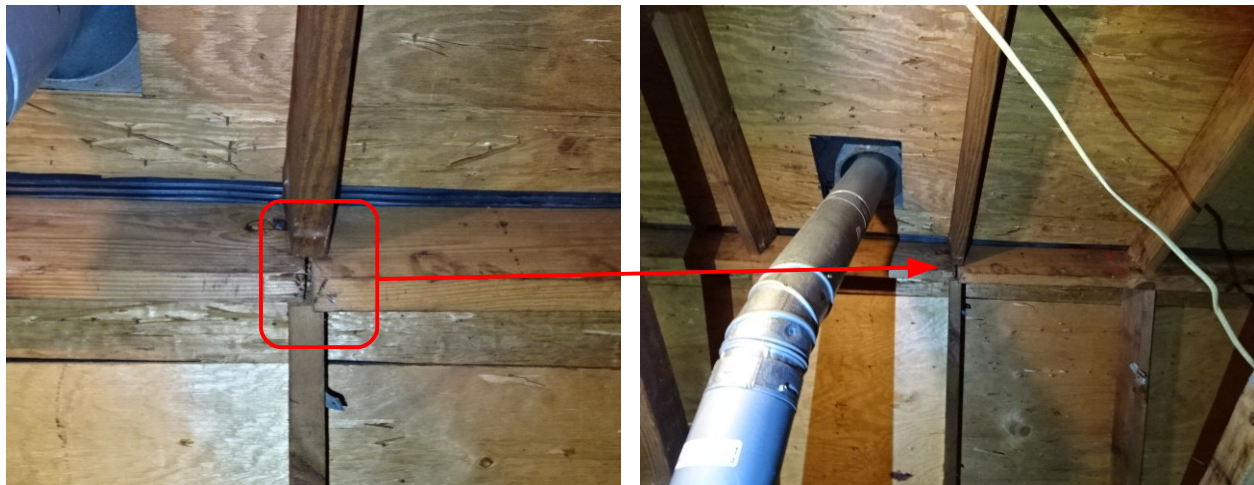
- There is no support beneath ridge board joint. Recommend further evaluation and repair as needed by a qualified roofing contractor to prevent possible sagging of ridge.

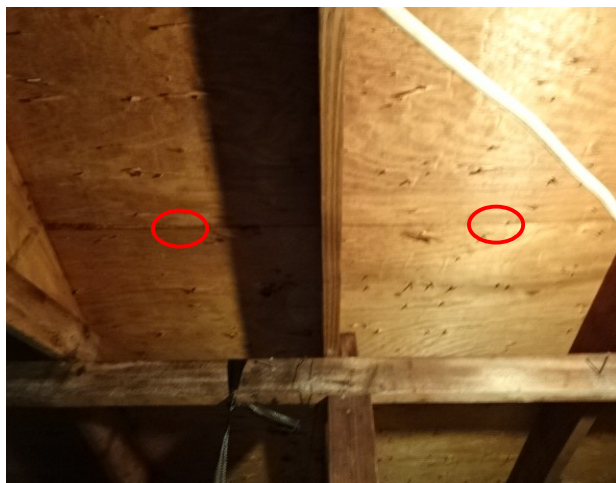
- Observed absence of “H” clips between sheathing **Note:** H-clips increase panel stiffness by allowing distribution of weight between adjacent panels.

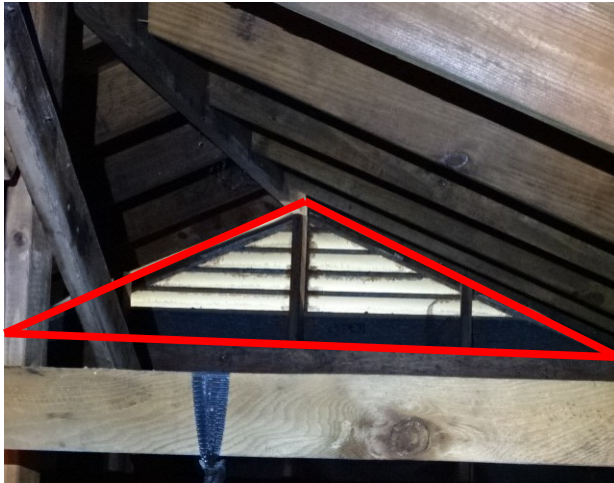
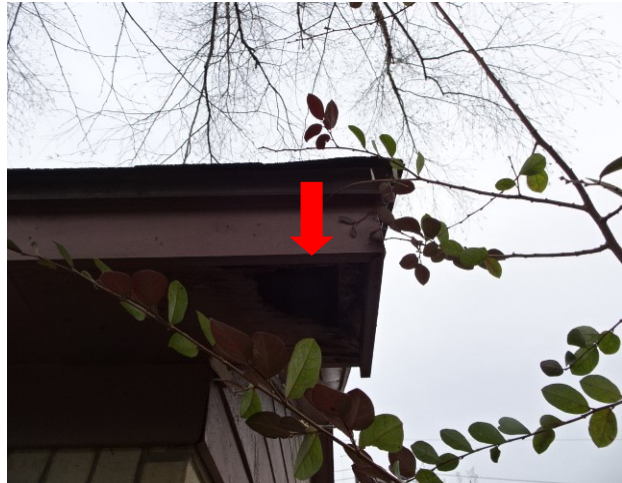
- Replace damaged soffits and screens on gable vents where needed to deter animal/insect entry into the attic space.

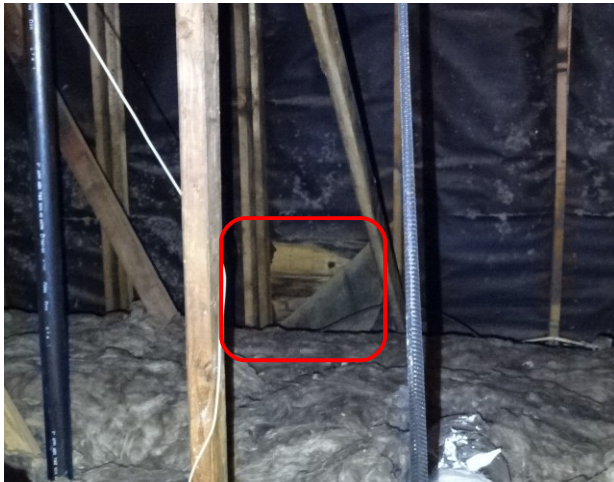
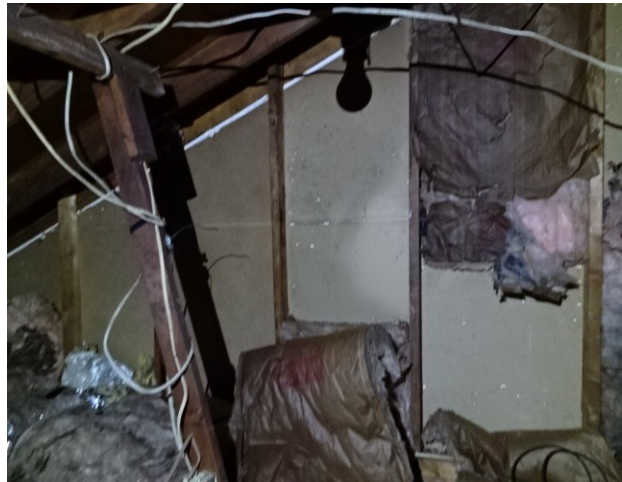
- Damaged underlayment and water damage noted on right exterior wall siding. Recommend repair.
- Loose insulation on attic walls. Recommend repair for energy conservation.

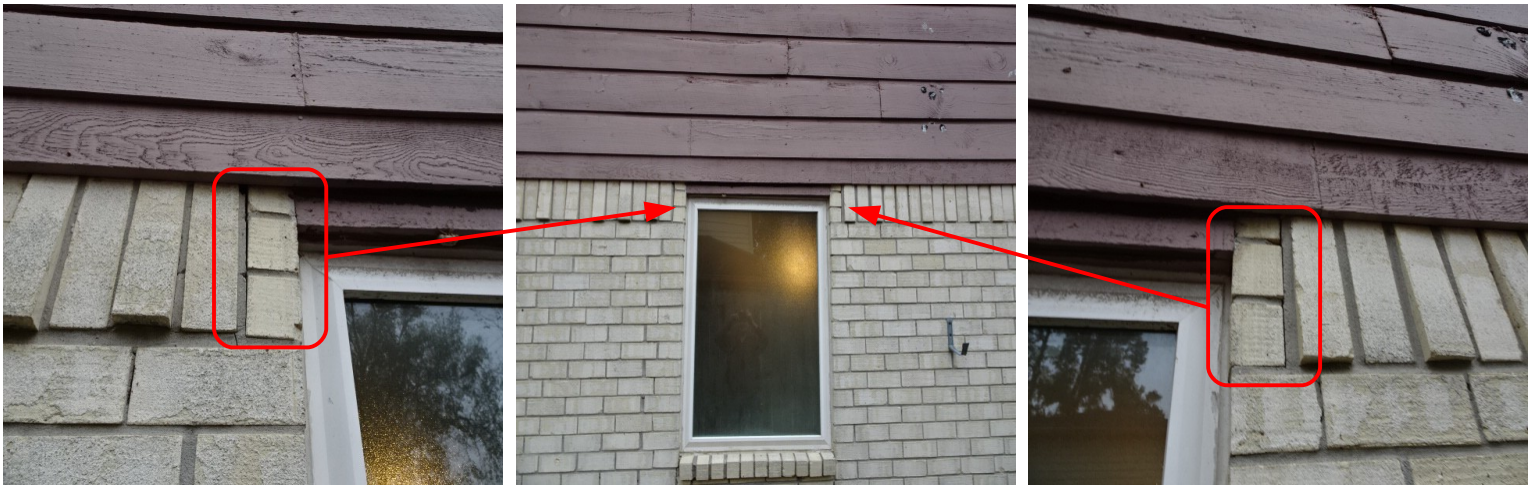
- Brick and/or mortar cracks on the right exterior wall. Recommend repair to prevent further deterioration of same.

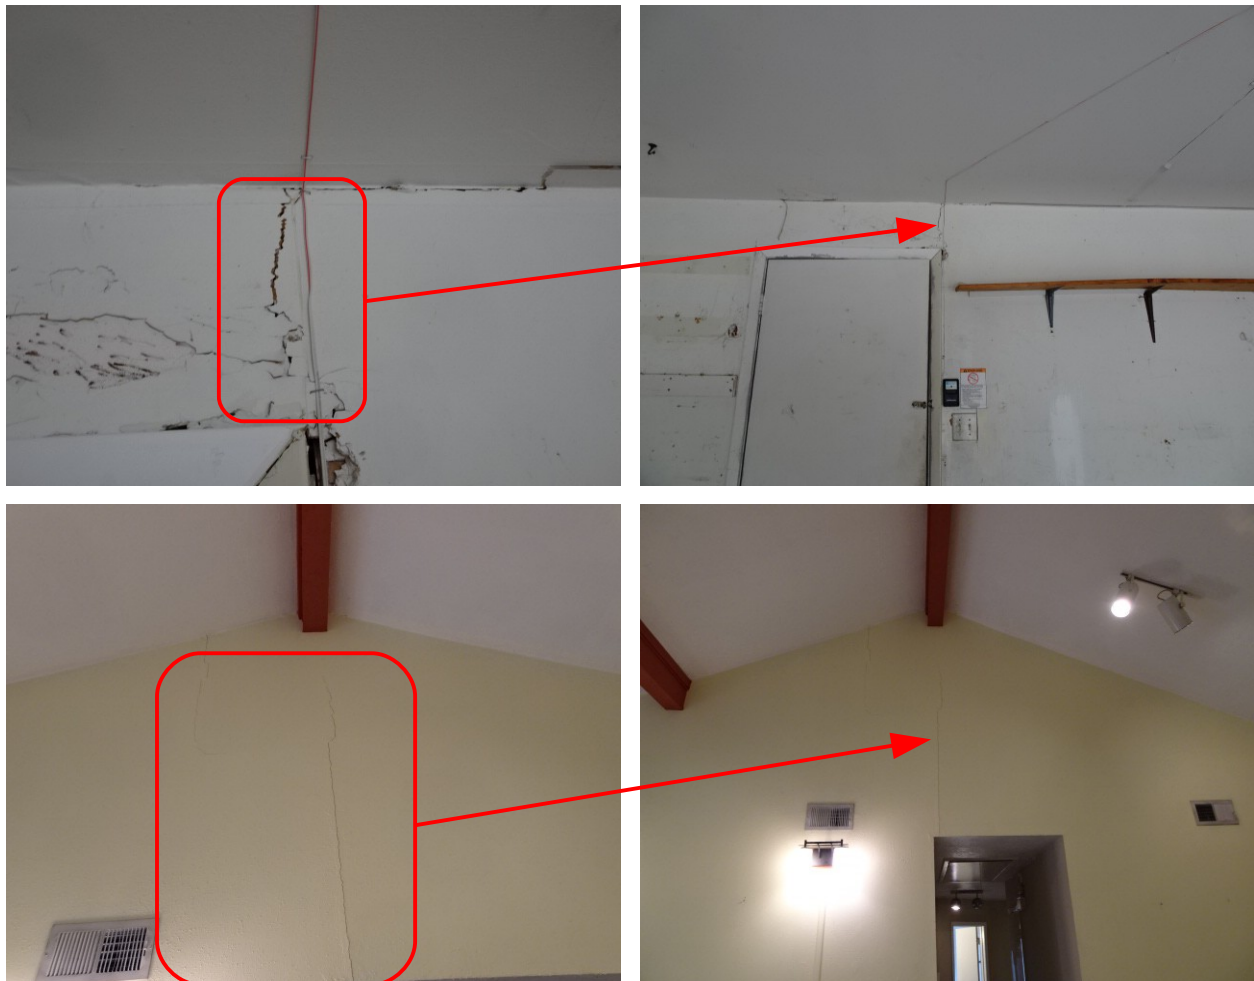
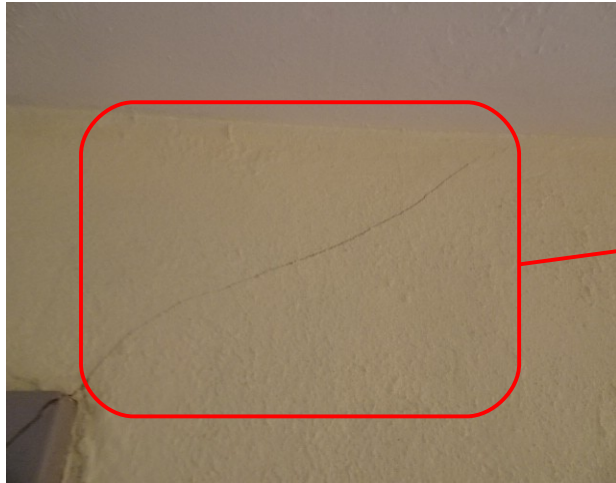
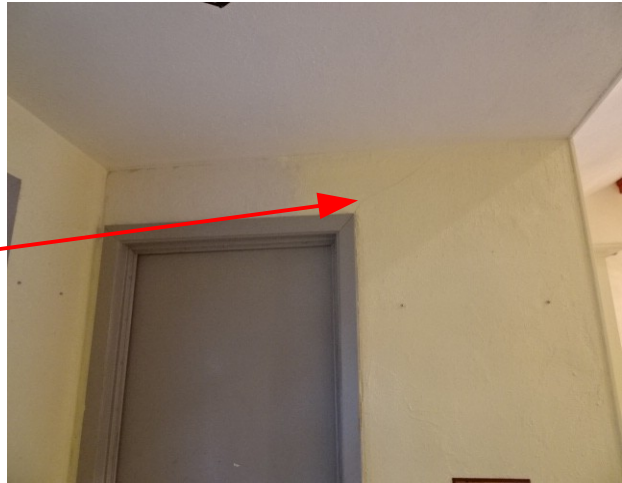
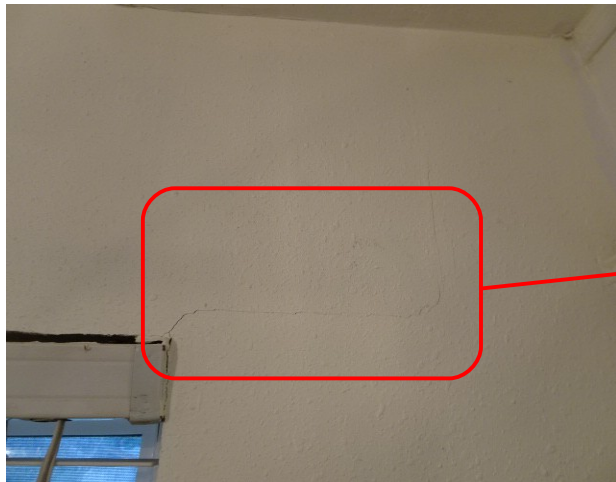
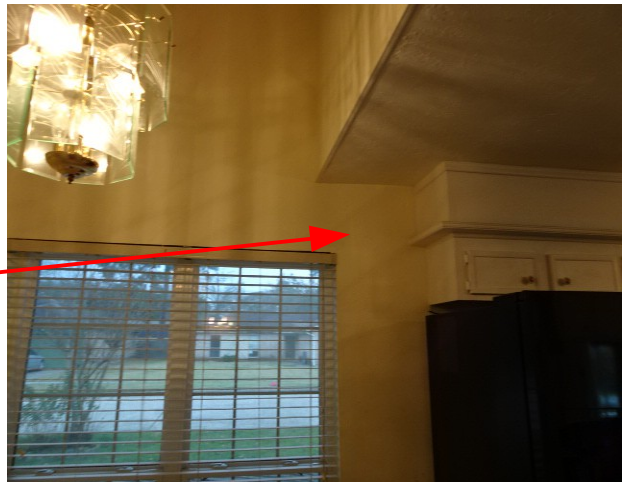
- Cracks on multiple interior walls that may be associated with structural movement. Recommend to consult with a structural engineer and/or foundation repair company to further assess the integrity of the foundation slab and determine corrective action details, if any. Samples below.

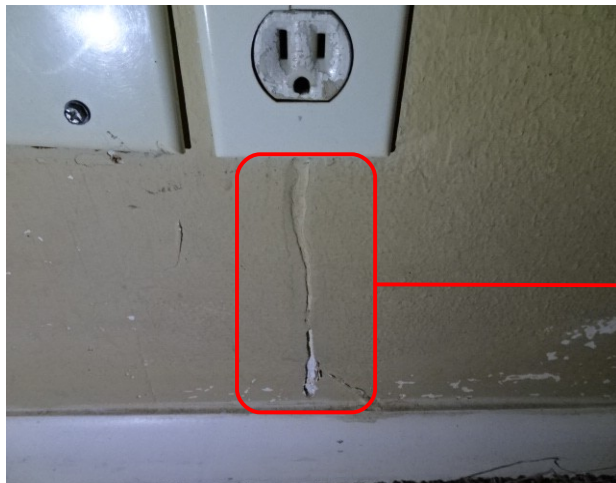
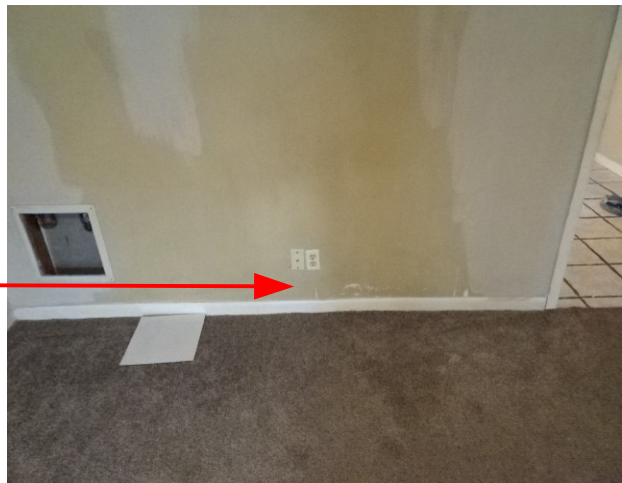
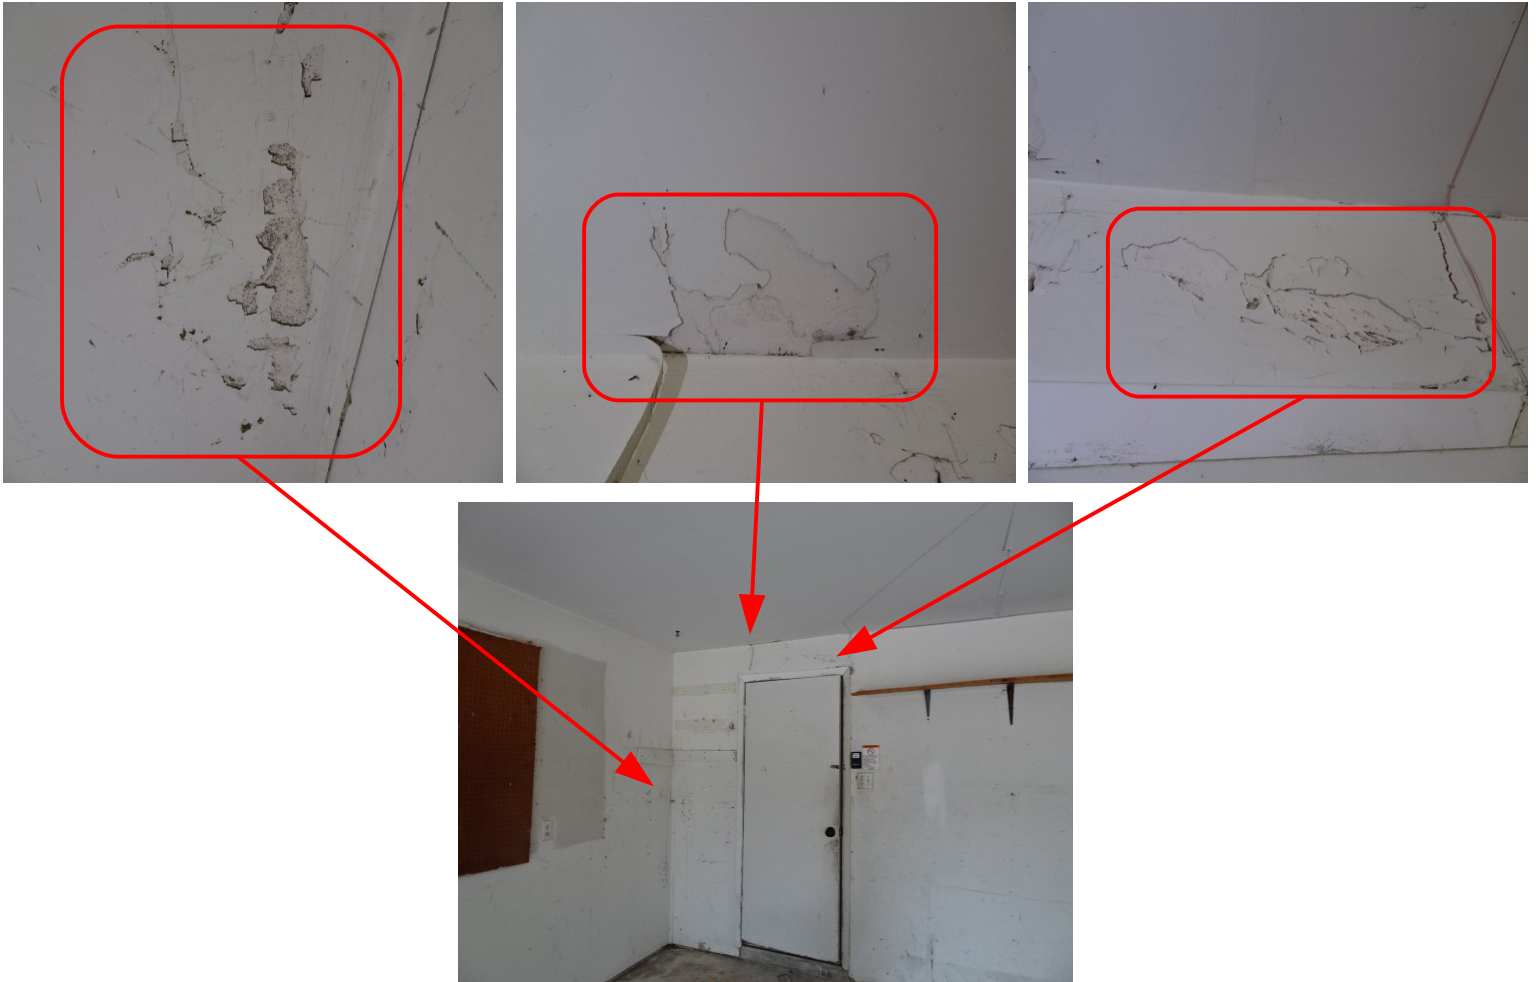
- Possible evidence of wood destroying insect damage on garage and master bedroom walls. Recommend further evaluation and treatment as needed by a qualified pest control contractor.

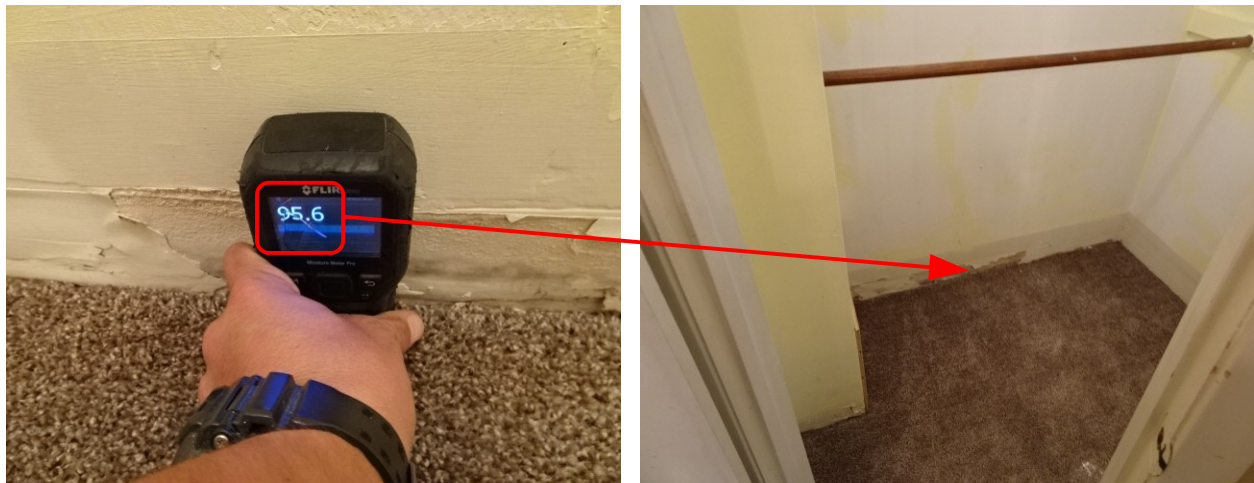
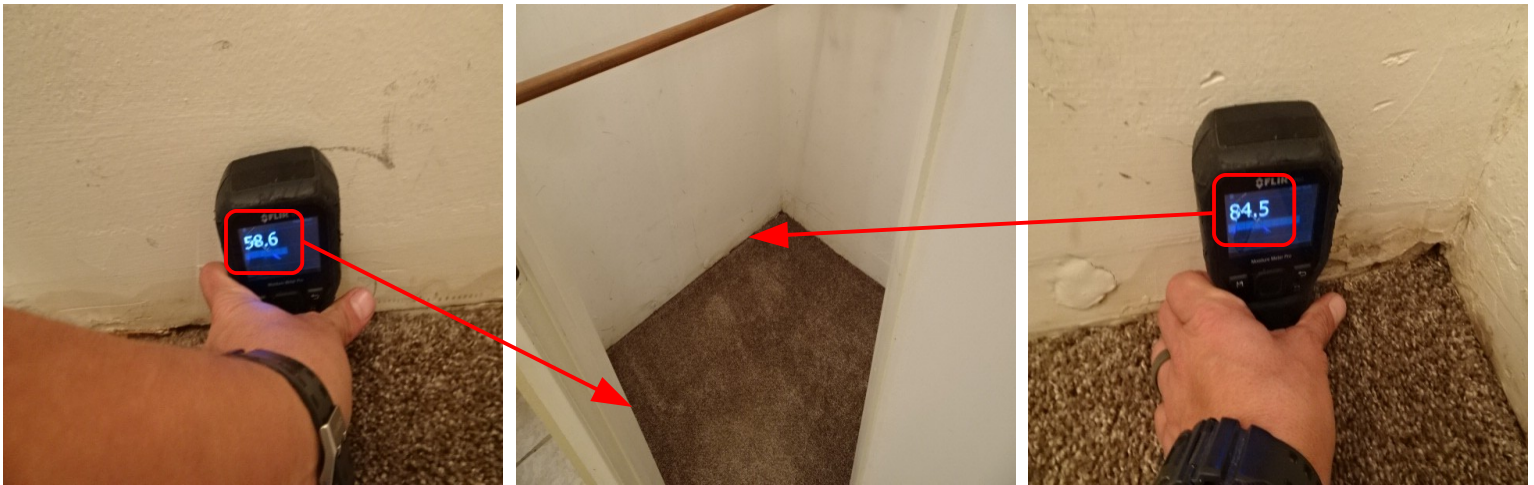
- Water damage and elevated moisture levels on both master bathroom walls. This should be further evaluated and properly repaired by qualified contractor(s).

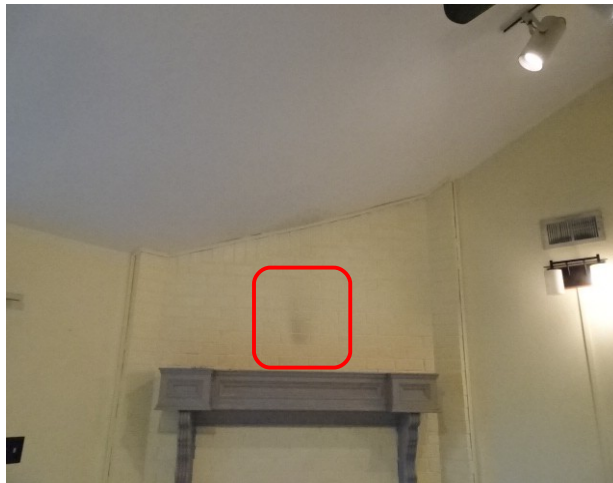
- Soot stains above the fireplace. Further investigate root cause and repair as needed.

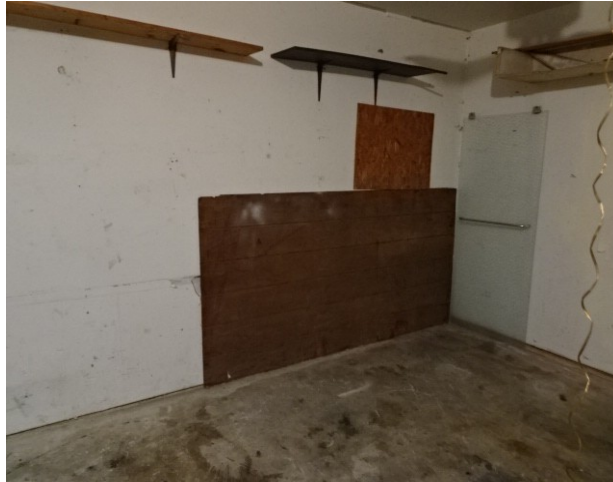
- Panel secured to the garage wall. Further investigate root cause and repair as/if needed.

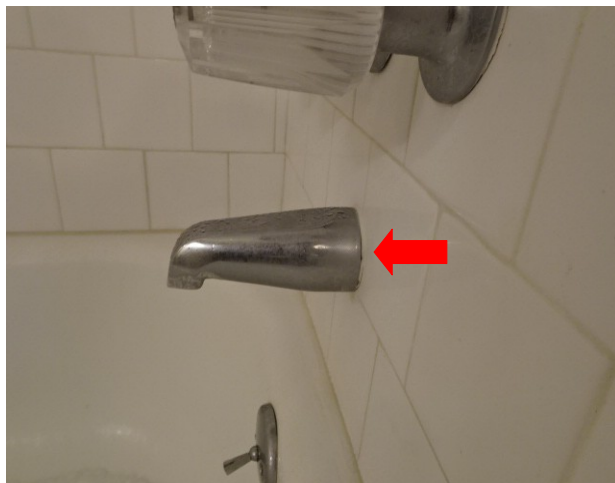
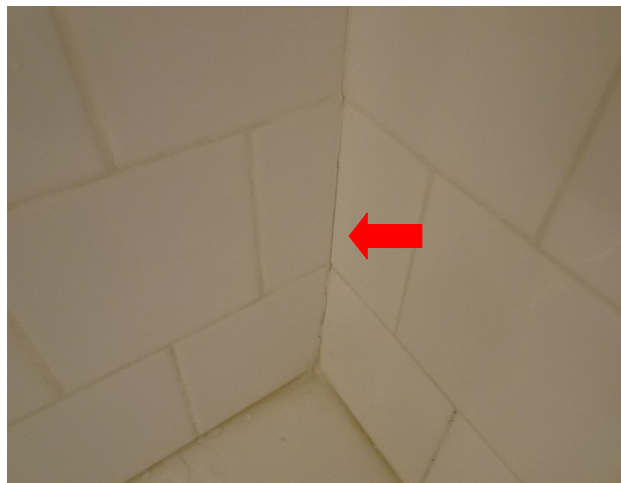
- Properly seal gaps in shower enclosures to avoid water infiltration and damage to property

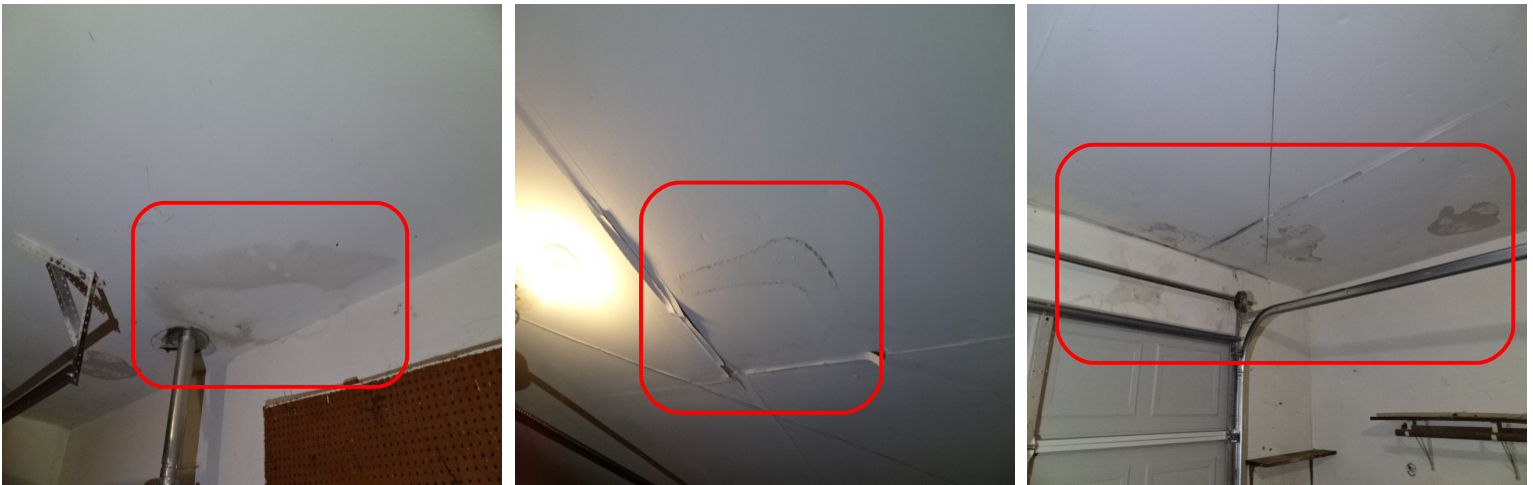
- Moisture on garage ceilings and walls. Elevated moisture levels were not detected at the time of inspection (Moisture Meter: Flir MR: 60). Further investigate root cause and properly repair same.

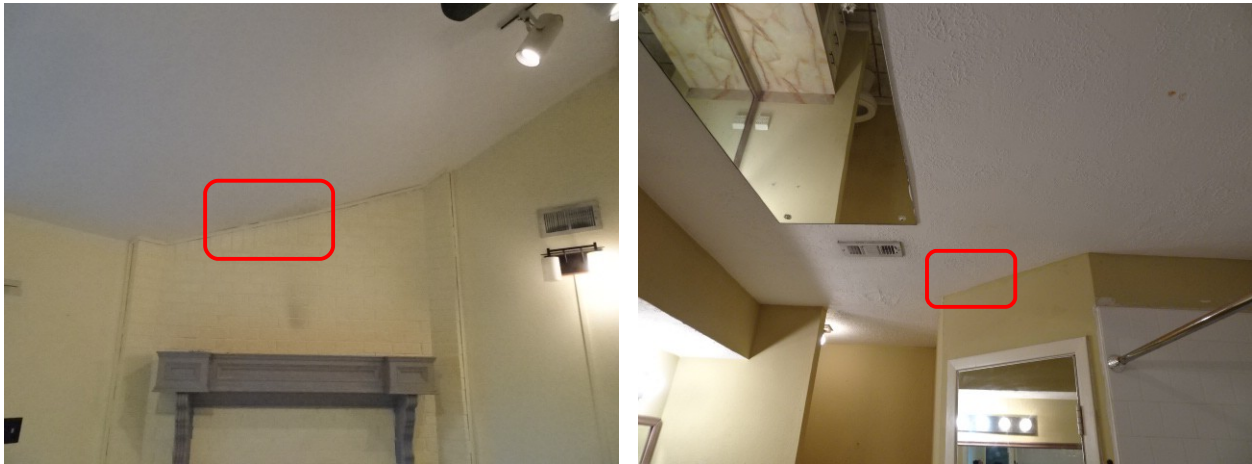
- Repaired water stains at in multiple areas. Elevated moisture levels were not detected at the time of inspection (Moisture Meter: Flir MR: 60) Investigate root cause and confirm that all affected areas such as but not limited to: sheetrock, insulation, joists, etc, have been properly repaired/treated by a qualified contractor. Note: If not properly repaired and or treated, it can lead to microbial growth.

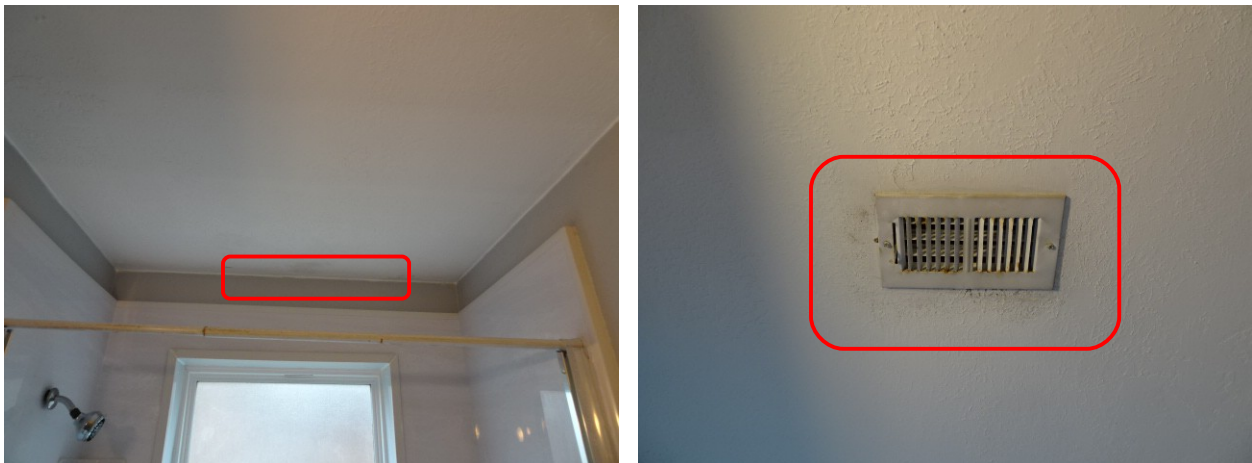
- Evidence of microbial growth on the hallway bathroom ceiling. This may be caused by improper ventilation of the bathroom. Further investigate root cause and properly repair and/or treat as needed by a qualified contractor(s).

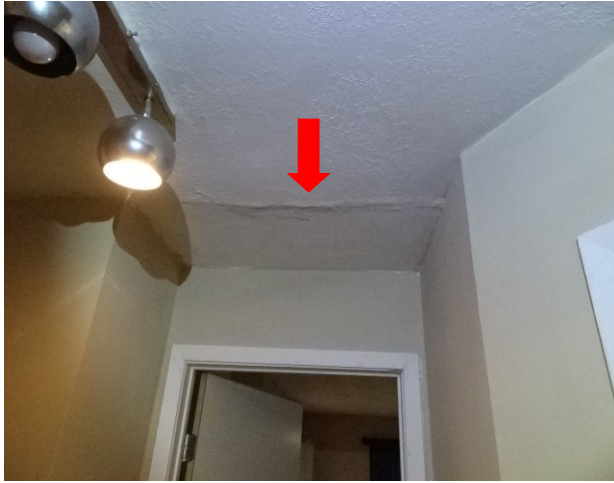
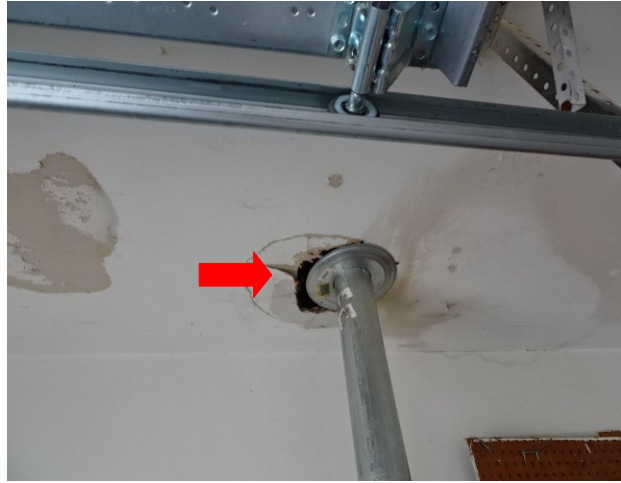
- Evidence of repaired crack on bedroom hallway ceiling. Further investigate root cause and properly repair as needed.
- Damaged ceiling around the water heater exhaust. Repair same for proper fire separation.

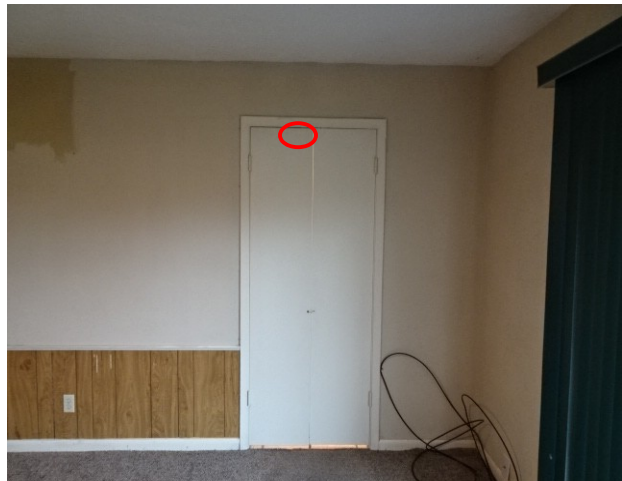
- Front right bedroom closet door is out of the track. Repair same.
- Master bathroom door did not latch shut and missing handles.

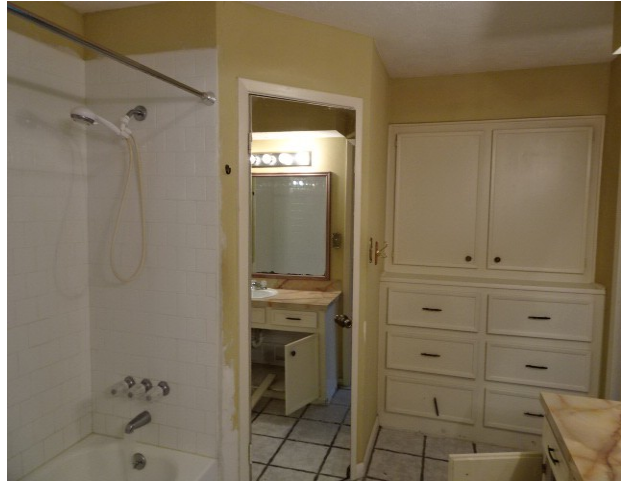
- Front left bedroom door swings open and master bathroom closet door sticks.. Further investigate root cause and properly repair as needed by a qualified contractor. This condition may also be indicative of structural movement. Further investigate root cause and repair as needed by a qualified contractor(s).
- Mirrors on master bathroom closet doors do not appear to be safety/tempered glass (not visibly labeled). **Note:** Proper use of safety glass is critical in areas that are subject to human impact.
- Install missing door stoppers where needed to avoid damage to wall.

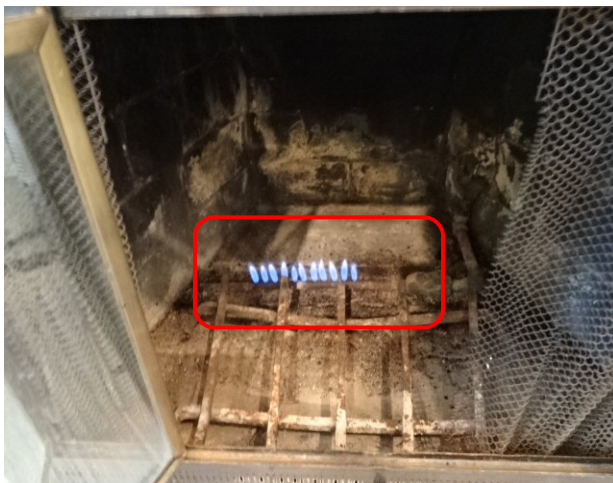
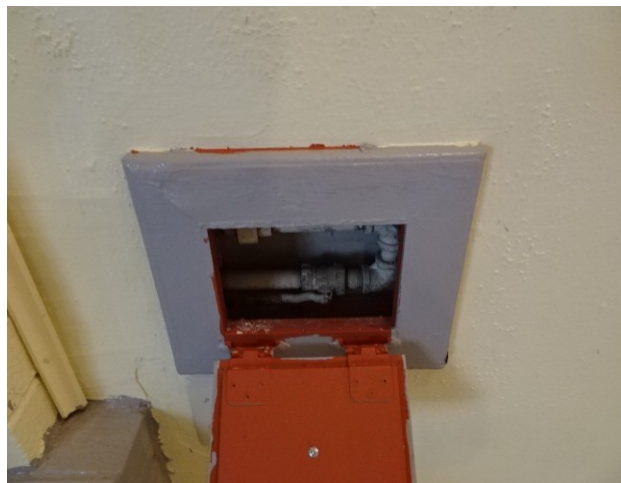
- Low fireplace flame when the gas valve was fully open. This should be further evaluated and properly repaired by a qualified fireplace specialist.

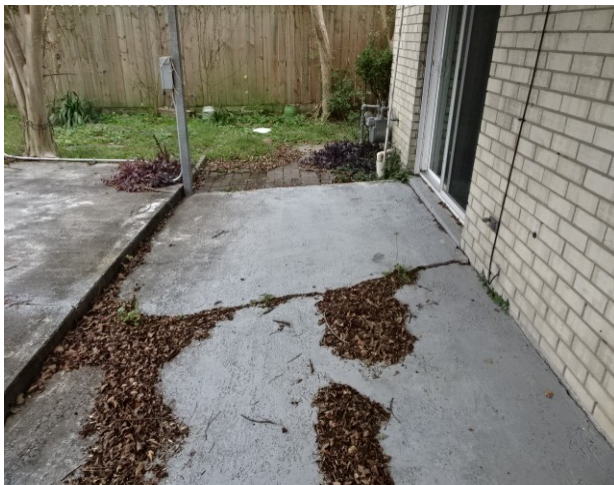
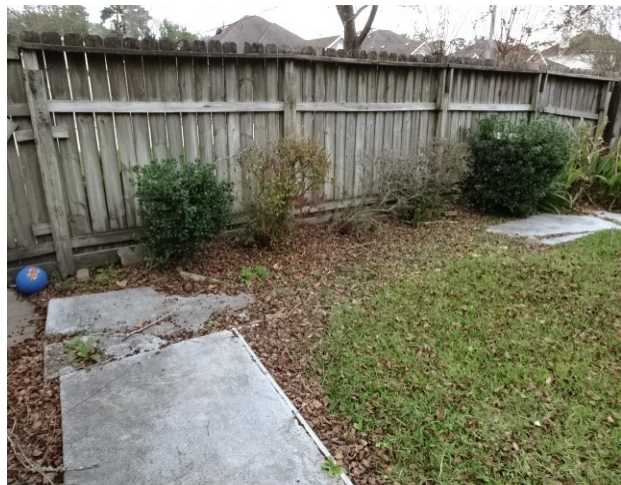
- Cracked rear porch slab and damaged walkway in the back yard. Repair to prevent possible trip hazards.

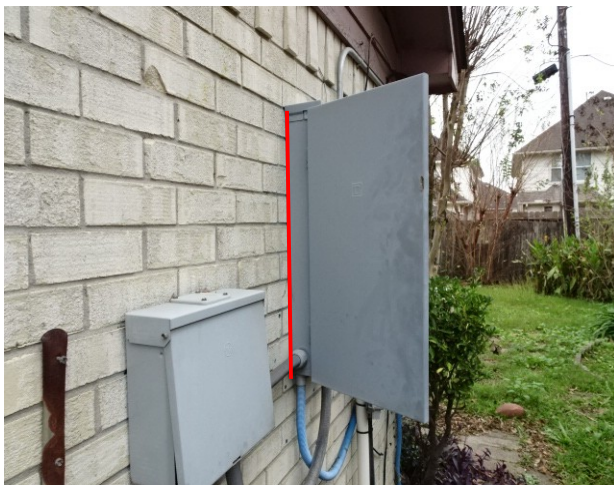
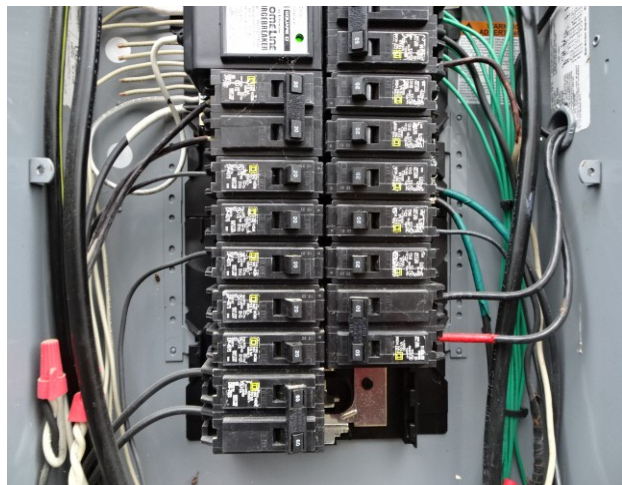
- Apply caulking on both sides and top of enclosure to prevent water/moisture seeping in the enclosure
- Multiple circuit breakers were not in use at the time of inspection.

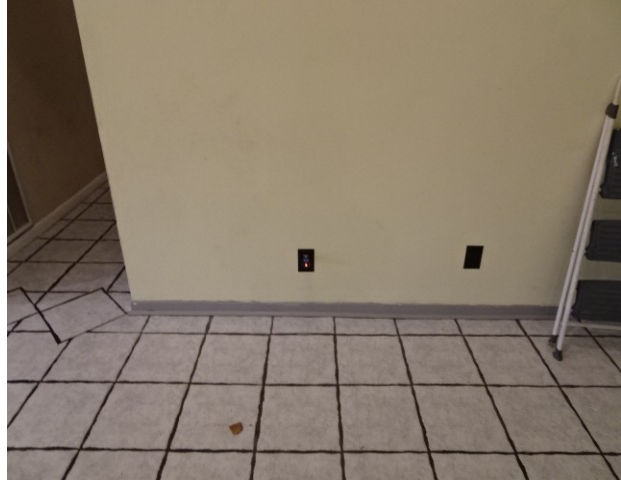
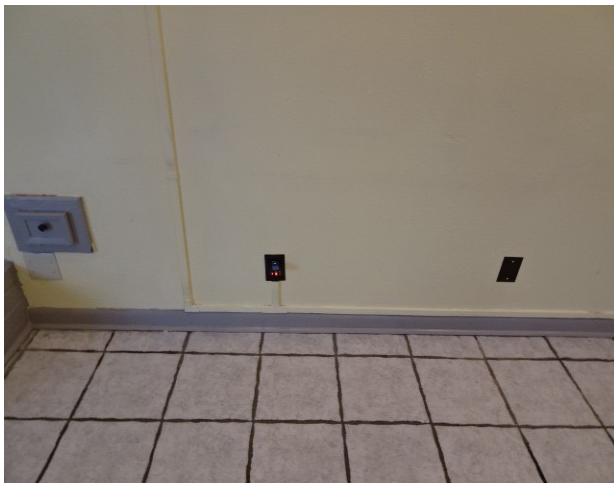
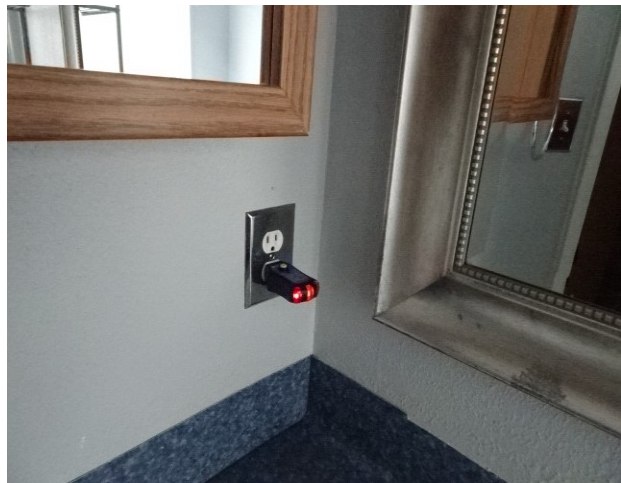
- Improperly wired outlets in multiple locations (Hot and neutral wires reversed, open ground, etc). In need of repair by a qualified electrical contractor for safety. Locations but not limited to: Exterior, living room, and hallway bathroom.

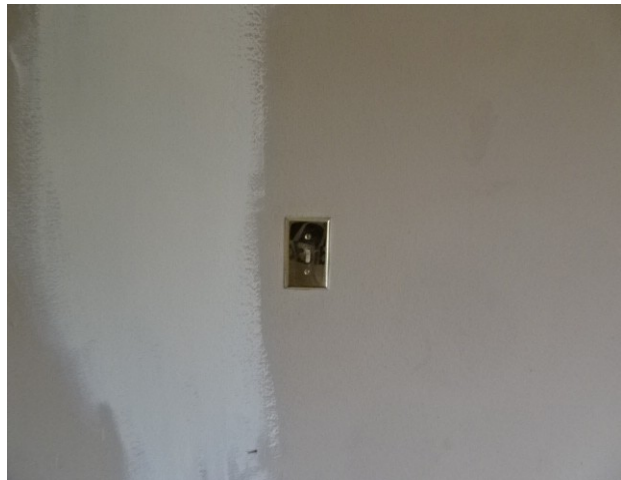
- No power supply to outlet in the garage. In need of repair by a qualified electrical contractor.
- Switch in the master bedroom did not function. Repair as needed by a qualified electrical contractor.

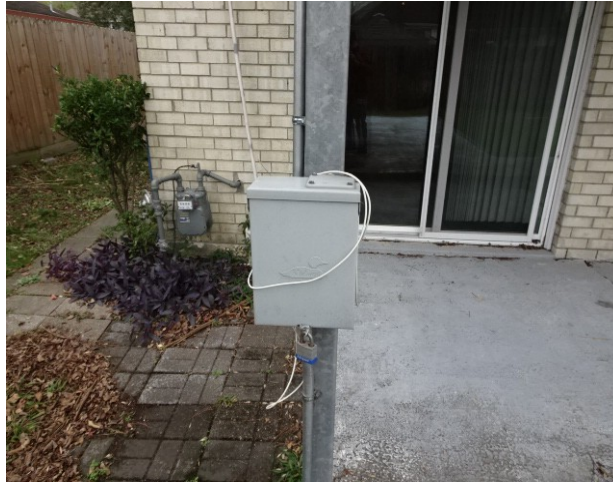
- Electrical box in the back yard is locked and inaccessible for inspection
