PROPERTY INSPECTION REPORT

Concerning: 23846 Beaverwood Dr. Spring, TX 77373
(Address or Other Identification of Inspected Property):

By: Giovanni Angel, 22909 12/13/2021
(Name and License Number of Inspector) (Date)

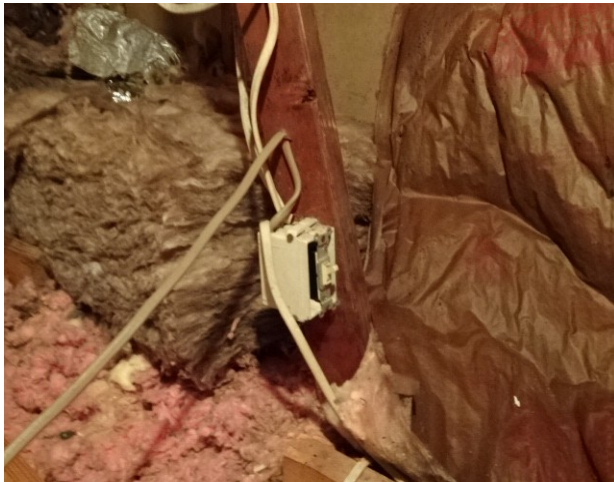
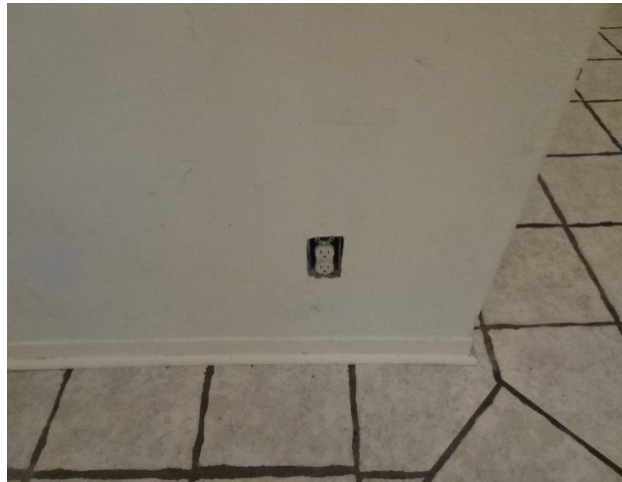
- Install missing face plate on outlets and switches for personal safety

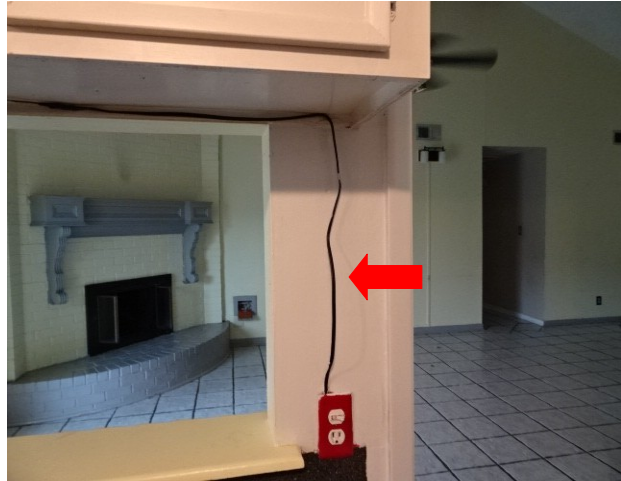
- There appears to be a field made extension cord in the garage. Note: Extension cords are only for temporary use. In need of proper repair ex: install a dedicated outlet
- Observed spliced wires in the garage (field made extension). Note: All spliced wires should be placed inside a junction box. Properly repair
- Electrical cable is exposed and loose in the garage and kitchen. Note: Cables should be concealed in walls or protected from physical damage using proper conduit.

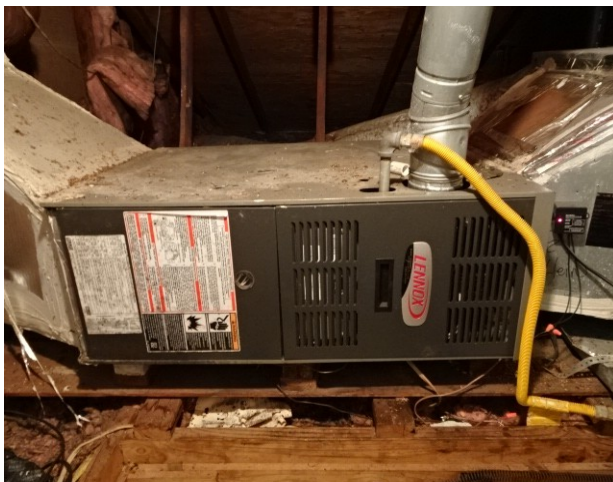
- Missing sediment trap on the furnace gas line. Note: The sediment trap shall be either a tee fitting having a capped nipple of any length installed vertically in the bottom most opening of the tee or other device approved as an effective sediment trap

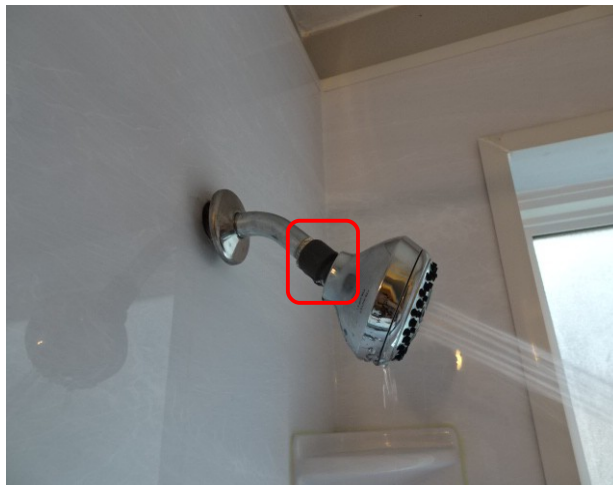
- Leak at the hallway bathroom shower head when operated. Repair as needed.
- Hallway bathroom in wall shower head plumbing is loose. Recommend repair by a qualified plumbing contractor to prevent possible damage to plumbing.

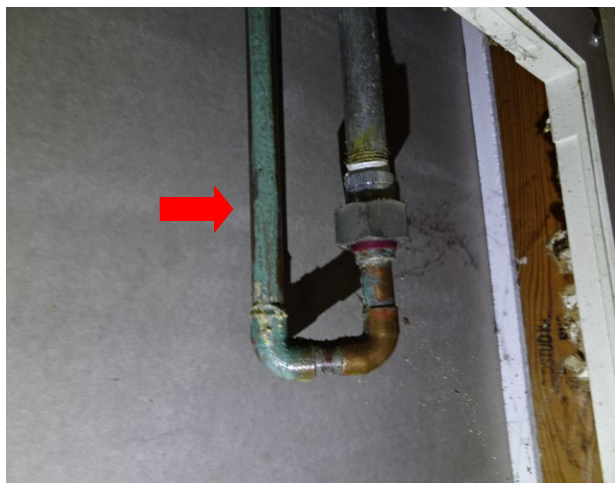
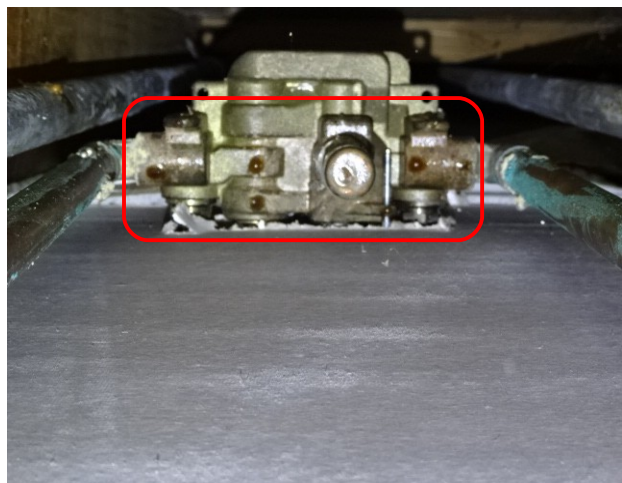
- Water/foreign substance and oxidation on the hallway bathroom shower plumbing visible in through the attic access. Recommend further evaluation and repair as needed by a qualified plumbing contractor.

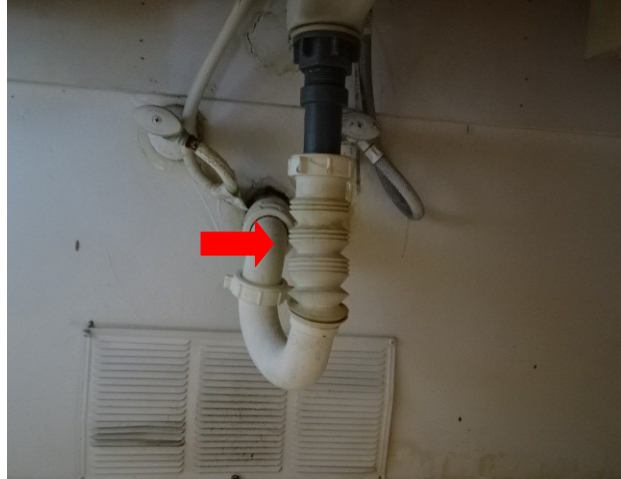
- Non-approved drain connector in both bathroom sinks plumbing. **Note:** Drainage fittings shall have a smooth interior waterway of the same diameter as the piping served. Drainage fittings shall have no ledges, shoulders or reductions which can retard or obstruct drainage flow in the piping. Any configuration other than smooth interior will cause solids to catch and begin to clog the pipe

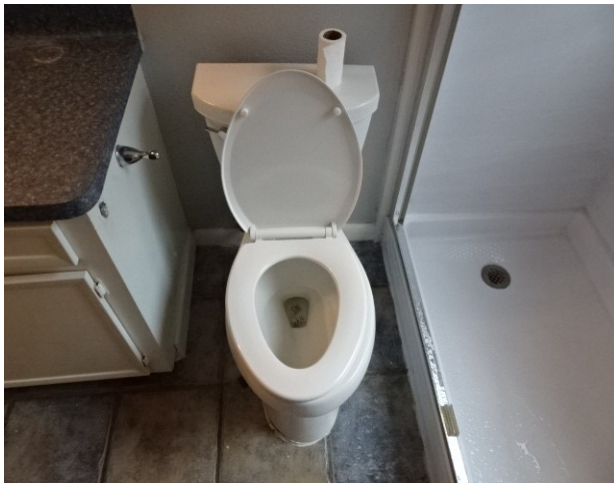
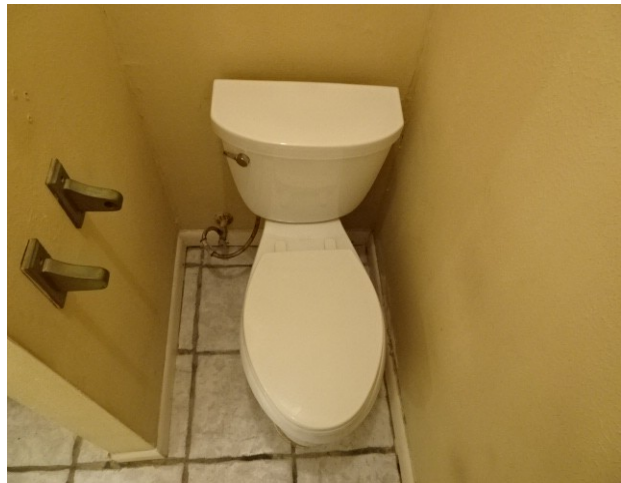
- Observed loose toilets in multiple bathrooms. Properly secure to avoid water leaks **Note:** If excessive movement of toilet is noticed, we recommend the seal be replaced.

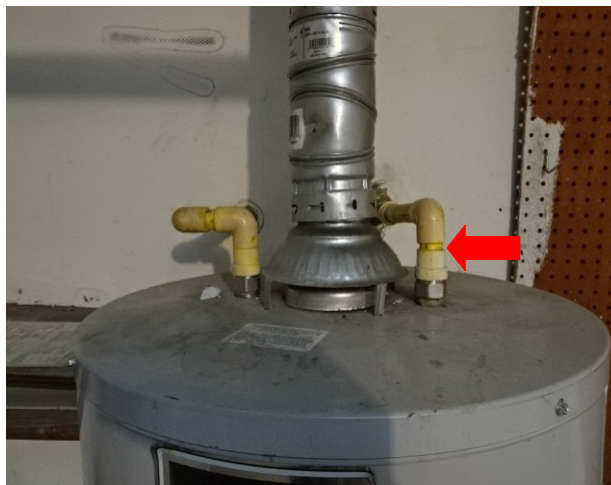
- CPVC piping (combustible) is connected directly to the water heater and is a substandard installation. **Note:** for gas fired water heater vents: 6" minimum clearance from single-wall vent pipe or flue-vent connector to any combustible material. In need of repair by a qualified plumbing contractor.

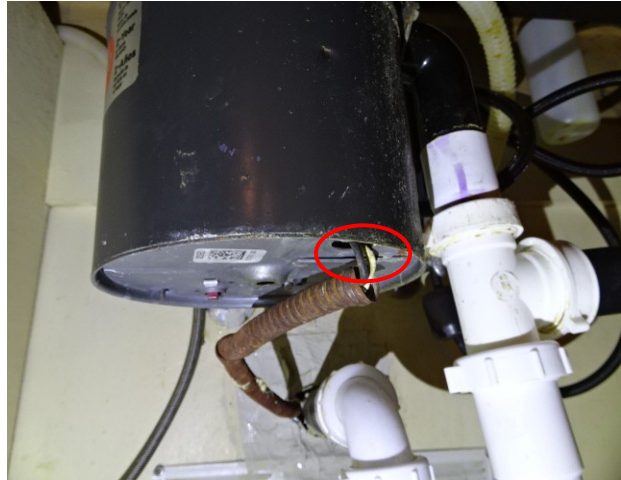
- Food waste disposer did not function. Repair same.
- Install missing clamp on power cord to protect cable from damage due to excess of movement

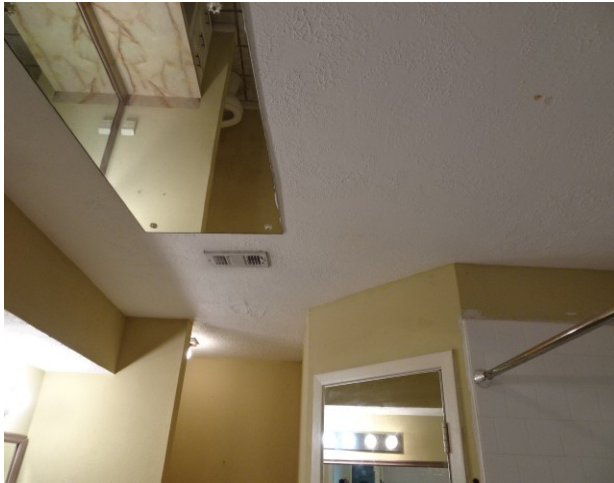
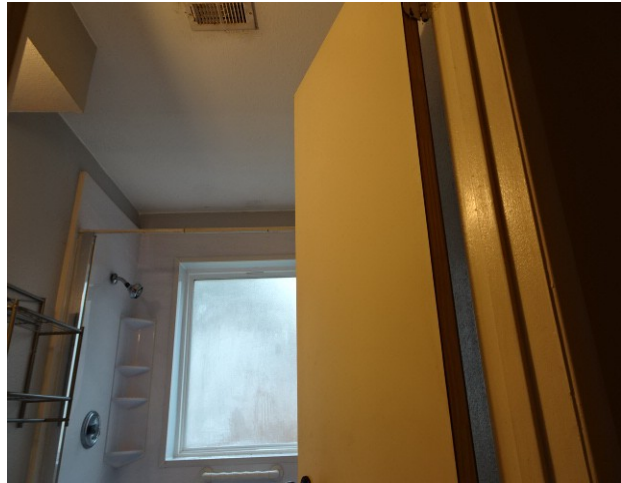
- Missing mechanical exhausts or operating windows in both bathrooms. Install same to comply with building regulations.

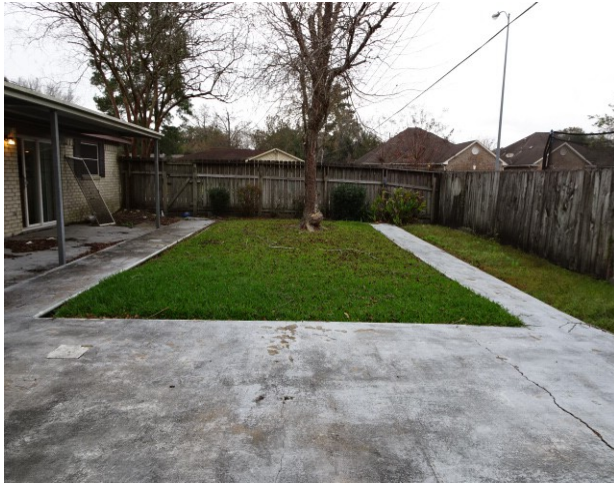
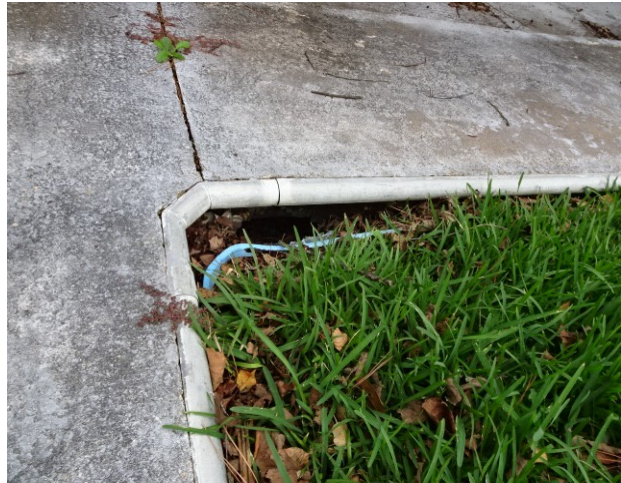
- There appeared to pool that has been abandoned and back-filled. Recommend to verify any applicable permits were obtained and pool was properly back-filled by a qualified contractor to prevent future issues with same.
