**SUMMARY**  
 3406 Watersedge Dr, Sugar Land TX  
 77478  
 Chet Pack  
 January 13, 2022

Phil Bullock  
 Professional Home Inspector (TREC ID:  
 24461)  
 Noble Home Inspections  
 (832) 319-8846  
[philbullock1223@gmail.com](mailto:philbullock1223@gmail.com)

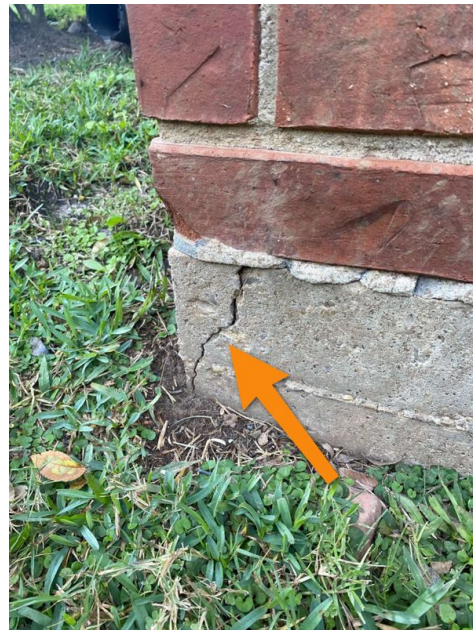
Back Left

**FOUNDATION CRACKS - CORNERS**

Corner cracks are visible in the foundation slab but are of minimal structural concern. Shrinkage is a natural part of the curing process of concrete and cracks located in corners of structures are common. Recommend monitoring to confirm the cracking does not worsen.

Recommendation  
 Recommend monitoring.

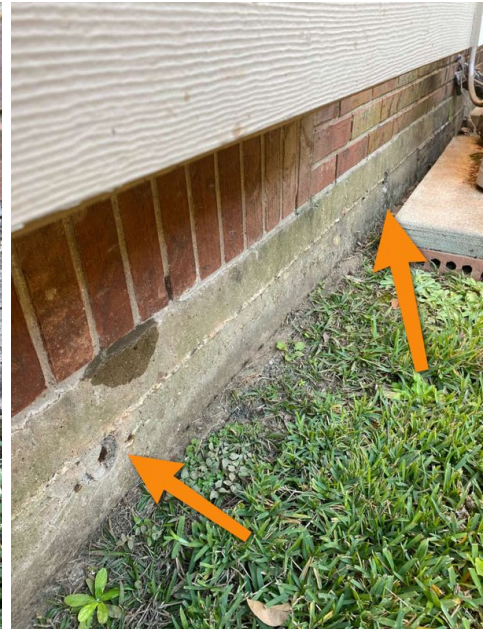
Left

**EXPOSED POST-TENSION ANCHORS**

Exposure of these ends can result in corrosion of the cable, anchor, or locking wedges and eventually cause the cable to lose its tension and leave the foundation concrete with insufficient compression to resist cracking. Inspector recommends masonry be placed to cover the exposed tension anchors

Contact a qualified masonry professional.

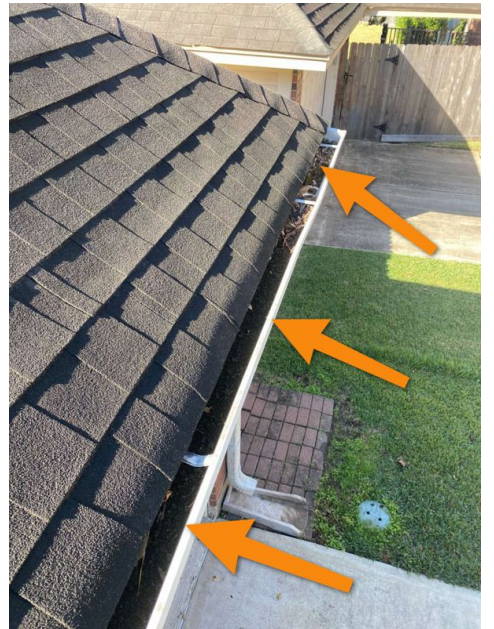
The gutters are full of leaves and debris. Recommend removal.

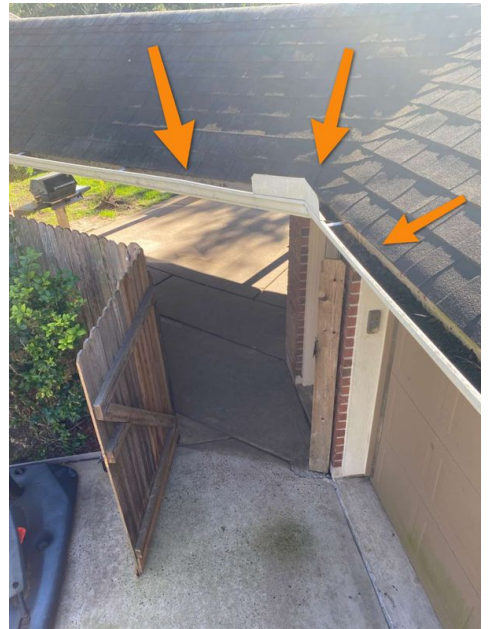
**GUTTER IS SAGGING**

A gutter is sagging. Sagging gutters will often hold water and debris, will leak at joints, and/or will be heavy to the fascia to withstand. Recommend a gutter contractor to correct the issue.

Contact a qualified gutter contractor

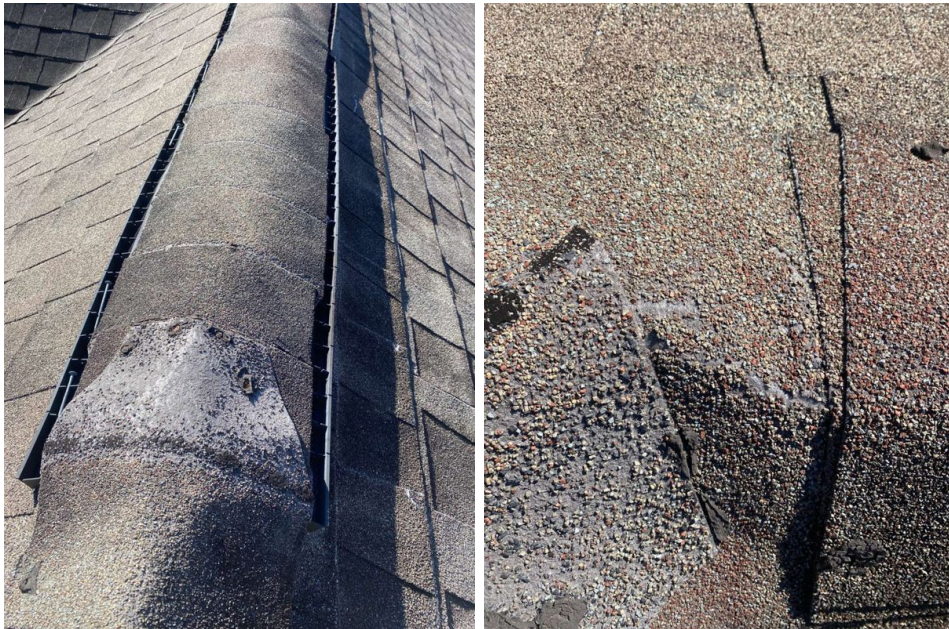
The asphalt shingle roof shows signs of delamination primarily at the roof ridges. Delamination is separation of the surface layer of asphalt on the shingle and can be a normal aging process of any roof. Ridge delamination occurs before standard shingle delamination because the gable ridge is more susceptible to traversing, direct sunlight, and shingle curvature. It is not always a sign of roofing shingle failure unless it is progressive and the severity does not match the age of the roof. Recommend monitoring the delamination for future issues.

Recommendation  
Contact a qualified roofing professional.

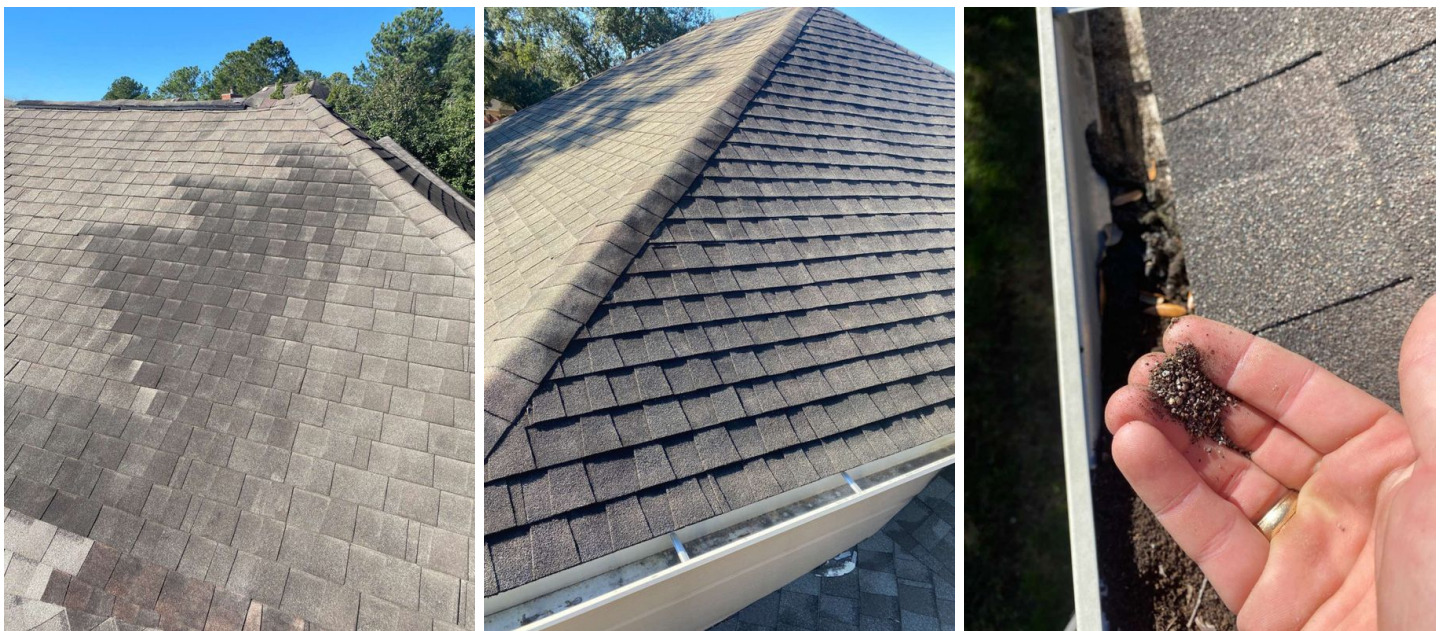
### 2.3.2 C. Roof Covering Materials **DELAMINATION - SHINGLE**

The asphalt shingle roof shows signs of delamination. Delamination is separation of the surface layer of asphalt on the shingle and can be a normal aging process of any roof. It is not always a sign of roofing shingle failure unless it is progressive and the severity does not match the age of the roof. Recommend monitoring the delamination for future issues.

Recommendation  
Contact a qualified roofing professional.

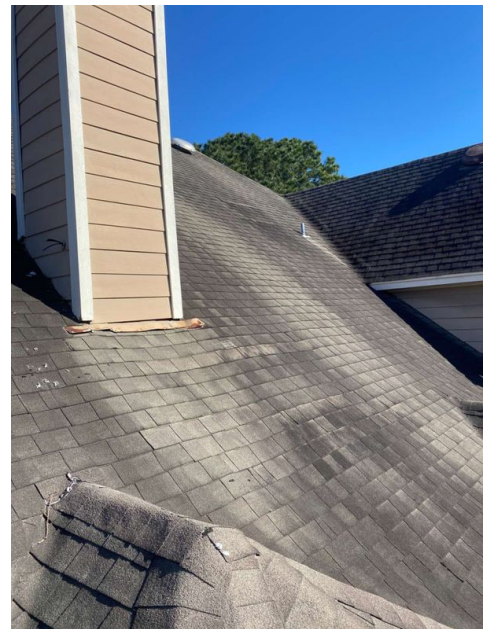
Roof shingles were discolored, which can be caused by moisture, rust or soot. Recommend a qualified roofing contractor evaluate and remedy with a roof cleaning or repair.

Recommendation  
Contact a qualified roofing professional.

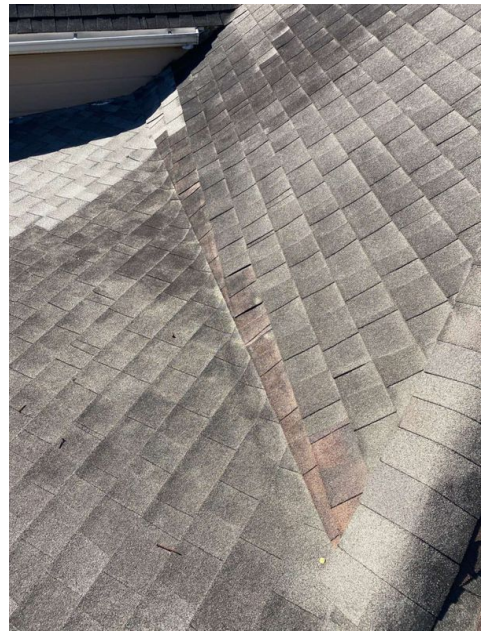
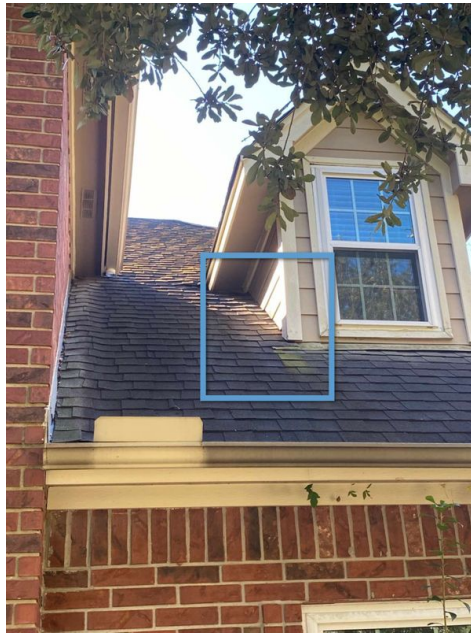
### 2.3.5 C. Roof Covering Materials **ROOF PATCH**

A roof patch was discovered and should be monitored for future leaks.

Recommendation  
Recommend monitoring.

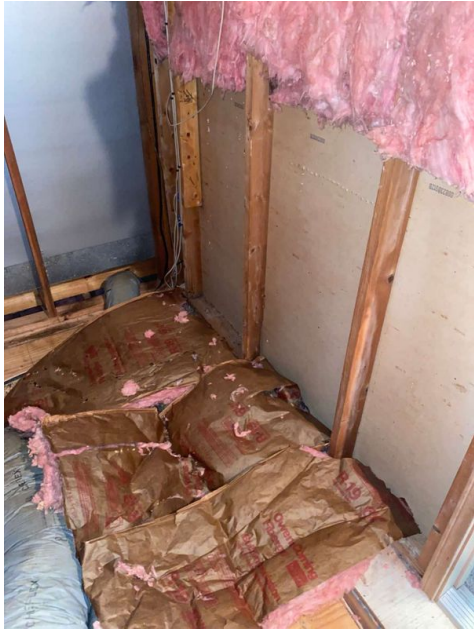
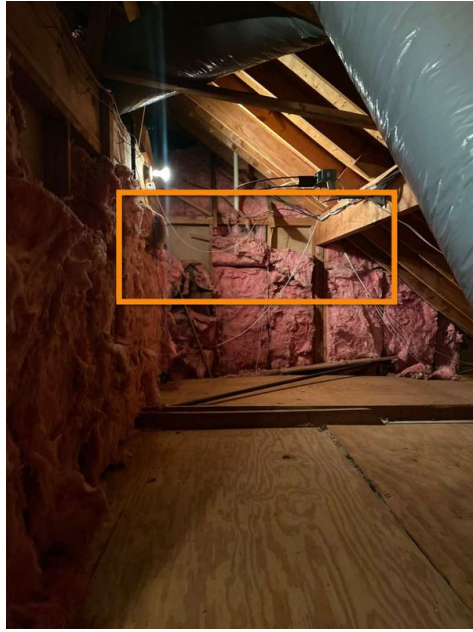
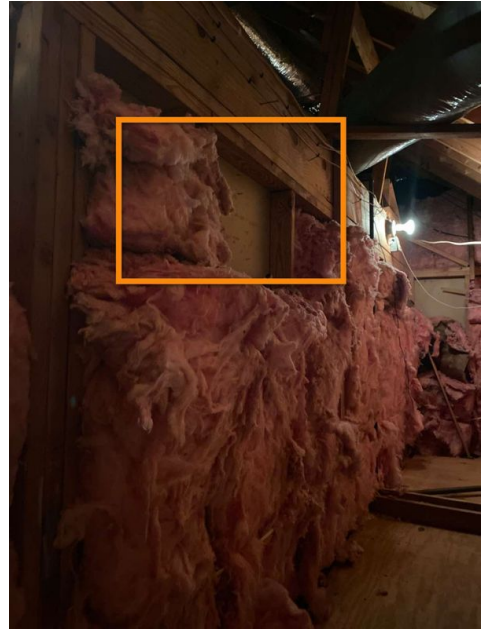
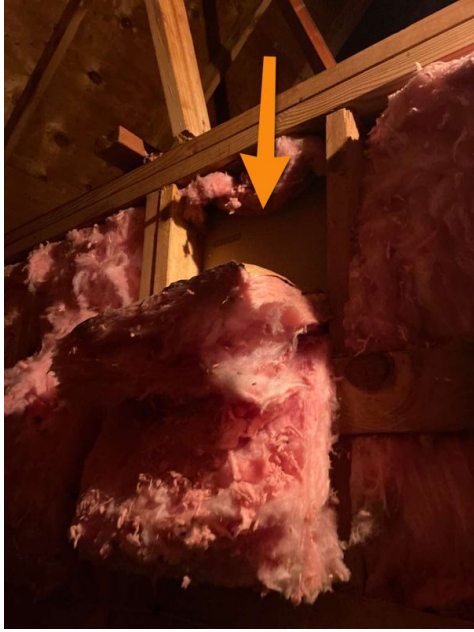
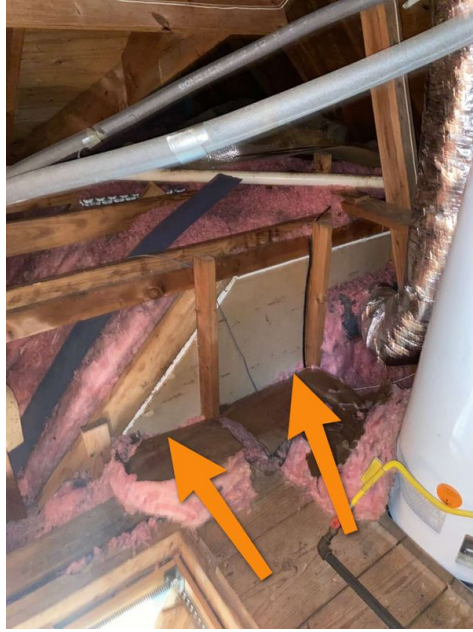
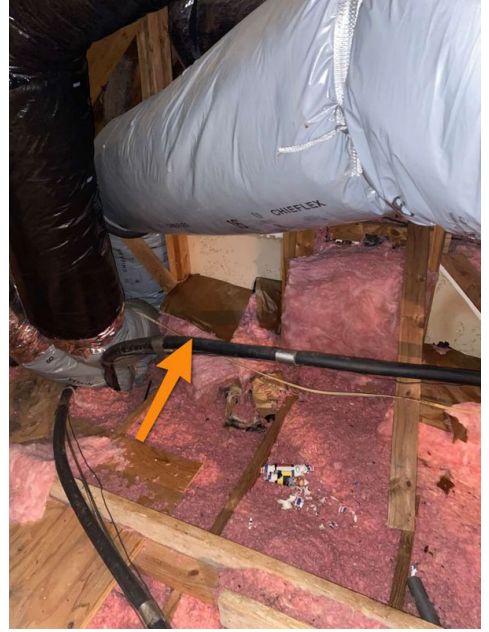
### DAMAGED INSULATION

Insulation appears to have been pulled out and/or damaged by contractors and/or pests. Recommend a qualified insulation contractor evaluate and repair.

Contact a qualified insulation contractor.

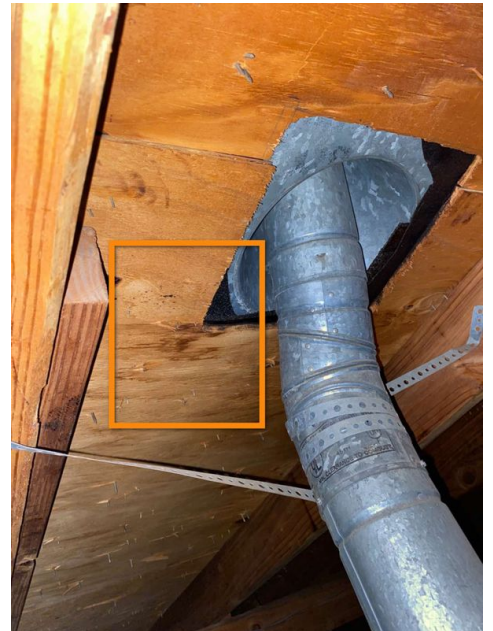
### ROOF LEAKAGE

Visible roof leaks were observed in the attic. Recommend a qualified roofer evaluate and repair.

Contact a qualified roofing professional.

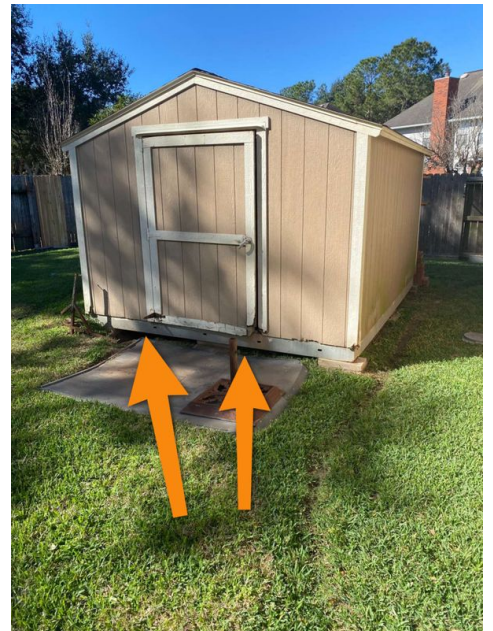
**WOOD ROT AND/OR PEELING PAINT**

There exists evidence of non-structural rot and/or peeling paint in these areas. Areas of wood that are exposed to the elements and missing paint will begin to rot if not corrected. Recommend sanding and repainting. Recommend areas of rotten wood to be replaced.

Contact a qualified general contractor.

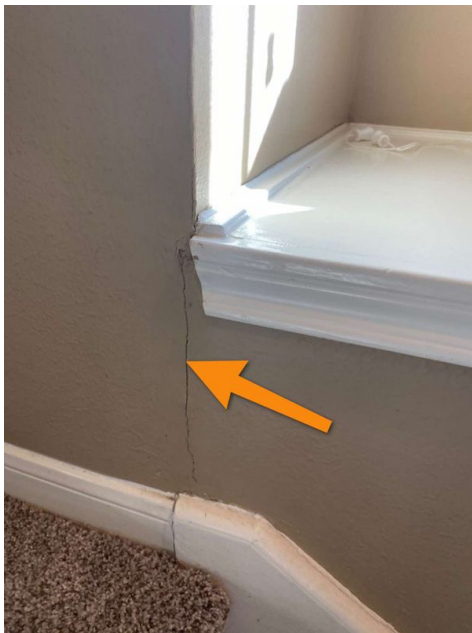
2nd Floor Hall

**CRACKS MINOR**

Minor cracking was observed in wall structure. This is common in homes this age and is often determined to be cosmetic. Cracks can grow over time; recommend monitoring.

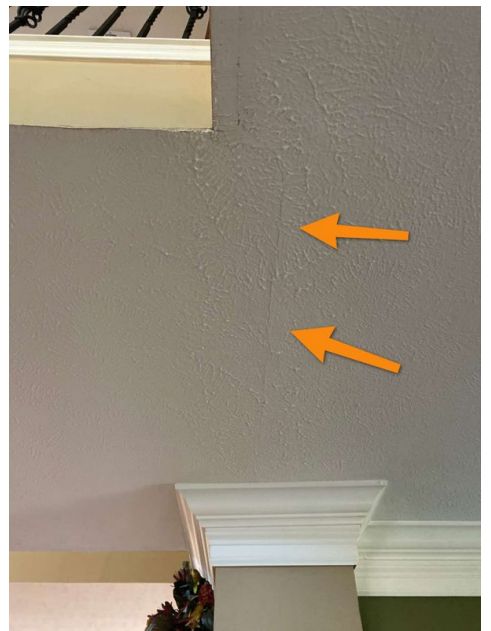
Dining

2.6.1 F. Ceilings and Floors  
**CEILING - CRACKS MINOR**

Minor cracking was observed on the ceiling. This is common in homes this age and is often determined to be cosmetic, most often the separation of drywall tape joints. Recommend monitoring.

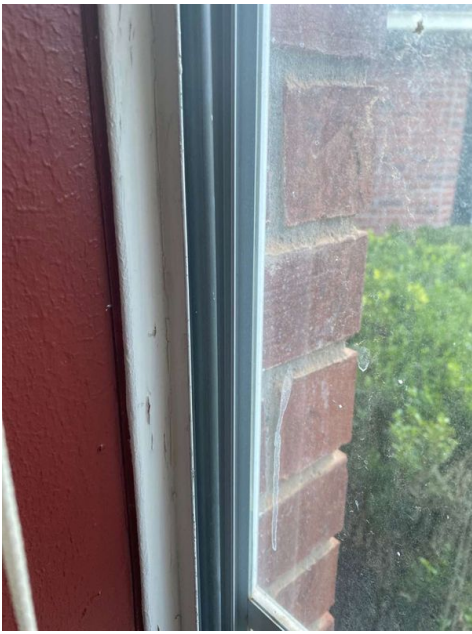
Living

Some windows in the home appear to be single pane. Single pane windows are less efficient and will lead to higher utility bills. Not all window photos are documented in the section, and photos here should be used as an example. Recommend budgeting for replacement of windows, as necessary, in the future for the entire property to undergo a window replacement.

Contact a qualified window repair/installation contractor.

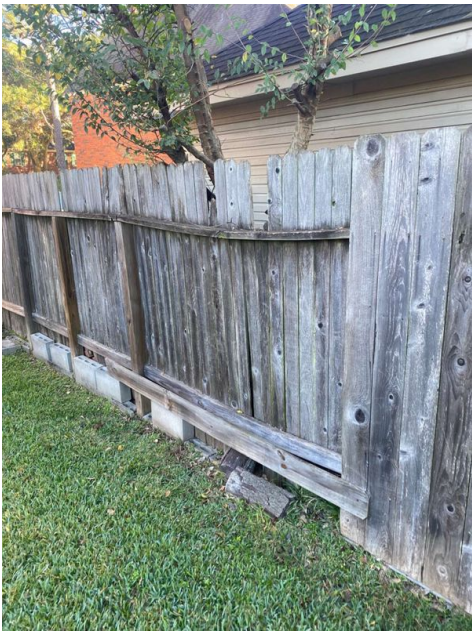
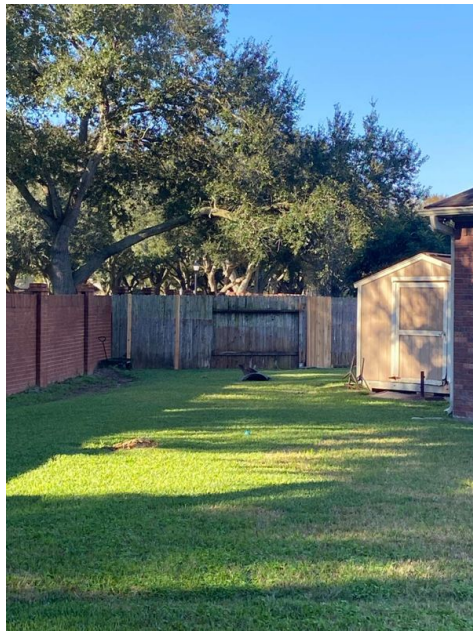
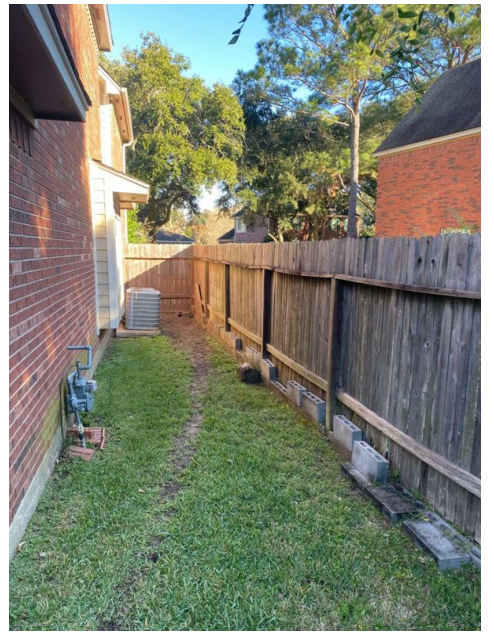
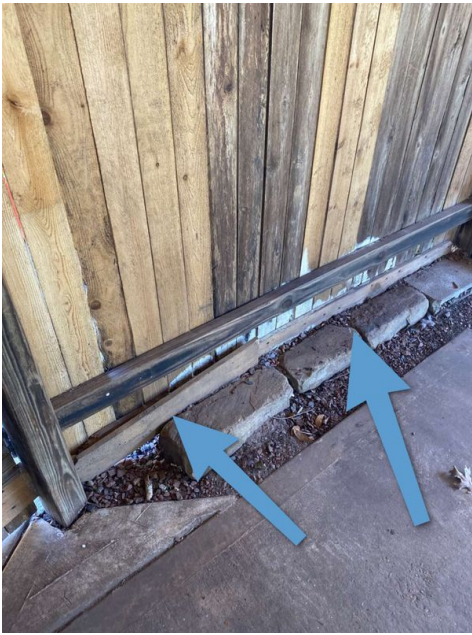
**GATE WON'T OPEN OR DIFFICULT TO OPEN/CLOSE**

Fence gate will not open, or is difficult to open/close and/or will not latch. This could be because of rot damage and/or support issues. Recommend a fencing contractor to resolve the gate issue.

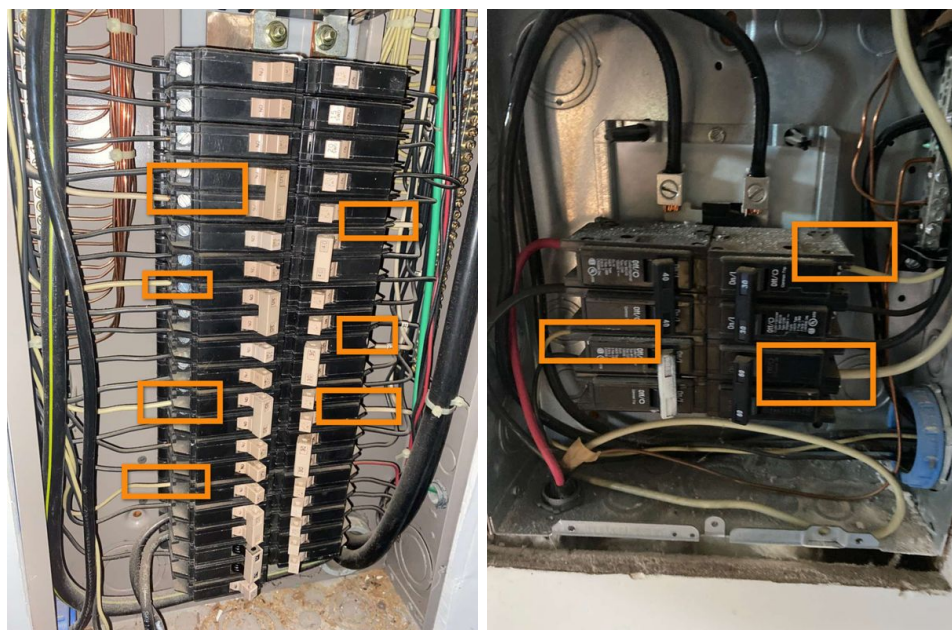
A white wire is connected directly to a breaker without black electrical tape, which would indicate that it is a hot conductor. This white wire is being used as a phase or hot conductor rather than neutral, which in itself is not an issue, but should be denoted as such with black electrical tape wrapped around a portion of it. This will allow an electrician servicing the panel to better understand how the electrical wires are routed. Recommend denoting the white wire as a hot conductor by wrapping it with black electrical tape.

Contact a qualified electrical contractor.

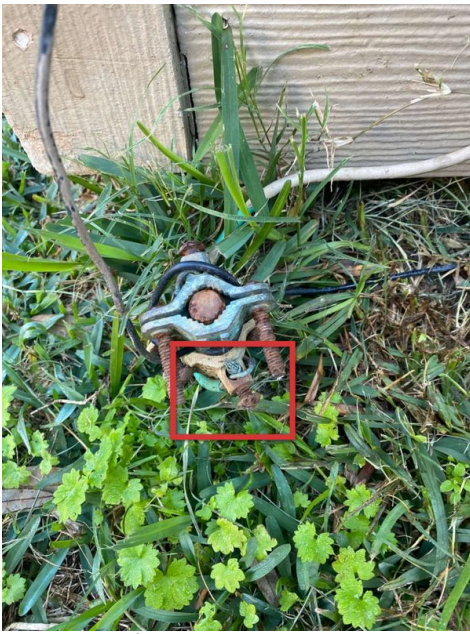
Garage Back

#### **GROUNDING ROD LOOSE OR DISCONNECTED**

The grounding rod is loose and/or disconnected from the main service panel. Recommend an electrical contractor re-establish local grounding to the panel by correcting the grounding deficiency.

Contact a qualified electrical contractor.

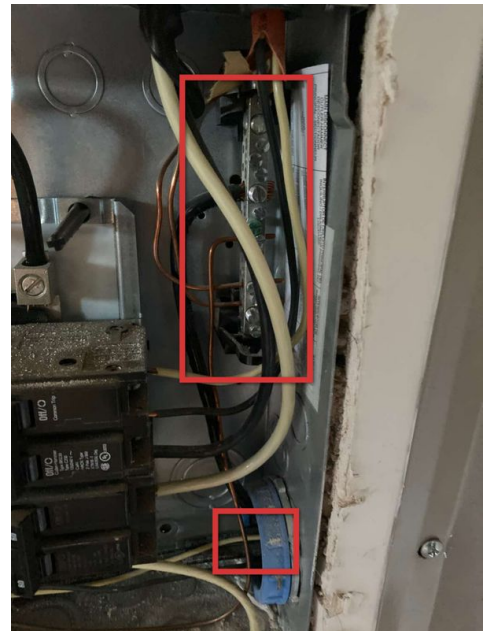
### 3.1.4 A. Service Entrance and Panels **NO SUBPANEL GROUNDING**

Code requires subpanels to have a ground connection that's independent of the main panel's. Panel does not appear to have a ground connection.

Recommendation  
Contact a qualified professional.

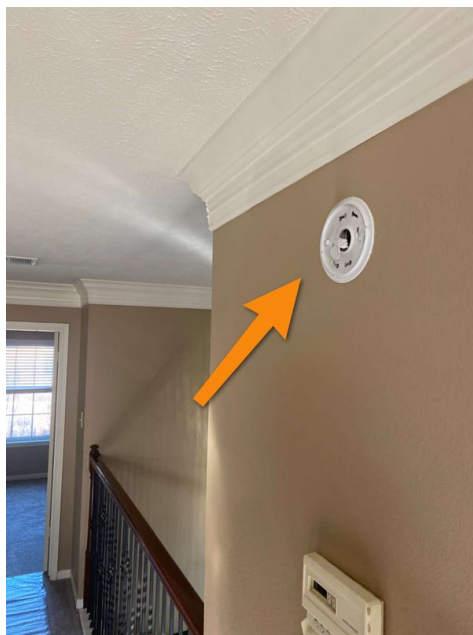
2nd Floor Hall

### SMOKE ALARMS MISSING (ENTIRE HOUSE)

Smoke alarms/detectors are missing in the house in multiple locations. It is recommended that smoke alarms be installed inside each bedroom, outside each sleeping area and on every level of the home. On levels without bedrooms, it is recommended that alarms be installed in the living room (or den or family room) or near the stairway to the upper level, or in both locations. Recommend installation of smoke alarms/detectors in all areas of the home that require them.

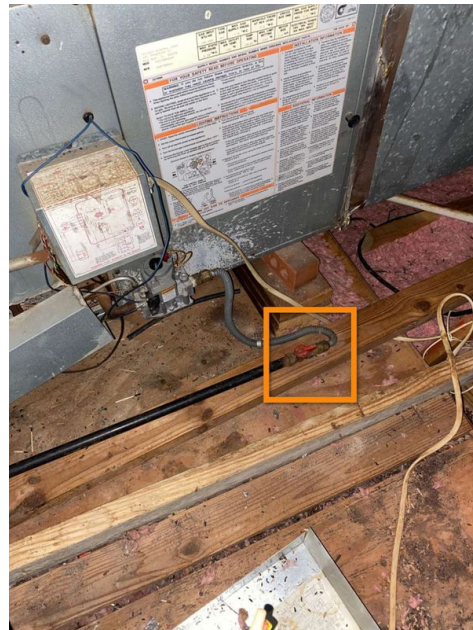
### FURNACE - SEDIMENT/DRIP TRAP MISSING OR INCORRECTLY ORIENTED

The sediment/debris and drip trap/leg on the gas line is incorrectly oriented or is missing. The trap should allow for condensation or sediment in the gas line to fall into the trap. Additionally the shut-off valve should be located before the trap to allow for cleanout. Recommend installing a correctly oriented sediment/debris trap on the gas line prior to entering the unit.

Contact a qualified plumbing contractor.

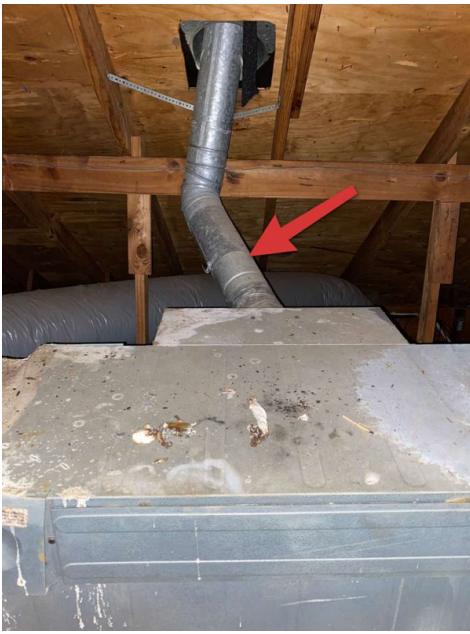
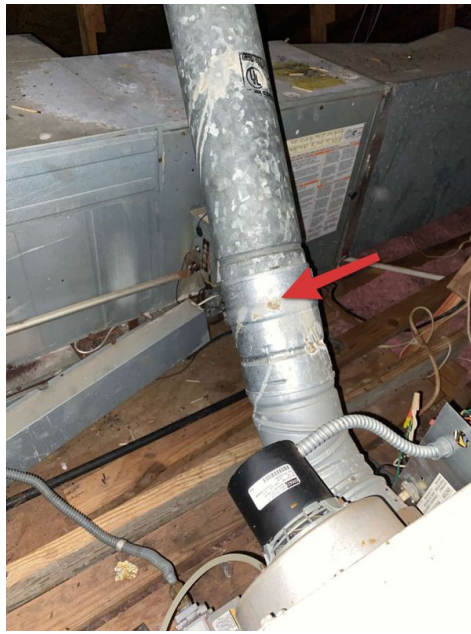
### FURNACE - RISER NOT SUFFICIENT LENGTH

The furnace vent should rise a minimum of 12-inches vertically after the vent connector before extending in any direction horizontally. The rise after the vent connector is not sufficient and could lead to carbon monoxide backdraft. Recommend reinstallation of the riser.

Contact a qualified HVAC professional.

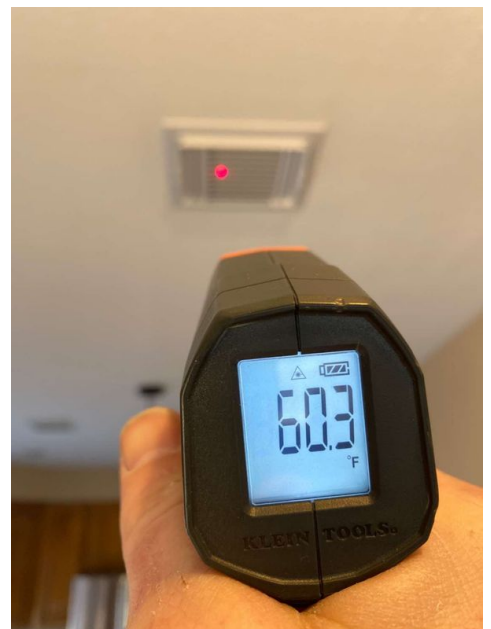
2nd Heating system (Downstairs home) was inoperable at time of inspection and was not producing hot air. Recommend qualified HVAC professional evaluate & ensure functionality.

Contact a qualified HVAC professional.

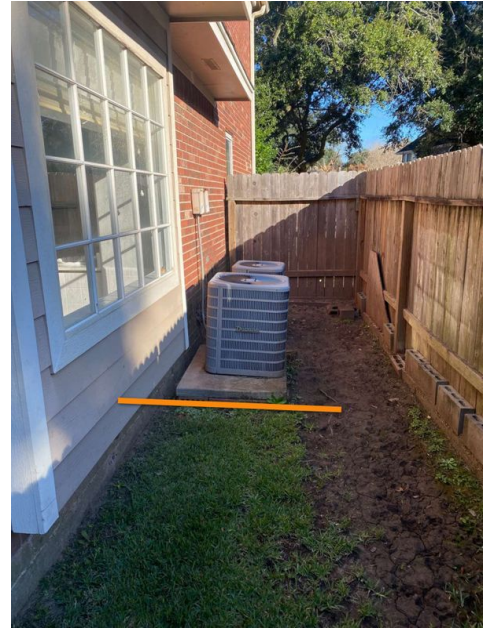
#### 4.2.1 B. Cooling Equipment **CONDENSER - UNIT NOT LEVEL**

Concrete pad supporting the outdoor condensing unit is not level. This can cause accelerated deterioration of components. Recommend licensed HVAC contractor level the unit.

Contact a qualified HVAC professional.

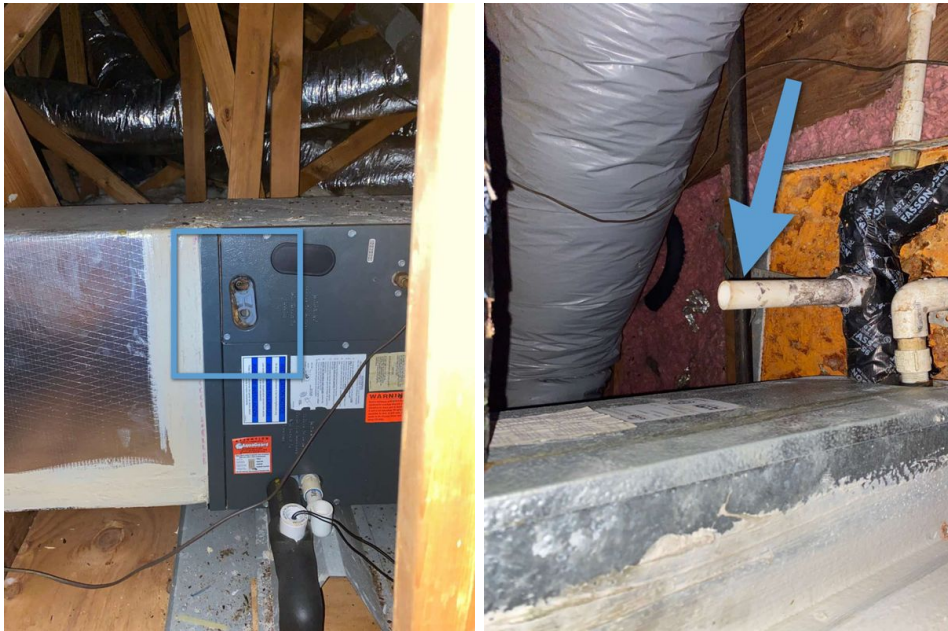
#### 4.2.2 B. Cooling Equipment **EVAPORATOR - CAP MISSING**

Cap Missing. Recommend installing cap.

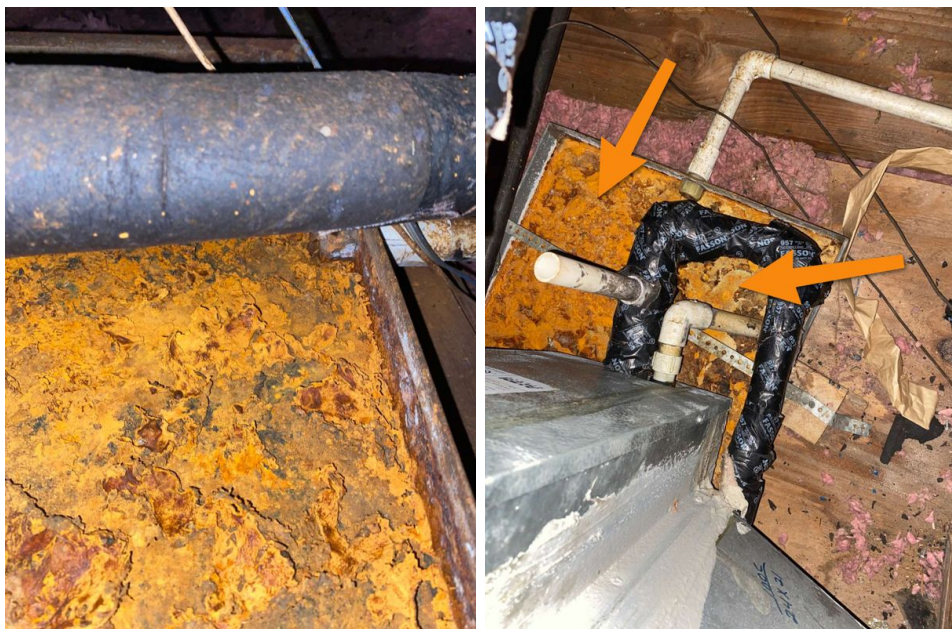
#### 4.2.3 B. Cooling Equipment **EVAPORATOR - RUST PRESENT IN PAN**

Rust is present in the cooling system emergency overflow pan under the AC evaporator (inside unit). This could be caused by malfunctioning with consistent overflows. No active condensation leak into the pan is observed. Recommend careful monitoring.

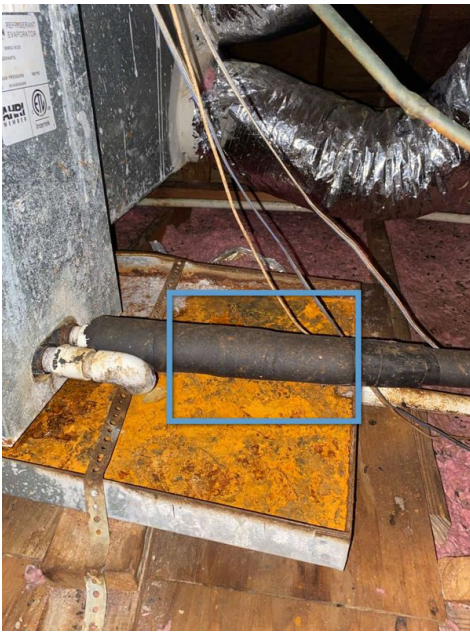
#### 4.2.5 B. Cooling Equipment **EVAPORATOR - MISSING CONDENSATION DRAIN CLEANOUT**

The condensation drain line from the evaporator (inside unit) should have a cleanout location to add bleach for treatment. This is typically done with a vertical T with a removable cap. Recommend adding a cleanout in the drain line.

Recommendation  
Contact a qualified plumbing contractor.

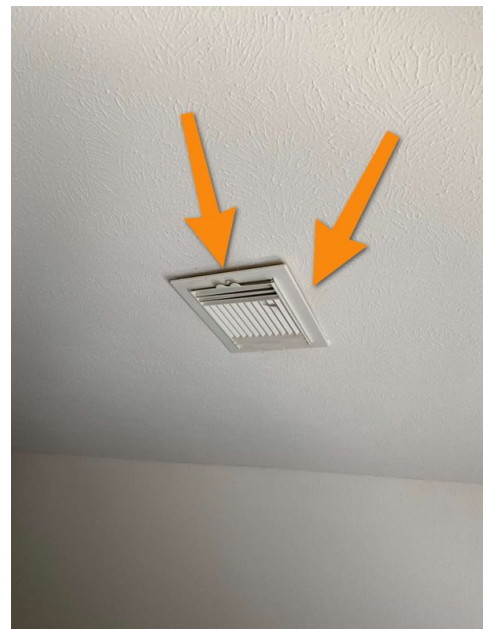
2nd Floor Bedroom

#### 4.3.3 C. Duct System, Chases, and Vents **SUPPLY VENT DAMAGED / MISSING**

Supply air vents were damaged or missing. This can result in a leak and poor heating / cooling efficiency. Recommend a qualified HVAC contractor evaluate and remedy.

Recommendation  
Contact a qualified HVAC professional.

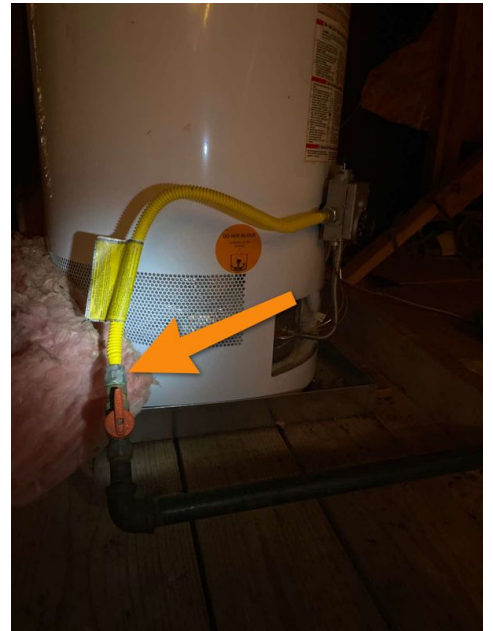
**GAS - SEDIMENT/DRIP TRAP MISSING OR INCORRECTLY ORIENTED**

The sediment/debris and drip trap/leg on the gas line is incorrectly oriented or is missing. The trap should allow for condensation or sediment in the gas line to fall into the trap. Additionally the shut-off valve should be located before the trap to allow for cleanout. Recommend installing a correctly oriented sediment/debris trap on the gas line prior to entering the unit.

Recommendation  
Contact a qualified plumbing contractor.

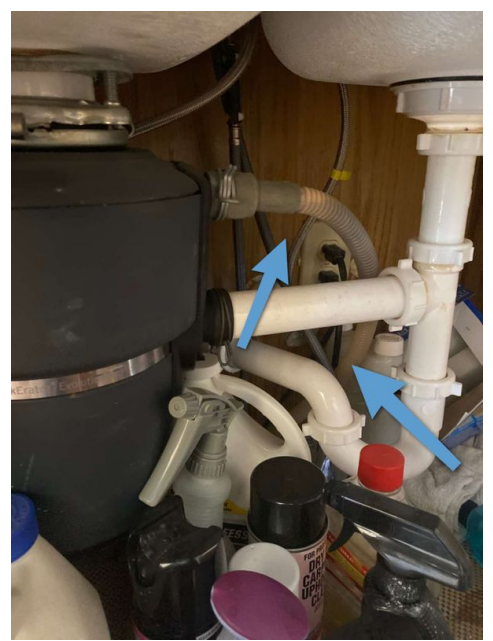
Dishwasher has no high-loop. The high-loop in the drain hose of your dishwasher is to keep water from settling in the hose if it were hanging down any lower or horizontally. This keeps the drain hose dried out and keeps any odors from backing up into the dishwasher.
