## PROPERTY INSPECTION REPORT

**Concerning:** 14724 Perthshire Road Unit F, Houston, TX 77079  
(Address or Other Identification of Inspected Property)

**By:** Kelly M Herbert, Lic #TREC21822 10/22/2021  
(Name and License Number of Inspector) (Date)

Report Identification: P21-1212 Bounds, 14724 Perthshire Road Unit F, Houston, TX

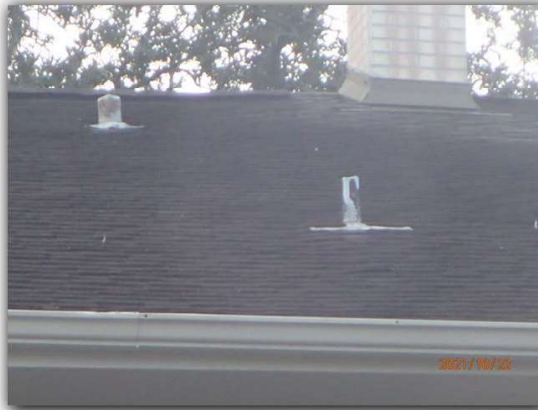
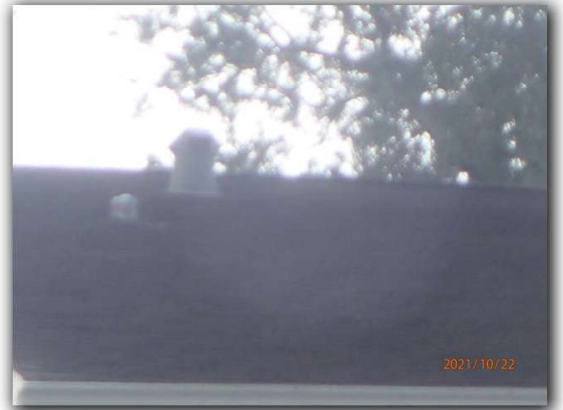
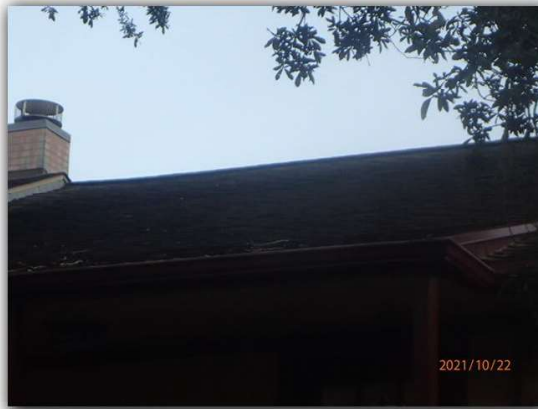
**Shingles appear to be weathered and stained with Grit loss. Recommend Roofing contractor inspect.**

**Observed Lifted Shingles at Front & Back Slopes. Recommend consulting with HOA for maintenance/repair.**

Shingles appear to be weathered and stained with Grit loss. Recommend Roofing contractor inspect.

Observed Lifted Shingles at Front & Back Slopes. Recommend consulting with HOA for maintenance/repair.

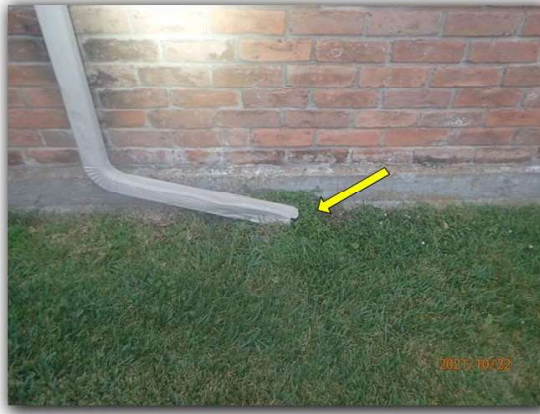
**Rain Gutter downspout missing Splash blocks to direct run-off away from Foundation.**

Rain Gutter downspout missing Splash blocks to direct run-off away from Foundation.

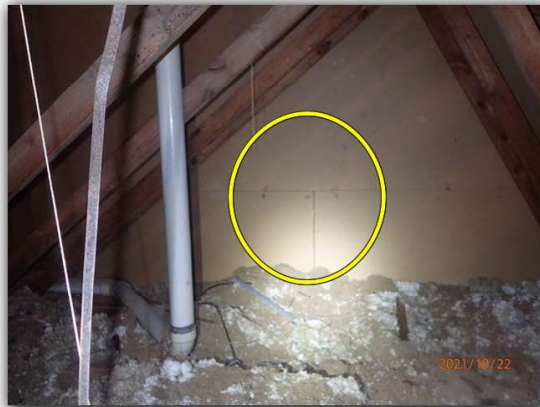
**Drywall between Units not taped (Fire Rated). Fire separation between units incomplete. Recommend a Qualified Contractor further inspect.**

Drywall between Units not taped (Fire Rated). Fire separation between units incomplete. Recommend a Qualified Contractor further inspect.

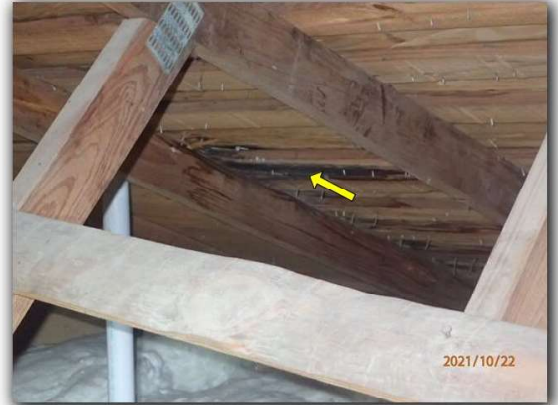
**Observed Water Stains on Roof Deck at Main Structure. Recommend Further inspection by Qualified Roofer.**

Observed Water Stains on Roof Deck at Main Structure. Recommend Further inspection by Qualified Roofer.

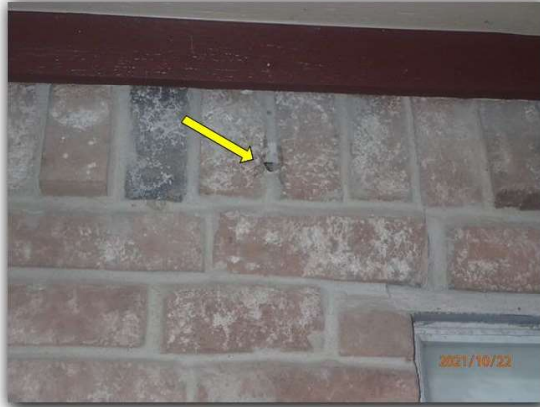
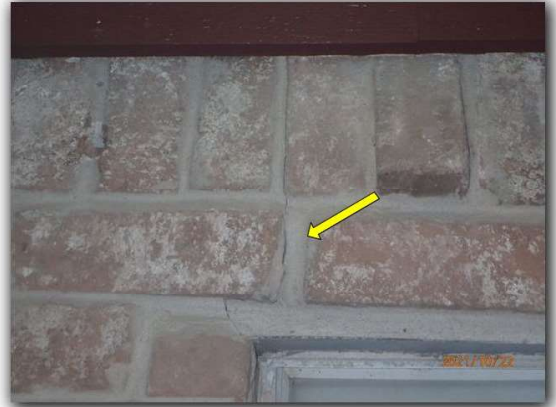
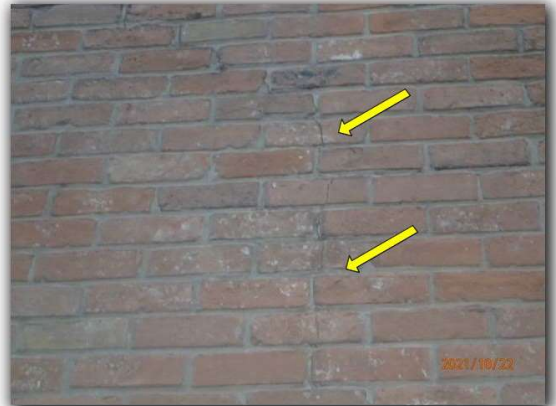
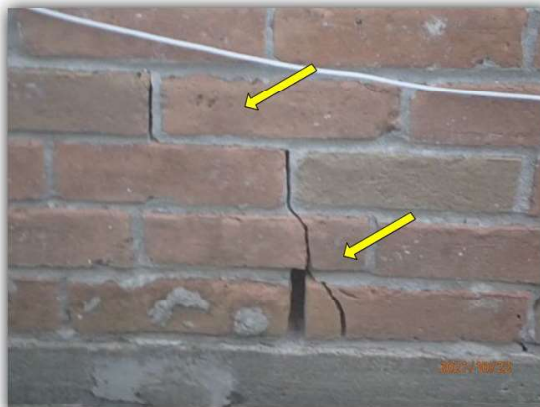
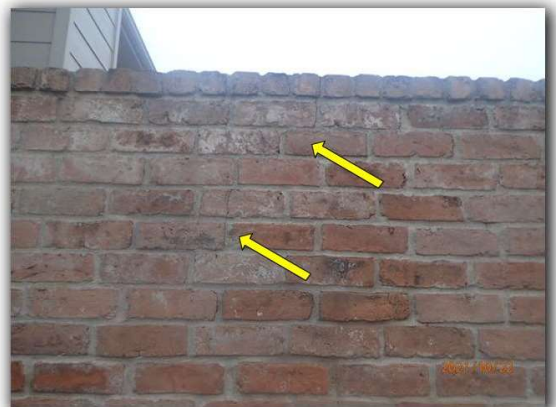
Observed mortar cracks/voids at Front & Right-sides of Structure. Recommend re-pointing mortar.

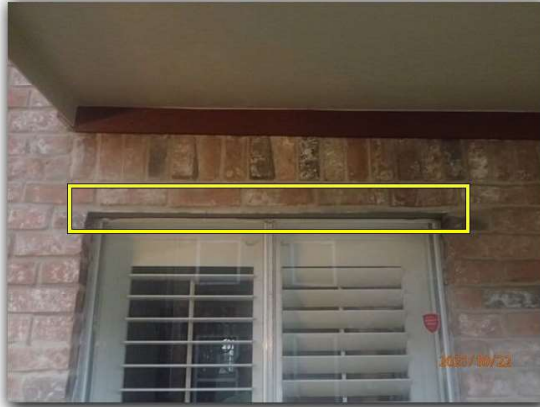
**Weep holes missing above Metal Lintel plates at Window & Door openings.**

Weep holes missing above Metal Lintel plates at Window & Door openings.

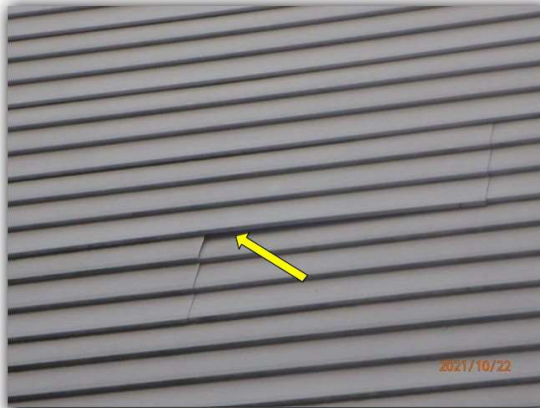
**Observed Loose siding at Upper Right Side. Repair as required.**

Observed Loose siding at Upper Right Side. Repair as required.

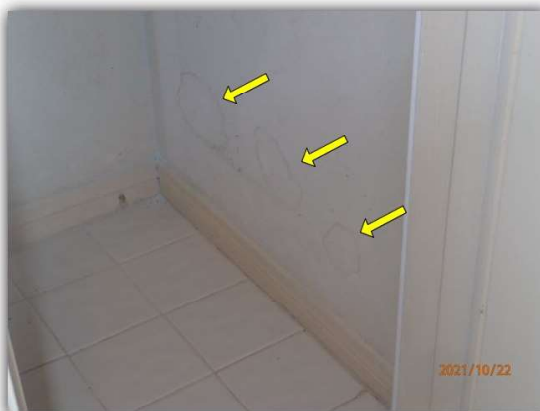
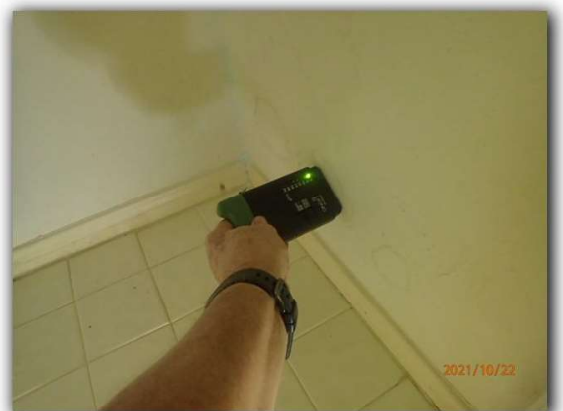
**Observed Water Stains on Drywall at Hall Bath Linen Closet. Area Dry at time of inspection. Measured with Moisture Meter.**

Observed Water Stains on Drywall at Hall Bath Linen Closet. Area Dry at time of inspection. Measured with Moisture Meter.

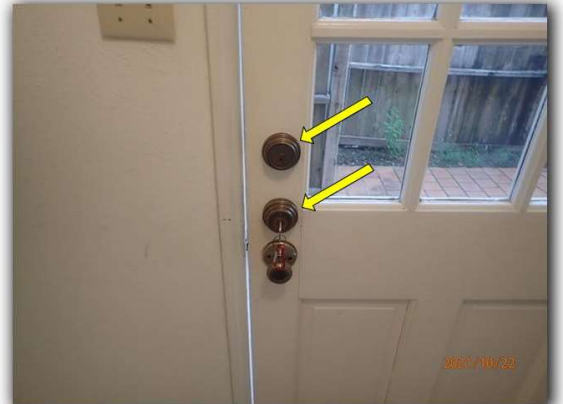
**Exterior door deadbolt double keyed. This could create an egress issue during an emergency. Recommend replacing with a thumb latch.**

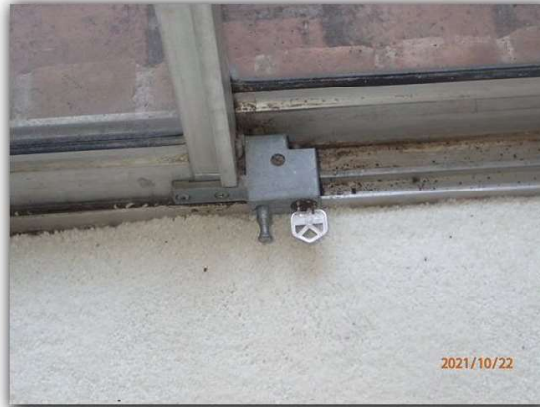
**Right Side Sliding Door Does Not Open. Proper Key not available at time of inspection to unlock.**

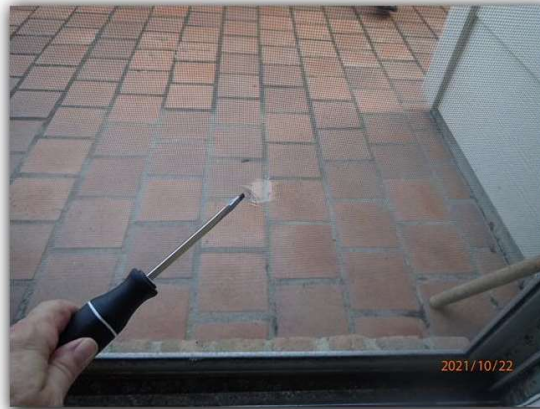
**Screen Damaged at Right-Side Sliding Door.**

Screen Damaged at Right-Side Sliding Door.

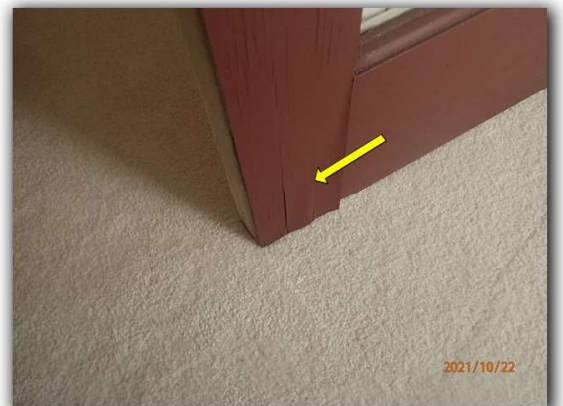
**Wood Deterioration observed on Right-Side Balcony Access Door. Recommend replacing Door.**

Wood Deterioration observed on Right-Side Balcony Access Door. Recommend replacing Door.

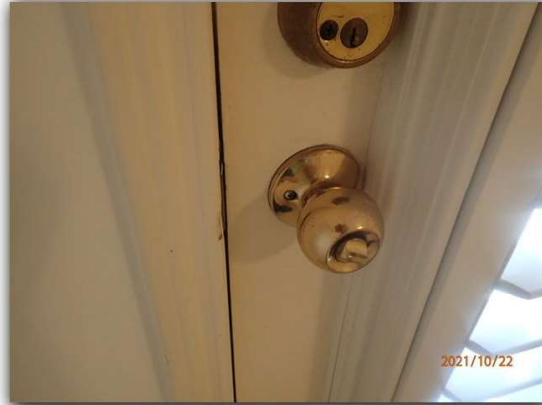
**Latch Set Loose on Door at Left-Side Balcony Access Door.**

Latch Set Loose on Door at Left-Side Balcony Access Door.

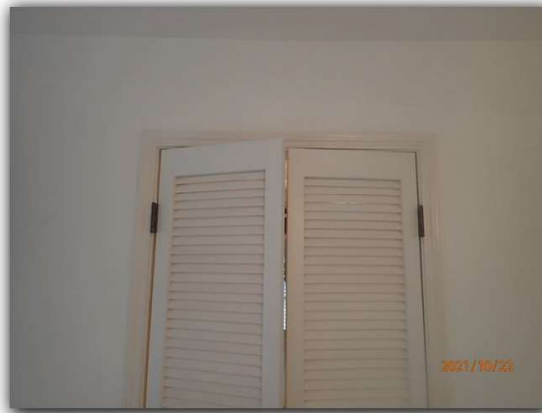
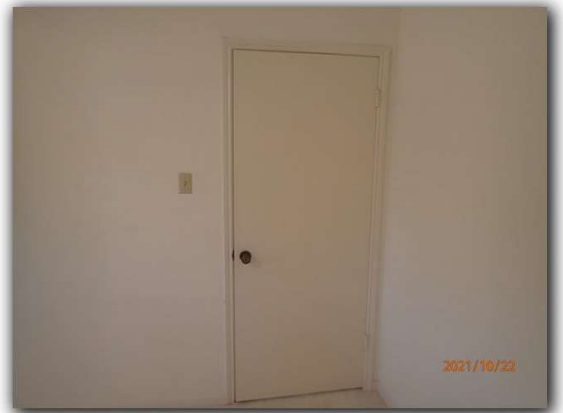
**NOTE: Dead Bolts for Balcony Doors Difficult to operate. Recommend lubricating mechanism.  
Doors Do Not Latch at Kitchen doors to Breakfast Area & Master Bedroom.**

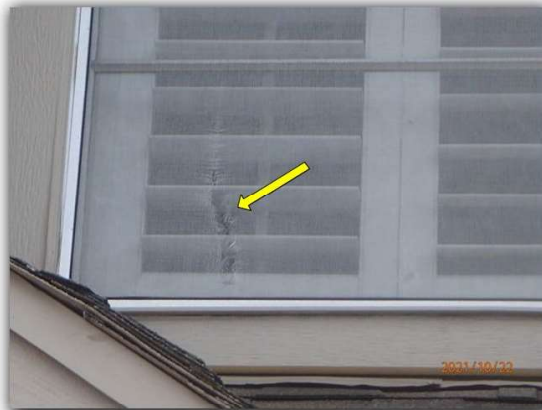
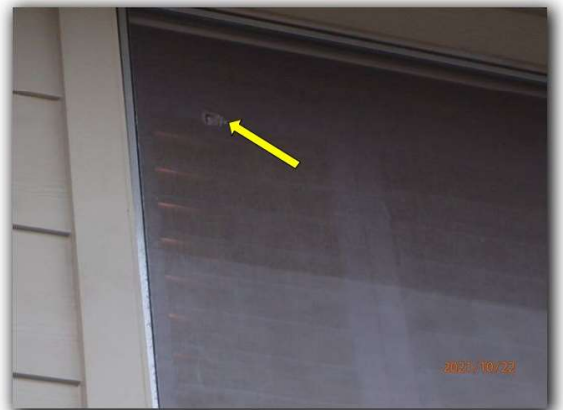
**Window screen damaged at Back Bedrooms.**

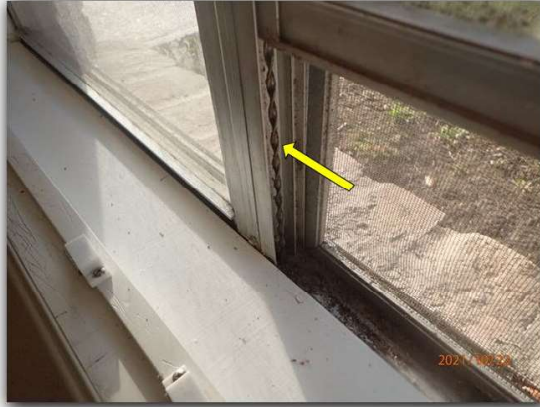
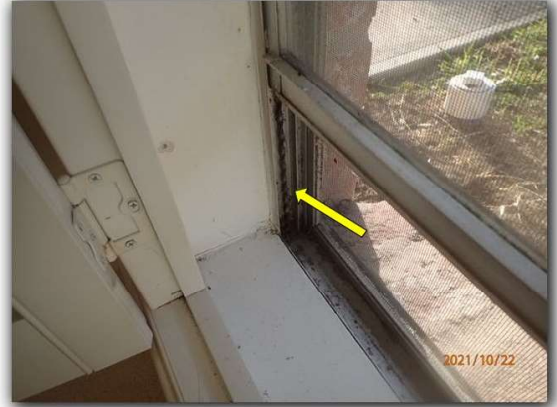
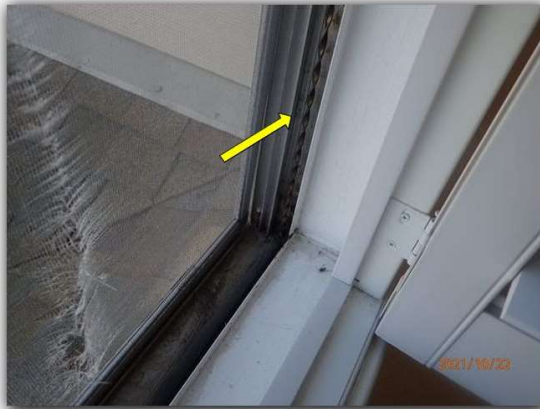
**The window springs have popped loose at Dining Room & Right-Rear Bedroom. Recommend securing guides to ensure proper operation of the window(s).**

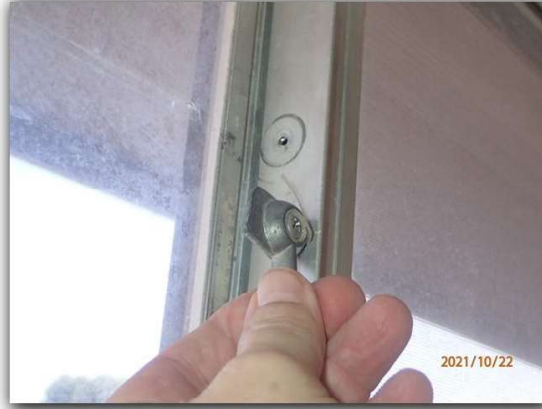
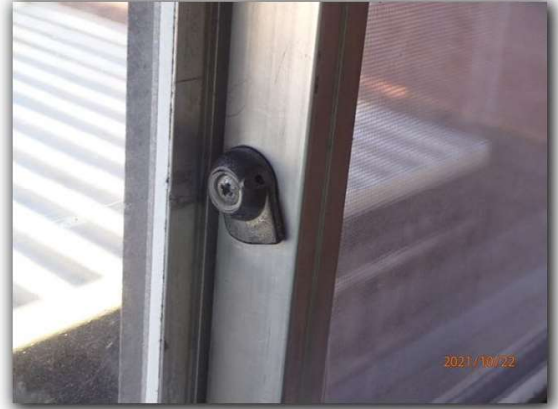
**Window Latches Broken/Missing at Master Bedroom.**

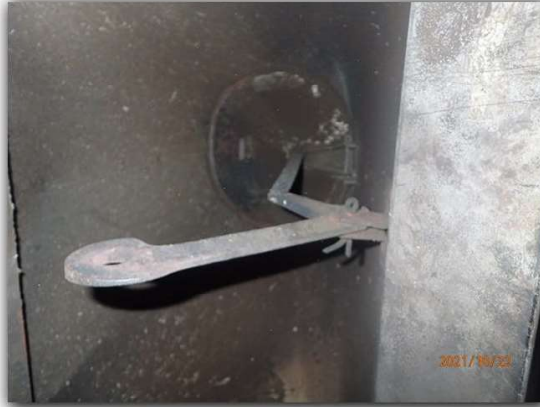
Damper does not open. Recommend not using Fire Place until condition is repaired.

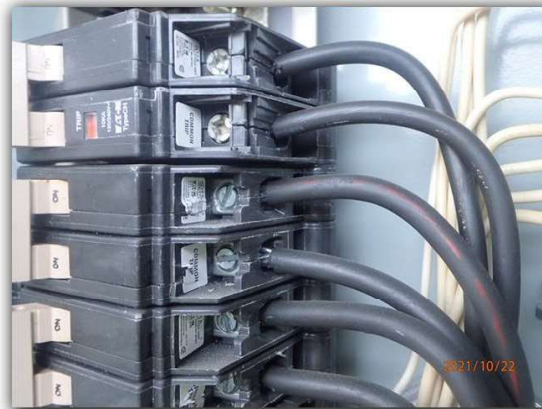
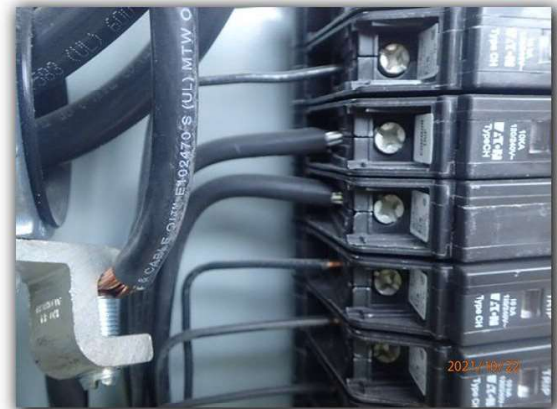
**The writer removed the breaker box cover in accordance with T.R.E.C. directives and found only single copper wiring for the circuits. Also, found aluminum cable that is assumed to go to appliances; therefore, proper connections should have been provided by the manufacturer at those appliances.**

Due to aluminum wiring being found, recommend service and complete system check by licensed electrician.

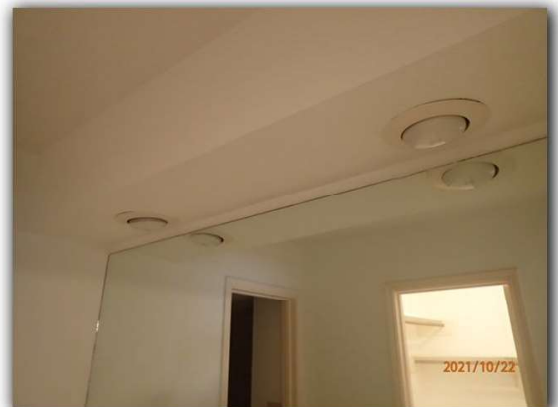
**Light fixture bulb missing/non-functional at Balcony, Left-Rear Bedroom & Master Bath.**

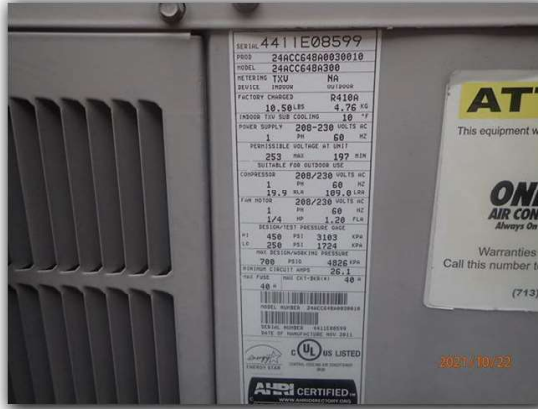
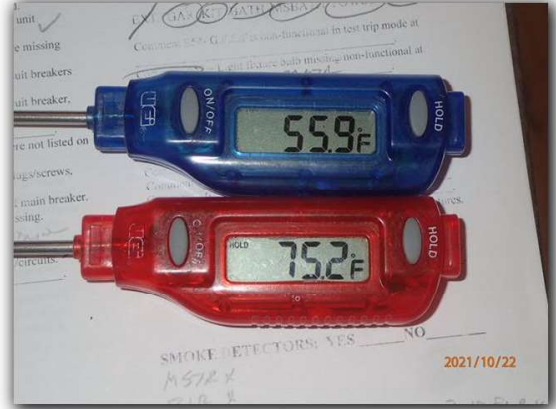
Insulation damaged/missing on Suction line at Condenser.

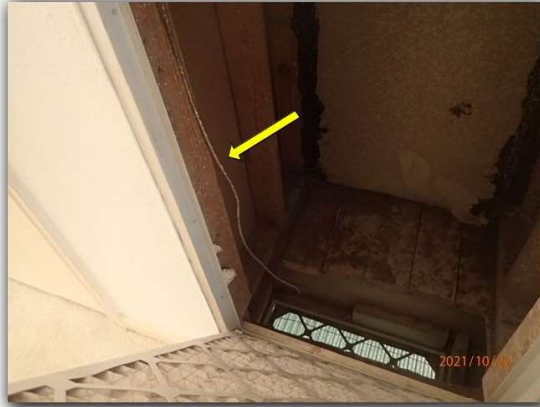
Wiring in return air chase. Wiring/Plumbing other foreign material should not "add" to the fuel load of a fire or add smoke to the Air Handler. NEC Section 300-21

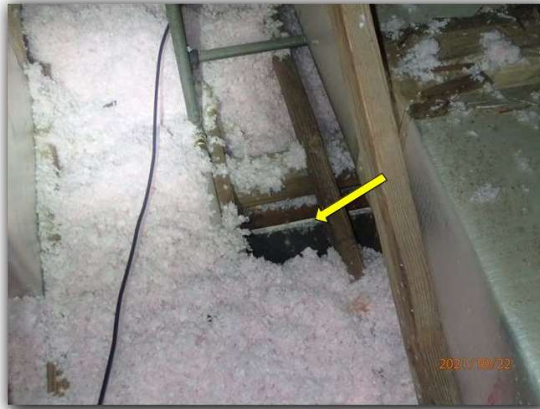
Observed open duct chase at Attic. Recommend covering opening with Insulation.

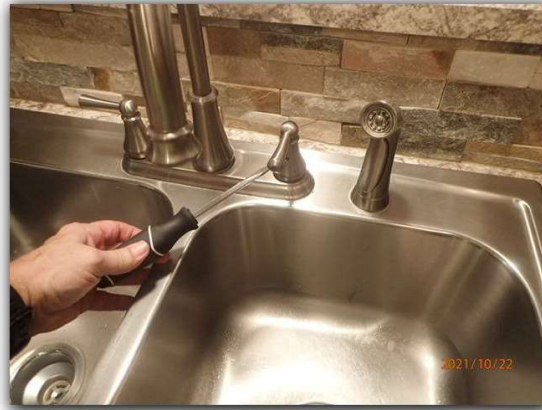
**Water Shut-off Valve Closed, No Supply, to Cold Water Valve.**

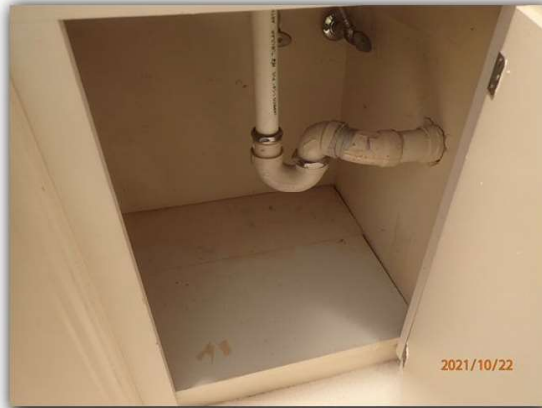
**Drain line leak observed at Sink. Repair as required.**

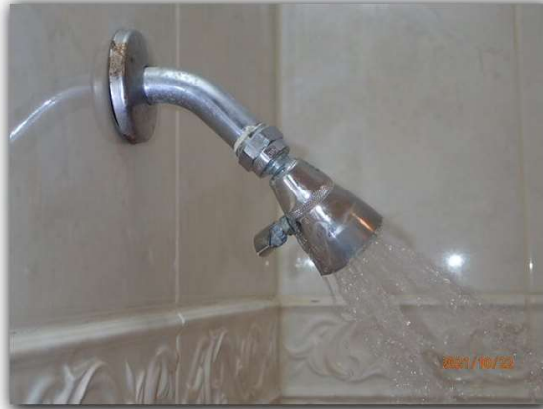
Master:  
**Showerhead leaking at Pipe Connection.**

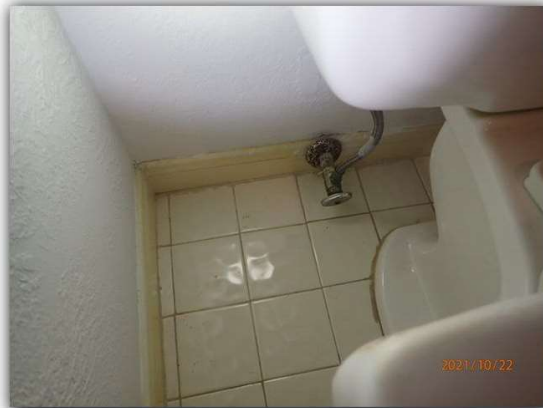
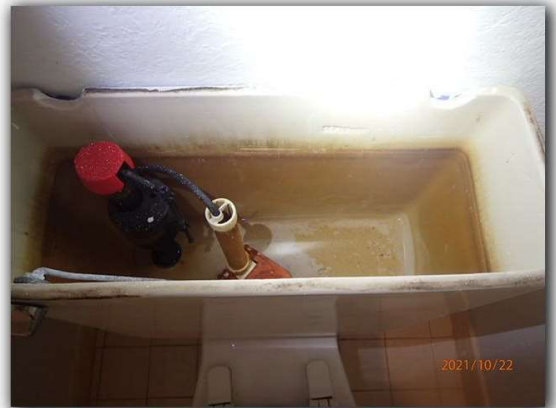
**Bath 3: Upstairs hall**  
**Water Shut-off valve Closed to Toilet. Toilet not operated.**

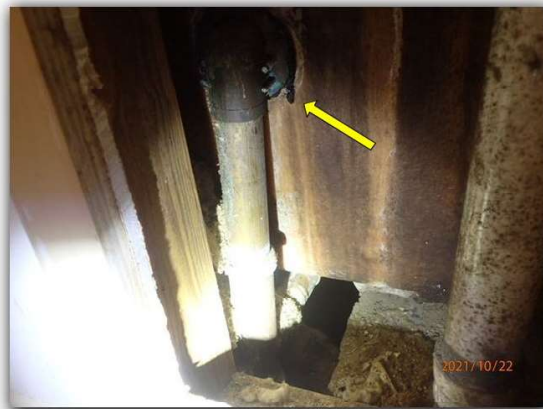
**Observed Drain line leak at Tub in Drain Area. Repair as required.**

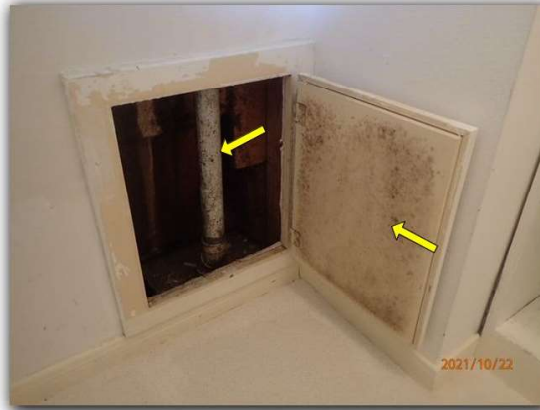
**Microbial Growth observed at Tub Drain Area.**

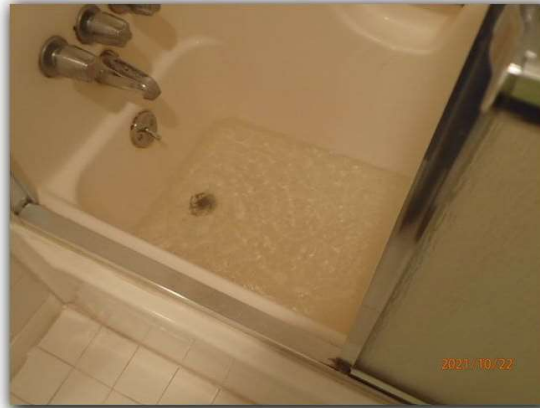
**Tub Drains Slower than Normal. Recommend clearing Drain Line.**

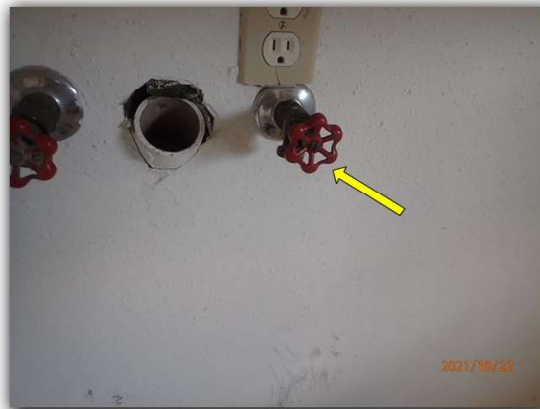
**Washer Connection Leaking at time of inspection. Cold Water Valve.**

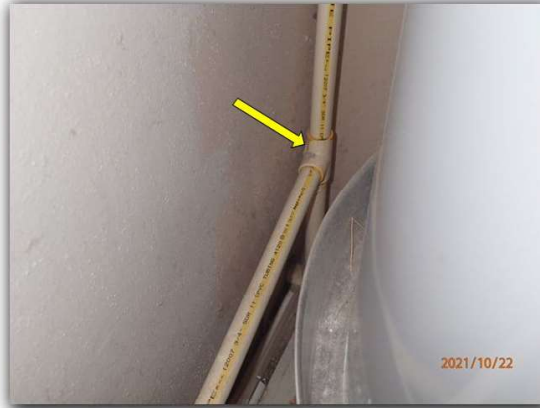
T/P Valve Discharge Line improperly installed. T/P Valve Shall not have any valve, T fitting or other obstruction between the relief valve and the drain.

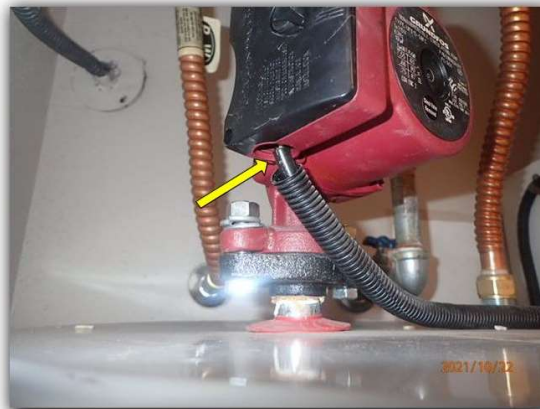
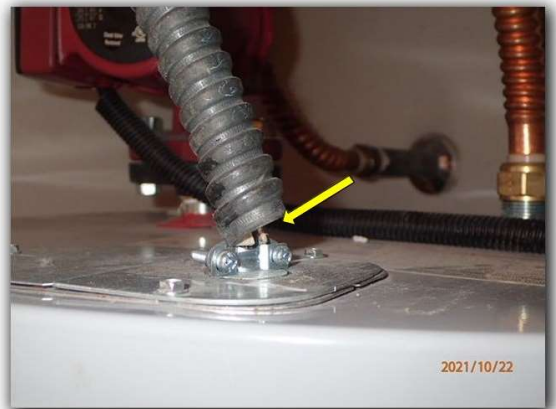
Wiring exposed out of Conduit at Water Heater Connection.

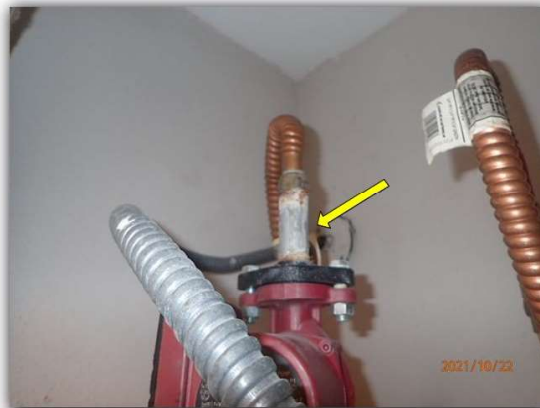
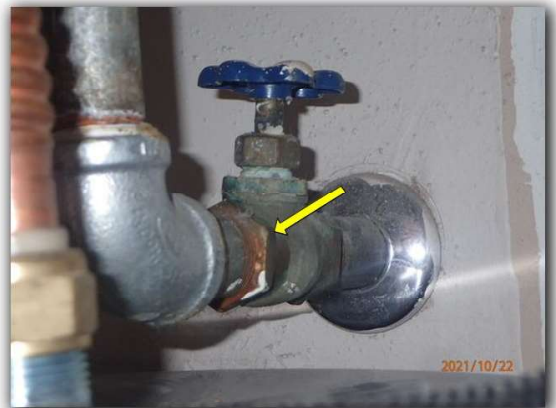
Corrosion at Inlet/outlet water lines at unit.

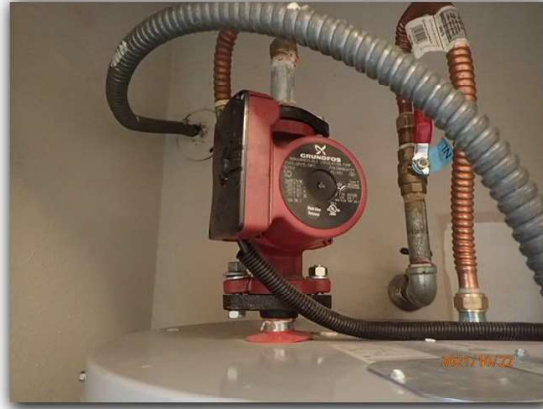
**Observed Circulation Pump installed at Water Heater. This unit is outside scope of inspection.**

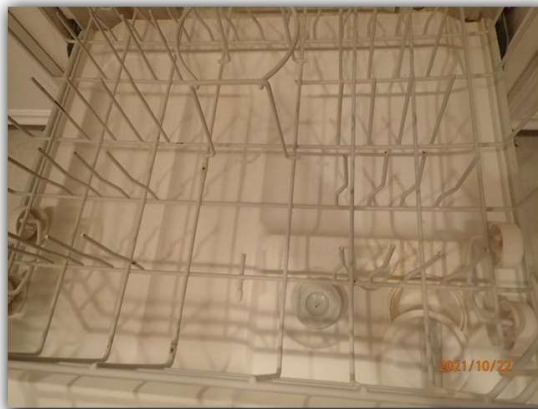
**Observed rust on Dishwasher Trays.**

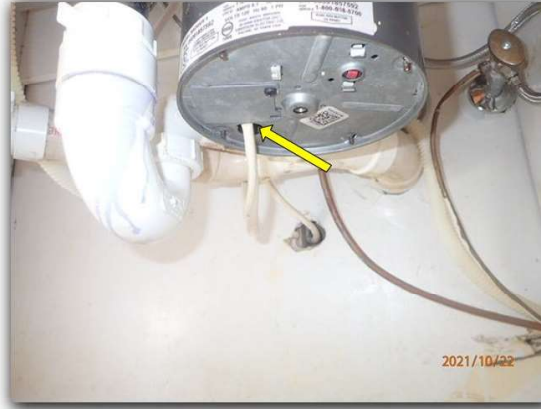
**Protective wire clamp missing at electrical connection.**

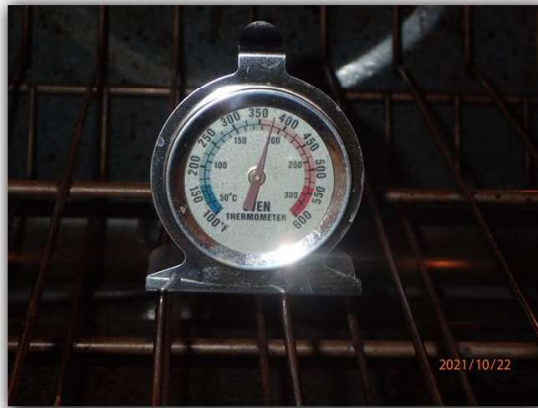
Thermostat set at 350°F      Achieved: Oven **375** °F  
**Oven off temperature. Recommend calibrating unit.**

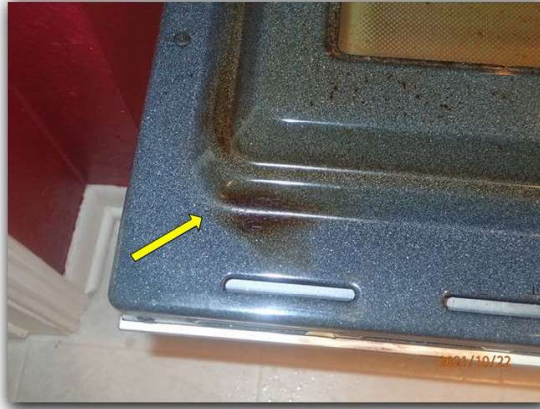
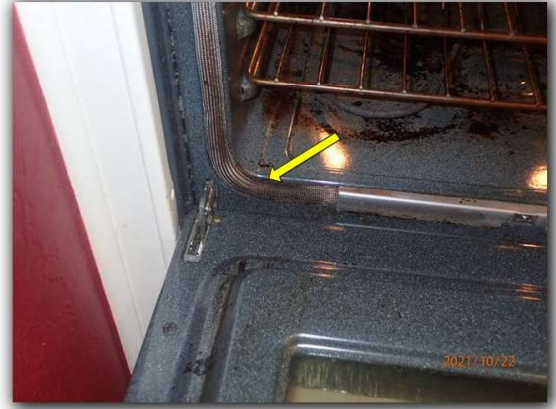
**Gasket in oven door is damaged, not sealing properly.**

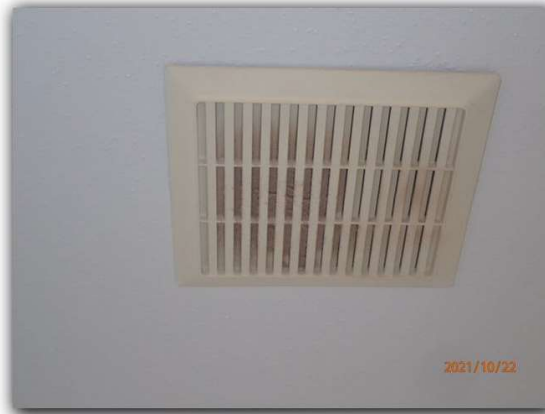
**Exhaust fans dirty at Master & Hall baths. Recommend cleaning to insure proper operation.**

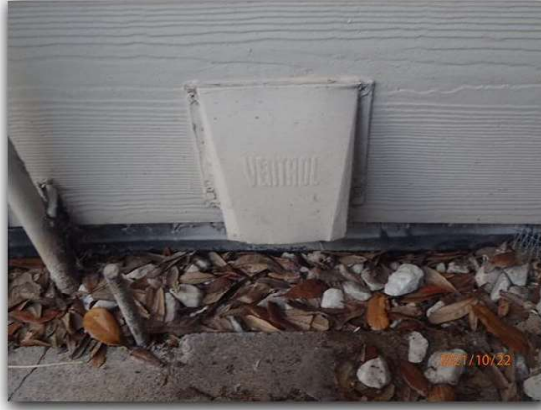
**Lint/Debris observed at dryer vent. Flapper blocked open. Recommend thorough cleaning.**

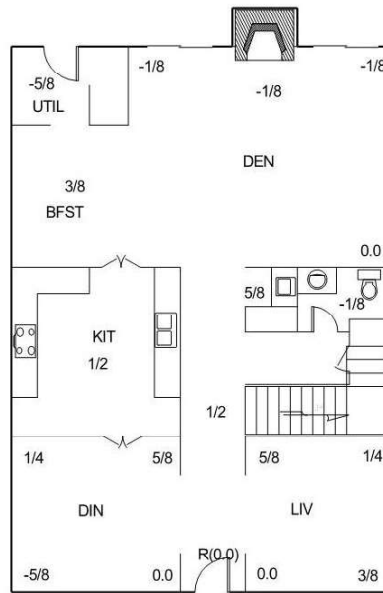
**Elevation survey as indicated on Sketch 1 showed no indication of settlement and or movement that would require foundation repair. Maximum elevation difference +/- 5/8" to reference (R0.0).**

Elevation survey as indicated on Sketch 1 showed no indication of settlement and or movement that would require foundation repair. Maximum elevation difference +/- 5/8" to reference (R0.0).
