# Inspection Report

**Property Address:**  
6606 Belmont Bend  
Katy TX 77450

# PROPERTY INSPECTION REPORT

**By:** Steven Walters TREC#22910 / Home Plate Inspections, LLC 11/23/2021

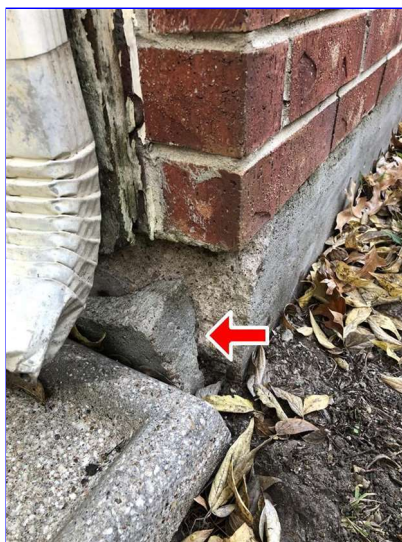
A. Item 2(Picture)

Corner pops were observed, on the back left corner recommend re-attaching piece of foundation that has been broken off. Item 2(Picture)

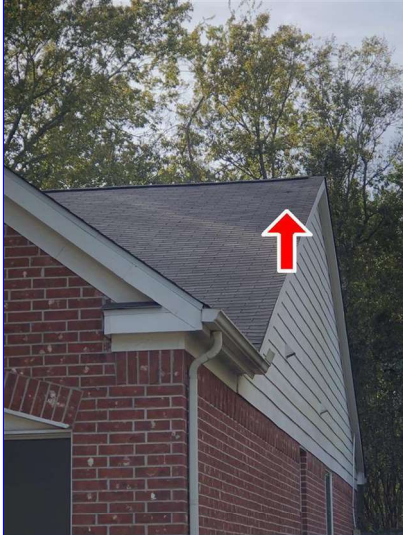
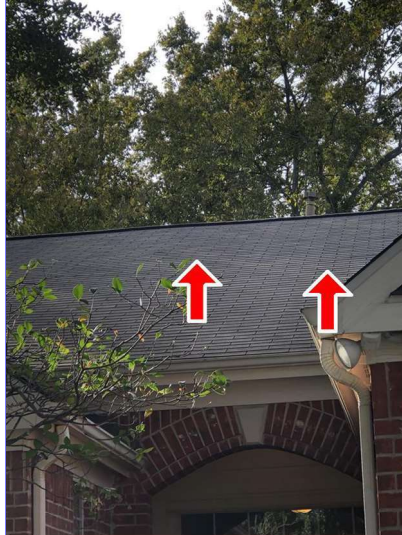
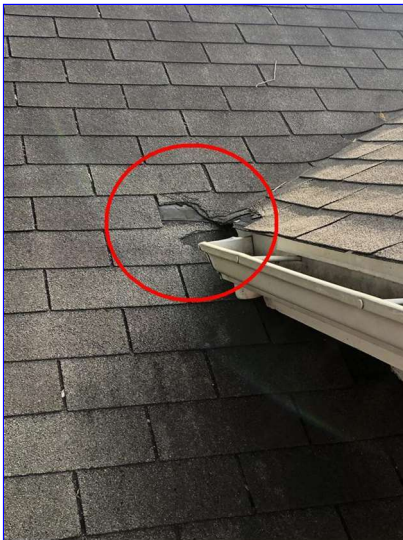
On the roof there were what appeared to be nail pops observed. Towards the front of the house there is a small section near a valley where shingle damage is present. Recommend a roofer to fix nail pops and make any other needed repairs.

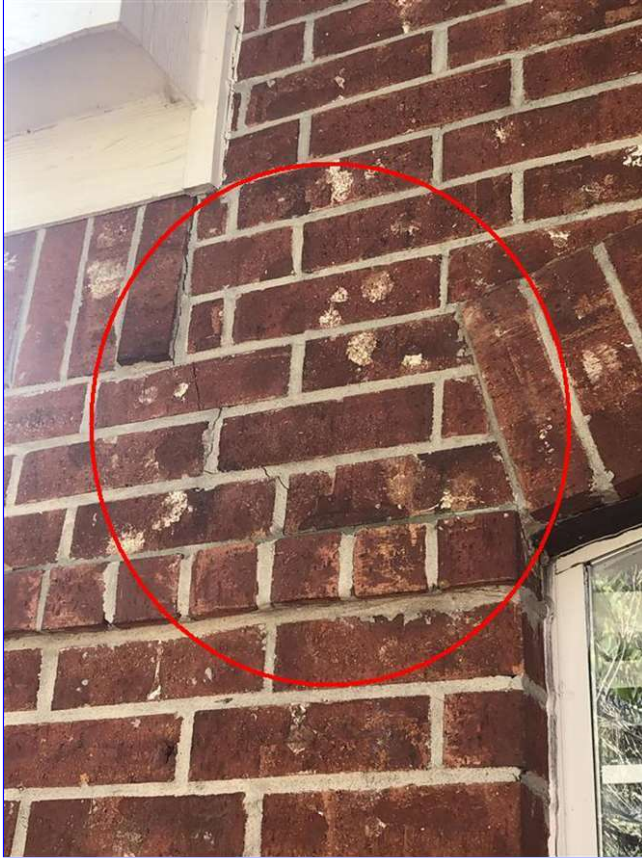
E. Item 1(Picture)

On the front of the home there is a crack that runs through the brick and the mortar towards the window casing. This crack needs to be sealed to prevent moisture penetration. Recommend monitoring cracked area for any changes or spreading over time. Item 1(Picture)

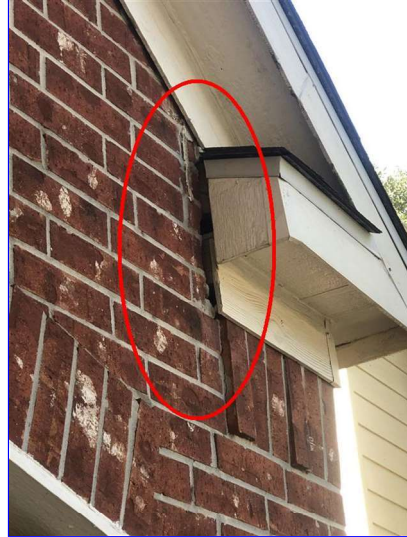
E. Item 2(Picture)

The right side of the garage door - near the soffit needs to be sealed. Currently an area of exposed framing. Item 2(Picture)

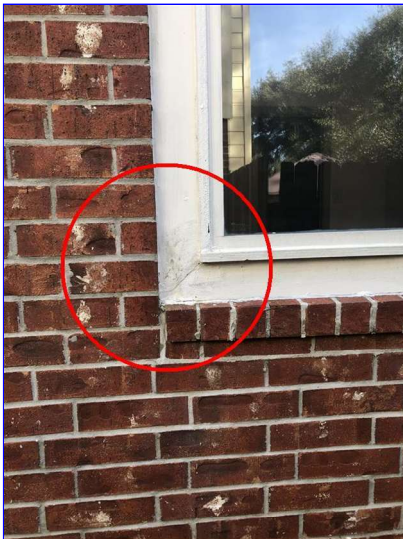
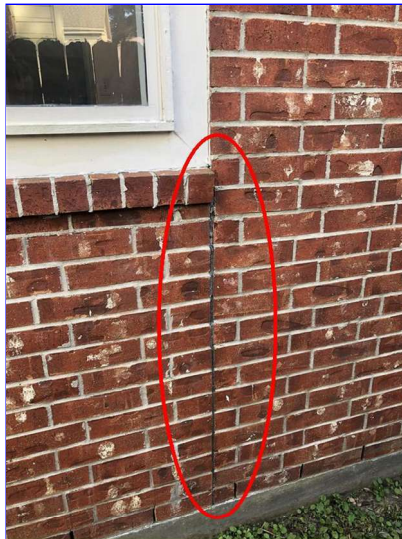
On the right side of the house there is some soft/rotten wood near the bathroom window. This casing around the window needs to be replaced before further damage occurs. Also below this window the expansion joint in the brick needs to be re-sealed. Item 3(Picture) Item 4(Picture)

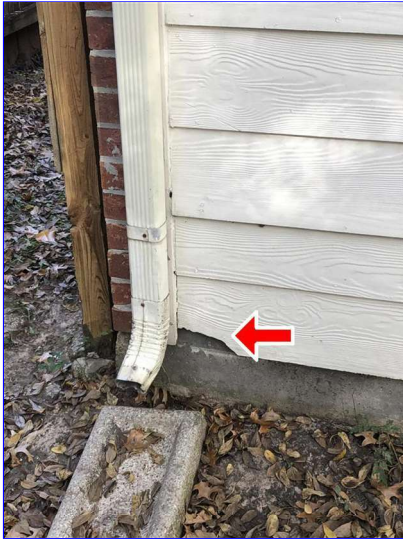
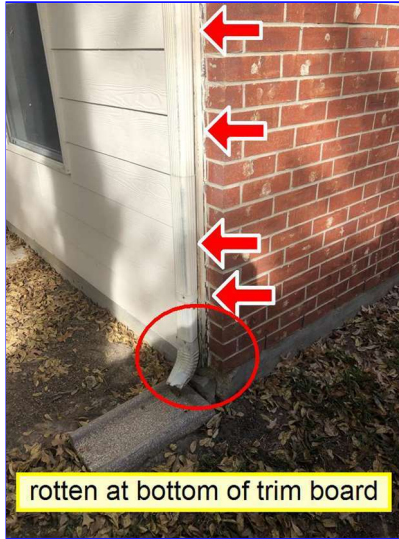
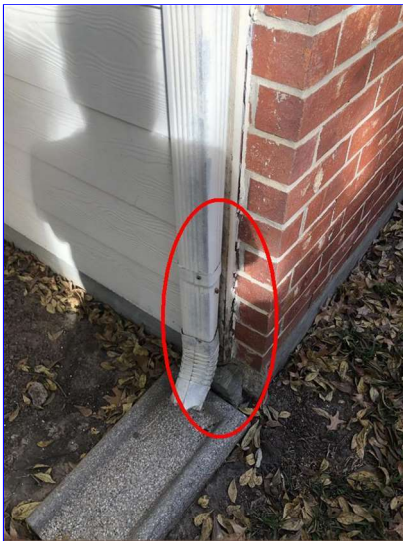
The back left corner of the house there is some rotten wood trim that needs to be replaced, this trim board should also be caulked/sealed the brick. Some broken siding on the back of the house was also observed. Item 5(Picture) Item 6(Picture) Item 7(Picture)

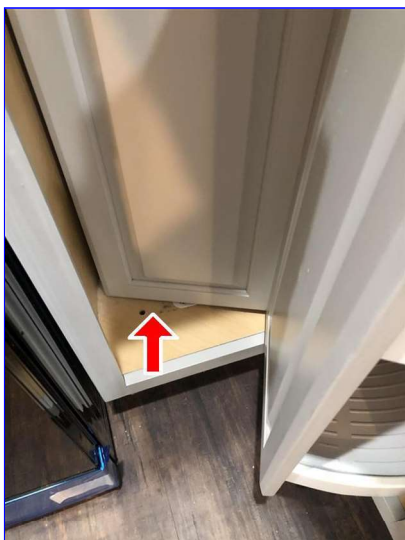
G. Item 1(Picture)

The corner cabinet door does not open/spin as it should, currently there is a screw head sticking up that is keeping the door from working as it is intended to. Recommend installing a flat head screw in place on the current one. Item 1(Picture)

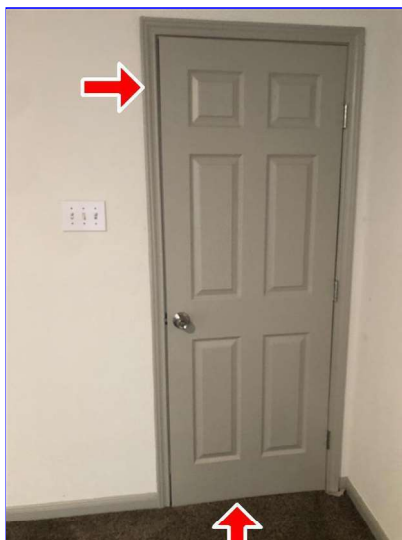
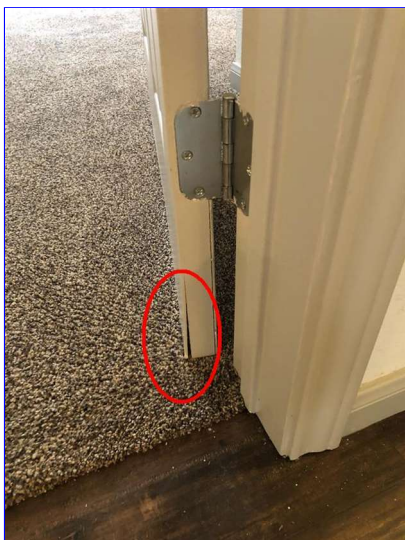
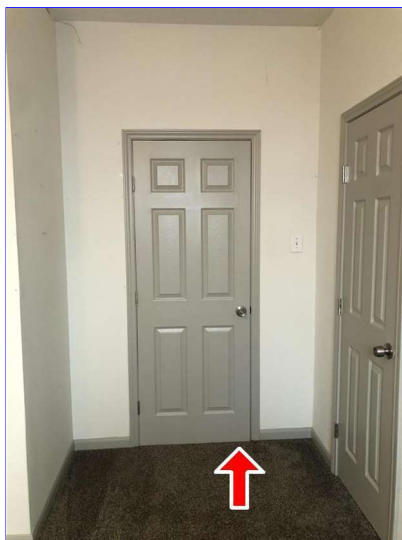
All bedroom doors need to be adjusted, they are dragging on the carpet which is causing the doors to separate. The tension on them is pulling the facing off the door. The primary bedroom door does not shut properly in the casing as well. Recommend contractor to adjust all interior doors before further damage is done to them. Item 2(Picture) Item 3(Picture) Item 4(Picture)

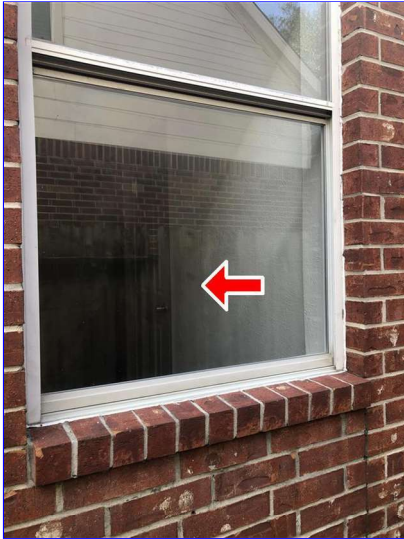
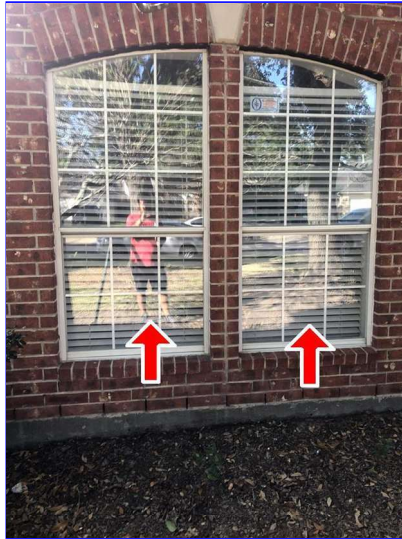
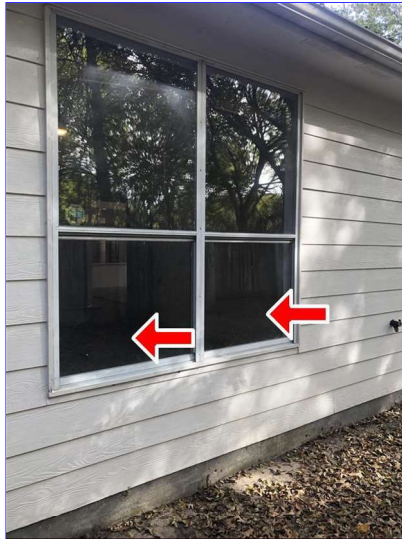
All windows that open are required to have screens for safety. There are numerous windows on the home that are missing these required screens. Recommend seller have proper screens installed. Item 1(Picture) Item 2(Picture) Item 4(Picture)

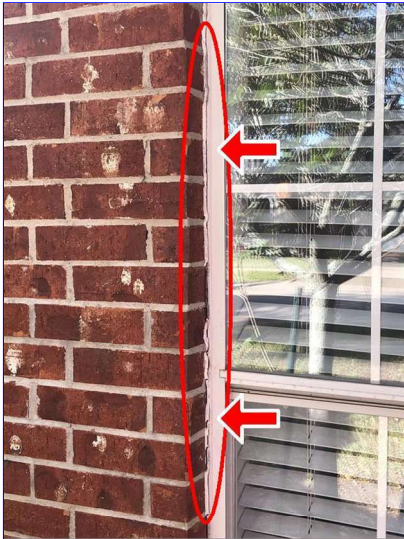
H. Item 3(Picture)

There are windows on the front of the house that need to be caulked around to seal to the casing, this is to prevent possible moisture penetration. Item 3(Picture)

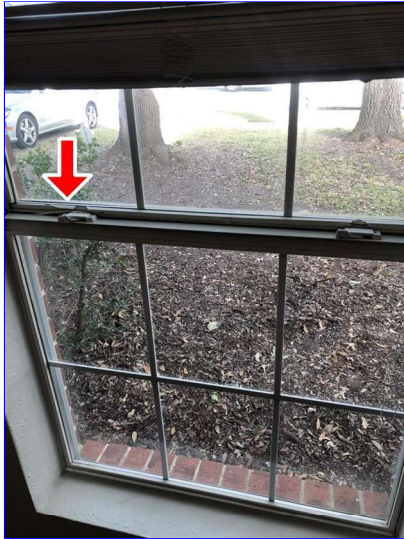
H. Item 5(Picture)

Inside - the front left bedroom - the window on the left has broken trim and will not stay open when raised. Recommend adjustment on the window. Item 5(Picture)

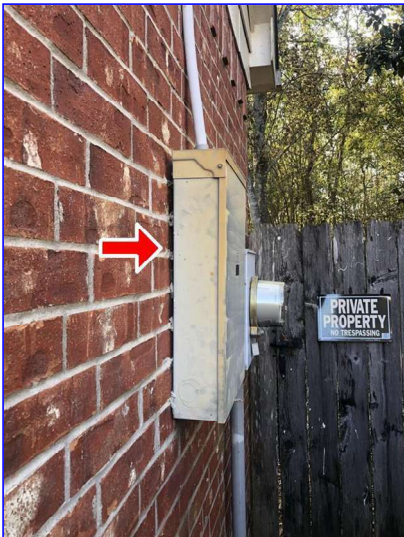
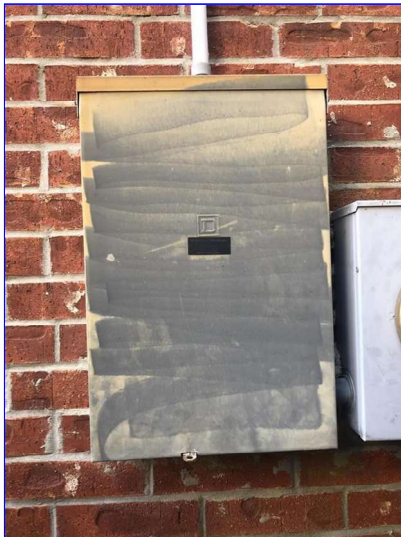
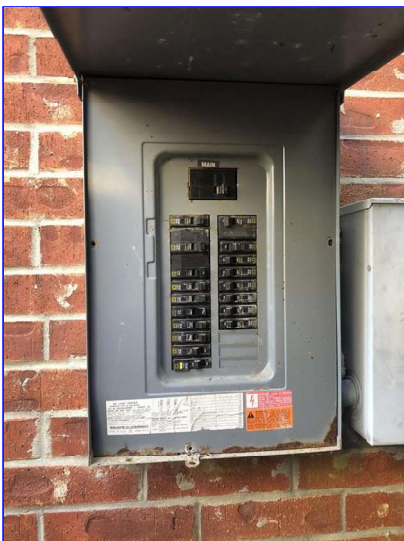
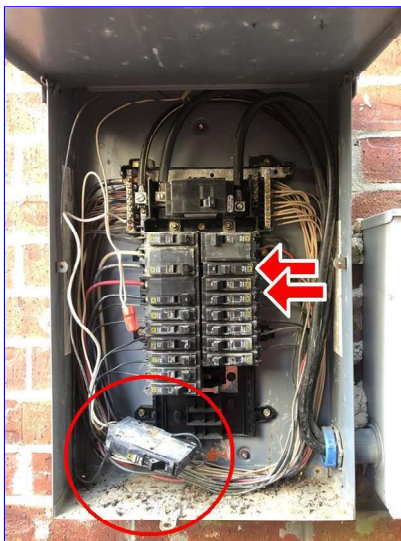
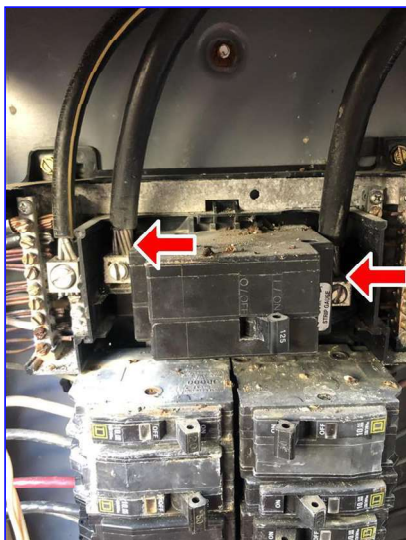
The main panel is located on the right side of the home on the exterior wall. This panel needs to be sealed around it to the brick to prevent moisture penetration behind and inside the panel. It was observed that the dead plate is missing some of the screws that hold it on.

When the inspector removed the dead plate, the main feed lines are missing the needed anti-oxidant paste to protect them from corrosion. Also the bottom left breaker is broken, it does not stay clipped into the panel, the breaker will need to be replaced. There are 2 other breakers that are very loose that had to be clipped back in as well.

Recommend a licensed electrician to assess over all panel and make any needed repairs.

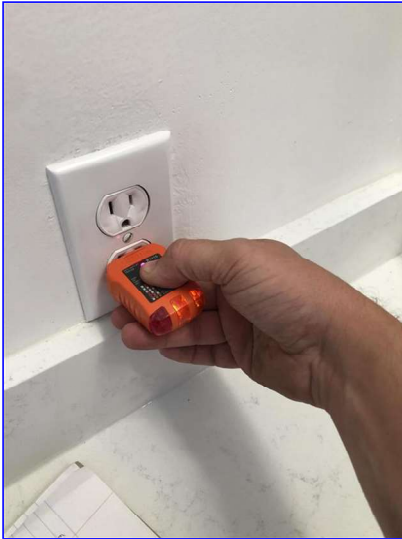
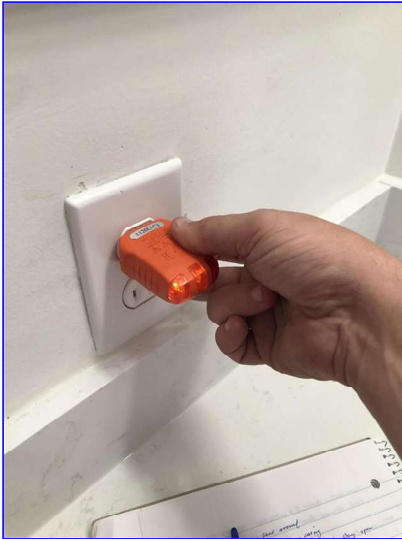
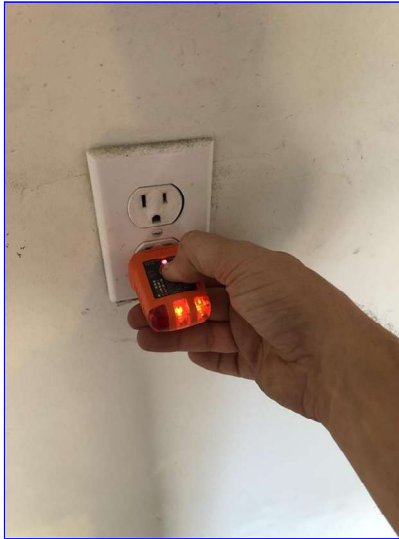
All bathroom plugs must be GFCI protected - none of the bathroom plugs are GFCI protected currently. Recommend a licensed electrician to install proper plugs. GFCI plugs are required within 6 feet of water sinks, as well as in the garage and laundry room. Item 1(Picture) Item 5(Picture) Item 6(Picture)

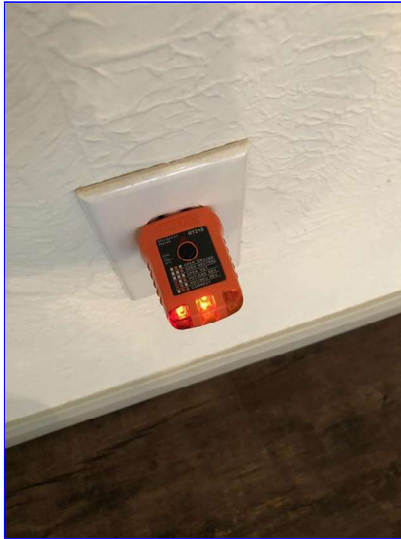
B. Item 2(Picture)

A plug in the front living area is wired with the hot and neutral wires reversed. Item 2(Picture)

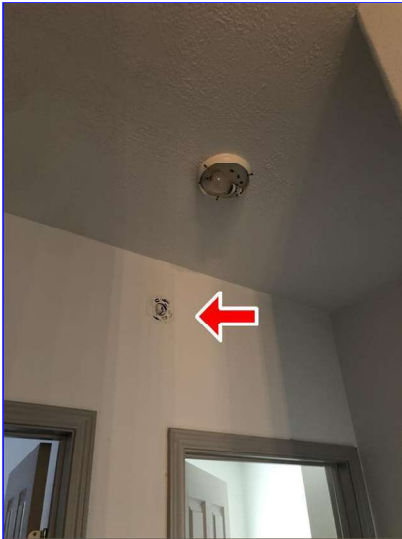
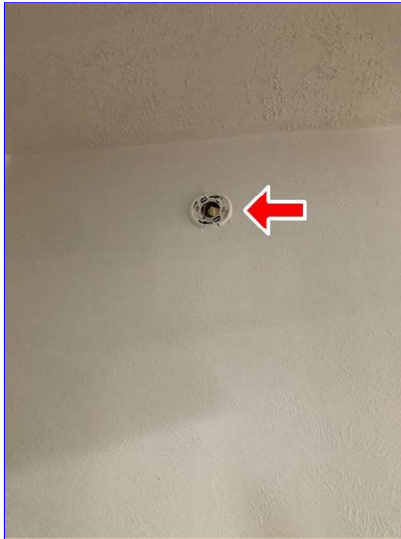
Numerous smoke detectors are missing and need to be installed and tested before the home is occupied. Item 3(Picture) Item 4(Picture)

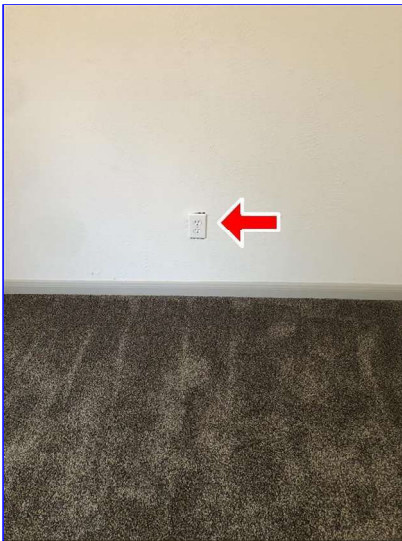
B. Item 7(Picture)

In the front right bedroom, near the garage, there are 3 plugs that are loose in the wall and need to be installed correctly by an electrician. Item 7(Picture)

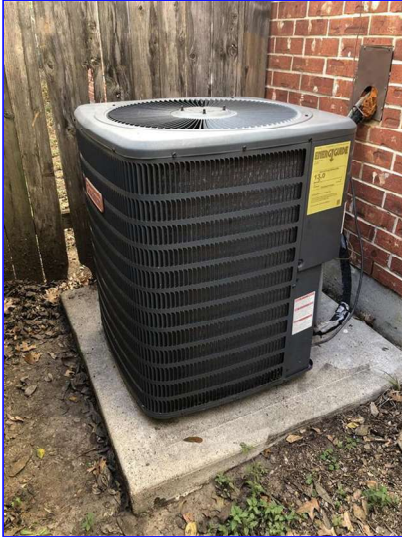
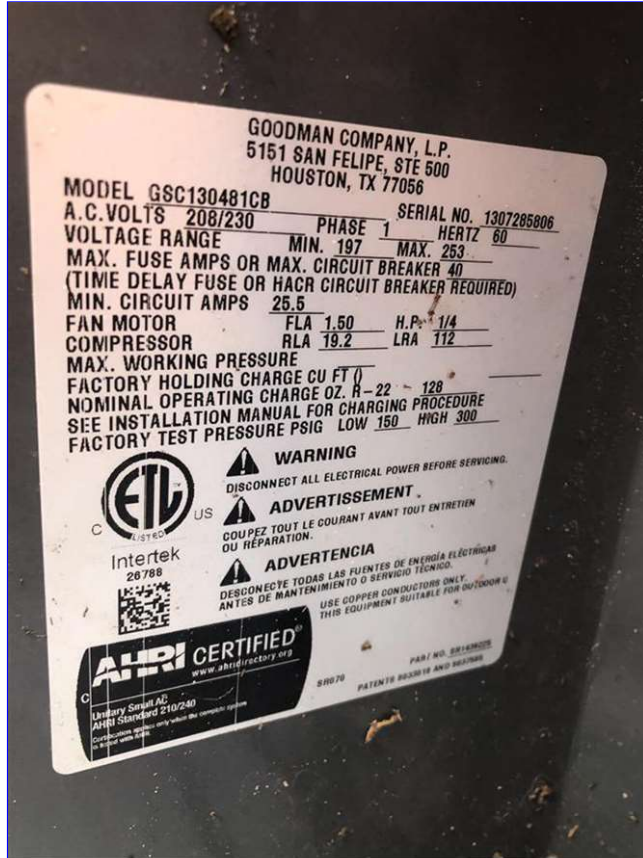
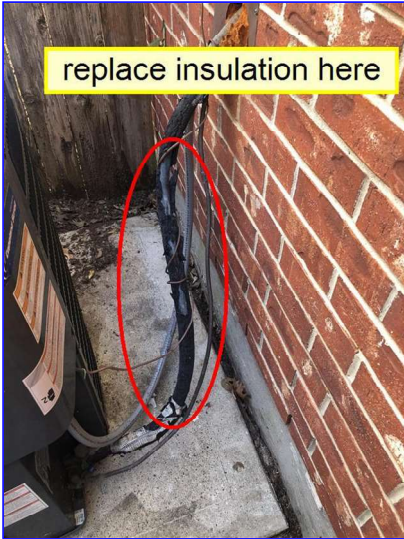
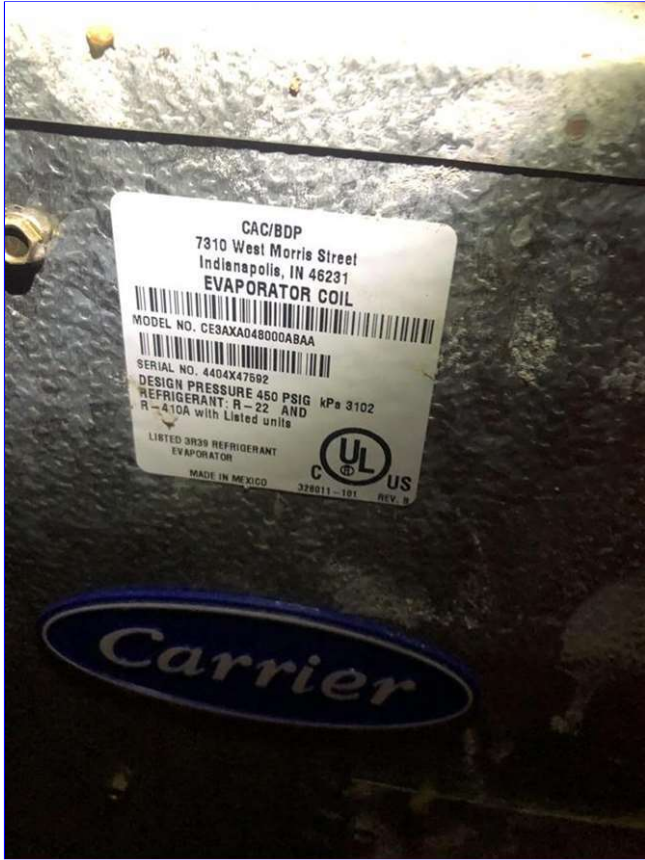
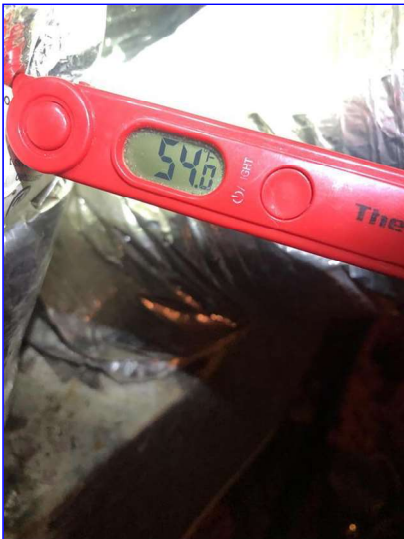
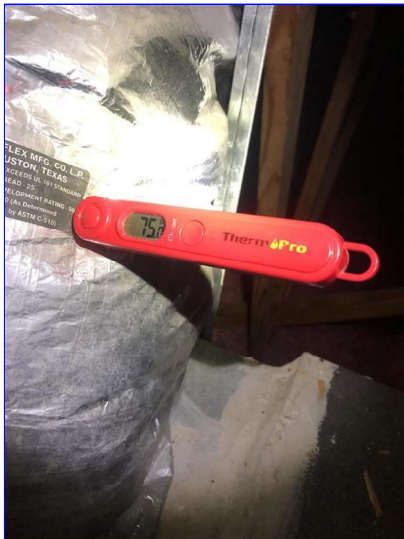
The ambient air test was performed by using thermometers on the air handler of Air conditioner to determine if the difference in temperatures of the supply and return air are between 14 degrees and 22 degrees which indicates that the unit is cooling as intended. The supply air temperature on your system read 54 degrees, and the return air temperature was 75 degrees. This indicates the range in temperature drop is normal.

The compressor is a 07/2013 goodman, the evaporator coil is a 10/2004 carrier.

The deficiency found is the suction line outside needs new insulation to improve it's efficiency.

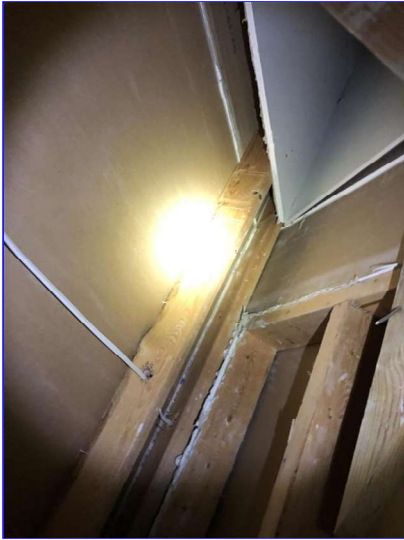
C. Item 1(Picture)

Return chases should be sealed to allow proper air flow back to the unit. The return in the hallway is not

properly sealed on the inside and is missing the bottom portion of the interior walls. Recommend a licensed HVAC installer properly seal the return chase. Item 1(Picture)

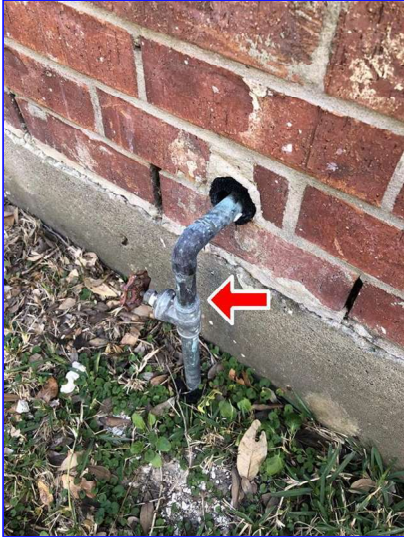
A. Item 1(Picture)

The main water supply for the house is located on the right side exterior wall near the garage. This main supply needs to be properly insulated to protect it from the weather. Item 1(Picture)

Recommend a plumber to address listed deficiencies and make needed repairs.

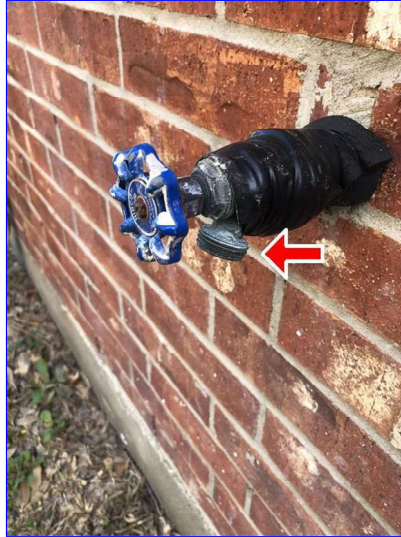
A. Item 2(Picture)

The exterior hose bib on the right side of the house is missing the required back flow preventer. These are installed to prevent possible waste water from back flowing into the home's plumbing system. They also relieve the pressure on the system when the water is turned off with an attachment on the end. Item 2(Picture)

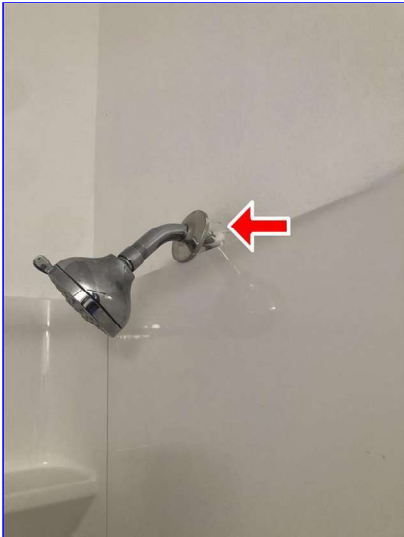
A. Item 3(Picture)

In the front bathroom the shower head trim ring needs to be properly installed. Item 3(Picture)

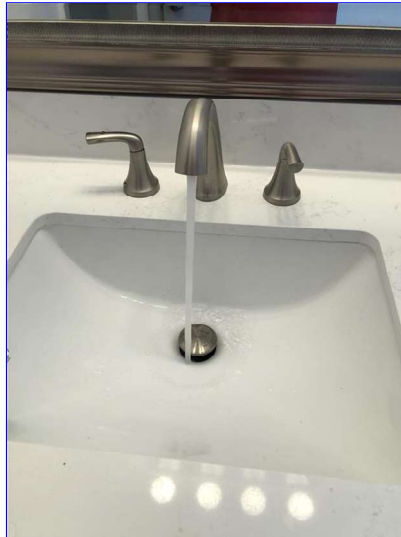
A. Item 4(Picture)

In the primary bathroom - the sink on the left has the supply lines crossed, currently the hot water is on the right and should be on the left. Item 4(Picture)

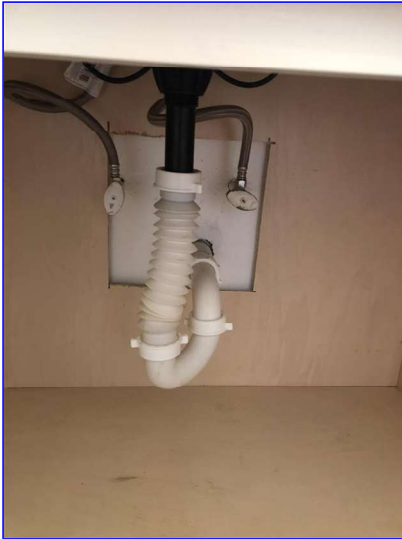
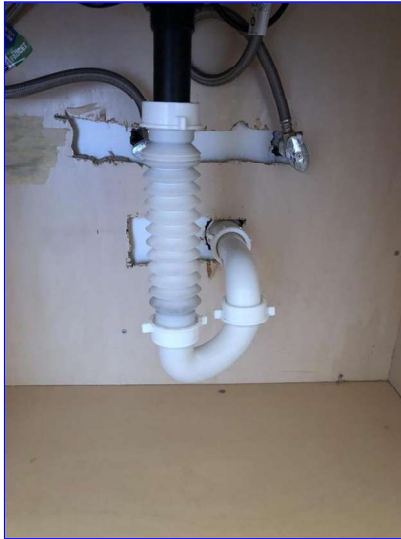
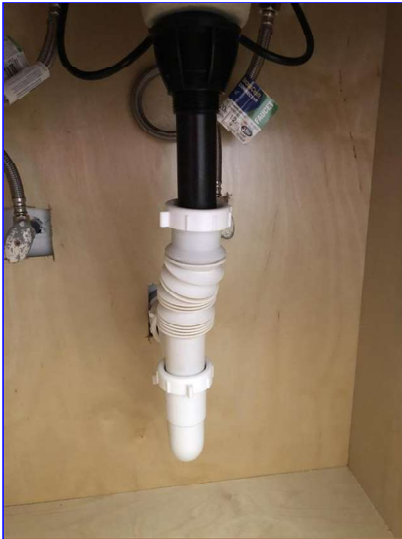
All bathroom sinks in the house currently have flex pieces installed on the drain lines. While these are sold at hardware stores, a flex line for a drain is not an acceptable material to be used. Sink drains should be made of solid smooth wall pipe. The flex lines can be hit by something put in the cabinet and move causing a possible leak. Recommend a plumber to properly fix drains. Item 1(Picture) Item 2(Picture) Item 3(Picture)

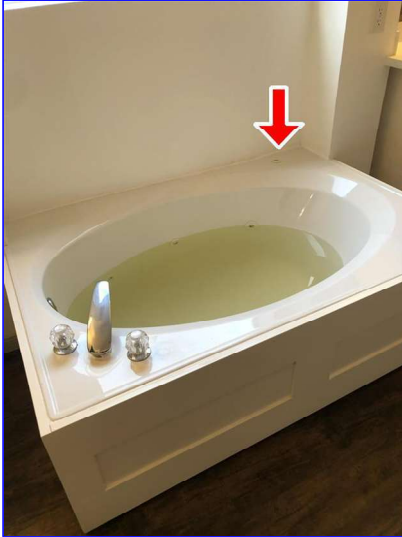
D. Item 1(Picture)

The hydro-massage equipment was tested and did not work. The pump never turned on when the button was pressed. The power button was sticking when used. Also the inspector was unable to located a GFCI safety reset for the equipment. Recommend a plumber to further assess.

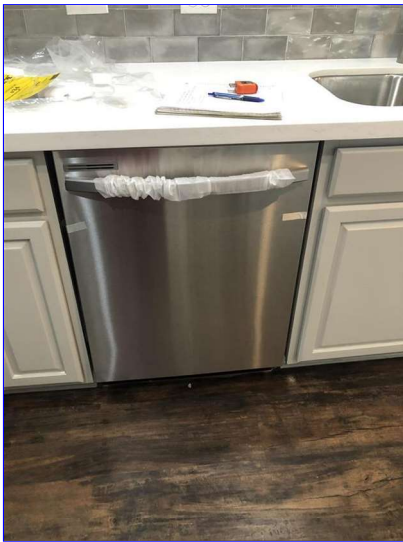
A. Item 1(Picture)

The dishwasher was brand new at the time of inspection, however it was unable to be tested due to an electrical issue where it was plugged in. Currently the plug it uses is on a switch and only has power when turned on, but that same switch turns on the sink disposal. Recommend an electrician to fix the electrical issues then test the dishwasher.

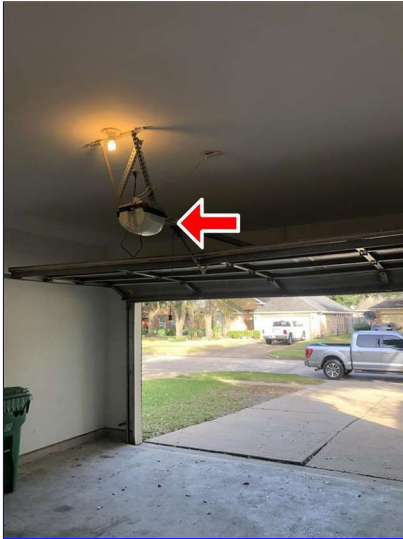
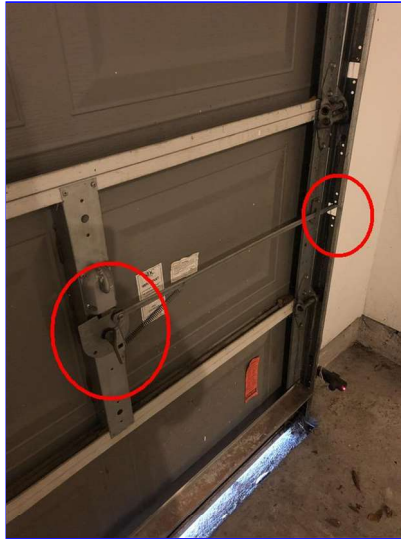
At the time of inspection the garage door opener was not working as it is intended to. The door opener was not connected to the door, the inspector connected it for testing. The automatic opener will open the door but will not allow it to shut all the way. Also the garage door currently has a manual lock still intact. When a automatic opener is installed this must be disabled, in the event it is latched and the opener is used, damage will happen to the door and the track.

Recommend garage door installer to assess and make needed repairs to allow the unit to work as intended.

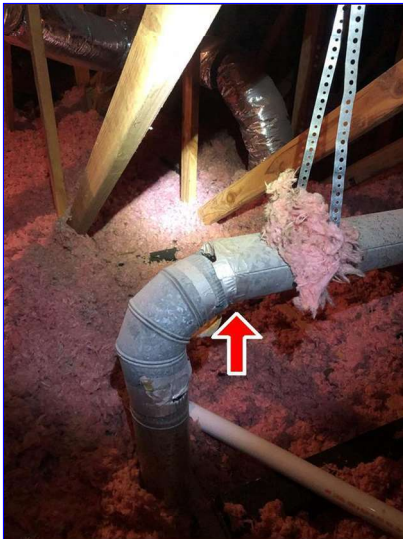
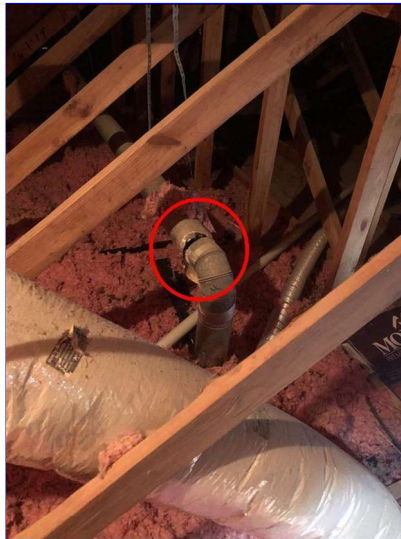
The dryer exhaust vent pipe is not properly connected in the attic. There is a joint in the two pieces where a gap is currently present. This joint needs to be properly put together and taped to seal it. Item 1(Picture)  
Item 2(Picture)
