Gerard J. Duhon, P.E., #59832
Engineered Foundation Solutions, #F-12259
281-788-7393 gerard@texashomeengineer.com

ENGINEERING OPINION
INVESTIGATION OF FOUNDATION PERFORMANCE
RESIDENCE AT 1521 CR 2291, CLEVELAND, TEXAS, 77327
Date of Inspection: December 17, 2021
Date of Report: December 30, 2021

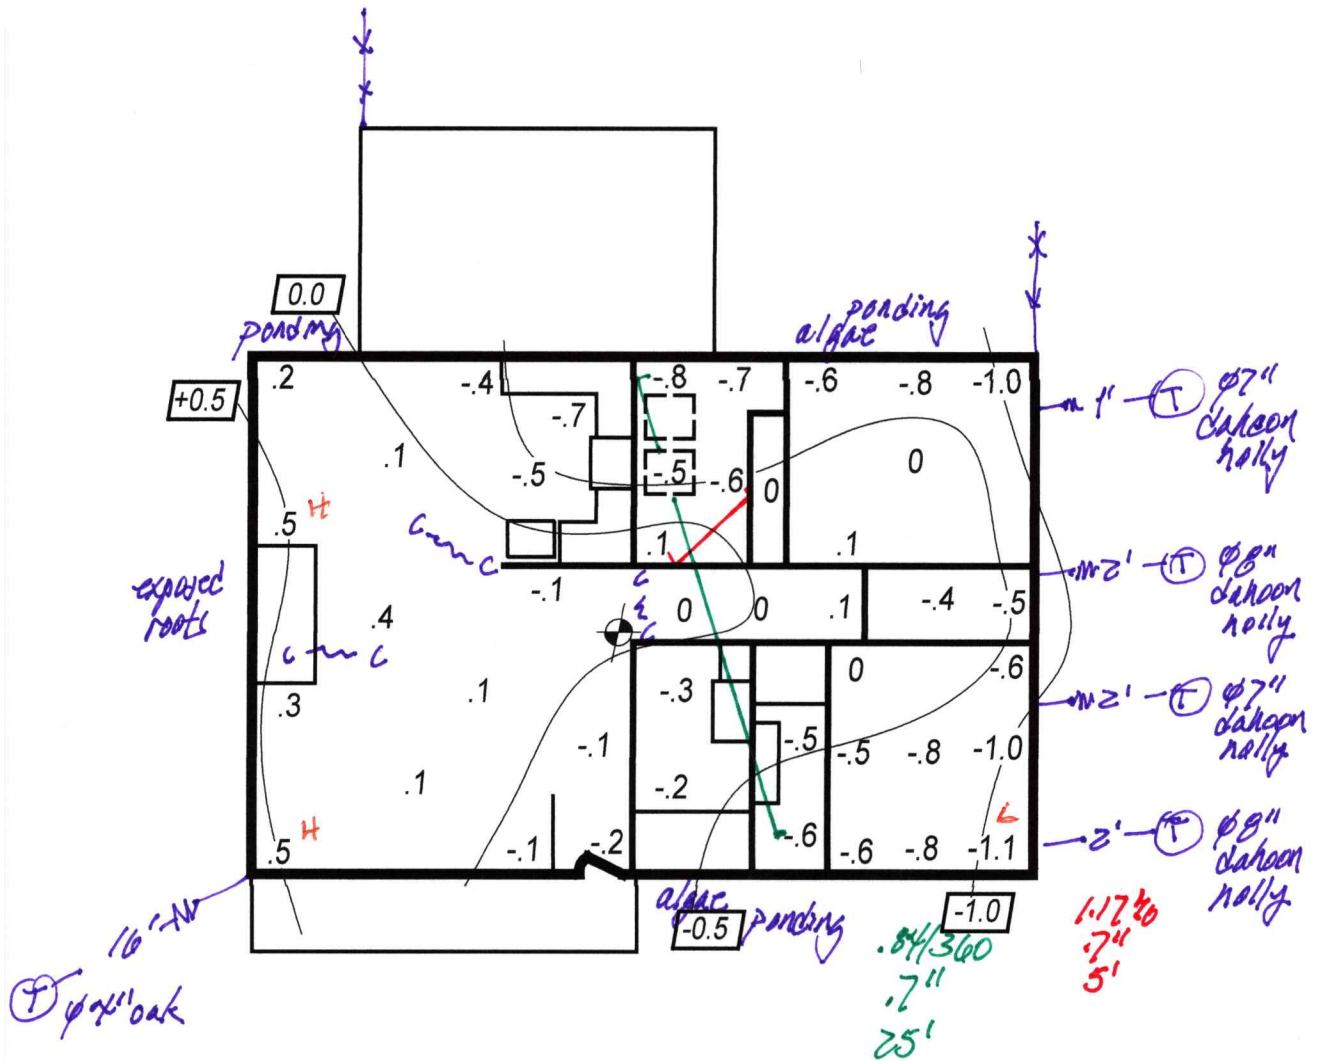
SLAB SURFACE ELEVATIONS AND OBSERVATIONS

Damages and conditions at the exterior are shown on the attached Elevation survey sheet. Brick mortar lines were straight and expansion joints unmoved, these are desirable conditions. No damage indicative of foundation movement was observed.

Inspection of the exterior found deficient drainage and landscape conditions at the perimeter of the foundation, as shown on the attached Elevation survey sheet.

Damages and conditions at the interior are shown on the attached Elevation survey sheet. A few ceiling cracks were observed.

An elevation survey throughout the house was performed using a Technidea Zipllevel. The reference zero was the middle interior area. The elevations have a range of 1.6 inches, highest at the left exterior wall, lowest at the front right corner of the house. The foundation generally is flat and level in the left third, and drops to the exterior in the right two-thirds.

The elevation deflections measured as bending of a straight line calculate to .84/360 (.7 inches in 25 feet, green line, worst case) which does not exceed the generally accepted criteria for foundation performance and repair of 1.00/360 (1 inch bend in 30 feet).

The elevations measured as slope of floors calculate to 1.17% (.7 inches in 5 feet, red line, worst case), which does not exceed 2.00% (1.2 inch difference across 5 feet).
