Home Inspection Report

6102 Seawall Blvd Unit 189, Galveston , TX 77551

082321b

PROPERTY INSPECTION REPORT

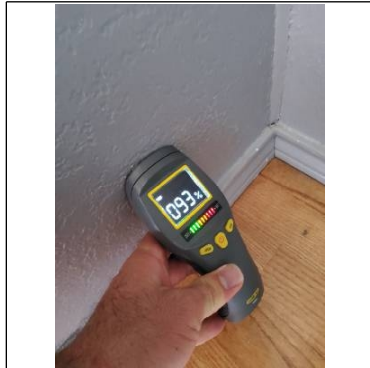
The interior walls were in pretty good shape however there were significant moisture readings picked up from the non invasive moisture meter at both sides of the sliding glass door. This likely indicates a leak from the balcony, recommend inquiring with the hoa on whose responsibility it would be to repair.

Right side of sliding glass door had 93% moisture reading

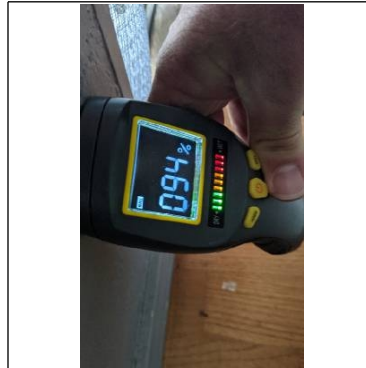
94% moisture reading from the left side of sliding glass door

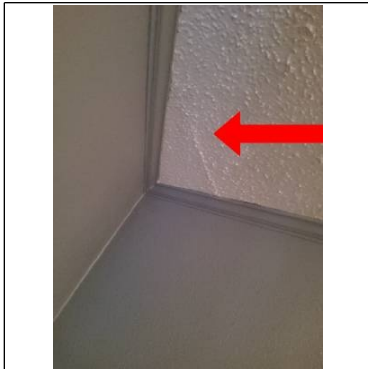
Northeast corner of bedroom

There were a few minor areas in the ceiling where the texturing was coming loose and needs repaired. The northwest corner of the bedroom, hallway had cracks, and above the built-in desk near the covered junction box.

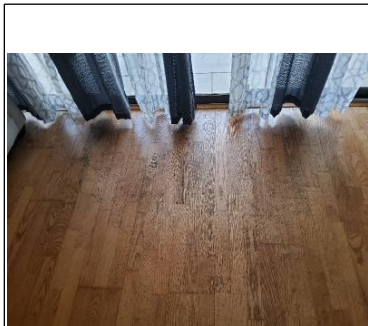
The flooring throughout was significantly worn from age and sun exposure, recommend that it be repaired or replaced.

Flooring is worn and has deterioration from sun exposure

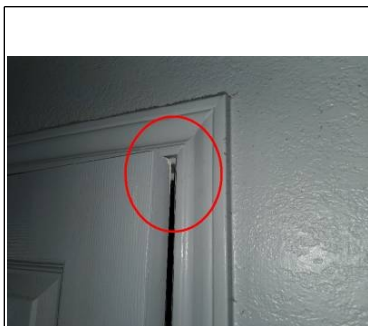
Door for water heater closet needs adjusted or trimmed

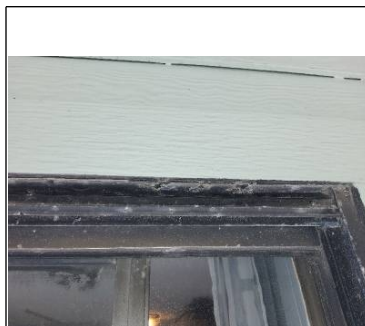
Comments: The door for the closet housing the water heater needs to be trimmed or adjusted as it rubs the top right corner. The sliding glass door's frame is made of aluminum and is starting to corrode and or pit in multiple at areas of the exterior. The locking mechanism is also broken so there is a security bar in its place. Recommend that the door be repaired.

Aluminum sliding glass door is corroding

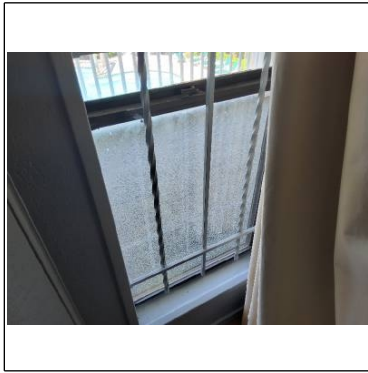
Comments: The bedroom window did function properly on the day of the inspection however it had burglar bars which hinder a second means of egress in the event of a fire. It is recommended that they be removed.

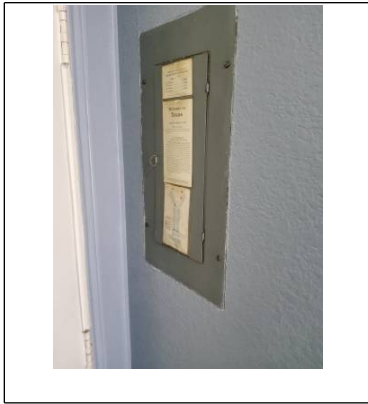
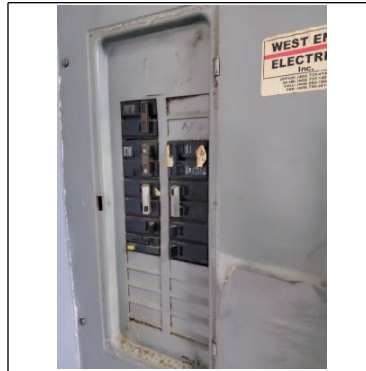
Comments: The breaker box located in the condo by the front door is a 100amp subpanel box. There is a main breaker located on the premises at a service trough to shut the power off to each condo. The panel box had a main breaker shut off as well. The panel box, wiring, and breakers all appeared to be functioning properly on the day of the inspection. It is recommended that the box be better labeled.

Need more labeling on panel box

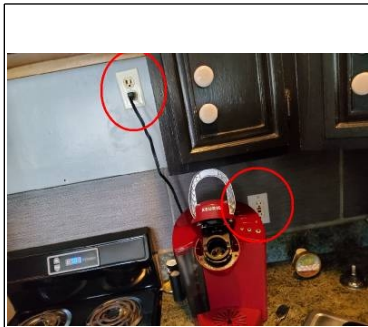
Comments: The GFCI outlet next to the kitchen sink was tripped prior to arrival and would not reset, recommend an electrician further evaluate the circuit. The outlet above the stove is recommended to be under the protection of a GFCI since it is in a wet location. The outlets along the southwest wall were not grounded, recommend that they be properly grounded by a qualified electrician or placed on GFCI's.

Outlet up top needs to be on GFCI and GFCI outlet needs to be replaced

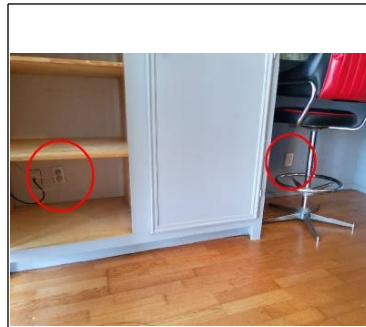
Outlets were not grounded

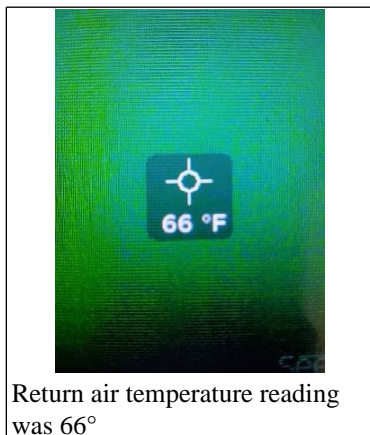
Comments: The exterior hvac unit was a Trane unit manufactured in 2019, is rated at 2 tons and uses the new refrigerant R410A. The cooling system however was found to be **not** functioning properly on the day of the inspection and only had a temperature differential of 11° between the return(66°) and supply(55°) air. The typical recommended temperature split from most manufacturer's is between 14 and 21 . It is recommended that a qualified hvac technician further evaluate the system for repair.

Return air temperature reading was 66°

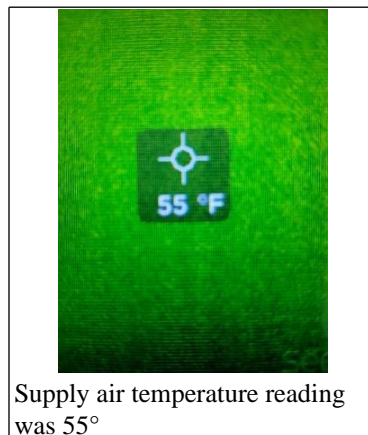
Supply air temperature reading was 55°

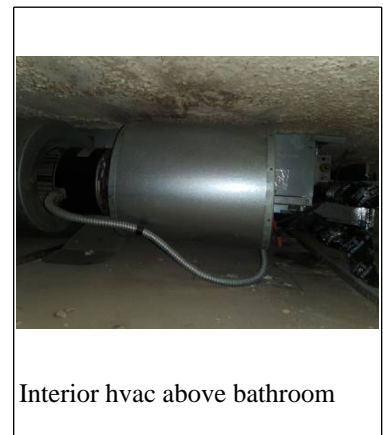
Interior hvac above bathroom

The drop tiles in the bathroom had high moisture readings and it's recommended that a few with the high moisture readings be replaced. They are getting moisture from hvac lines that are condensating from above.

There were a few of the air conditioner lines above the bathroom that were condensating causing moisture issues in the drop ceiling tiles, recommend that a pan be placed under these areas.

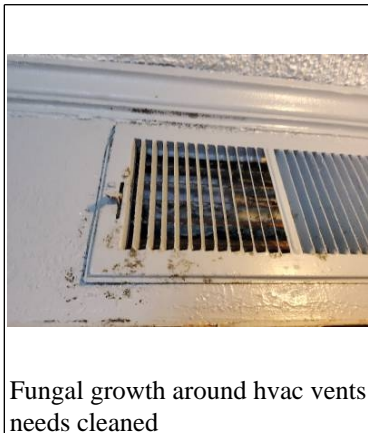
Comments: There were multiple hvac vents that had fungal growth, it is recommended that they be cleaned.

Fungal growth around hvac vents needs cleaned

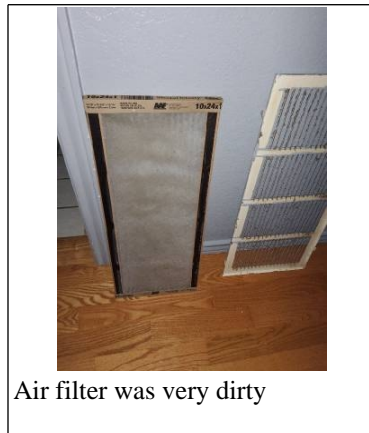
The air filter was very dirty and needs to be replaced, filter size is 10x24x1.

Air filter was very dirty

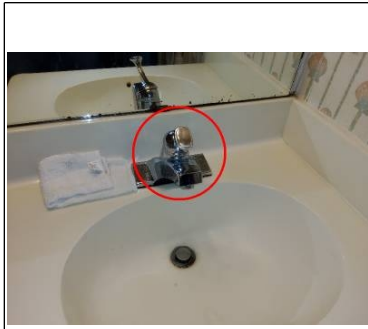
The bathroom sink fixture leaks at the connection, recommend that it be repaired.

Bathroom sink faucet leaked

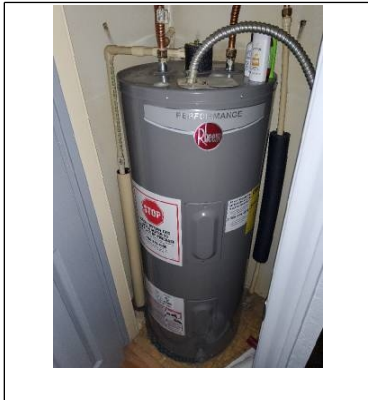
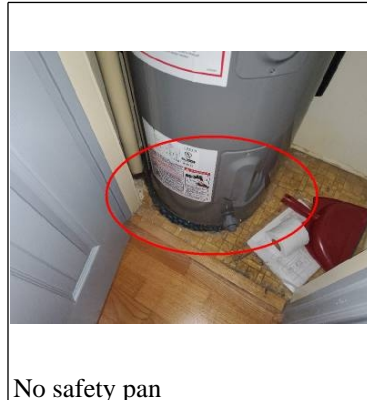
*Comments:*The Rheem brand water heater was manufactured in 2017 and is rated at 30 gallons. The unit had a plumbed temperature pressure relief line or TPR line however it was missing a safety pan under the unit. It is recommended that a safety pan be placed under the unit with a safety switch attached to the pan which will alert the occupant of a leak and shut the water off to the appliance.

No safety pan

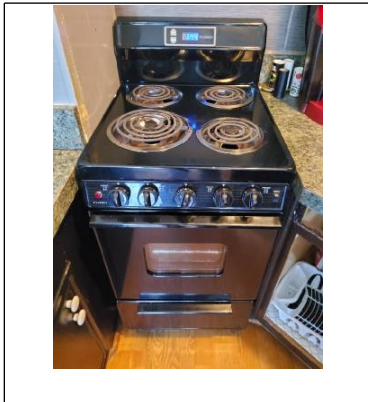
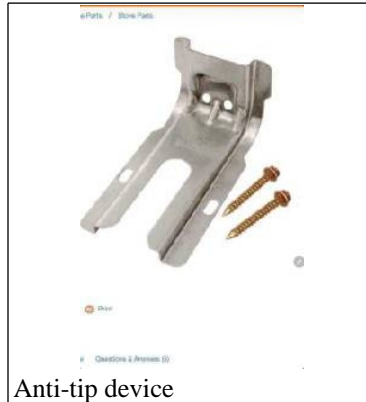
Anti-tip device

Comments: The Premier brand oven reached the desired temperature set of 350°(361°) in a timely manner and all of the electric stove top burners were functioning properly on the day of the inspection. The oven is however missing the anti-tip device that secured the unit to the floor. Recommend that one be installed for safety reasons to keep the oven from tipping over and causing injury.
