RESIDENTIAL HOME INSPECTION

3518 Durness Way
Houston TX 77025

PROPERTY INSPECTION REPORT

10/15/2021 8:30 am

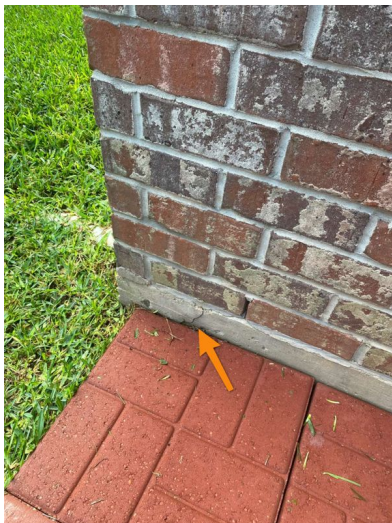
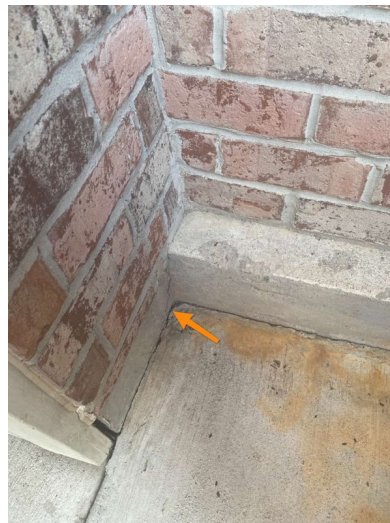
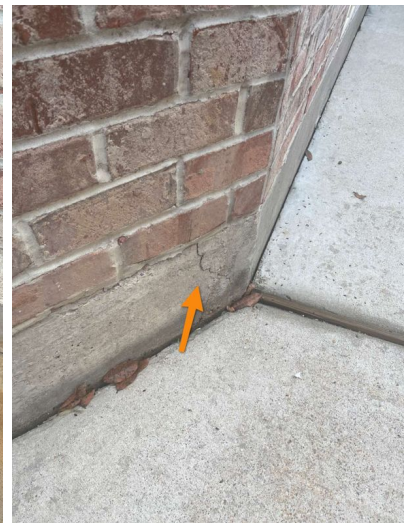
1: Foundation cracks - corners

Corner cracks are visible in the foundation slab but are of minimal structural concern. Shrinkage is a natural part of the curing process of concrete and cracks located in corners of structures are common. Recommend monitoring to confirm the cracking does not worsen.

Recommendation: Recommend monitoring.

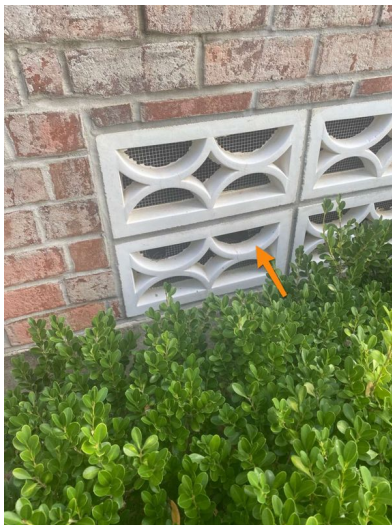
Front

2: Damaged Vent

Recommendation: Contact a qualified professional.

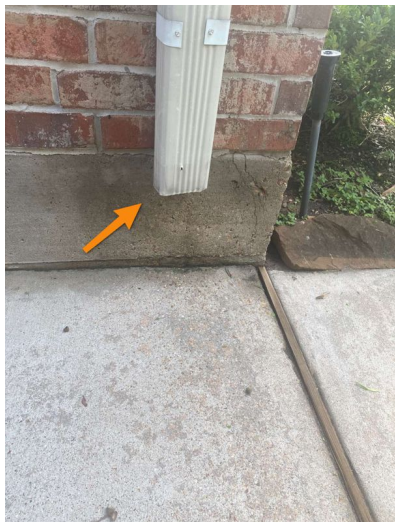
1: Gutter is broken

The gutter is broken at this location and should be replaced or fixed. Recommend a gutter contractor to resolve the issue.

Recommendation: Contact a qualified gutter contractor

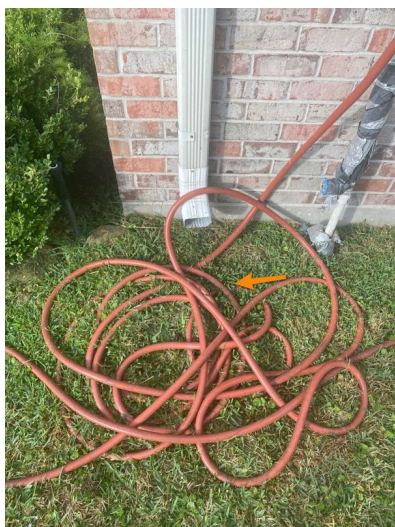
Right

2: Gutters missing splashblocks

Some or all of the gutter downspouts are missing splashblocks. Splashblocks help to disperse the water away from the foundation and prevent erosion of soils. Recommend installation.

Recommendation: Recommended DIY Project

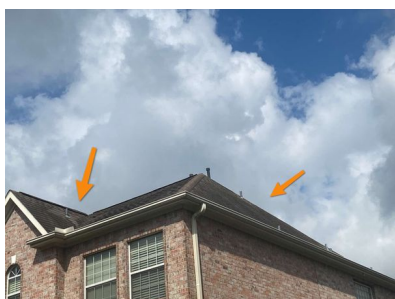
Roof shingles were discolored, which can be caused by moisture, rust or soot. Recommend a qualified roofing contractor evaluate and remedy with a roof cleaning or repair.

Recommendation: Contact a qualified roofing professional.

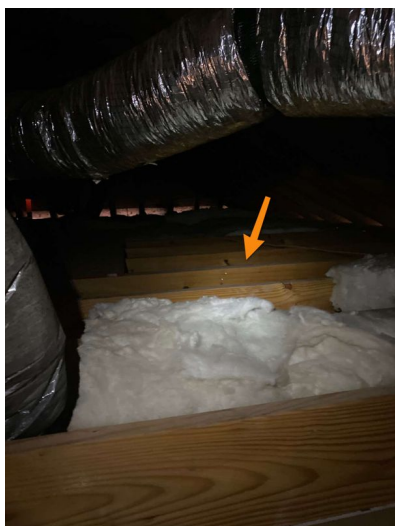
1: Insufficient insulation

Insulation depth was inadequate. Recommend a qualified attic insulation contractor install additional insulation.

Recommendation: Contact a qualified insulation contractor.

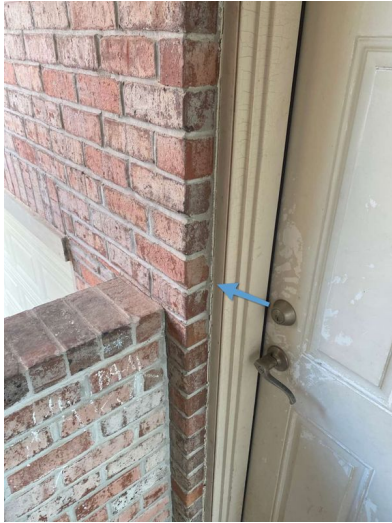
Back

1: Caulking deteriorated and/or missing

Caulking is necessary to seal gaps less than 1/2-inch. Caulking that is missing can provide for water penetration and allow insect access into the home.

Recommendation: Contact a qualified general contractor.

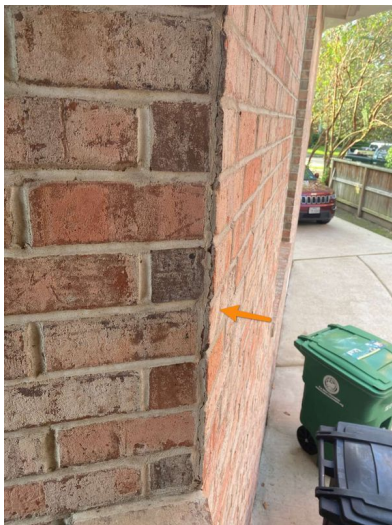
Back

2: Cracks minor

Minor cracking was observed in wall structure. This is common in homes this age and is often determined to be cosmetic. Recommend monitoring.

Recommendation: Recommended DIY Project

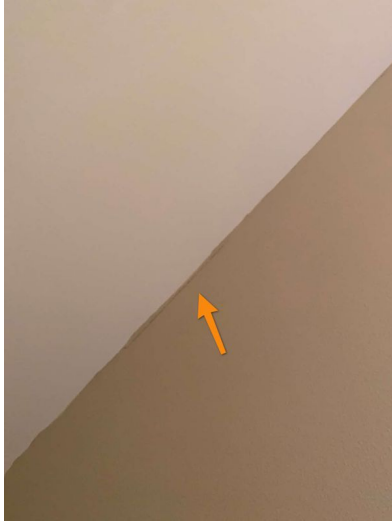
1st Floor Hall Bathroom

1: Ceiling - cracks minor

Minor cracking was observed on the ceiling. This is common in homes this age and is often determined to be cosmetic, most often the separation of drywall tape joints. Recommend monitoring.

Recommendation: Recommended DIY Project

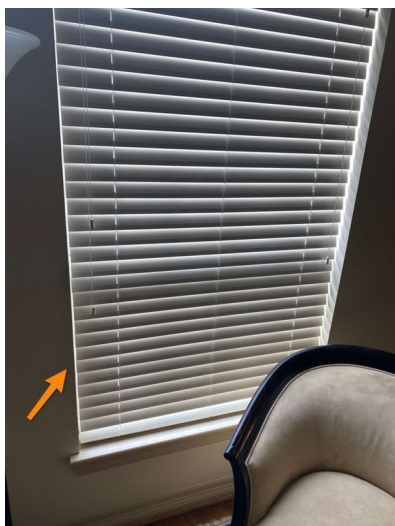
Front Dining

One or more windows won't open. This could be caused by a number of reasons including structural deficiencies in the home, windows are locked, broken, or are painted shut. Recommend windows be restored to functional use by a window repair and installation contractor.

Recommendation: Contact a qualified window repair/installation contractor.

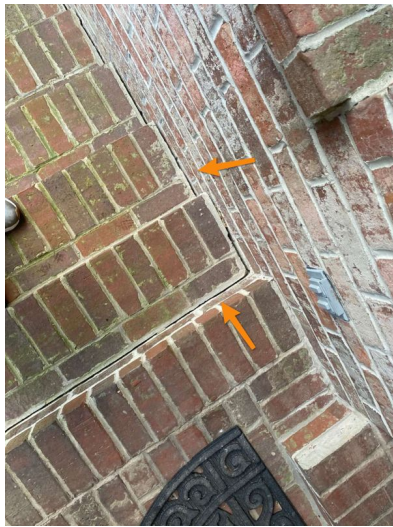
Back

1: Old concrete - porch cracks, separation, or heaving

The porch show signs of aged cracking, separation, heaving, and/or deterioration. This is common in areas of Texas that have clay-based soils. Compromised concrete will continue to exhibit decay, failure, collapse, and uplift if not remediated. Cracking can also be a safety tripping hazard for pedestrians.

Recommendation: Recommend monitoring.

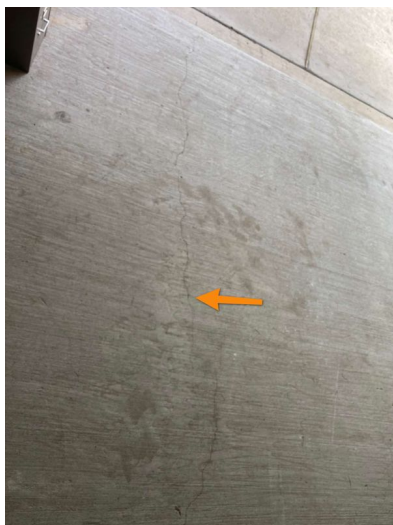
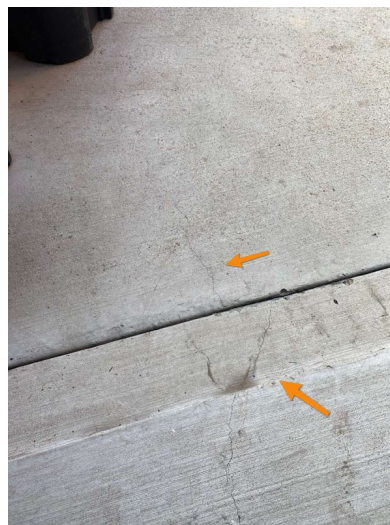
1: Old concrete - cracks, separation, and heaving

The driveway and/or sidewalks show signs of aged cracking, separation, heaving, and/or deterioration. This is common in areas of Texas that have clay-based soils. Compromised concrete will continue to exhibit decay, failure, collapse, and uplift if not remediated. Cracking can also be a safety hazard for pedestrians if it becomes (or is currently) a trip hazard.

Recommendation: Recommend monitoring.

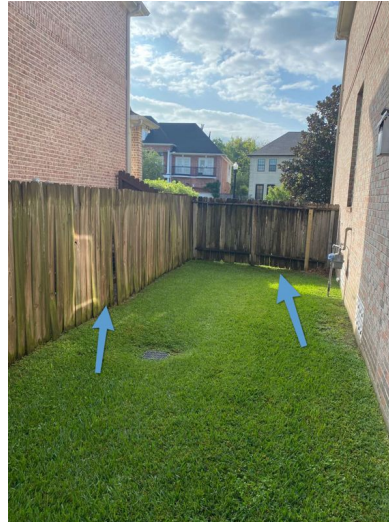
Right

1: Minor fence deficiencies - rot and/or structural issues

Fence appears to have minor rot damage and/or structural issues. Recommend contract a fencing contractor for repair and/or replacement of the elements that are exhibiting rot or structural issues.

Recommendation: Contact a qualified fencing contractor

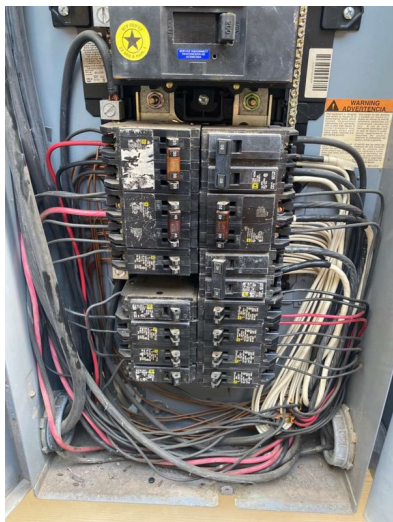
Main

1: Missing AFCI breakers

Arc Fault Circuit Interrupters (AFCI) safety devices are not installed for all of the living and bedroom areas. The National Electric Code made this protection a requirement for homes built after 2008, The Texas Real Estate Commission requires inspectors regardless of the home's age to mark as "deficient" where any (AFCI) protection is not installed in these areas.

Recommendation: Contact a qualified electrical contractor.

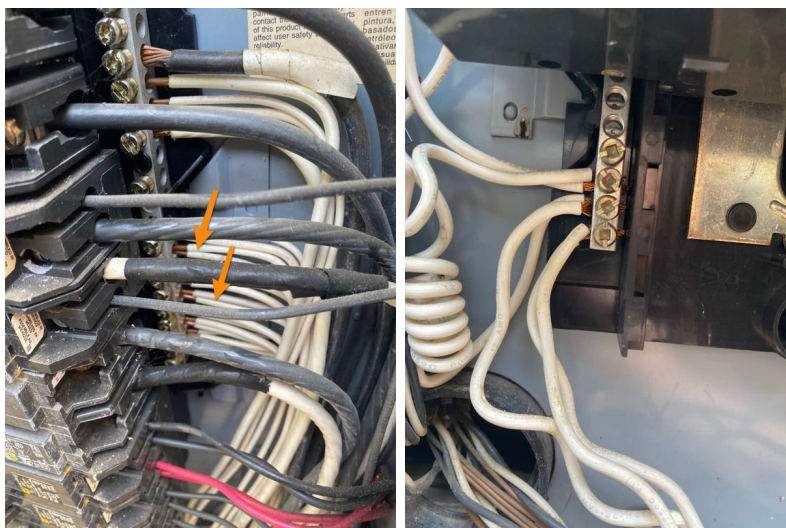
2: Double lug neutral wires

Neutral wires have been double lugged. This means there are two or more neutral wires under each screw on the bus bar. Ideally only one wire should be under each screw.

Recommendation: Contact a qualified electrical contractor.

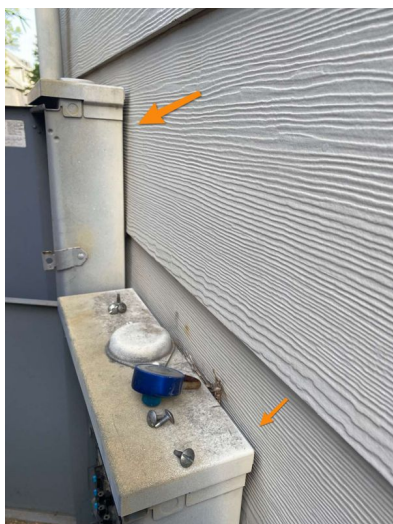
The electrical panel is not sealed at the wall. This can result in water intrusion down the back of the electrical panel and into the wall or panel itself. This should be resolved by sealing the panel against the wall to prevent water intrusion, electrical issues, and structural rot. Recommend an electrical or siding contractor to resolve the issue.

Recommendation: Contact a qualified electrical contractor.

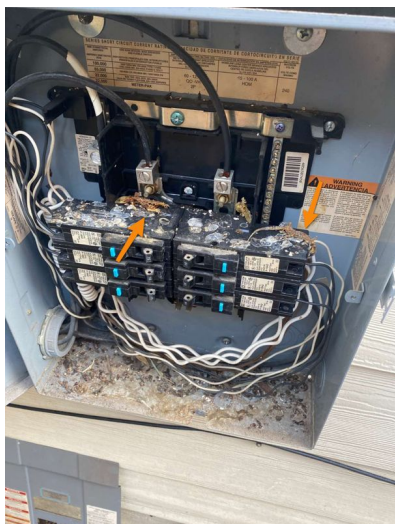
Sub

4: Debris in panel

There is a build-up of debris and/or pest waste in the electrical panel. Under the right circumstances, this could cause a fire. For safety reasons, this debris should be cleared from the panel and re-sealed.

Recommendation: Contact a qualified professional.

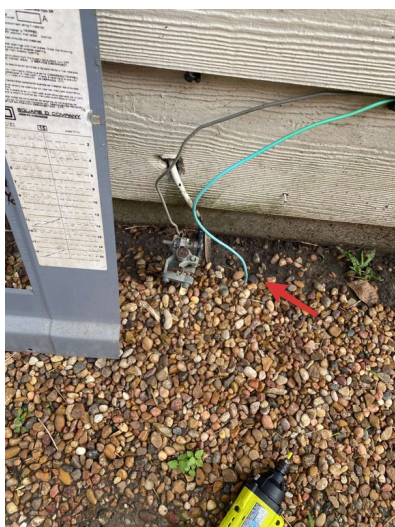
5: Grounding rod missing or disconnected

The grounding rod is missing and/or disconnected from the main service panel. Recommend an electrical contractor re-establish local grounding to the panel by correcting the grounding deficiency.

Recommendation: Contact a qualified electrical contractor.

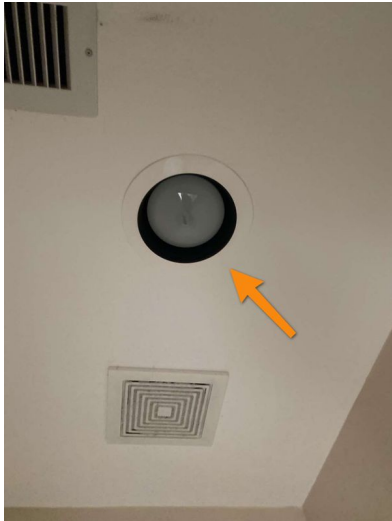
1: Light inoperable / bulb needs replacement

One or more light fixtures were inoperable (didn't turn on when nearby switches were operated). Recommend further evaluation by replacing bulbs and/or consulting with the property owner. If replacing bulbs doesn't work and/or no other switch(es) can be found, then recommend that a qualified electrician evaluate and repair or replace light fixtures as necessary.

Primary Bathroom - Switch is Finicky

Recommendation: Contact a qualified electrical contractor.

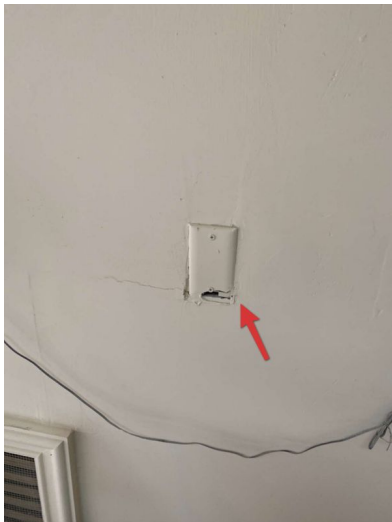
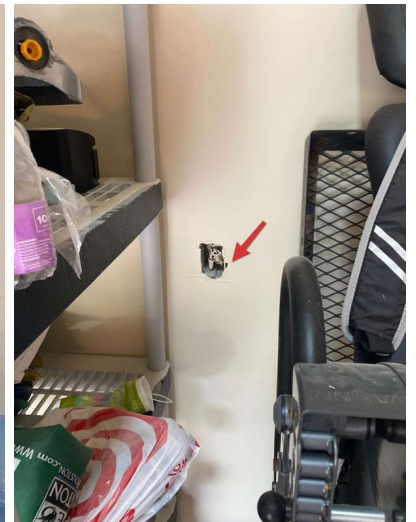
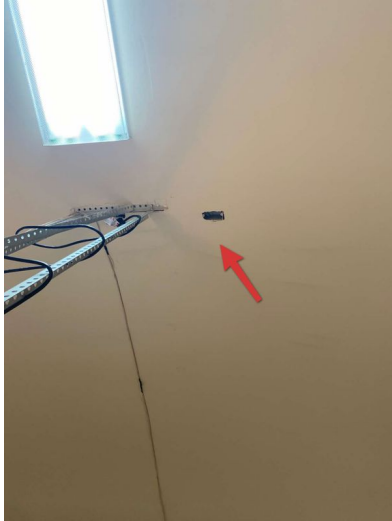
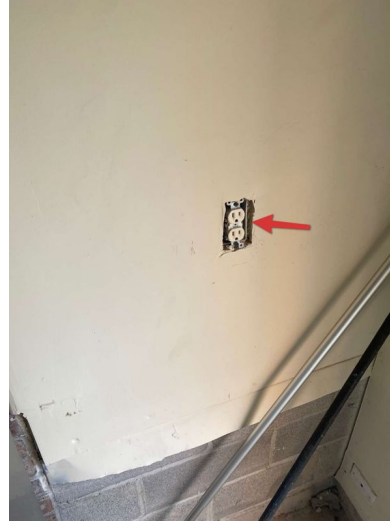
2: Cover plates missing or damaged

One or more receptacles are missing a cover plate or the cover plate is damaged. This causes short and shock risk. Recommend installation of plates.

Recommendation: Contact a qualified electrical contractor.

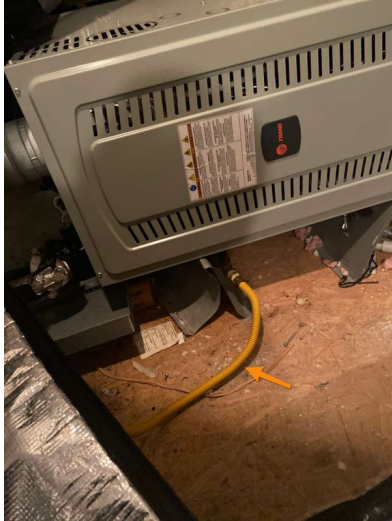
Front Unit

1: Furnace - sediment/drip trap missing or incorrectly oriented

The sediment/debris and drip trap/leg on the gas line is incorrectly oriented or is missing. The trap should allow for condensation or sediment in the gas line to fall into the trap. Additionally the shut-off valve should be located before the trap to allow for cleanout. Recommend installing a correctly oriented sediment/debris trap on the gas line prior to entering the unit.

Recommendation: Contact a qualified plumbing contractor.

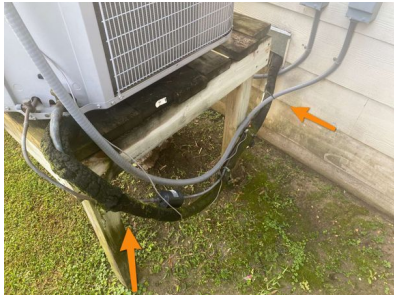
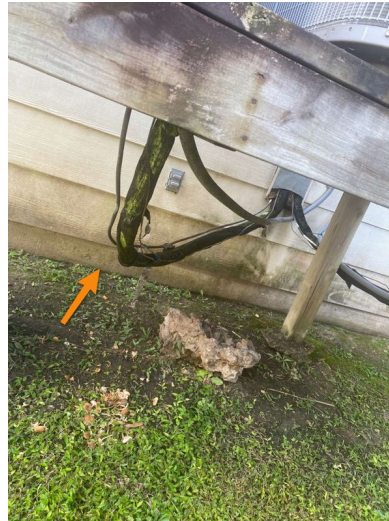
1: Condenser - freon insulation missing or damaged

Missing or damaged insulation on the refrigerant line can cause energy loss and condensation. Recommend contacting an HVAC professional to replace the missing or damaged insulation.

Recommendation: Contact a qualified HVAC professional.

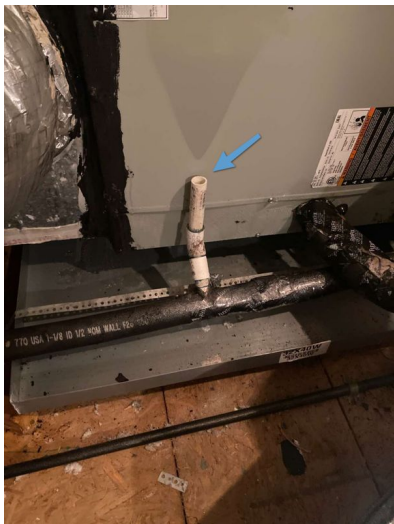
Front Unit

2: Evaporator - cap missing

Cap Missing. Recommend installing cap.

Recommendation: Recommended DIY Project

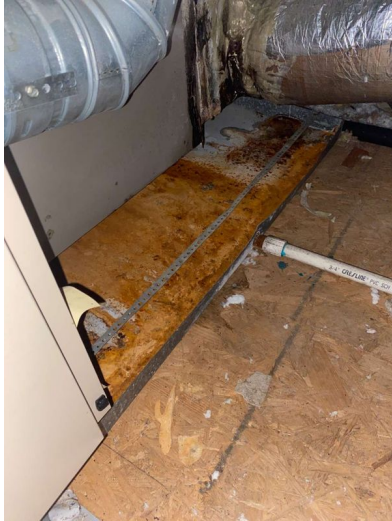
Back

3: Evaporator - rust present in pan

Rust is present in the cooling system emergency overflow pan under the AC evaporator (inside unit).

This could be caused by malfunctioning with consistent overflows. No active condensation leak into the pan is observed. Recommend careful monitoring.

Recommendation: Contact a qualified HVAC professional.

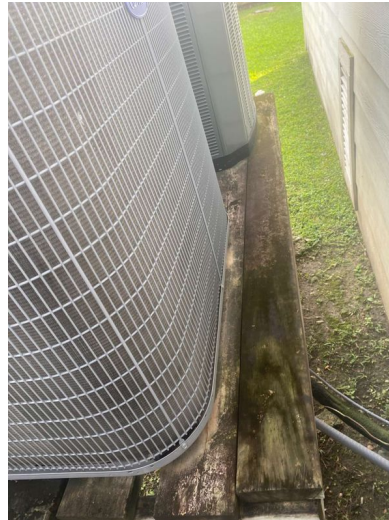
4: Condenser - Wood Support

The condensers are sitting on wood platforms that are starting to rot. Recommend replacing supports with concrete pads.

Recommendation: Contact a qualified professional.

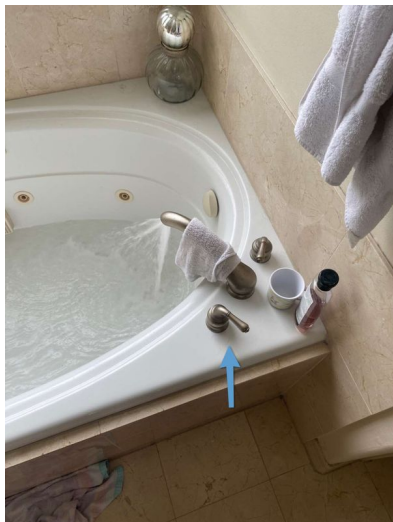
Primary Bathroom

1: Loose fixture handle

Plumbing fixture handle is loose. This often requires re-tightening using a screwdriver or allen wrench (if corrosion does not prevent tightening). Recommend attempting to tighten the fixture and unsuccessful then hiring a qualified professional to tighten the fixture.

Recommendation: Recommended DIY Project

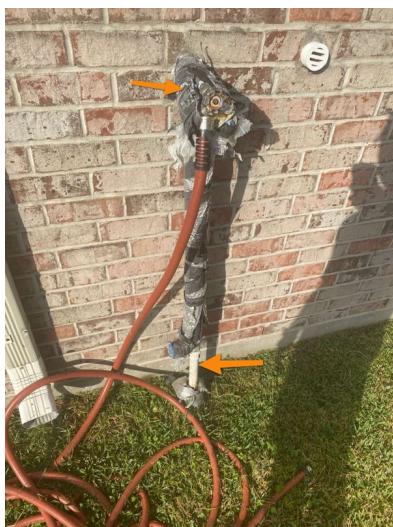
2: Pipe insulation damaged / missing

Recommendation: Contact a qualified plumbing contractor.

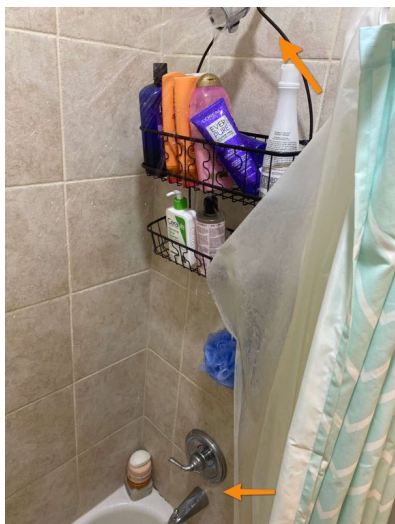
2nd Floor Hall Bathroom

3: Shower Diverter

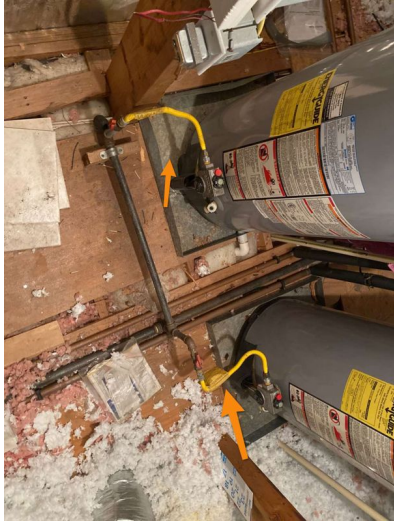
1: Gas - sediment/drip trap missing or incorrectly oriented
