PROPERTY INSPECTION REPORT

Prepared For: Bryon Bauer
Concerning: 15200 Moonlight Trail Conroe, Texas 77384
Inspection Date: 06/25/2019

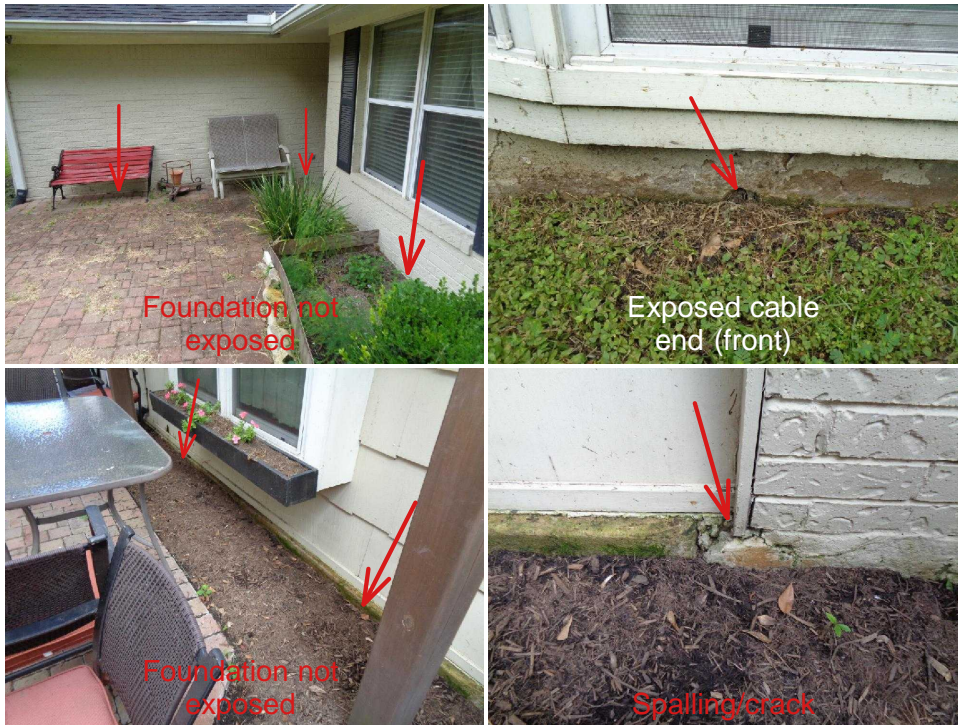
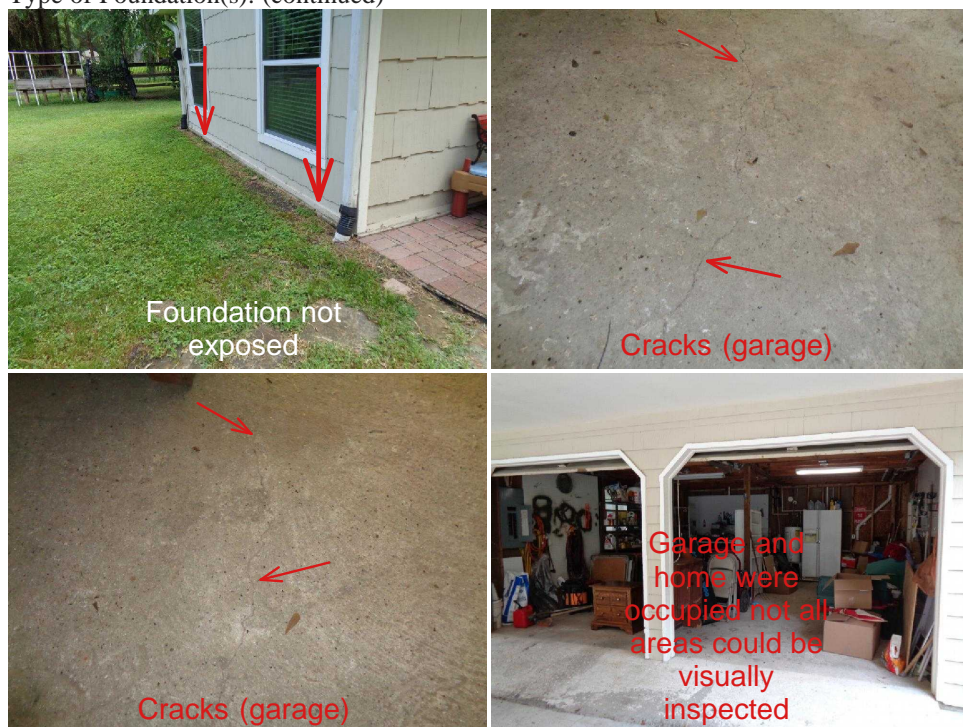
- The foundation walls should be exposed at a minimum 4" for masonry siding (Brick, Stone, Stucco), and a minimum of 6" for non-masonry siding material. Recommend removing excess grade for proper exposure and to assure proper drainage away from the foundation walls and to deter wood destroying insects.

- The tension cables installed within the foundation were observed to be exposed at the front of the structure at the visible foundation wall. The cable end should be properly sealed with epoxy to prevent exposure and rapid deterioration to the cables. Repair as needed.

- There was spalling and settling noticed at the exposed foundation wall near the patio, between the garage and home. This does not appear to be causing any structural issues at this time. Repair as needed.

- The garage floor was noticed to have minor cracks in the surface of the concrete. These appear to be hydration/shrinkage cracks or settling, and are not an issue at this time. Cracking is inevitable and expected, however these areas should be sealed and monitored for further deterioration.

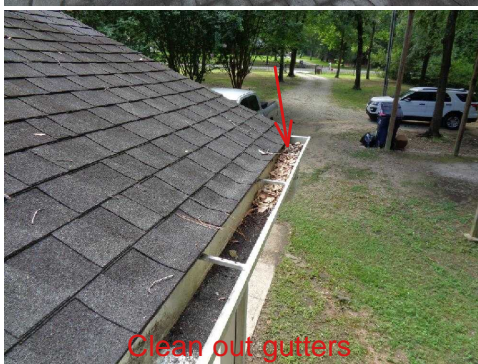
- There appears to be improper grading and drainage of the property at the front, right and rear side of the main house, and also at the left and rear side of the garage. The property should be graded so that surface water will drain away from foundation walls at a minimum slope of 6" within 10'. Lot drainage should divert to the street as to not create a hazard on the property. A few subsurface drains were noticed around the yard, effectiveness can not be determined.

- The gutters installed at the apartment/garage, were noticed to be full of debris. Recommend clearing the gutters for proper drainage.
- The gutter guards at the front of the house, were observed to be damaged. Repair/Replace as needed.

- The section of gutters above the balcony, was observed to be damaged and starting to separate from the structure, causing

B. Grading and Drainage (continued)
the a negative slope. Repair/Replace as needed.

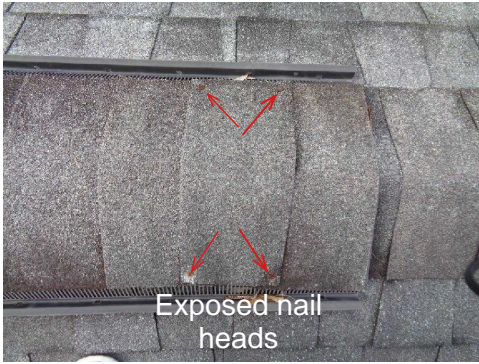
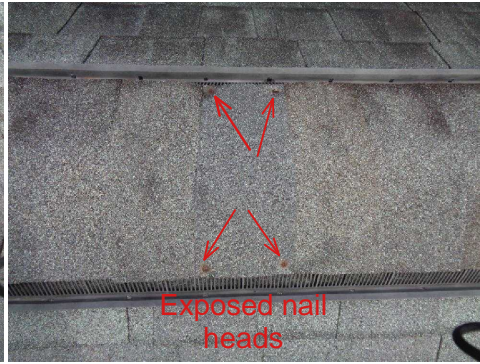
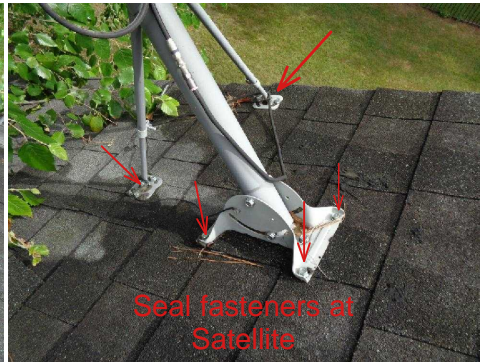
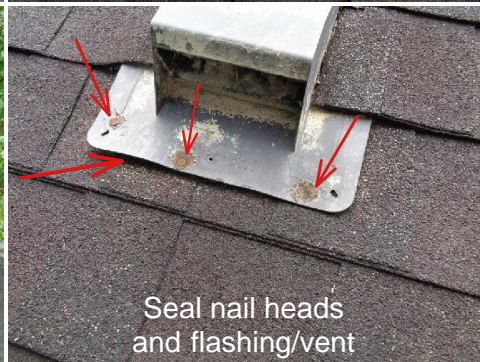
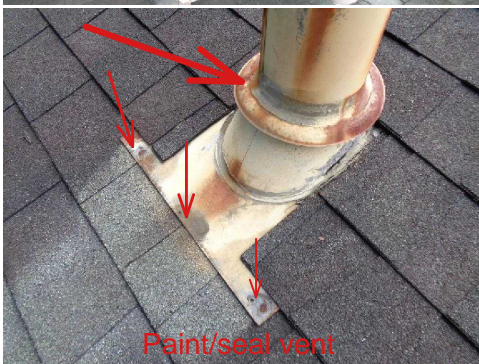
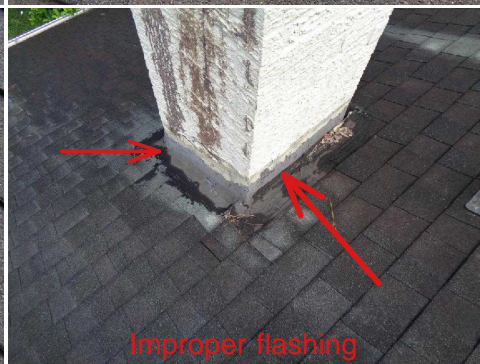
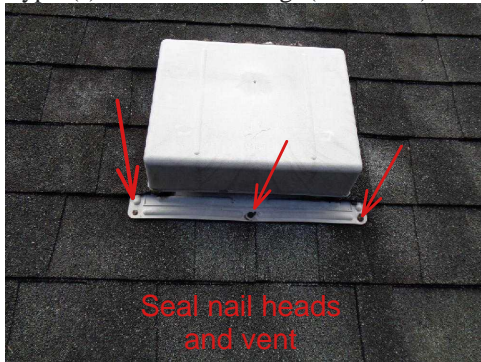
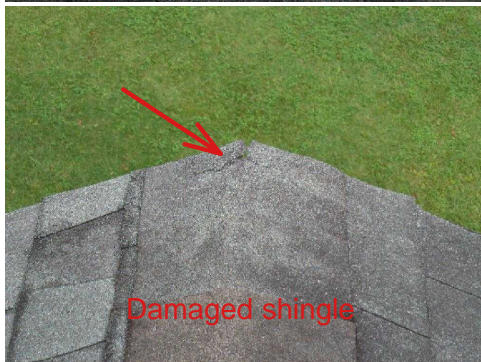
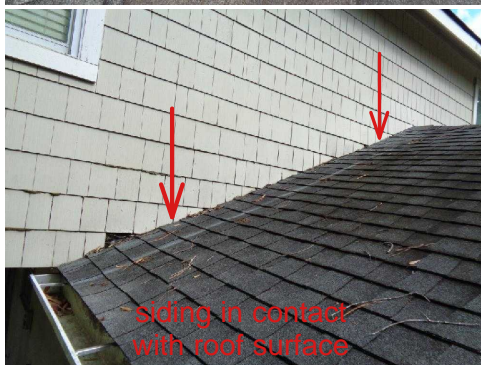
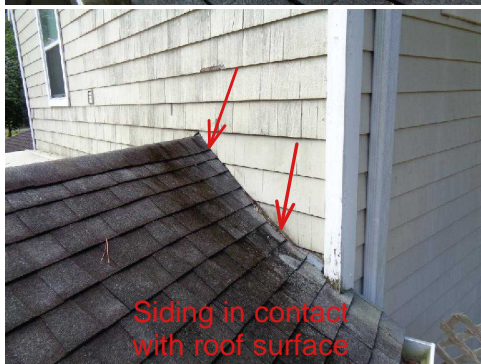
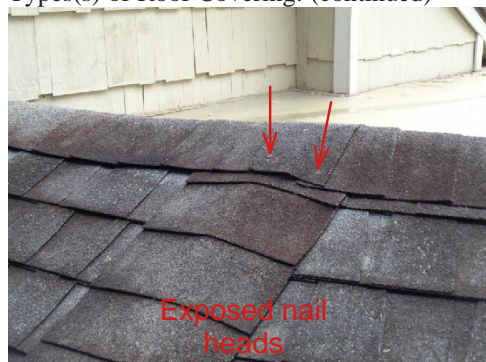
- Exposed nail heads were observed at the roof surface at both the house and apartment. Recommend sealing all exposed heads to prevent moisture penetration into the attic space. Correct as needed.

- Trees were observed to be in contact with the roof surface. Recommend trimming trees to give 36" clearance to prevent rapid deterioration of the roof covering material. Correct as needed.

- Raised flashing was observed at several vents and penetrations at the roof. Flashing helps prevent moisture penetration, and should be sealed periodically as a part of regular homeowner maintenance. Repair and seal as needed.

- There appears to be improper flashing at the chimney. See illustration. Repair as needed.
- A few areas on the roof were noticed to have damaged, loose or missing shingles. Repair/Replace as needed.

- There should be a 2" space of exposed underlying flashing where the exterior siding meets the roof surface. The spacing allows for visual inspection of the flashing and to prevent rapid deterioration of the siding and roof covering. Repair/Replace as needed.

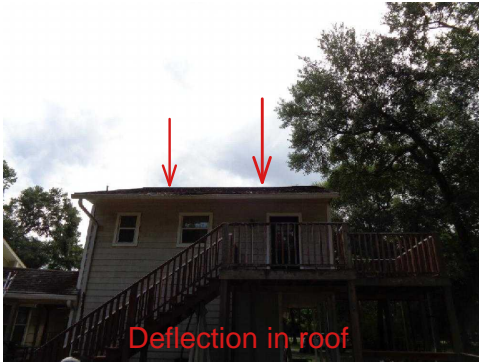
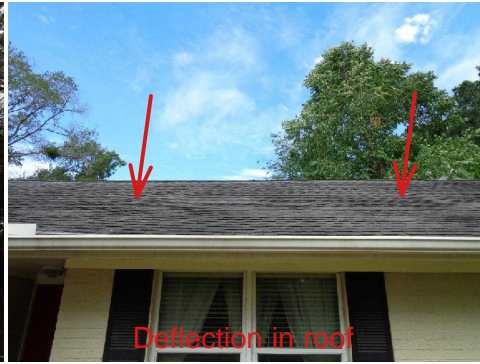
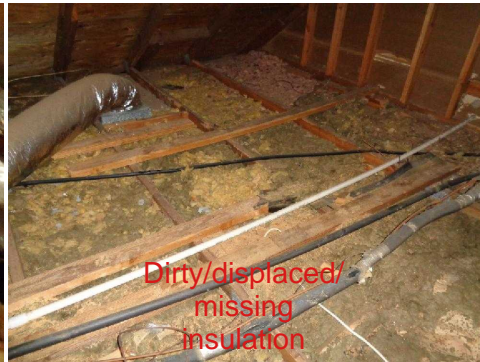
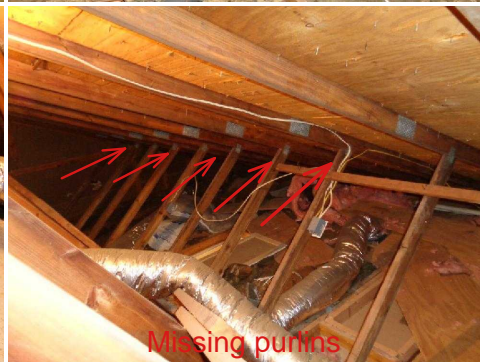
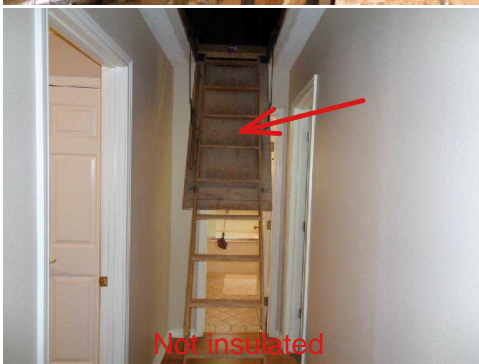
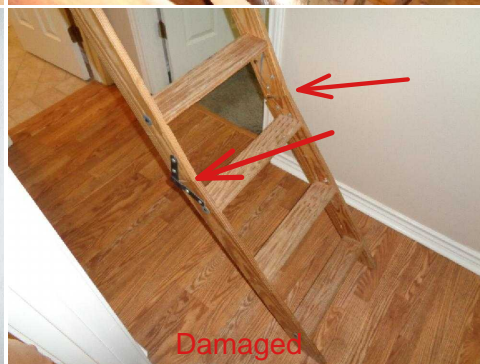
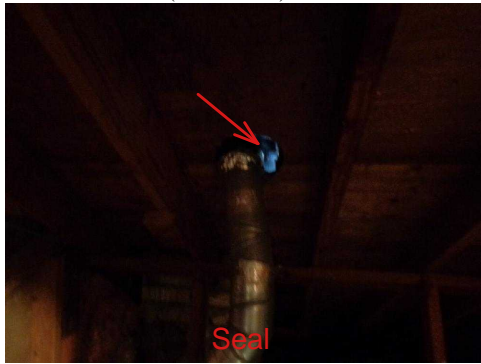
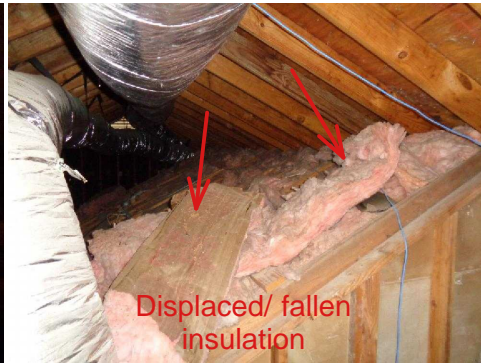
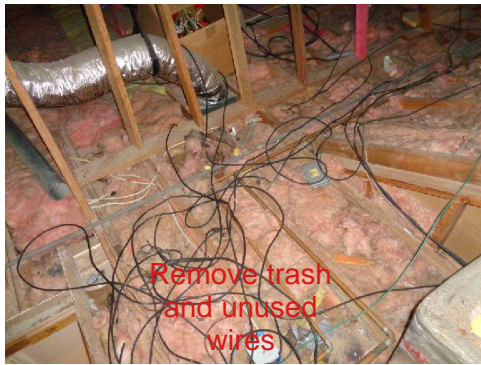
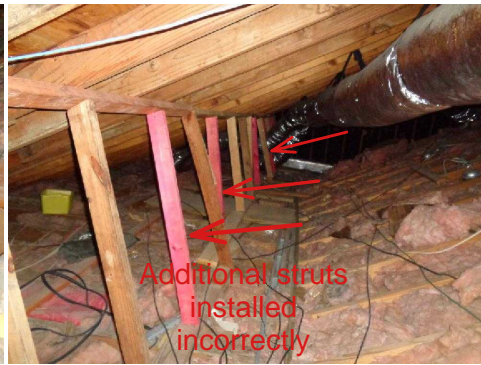
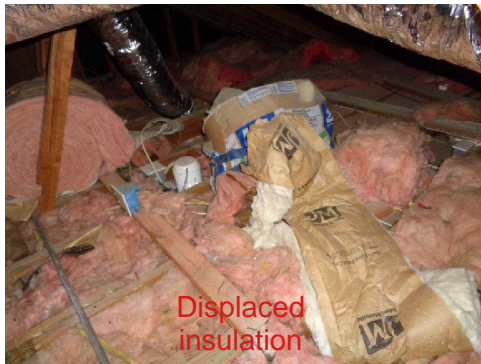
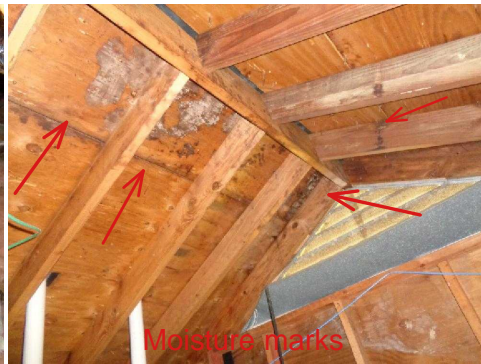
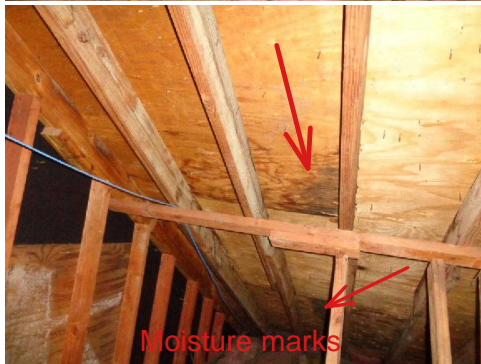
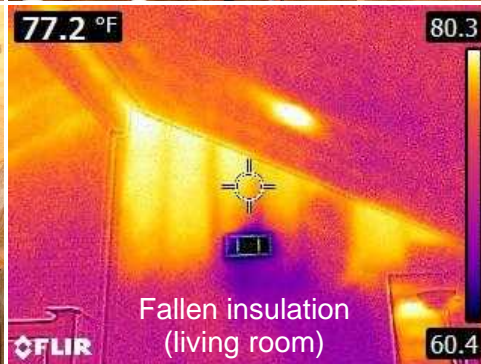
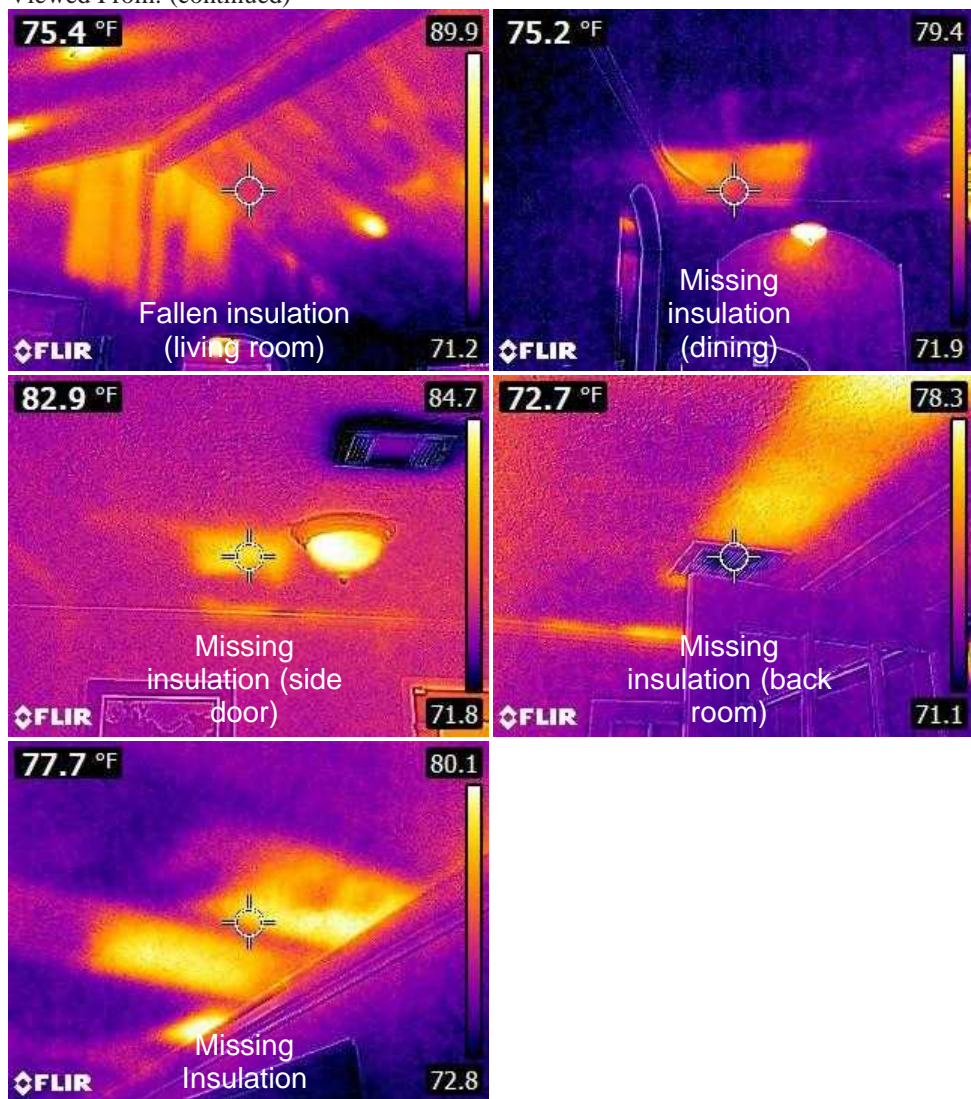
- There was deflection observed at the house and apartment roof. after inspecting the roof structure in the attics, it appears the roof structure is not adequately supported and should have struts/purlins installed that will help reduce the sag the roof. The roof was not holding water and no leaks were present at the time of the inspection. However, I do recommend a licensed and insured roofer/framer further evaluate the roof structure and make any necessary repairs.

- The loose fill and batt insulation at both attics, was noticed to be displaced, missing and contain a lot of trash/debris in several locations. Insulation should be evenly installed throughout the attic space so the proper R-value is achieved at all required locations.

- The attic access door was not insulated. Recommend installing insulation or a properly rated cover to prevent AC/heat loss.
- The ladder for the attic access was noticed to be damaged. This is a safety concern, repair/replace as needed.

- The vent covers for the exhaust pipes, were observed to have daylight coming through. All vents at the roof should be properly sealed to prevent moisture from entering the home. Correct as needed.

- Moisture marks were observed on the rafters and decking at both attics. There was no moisture detected at the time of the inspection. Recommend consulting with seller to determine if these areas were repaired in the past.

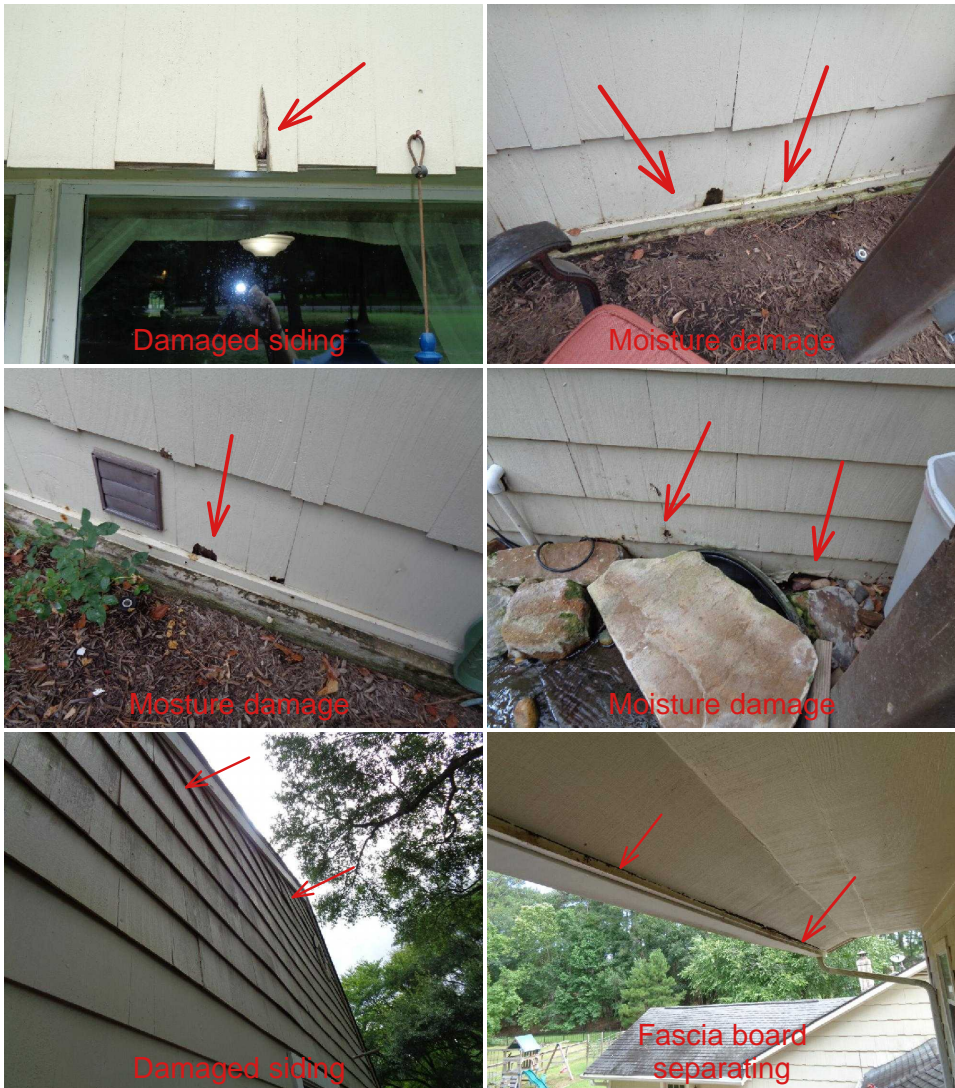
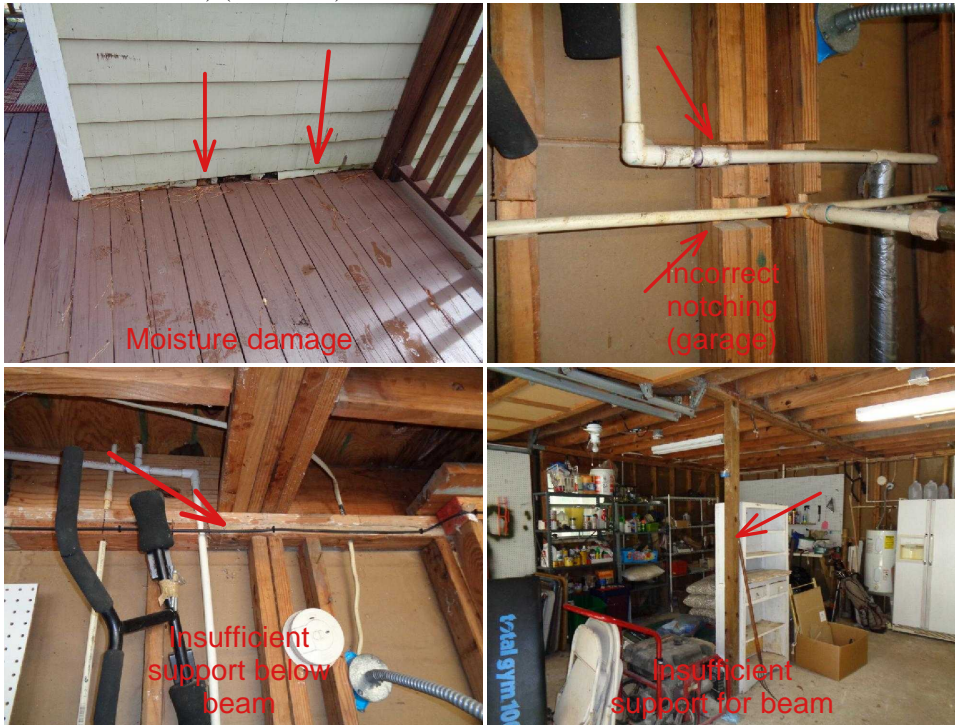
- Several areas of the wood siding was observed to be soft and deteriorated due to moisture damage. All areas were not documented with pictures. Recommend Replacing siding to prevent further deterioration.
- The siding was observed to be loose and wavy at the left side of the apartment above the garage. Repair/Replace as needed.
- The fascia board above the balcony is starting to separate from the structure. the damaged/sagging gutter system is the cause of the damage and should be repaired to prevent further deterioration.

- The garage had several frame issues at the time of the inspection (Not all areas were documented with pictures). I recommend a professional and insured framer further evaluate the structure and make any necessary repairs. See list of issues below.

- There were several studs, top plates, and joists that were bored or notched incorrectly.
- There was areas of missing fire-blocking between the garage and the apartment above. The bottom of the tub basin was visible from the garage, leaving an opening to the apartment above. Fire-blocking does not prevent the spread of fires throughout a structure, but it does slow it down to allow for personnel to get to safety. This is a safety issue and should be corrected as soon as possible.

- The support beam that runs through the middle of the garage ceiling, was not properly supported by the studs or post below it. The studs and post must be the same width or wider than the beam they are supporting above.

- The support post at the center of the garage was not properly secured to the beam or the foundation.
- When electrical wiring and plumbing are run through a stud, joist, or top plate they should be properly protected by metal plates to prevent damage by nails. The requirements for installing protective plates over bores and notches differs with depth.

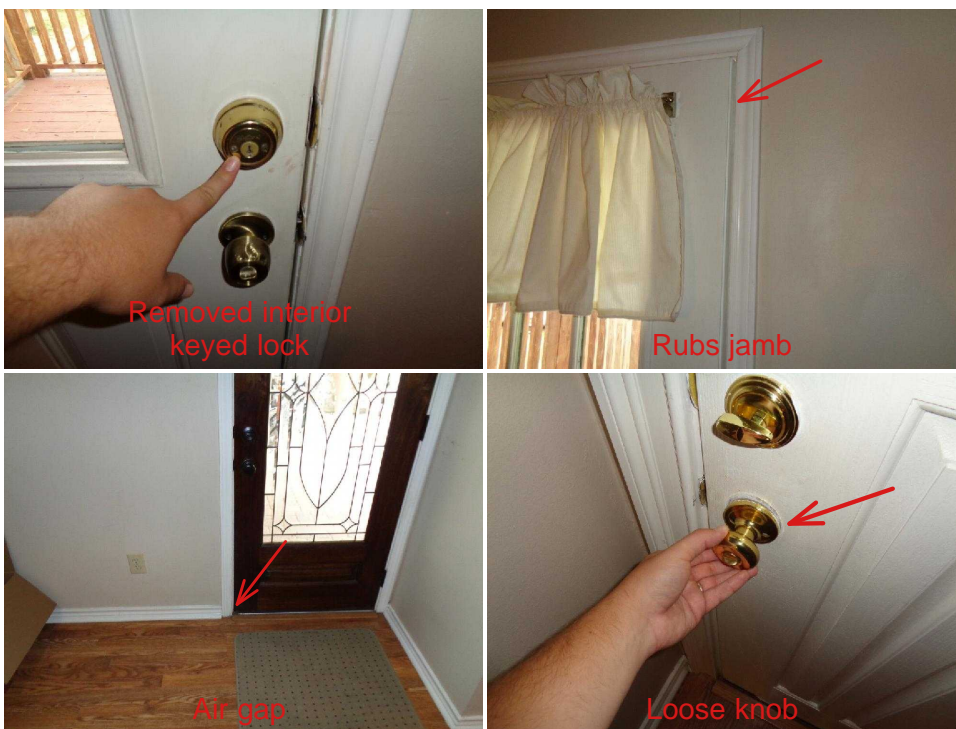
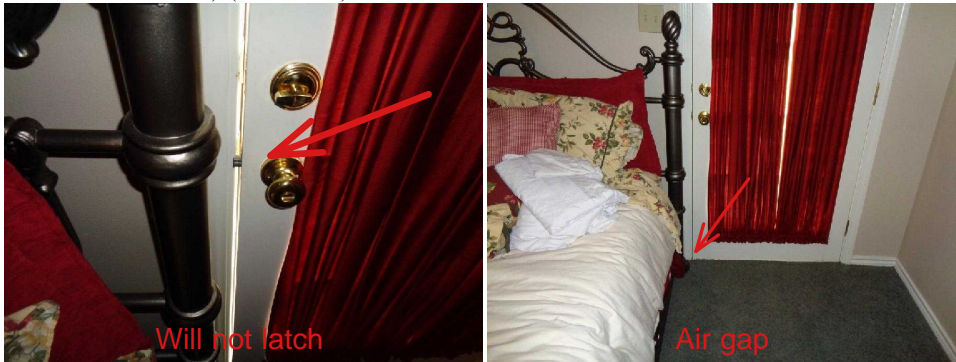
- The apartment entry door did not have a key to operate the lock on the doors at the time of the inspection. Any keyed locks for exterior doors should be changed to manual locks that do not require a key to operate from the inside. These doors are main paths of egress and pose a potential safety hazard if the home needs to be evacuated. Correct as needed.
- The apartment entry door was observed to rub against the jamb. Adjust the door for proper function.
- The left and right side doors were observed to have air gaps where visible sunlight was coming through when the door was closed. recommend adjusting door/weather stripping for proper seal.
- The front entry door knob was loose. Repair as needed.
- The left side entry door was not latching when closed. Adjust as needed.

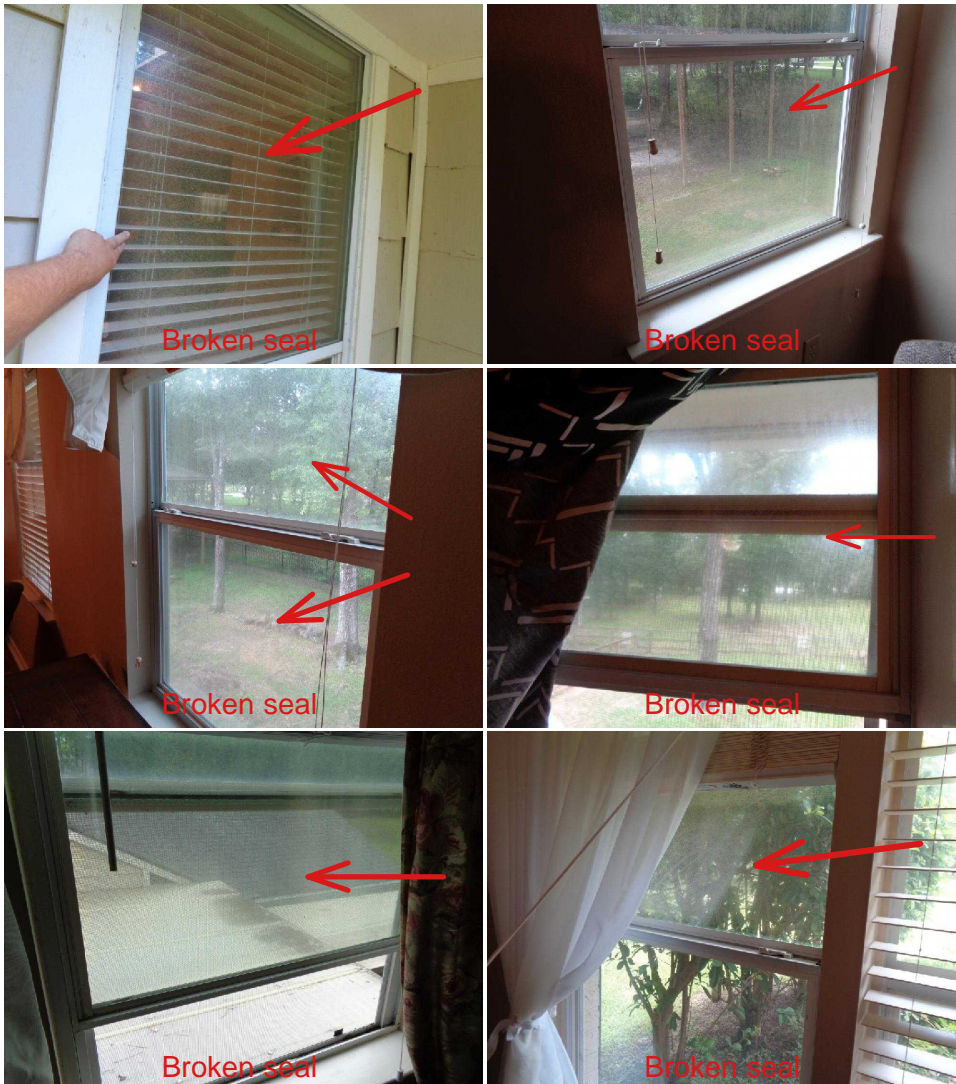
- Several windows throughout both structures were observed to have stains on the interior sides of the panes. This is the result of broken seals. A broken seal does not diminish the integrity of the windows. However it does lose the majority of its energy efficiency features once the seal is broken. Repair/Replace as needed.

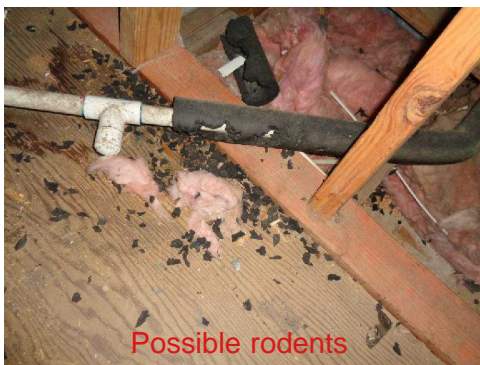
- There is evidence of possible rodents or squirrels on the attic. Several pieces of insulation was chewed or damaged. Recommend asking owners if the home has a history of rodents in the attic space.

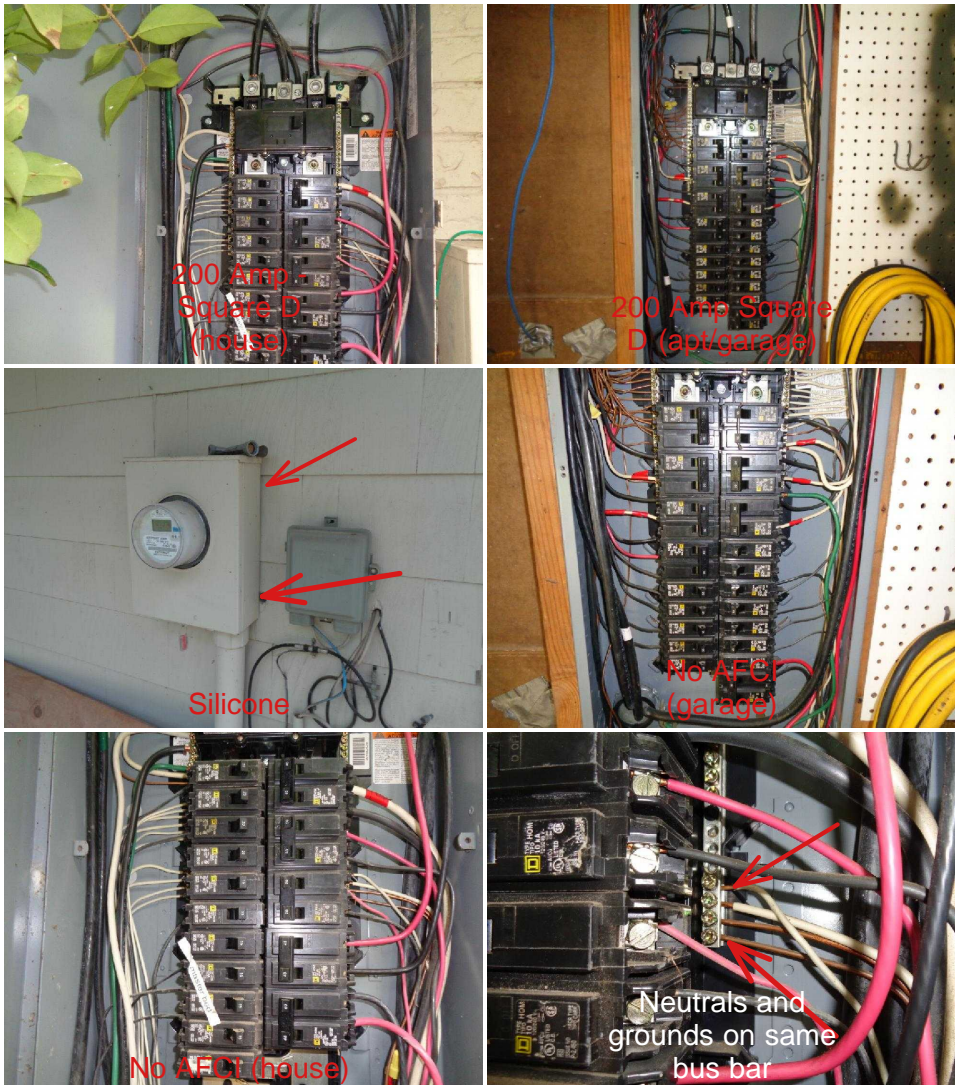
- The electrical meter box and panel should have caulk or silicone around the perimeter to prevent moisture or pests from entering the home. Correct as needed.

- There were no AFCI breakers installed at the time of the inspection. AFCI breakers were not required in older residential construction. However, they are required in all living areas of the home, such as bedrooms, living rooms, study, game-room, hallways, etc. Recommend a licensed Electrician come out and make all necessary repairs.

- Grounds and Neutrals should be secured to the provided bus bars (ground to ground bar) (neutral to neutral bar). Correct as needed.

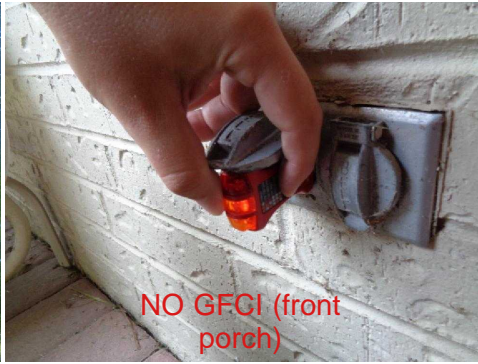
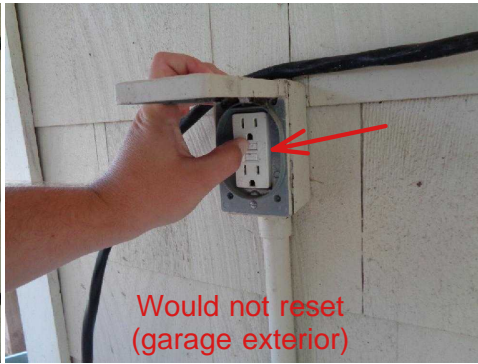
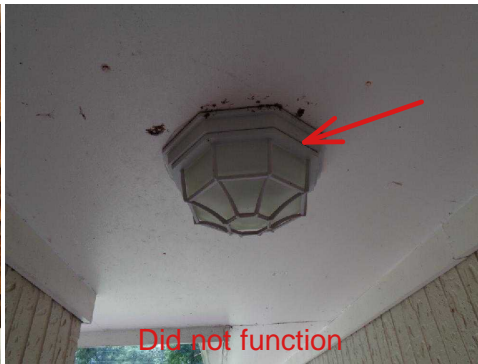
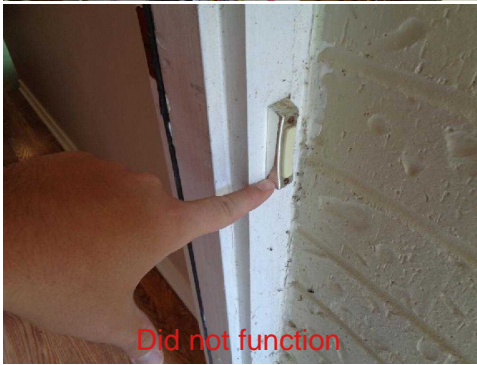
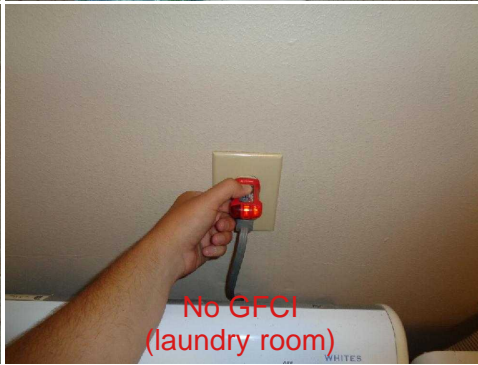
- All exterior electrical fixtures/switches should have silicone around them to prevent moisture from getting behind the fixture/switch and into the wall space. Correct as needed.
- Several light fixtures throughout the home were not functioning at the time of the inspection. Possibly bulb related. Repair/replace as needed.
- The doorbell did not function at the time of the inspection. Repair/Replace as needed.

- There were no GFCI protected outlets installed at the following areas. GFCI protected outlets are required to prevent electrical shock. GFCI protected outlets should be installed at all exterior, garage, kitchen, bathroom, laundry room, and wet bar outlets. Recommend a licensed and insured electrician further evaluate the electrical system and make any necessary changes/repairs.
 - Exterior outlet at front porch
 - Exterior outlet at garage would not reset
 - Laundry room outlets
- Several outlets were noticed to be loose when testing them Repair as needed.
- Unused wires were observed at the rear side of the garage. Appear to be for a hot tub. Secure or remove unused wires.
- All accessible outlets were checked for open grounds, open neutrals, open hot, hot/ground reverse, hot/neutral reverse, and proper GFCI requirements.

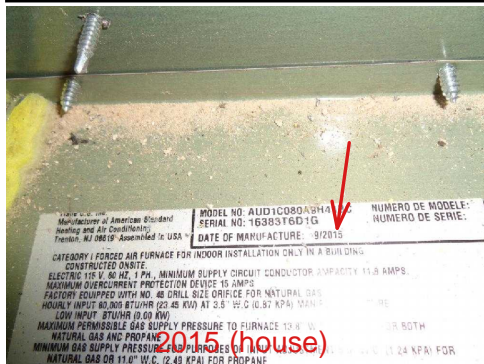
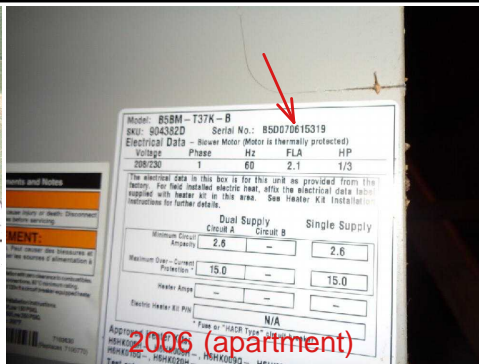
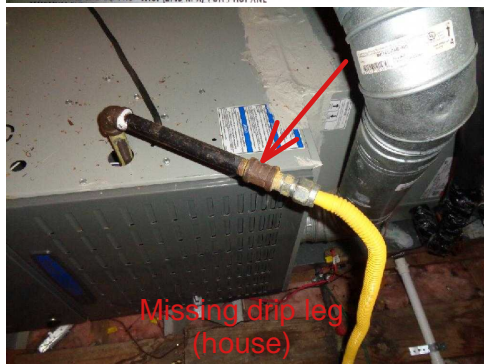
- The gas line for the furnace was noticed to be missing its drip leg. The drip leg helps prevent blockage and should be installed to prevent build-up of sediment inside the gas line. Install for proper functionality.

- The heating equipment is an older unit and is past its usual life expectancy. Recommend getting the equipment serviced by a licensed HVAC technician if not done so in the past year.

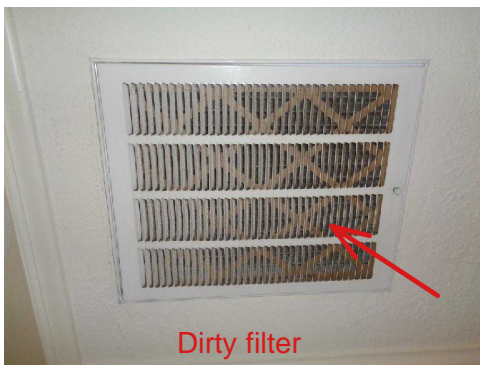
- The filters were observed to be dirty and in need of replacement. Recommend replacing filters every 3-6 months for maximum efficiency of the system.
- The ductwork should be suspended from the rafters and not resting on the ceiling joists. This helps to prevent kinks and warped ducts for better air flow of the system. Correct as needed.
- Duct work touching / overlapping at several locations. These areas should be separated with batt insulation to prevent the buildup of condensation between the ductwork.
- There were no supply vents noticed at the master bathroom or laundry room. Recommend installing ducts to these rooms for better air balance and comfort in the home.

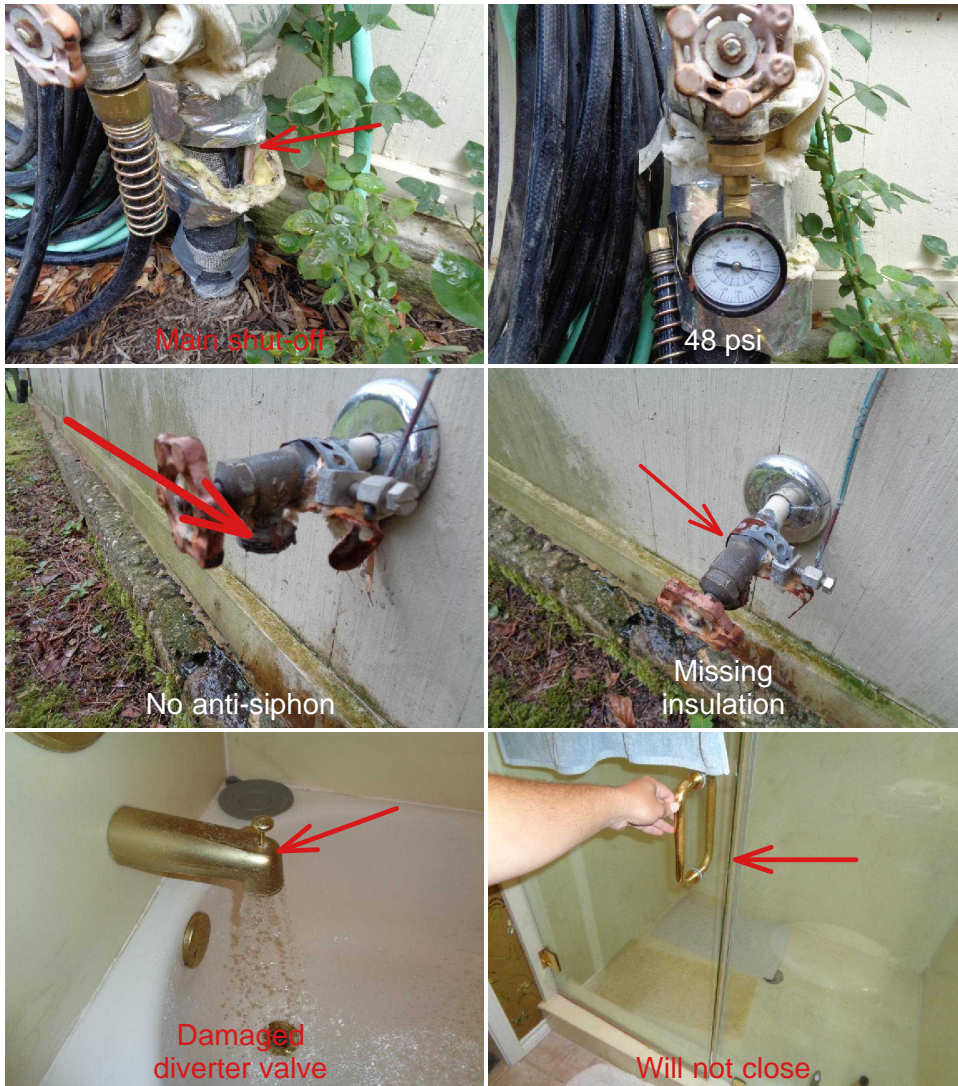
- The hose bibs located at the exterior were noticed to be missing the proper insulation material around the exposed pipe. Recommend installing to prevent freezing during lower temperatures.
- The exterior hose bibs did not have anti-siphon devices installed. These are required on all exterior supply fixtures to prevent dirty water from backing up into the clean water supply. Install as needed.

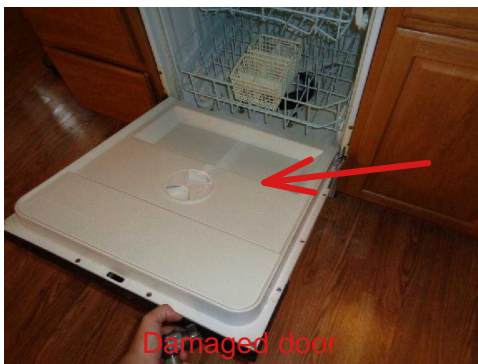
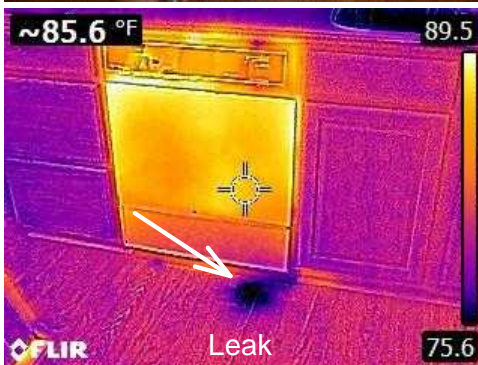
- The dishwasher at the house completed a full cycle and was performing as intended at the time of the inspection.
- The dishwasher for the apartment was noticed to have damaged door and was also leaking at the time of the inspection. Repair/Replace as needed.

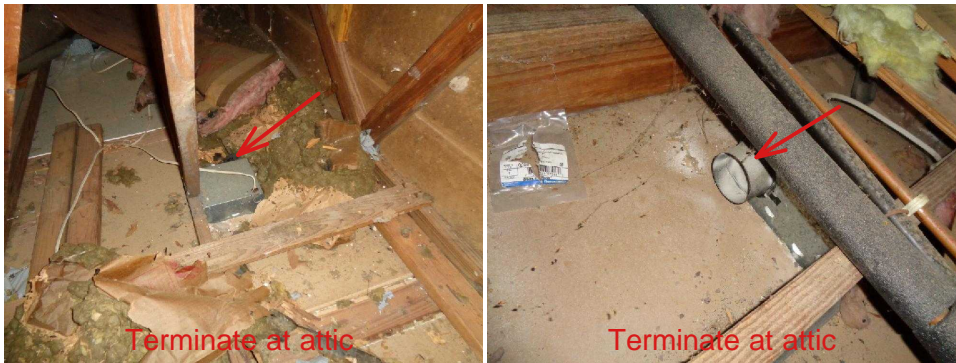
- All of the exhaust fans terminate into the attic area. All exhaust fans should terminate to the exterior of the structure to prevent warm moist air from being trapped in the attic space. Correct as needed.

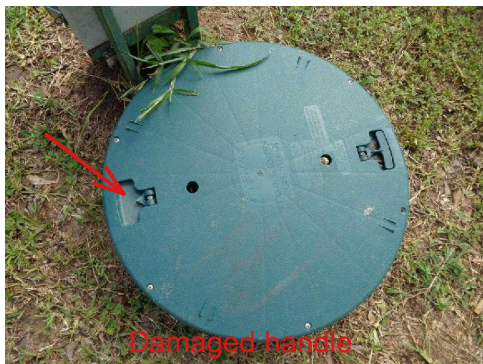
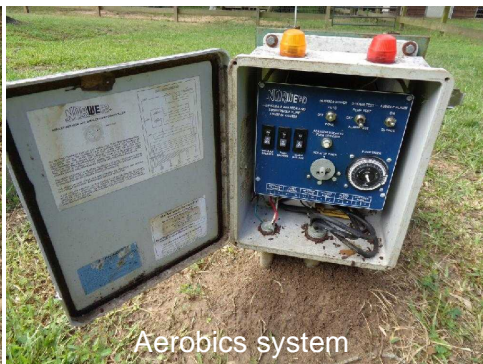
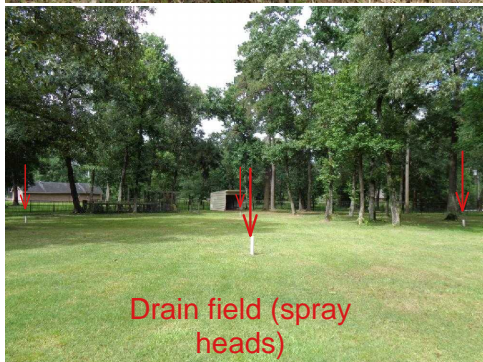
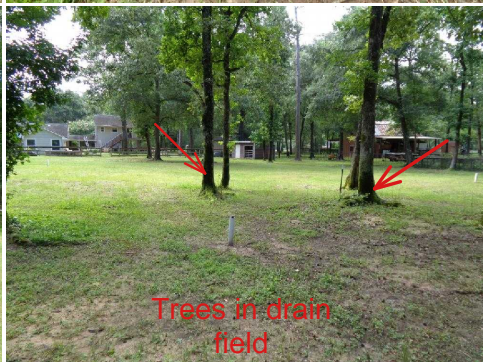
- The handle for the lid of the aerobics pump, was observed to be damaged. Repair/replace as needed.
- Trees were observed to be within the perimeter of the drain field. Trees should not be located in or near the drain field to prevent damage to subsurface drain piping.
- The rear right spray head for the septic system would not retract back into the housing compartment. Repair/Replace as needed.
- The septic system appears to be performing as intended at the time of the inspection.

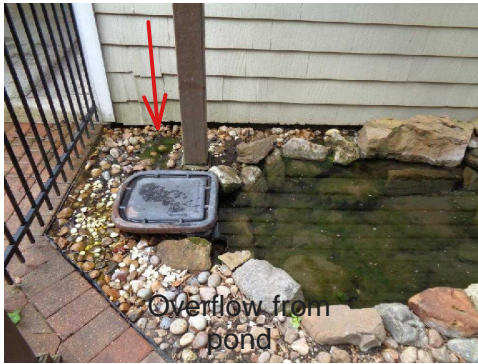
- Pond is not retaining the water and starting to drain out towards the front driveway/walk.
