RESIDENTIAL INSPECTION REPORT

727 Davis Rd
League City TX 77573

PROPERTY INSPECTION REPORT

Concerning: 727 Davis Rd, League City TX 77573
(Address or Other Identification of Inspected Property)

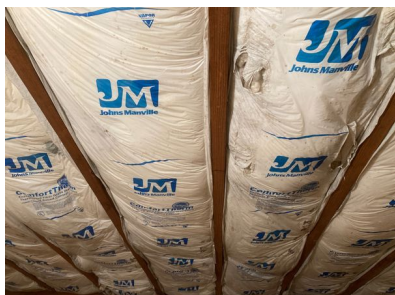
1: Note: Rodent activity

There was evidence of prior and/or current rodent activity in one or more areas of the home. Pest control services are available through our sister company, Green Team Pest, and can be scheduled through our office. If you have any concerns regarding rodent infestation we strongly recommend you schedule this service.

Recommendation: Contact a qualified pest control specialist.

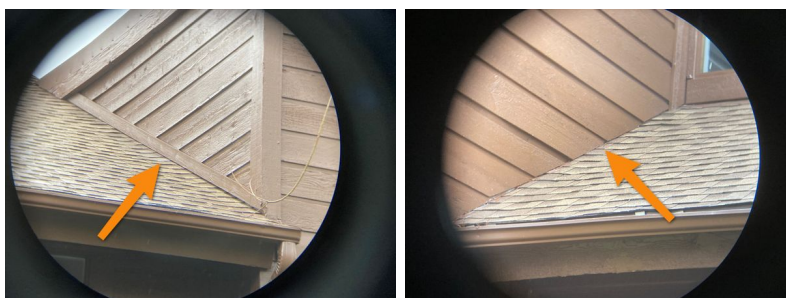
The siding does not adequately clear the roof surface. Installation guidelines generally require 1-2 inches of clearance between the siding and the roof covering. Evaluate and remedy as needed.

Recommendation: Contact a qualified professional.

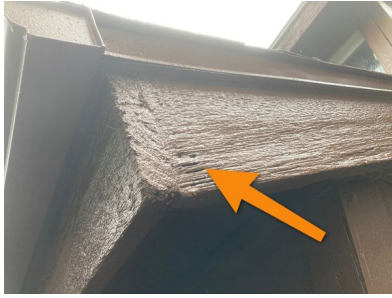
2: Exterior: Evidence of Wood Rot

Wood rot/deterioration was observed. Evaluate and remedy as needed.

Recommendation: Contact a qualified professional.

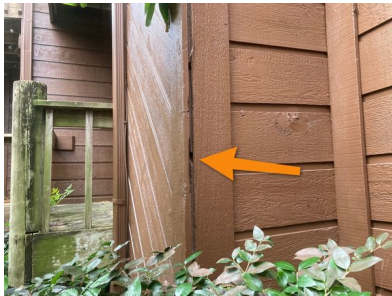
3: Exterior: Trim missing, loose, or damaged

Sections of exterior trim were either missing, loose, or damaged. Evaluation and remediation is recommended.

Recommendation: Contact a qualified professional.

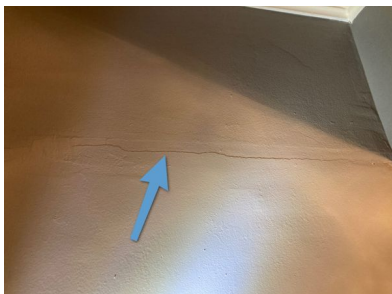
4: Interior: Hairline Cracks on Drywall

Hairline cracks were observed on the interior drywall. Hairline cracks may be related to the following:

Monitor and/or remedy as needed.

Recommendation: Recommend monitoring.

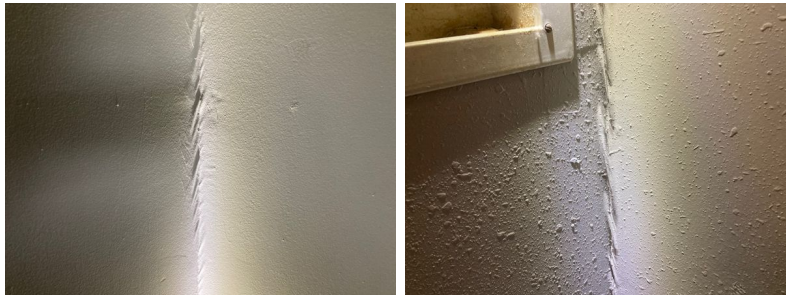
5: Interior: Wrinkled Tape Joint

Wrinkled tape joint can be evidence of current and/or previous structural movement. Evaluation and remediation is recommended.

Recommendation: Contact a qualified professional.

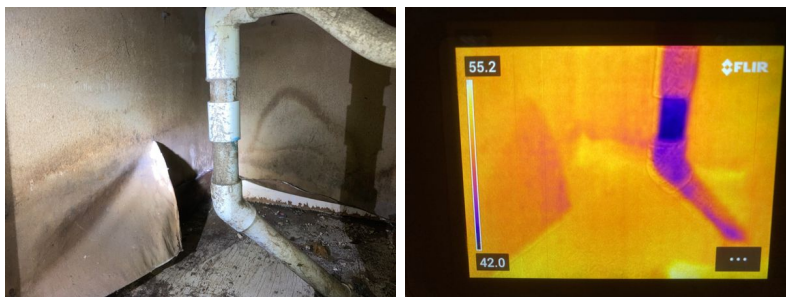
6: Interior: Evidence of Previous Moisture Contact

Wall structure showed signs of previous water intrusion. Tested negative for moisture at the time of the injection. Evaluate and remedy as needed.

Recommendation: Contact a qualified professional.

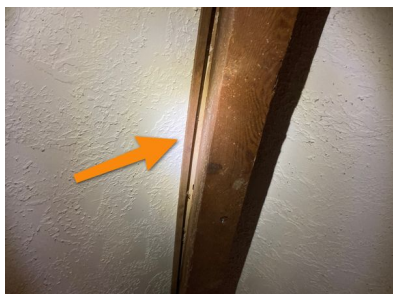
7: Interior: Loose Trim

Loose trim was observed upon inspection. Remedy as needed.

Recommendation: Contact a qualified handyman.

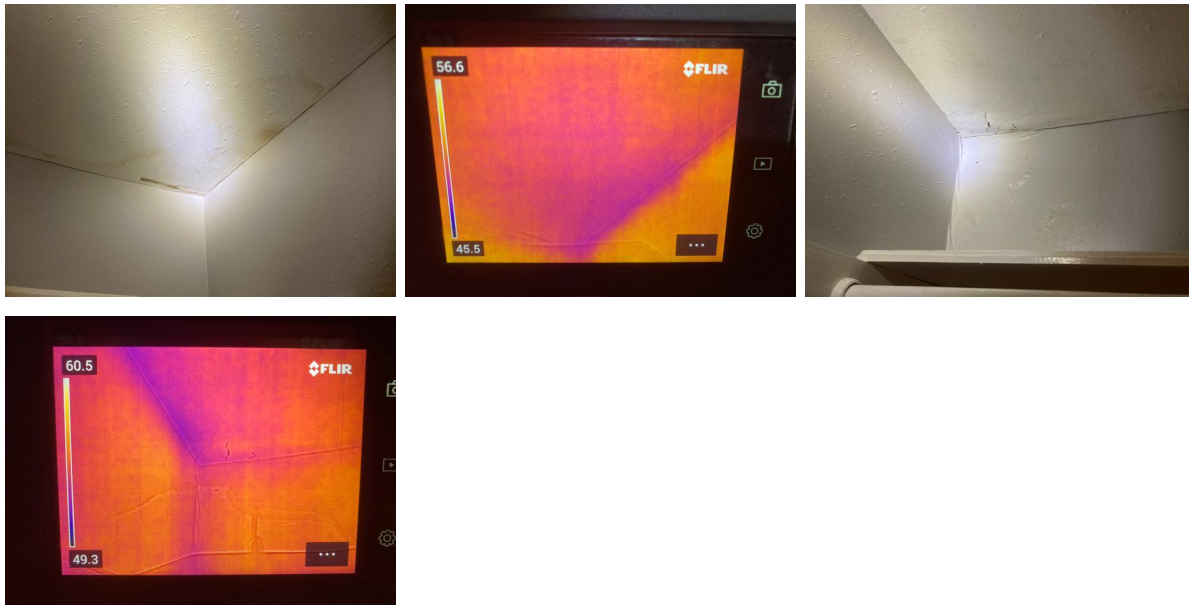
1: Ceiling: Evidence of Previous Moisture Contact

Ceiling showed signs of previous water intrusion. Tested negative for moisture at the time of the inspection. Evaluate and remedy as needed.

Recommendation: Contact a qualified professional.

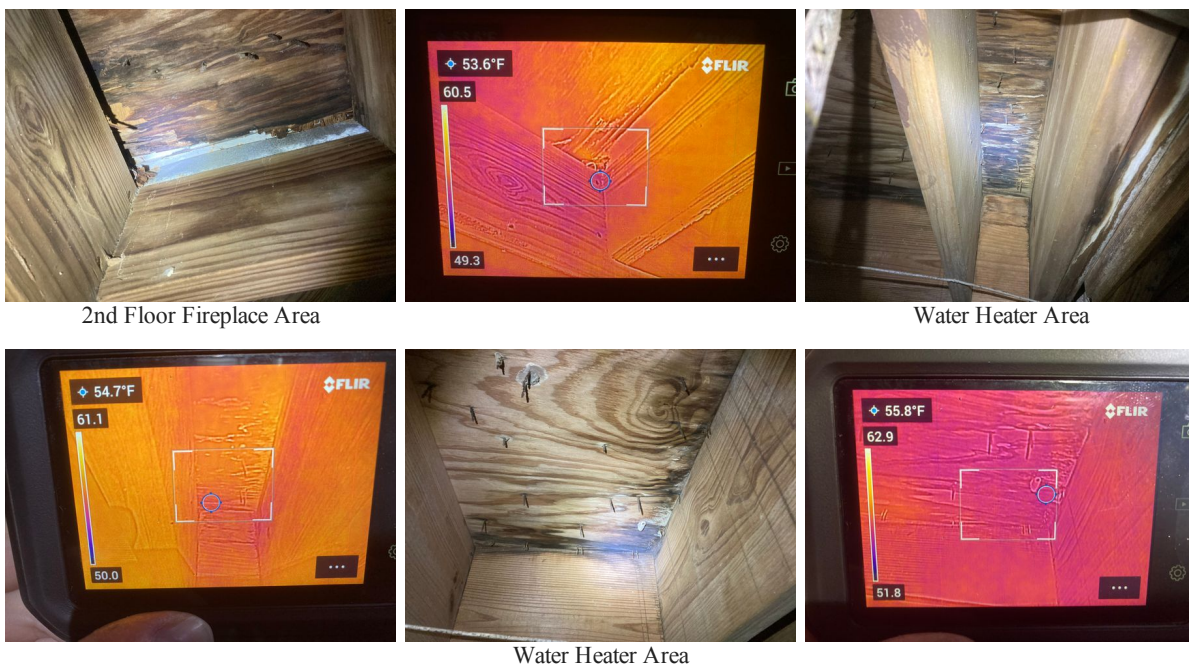
2: Flooring: Water Damage

Flooring had evidence of previous moisture contact at the time of inspection. Evaluation and remediation is recommended.

Recommendation: Contact a qualified professional.

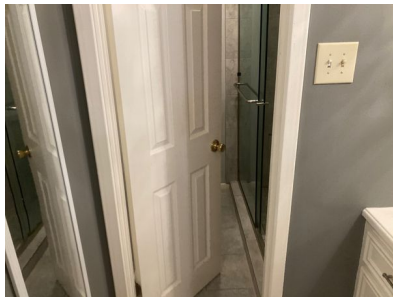
Evaluate and remedy as needed.

Recommendation: Contact a qualified professional.

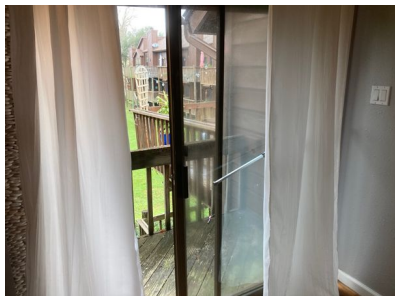
2: Door: Sticks/Difficult to Operate

Door sticks and is tough to open. Evaluation and remediation is recommended.

Recommendation: Contact a handyman or DIY project

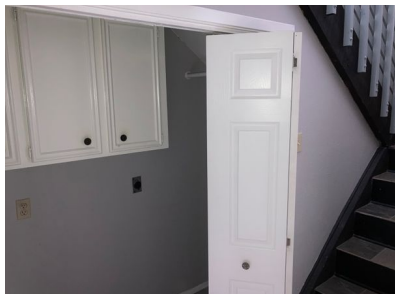
3: Doors: Closet Door Off Track

Evaluate and remedy as needed.

Recommendation: Contact a handyman or DIY project

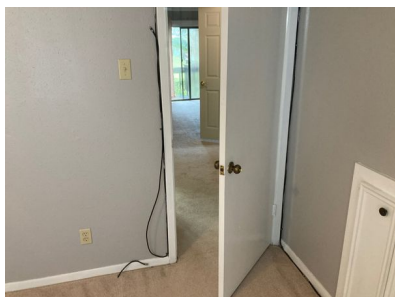
4: Door Hardware: Doesn't Latch

Door did not latch properly. Evaluation and remediation is recommended.

Recommendation: Contact a qualified handyman.

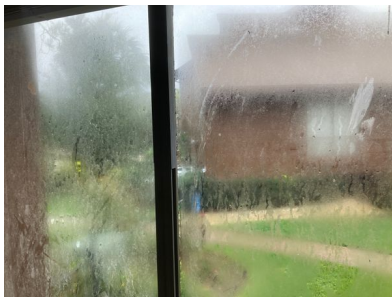
1: Note: Stain/Condensation on Window Sill

Note: Water stains observed on the window sill. This is typically caused by condensate build up on metal frames or single pane glass and is not generally due to window leaks. Keeping the sill painted will protect it.

Recommendation: Contact your builder.

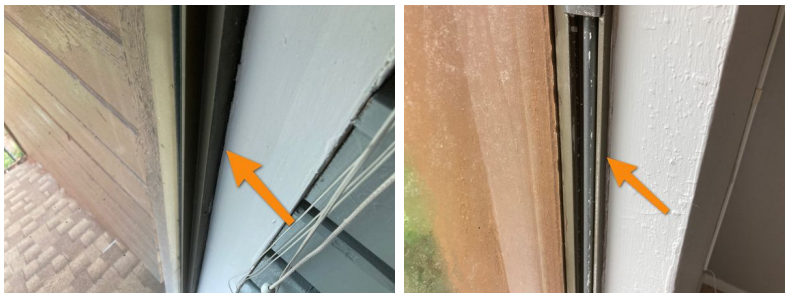
2: Caulking: Missing/Damaged

Caulking around window frames was missing or deteriorated. Caulking around window frames is an important barrier to moisture and air intrusion. Most exterior sealants have a lifespan of 5 to 8 years and should be regularly maintained with that lifespan in mind. Evaluate and remedy as needed.

Recommendation: Contact a qualified professional.

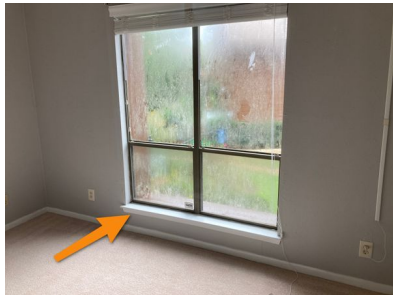
3: Sill Height: Too Low

Current building standards require any window with an exterior sill height of 72 inches or more to have a minimum interior sill height of 24 inches. Evaluation and remediation is recommended.

Recommendation: Contact a qualified professional.

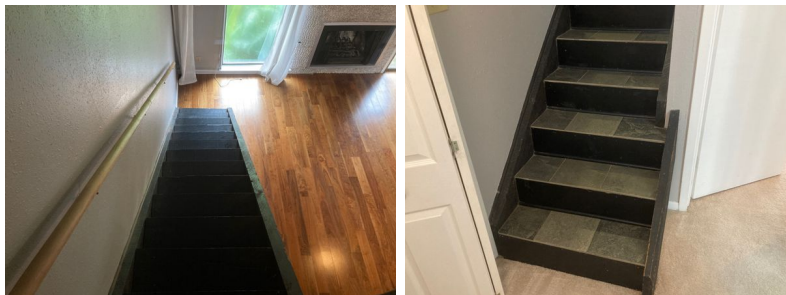
1: Handrails/Guardrails: Missing

Staircase had no handrails and/or a guardrail was missing. This is a safety hazard. Installation of a handrail or guardrail by a qualified professional is recommended.

Recommendation: Contact a qualified professional.

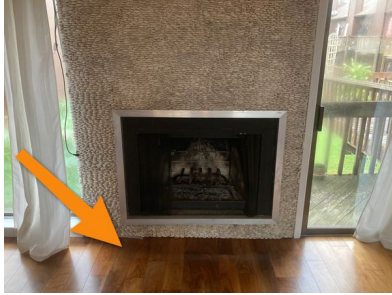
Fireplace hearth should extend a minimum of 20 inches from the front and 12 inches to both sides of fireplace. Evaluation and/or repair by a qualified fireplace contractor is recommended.

Recommendation: Contact a qualified fireplace contractor.

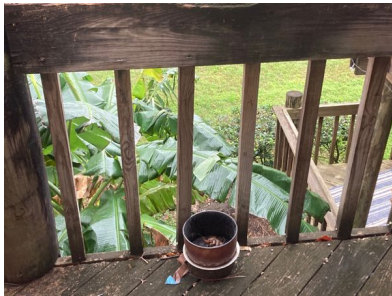
1: Handrails/Guardrails: Inadequate

- is at least 36 inches in height from the deck surface
- is not climbable
- has spindle gaps that are no greater than 4 inches

Recommendation: Contact a qualified professional.

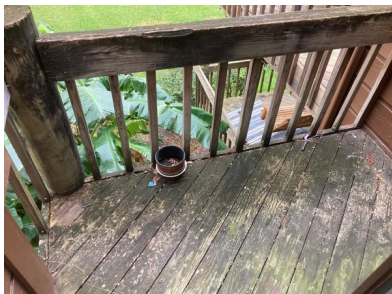
2: Water Sealant Needed

Deck is weathering and/or water damaged. Application of water sealant or weatherproofing is recommended.

Recommendation: Contact a handyman or DIY project

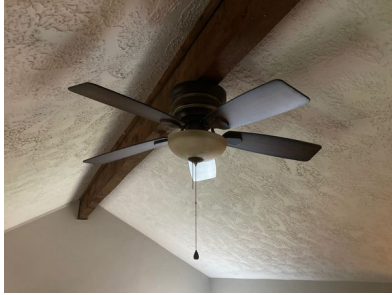
3: Ceiling Fan Defects

Further evaluation is recommended.

Recommendation: Contact a qualified professional.

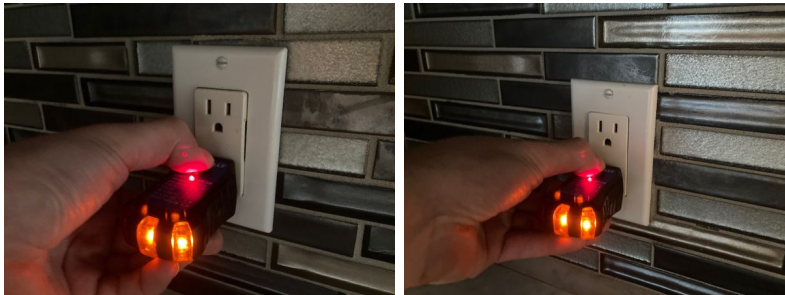
4: Receptacles: No GFCI Protection Observed

There was no GFCI protection observed in the home. Current building standards recommend the installation of ground fault protection:

GFCI protection was not present in these required locations. Evaluate and remedy as needed.

Recommendation: Contact a qualified electrical contractor.

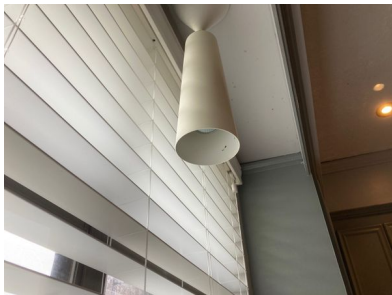
5: Light: Inoperable

One or more light fixtures were not operating at time of inspection. Cause was not determined. Evaluation and remediation is recommended.

Recommendation: Contact a qualified electrical contractor.

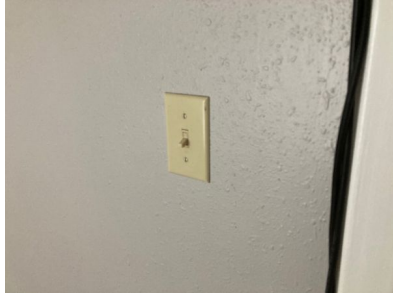
6: Light: Switches Installed Improperly

One or more switches were installed improperly. Evaluate and remedy as needed.

Recommendation: Contact a qualified electrical contractor.

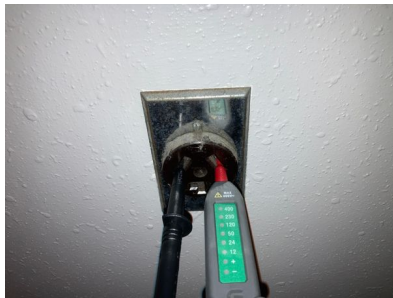
7: 220V Inoperable

The 220 volt outlet had no power at the time of inspection. Remedy as needed.

Recommendation: Contact a qualified electrical contractor.

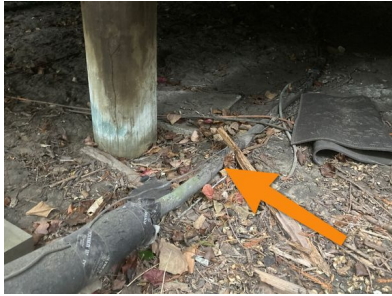
1: Condenser: Insulation Missing or Damaged on Refrigerant Lines

Missing or damaged insulation on refrigerant line can cause energy loss and condensation. Evaluation and remediation is recommended.

Recommendation: Contact a qualified HVAC professional.

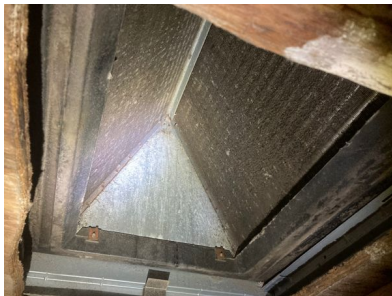
2: Evaporator Coil: Dirty

The evaporator coil was dirty. Full servicing by a licensed HVAC contractor is recommended.

Recommendation: Contact a qualified HVAC professional.

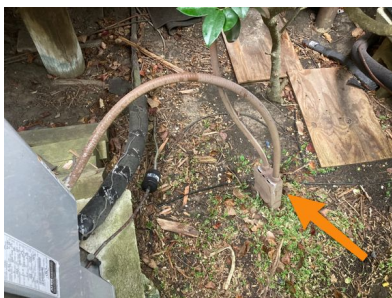
3: Condenser: Service Disconnect Detached

The service disconnect was detached from the home upon inspection. Remedy as needed.

Recommendation: Contact a qualified professional.

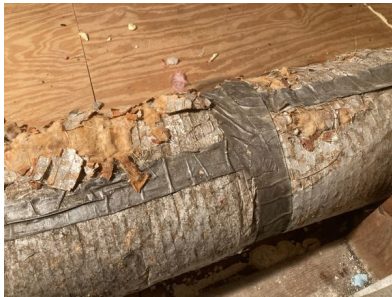
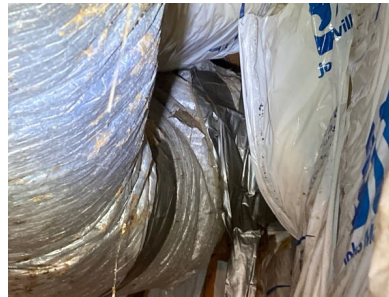
2: Ducts: Duct Tape Used (improper)

Duct tape had been used on sections of ducting. Despite the name, duct tape is not an approved material for HVAC ducts. Evaluation and remediation is recommended.

Recommendation: Contact a qualified professional.

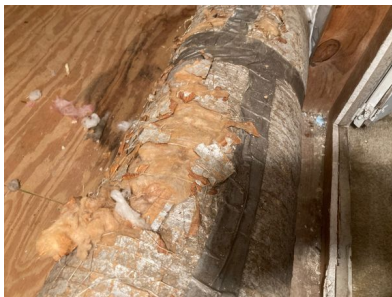
3: Ducts: Damaged

The air supply duct was damaged. Evaluation and remediation by a licensed HVAC contractor is recommended.

Recommendation: Contact a qualified HVAC professional.

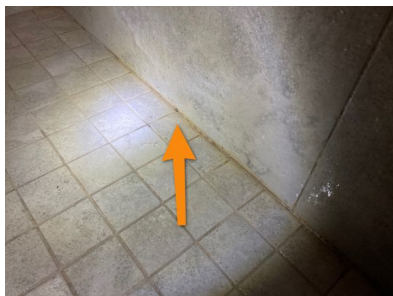
1: Shower: Missing/Deteriorated Caulking or Grout

Evaluation and remediation is recommended.

Recommendation: Contact a qualified professional.

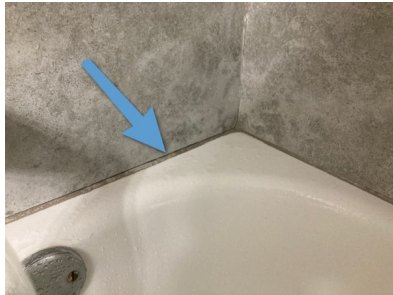
2: Tub: Caulk Deteriorated/Missing

Deteriorated or missing caulk was present at tub. Remedy as needed to maintain an optimal moisture barrier. Evaluation and remediation is recommended.

Recommendation: Contact a handyman or DIY project

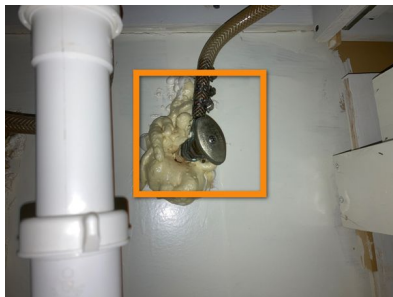
3: Supply Piping: Leak

Water pipes/fittings leaked. Evaluation and remediation is recommended.

Recommendation: Contact a qualified plumbing contractor.

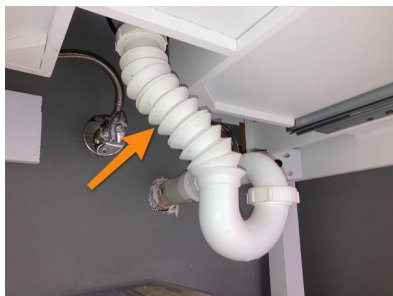
Current plumbing standards require all drains to have smooth interior surfaces. Corrugated materials are not approved. Evaluation and remediation is recommended.

Recommendation: Contact a qualified plumbing contractor.

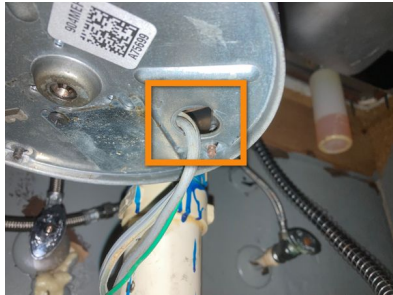
No wire clamp had been installed at the base of the unit. Evaluation and remediation is recommended.

Recommendation: Contact a qualified professional.

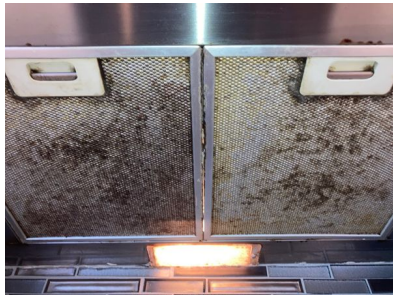
Kitchen exhaust filter had excessive grease build-up. Clean and/or replace as needed.

Recommendation: Contact a qualified professional.

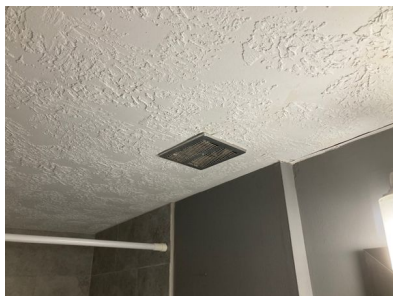
The exhaust fan was inoperative at time of inspection. Evaluation and remediation is recommended.

Recommendation: Contact a qualified professional.
