## MECHANICAL INSPECTION

13515 St Marys Ln  
Houston TX 77079

# PROPERTY INSPECTION REPORT

07/12/2021 9:00 am

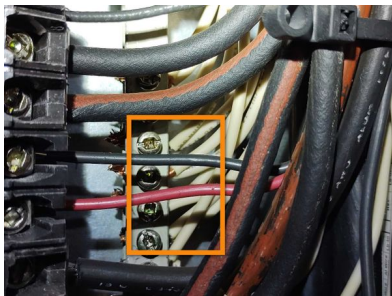
The neutral wires were improperly double lugged in the grounding buses inside the breaker panel. Each wire should be connected to its own lug.

**Obtain Cost Estimate**

Repaired

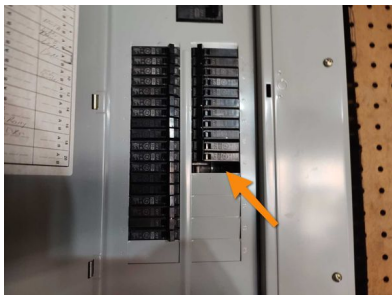
**3: Cover Plate - Missing knock out clip**

The dead front cover plate was missing one or more knock-out clips.

**Obtain Cost Estimate**

Repaired

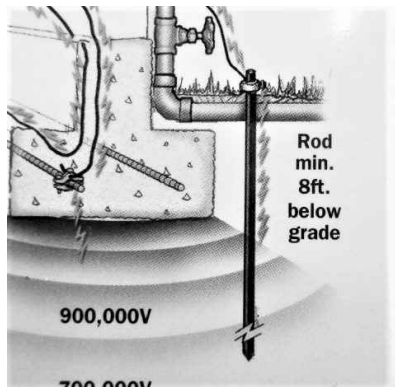
**4: Ground Rod - Not flush with grading**

The ground rod was sticking out of the ground a few inches, and, since ground rods are typically 8 feet long and all 8 feet of the rod are required to be in the ground, it is recommended that the ground rod be pounded down flush with the top of the ground. The clamp on the rod should be an acorn clamp is approved for direct burial in the ground.

**Obtain Cost Estimate**

**Repaired**

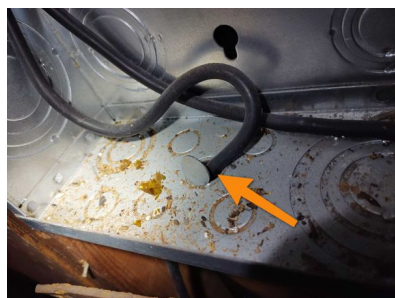
A hole in the panel where a circuit wire enters the panel was a missing bushing.

**Obtain Cost Estimate**

**Repaired**

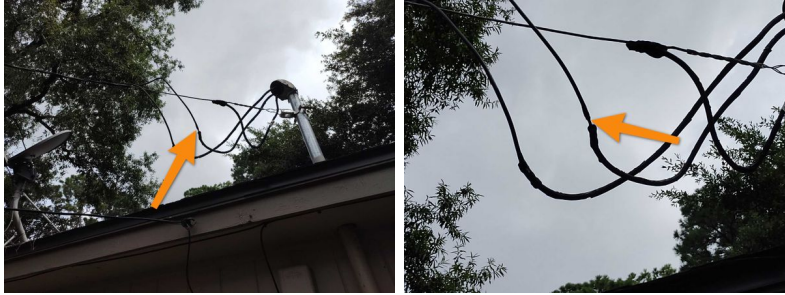
### 7: Service Conductor - Exposed wire

An exposed "hot" wire was observed on the service entrance conductors and needs to be properly taped.

Repaired by  
Center Point Energy

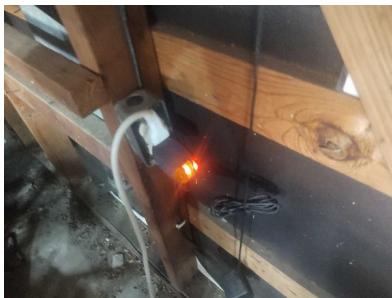
An outlet in which the hot and neutral (black and white) wires were reversed, causing reversed polarity.

**Obtain Cost Estimate**

Repaired

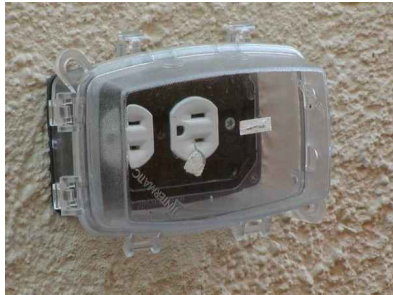
**5: Exterior Outlet - No water tight cover**

An exterior outlet that was not protected by a water tight cover plate was observed.

**Obtain cost estimate**

Repaired

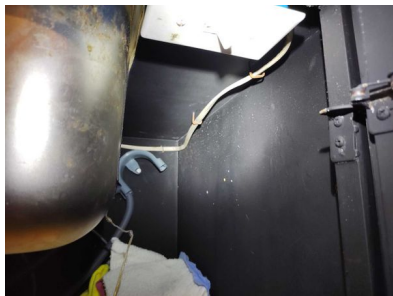
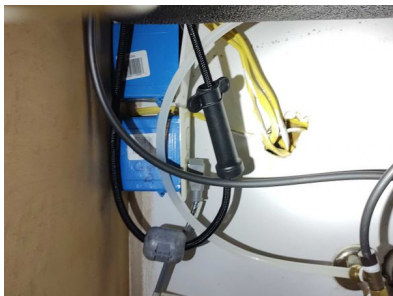
**10: Conduit Missing**

A portion of the electrical wiring was exposed where electrical conduit was not properly or not completely installed.

**Obtain Cost Estimate**

Repaired

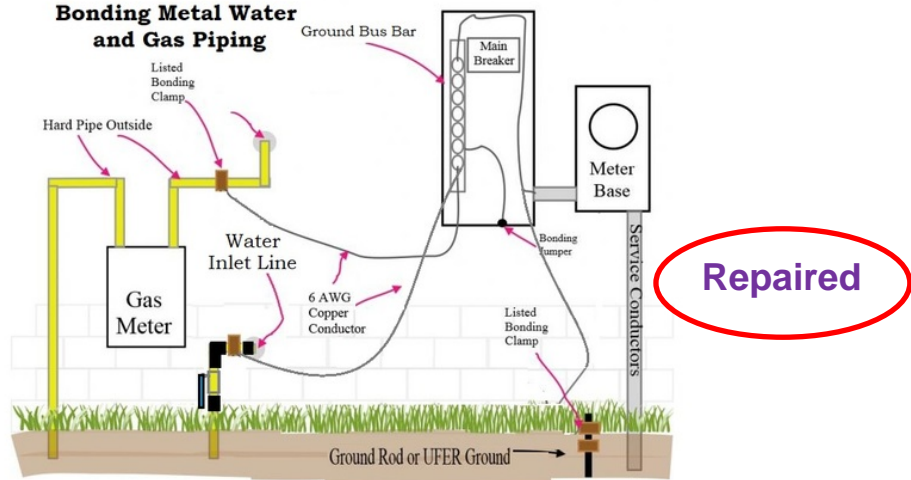
**11: Gas Piping - Bonding not visible**

The location where the gas supply piping was bonded back to the electrical ground system was not visible at the time of the inspection. It is recommended that an electrician be contacted to determine if the plumbing in the house is properly bonded and to make any needed repairs.

**Obtain Cost Estimate**

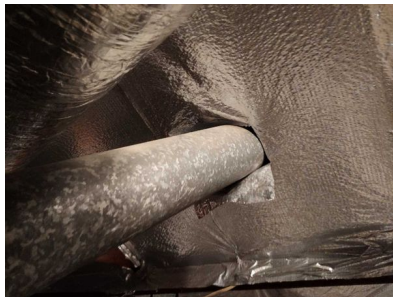
**1: Vent Pipe - Inadequate Clearance**

Double wall vent pipes require a minimum of one-inch clearance to any material that is combustible. The vent pipe was located too close to a combustible material, which is a fire hazard.

**Obtain Cost Estimate**

**This was the original configuration from 1967. We cannot justify demolition and construction to change it now.**

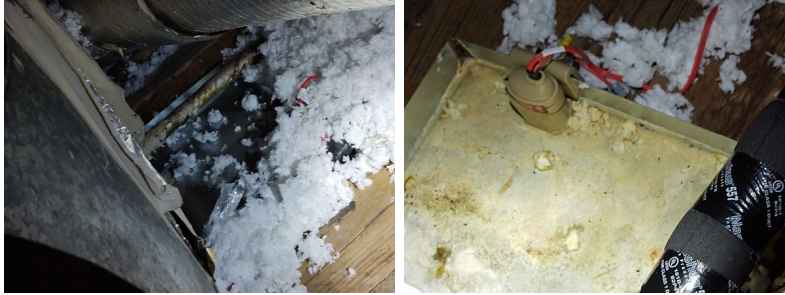
**4: Overflow Pan - Debris in pan**

Insulation and/or debris was observed in the overflow pan. The pan needs to be cleaned out to prevent clogging of the drain line.

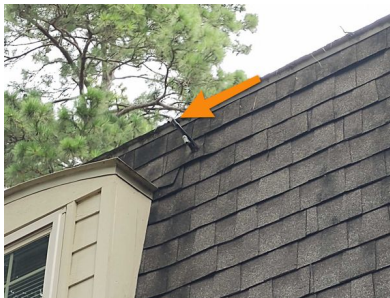
**5: Overflow Pan - Drain not properly sloped**

The overflow pan drain was not sloped properly to allow water to flow properly towards the exterior.

**Obtain Cost Estimate**

**Pan has been elevated to assist draining.  
Pan has been tested and water drained.**

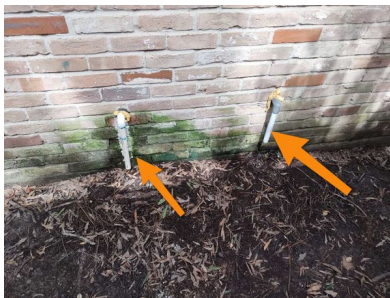
**6: Primary Drain Line - Terminated outside**

The primary condensate drain line terminates outside at the side of the foundation. Over time, the constant moisture that is produced by the HVAC system and emptied onto the ground can contribute to foundation settlement. The drain line should be rerouted to an approved location.

**Obtain Cost Estimate**

**This is the original condition. The foundation has been monitored and remains within tolerance.**

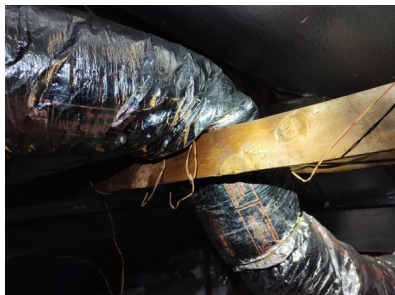
One or more of the air ducts were crushed/pinched/kinked causing a restriction in the air flow through the system. The ducts need to be adjusted or repaired.

**Obtain Cost Estimate**

**Ductwork has been inspected and repaired as the A/C technician recommended.**

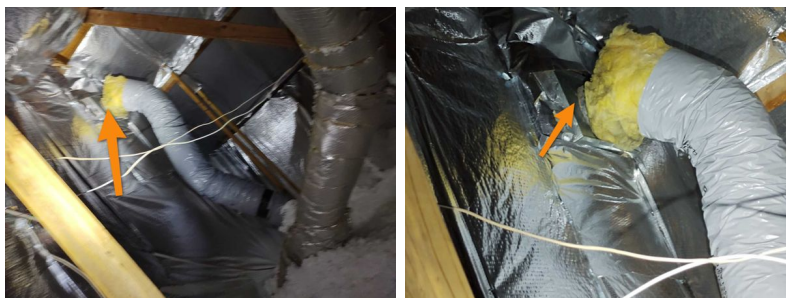
**2: Ducts - Sheathing/Insulation damaged**

The sheathing and/or insulation around the air ducts is damaged/missing, and the damaged duct work needs to be repaired or replaced.

**Obtain Cost Estimate**

**Ductwork has been inspected and repaired as the A/C technician recommended.**

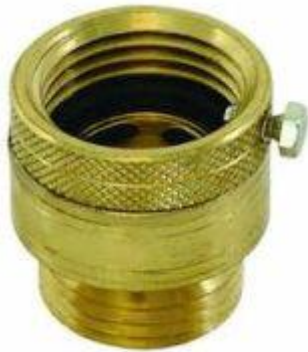
The atmospheric vacuum breaker devices were missing at one or more of the hose bibbs, and it is recommended that they be installed to prevent cross connections, which can allow contaminated water to enter the potable water supply.

**Obtain Cost Estimate**

**Homeowner has acquired the vacuum breakers, they can be installed at anytime.**

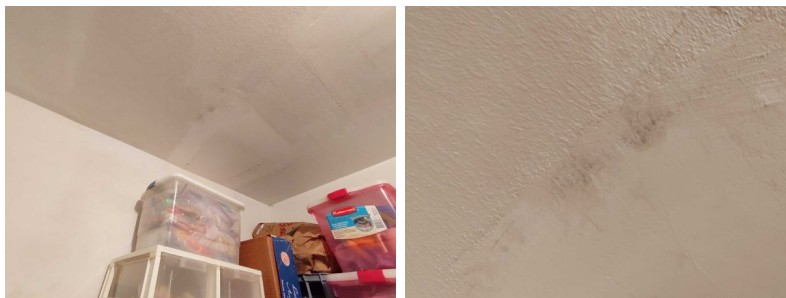
**2: Water Stains/Damage/Microbial Growth**

Further investigation is recommended with a contractor to determine the source of the condition and to make any necessary repairs to correct the moisture condition and, if present, any secondary damage.

**Obtain Cost Estimate**

**Water source not found, cleaned treated and painted. This is possibly from the time right before the repipe.**

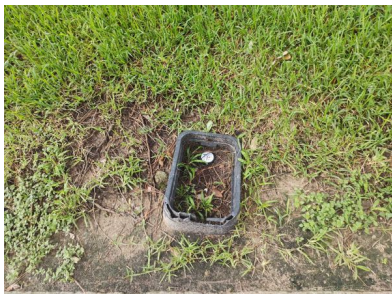
The cover was damaged/missing at the water meter. This is a hazard to foot traffic and needs to be corrected.

**Obtain Cost Estimate**

**Repaired by city**

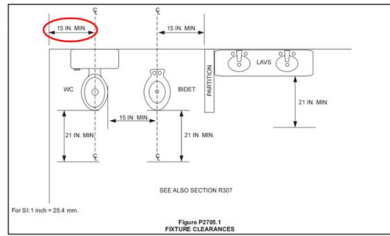
The toilet was located too close to the adjacent tub or cabinet. A properly installed toilet requires a minimum of 15 inches of clearance. Further investigation is recommended with a plumber to determine a solution for the condition and to provide cost estimates for any needed repairs.

Obtain Cost Estimate

This was the original configuration from 1967. We cannot justify demolition and construction to change it now.

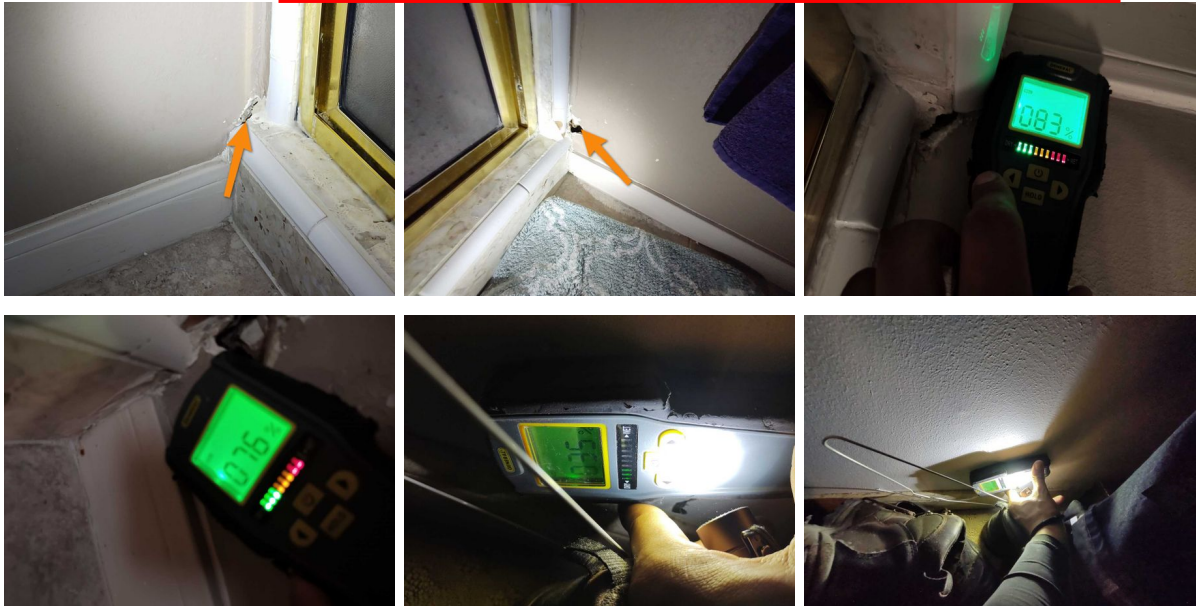
**13: Shower Pan - Evidence of leak**

Master bathroom,

Obtain Cost Estimate

**A shower pan leak test was performed with no sign of a leak see Strutton Plumbing**

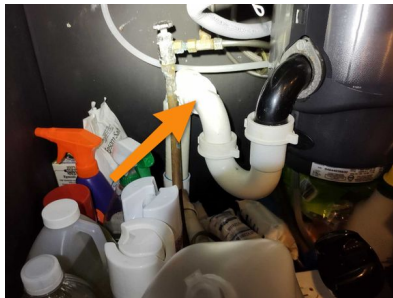
A means of venting sewer gases was not observed at the kitchen island sink.

**Obtain Cost Estimate**

**Plumber advised us that it was not practical. This sink has always drained with no issues.**

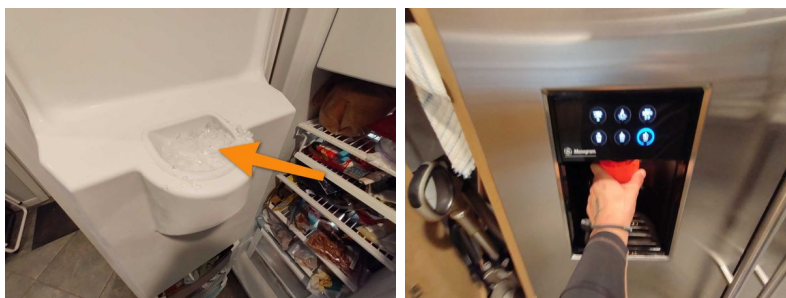
The ice dispenser for the built in refrigerator was clogged at the time of the inspection. It was also disclosed to us that the water dispenser was non-functional.

**Obtain cost estimate**

**Repaired and replaced**
