## STRUCTURAL INSPECTION

13515 St Marys Ln  
Houston TX 77079

JULY 12, 2021

REF: CONDITION OF PROPERTY SURVEY

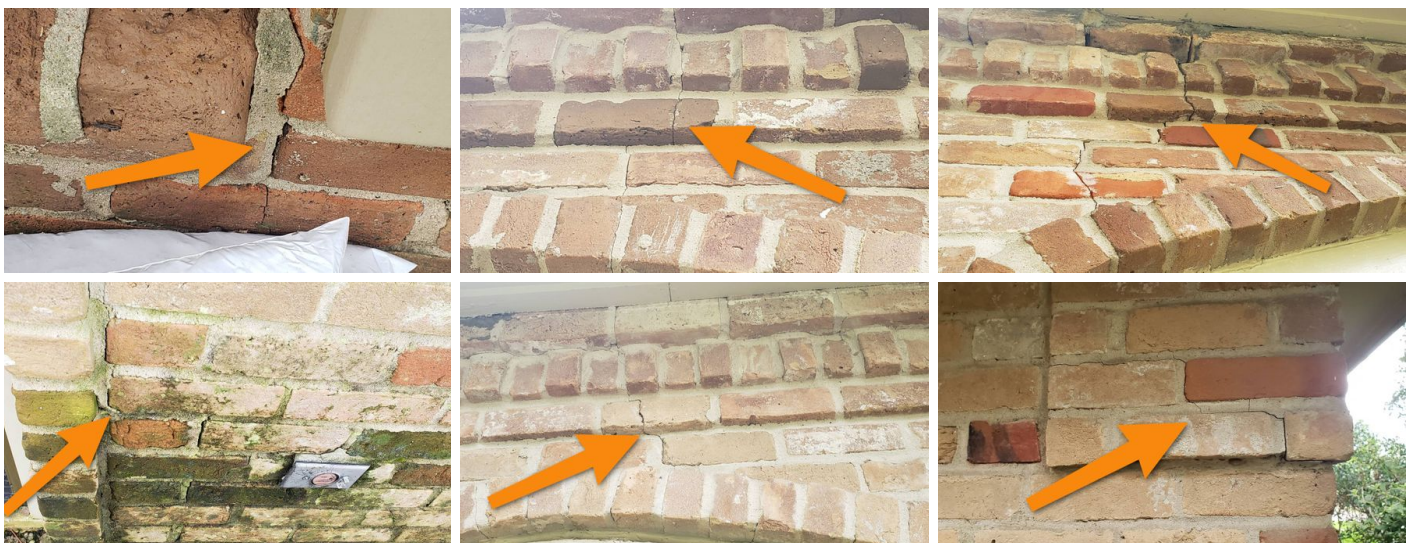
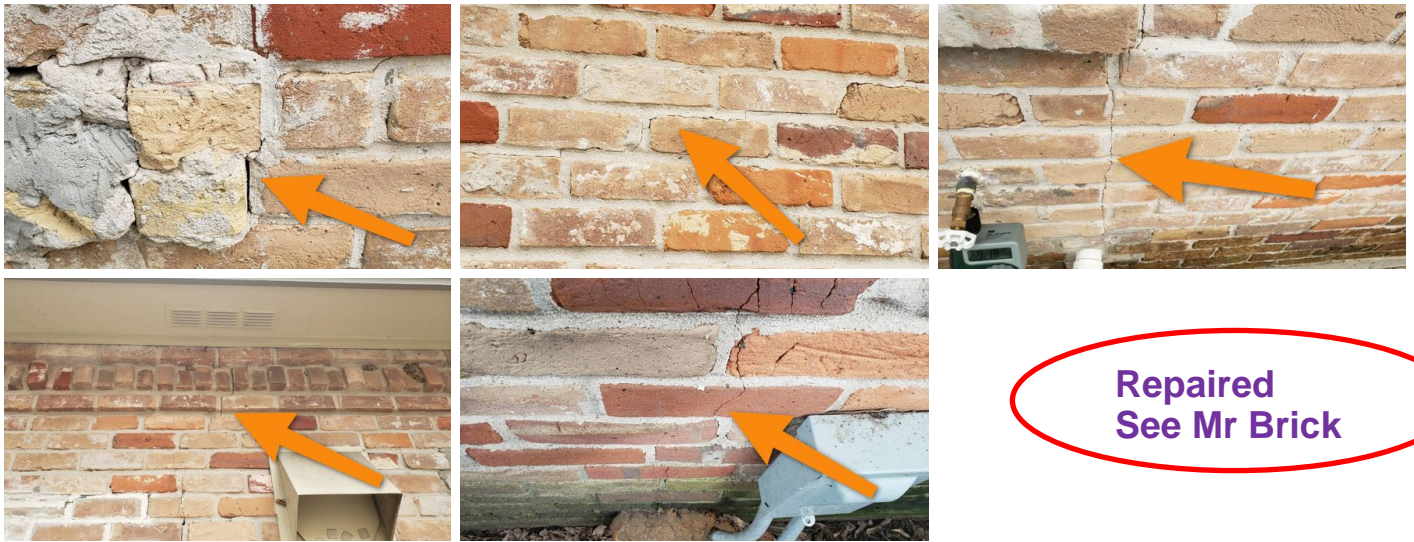
Front West East

**Differential Movement: Veneer - Cracks/Patches**

Cracks and/or patches were observed in the exterior veneer at the time of the inspection, including at the locations shown in the photos.

**Repaired  
See Mr Brick**

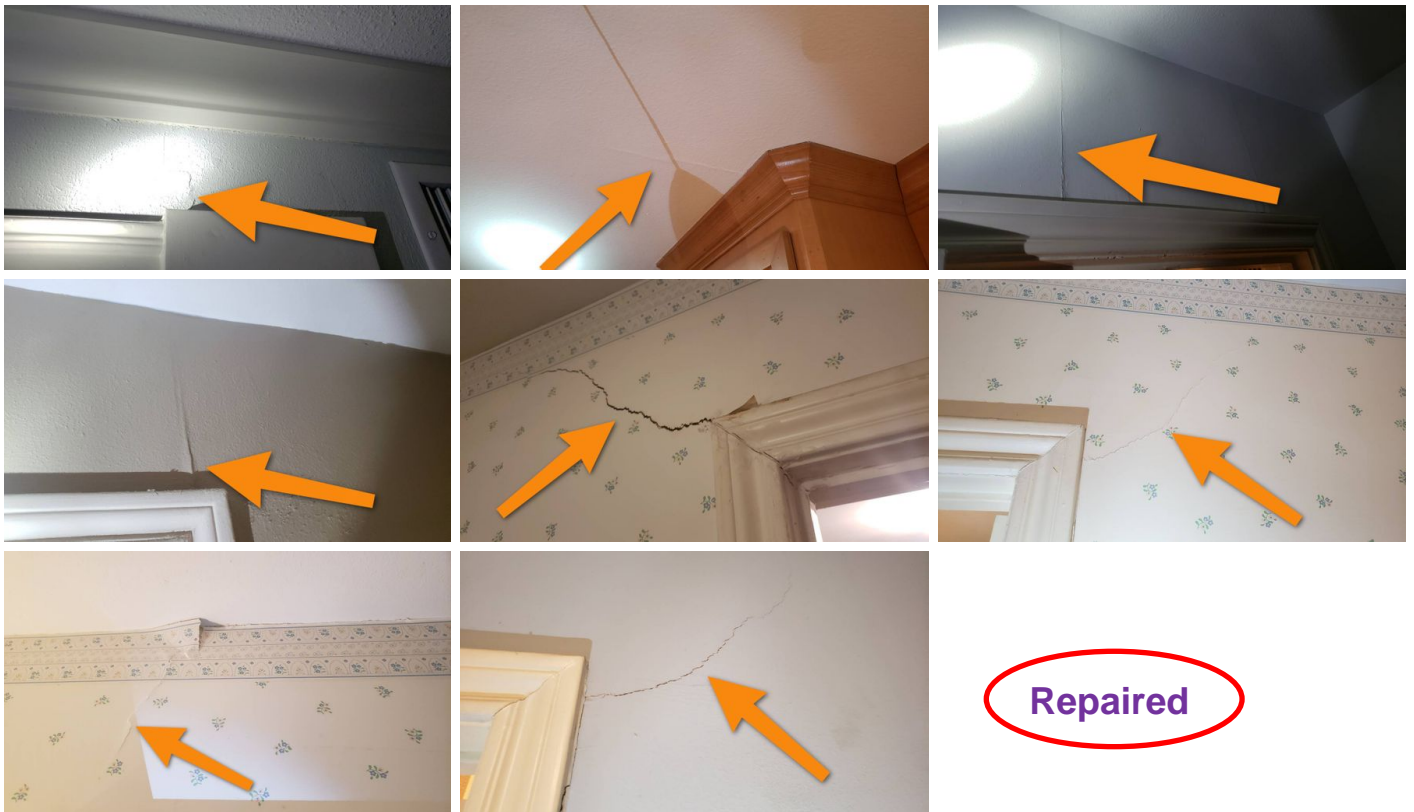
Throughout the house

**Differential Movement: Sheetrock Cracks/Patches/Compression ridges**

Sheetrock cracks, patches, and/or compression ridges were observed in the house during the inspection, including at the specified locations.

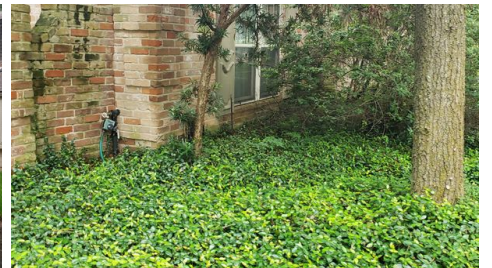
**Differential Movement: Slab Not visible - High Soil**

It is pointed out that a portion of the foundation concrete could not be viewed due to soil that was graded near or above the top of the foundation and/or heavy foliage growing against the house. The soil and/or foliage should be removed, and 3-4 inches of foundation concrete exposed.

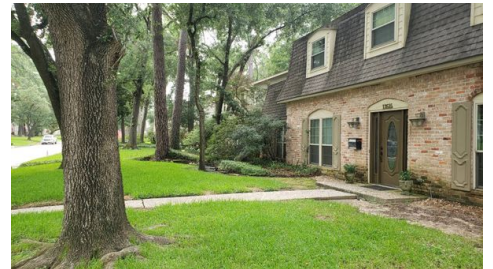
**TREES AND/OR FOLIAGE**

Trees and/or foliage were observed in the vicinity of the house which can contribute significantly to differential movement of the house foundation. Care should be taken to prevent the trees and foliage from removing an excessive amount of water from near the foundation of the house.

Contact a qualified professional.

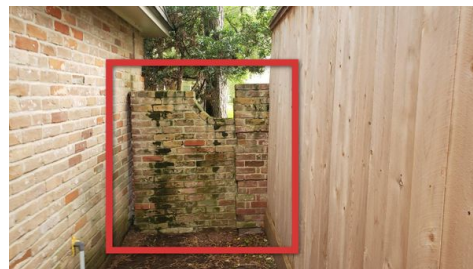
**SETTLEMENT ON WING WALL**

We observed movement on the wing wall. While this is not the house foundation, you may want to give consideration to doing further investigation with a service company should you desire repairs.

Contact a qualified professional.

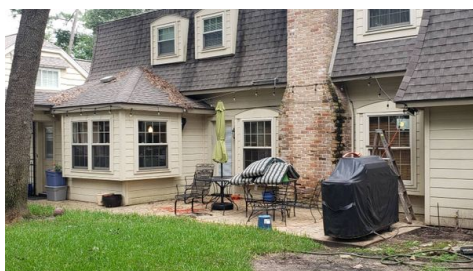
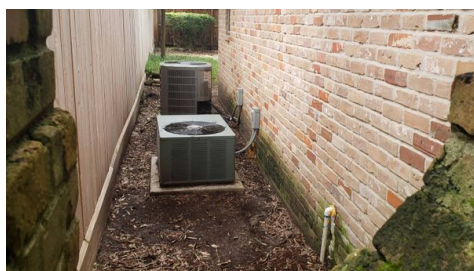
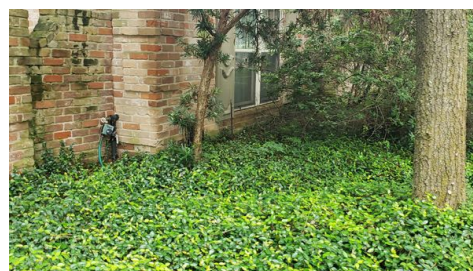
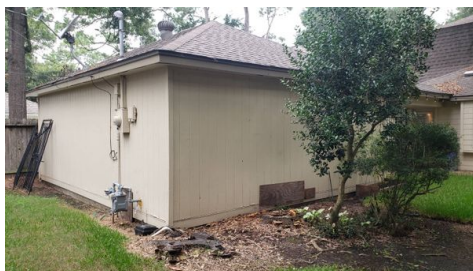
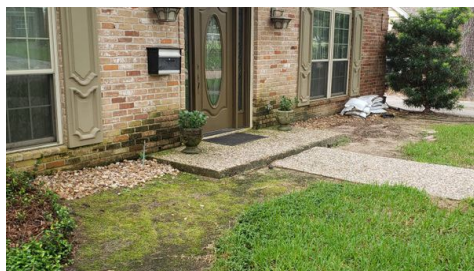
The perimeter grading and/or flower beds was too high at some areas, and was graded near or above the top of the foundation. It is recommended that the beds/soil be regraded as needed to prevent water penetration into the house, and to allow for proper drainage.

Contact a qualified landscaping contractor

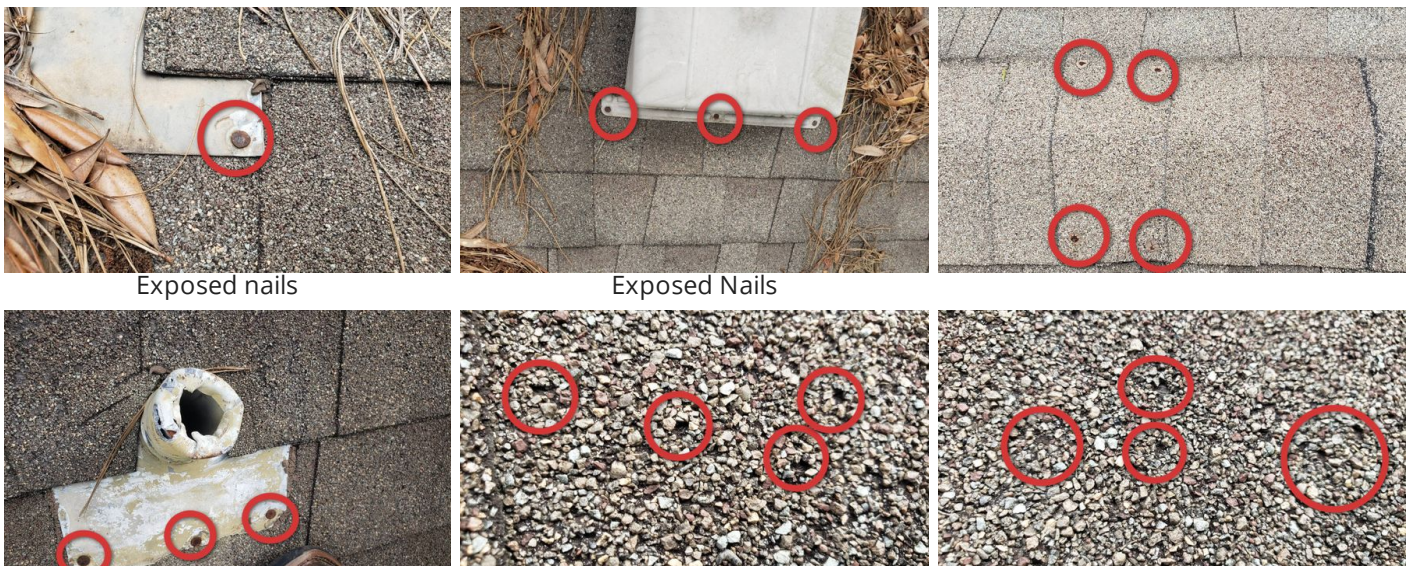
**Wear and Deterioration: Composition - Some**

Discolored, Brittle, Nail Heads not Sealed, Aggregate Missing, Rusted Roof Jack, Damaged Shingles

The composition roof surface was showing evidences of some deterioration of the roof surface as described above and shown below.

Exposed nails

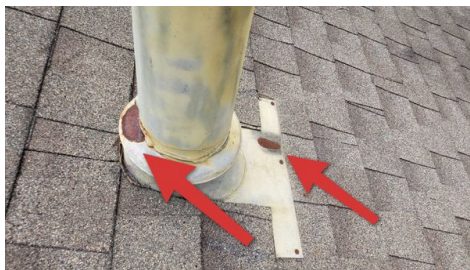
Rusted Roof Jack

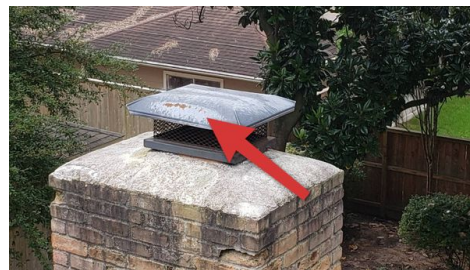
Rusted chimney cap

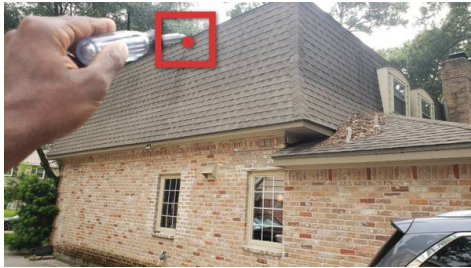
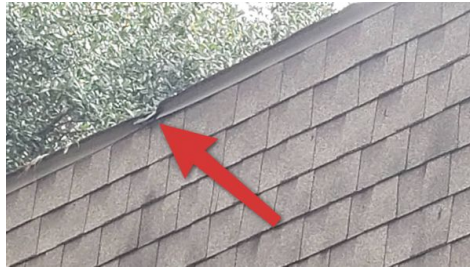
**FLASHING/COUNTER FLASHING**

## Drip Edge flashing loose/damaged

We observed one or more conditions with the roof flashing as pointed out above. Have a roofing contractor provide a cost estimate to make all needed repairs

**Repaired**

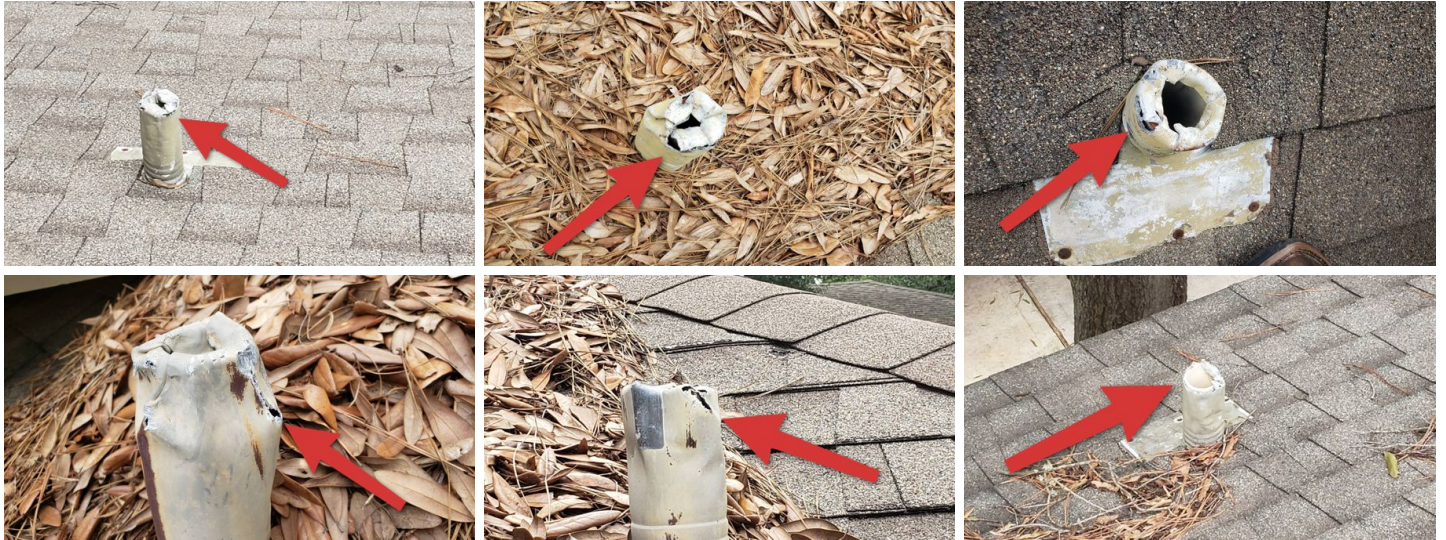
**ROOF JACKS**

Lead - Squirrel Damage

The roof jacks at the plumbing vent pipes were observed to have the conditions as described above. Further investigation with a roofing contractor is recommended to make all needed repairs.

**Repaired**

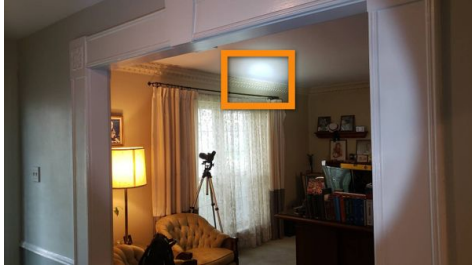
Study ceiling

After observing the interior of the structure, evidences of roof leaks were visible, where the ceiling was water stained. It is recommended that a roofing contractor be contacted to find the source of the leaks, and to make any needed repairs.

**Cleaned, Treated, and painted  
No water source found**

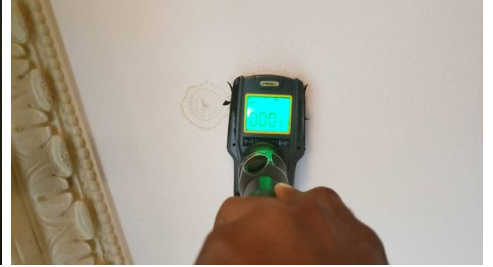
Stained area was dry

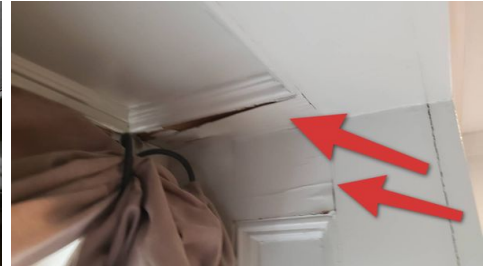
Water damaged finish details

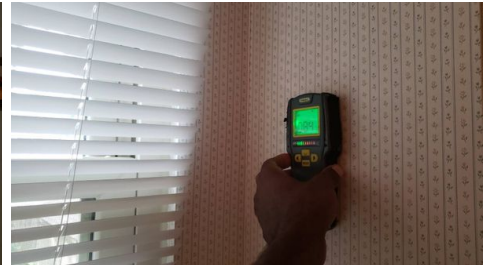
High moisture

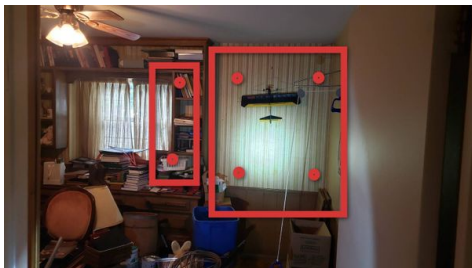
High moisture at and around southeast bedroom dormer window

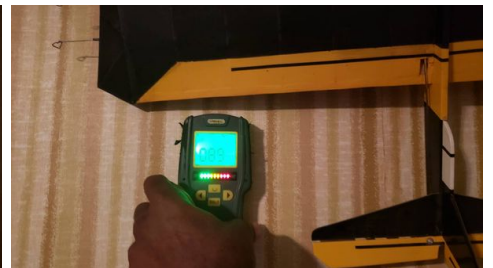
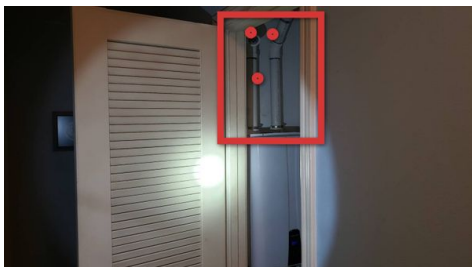
Water stains at water heater closet

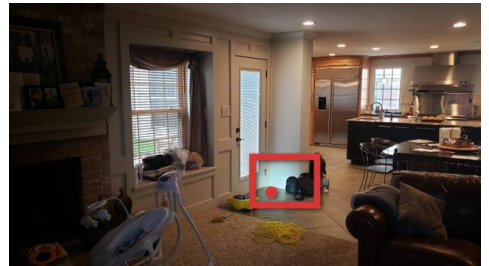
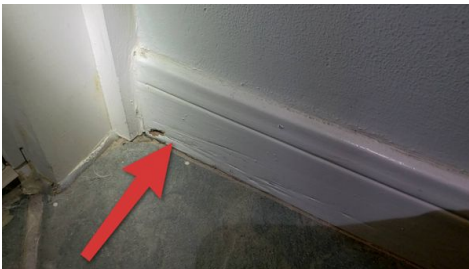
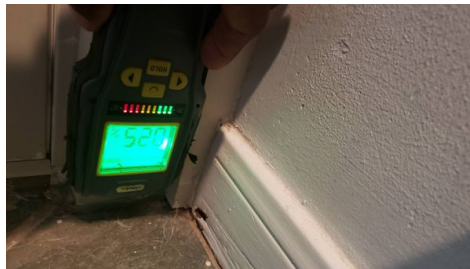
#### MOISTURE METER - HIGH READING

Evidences of water penetration to the interior of the structure were observed, including the following conditions and locations shown below. Further investigation is recommended with service companies to determine the source(s) of the water penetration along with any secondary damages, and also to provide a cost estimate for any needed repairs.

Our moisture meter showed a higher than normal reading.

**No water sources identified**

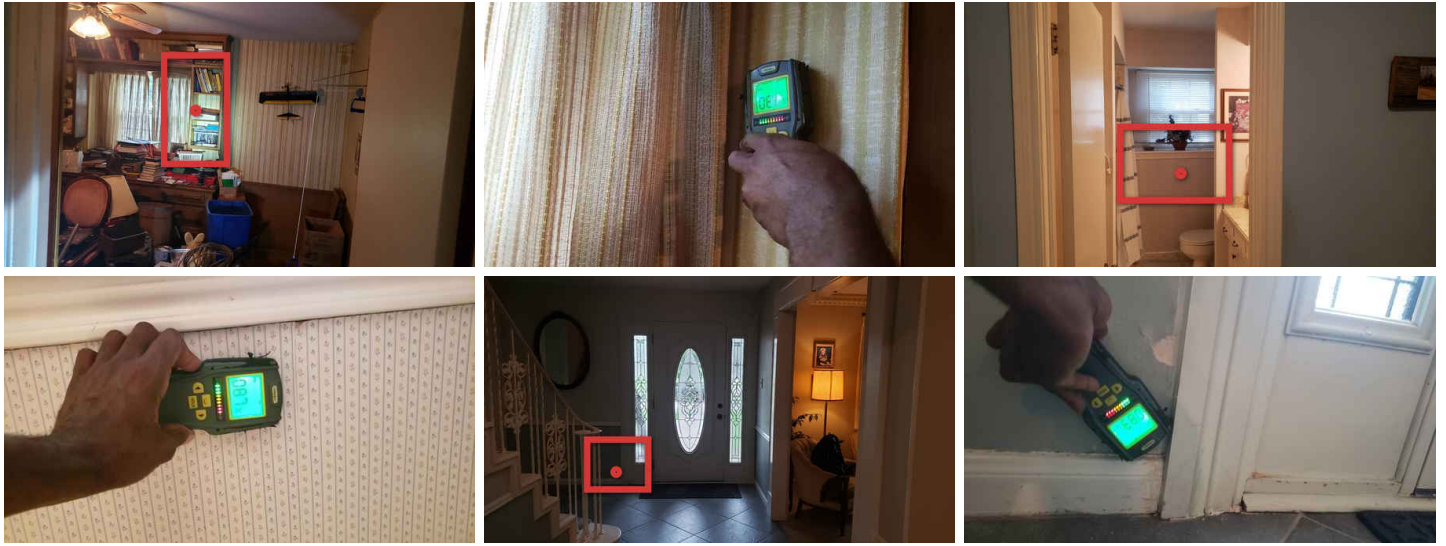
**MOISTURE METER - ADDITIONAL PHOTOS OF HIGH READINGS**

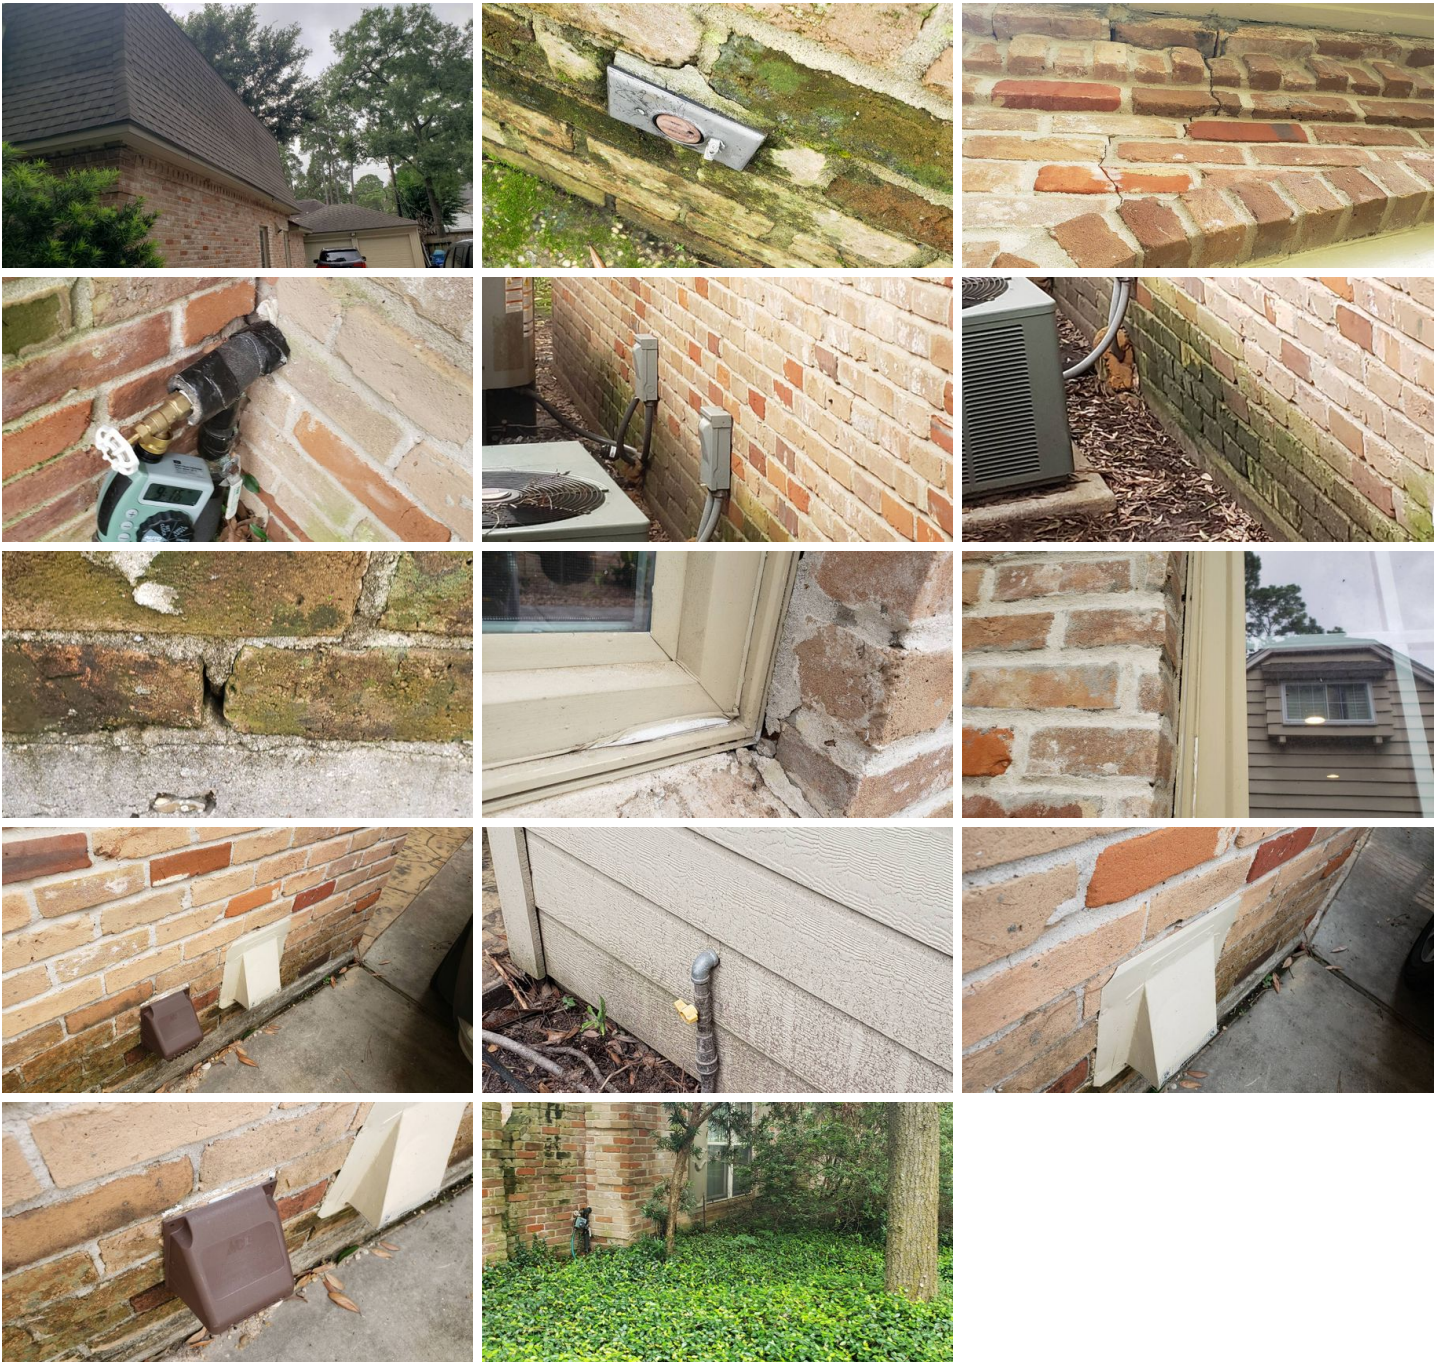
Sealants deteriorated/missing, Window sealants, Light Fixtures, Hose Bibb, Gas Line, Electric outlet, Vent Caps, Dryer Vent, Brick Veneer, High Soil, Grading, Weepholes Missing, Weepholes Clogged, Water Stains, Lack of Gutters

A substantial vulnerability to water penetration was observed at penetrations/openings through the exterior building envelope, and it is recommended that all penetrations/openings be sealed against water penetration. Typical examples on a structure may include light fixtures, air conditioning refrigerant lines, water piping, gas piping, vent caps, windows, doors, expansion joints, etc. Below is a representative sample of locations and/or photographs showing some, but not necessarily all, locations where there is a vulnerability to water penetration. Have a contractor provide a cost estimate to seal all vulnerable areas on the exterior building envelope against water penetration and/or open up any clogged weepholes in the veneer.

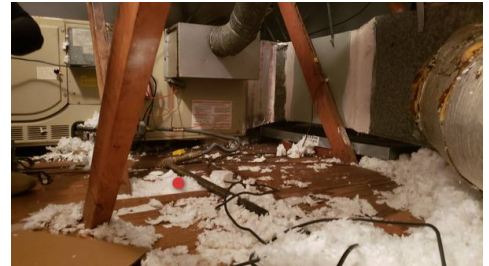
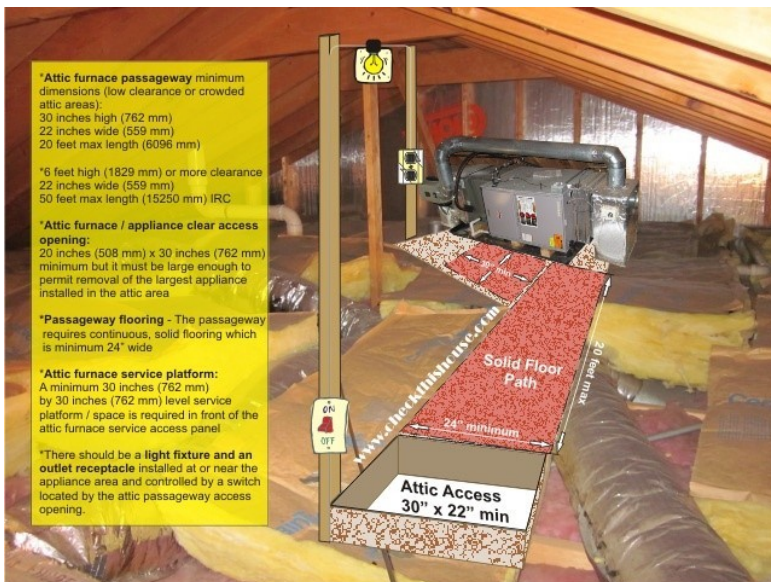
**INADEQUATE WALKWAY AND PLATFORM DECKING**

The attic did not have adequate service decking to all the equipment in the attic. The service decking should be a continuous deck that is a minimum of 24 inches wide, that extends from the attic access opening to all equipment in the attic. The platform decking should be a continuous deck that is a minimum of 30 inches wide, that extends along all sides of the appliance where access is required. In addition, the decking should be free from any obstructions, such as gas lines, electrical wiring, ductwork, framing members, etc.

**Obtain Cost Estimate**

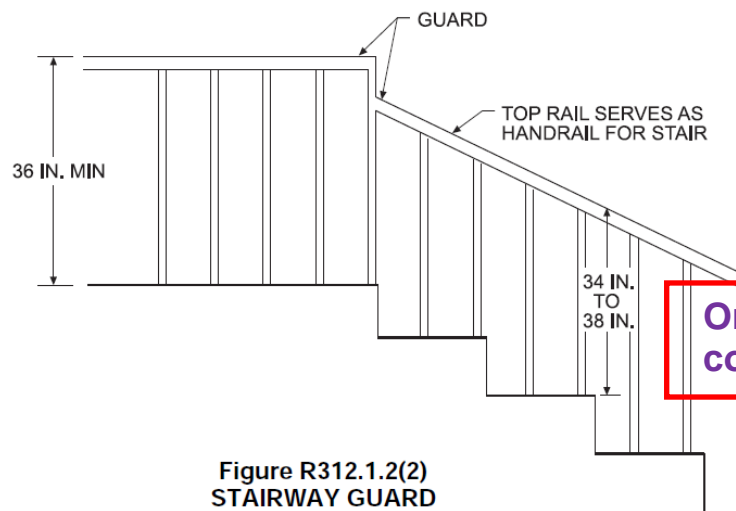
R311.7.8.1

**Original condition from 1967. Demolition and construction not justified**
