# True Grit Home Inspection

# **Property Inspection Report**

5515 W Airport Blvd, Houston, TX 77035 Inspection prepared for: Seth Carlsen Real Estate Agent: Stephen Kingsberry -

Date of Inspection: 1/22/2022 Time: 10:00 AM

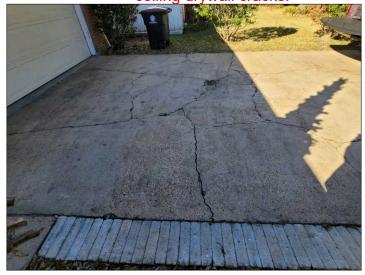
Driveway / sidewalk is cracked and has some tripping hazards.

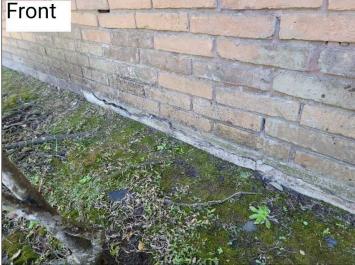
Spalling observed. Spalling is a result of water entering brick, concrete or natural stone and forcing the surface to peel, pop out or flake off

• It is my opinion that the foundation has several deficiencies and should be further evaluated by a reputable foundation contractor or structural engineer. Based primarily on floor slope, several exterior brick cracks, and numerous wall and ceiling drywall cracks.

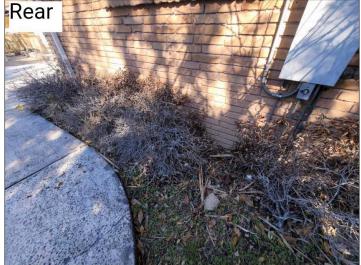
Grade level (dirt) too close to top of foundation. 6" from siding, and 4" minimum from brick / stone.

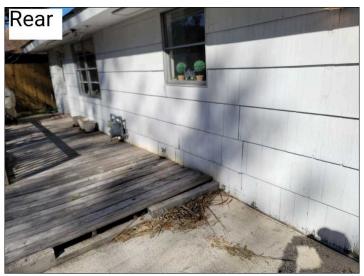
Grade level (dirt) too close to top of foundation. 6" from siding, and 4" minimum from brick / stone.

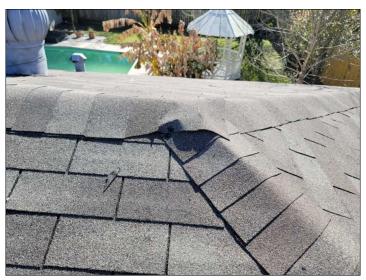
Lifted shingles noted. Ridge shingles installed improperly. These are subject to wind drive rain and water entering house.

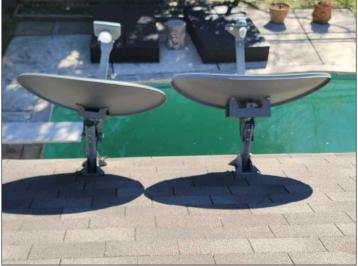
Antenna mounted directly to shingles. Sealant prevents water penetration through screws/nails. Monitor sealant to reduce the risk of water leaks.

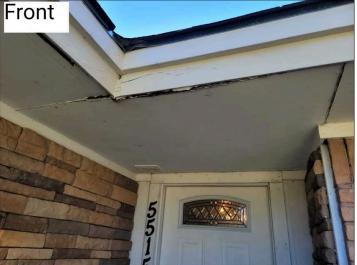
Open holes noted at edge of attic space. These could be a location for rodents to enter.

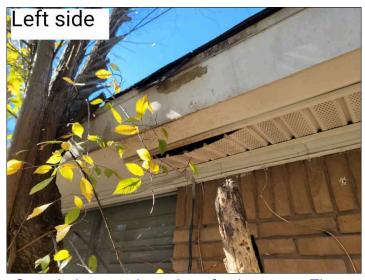
Open holes noted at edge of attic space. These could be a location for rodents to enter.

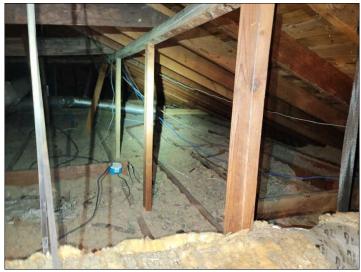
Insulation thickness varies. Suggest additional insulation to meet R30 requirements for our area.

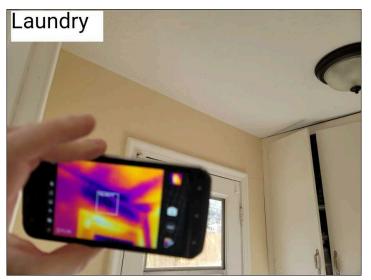
Appears to be missing insulation in numerous locations.

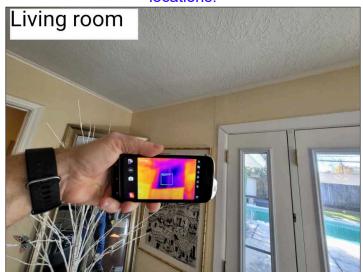
Appears to be missing insulation in numerous locations.

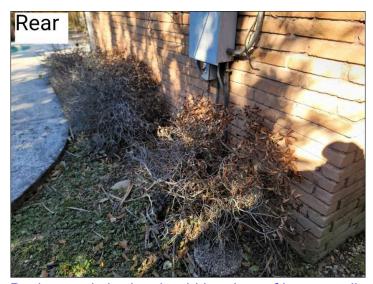
Bushes and shrubs should be clear of house walls by 12" or more. Some in contact with house.

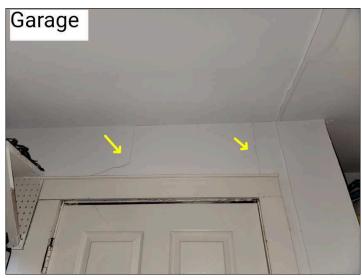
Cracks and/or holes in drywall noted.

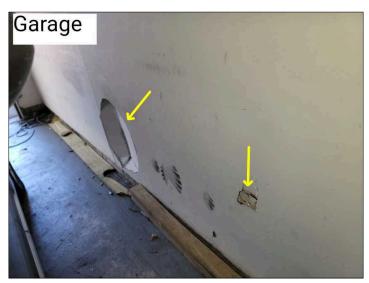
Holes in drywall in garage. These are breaks in the "firewall" and should be repaired to ensure fire rating.

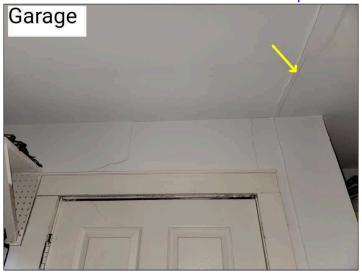
Cracks on ceiling noted.

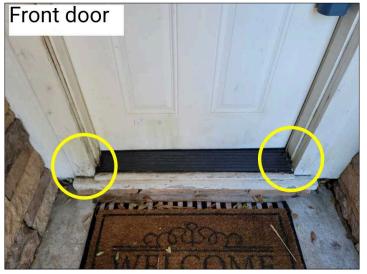
Wood rot / damage noted at door and door trim.

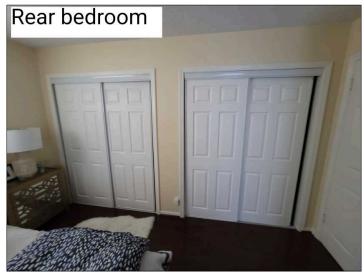
Closet doors difficult to operate, off tracks

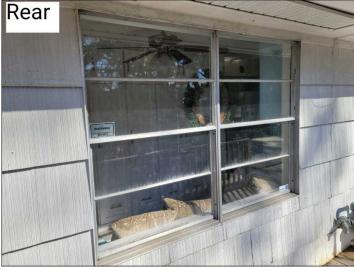
Missing and/or damaged screens noted.

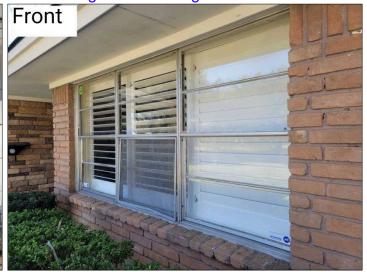
Missing and/or damaged screens noted.

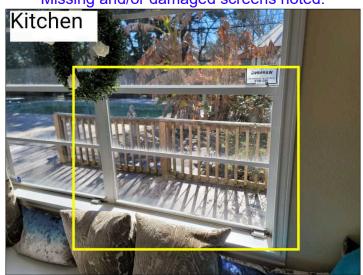
Window did not open in several locations.

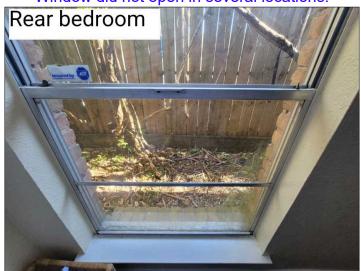
Window did not open in several locations. Evidence of present/previous water staining on window ledge, dry at time of inspection. May still leak.

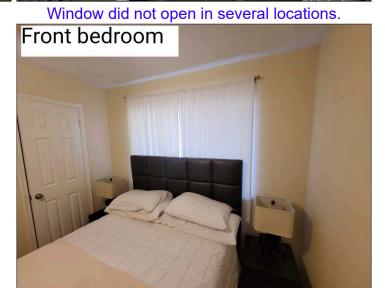
Some windows/walls inaccessible due to personal items stored.

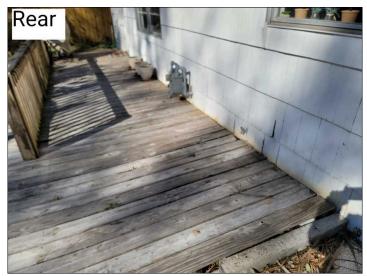
Deck in contact with house. Possible termite penetration location.

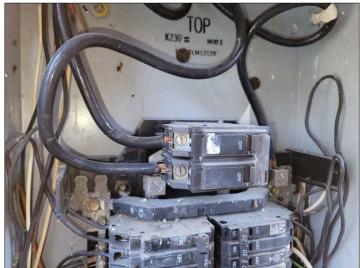
Service entry lugs should be protected with barriers.

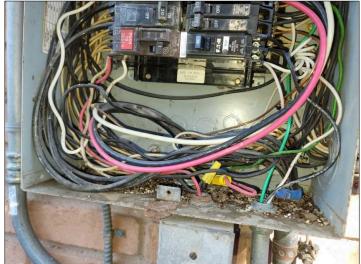
There is a wire joint made up in the panel. This should be made up outside of the panel in a junction box

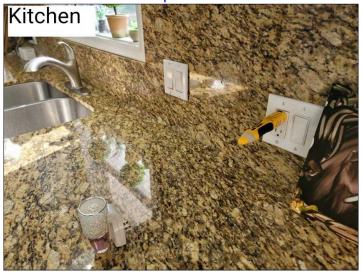
All receptacles near "wet" locations should be GFCI protected. This includes bathrooms, kitchen counter area, outside receptacles, garage and utility areas.

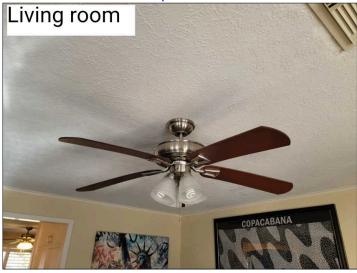
Inoperable ceiling fixture, no switch located.

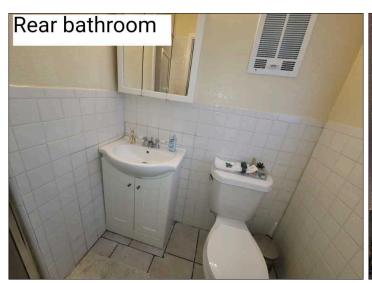
Bathroom should have at least one GFCI protected outlet. None installed.

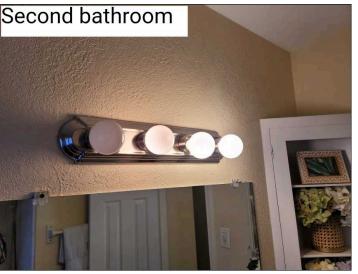
Some lights / switches did not function at time of inspection.

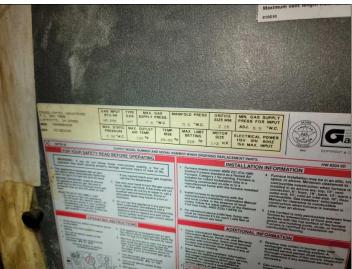
Access to equipment should have an open 30" x 30" landing to work, with 3/4" minimum decking.

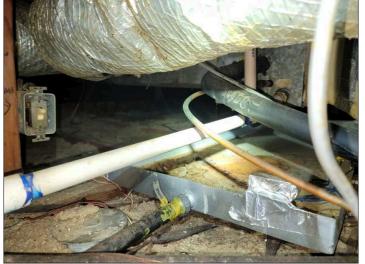
Light rust in condenser pan. Heavy rust may cause pan to leak. Recommend replacement or evaluation over time.

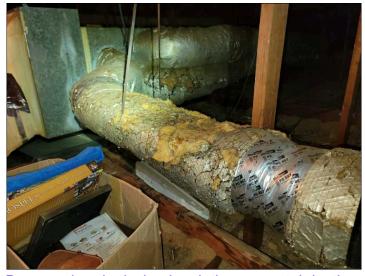
Damaged and missing insulation on metal ducting. Insulation factors may not reach R6.

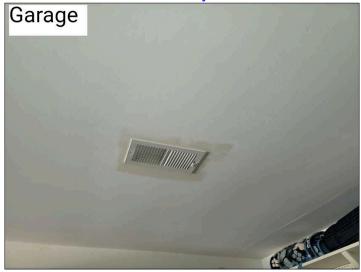
Supply register in garage. This added square footage may be more than the HVAC system was intended to climate control.

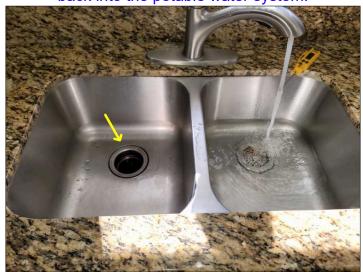
Missing stopper in sink / tub.

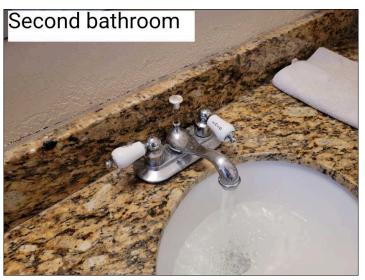
Loose fixture noted.

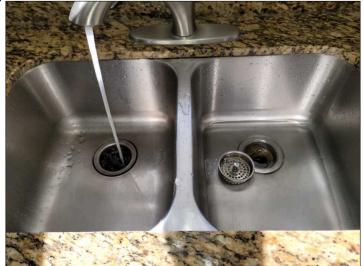
Drains slow. Suggest having plumber to snake drains.

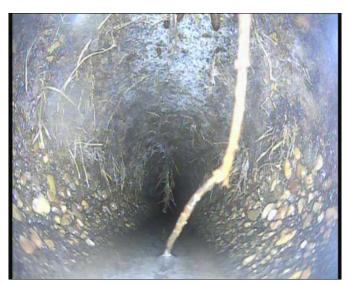
Tree roots were observed with a camera inspection. Tree roots are intrusive, may cause clogs and can grow very rapidly. Main Lateral Sewer -Yard to City Connections

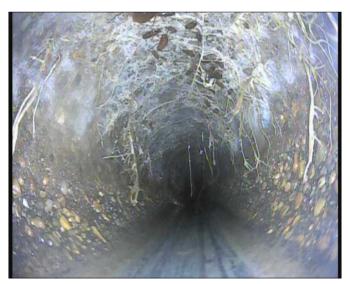
Tree roots were observed with a camera inspection. Tree roots are intrusive, may cause clogs and can grow very rapidly. Main Lateral Sewer -Yard to City Connections

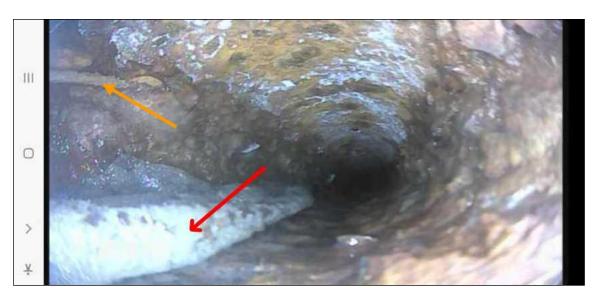
A sewer camera inspection revealed heavily rusted and deteriorated piping materials. Breaks or collapse can be costly repairs and should be repaired of prepared for repair. Grease, soap or debris build up noted (red arrow). Possible root penetration (orange arrow). Main Lateral Drain- Under House

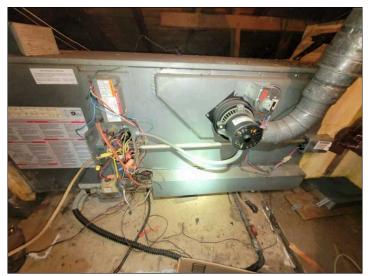
Sediment trap missing / not correct at fuel fired appliance.

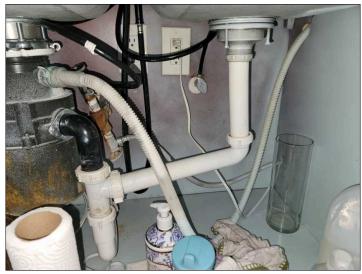
Drain line should create a trap by moving the flex drain line to the bottom of the counter top and securing.

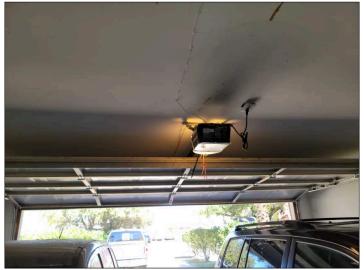
Garage door did not want to close. Suggest adjustment to operator.

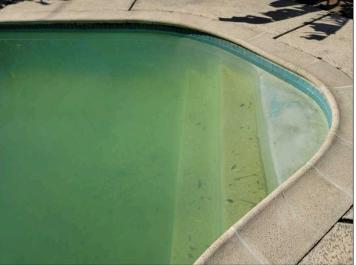
Pool water cloudy, dirty at time of inspection. Unable to determine condition of plaster, drains, jets, etc.

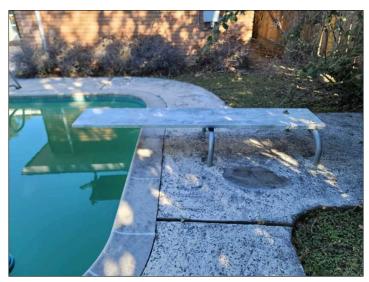
Diving board noted. Pool depth appears shallow for diving. Diving boards can increase the risk of injury or drowning if pool design is improper.

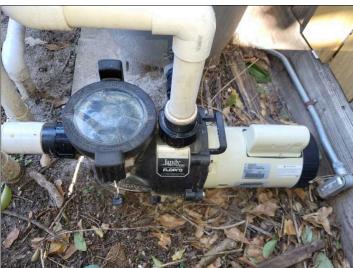
Missing bonding wire from pump
