Inspection Report

Property Address: 4031 Basswood Drive Dickinson Texas 77539

PROPERTY INSPECTION REPORT

By: Christopher Newby Texas 24503 / RSCH One Inspections 1/18/2022

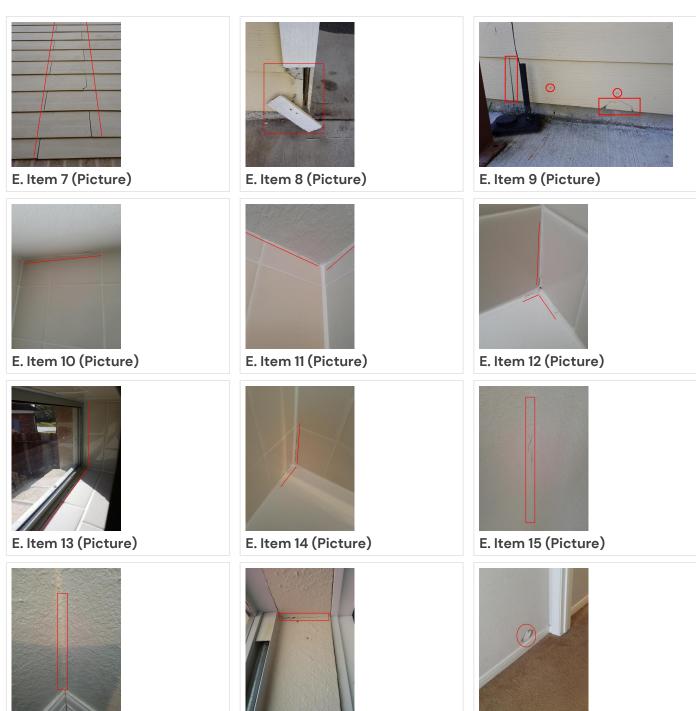
E. Item 16 (Picture)

- inspected, deficient
- 1) Cracks were observed running vertically through exterior brick and mortar wall material at the right (front facing) side of the home at the time of inspection. This is considered deficient as the cracks running vertically through individual bricks is an indication that the foundation may no longer be performing as intended. These cracks are also openings for moisture intrusion which will degrade the exterior wall material in this area.
- 2) Cracks were noted in the mortar between stones at the front of the home, as well as in the corner of exterior brick wall material at the front of the home. Missing/degraded caulking was also noted between

exterior brick and siding/fascia board material, and along the edge of the exterior receptacle at the front porch. Separated/damaged siding boards and exposed nail heads were also noted at both sides and at the back of the home. This is considered deficient as these are openings for moisture intrusion which will degrade the exterior wall material in these areas.

Recommend having this looked at further by a licensed general contractor and all required repairs be made.
