Home Inspection Report

4635 Pippin Glen Dr, Humble, TX 77396

Thursday, October 14, 2021

PROPERTY INSPECTION REPORT

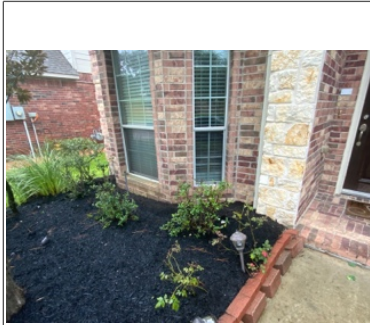
Comments: • The inspector had limited visibility of the foundation due to high soil in areas around home. This prevents the inspector from making an opinion on the performance and condition of the foundation in these areas. The inspector will base their opinion on other structural conditions.

High soil blocking visual inspection of foundation at front of home.

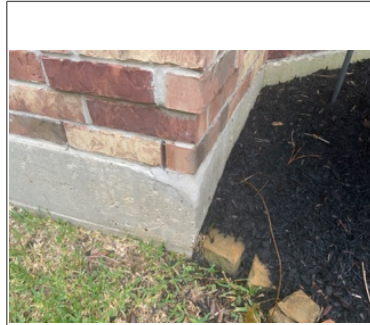
•Corner(s) of the foundation were broken at the time of Inspection. The corners of the foundation provide a ledge for the bricks to rest on. Broken corners could possibly lead to brick damage during settlement of the home. It's recommended that the corner(s) be repaired.

Broken front left corner.

Foundation: Repair all broken corners.

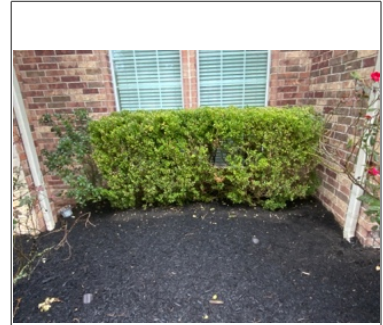
•Vegetation was blocking areas of the foundation, which prevented the inspector from visually inspecting the performance and conditions of the foundation. Inspector can not render an opinion of the performance of the foundation due to these conditions.

Vegetation and high soil blocking visual inspection of foundation at front of home.

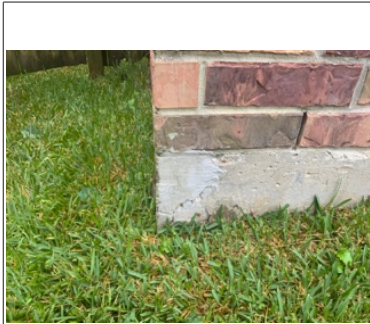
Broken back right corner.

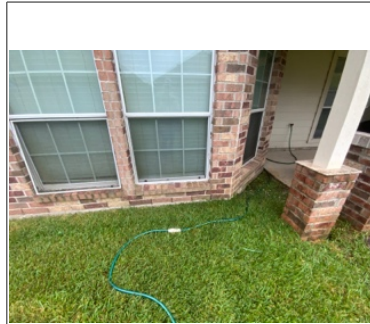
High soil blocking visual inspection of foundation at Back of home.

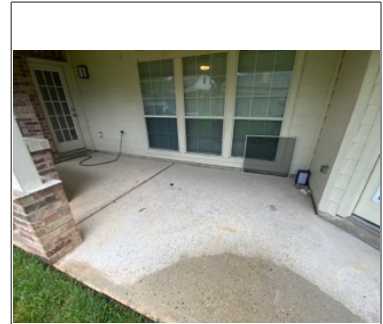
• Patio/Deck has been installed at the same time and against the foundation. This prevents the inspector from making an opinion on the performance and condition of foundation in this area. The inspector will base their opinion on other structural conditions.

Patio blocking visual inspection of foam at Back of home.

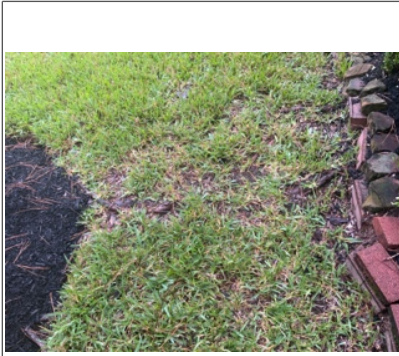
Comments: •Tree roots are beginning to encroach driveway, walkway, and/or foundation. Roots can cause damage to structures and flat work. Repairs may want to be considered before damage occurs.
•The grading should be improved to promote the flow of storm water away from the house. This can usually be accomplished by the addition of top soil. The ground should slope away from the house at a rate of one inch per foot for at least the first ten feet. Ideally, at least eight (8) inches of clearance should be maintained between soil level and the top of the foundation walls.
•Driveway cracks were noted and its recommended to seal these cracks to protect against further damage to surface.

Root encroachment

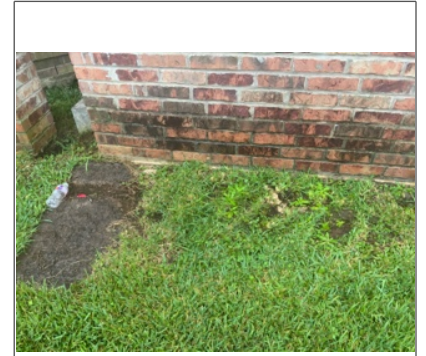
Grading improvements needed at
Back of home.

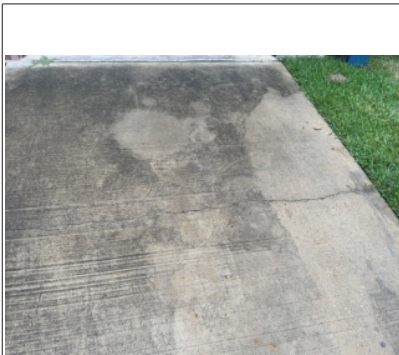
Driveway cracks.

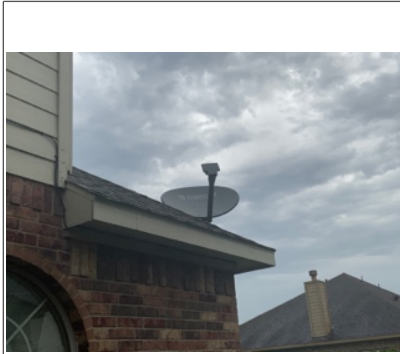
- Installation of dish systems mounted to a home may be cause of concern. Installation is normally with the use of large fastening bolts or screws. If not properly installed water penetration is possible.
- Home was found to have one or more areas where the flashing materials is either missing, needing replacement, or needing to be resealed.
- Flashing(s) and or Roof jack over time may have lifted or shifted over time. Seals at these locations are important. Flashing(s) and or Roof jack may need to be fastened and sealed to prevent water penetration and or pest entry.
- Nail heads are exposed at the flashing. They should be sealed to reduce risk of leaks.
- Areas of the roof were soft upon inspection. This should be further investigated by a professional roofer, and all repairs deemed necessary should be made.

Satellite dish mounted on Roof.

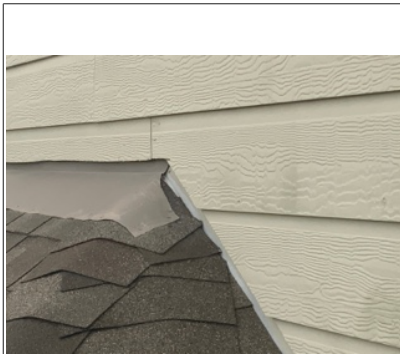
Damaged flashing.

- Repair/Replace damaged and flashings.
- seal all exposed nail heads.

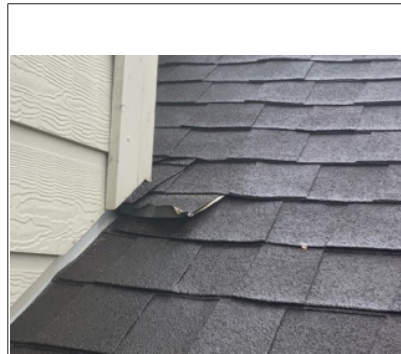
Lifting flashing.

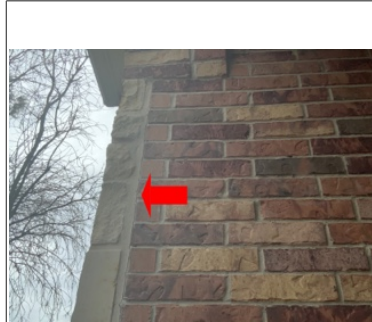
•Typical minor cracking was observed on the exterior walls of the house. This implies that some structural movement of the building has occurred, as is typical of most houses. New seal recommended at all gaps and areas that caulk has failed or holes are present.

Minor settlement crack at entryway.

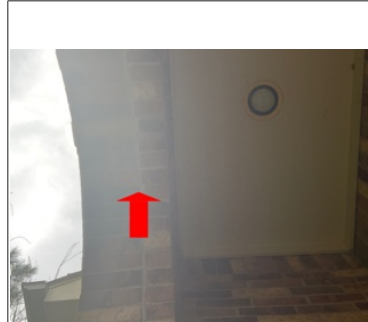
Minor settlement crack at entryway.

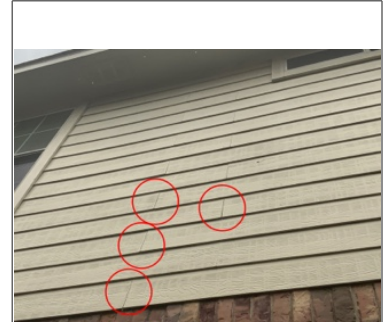
•Due to settlement of home siding materials have separation at the seams and should be repaired to prevent moisture damage.

Siding seam separation at left of home.

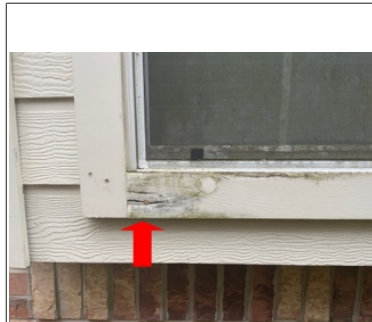
•Observed damaged and decaying siding. Repairs at present needed to prevent pest and

Decaying siding at left of home.

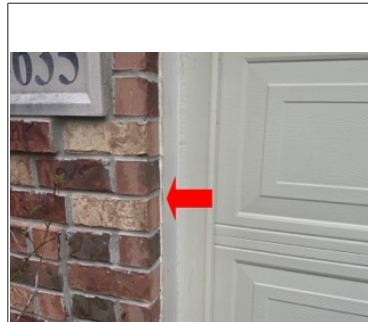
Trim board seal improvements needed at garage.

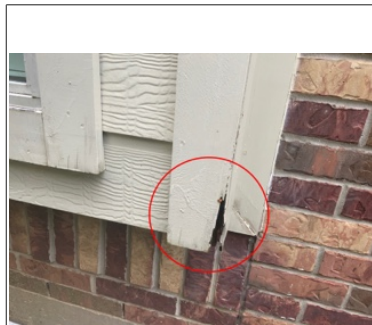
Decaying siding at right of home.

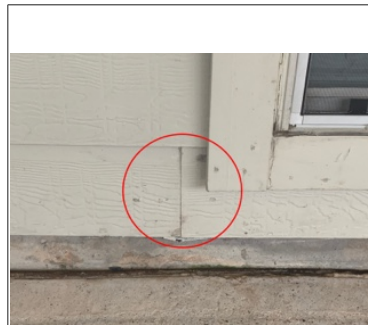
Siding seam separation at Back of home.

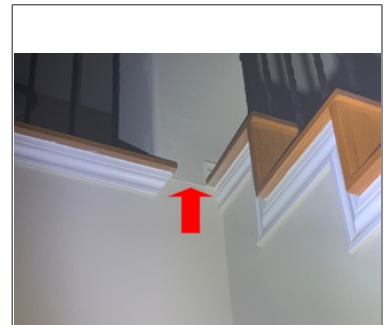
Seam failure in living room.

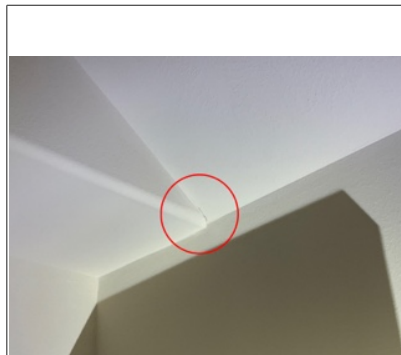
Seam failure at upstairs front left bedroom.

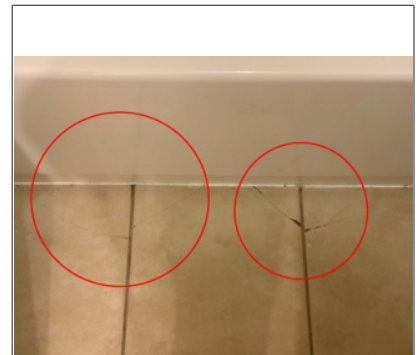
Cracked tiles at upstairs J&J bathroom.

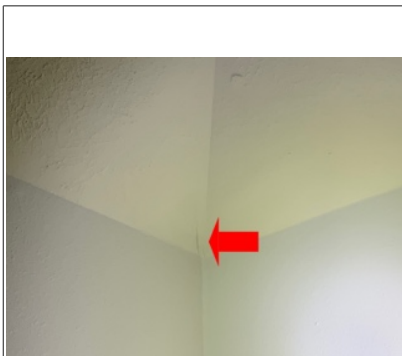
Seam failure at upstairs front right bedroom.

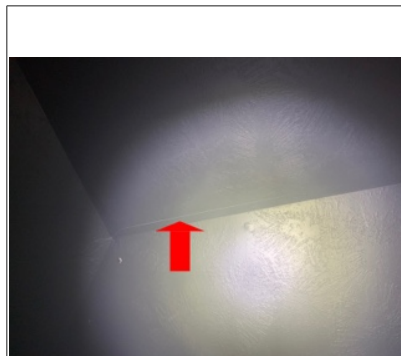
Seam failure at upstairs media room.

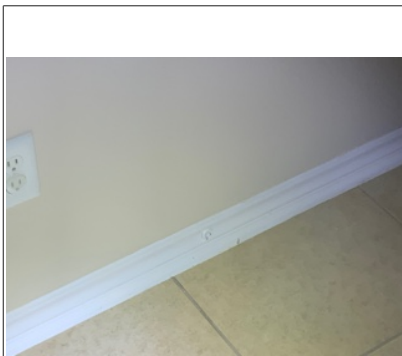
Comments: •During inspection door stop(s) were noted to be either missing, installed incorrect and or damaged. Door stops are important to protect the surrounding areas from damage as well as the door.

Damaged or Missing door stops throughout home.

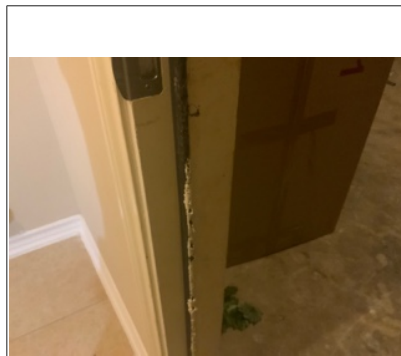
Damaged door seal at garage man door.

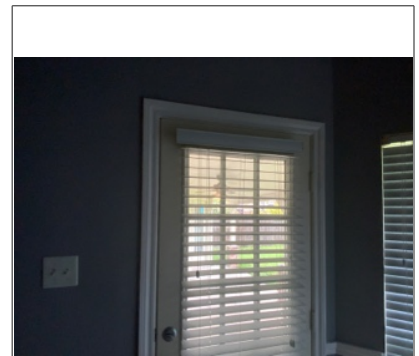
Trim adjustments needed at primary bedroom door to backyard.

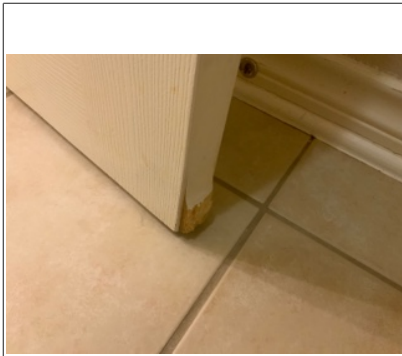
Damaged door at upstairs J&J bathroom.

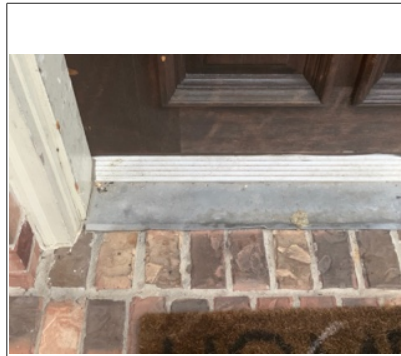
Damaged threshold at entryway door.

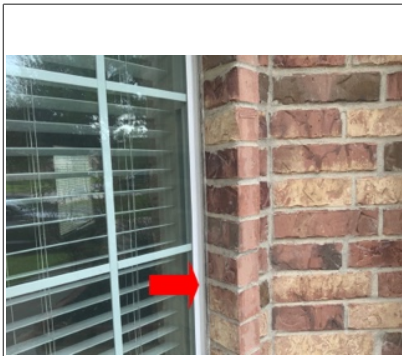
Exterior caulking improvements needed at front of home

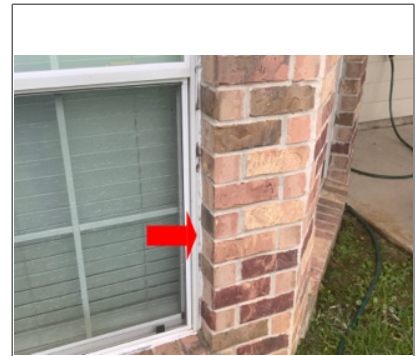
Exterior caulking improvements needed at Back of home.

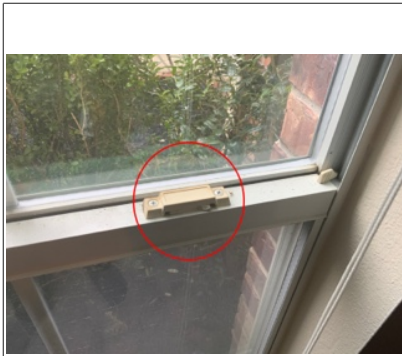
Damaged hardware at office.

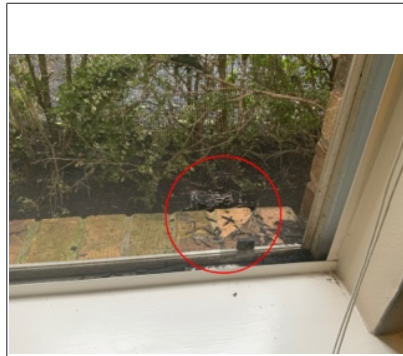
Damaged screen in office.

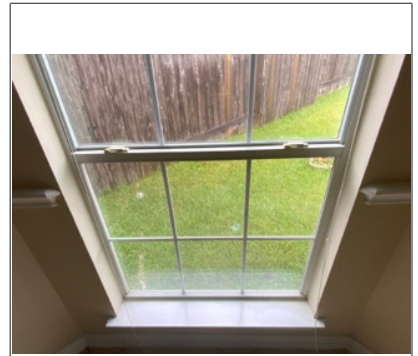
Missing screen in kitchen.

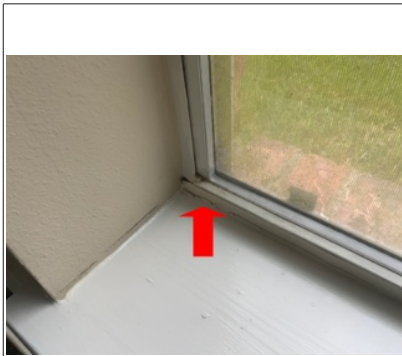
Interior caulking improvements needed throughout home.

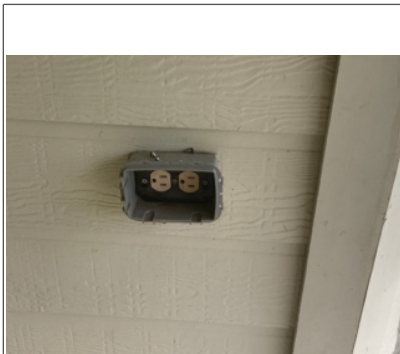
Damaged weatherproof cover at front and back of home.

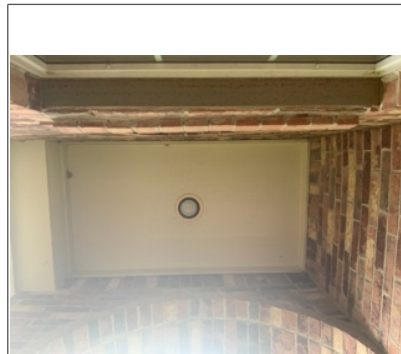
Inoperative outdoor lights.

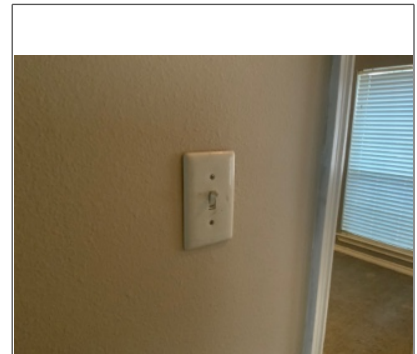
Loose switch plate at stairway.

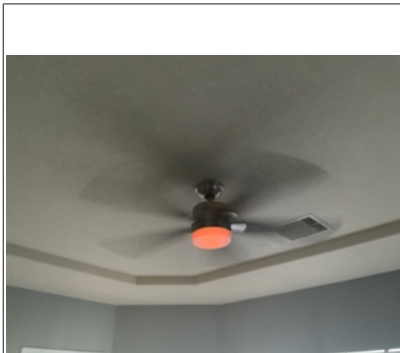
Repairs needed at primary bedroom fan.

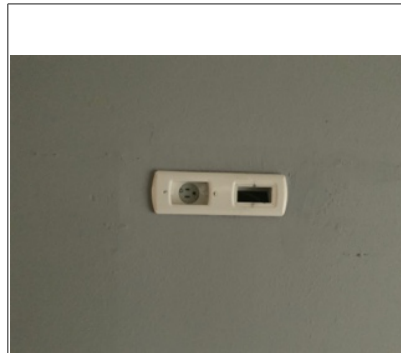
Inoperative outlet in primary bedroom.

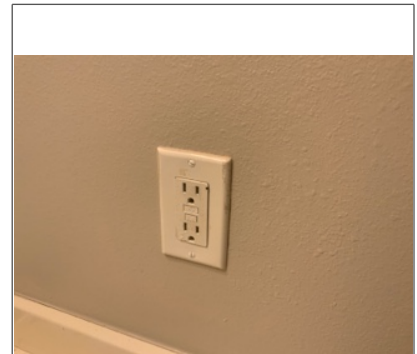
Inoperative GFCI outlets throughout all bathrooms, replacement needed.

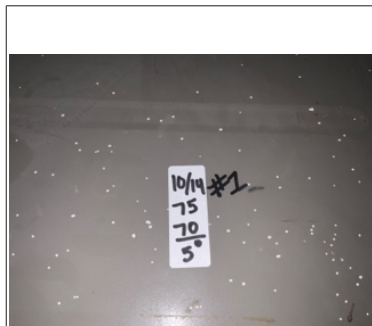
- At the time of inspection, temperatures were monitored at the coil of the second floor unit. The recommended temperature drop at the coil is 14 - 21 degrees. The second floor system operated within these standards.
- The temperature drop measured across the evaporator coil of the first floor air conditioning system is lower than considered typical. This usually indicates that servicing is needed. A qualified heating and cooling technician should be consulted to further evaluate this condition and the remedies available for correction.
- The air conditioning system requires servicing.

Ref photo at Unit 1. 5° differential.

- further evaluation insufficient temperature differentials at the cooling system, and make all repairs/replacement deemed necessary to allow proper operation.
- Repair ductwork seals.

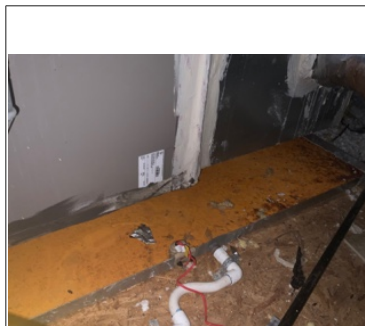
• Rust was observed in the condensate drain pan. Repairs/replacement of the pan is needed to reduce the risk of water damage should the pan corrode away to the point of leaking.

Rust in drip pan under unit 1.

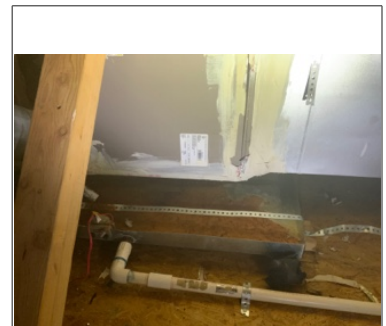
Rust in drip pan under unit 2.

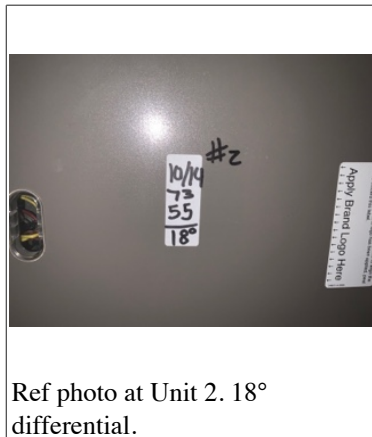
Ref photo at Unit 2. 18° differential.

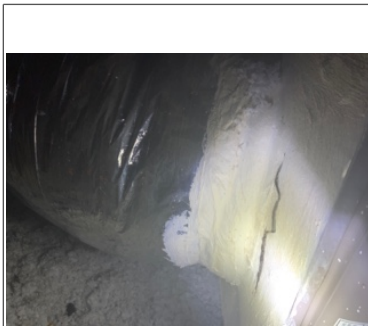
Comments: •Loose fitting joints and/or openings in the ductwork should be improved.

Damaged seal at plenum connections at unit 1.

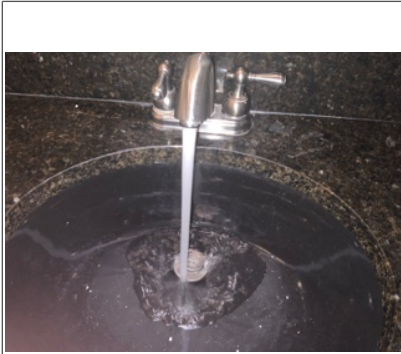
Inoperative stopper in primary bathroom.

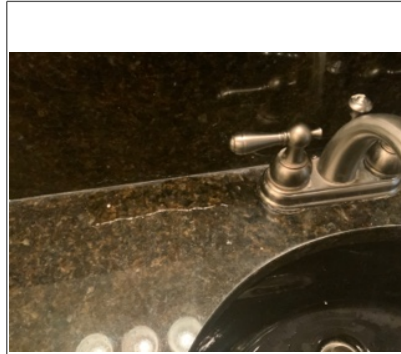
Leaking faucet at primary bathroom sink.

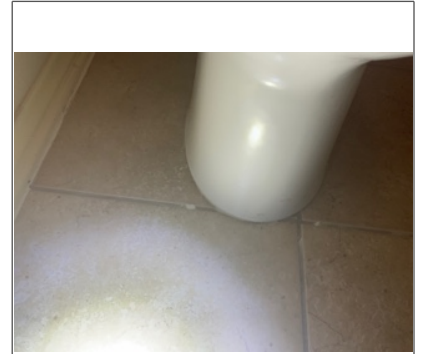
Toilet base seal improvements needed at primary bathroom.

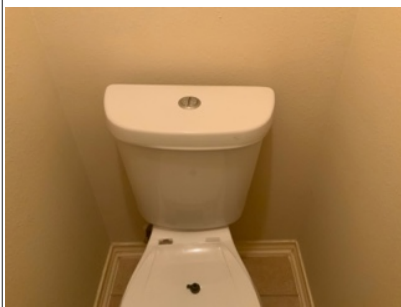
Loose tank at primary bathroom toilet.

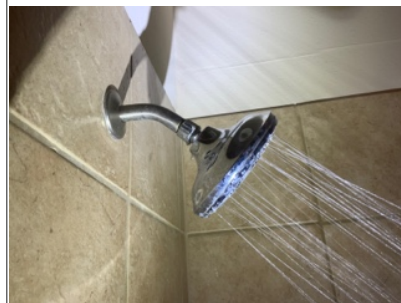
Leaking shower head at primary bathroom shower.

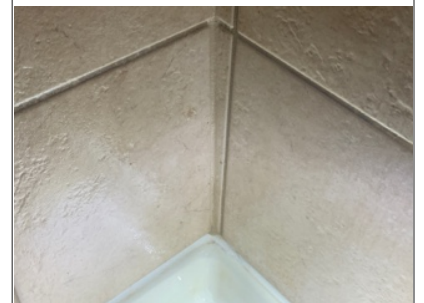
Enclosure caulking improvements needed at primary bathroom shower.

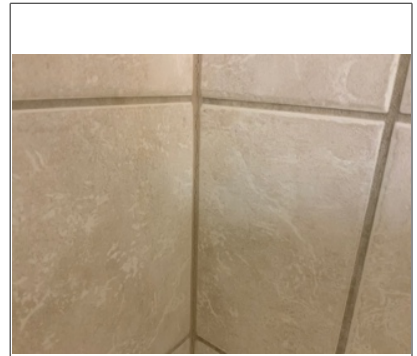
Enclosure caulking improvements needed at upstairs bathroom bathtub.

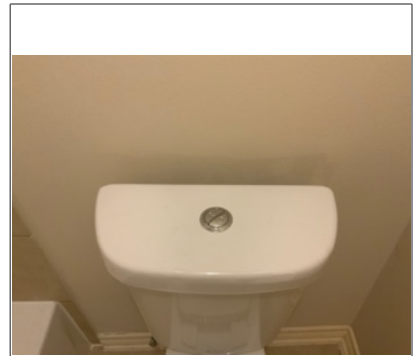
Damaged toilet mechanicals at upstairs J&J bathroom.

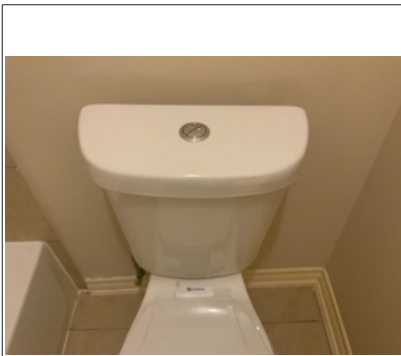
Loose tank at upstairs J&J bathroom.

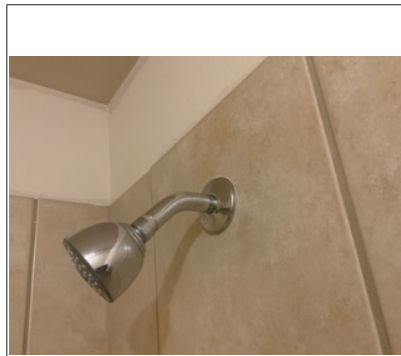
Faucet seal improvements needed at upstairs J&J bathroom bathtub.

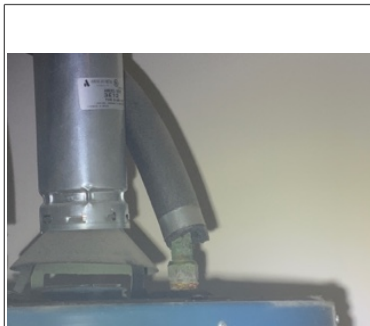
- The supply piping shows evidence of corrosion where it meets the water heater. This is a common condition and should be repaired.
- The TPRV (temperature pressure relief valve) has sealed shut. A licensed plumber is needed to repair/replace the inoperative TPRV for safety purposes. Manufacturers recommended TPRVs be operated 1-2 times a year to prevent them from being clogged with minerals and deposits.
- It is recommended that the water heater be serviced.

Corrosion at supply line.

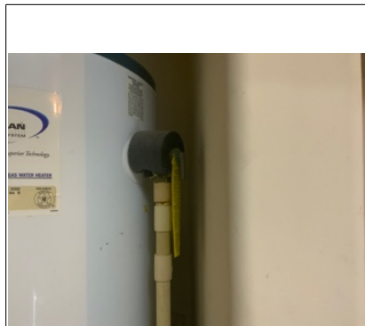
Inoperative TPR valve.

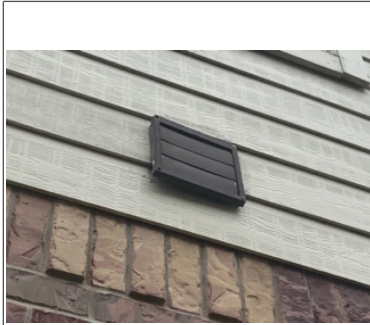
Comments: •Exterior vent is in need of repairs and or replacement.

Vent cover damaged at left of home.

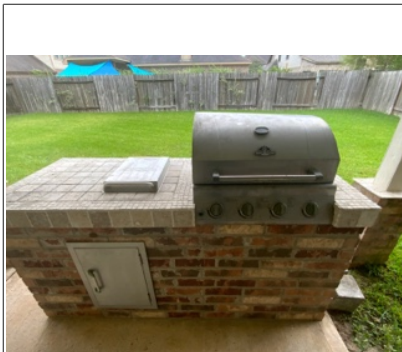
Comments: •The oven light is inoperative and should be repaired.
•All components on gas cooktop operated as intended at time of inspection.
•The outdoor grill and burner did not operate at the time of the inspection.

Inoperative at the time of the inspection.

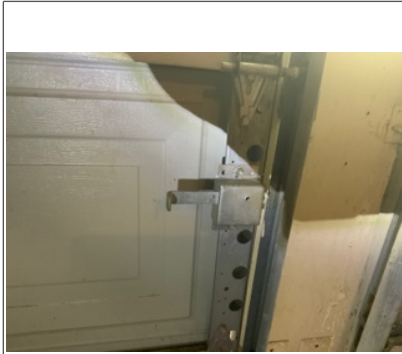
Comments: •Door latch assemblies are required to be disabled when garage door opener is installed.
•The garage door opener(s) were inoperative. Repairs or replacement of the unit(s) may be needed.

Manual locks are required to be disabled or removed when electric switches are in operation.

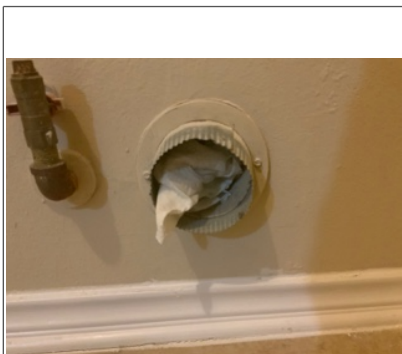
Comments: • Dryer vent shows signs of lint and other material buildup. This is a possible safety and fire risk. Cleaning vent is recommended.

Dryer vent dirty.

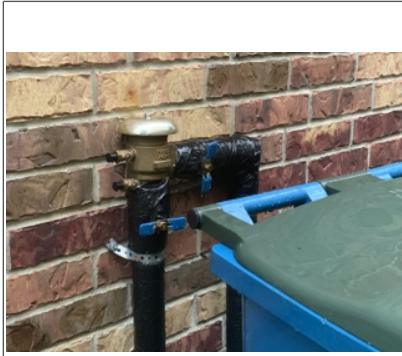
Comments: • The water to the sprinkler system was turned off at the time of the inspection. The inspector was unable to determine operating condition of each zone at the time of the inspection.

Water shut off at the time of the inspection.
