Home Inspection Report

20007 Sky Hollow Ln
Katy, Texas 77450

PROPERTY INSPECTION REPORT

Prepared For: Shamecca Serfling
Concerning: 20007 Sky Hollow Ln Katy, Texas 77450
Inspection Date: 9/29/2021
By: Inspector Name: Darrel Creacy License Number: 6473 Date: 4/30/2022
Signature:

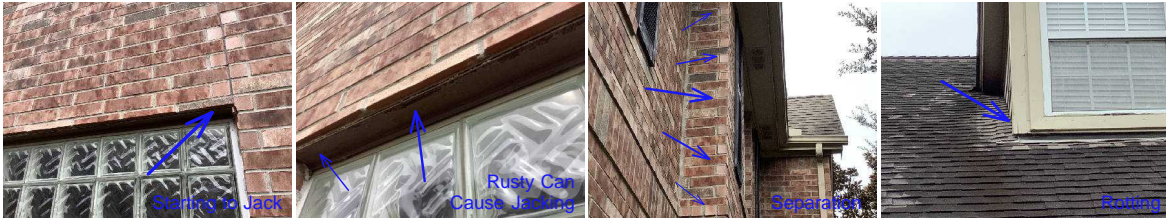
1. The steel angle iron at the lintel over the window was starting to rust. Some sucking in the right corner had cracked a brick. If rust continues the possibility of more oxide jacking (cracking) of the walls could occur over time.
2. Separation and crack front left column from some settling of the structure. Repairs possible.
3. A little rotted trim wood in front at bottom of dormer trim.

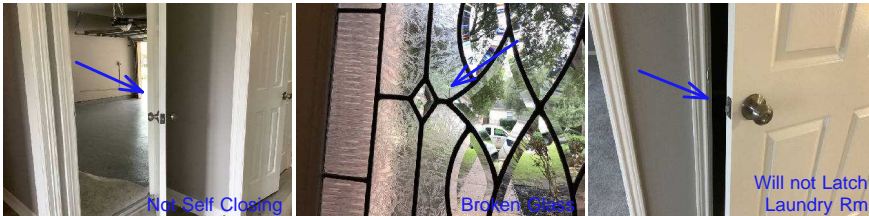
1. The garage access door was not self closing, current standards have the door close automatically with spring hinges for safety purposes.
2. Glass in the front door cracked.
3. Laundry room door would not latch closed.

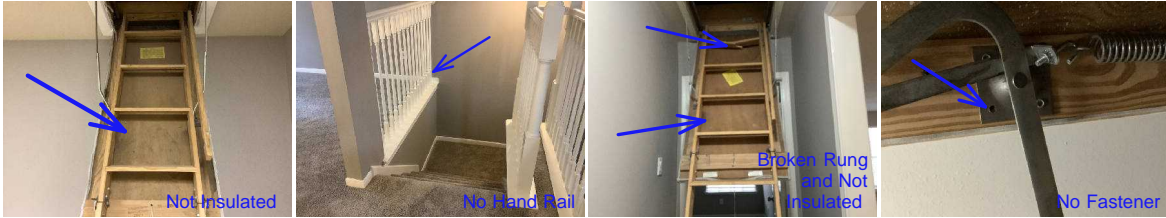
1. The attic access ladders inside the house were not fully insulated or fire rated.
2. Primary latter had a broken rung at the top.
3. The attic access ladders were not installed to the manufacturer's recommended procedures, there were not enough of the proper size fasteners installed, reducing design rating.

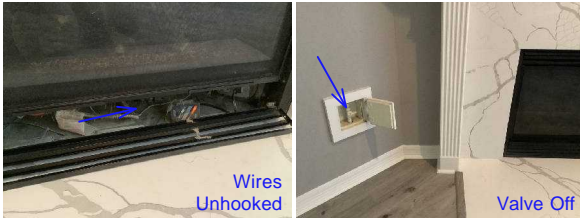
1. The controller wires were not hooked up and gas valve was off. Recommend repairs and testing.

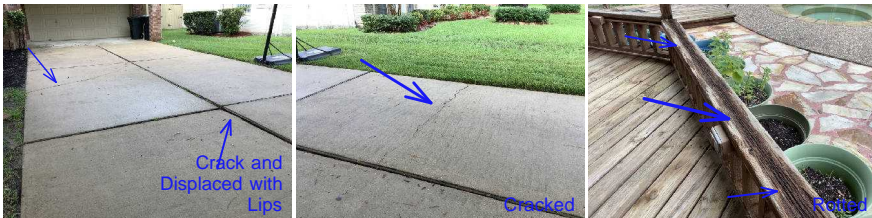
1. Cracks in driveway panels.
2. Panels displaced a little leaving lips and trip hazards at the does of those panels.
3. Some rotted wood at the deck in the back.

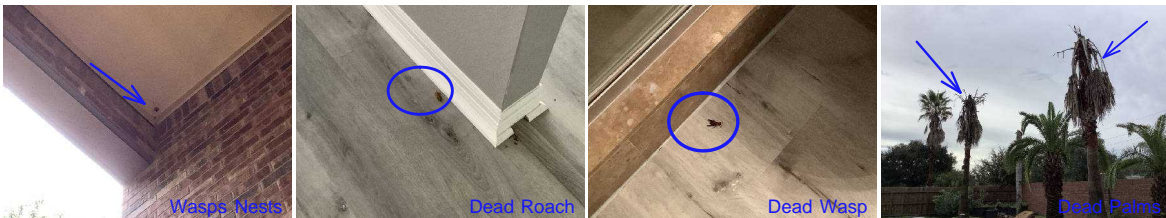
1. Active wasp nests on house.
2. Evidence of some pests.
3. Two large dead palm trees on property.
4. Evidence of rodent activity in the attic.

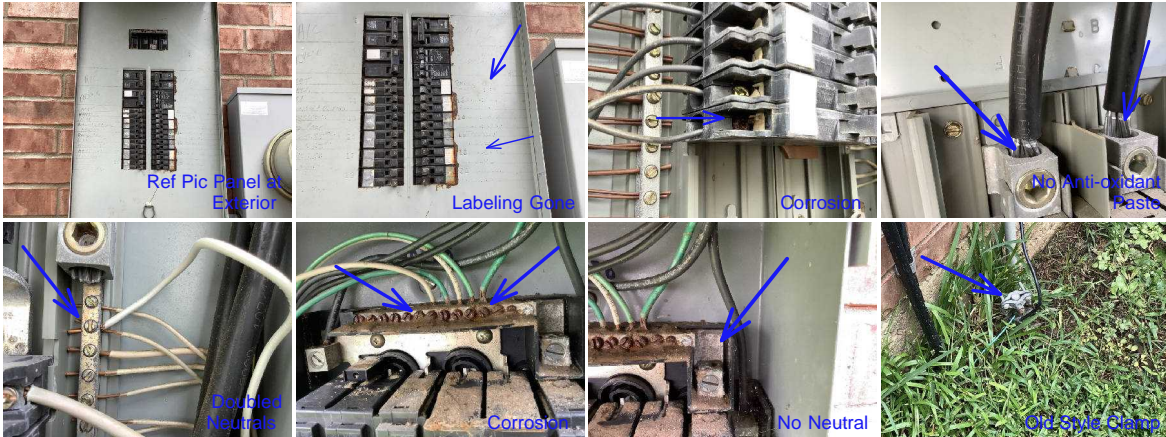
1. The panel was not fully and clearly labeled.
2. Some corrosion at the breaker lugs.
3. Missing anti-oxidant paste on aluminum, multi-strand service entrance wires, manufacturers installation instructions require it.
4. White (Neutral) wires "Double Lugged" under lugs on the buss bar. There should only be one wire per lug.
5. Some heavy corrosion at ground/neutral bar in sub panel.
6. Grounds and neutrals bonded in sub-panel. Modern standards have them unbounded in sub-panels.
7. There was no neutral carried to the sub panel from main panel.
8. The ground clamp was the old type pipe clamp not the newer style acorn clamp.
9. A licensed electrician is recommend to evaluate the panel and system for repairs of deficiencies listed herein and any others that they may find.

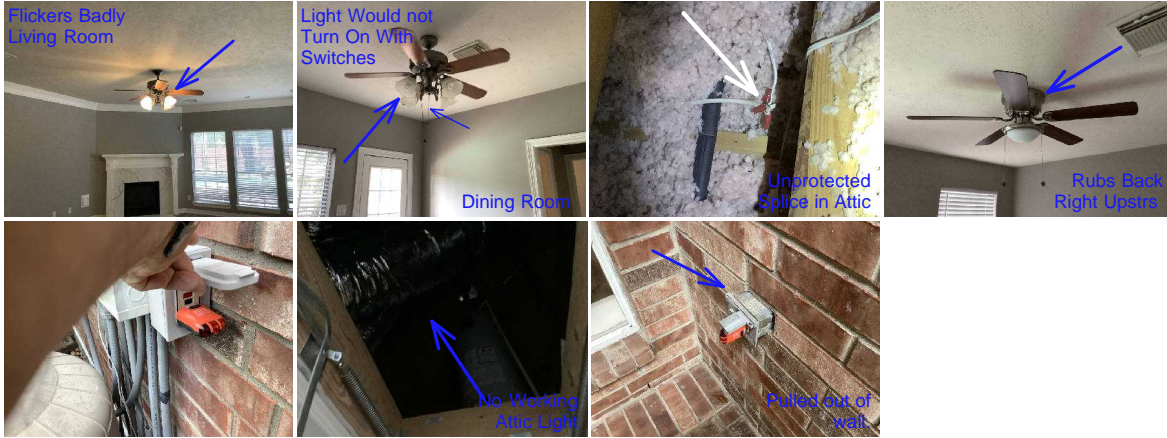
1. The living room light fixture had three switches, in one configuration the light flickered badly.
2. Could not get dining room light to turn on.
3. Poor splices made outside of protective box in in attic.
4. Ceiling fan right upstairs bedroom rubs loudly.
5. GFCI fro pool light did not trip when tested. Big deal needs fixed.
6. No working attic light.
7. Box pulled out of the wall front porch receptacle.
8. A licensed electrician is recommend to evaluate the system for repairs of deficiencies listed herein and any others that they may find.

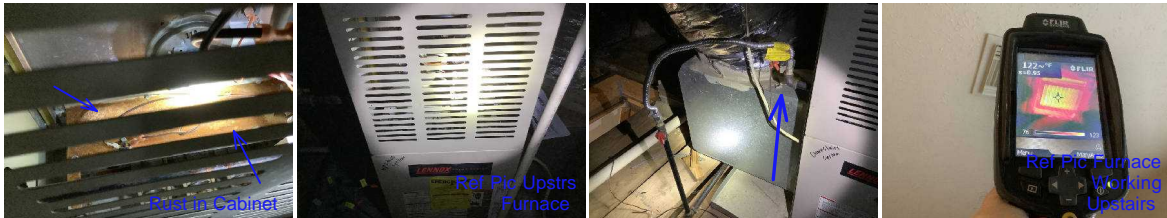
1. The furnace serving the first floor would not turn on for me. I reset the unit and it still did not complete an ignition cycle.
 2. Both furnaces were original as far as I could tell. They were rusty. I am unable to confirm the integrity of the heat exchange. Evaluation by a licensed HVAC contractor is recommended to determine the issue with the down stairs unit and to determine if they should be replaced.
 3. Missing a drip-leg (sediment trap) on the gas lines servicing the unit(s).
- Note: The upstairs unit heated well.

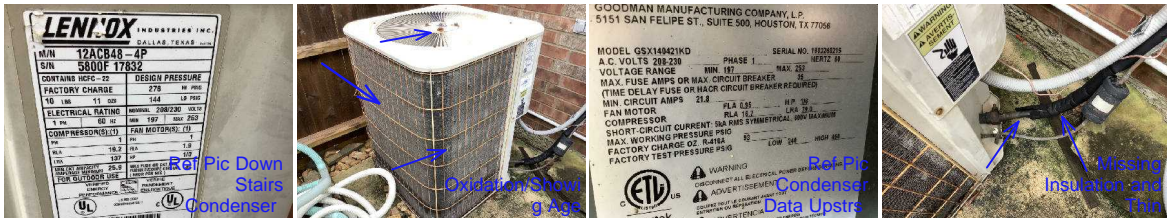
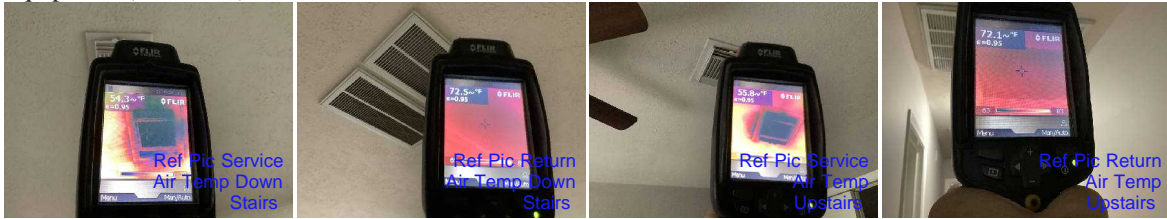
1. The original Lennox unit was showing some age with oxidation of the coils and rusting of the cabinet. The unit worked well, but was the older refrigerant R22.
2. Some missing and thin insulation on the refrigerant suction line.

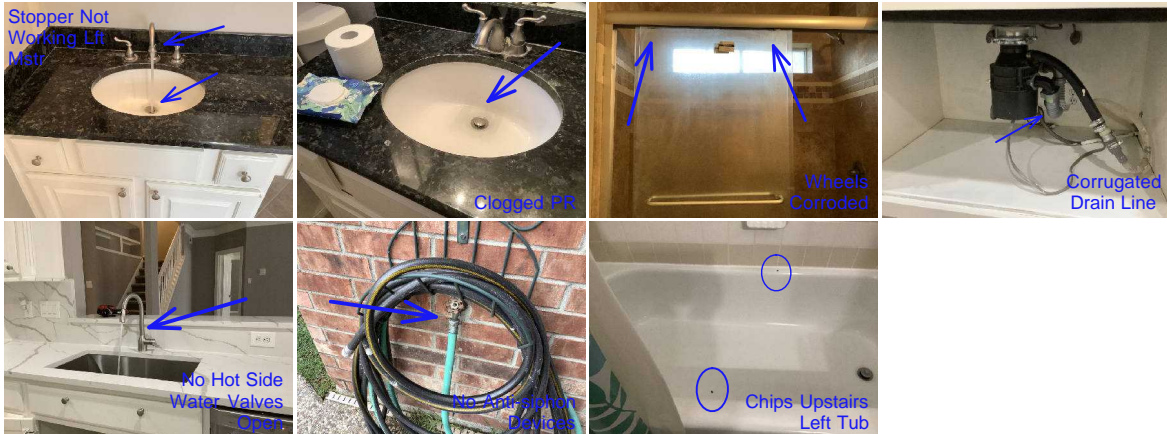
- Location of water meter: Front Left
- Location of main water supply valve: Left Side Wall
- Static water pressure reading: 60 PSI
- Comments: Copper
- 1. Stopper Not Working Lft Mstr Sink
- 2. Sink in first floor bathroom clogged.
- 3. Glass doors in first floor bathroom had corroded rollers and was were off the track. Doors not sliding.
- 4. Corrugated drain lines installed, those are not permitted by standard, the drain pipes should be smooth walled.
- 5. No hot water to kitchen faucet. All valves were open or stuck.
- 6. Missing ant-siphon devices from exterior hose bibs.
- 7. Tub upstairs left bathroom chipped.

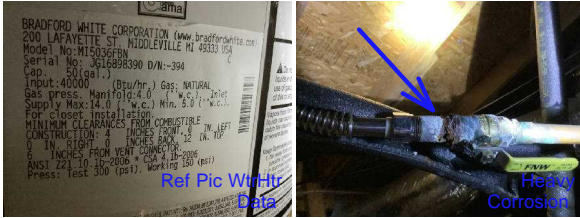
1. Some heavy corrosion at the service water fitting. That needs repaired because a failure there could cause damage to the structure.
2. Gas water heater advertised life expectancy is generally between 8-12 years. Some work longer, but failure rates get increasingly higher as they age beyond that. This unit was 9 years old but working well.

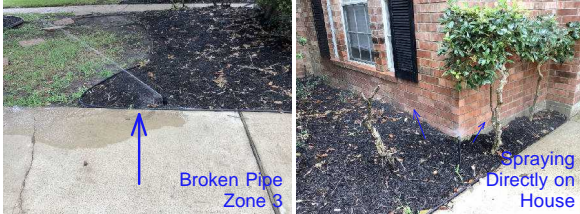
1. Broken pipe front left of driveway in zone 3.
2. Many heads out of adjustment and spraying directly on the house or concrete.
3. I could not get all the zones to respond to manual inputs at the controller, same zone operated when I needed a separate zone.
4. Given the number of deficiencies I recommend a professional irrigation company evaluate and repair items listed herein and adjust the entire system.

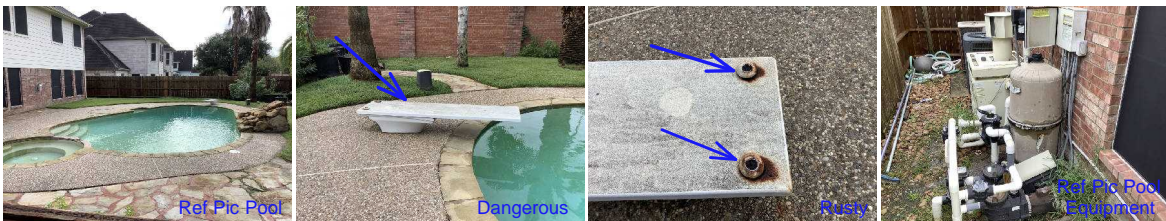
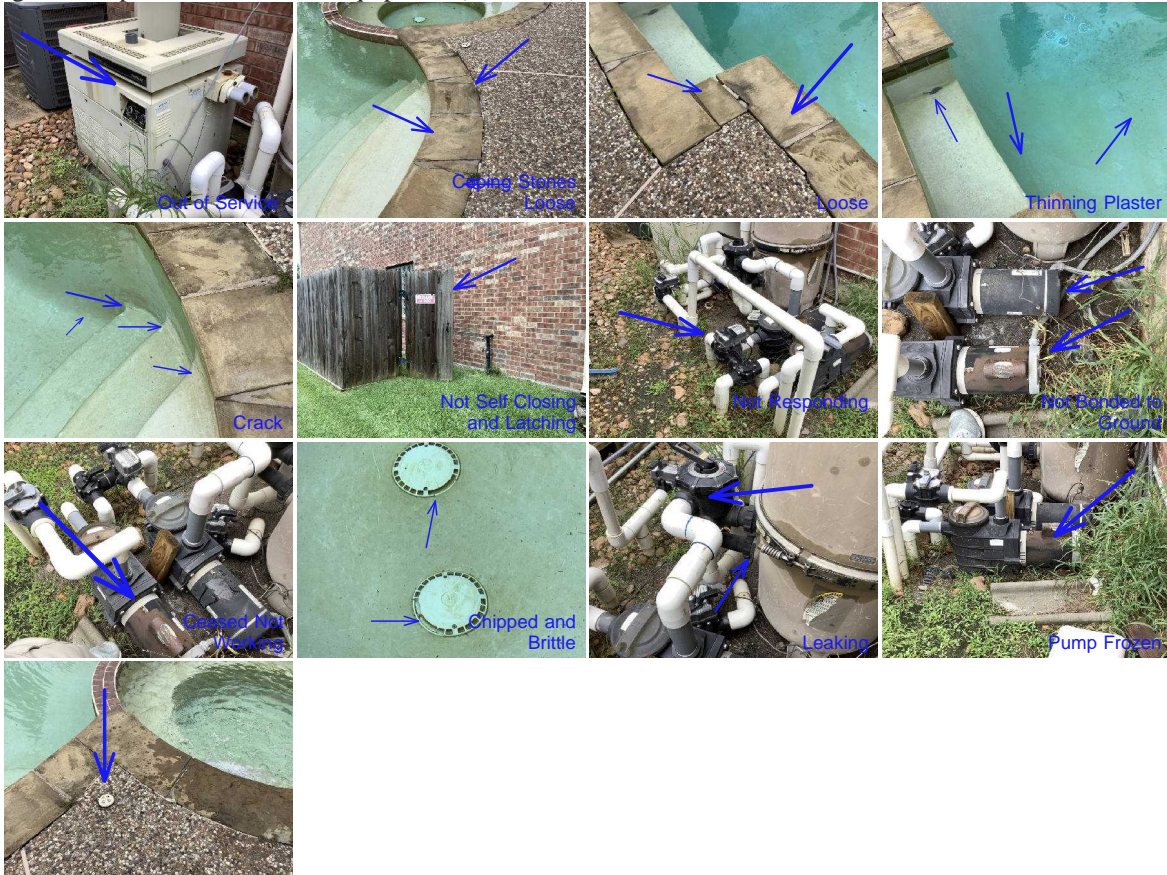
1. I turned on all of the pumps and equipment at once and it tripped the main breaker in the sub panel. There is a ceased pump that could have added to the overall load.

2. Aux pump ceased, it would not work.
3. Diving boards are one of the leading causes of injury when it comes to pools. I recommend removing the diving board. The attachment point for the board were rusty.

4. Pool heater cut out of system, it was essentially debris left on the side of the house.
5. Many of the coping stones were loose.
6. Pool finished plaster showing age and thinning in some areas.

7. Motorized selector valve not responding to call, it didnt move when needed.
8. Pump motors not electrically bonded and grounded.
9. Drain covers in spa had broken slats and appeared brittle.

10. Leaks at equipment from valves and filter housing.
11. Remote controls not working for the spa.
12. All doors leading from the house to the pool area should be equipped with a unique alarm indicating when those doors are opened.

13. Recommend a professional pool company evaluate the pool and systems for safety compliance, needed repairs they my find and address items noted herein.

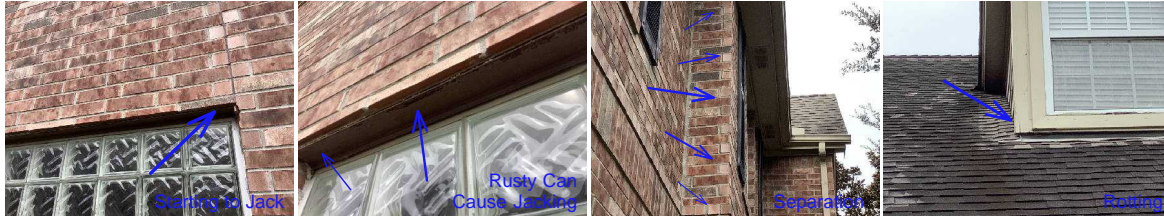
- 1. The steel angle iron at the lintel over the window was starting to rust. Some sucking in the right corner had cracked a brick. If rust continues the possibility of more oxide jacking (cracking) of the walls could occur over time.
- 2. Separation and crack front left column from some settling of the structure. Repairs possible.
- 3. A little rotted trim wood in front at bottom of dormer trim.

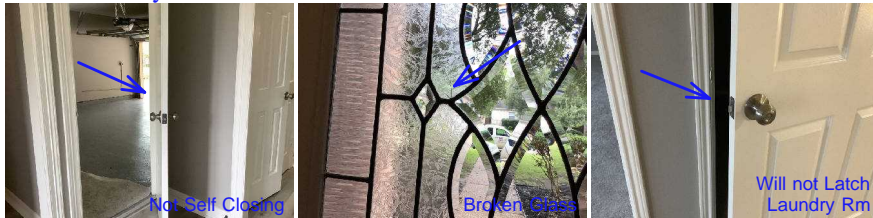
- 1. The garage access door was not self closing, current standards have the door close automatically with spring hinges for safety purposes.
- 2. Glass in the front door cracked.
- 3. Laundry room door would not latch closed.

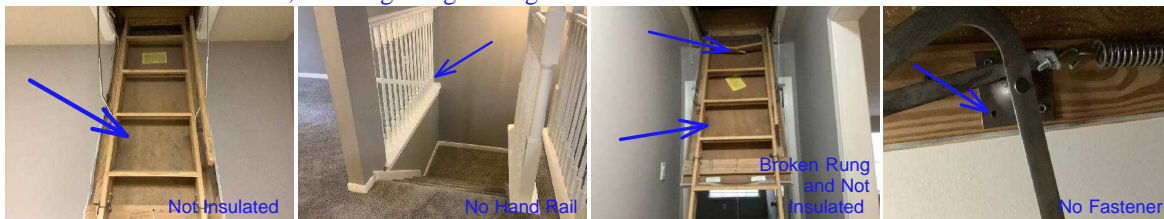
- 1. The attic access ladders inside the house were not fully insulated or fire rated.
- 2. Primary ladder had a broken rung at the top.
- 3. The attic access ladders were not installed to the manufacturer's recommended procedures, there were not enough of the proper size fasteners installed, reducing design rating.

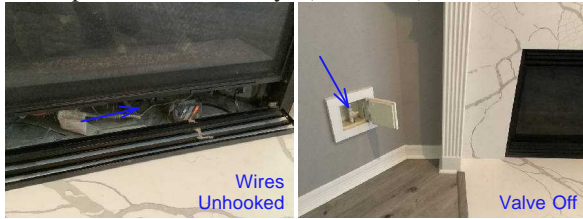
- 1. The controller wires were not hooked up and gas valve was off. Recommend repairs and testing.

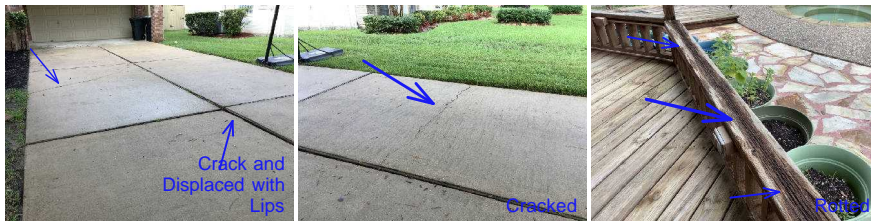
1. Cracks in driveway panels.
2. Panels displaced a little leaving lips and trip hazards at the doors of those panels.
3. Some rotted wood at the deck in the back.

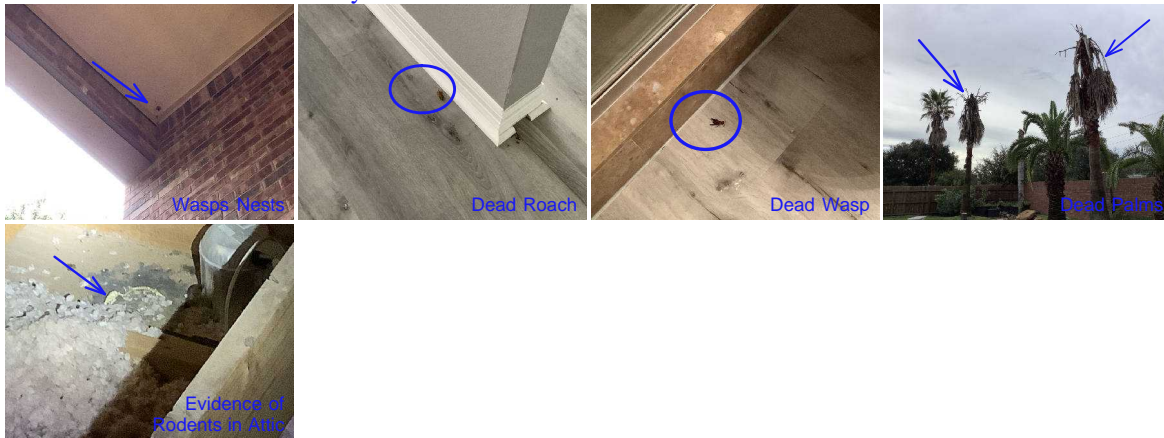
1. Active wasp nests on house.
2. Evidence of some pests.
3. Two large dead palm trees on property.
4. Evidence of rodent activity in the attic.

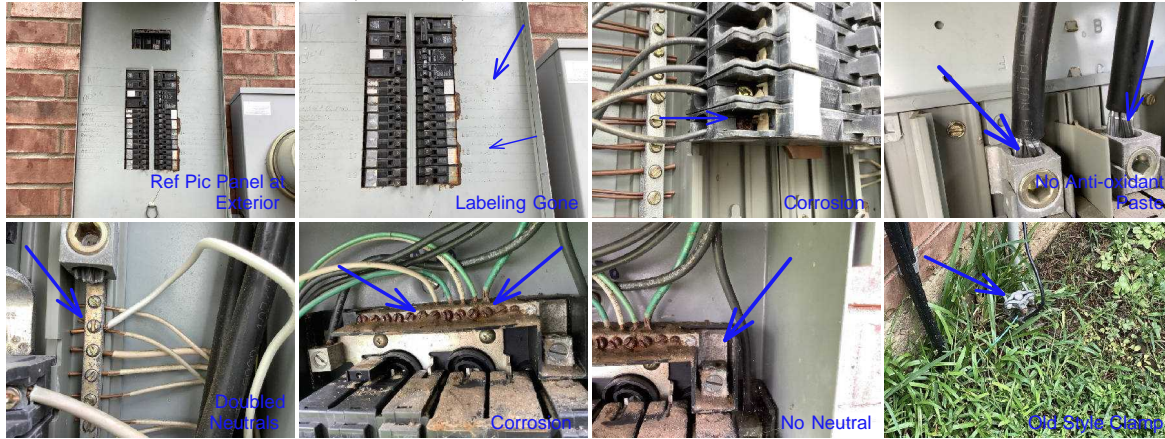
1. The panel was not fully and clearly labeled.
2. Some corrosion at the breaker lugs.
3. Missing anti-oxidant paste on aluminum, multi-strand service entrance wires, manufacturers installation instructions require it.
4. White (Neutral) wires "Double Lugged" under lugs on the buss bar. There should only be one wire per lug.
5. Some heavy corrosion at ground/neutral bar in sub panel.
6. Grounds and neutrals bonded in sub-panel. Modern standards have them unbounded in sub-panels.
7. There was no neutral carried to the sub panel from main panel.
8. The ground clamp was the old type pipe clamp not the newer style acorn clamp.
9. A licensed electrician is recommend to evaluate the panel and system for repairs of deficiencies listed herein and any others that they may find.

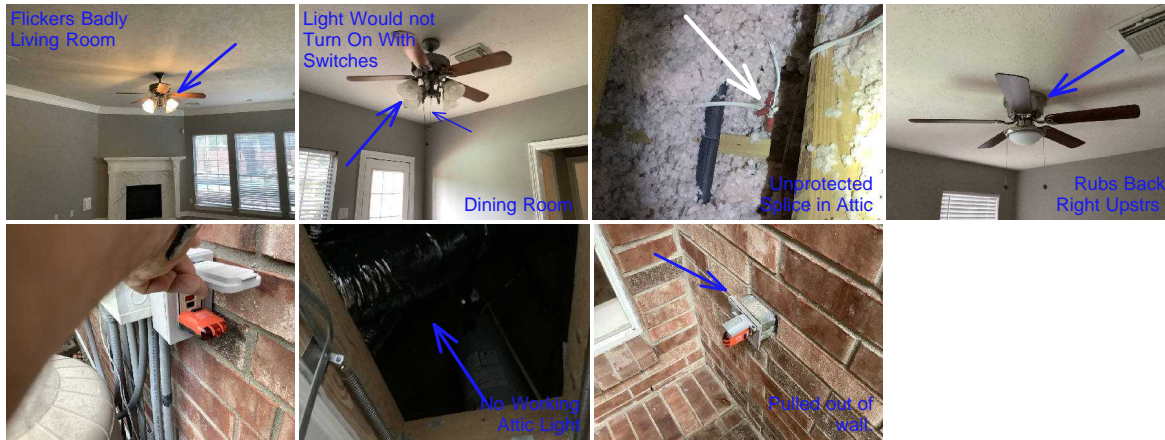
1. The living room light fixture had three switches, in one configuration the light flickered badly.
2. Could not get dining room light to turn on.
3. Poor splices made outside of protective box in in attic.
4. Ceiling fan right upstairs bedroom rubs loudly.
5. GFCI fro pool light did not trip when tested. Big deal needs fixed.
6. No working attic light.
7. Box pulled out of the wall front porch receptacle.
8. A licensed electrician is recommend to evaluate the system for repairs of deficiencies listed herein and any others that they may find.

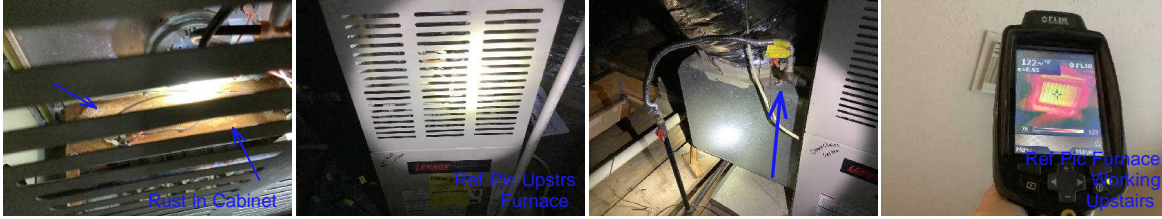
1. The furnace serving the first floor would not turn on for me. I reset the unit and it still did not complete an ignition cycle.
2. Both furnaces were original as far as I could tell. They were rusty. I am unable to confirm the integrity of the heat exchange. Evaluation by a licensed HVAC contractor is recommended to determine the issue with the down stairs unit and to determine if they should be replaced.
3. Missing a drip-leg (sediment trap) on the gas lines servicing the unit(s).
Note: The upstairs unit heated well.

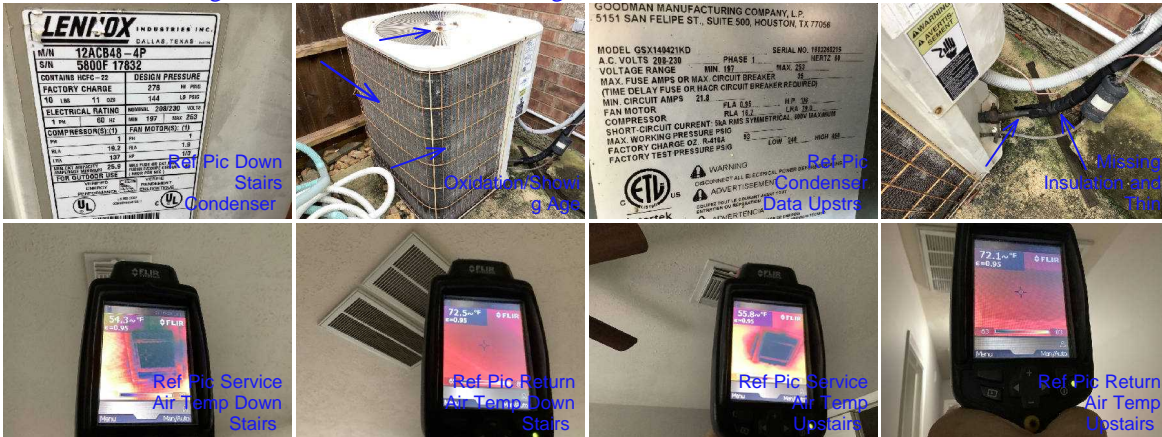
1. The original Lennox unit was showing some age with oxidation of the coils and rusting of the cabinet. The unit worked well, but was the older refrigerant R22.
2. Some missing and thin insulation on the refrigerant suction line.

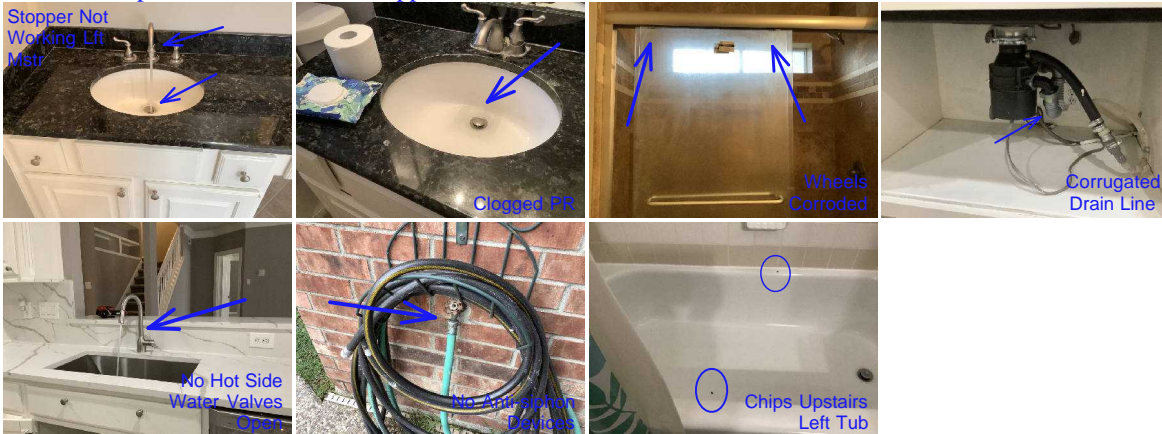
1. Stopper Not Working Lft Mstr Sink
2. Sink in first floor bathroom clogged.
3. Glass doors in first floor bathroom had corroded rollers and was were off the track. Doors not sliding.
4. Corrugated drain lines installed, those are not permitted by standard, the drain pipes should be smooth walled.
5. No hot water to kitchen faucet. All valves were open or stuck.
6. Missing ant-siphon devices from exterior hose bibs.
7. Tub upstairs left bathroom chipped.

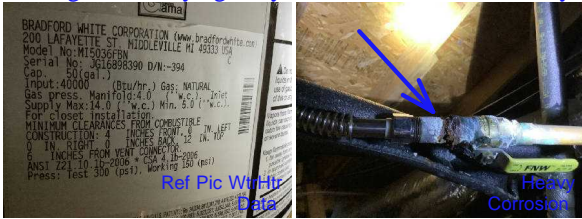
1. Some heavy corrosion at the service water fitting. That needs repaired because a failure there could cause damage to the structure.

2. Gas water heater advertised life expectancy is generally between 8-12 years. Some work longer, but failure rates get increasingly higher as they age beyond that. This unit was 9 years old but working well.

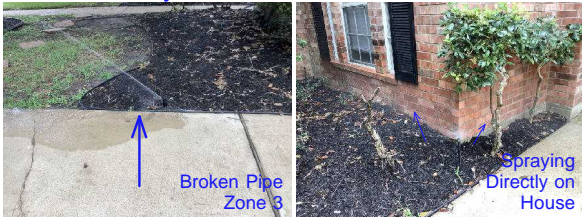
1. Broken pipe front left of driveway in zone 3.
2. Many heads out of adjustment and spraying directly on the house or concrete.
3. I could not get all the zones to respond to manual inputs at the controller, same zone operated when I needed a separate zone.
4. Given the number of deficiencies I recommend a professional irrigation company evaluate and repair items listed herein and adjust the entire system.

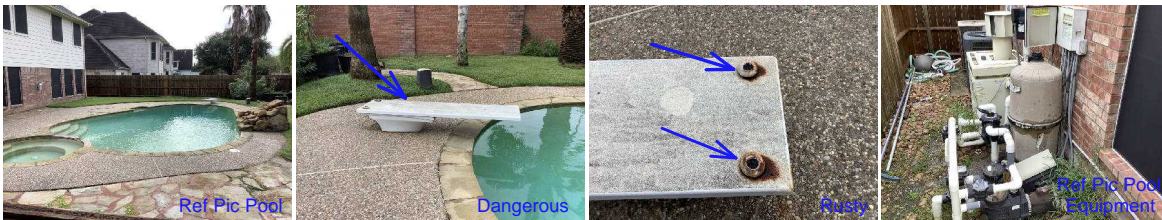
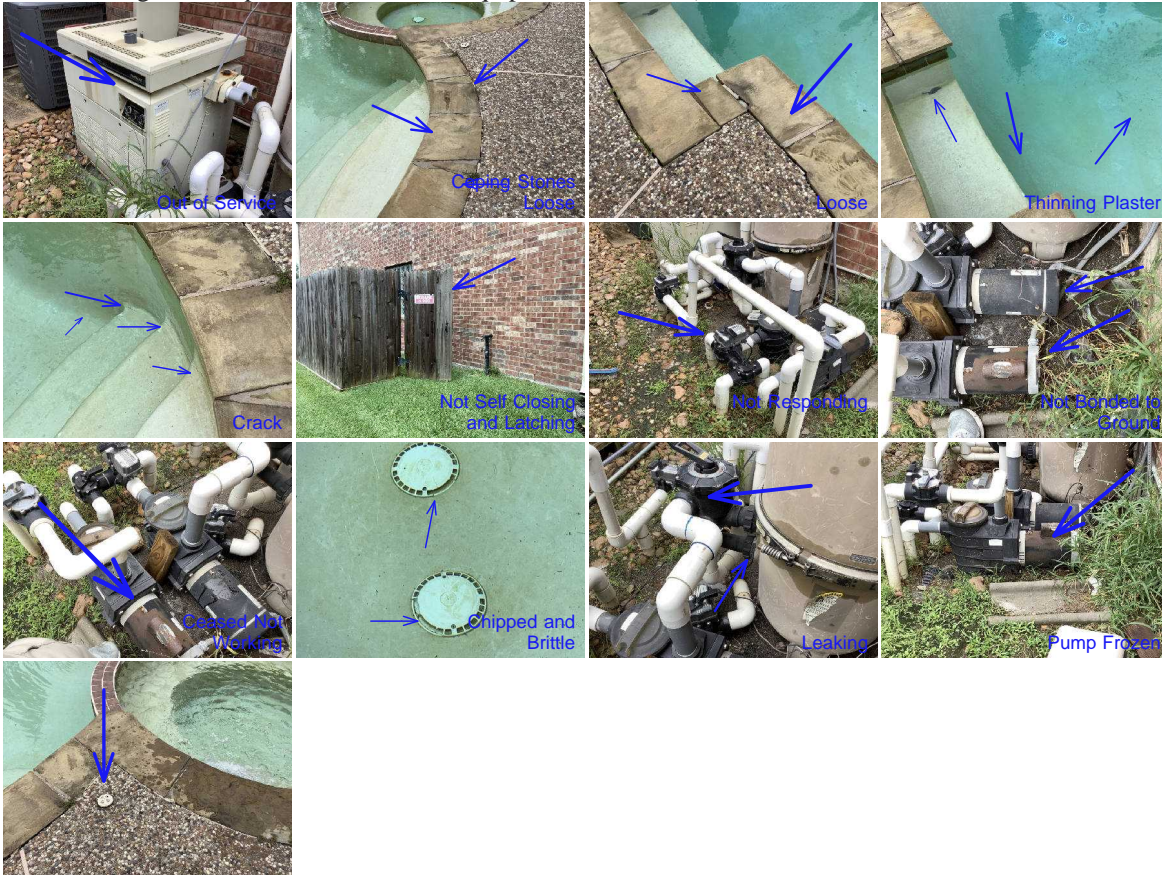
1. I turned on all of the pumps and equipment at once and it tripped the main breaker in the sub panel. There is a ceased pump that could have added to the overall load.

2. Aux pump ceased, it would not work.
3. Diving boards are one of the leading causes of injury when it comes to pools. I recommend removing the diving board. The attachment point for the board were rusty.

4. Pool heater cut out of system, it was essentially debris left on the side of the house.
5. Many of the coping stones were loose.
6. Pool finished plaster showing age and thinning in some areas.

7. Motorized selector valve not responding to call, it didnt move when needed.
8. Pump motors not electrically bonded and grounded.
9. Drain covers in spa had broken slats and appeared brittle.

10. Leaks at equipment from valves and filter housing.
11. Remote controls not working for the spa.
12. All doors leading from the house to the pool area should be equipped with a unique alarm indicating when those doors are opened.

13. Recommend a professional pool company evaluate the pool and systems for safety compliance, needed repairs they my find and address items noted herein.
