Lone Star Stucco, LLC

Moisture Assessment Report

2301 Hazard St Unit A

4/21/2020

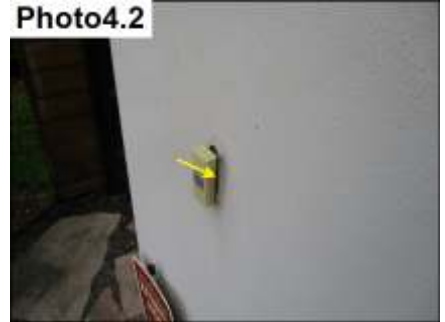
Photo4.2

Penetration Sealants/ Seal

Grid Location	Item Description	Moisture Readings	Substrate Condition	Observations
Yellow Arrows	Penetration Sealants			The penetration sealants are separated or missing. The inspector suggests to have a qualified stucco waterproofing contractor seal this area with NP1 or low modulus sealant in an effort to prevent moisture intrusion. These types of sealants are of high quality and compatible with stucco and other termination points. Please refer to photos #4.2, #4.3, #4.4, #4.5 and #4.6 for more detail.

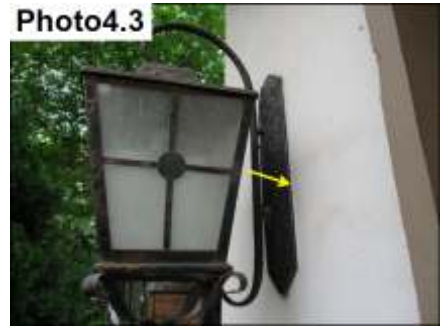
Photo4.3

Penetration Sealants/ Seal

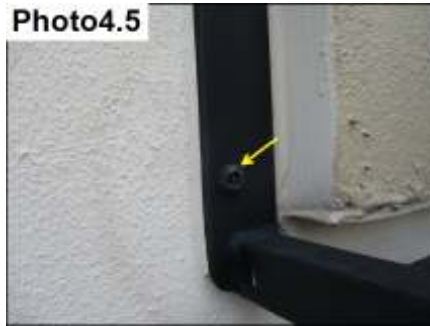
Photo4.5

Penetration Sealants/ Seal

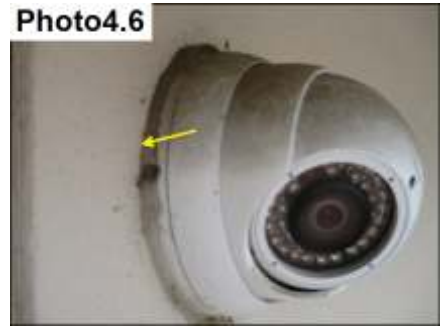
Photo4.6

Penetration Sealants/ Seal

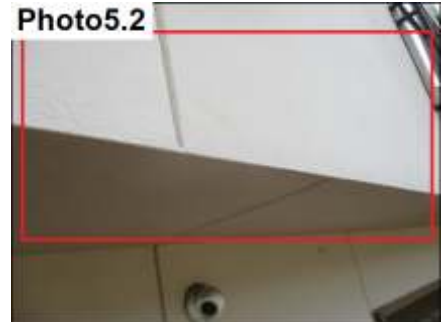
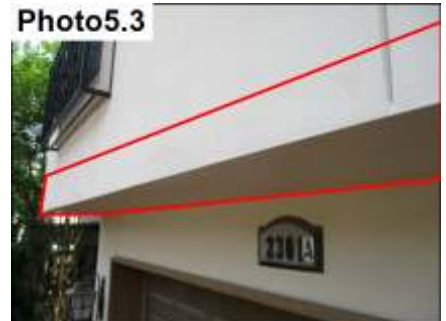
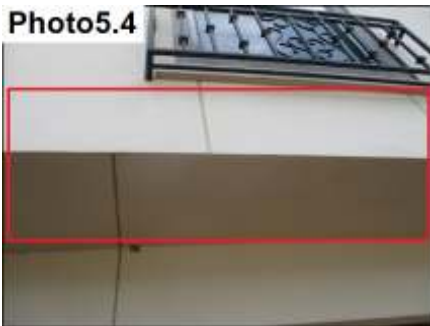
Bottom Bumpout Wall/ Create Relief

Grid Location	Item Description	Moisture Readings	Substrate Condition	Observations
Red Box	Bottom Bumpout Wall			Note that the bottom bumpout wall at this location is an improper detail with semi-firm substrate noted. The inspector suggests to have a qualified stucco waterproofing contractor further assess this area as needed and to install a relief in an effort to allow proper moisture evacuation. Please refer to photos #5.2, #5.3, #5.4 and #5.5 for more detail.
D5	Bottom Bumpout Wall	27%	Semi-Firm	A moisture probe was made at the bottom bumpout wall. An elevated moisture reading was noted with a semi-firm substrate.
E5	Bottom Bumpout Wall	28%	Semi-Firm	A moisture probe was made at the bottom bumpout wall. An elevated moisture reading was noted with a semi-firm substrate.
F5	Bottom Bumpout Wall	26%	Semi-Firm	A moisture probe was made at the bottom bumpout wall. An elevated moisture reading was noted with a semi-firm substrate.

G5	Bottom Bumpout Wall	23%	Semi-Firm	A moisture probe was made at the bottom bumpout wall. An elevated moisture reading was noted with a semi-firm substrate.

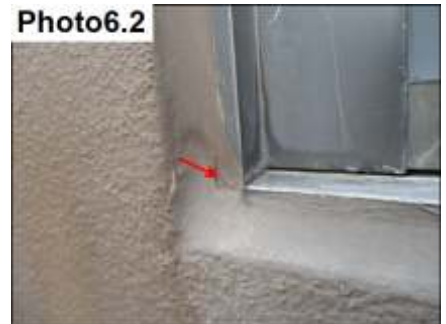
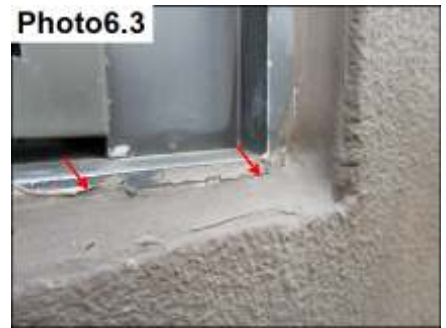
Window Sealants/ Seal

Grid Location	Item Description	Moisture Readings	Substrate Condition	Observations
Red Arrows	Window Sealants			The window sealants are aged and separated. The inspector suggests to have a qualified stucco waterproofing contractor seal this area with NP1 or low modulus sealant an effort to prevent moisture intrusion. These types of sealants are of high quality and compatible with stucco and other termination points. Please refer to photos #6.2 and #6.3 for more detail.
E5	Window Bottom Right	22%	Firm	A moisture probe was made below the window bottom right. An elevated moisture reading was noted with a firm substrate.
F5	Window Bottom Left	24%	Firm	A moisture probe was made below the window bottom left. An elevated moisture reading was noted with a firm substrate.
E3	Second Floor Window Bottom Right	18%	Firm	A moisture probe was made below the second floor window bottom right. The substrate was firm with no damage noted at this time.

F3	Second Floor Window Bottom Left	20%	Firm	A moisture probe was made below the second floor window bottom left. An elevated moisture reading was noted with a firm substrate.

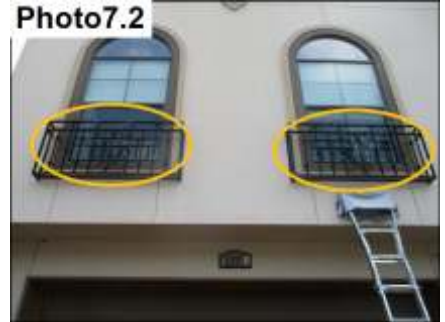
Photo7.2

Deteriorating Paint/ Clean And Paint

Grid Location	Item Description	Moisture Readings	Substrate Condition	Observations
Orange Circles	Deteriorating Paint			The paint on the Juliet railing and second floor window frames is deteriorating. The inspector suggests to clean this location with a wire brush and paint as needed. Please refer to photos #7.2, #7.3, #7.4, #7.5 and #7.6 for more detail.

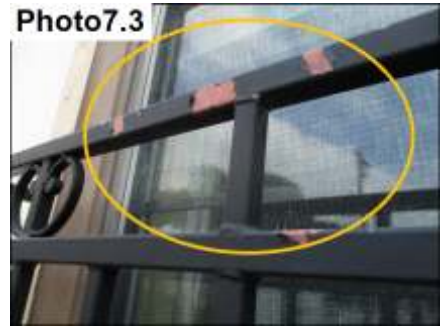
Photo7.3

Deteriorating Paint/ Clean And Paint

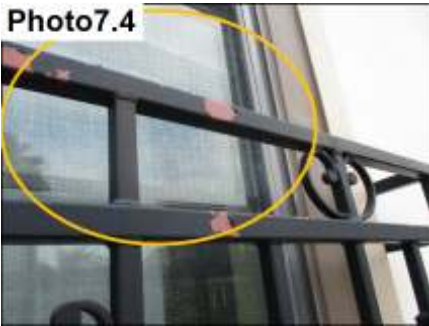
Photo7.4

Deteriorating Paint/ Clean And Paint

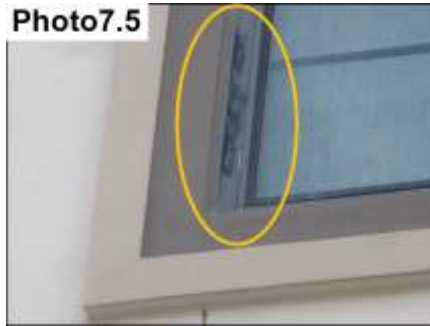
Photo7.5

Deteriorating Paint/ Clean And Paint

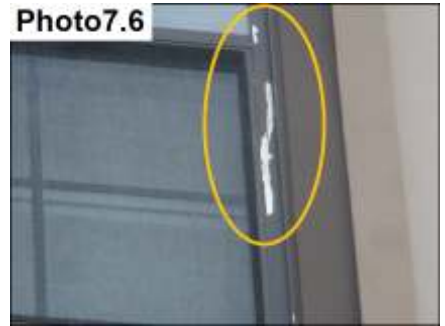
Photo7.6

Deteriorating Paint/ Clean And Paint

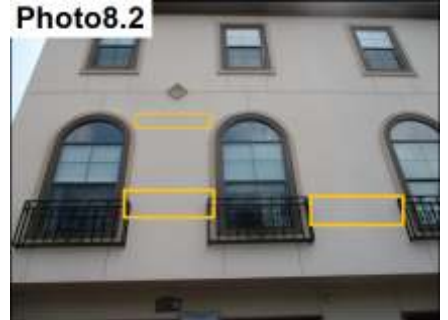
Photo8.2

Hairline Cracks And Efflorescence Noted/ Clean/ Paint

Grid Location	Item Description	Moisture Readings	Substrate Condition	Observations
Orange Boxes	Hairline Cracks And Efflorescence			Hairline cracks and efflorescence has been noted in this area of the home. This is when a naturally occurring salt migrates to the surface of the system causing a coating. The inspector suggests to consult with a qualified stucco contractor to treat this area with commercial cleaners and then paint. Please refer to photos #8.2, #8.3 and #8.4 for more detail.

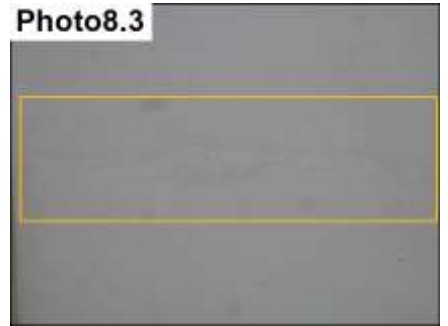
Photo8.3

Hairline Cracks And Efflorescence Noted/ Clean/ Paint

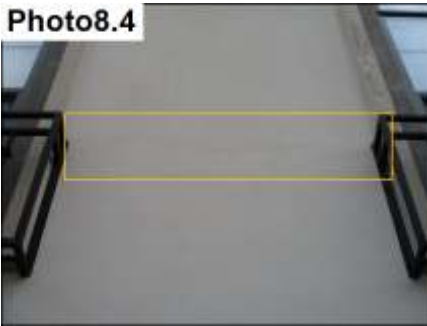
Photo8.4

Hairline Cracks And Efflorescence Noted/ Clean/ Paint

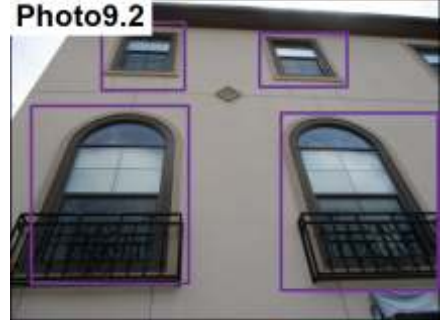
Photo9.2

Delaminating Paint/ Clean, Prime And Re-Paint

Grid Location	Item Description	Moisture Readings	Substrate Condition	Observations
Purple Boxes	Delaminating Paint			The paint on the window accents is delaminating from the stucco, as depicted in attached photo. This typically occurs when the previous stucco finish is not cleaned, primed, or otherwise not properly prepared prior to painting. The inspector suggests to consult a qualified stucco waterproofing contractor to remove all peeling paint, clean, prime, and re-paint per stucco industry standards. Please note not all delaminating areas are necessarily identified in this report. Please refer to photos #9.2, #9.3, #9.4 and #9.5 for more detail.

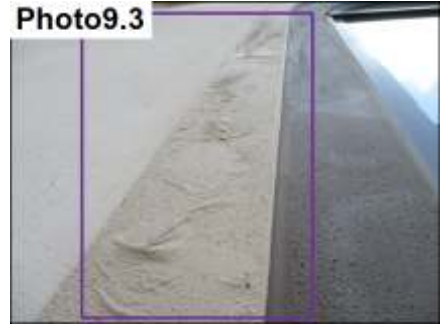
Photo9.3

Delaminating Paint/ Clean, Prime And Re-Paint

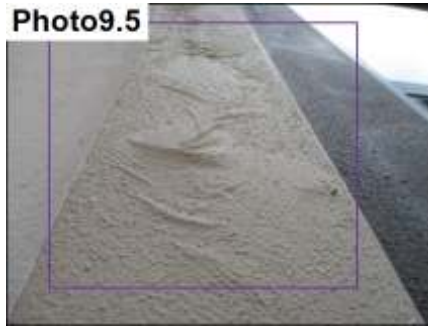
Photo9.5

Delaminating Paint/ Clean, Prime And Re-Paint

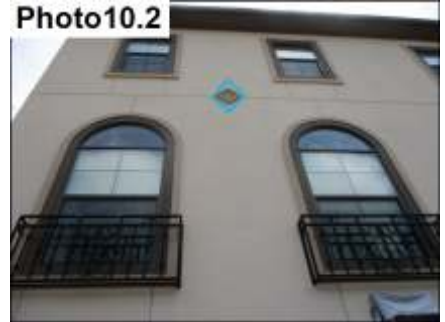
Photo10.2

Accent Sealants/ Seal

Grid Location	Item Description	Moisture Readings	Substrate Condition	Observations
Blue Box	Accent Sealants			The accent sealants are aged and separated allowing moisture to penetrate the system.. The inspector suggests to have a qualified stucco waterproofing contractor seal this area with NP1 or low modulus sealant an effort to prevent moisture intrusion. These types of sealants are of high quality and compatible with stucco and other termination points. Please refer to photos #10.2, #10.3 and #10.4 for more detail.

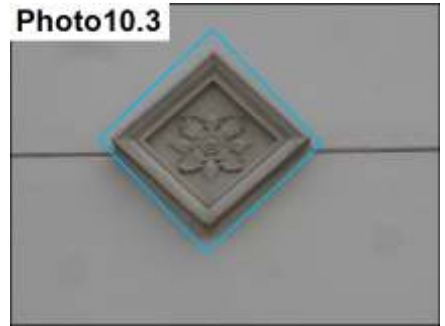
Photo10.3

Accent Sealants/ Seal

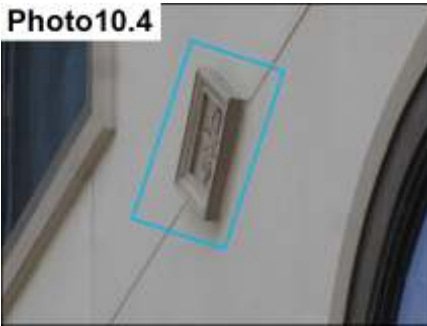
Photo10.4

Accent Sealants/ Seal

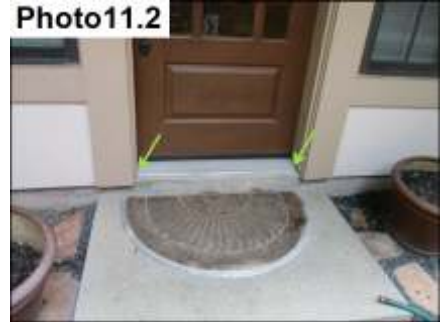
Photo11.2

Door Trim and Miter Sealants/ Seal

Grid Location	Item Description	Moisture Readings	Substrate Condition	Observations
Green Arrows	Door Trim And Miter Sealants			The door trim and miter sealants are separated or missing. The inspector suggests to have a qualified stucco waterproofing contractor seal this area with NP1 or low modulus sealant an effort to prevent moisture intrusion. These types of sealants are of high quality and compatible with stucco and other termination points. Please refer to photos #11.2, #11.3 and #11.4 for more detail.

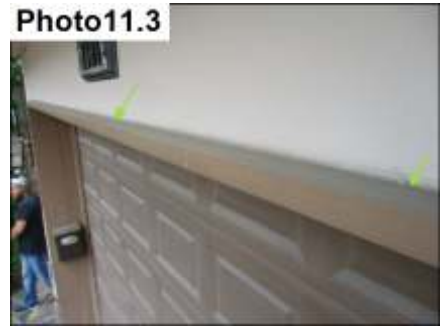
Photo11.3

Door Trim and Miter Sealants/ Seal

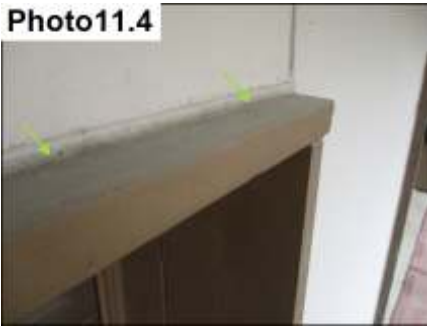
Photo11.4

Door Trim and Miter Sealants/ Seal

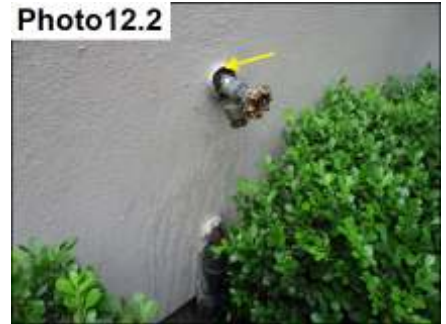
Photo12.2

Penetration Sealants/ Seal

Grid Location	Item Description	Moisture Readings	Substrate Condition	Observations
Yellow Arrows	Penetration Sealants			The penetration sealants are separated or missing. The inspector suggests to have a qualified stucco waterproofing contractor seal this area with NP1 or low modulus sealant an effort to prevent moisture intrusion. These types of sealants are of high quality and compatible with stucco and other termination points. Please refer to photos #12.2, #12.3, #12.4, #12.5 and #12.6 for more detail.
D8	Bottom Wall	18%	Firm	A moisture probe was made at the bottom wall. The substrate was firm an no damage was noted at this time.
C8	Bottom Wall	18%	Firm	A moisture probe was made at the bottom wall. The substrate was firm an no damage was noted at this time.
E5	Window Lower Left	23%	Firm	A moisture probe was made at the window lower left. An elevated moisture was noted with a firm substrate.

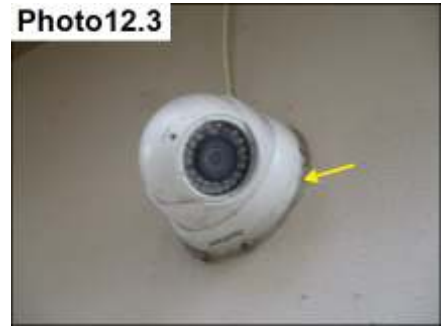
Photo12.3

Penetration Sealants/ Seal

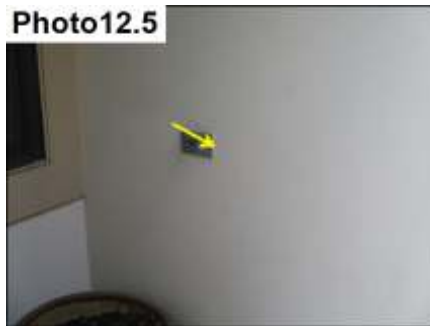
Photo12.5

Penetration Sealants/ Seal

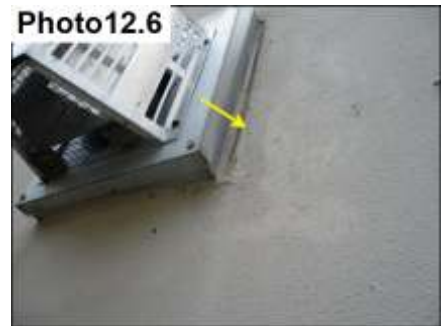
Photo12.6

Penetration Sealants/ Seal

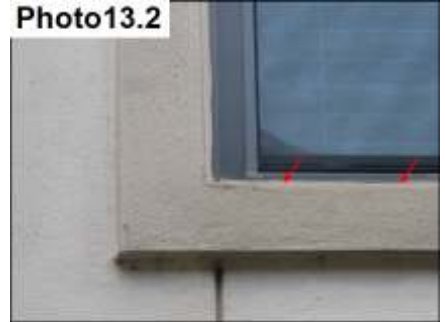
Photo13.2

Window Sealants/ Seal

Grid Location	Item Description	Moisture Readings	Substrate Condition	Observations
Red Arrows	Window Sealants			The window sealants are separated or thin. The inspector suggests to have a qualified waterproofing contractor seal this area as needed in an effort to prevent moisture intrusion. Please refer to photos #13.2, #13.3, #13.4, #13.5 and #13.6 for more detail.

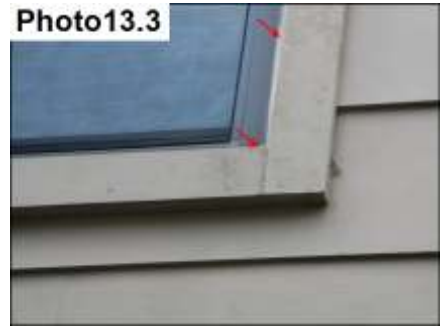
Photo13.3

Window Sealants/ Seal

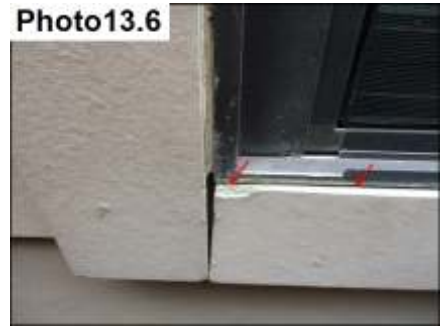
Photo13.6

Window Sealants/ Seal

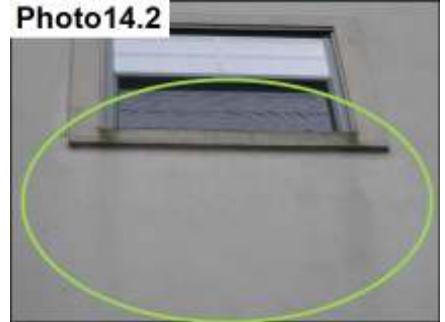
Photo14.2

Mildew/Clean

Grid Location	Item Description	Moisture Readings	Substrate Condition	Observations
Green Circles	Mildew			Mildew has been noted in this location. The inspector suggests to clean the area as needed. Please refer to photos #14.2, #14.3 and #14.4 for more detail.

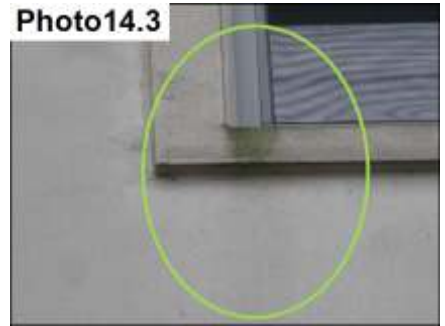
Photo14.3

Mildew/Clean

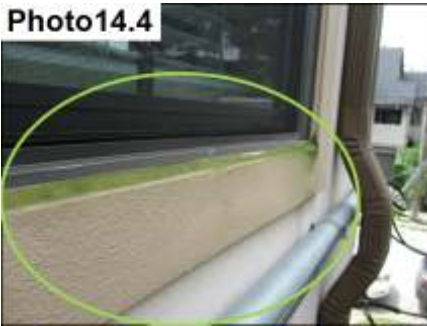
Photo14.4

Mildew/Clean

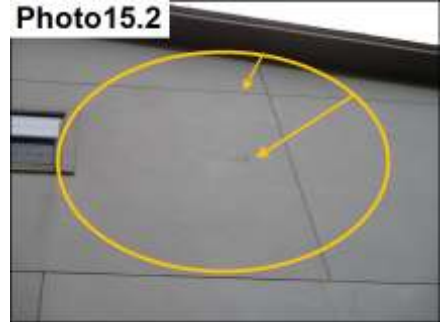
Photo15.2

Delaminating Paint And Moisture Intrusion/ Repair And Resurface

Grid Location	Item Description	Moisture Readings	Substrate Condition	Observations
Orange Circle	Delaminating Paint / Moisture Intrusion			The paint in this location is delaminating and moisture intrusion was noted at the upper panel below the cracked control joint. The inspector suggests to have a qualified stucco waterproofing contractor further assess repair and resurface this area as needed in an effort to prevent moisture intrusion. Please refer to photos #15.2, #15.3 and #15.4 for more detail.

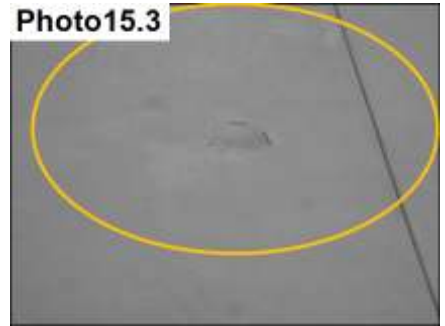
Photo15.3

Delaminating Paint And Moisture Intrusion/ Repair And Resurface

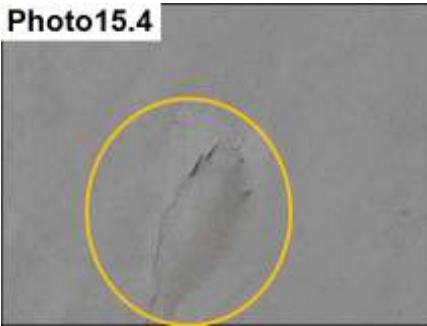
Photo15.4

Delaminating Paint And Moisture Intrusion/ Repair And Resurface

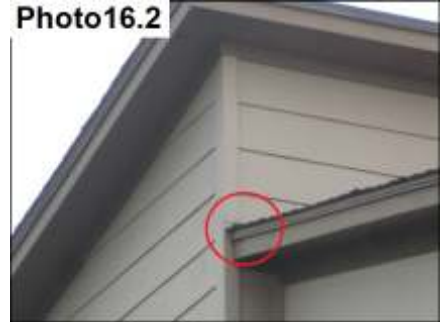
Photo16.2

Roof Diverter Flashing Sealants/
Seal

Grid Location	Item Description	Moisture Readings	Substrate Condition	Observations
Red Circle	Roof Diverter Flashing Sealants			The roof diverter flashing sealants are separated or aged. The inspector suggests to have a qualified waterproofing contractor seal this area as needed in an effort to prevent moisture intrusion. Please refer to photos #16.2, #16.3 and #16.4 for more detail.

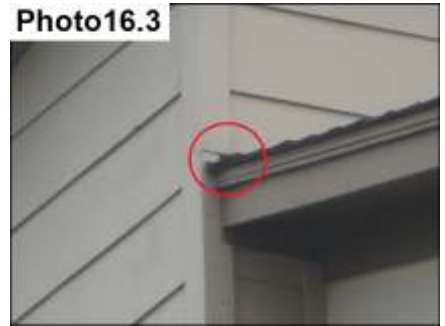
Photo16.3

Roof Diverter Flashing Sealants/
Seal

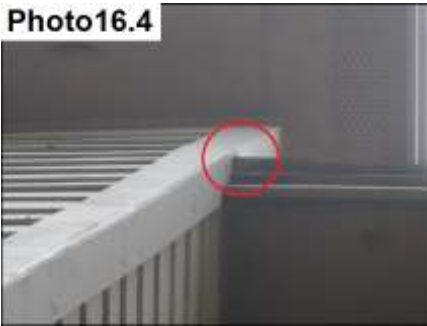
Photo16.4

Roof Diverter Flashing Sealants/
Seal

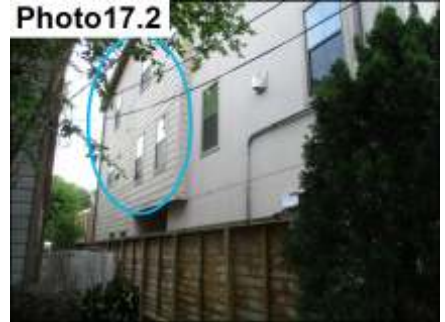
Photo17.2

Siding Sealants/ Seal

Grid Location	Item Description	Moisture Readings	Substrate Condition	Observations
Blue Circle	Siding Sealants			The siding sealants are aged. The inspector suggests to have a qualified waterproofing contractor seal and paint this area as needed in an effort to prevent moisture intrusion. Please refer to photos #17.2, #17.3, #17.4 and #17.5 for more detail.

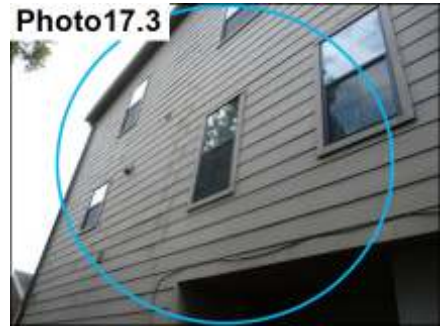
Photo17.3

Siding Sealants/ Seal

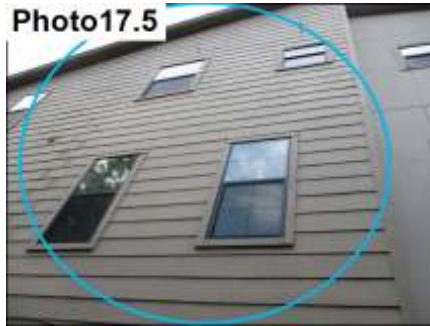
Photo17.5

Siding Sealants/ Seal

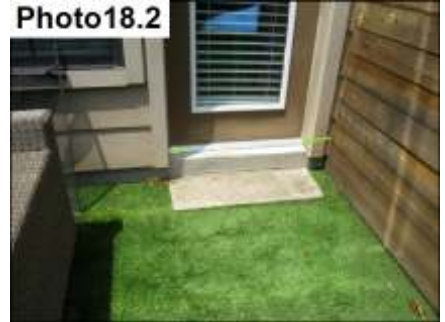
Photo18.2

Door Miter Sealants/ Seal

Grid Location	Item Description	Moisture Readings	Substrate Condition	Observations
Green Arrows	Door Miter Sealants			The door miter sealants are separated or missing. The inspector suggests to have a qualified waterproofing contractor seal this area as needed in an effort to prevent moisture intrusion. Please refer to photos #18.2 and #18.3 for more detail.
Yellow Arrows	Penetration Sealants			The penetration sealants are separated or missing. The inspector suggests to have a qualified waterproofing contractor seal this area as needed in an effort to prevent moisture intrusion. Please refer to photos #18.4, #18.5 and #18.6 for more detail.

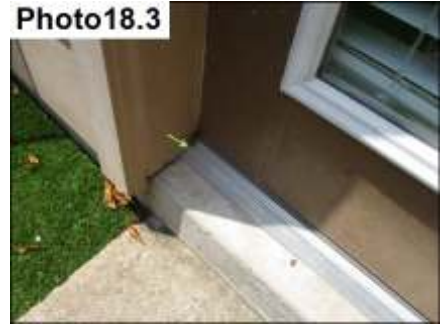
Photo18.3

Door Miter Sealants/ Seal

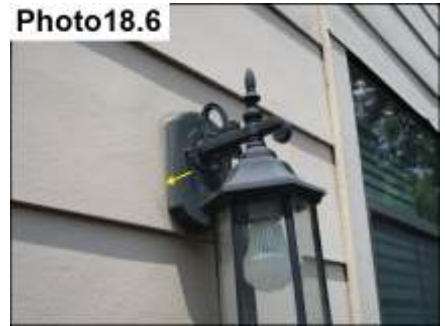
Photo18.6

Penetration Sealants/ Seal

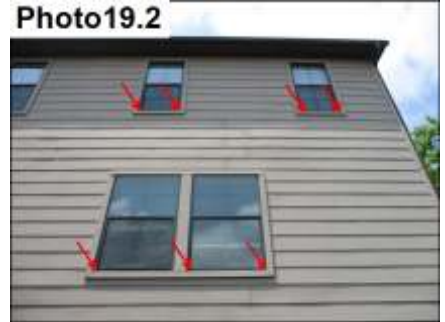
Photo19.2

Window Sealants/ Seal

Grid Location	Item Description	Moisture Readings	Substrate Condition	Observations
Red Arrows	Window Sealants			The window sealants are separated. The inspector suggests to have a qualified waterproofing contractor seal this area as needed in an effort to prevent moisture intrusion. Please refer to photos #19.2, #19.3 and #19.4 for more detail.
Purple Circle	Rust Stains			Rust stains are noted in this area. The inspector suggests to clean this location with a wire brush and paint as needed. Please refer to photos #19.5 and #19.6 for more detail.

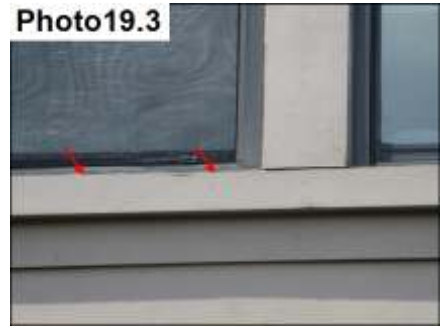
Photo19.3

Window Sealants/ Seal

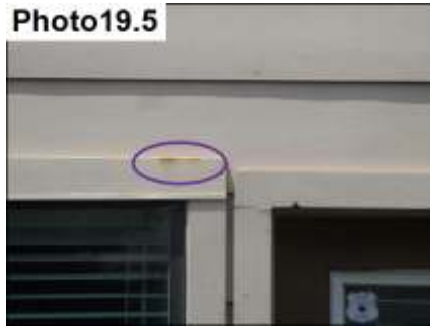
Photo19.5

Rust Stains/ Clean And Paint

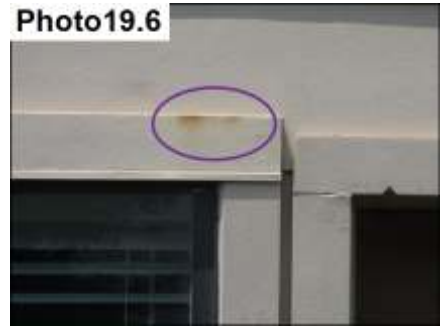
Photo19.6

Rust Stains/ Clean And Paint
