Customer Information	Order#: 06938	Date 1/21/2022
File #: EE220018	Location	
Customer: WHR Group, Inc	Robert Childress	
Attention: Lauren Sherwood	27110 Cardiff Rocks Drive	
	Katy TX 77494	
Phone: 2625237511		
Type of Service		
		Estimated Repair
Inspection	Result	Cost pCi/L
Pest Inspection w/RAL 180 Day Gua	rantee	
Service Summary		
	nat no visible evidence of active wood destroying ble areas at the time of this inspection. See repor	
	o wood destroying insects/organisms were noted buld lead to future infestation if not properly addr	
Thank you for your business.		
main you for your baomoos.		
	Report Reviewed by:	
Ва	arb Obert (317) 867-7768 Ext:273 bobert@ralis.com	
AI WAYS I	Read Entire Report for Detailed Informa	ation

TEXAS OFFICIAL WOOD DESTROYING INSECT REPORT

27110 Cardiff Rocks Dr	Katv	77494
Inspected Address	City	Zip Code
	SCOPE OF INSPECTION

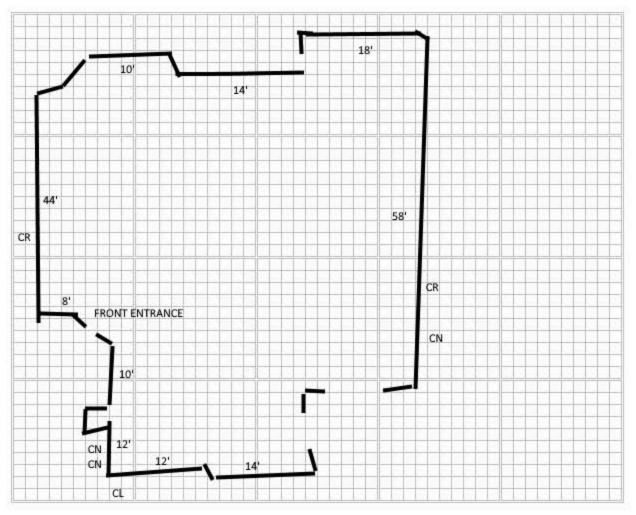
Diagram of Structure(s) Inspected

B. The obstructed or inaccessible areas include but are not limited to the following:		5000 SING.		020
tic 🔲 Insulated area of attic 🗹 PI	lumbing Areas	Planter	box abutting structu	re 🔲
eck 🔲 Sub Floors 🔲 SI	lab Joints	☑ Crawl:	Space	
oil Grade Too High 🗹 Heavy Foliage 🗹 E:	aves	☑ Weeph	oles	₽2
ther I specify: <u>Wall Voids, behind c</u> a	binets, an	pliances		
OA. Conditions conductive to wood destroying insect infestation? Yes Refer to Part J, Scope of Inspection) If "Yes" specify in 10B.	<u> </u>			
relei to Talto, ocope of hispectori) ii Tes specify ii Tob.				
		ards left in place (I)	Excessive Moisture	e (J)
DB. Conducive Conditions include but are not limited to:	Formboa	and the orange (ii)		100 Control (100 C
DB. Conducive Conditions include but are not limited to: Wood to Ground Contact (G)	<u> </u>	+ (M)	Heavey Foliage	(N) MT
DB. Conducive Conditions include but are not limited to:	Wood Ro	ot (M)	Heavy Foliage ((N) 2
