# PROPERTY INSPECTION REPORT

Prepared For: WHR Group, Inc

**Concerning:** 27110 Cardiff Rocks Drive Katy TX 77494

By: **Marc Gessner** 6033 1/20/2022 (Date)

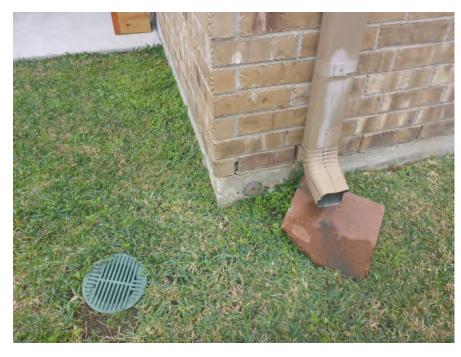
Exposed post tension cable end at the left rear corner of the home.

1. Qualified contractor to correct as determined necessary the exposed post tension cable end at the left rear corner of the home.

Qualified licensed structural engineer to further evaluate the post tension cable ends at the left rear corner of the home. Qualified structural engineer to further evaluate, make any necessary repairs and verify in writing no further action needed. WHR Group to obtain bid.

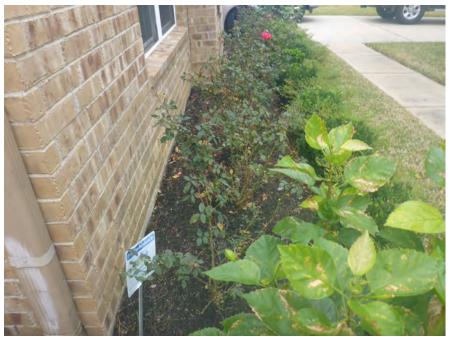
Line Item #: I.B.

Negative grading and high soil line at the front.

1. Qualified contractor to correct as determined necessary the negative grading and high soil line at the front.

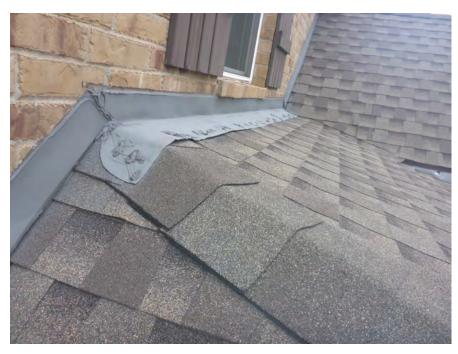
Loose flashing at the lower front center.

1. Qualified roofing contractor to correct as determined necessary the loose flashing at the lower front center.

Qualified licensed roofing contractor to further evaluate and correct as determined necessary the loose flashing at the lower front center of the roof. Qualified roofing contractor to make any necessary repairs and verify in writing no further action needed. WHR Group to obtain bid.

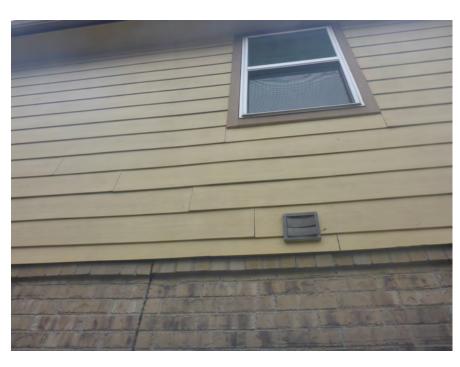
Line Item #: I.E.

Example of siding seams need sealing at the left and right sides of the home.

- 1. Qualified siding contractor to correct as determined necessary the deficiencies listed below:
- a. Siding seams need sealing at the left and right sides of the home.
- b. Cracked sealant around the window frames and garage door trim.
- 2. Qualified contractor to correct as determined necessary the crack at the wall in the second floor utility room

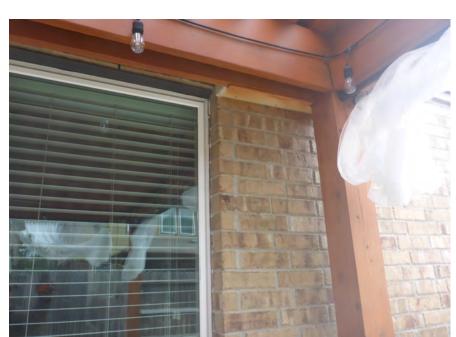
Line Item #: I.E.

Example of cracked sealant around the window frames.

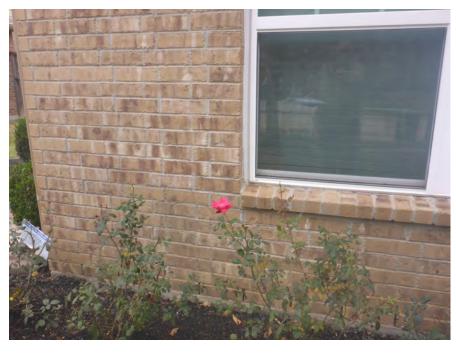
Line Item #: I.E.

Example of cracked sealant around the window frames.

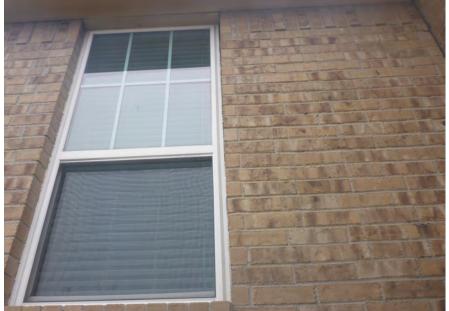
Line Item #: I.E.

Example of cracked sealant around the window frames.

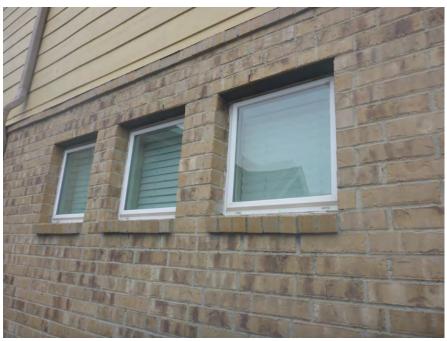
Line Item #: I.E.

Example of cracked sealant around the window frames.

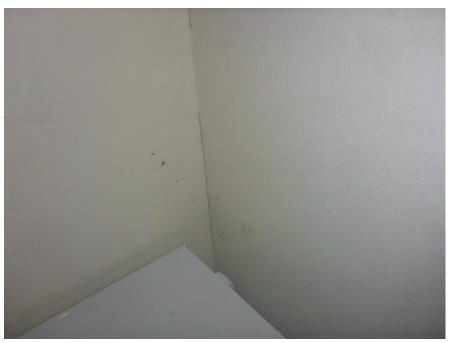
Line Item #: I.E.

Crack at the wall in the second floor utility room.

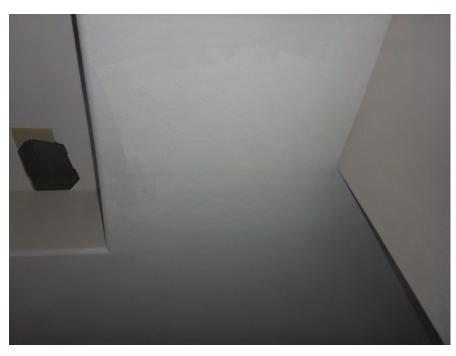
Crack at the family room ceiling.

1. Qualified contractor to correct as determined necessary the crack at the family room ceiling.

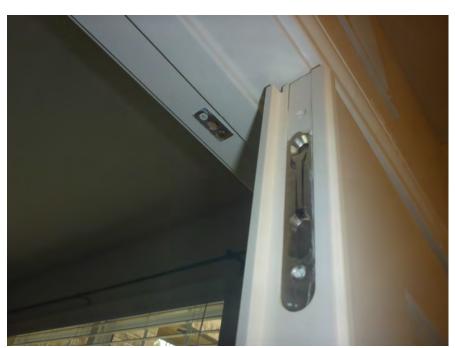
Line Item #: I.G.

Description:
Doors to study have been moved to exterior of the door frame and do not lock properly.

1. Qualified contractor to correct as determined necessary the doors to study that have been moved to exterior of the door frame and do not lock properly.

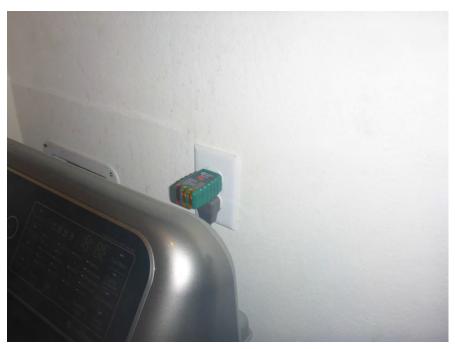
Line Item #: II.B.

Description:
Missing GFCI protection at the outlets in the upper and lower utility rooms.

1. Qualified electrical contractor to correct as determined necessary the missing GFCI protection at the outlets in the upper and lower utility rooms.

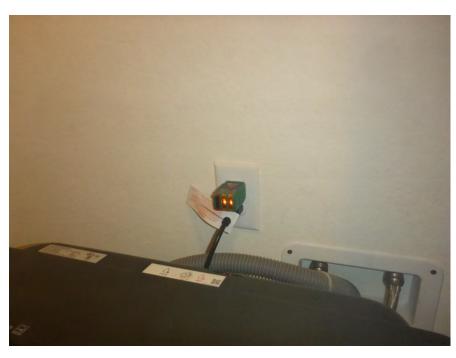
Missing GFCI protection at the outlets in the upper and lower utility rooms.

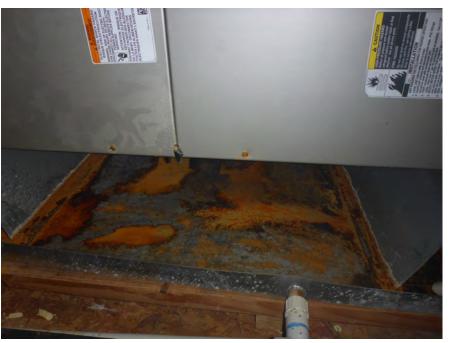
Line Item #: III.B.

Description: Rust in the emergency drain pan.

1. Qualified HVAC contractor to correct as determined necessary the rust in both of the emergency drain pans.

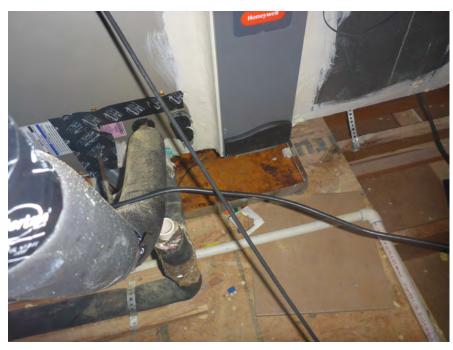
Rust in the emergency drain pan.

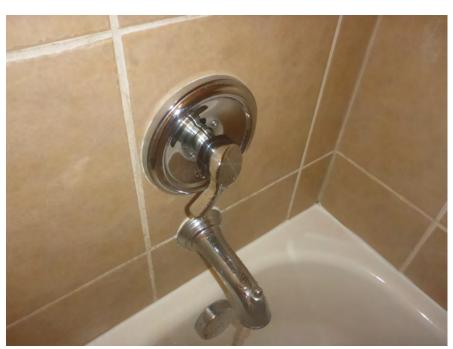
Line Item #: IV.A.

Description: No positive stop on the hall bathtub faucet.

- 1. Qualified plumbing contractor to correct as determined necessary the deficiencies listed below:
- a. No positive stop on the hall bathtub faucet.
- b. Missing anti-siphon devices at the exterior hose bibs.
