Homesmith  
*Home Inspections*

Home Inspection Report

12400 Brookglade Circle - Unit 11  
Houston, TX 77099

**Prepared For:** Busayo Okusaga  
**Concerning:** 12400 Brookglade Circle - Unit 11 Houston, TX 77099  
**Inspection Date:** 02/11/2022

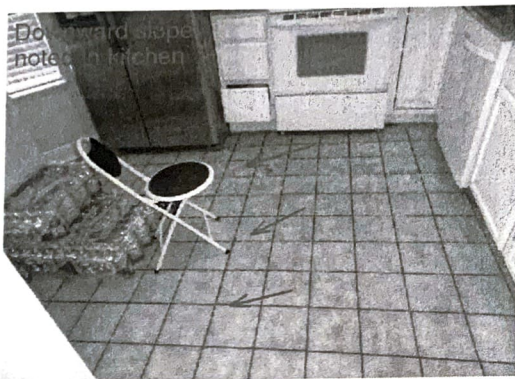
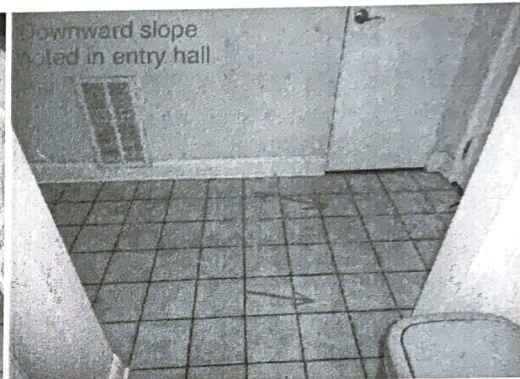
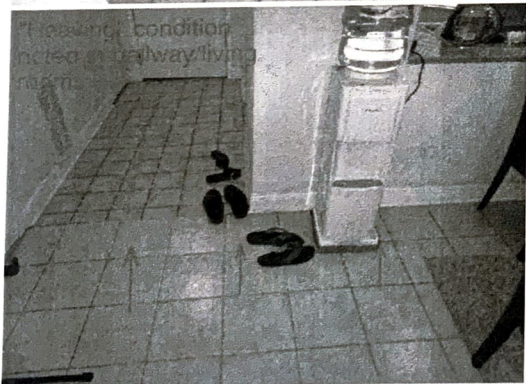
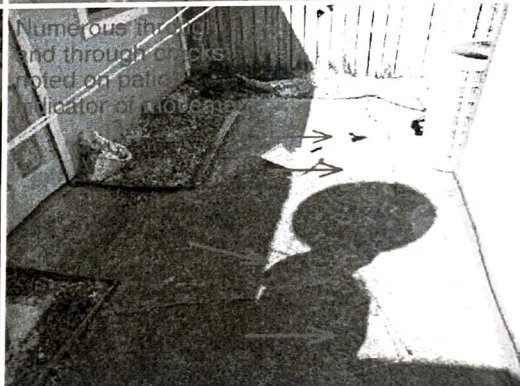
Type of Foundation: - Property is a townhouse/condominium  
 Comments: - Poured slab - Foundation exhibited deflection in different locations the home - further review by a competent foundation specialist is highly recommended to evaluate scope and cost of repairs.

*Handwritten notes:*  
 Downward slope noted in kitchen  
 Downward slope noted in entry hall  
 Numerous insects and through cracks noted on patio - indicator of moisture

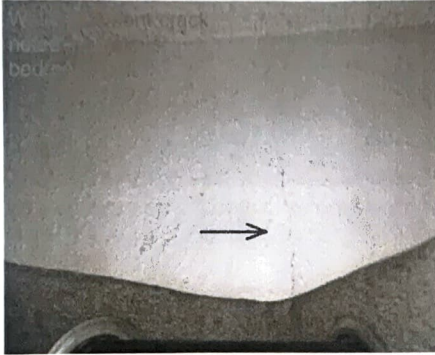
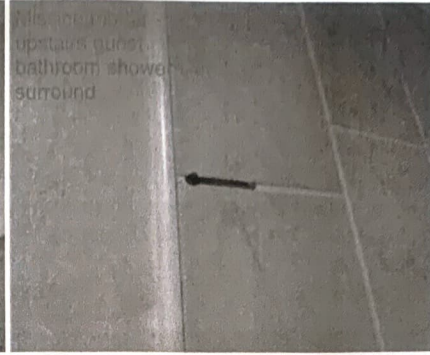
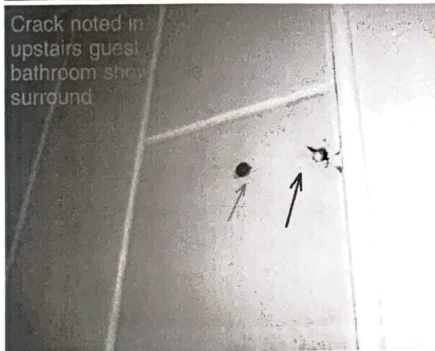
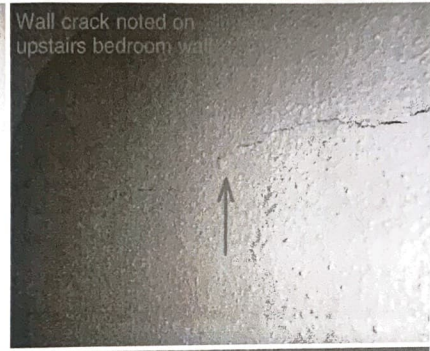
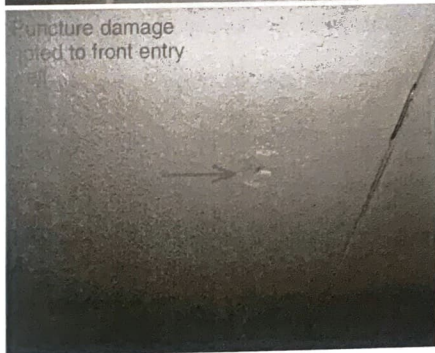
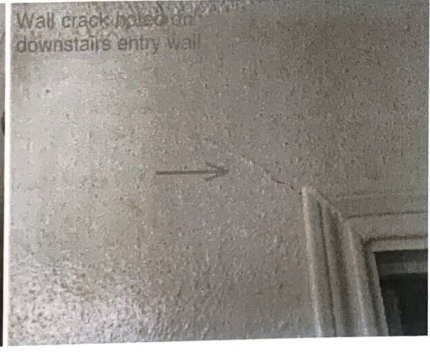
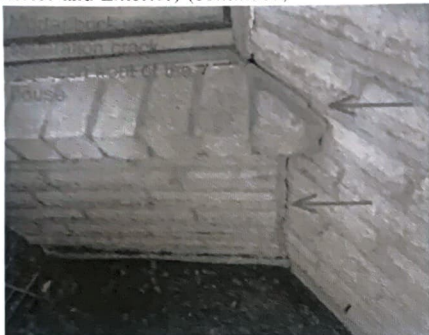
**E. Walls (Interior and Exterior)** - Comments: - Drywall/brick veneer and hardiplank siding. - Numerous interior wall cracks noted - see labeled photos - general condition of the house - need repair.

- Exterior brick veneer/mortar crack noted on the front of the house - need repair.

- Damaged/cracked tiles noted on upstairs guest bathroom tile surround - needs repair.

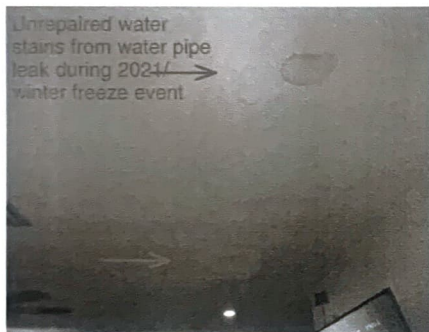
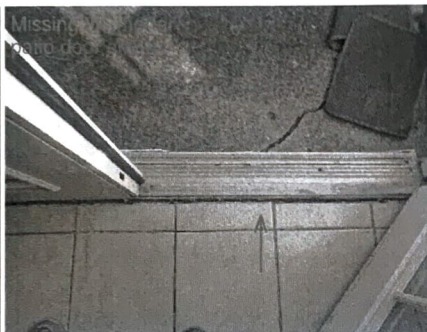
**F. Ceilings and Floors** - Comments: - Drywall/ceramic tile/wood laminate/carpet. - Stains on living room ceiling from water pipe burst during 2021 freeze event noted. Water pipe has been repaired. Ceiling stain needs repair.

- Missing mortar tile - patio door entry - needs repair.

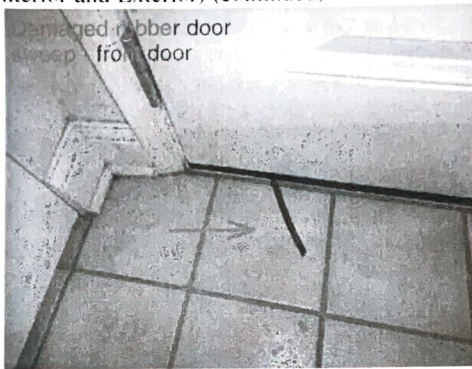
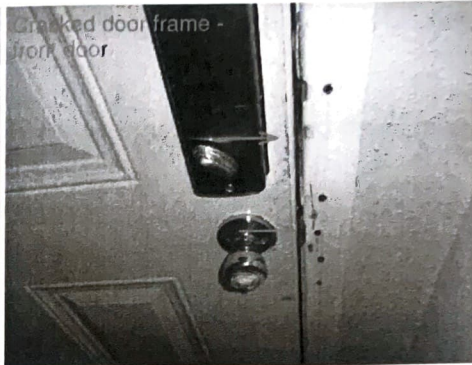
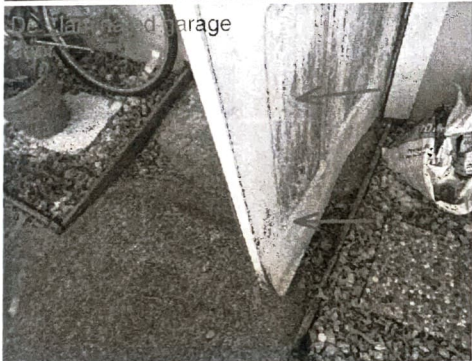
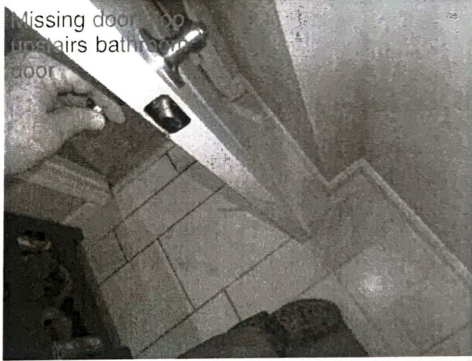
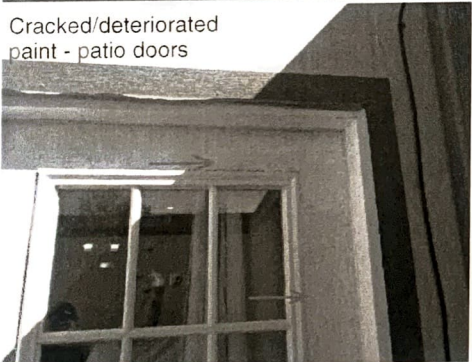
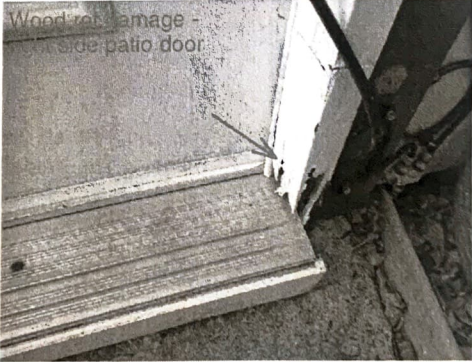
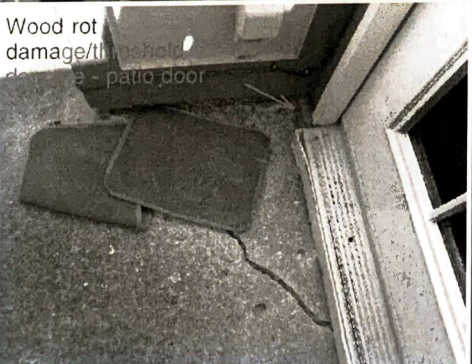
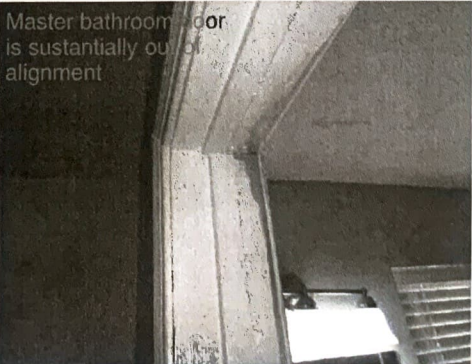
**G. Doors (Interior and Exterior)** - Comments: - Aluminum/Wood solid core/wood hollow core. - Damaged rubber door sweep noted on front door - needs repair.

- Garage door is deteriorated/de-laminated - needs replacement.

- Damage noted to front door trim - needs repair.

- Missing door stop - upstairs guest bathroom - needs replacement.

- Cracked paint noted on the exterior of both patio doors - needs paint.

- Wood rot noted to both sides of the patio door trim - needs repair.

- Damage noted to patio door threshold - needs repair.

- Upstairs bathroom door is significantly out of alignment - abrasion damage noted.

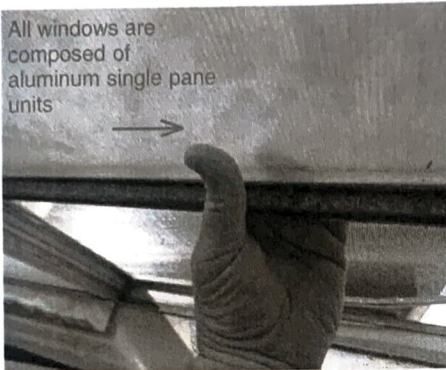
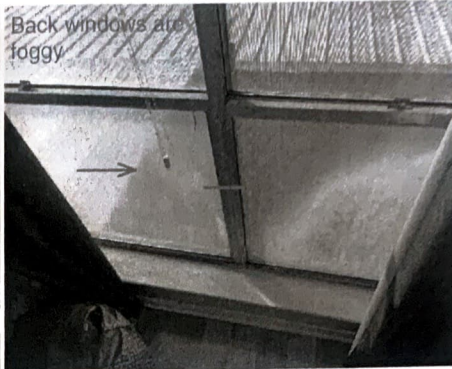
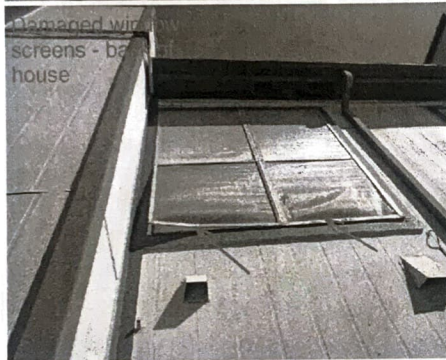
**H. Windows** - Comments: - Aluminum single pane, - All windows are at the end of their designed life cycle. foggy, loose/deteriorated glass window panes noted on the back of the house - need replacement.

- Missing screens - need replacement.

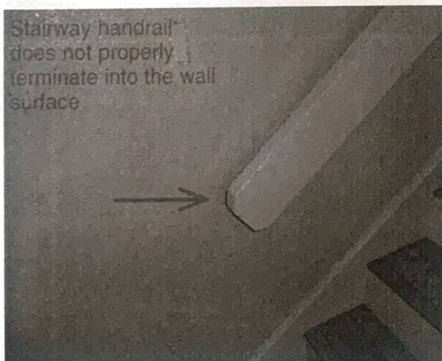
**I. Stairways (Interior and Exterior)** - Comments: - Wood stairs with wood handrails, - Stairway handrail does not properly terminate into the wall surface - safety hazard - needs repair.

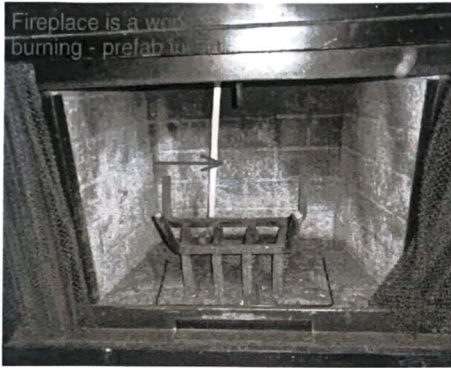
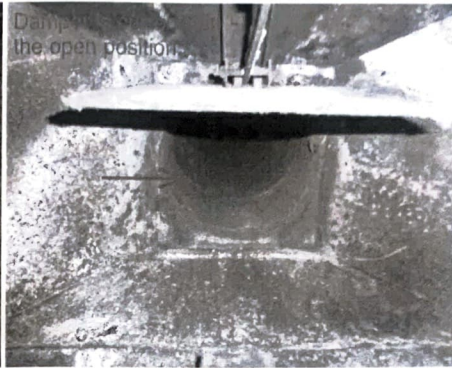
J. Fireplaces and Chimneys - Comments: - Prefab. - The fireplace is a wood burning fireplace.

- The damper is currently in the open position.

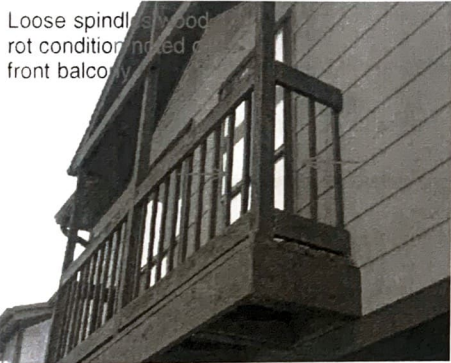
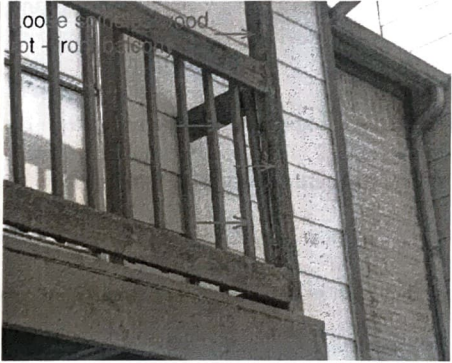
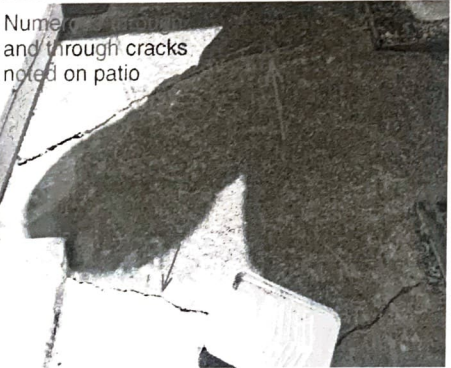
K. Porches, Balconies, Decks, and Carports - Comments: - Concrete. - Wood rot damage and loose spindles noted on front balcony - needs repair.

- Numerous through and through cracks noted on patio surface - needs replacement.

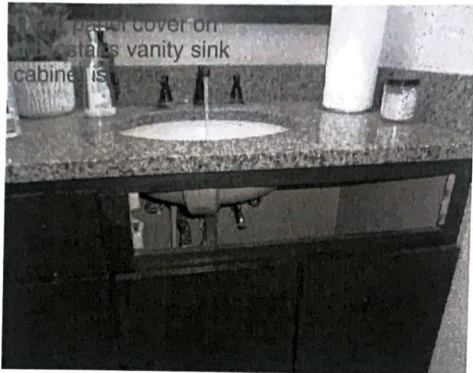
**L. Other** - Comments: - Counter tops/cabinets/drawers, - Downstairs guest bathroom vanity cabinet front panel is loose - needs to be securely attached.

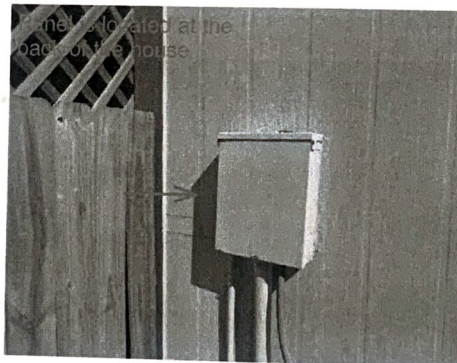
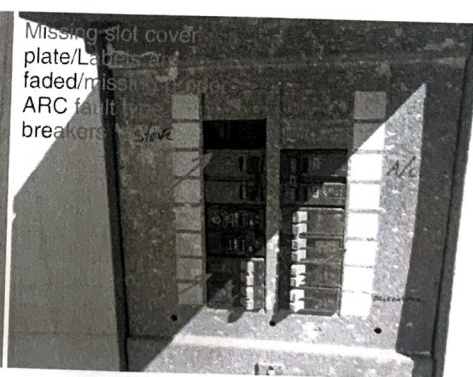
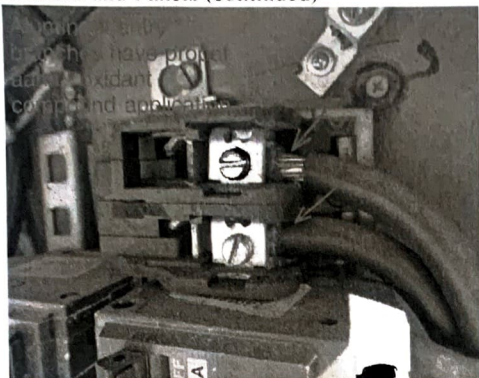
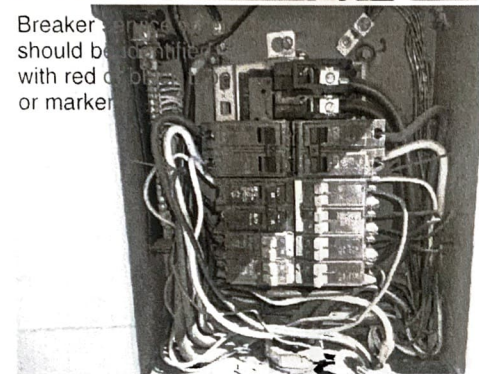
- The panel is missing breaker slot cover(s) - needs repair.
- The panel labels should be typed to prevent fading.
- The aluminum entry branches appear to have anti - oxidant compound which prohibits oxidation.
- The panel does not appear to have double lugged neutrals (double lugged neutrals can cause excessive heat in the panel).
- The panel is missing proper ARC fault type breakers - Does not meet today's standard.
- Breaker service wires should be either black or red - White breaker service wires need to be marked with appropriate color - Does not meet today's standard.
- Inspector could not locate the 8 ft grounding rod which is a safety hazard. It is possible the entire building has an 8 ft grounding rod. Client is encouraged to place an inquiry with the HOA to determine status.

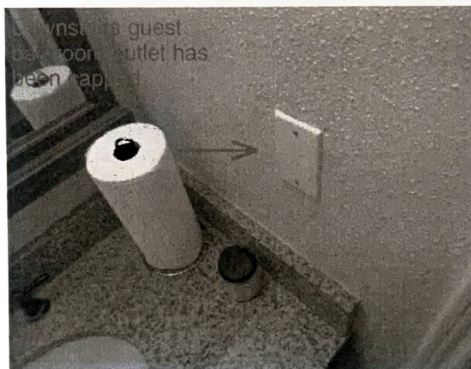
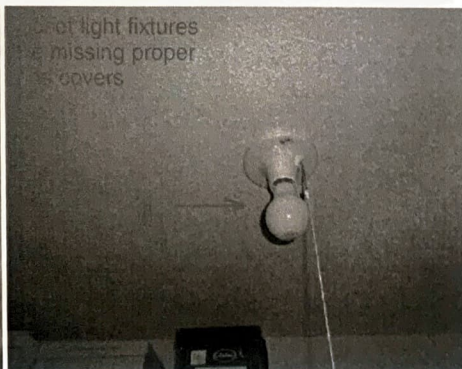
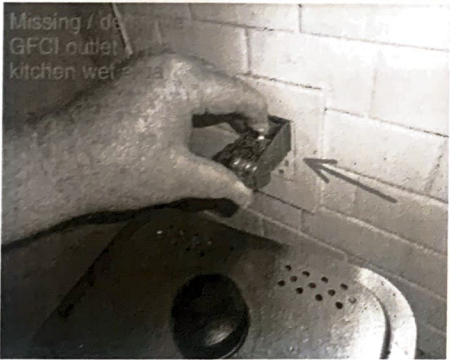
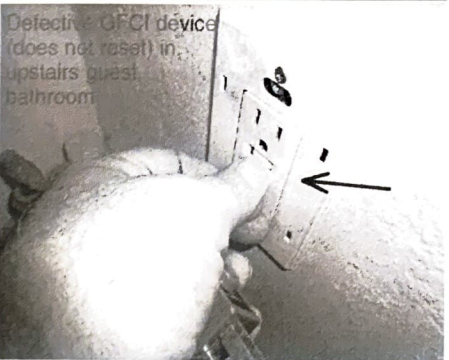
Comments: - Copper - Outlet in downstairs guest bathroom has been removed and capped.

- Closet light fixtures are missing proper lens covers - Does not meet today's standard.
- Light bulbs out/missing from numerous ceiling fans - see labeled photos - need replacement.
- defective GFCI outlet noted in upstairs bathroom - safety hazard - needs repair.
- One (1) missing GFCI device in kitchen wet area - needs repair.

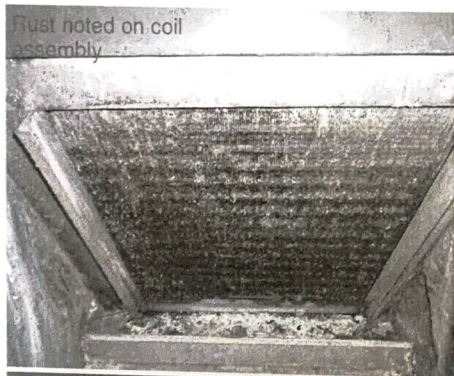
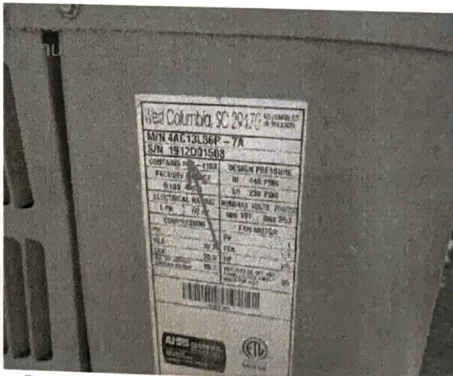
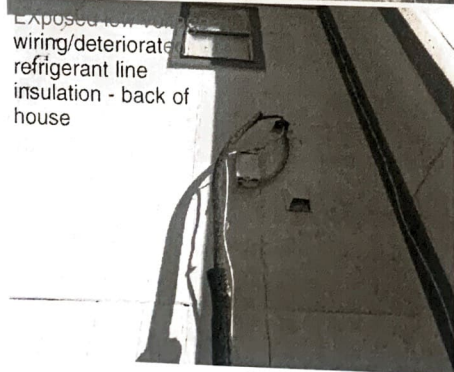
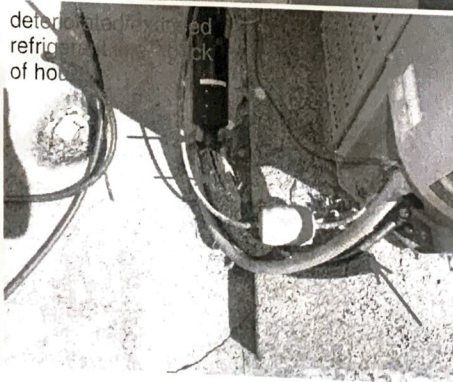
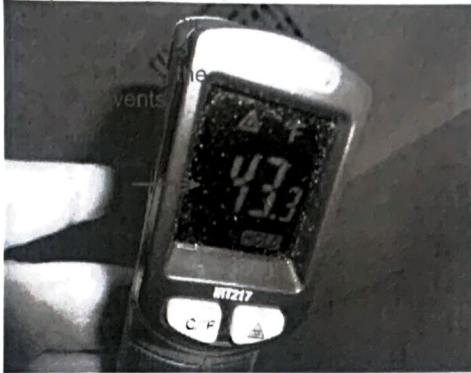
- The condenser was manufactured in 2012.
- Rust noted on coil - should be replaced soon.
- The exterior portion of the refrigerant line insulation is deteriorated - needs replacement.
- Exposed low voltage wiring noted on the exterior of the house - needs repair.
- A/C system appeared to be functioning as designed. Conditioned air exiting the supply air vents was 43 degrees vs an ambient air temperature of 70 degrees produces a differential of 23 degrees which is acceptable per industry standards.

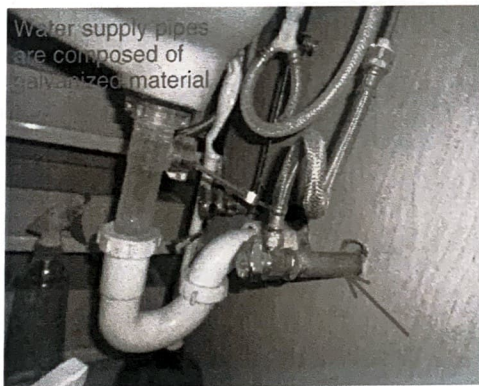
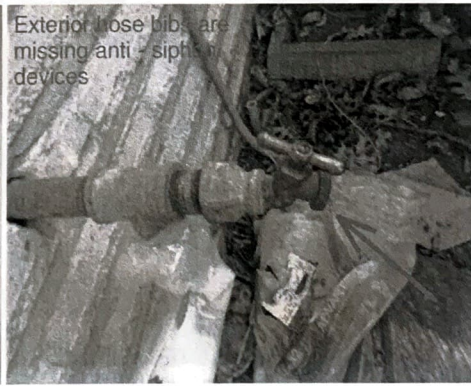
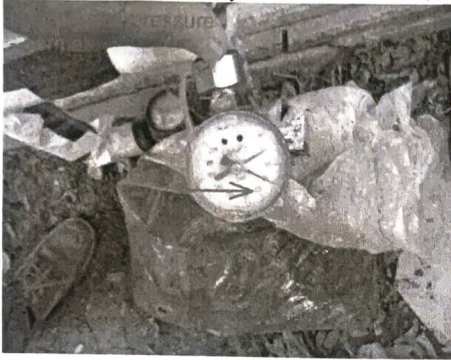
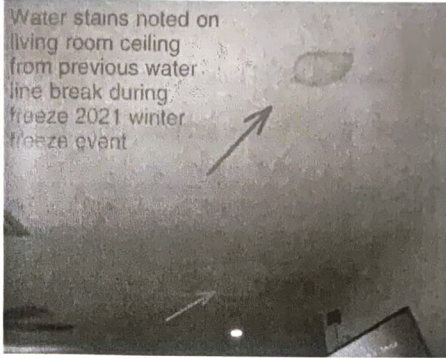
Comments: - Galvanized - Anti - siphon devices are missing on the exterior hose bibs. Anti - siphon devices are designed to prevent water exiting the hose bibs from entering the potable (domestic water supply) - needs replacement.

- Previous water supply pipe leak in living room was repaired in 2021.

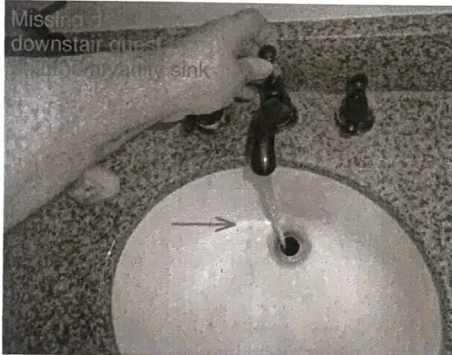
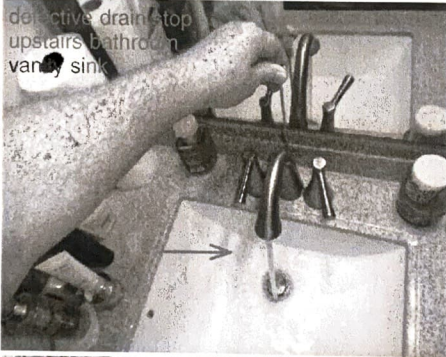
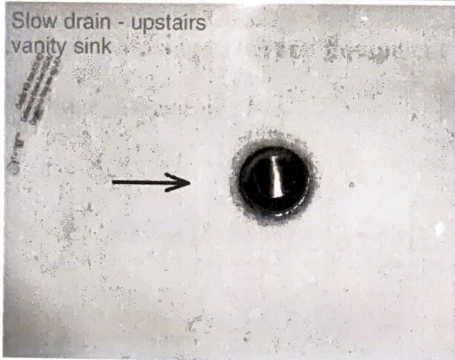
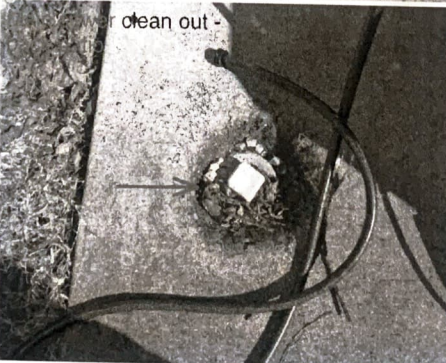
**B. Drains, Wastes, and Vents** - Comments: - PVC, - Defective/missing drain stops noted on various vanity sinks - see labeled photos - needs repair.

- Slow water drainage noted in upstairs vanity sink - needs to be cleared.

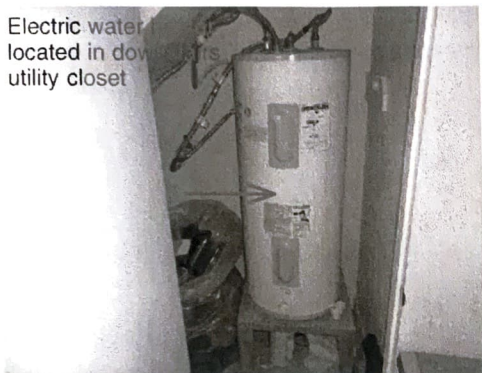
Electric water heater located in downstairs utility closet

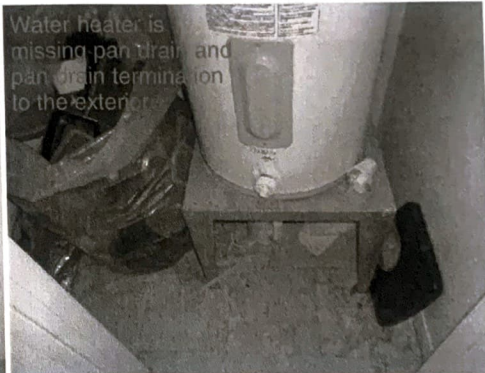
Water heater is missing pan drain and pan drain termination to the exterior

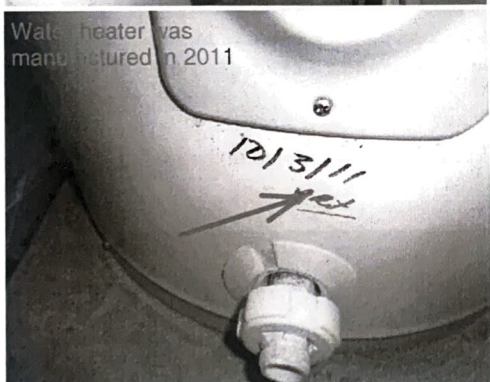
Water heater was manufactured in 2011

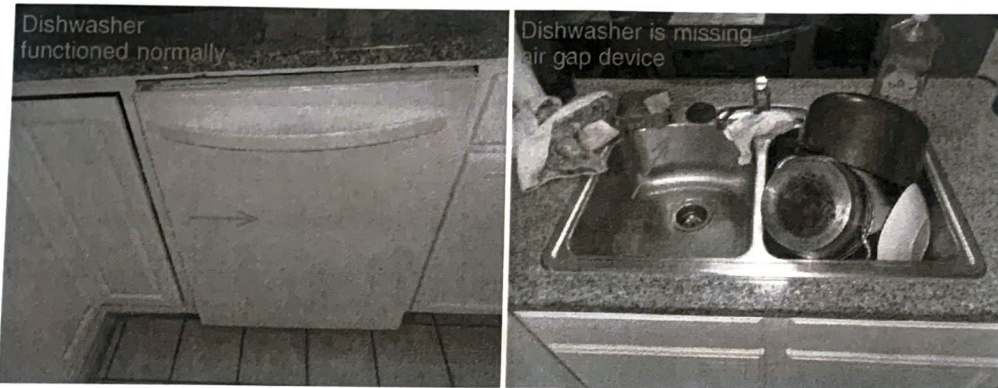
- Dishwasher is missing an air gap or high loop device to prevent cross contamination - Does not meet today's standard.

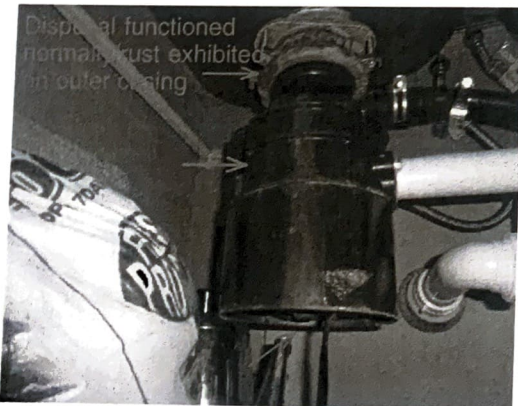
- Rust was exhibited on outer casing - will need to be replaced soon.

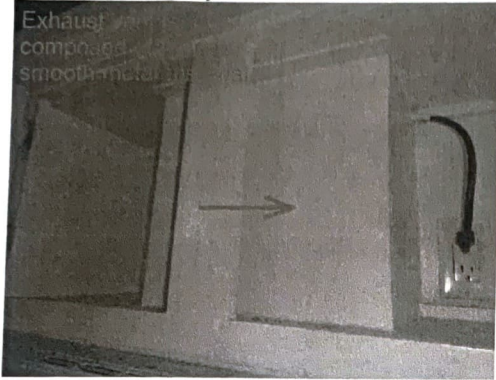
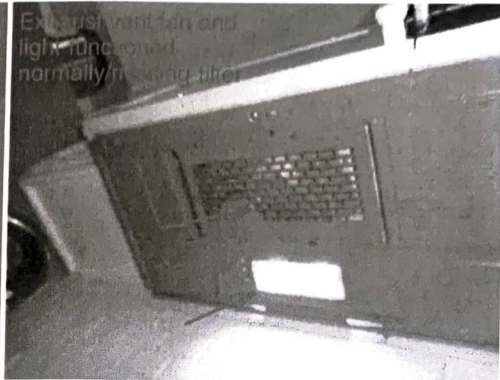
- Filter is missing/grease build up noted under vent.

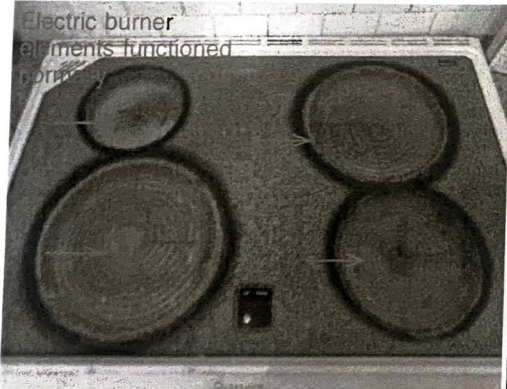
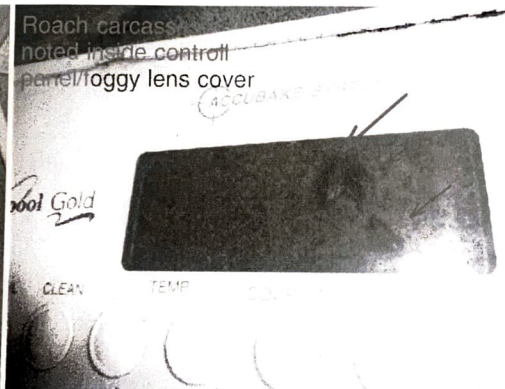
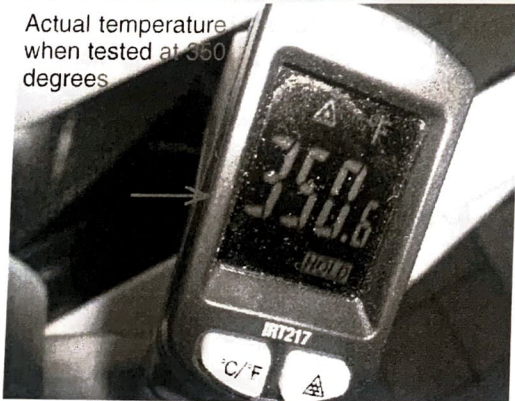
- Electric burner elements appeared to function properly at the time of the inspection.
- Digital lens cover is foggy. Dead roaches were noted inside the enclosure.

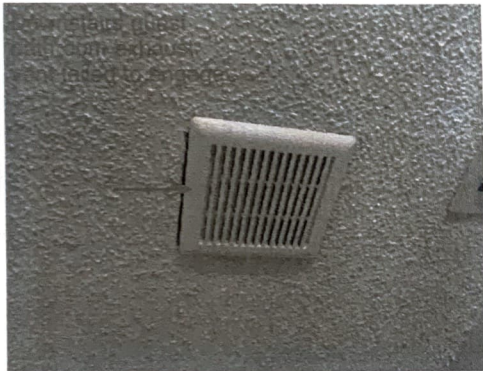
**F. Mechanical Exhaust Vents and Bathroom Heaters** - Comments: - N/A. - Exhaust fan in downstairs guest bathroom failed to engage - needs repair.

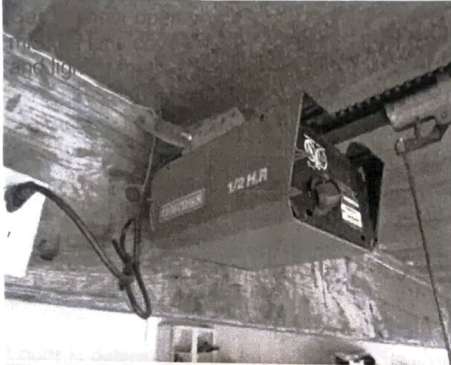
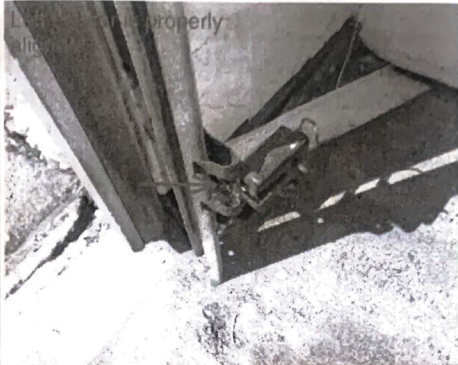
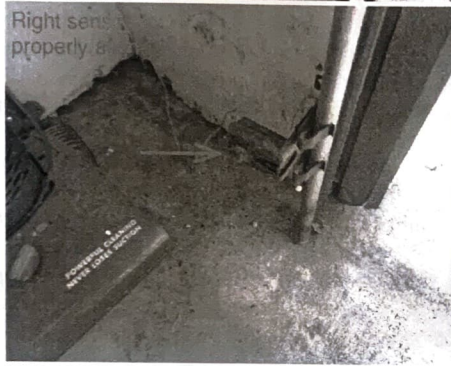
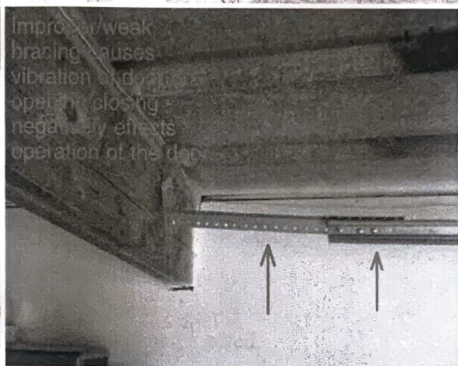
- Light lens cover and light bulb are missing.

- improper/missing bracing on left side rail causes the door to vibrate/bounce when opening and closing which effects operation - needs repair.
