13430 Greenbrier Dr
Montgomery, TX 77356

PROPERTY INSPECTION REPORT

Concerning: 13430 Greenbrier Dr, Montgomery, TX 77356
(Address or Other Identification of Inspected Property)

By: Chris Stull, Lic #20945 06/29/2020
(Name and License Number of Inspector) (Date)

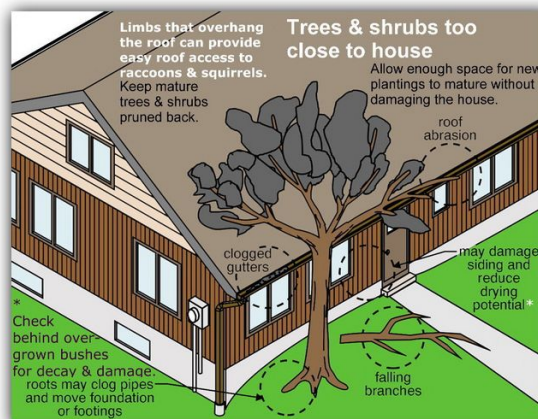
Recommend keeping vegetation cut back away from exterior of home to prevent damage.

Buyer's note; ensure flower bed soil does not rise above foundation to prevent water and wood destroying insect entry into house.

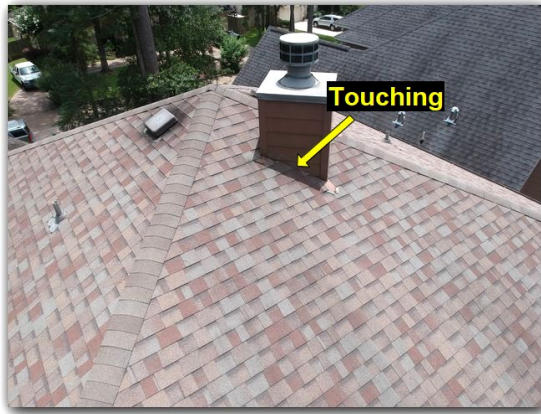
Observed siding touching shingles in one or more areas of roof. Common industry practice calls for at least a two inch separation from bottom edge of siding and roof surface. The two inch separation helps prevent moisture from being trapped which can cause deterioration. This is most important when the siding is made of stucco or wood. The siding on this home is cement fiber board (Hardi Plank) which is difficult to deteriorate.

Recommend clearing pine needles and other debris off roof surface to allow proper drainage.

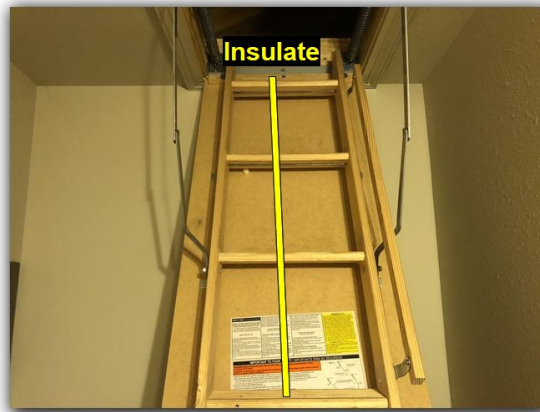
For optimum energy efficiency, I recommend insulating the pull down attic access.

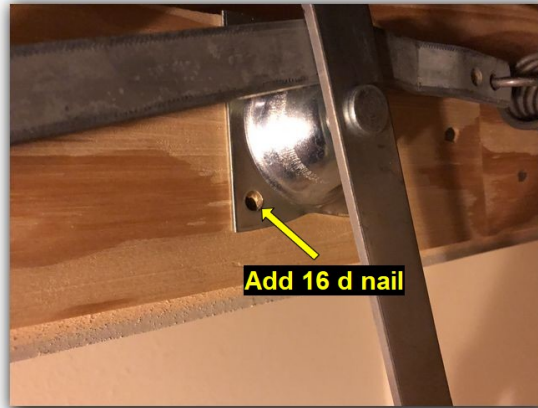
Observed one or more nails/screws missing from attic access ladder frame. Recommend installing a 16d nail or 1/4 inch diameter lag screw to properly secure stairway frame to ceiling.

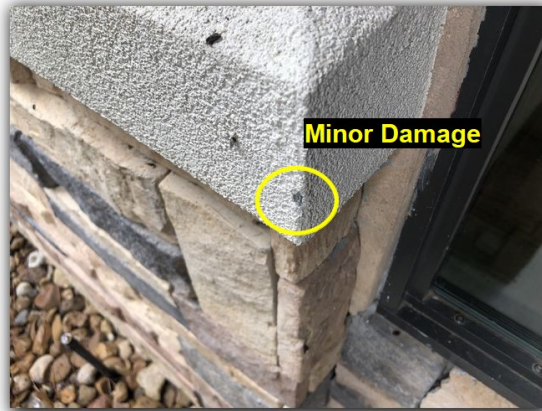
Minor damage observed to siding.

Recommend sealing/caulking around all holes, gaps, cracks and exterior siding penetrations to prevent water entry.

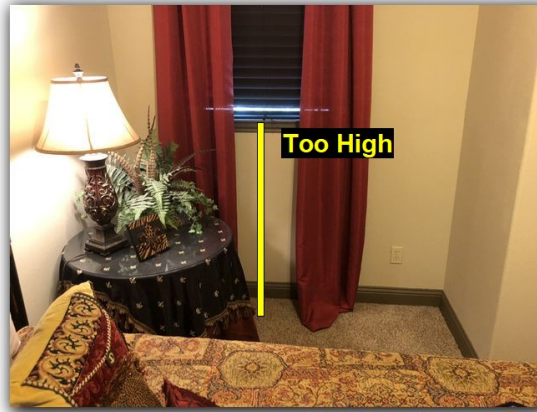
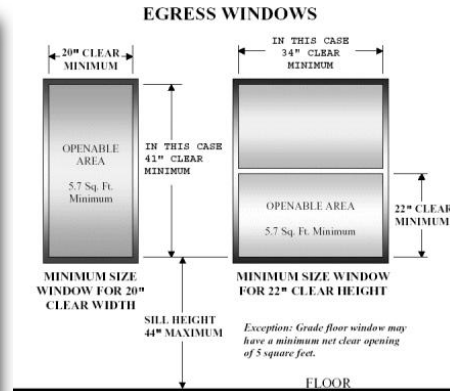
Observed several windows on the second story that were too high from the floor. Current standards call for windows to not be higher than 44 inches in bedrooms. This is to allow easy escape during a fire (egress). Recommend adding furniture under windows to allow easy escape.

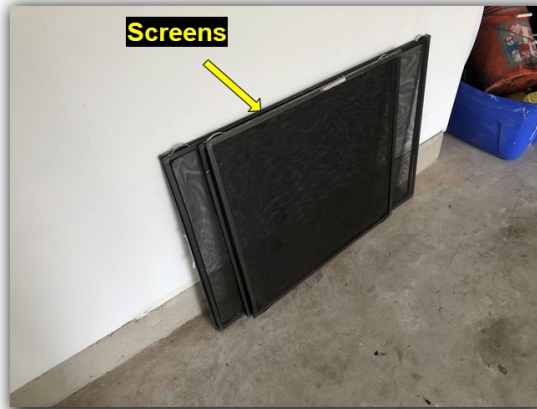
Observed screens missing from several windows. Note: I did observe screens in the garage.

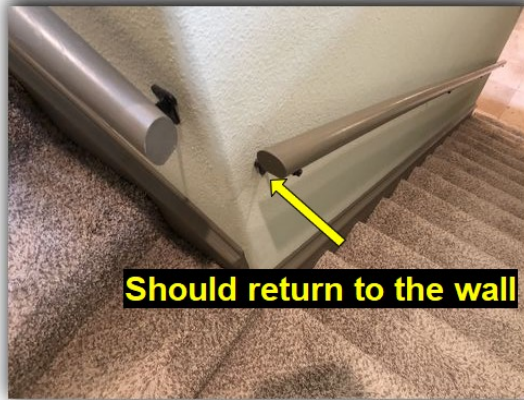
Observed the handrails did not terminate into the wall as required by current standards. This is considered a tripping hazard as someone's purse or article of clothing could catch on the rail's end causing them to fall.

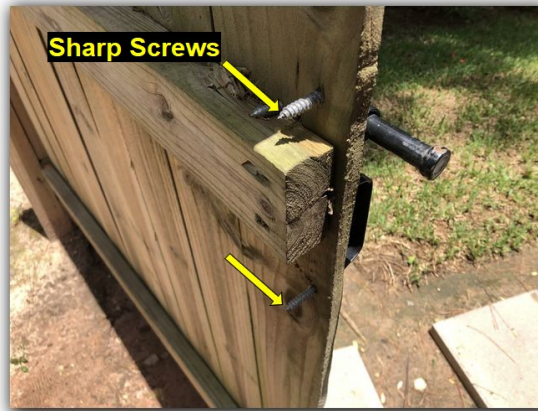
Recommend adding caps to the sharp metal screws on the gate to prevent injury.

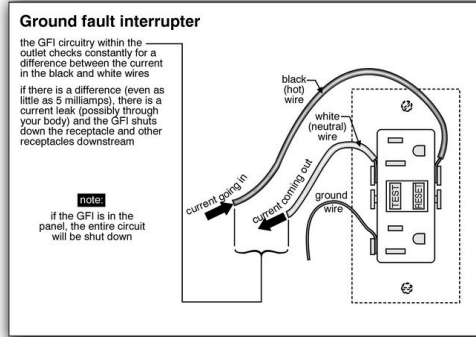
Did not observe GFCI protection for all outlets in the laundry room or at the backyard exterior patio. Current standards call for all laundry room and exterior outlets to have GFCI protection.

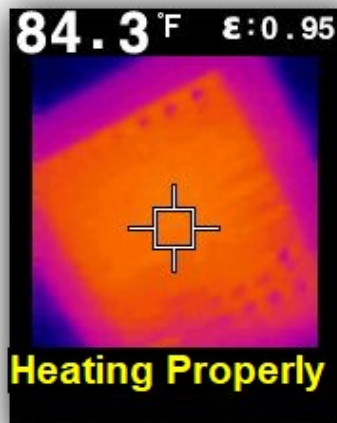
A thermal image of the air vents show the furnace(s) was / were heating properly at time of inspection.

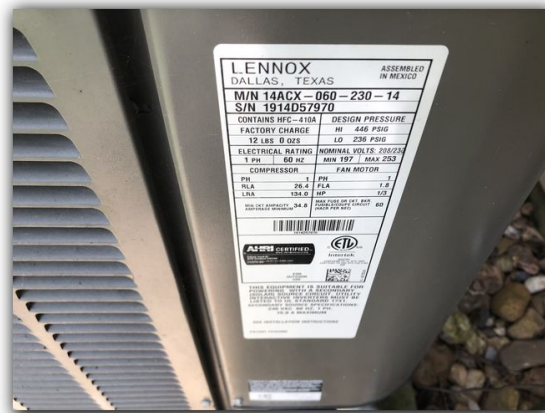
CONDENSING UNIT(S): Lennox 2014

No significant deficiencies or anomalies observed.

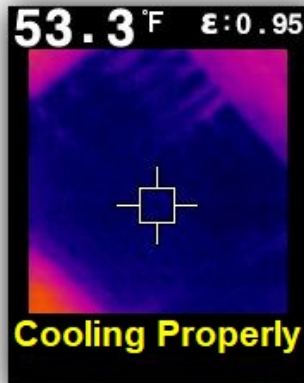
A thermal image of the air vents show the air conditioning unit was cooling properly at time of inspection.

TEMPERATURE DIFFERENTIAL: 19 degrees (72, 53) **GOOD**

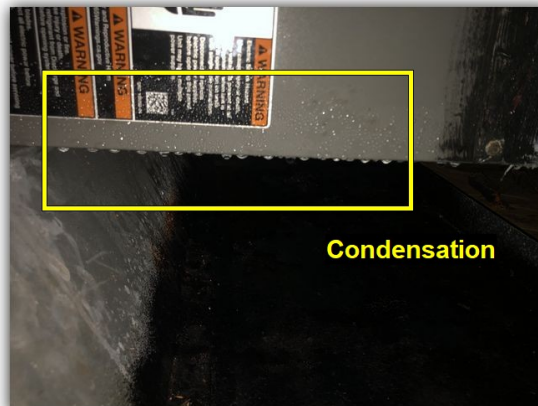
Observed excessive condensation forming on the unit in the attic. The condensation was dripping onto the attic floor. The attic may need additional ventilation such as a thermostatic attic fan, but I recommend consulting an HVAC technician on ways to prevent condensation from forming.

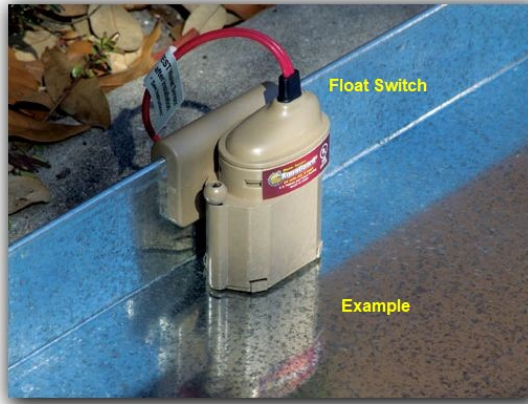
Did not observe a float switch installed for the A.C. drain pan. Although not required, I recommend adding a float switch to help prevent accidental flooding of the attic if a leak occurs.

Recommend installing Safe-T-Switches on all condensate drain lines. This is not required, but highly recommended to help prevent flooding if the condensate drain line becomes clogged.

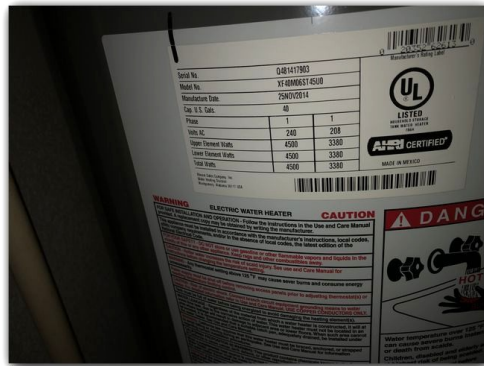
WATER HEATING UNIT(S): Rheem 2014

No significant deficiencies or anomalies observed.
