# *514 Inspections*

22 Artist Grove, Spring , TX 77382

Date of Inspection: 12/11/2021 Time: 8:30 AM Size: 0

## PROPERTY INSPECTION REPORT

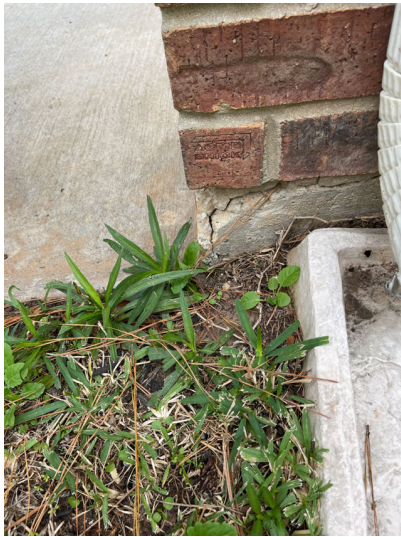
*Cosmetic corner pop*

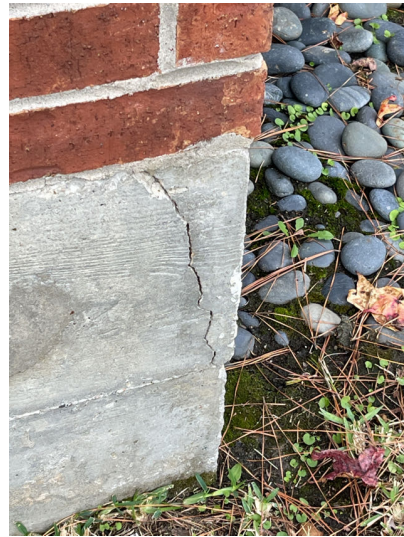
*Cosmetic corner crack at rear*

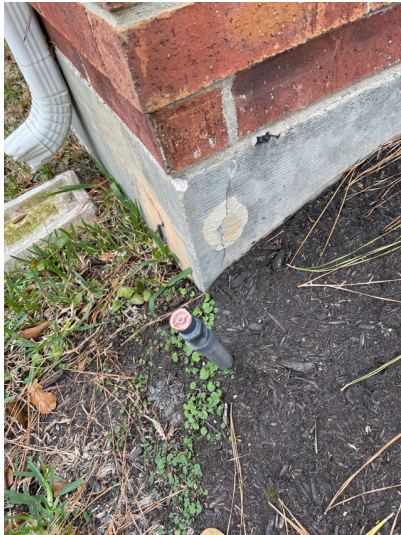
*Cosmetic crack at front left corner*

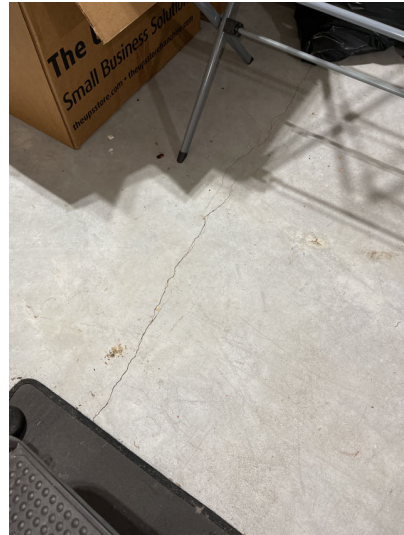
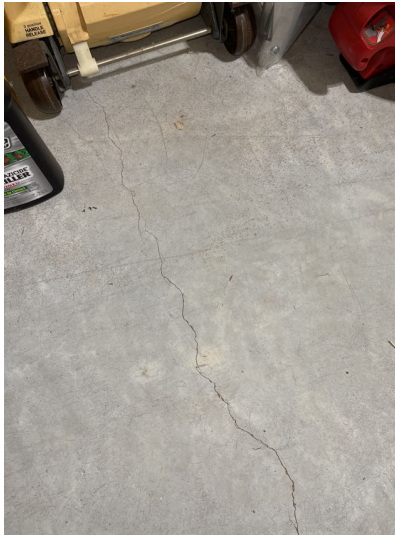
*Normal shrinkage cracks in garage*

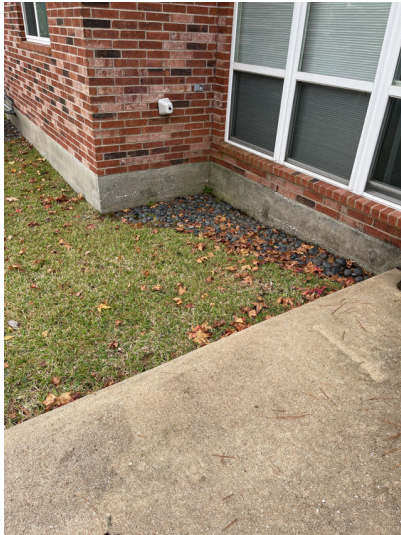
*Improper slope at rear - both sides of patio*

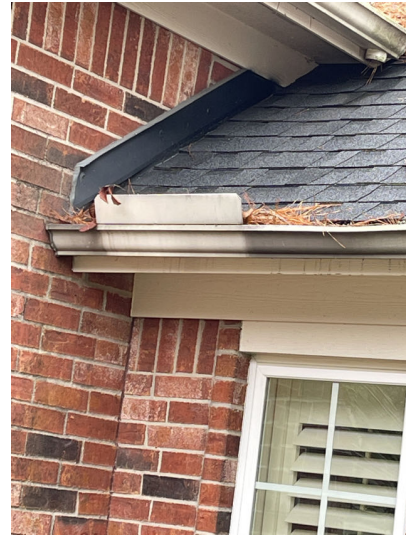
*Gutters full*

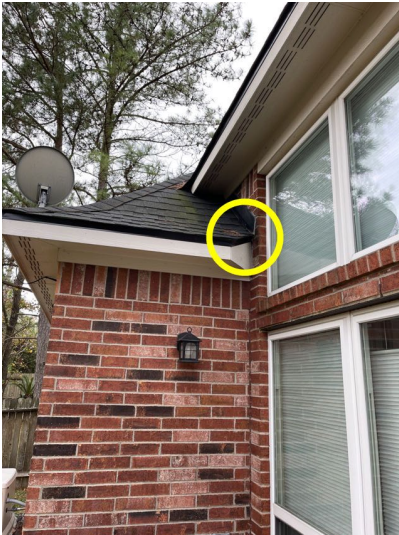
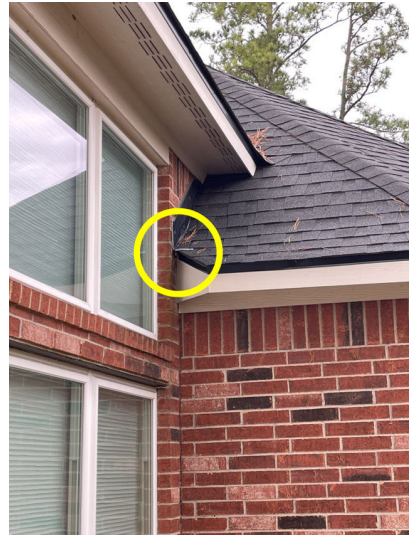
*Kick out flashing needed at rear*

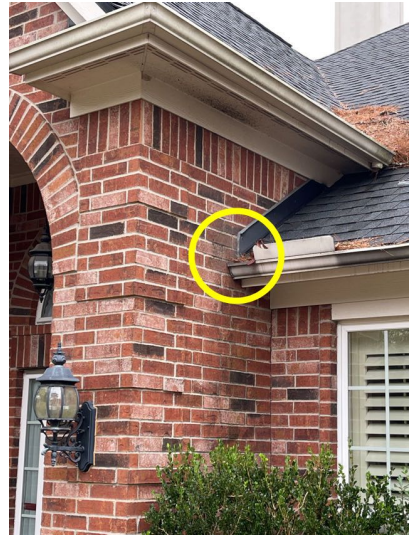
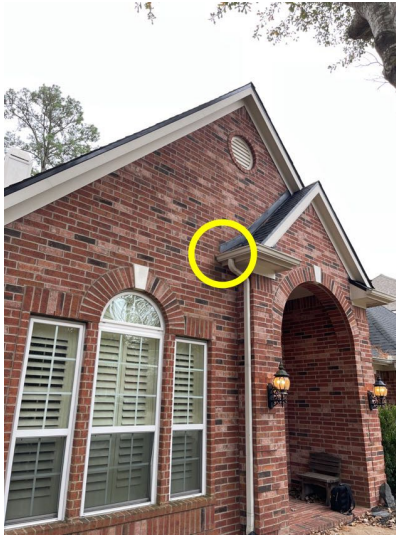
*Kick out flashing needed at front*

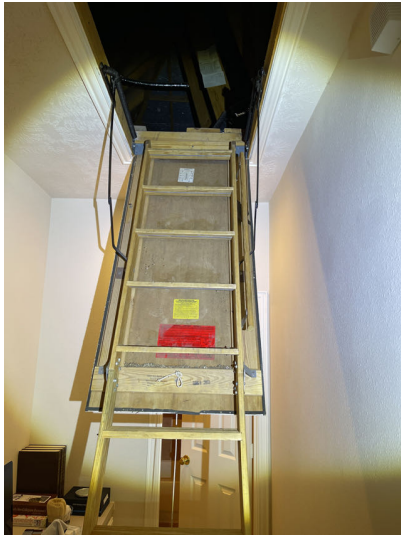
*Attic ladder not insulated*

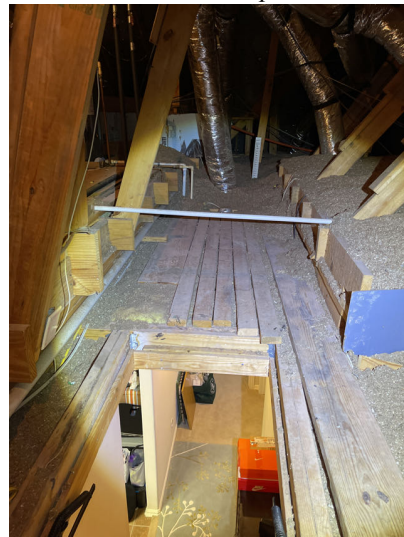
*Pipe in walkway not protected*

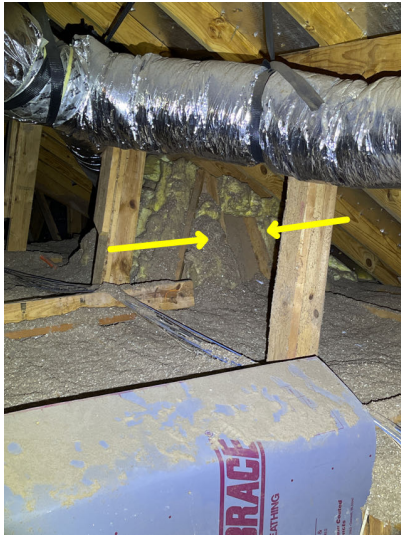
*Missing insulation at left skylight wall*

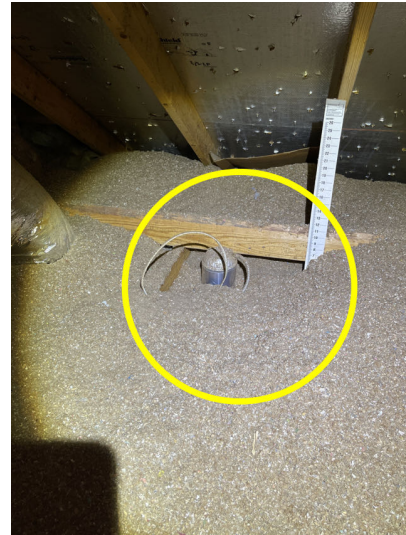
*Low insulation around right side sunroom ceiling*

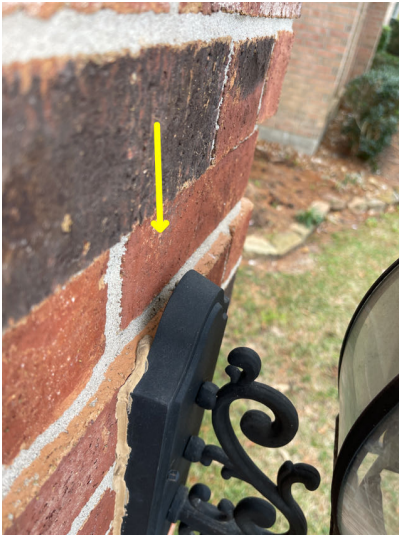
*Sealant needed at exterior lights*

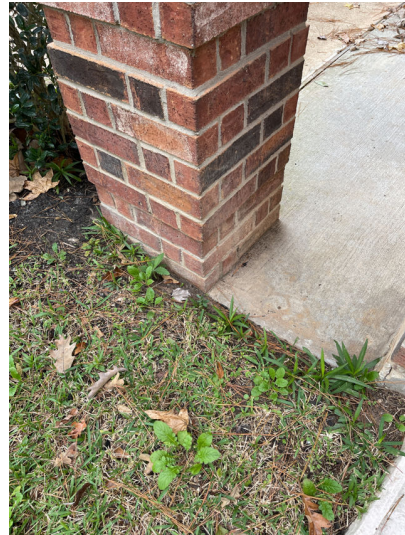
- There were weep holes missing in the brick column near the garage. Weep holes aid in the escape of moisture and condensation that build up behind the brick. New holes can be drilled as a simple repair

*No weep holes at column*

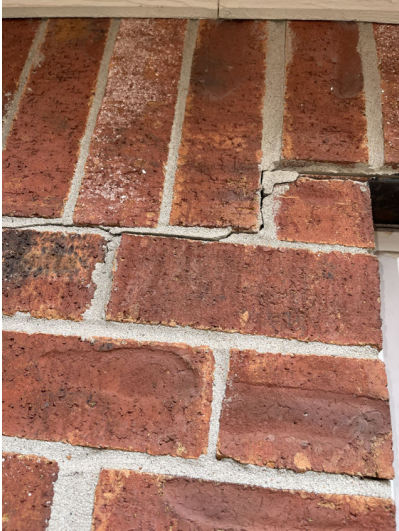
*Loose mortar at right side window*

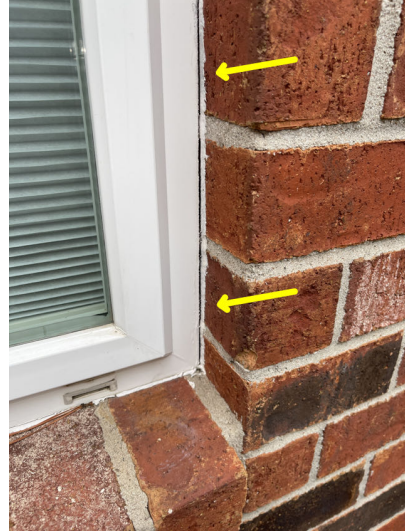
*Additional sealant needed at all windows*

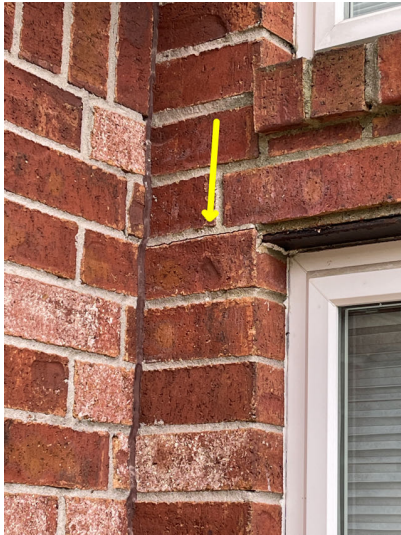
*Minor mortar crack at rear window*

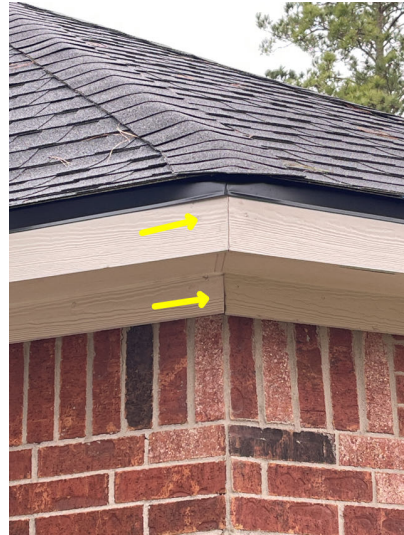
*Sealant needed at siding joints - multiple locations*

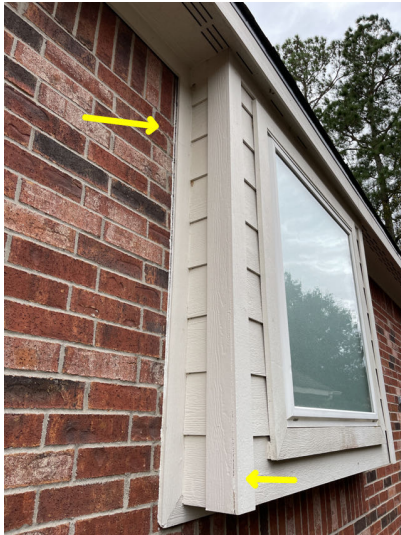
*Sealant needed at left side window trim*

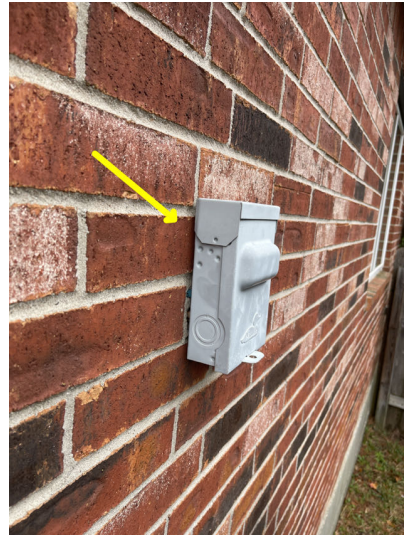
*Sealant needed at left side disconnect box*

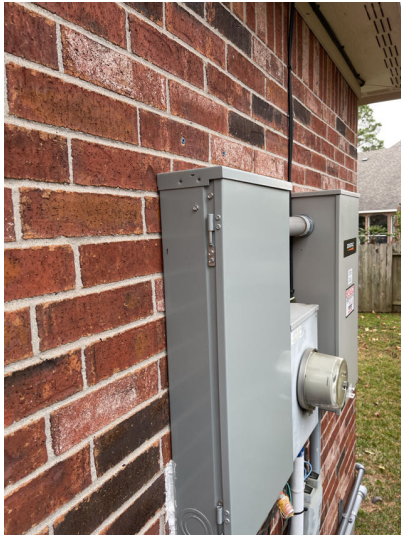
*Sealant needed around right side electrical boxes*

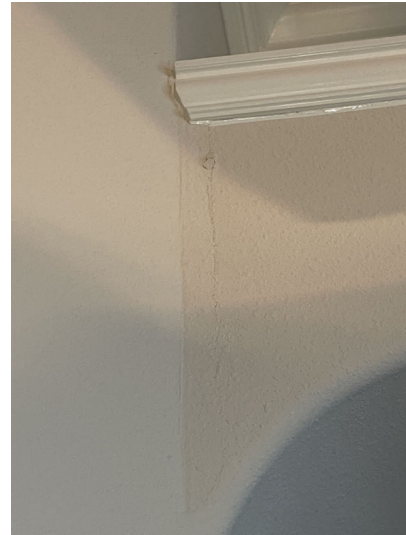
*Cosmetic drywall tape joint at living room*

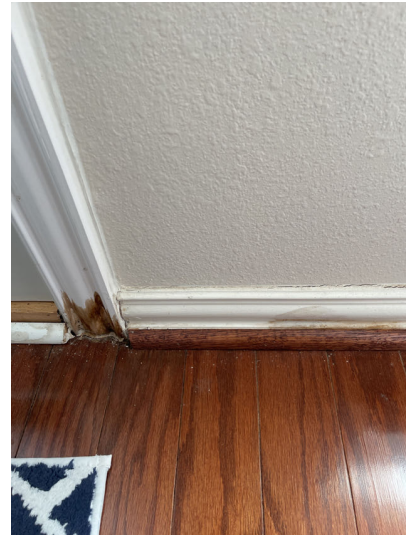
- Water damage was noted at the interior side of the back door. A moisture meter was used, and readings were acceptable

*Minor water damage noted*

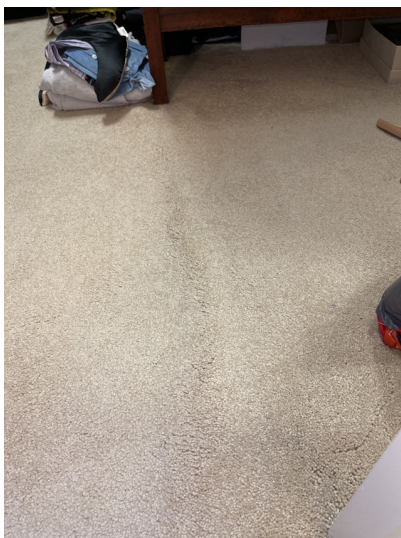
Loose carpet at master closet

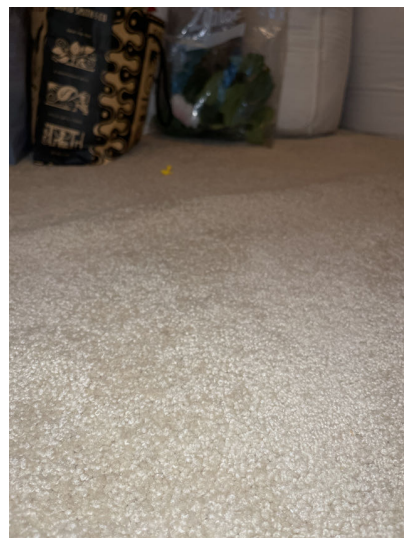
Loose carpet at rear right bedroom closet

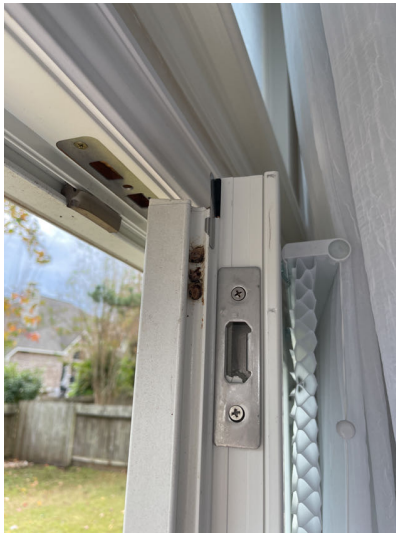
- One master bath door did not latch at the top
- The passenger door leading to the home from the garage was not self-closing as required
- **The rear door did not have flush bolts installed at the top or bottom. These doors were unable to be secured**

*Flush bolts not installed*

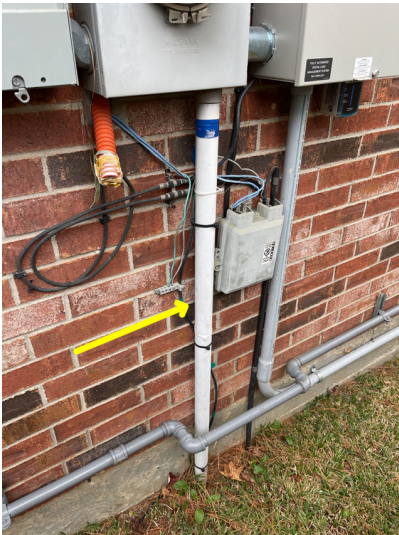
*Support bracket needed*

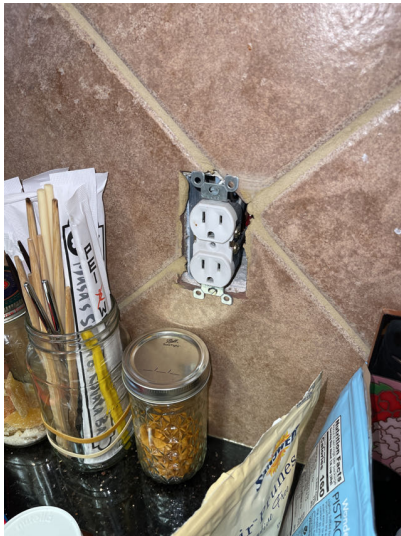
*No box extenders at backsplash*

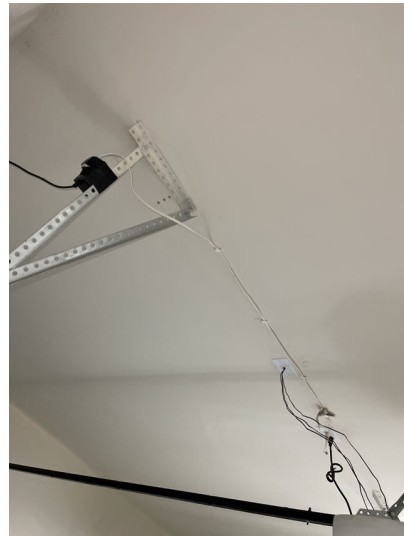
*Extension cord permanently in use in garage for irrigation system*

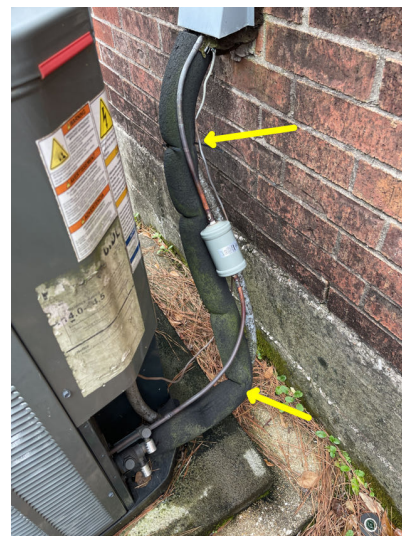
Insulation not sleeved

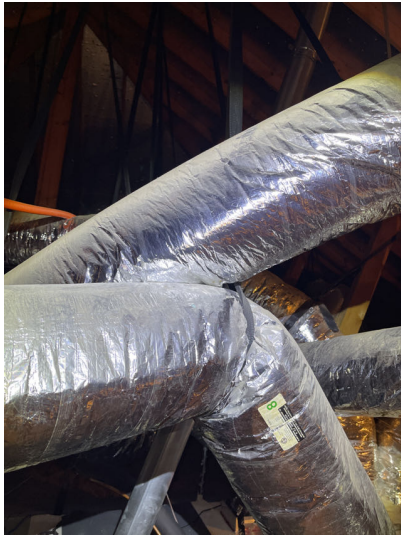
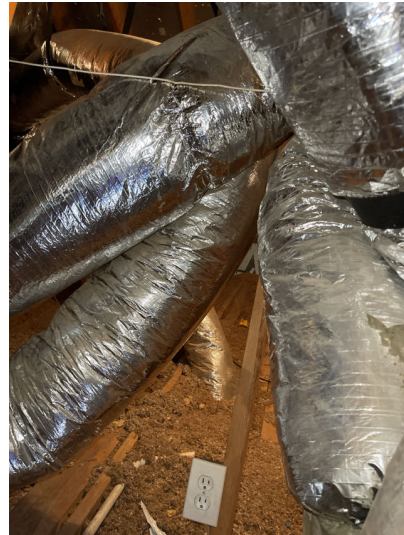
*Ducts in contact*

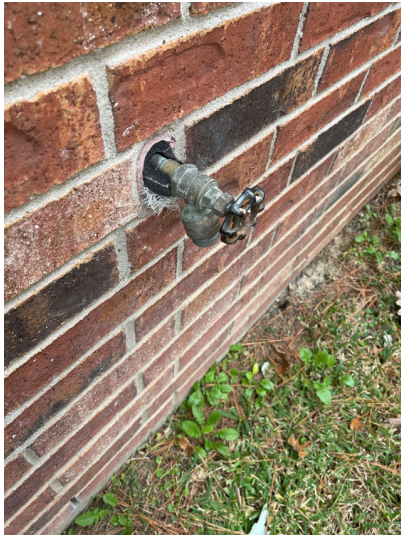
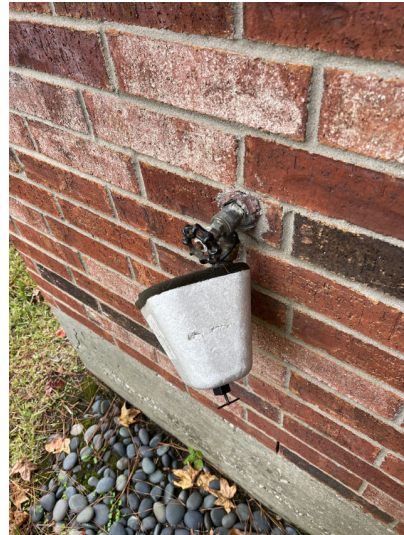
*Insulation needed*

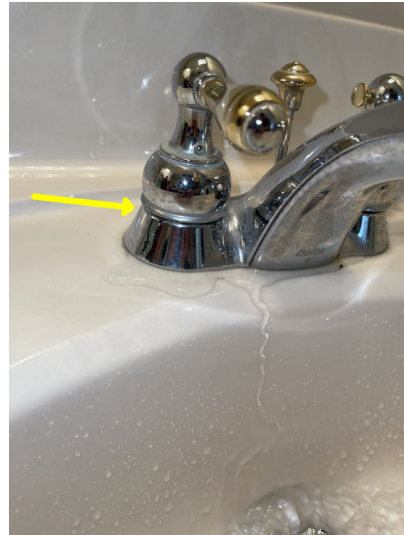
*Hot water valve leaked - right master vanity*

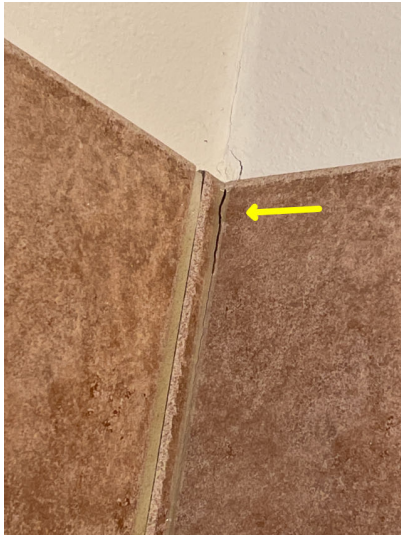
*Grout/sealant needed at top corner of master shower*

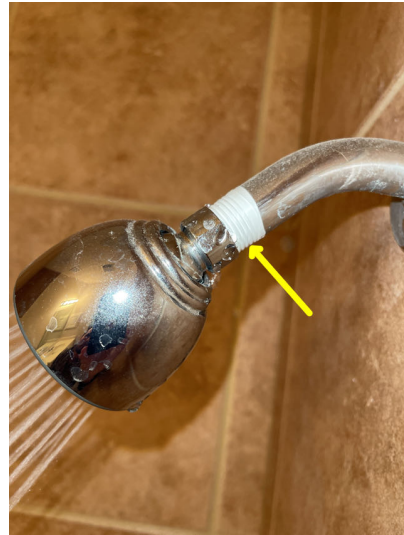
- The shower head at the right side hall bath had a slow leak while operating

*Slow leak at right hall bath shower head*

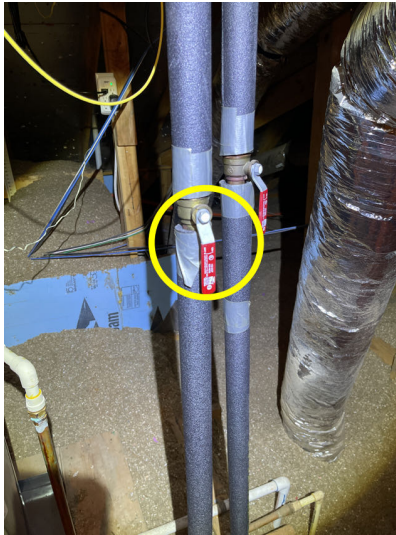
- The water heater and its components were found to be performing and in satisfactory condition at the time of the inspection
- There was a shut off valve on the hot water supply. This should be removed or disabled

Valve on hot supply

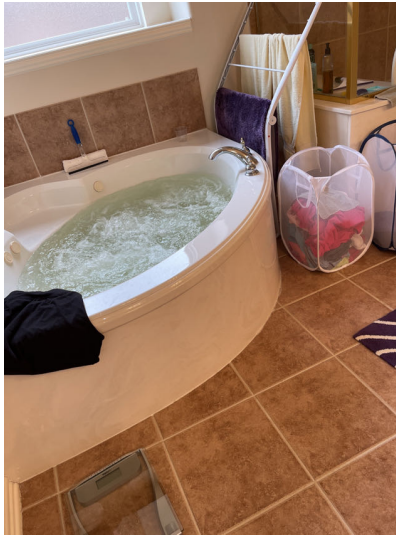
*No access panel to view motor*

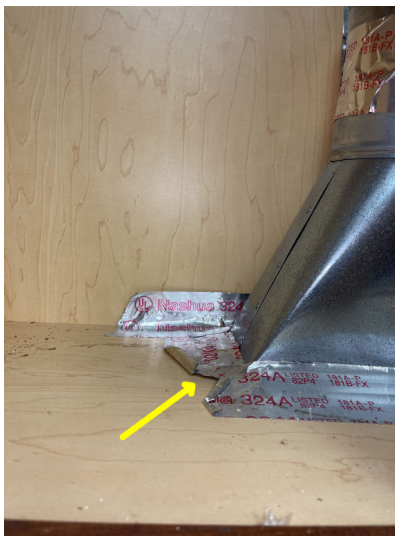
*Minor air loss*

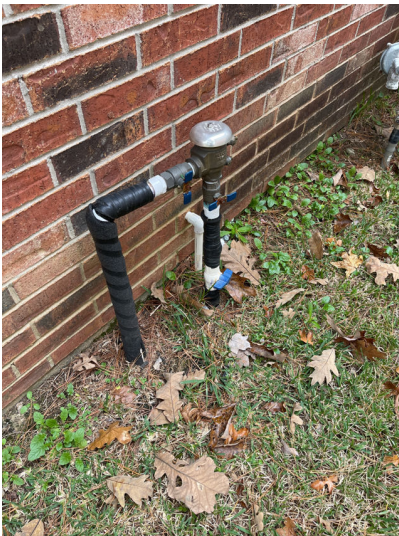
- The system backflow preventer is not anchored in place and was not fully insulated
- The sprinkler system was not inspected due as the main irrigation water supply was turned off and all pipes were drained

*Not anchored in place, not fully insulated*
