## Property Inspection Report

**12642 Ashford Meadow Drive - Houston TX 77082**

**Date of Inspection: 8/4/2021 Time: 4:00PM**

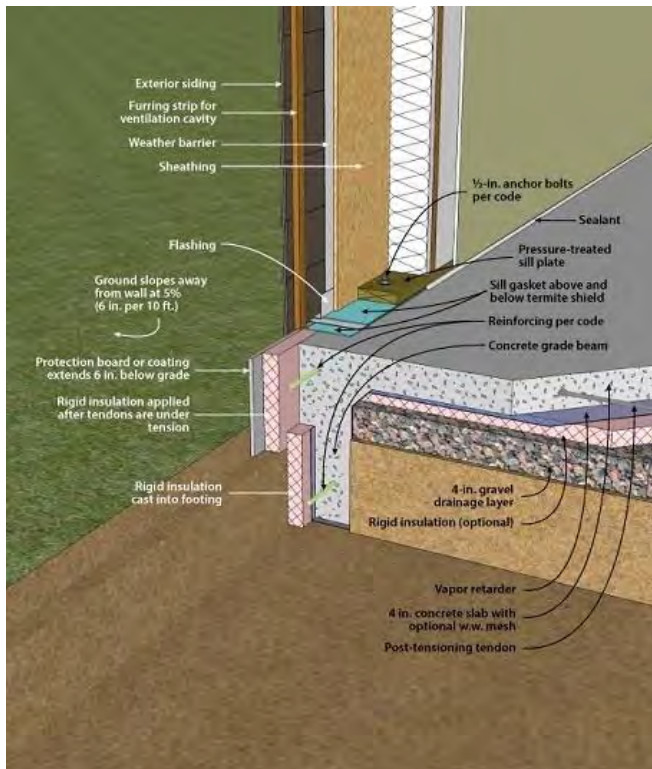
Structural movement and/or settling noted; however, the foundation is supporting the structure at this time.

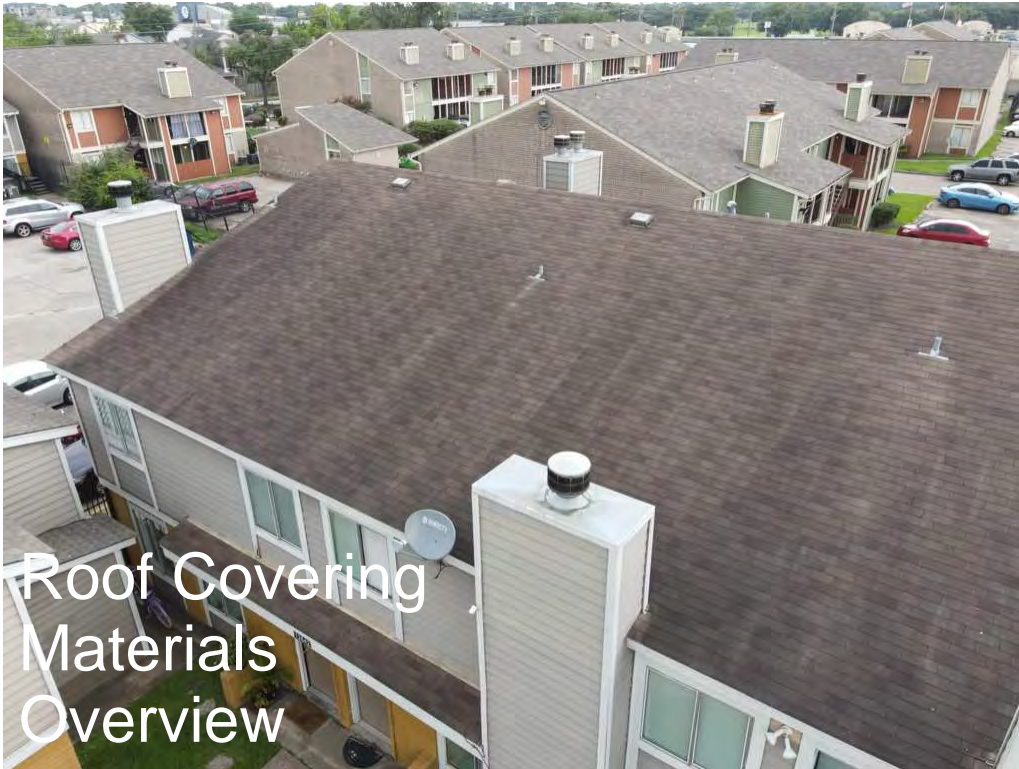
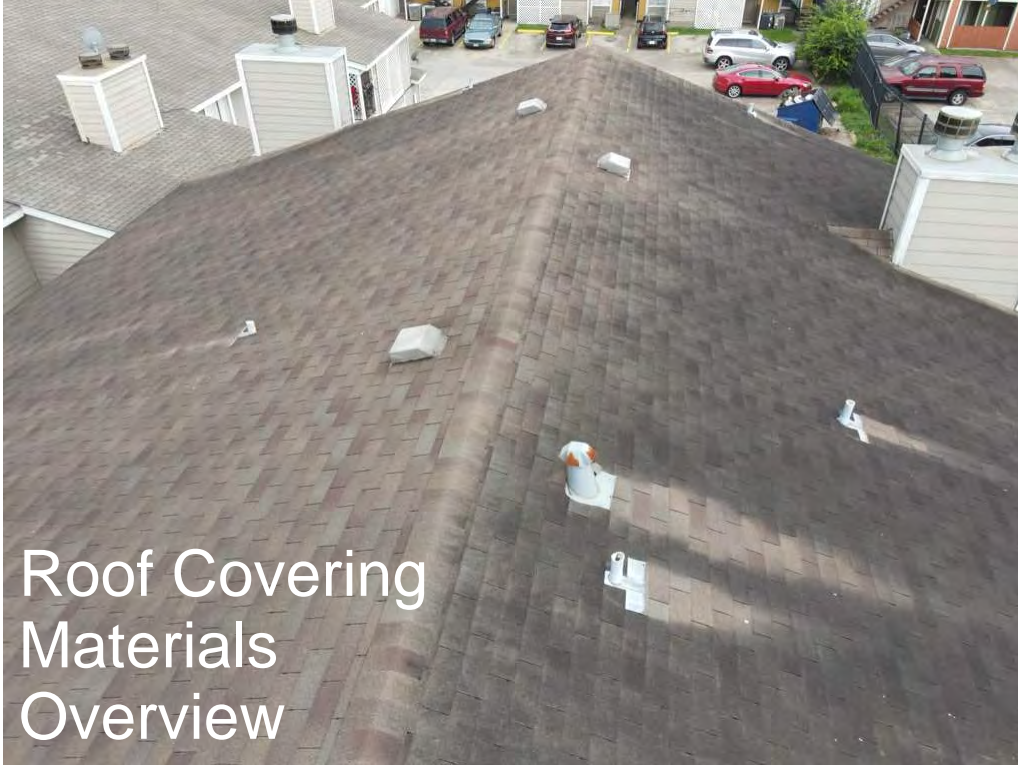
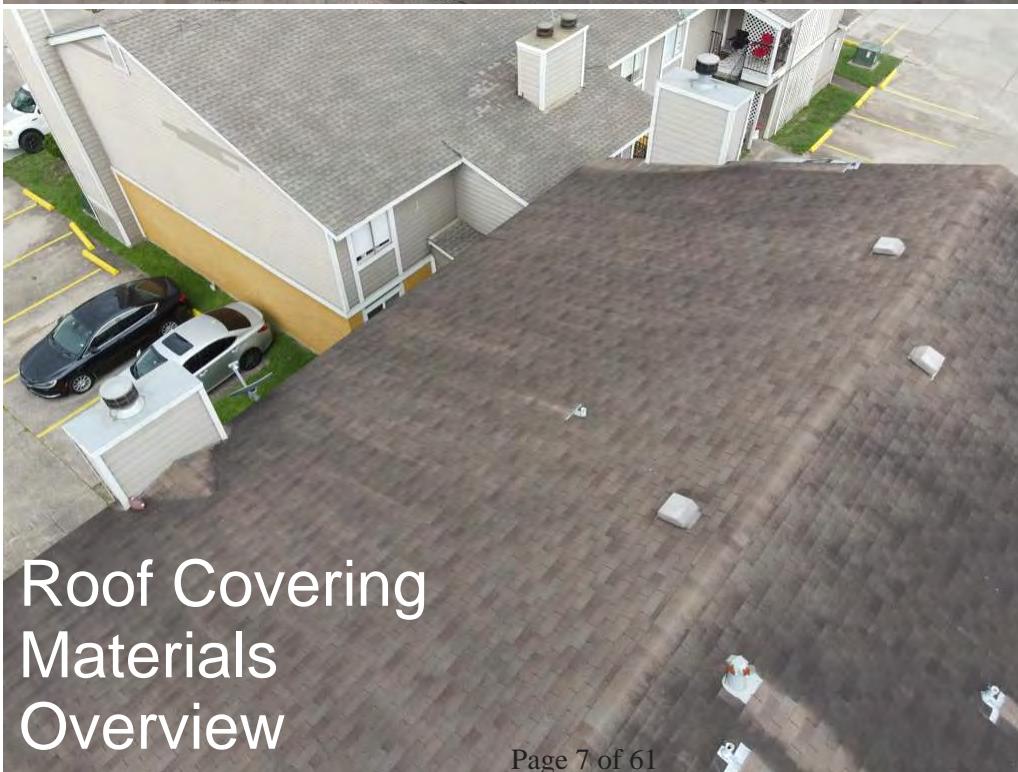
Shingle / flashing uplift observed (Insufficient chimney flashing observed).

Shingle / flashing uplift (insufficiency) can possibly result in moisture penetration at roof.

Correction recommended by qualified contractor.

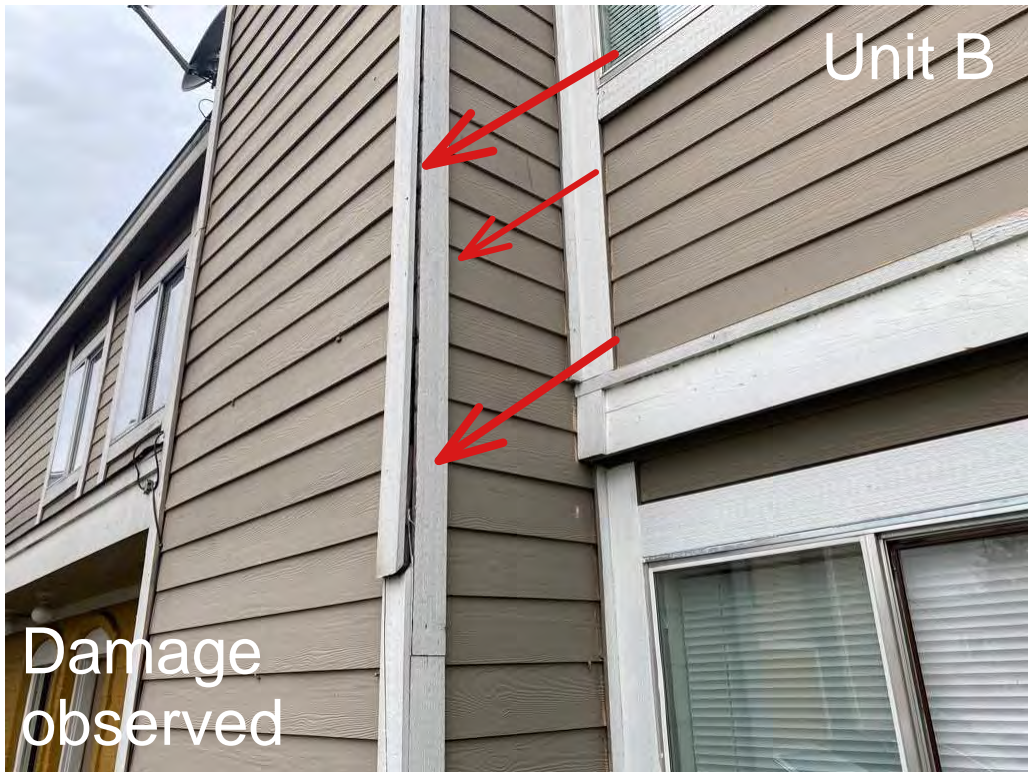
Damaged wall covering (exterior) observed wood rot observed.

Correction recommended to minimize possibility of moisture / pest intrusion.

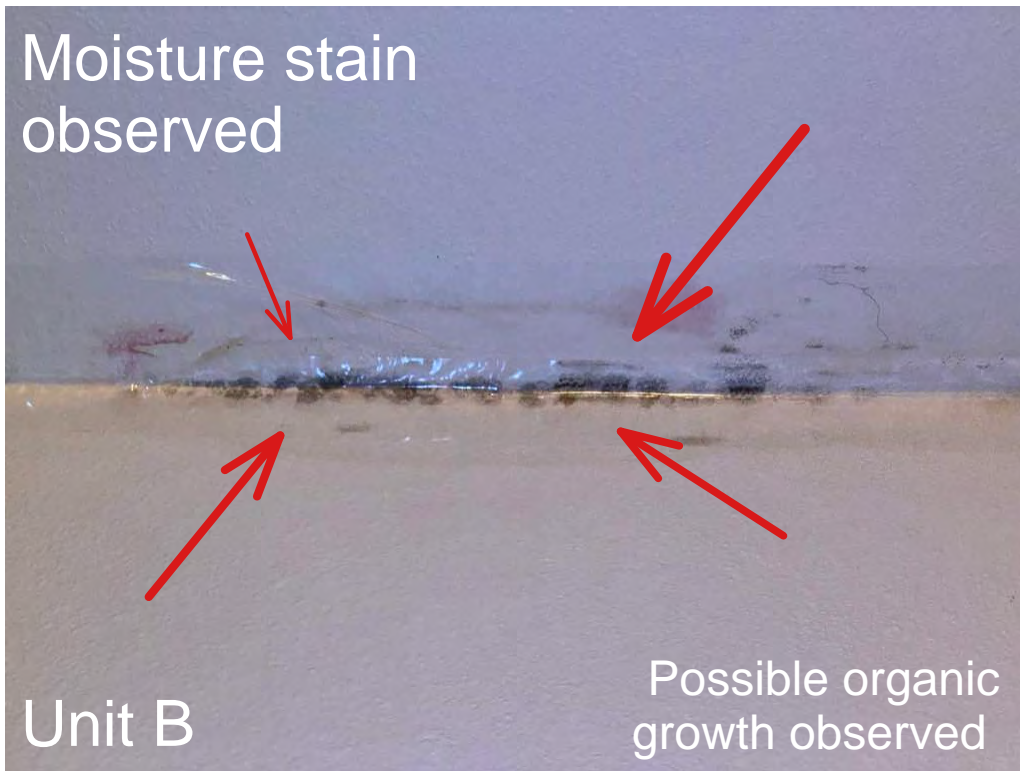
Damage at ceiling observed (water stains observed).  
Possible organic growth observed (Unit B).

All damage should be corrected / repaired to prevent further deterioration.

Correction recommended by qualified contractor.

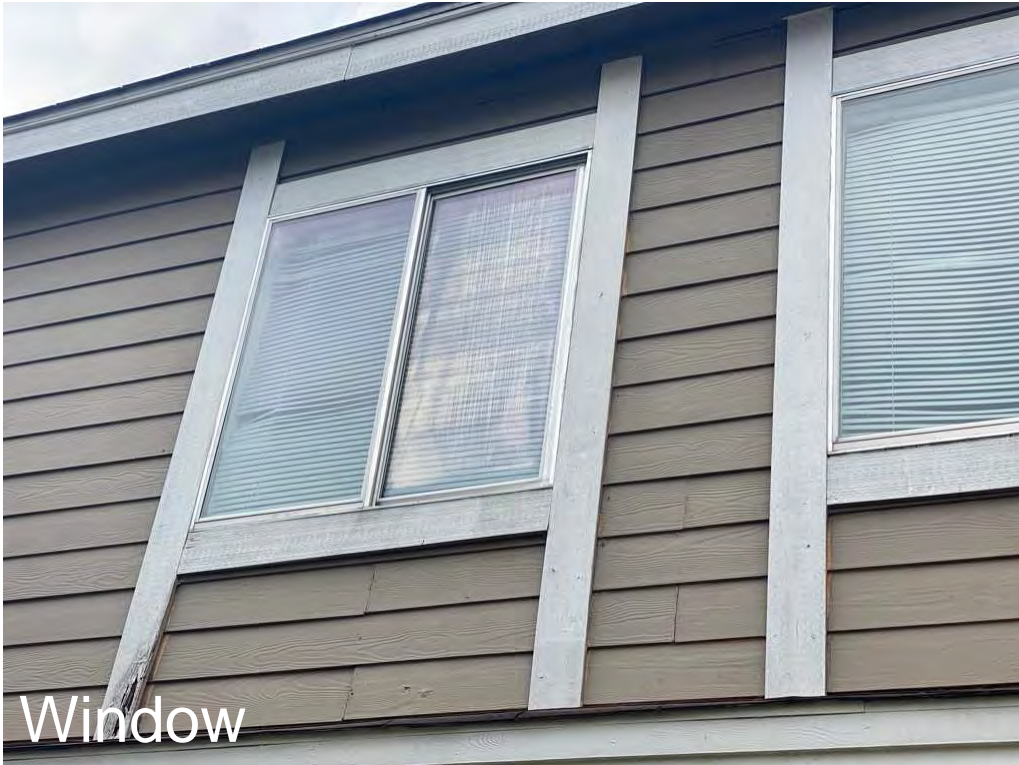
Observed windows with fogging between the layers of glass (multiple units).

Further evaluation and correction recommended by qualified contractor.

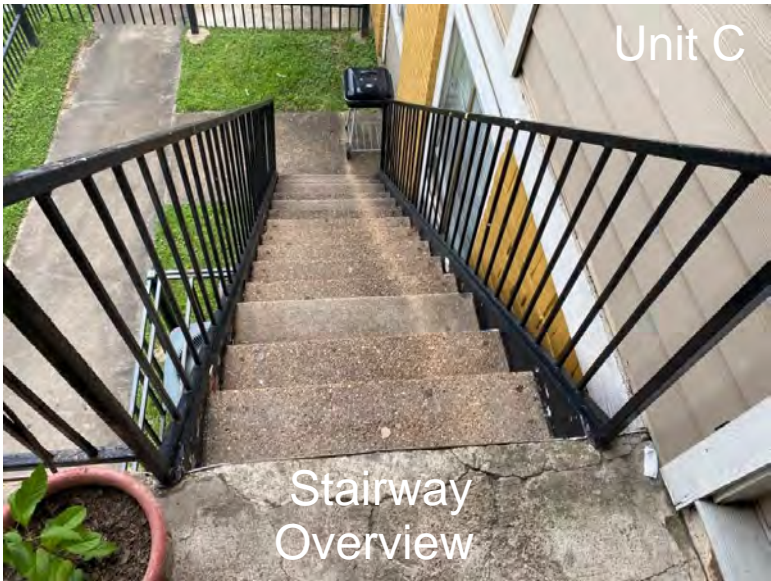
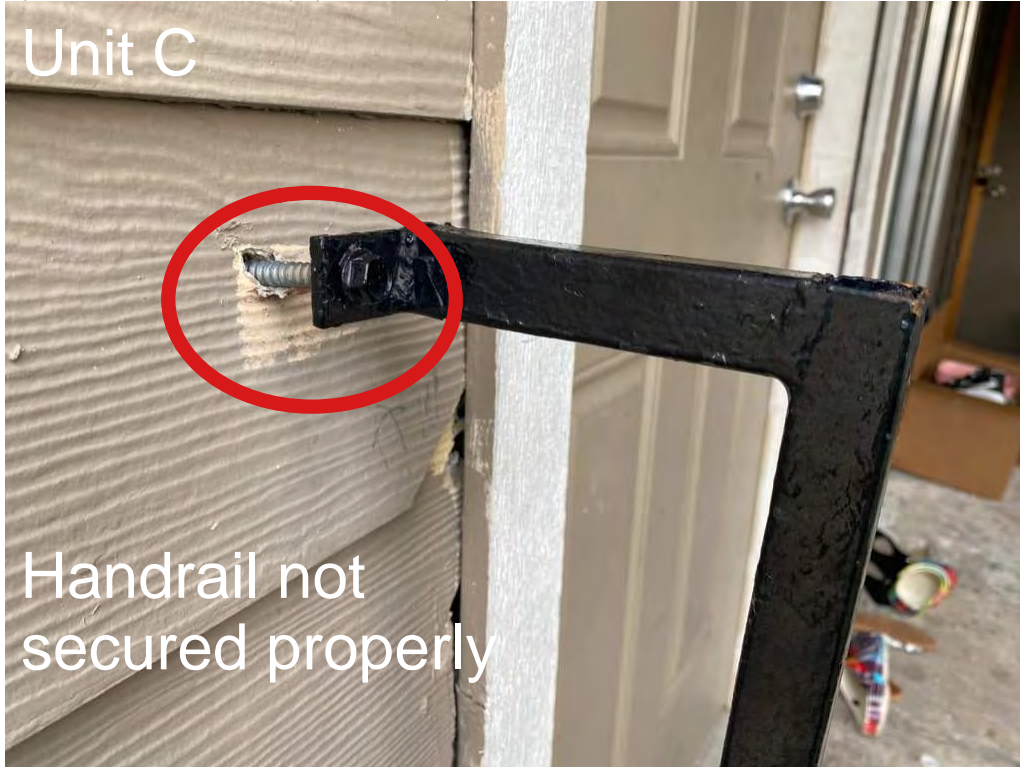
Stair handrail not secured properly (Unit C).

Correction recommended by qualified contractor.

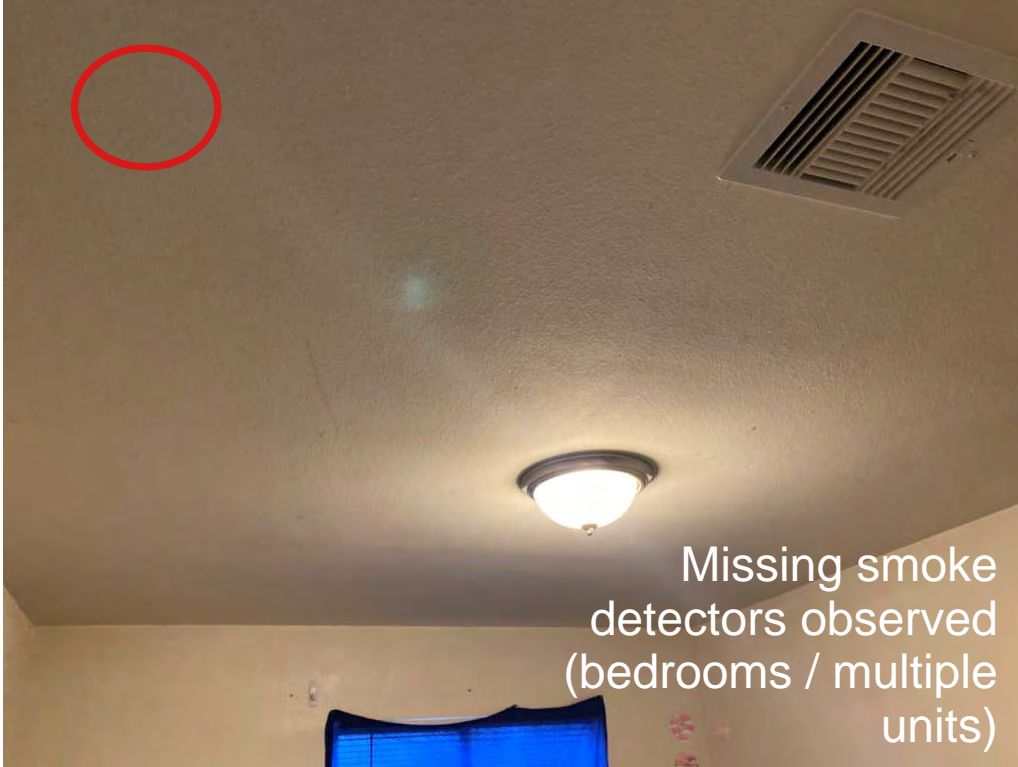
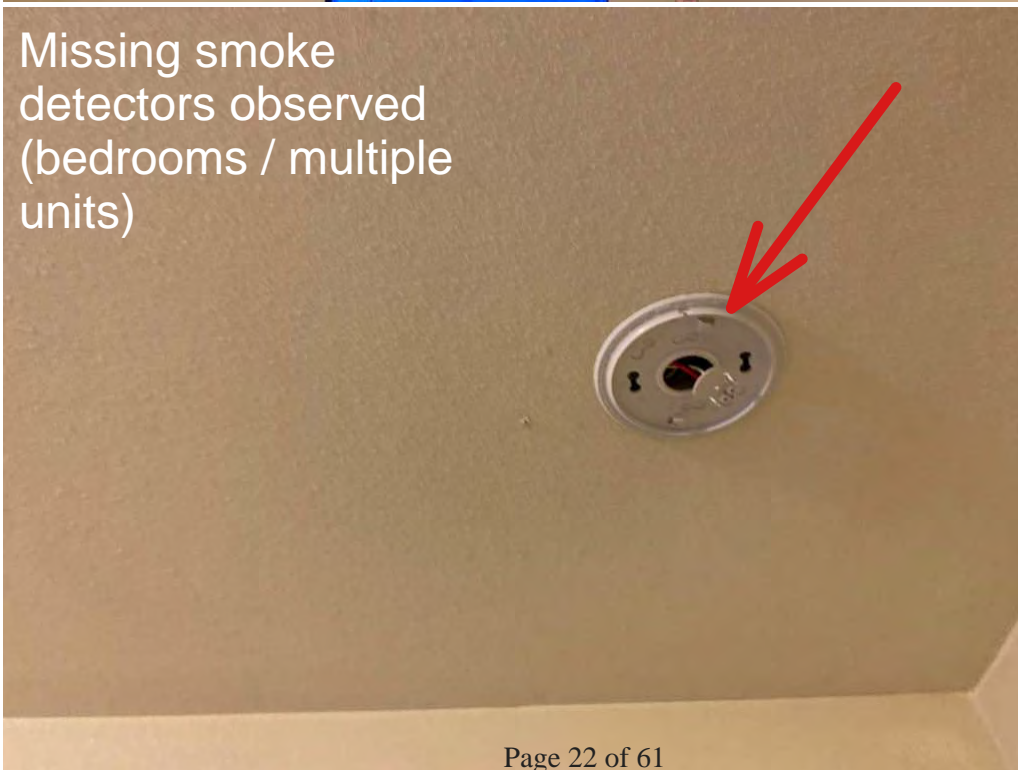
Missing smoke detector observed in (at least one) bedroom.

Correction recommended by qualified contractor to ensure proper safety.

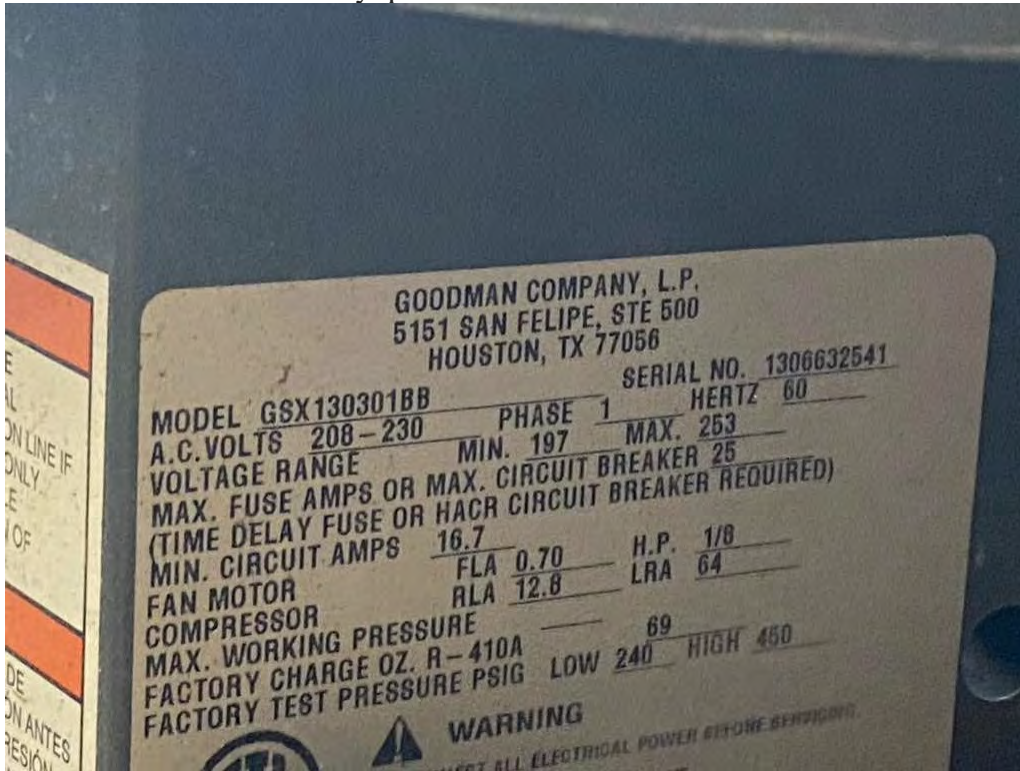
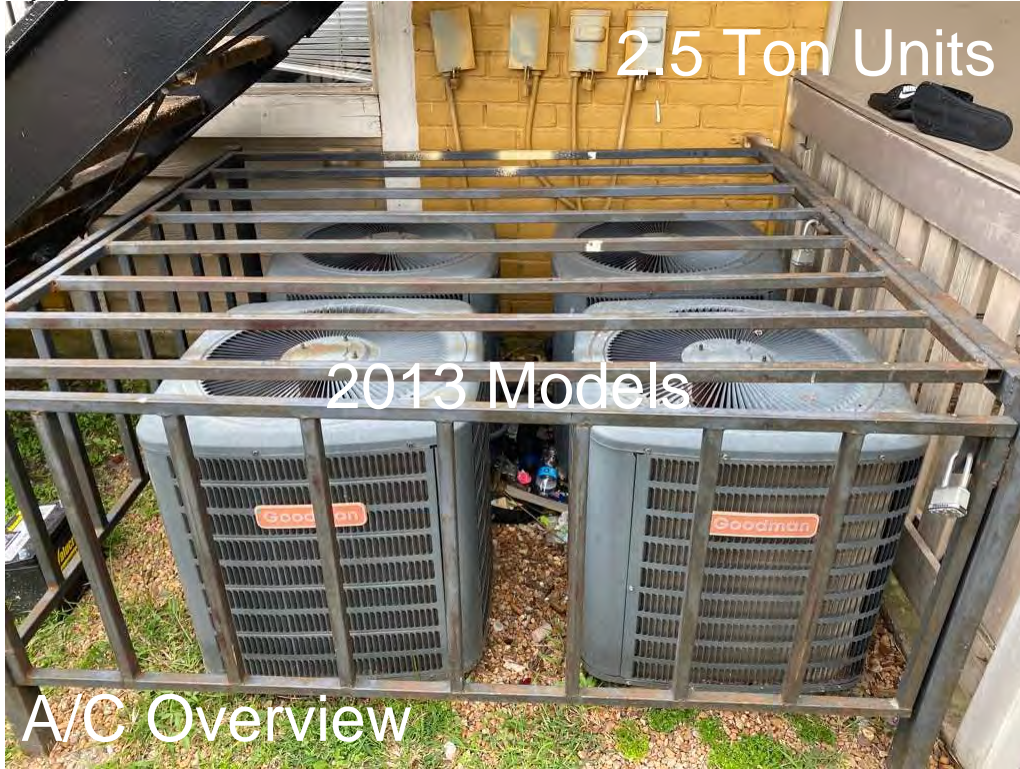
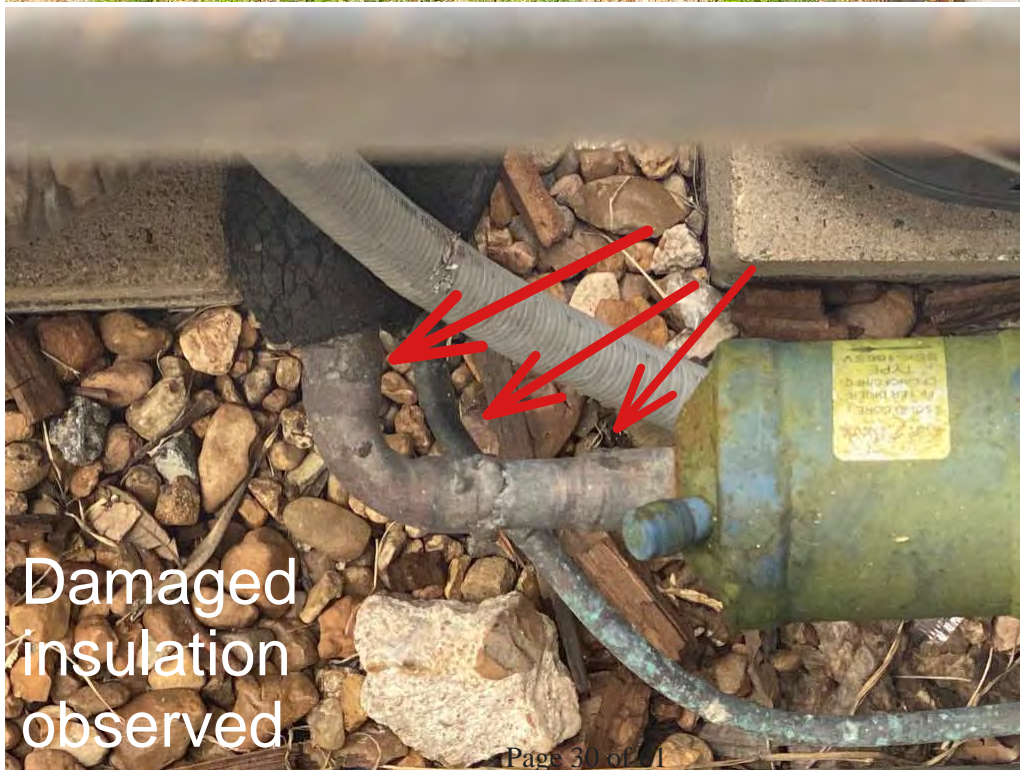
1. Observed no cap flashing (& not weathertight) where the A/C lines enter the structure.

2. Damaged insulation at A/C line (exterior).

Insulation helps optimize A/C efficiency.

Correction recommended by qualified contractor to avoid moisture / pest intrusion.

Correction recommended by qualified contractor.

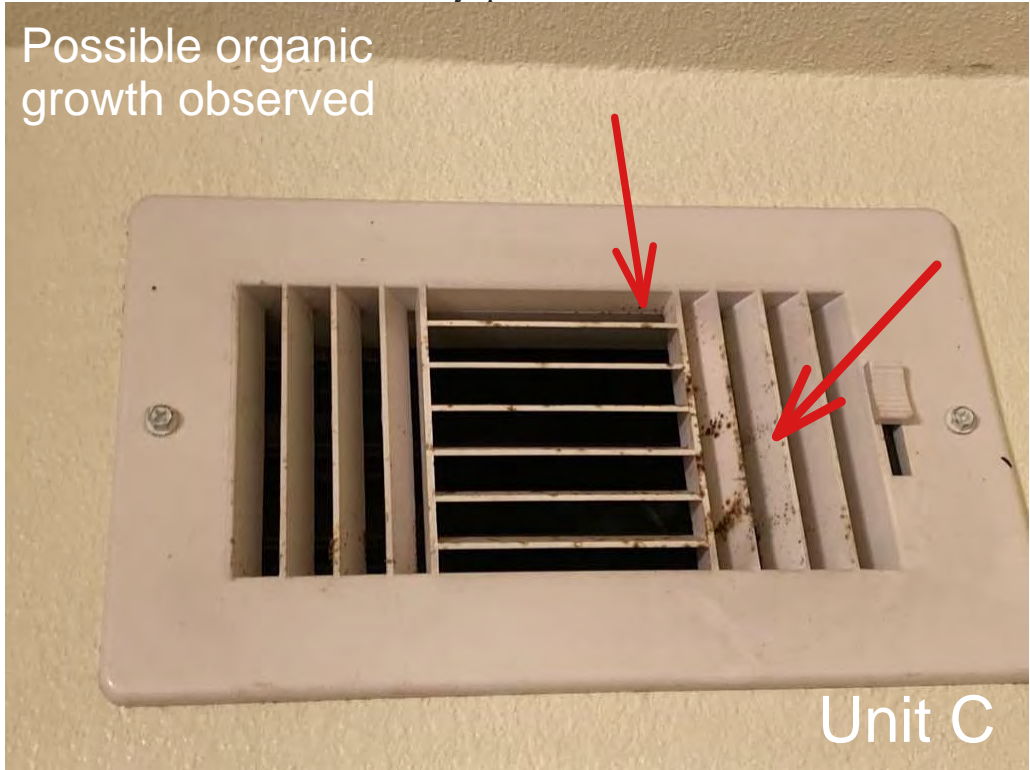
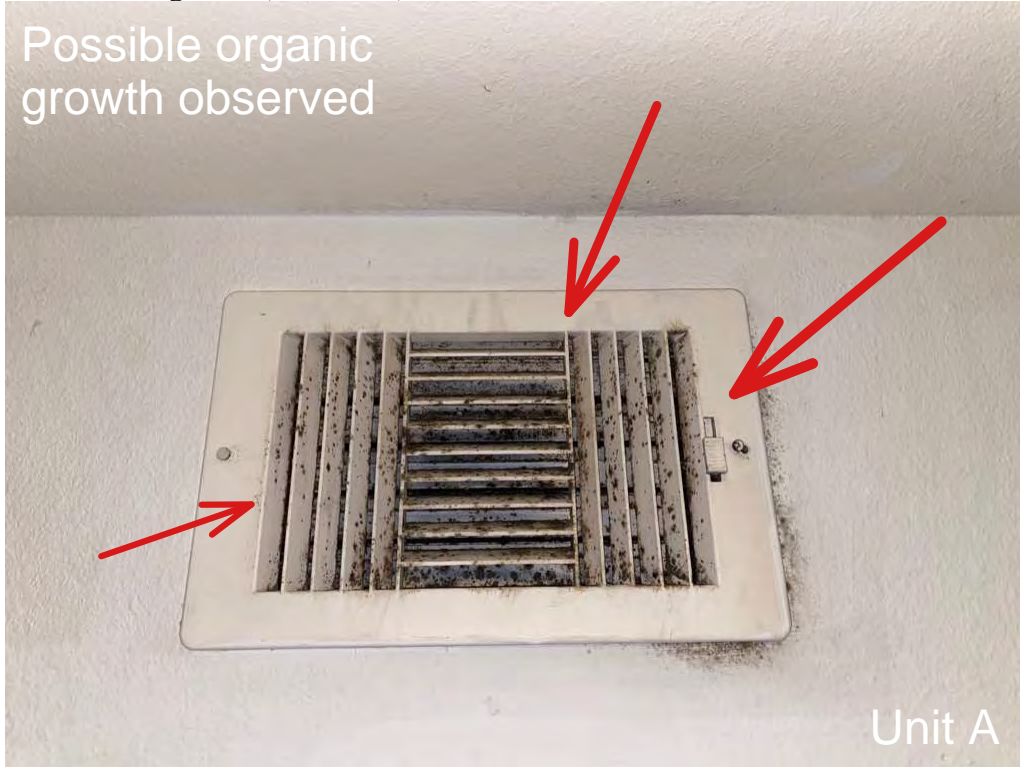
Possible organic growth substance on air vents observed at time of inspection.

Further evaluation recommended by qualified contractor.

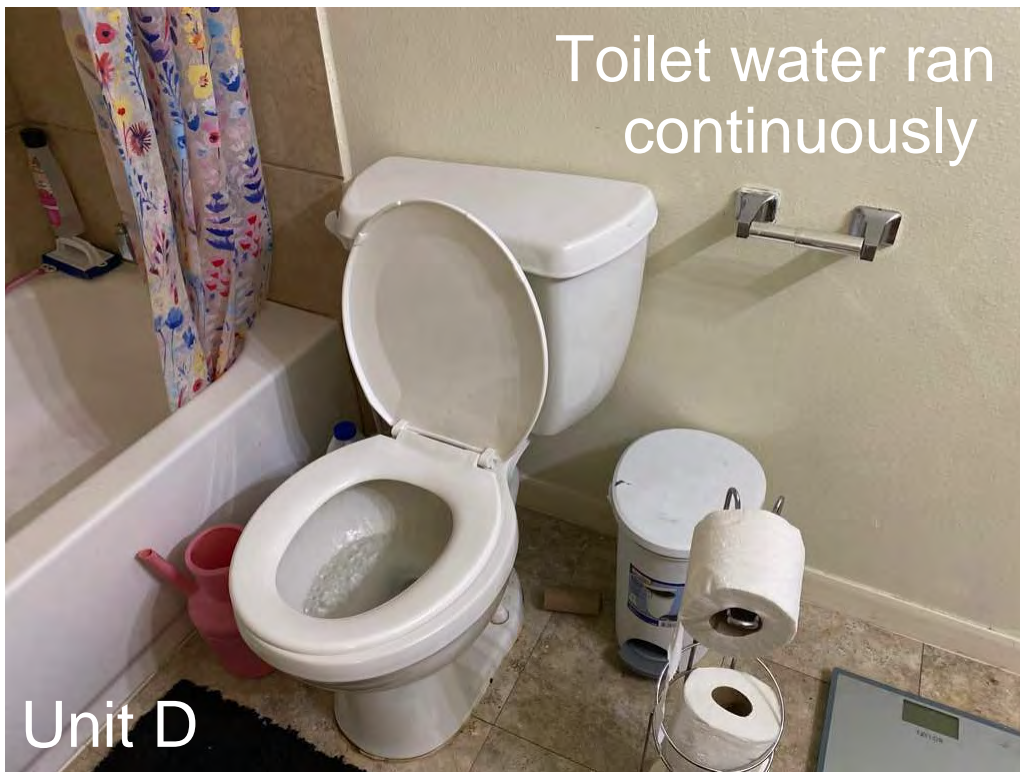
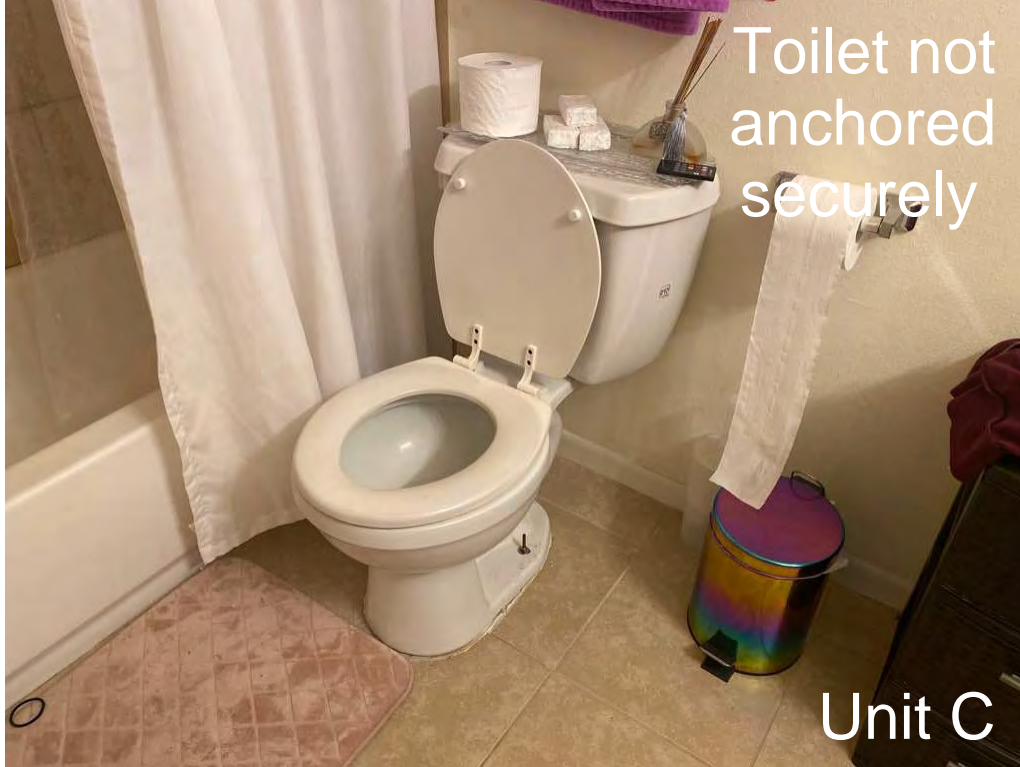
2. Observed toilet loose at floor mounting (Unit C)

Correction recommended by qualified contractor.

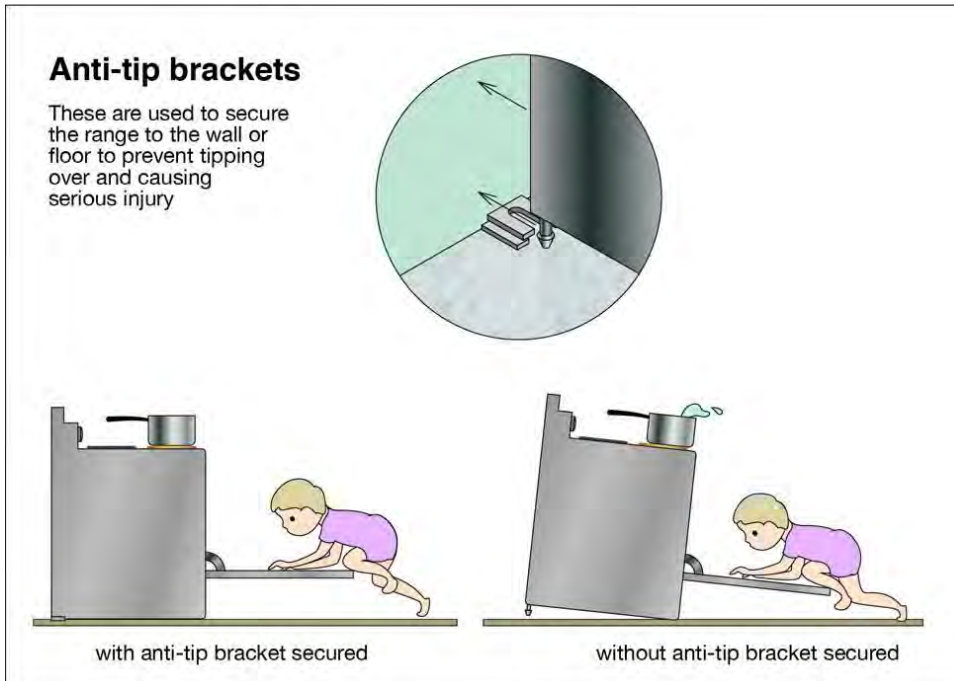
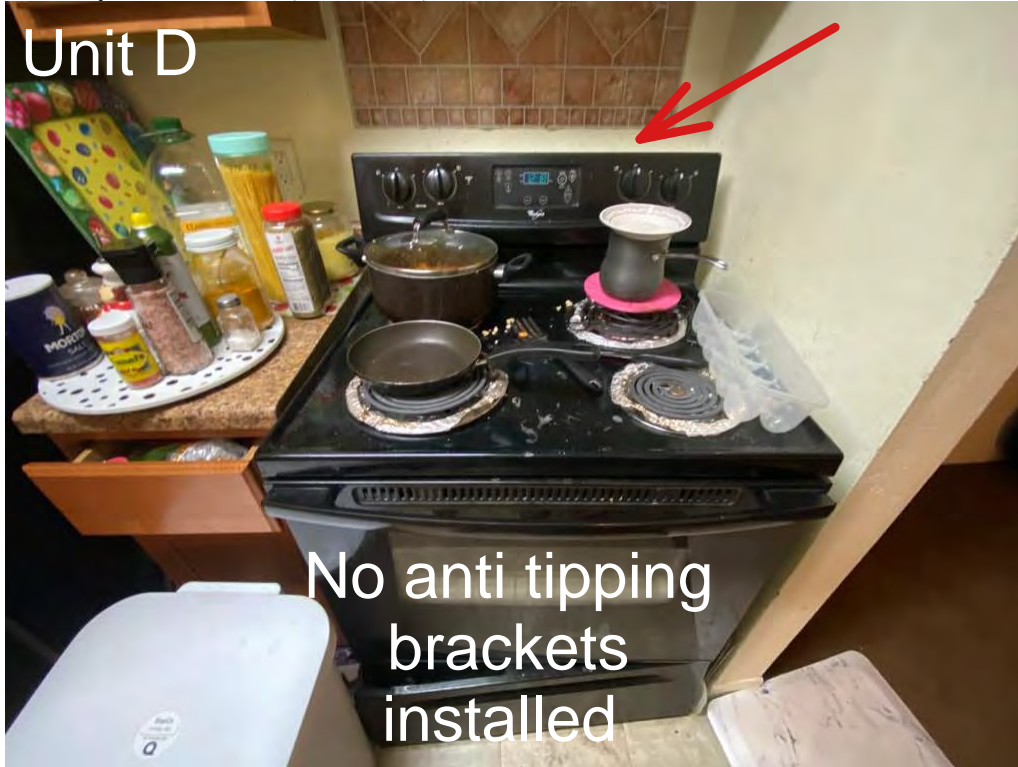
No anti-tip brackets installed on oven (safety).

Correction recommended by qualified contractor.

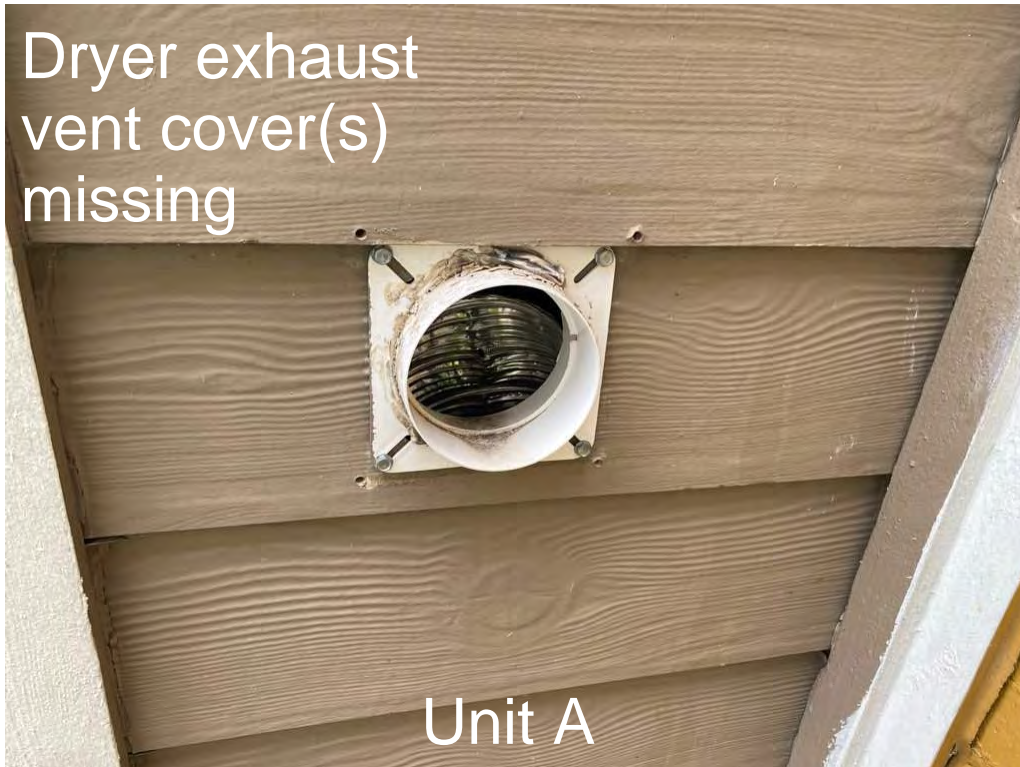
Dryer exhaust vent cover (at exterior) not sealed / secured properly.

Correction recommended by qualified contractor to minimize potential of pest / moisture intrusion.
