1 Southgate Dr  
Spring, TX 77380

# PROPERTY INSPECTION REPORT FORM

<u>Libby Chisholm</u> <i>Name of Client</i>	<u>02/07/2023</u> <i>Date of Inspection</i>
<u>1 Southgate Dr, Spring, TX 77380</u> <i>Address of Inspected Property</i>	
<u>Justin Hale, Hunter Lamb</u> <i>Name of Inspector</i>	<u>22124, 24864</u> <i>TREC License #</i>
<u>Chris Stull</u> <i>Name of Sponsor (if applicable)</i>	<u>20945</u> <i>TREC License #</i>

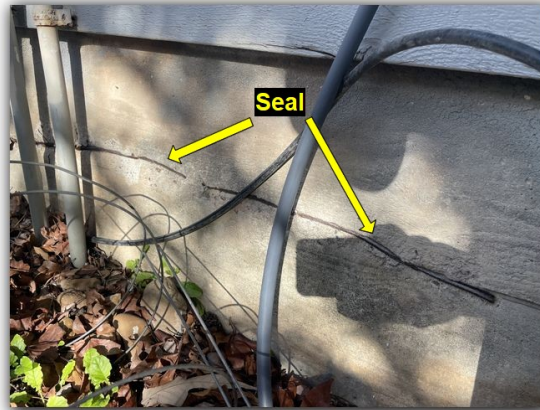
Observed rebar in one or more areas around the foundation. Metal rebar will expand when rusted and can cause spalling (chipping, flaking) of the foundation. Recommend sealing these areas with parging mix or other material to slow the rusting process.

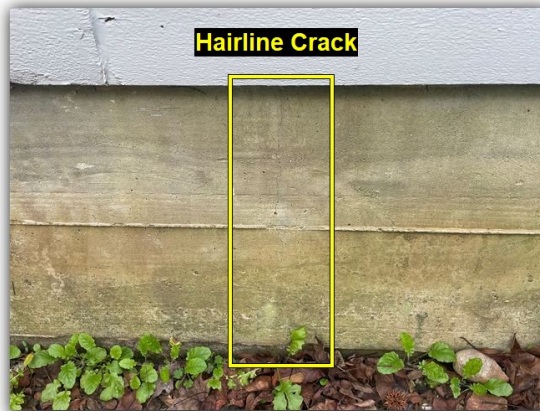
Observed hairline cracks on one or more areas of the foundation. Hairline cracks are common to find and does not appear to have any structural integrity issues at the time of inspection.

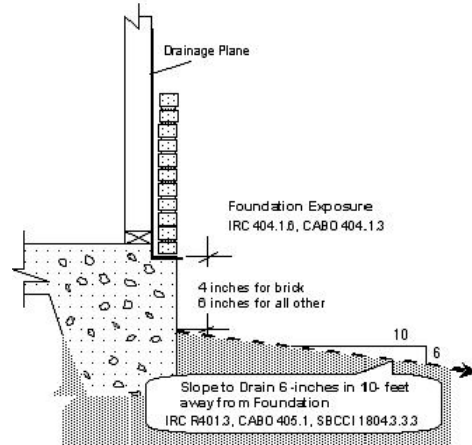
Observed the grading did not slope away from the home in one or more areas around the exterior. Current standards call for the grading to slope away from the home at least 6 inches per 10 feet. This is to prevent water from pooling close to the foundation which can cause damage. Remedies may include adding rain gutters, French drains or re-grading around the home.

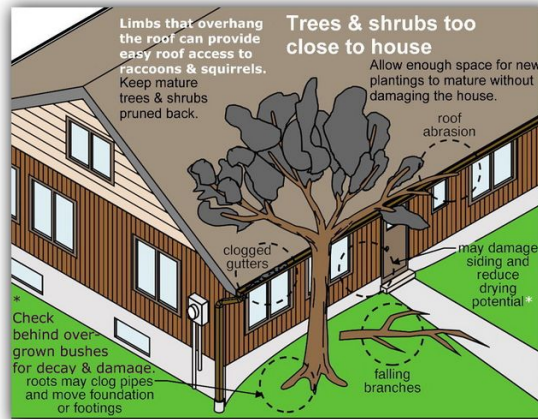
Observed soil levels too high around the foundation in one or more areas. High soil levels are considered a conducive condition to termite activity and water penetration.

*Recommend vegetation be cut back away from exterior of home to prevent damage.*

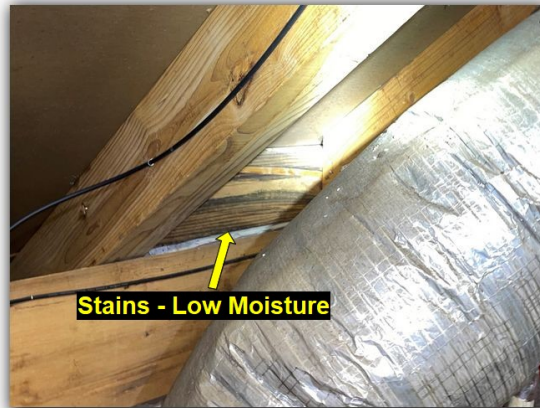
*Observed water stains on the roof decking and framing in the attic in one or more areas. Moisture readings were low at time of inspection which usually indicates the stains are from previous leaks, but I could not be certain. Recommend asking the seller about previous leaks that may have been repaired or having further evaluation by a contractor.*

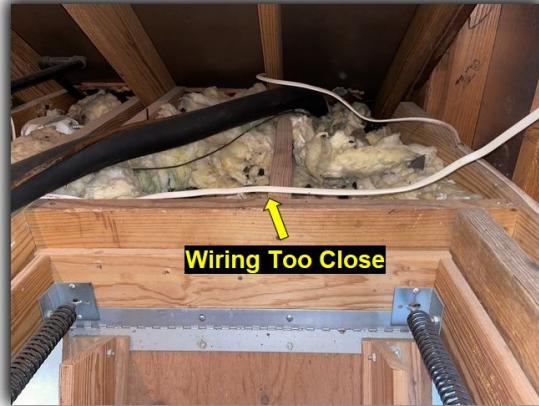
Observed wiring too close to attic access opening. Wiring should be at least 6 feet away from attic opening. One reason for this code is that someone falling from the access ladder might grab onto an electrical wire. Usually securing the wiring so that it can not be grabbed will alleviate this danger.

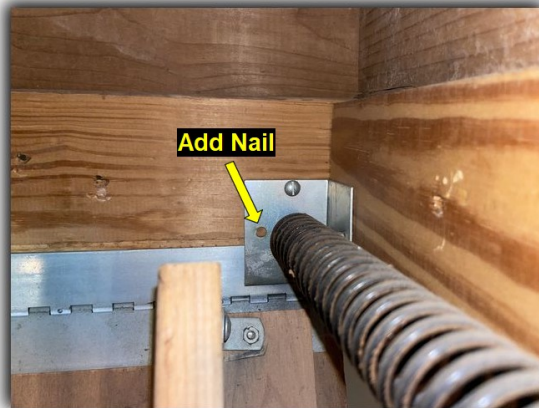
Observed one or more nails missing from attic access ladder frame. Recommend installing a 16d nail or 1/4 inch diameter lag screw to properly secure stairway frame to ceiling.

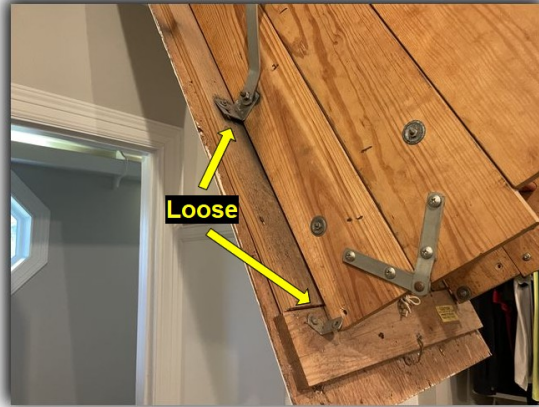
Observed the attic access ladder in the primary closet was loose and missing hardware in multiple areas. Recommend securing the ladder to prevent damage and personal injury.

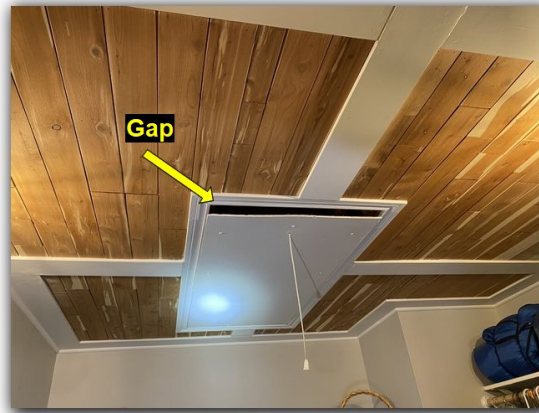
Observed the attic access in the primary bedroom closet did not shut all the way at the time of inspection.

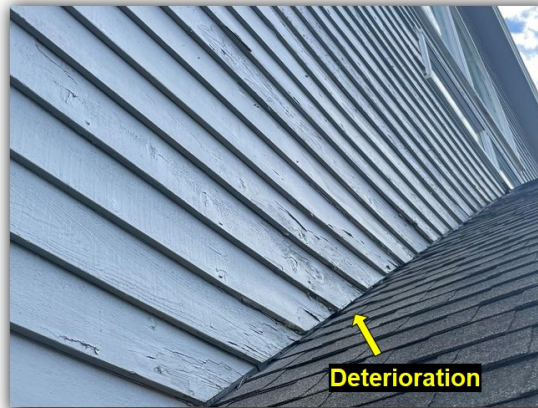
Observed deteriorated siding and trim in one or more areas of the exterior. Multiple areas appear to be painted over deterioration. Recommend further evaluation by a qualified contractor.

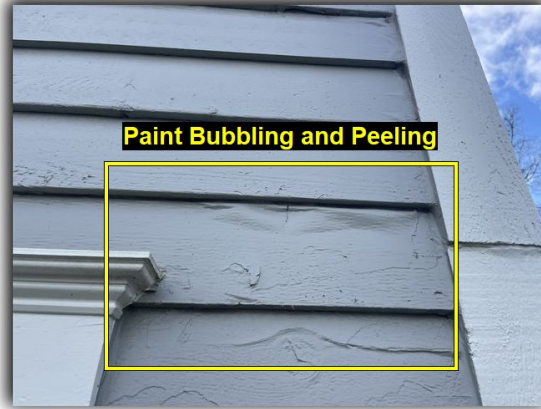
Observed paint was bubbling and peeling from the exterior siding in multiple areas.

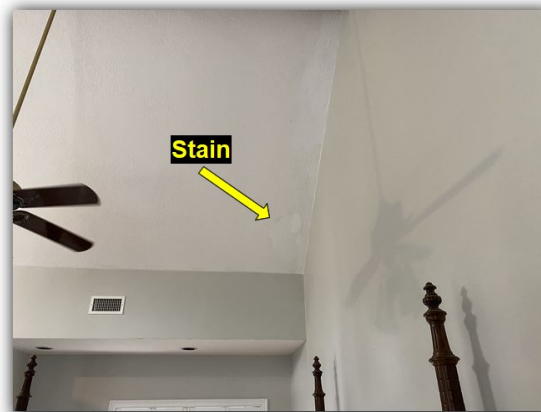
*Observed water stains on the ceiling in one or more areas. Moisture readings were low at time of inspection which usually indicates the stains are from previous leaks, but I could not be certain. Recommend asking the seller about previous leaks that may have been repaired or having further evaluation by a contractor.*

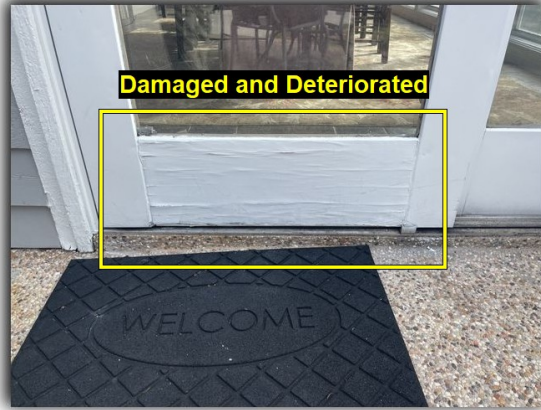
Observed damage and deterioration to one or more exterior doors. Recommend further evaluation by a qualified contractor.

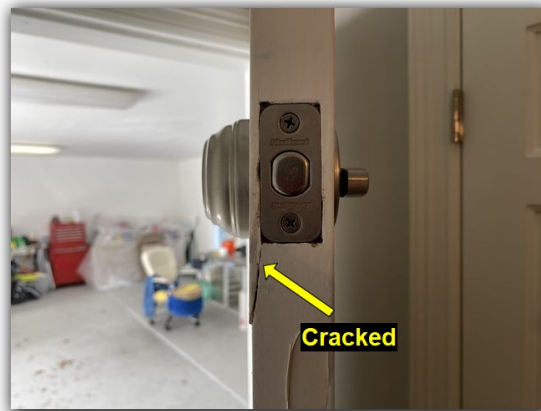
Observed the garage entrance door was cracked in one or more areas.

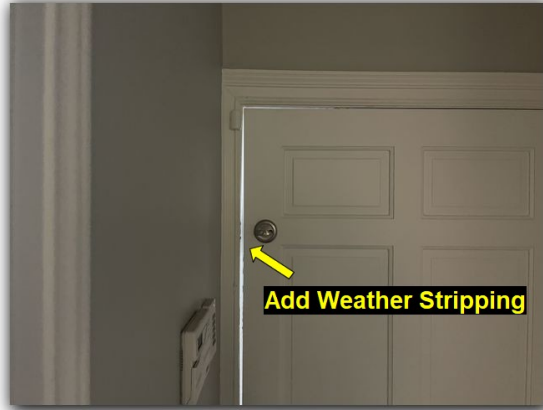
Did not observe weather stripping for the door to the garage. Recommend adding weather stripping for optimum energy efficiency.

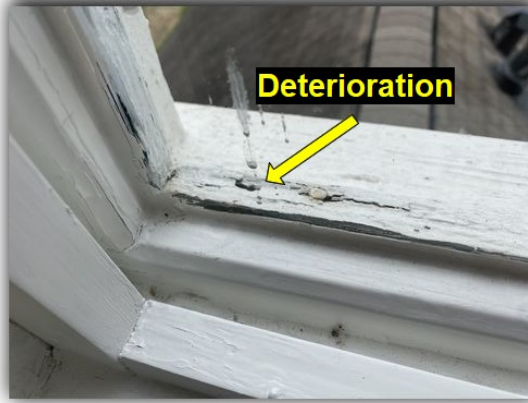
Observed deteriorated window trim in multiple areas around the home.

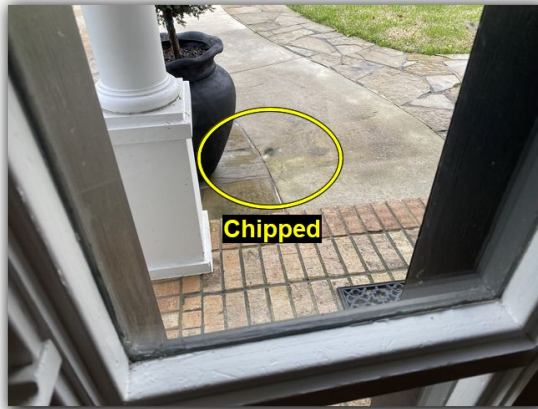
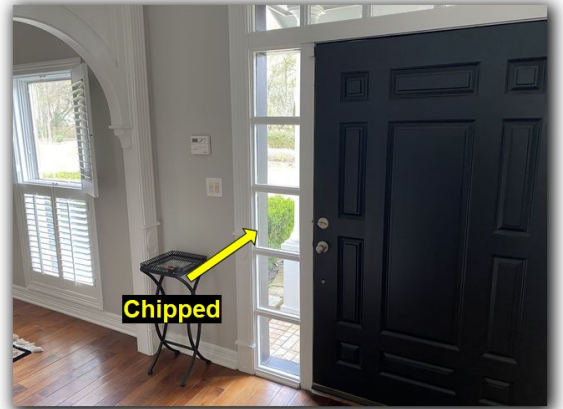
Observed a chipped window on the side view window near the front door.

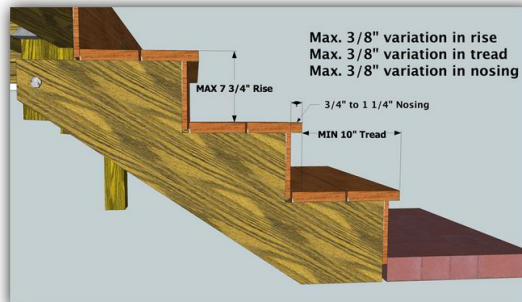
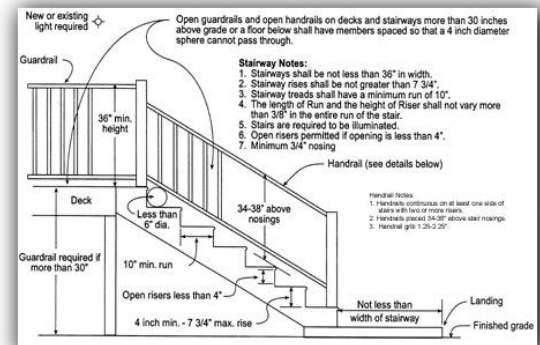
Observed the stairs were not up to current standards with deficiencies that may include, but are not limited to; riser height, riser variance, improper handrail, headroom height and baluster spacing. Note: Standards for stairs have changed significantly since time of construction.

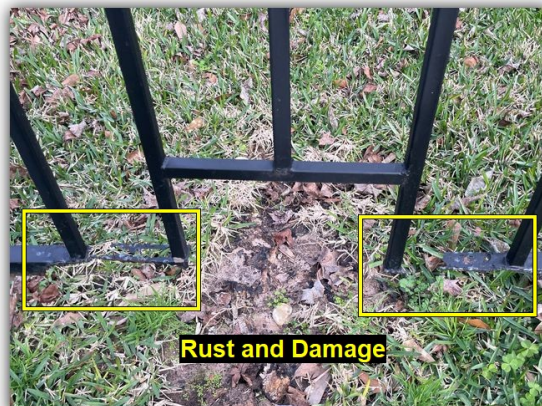
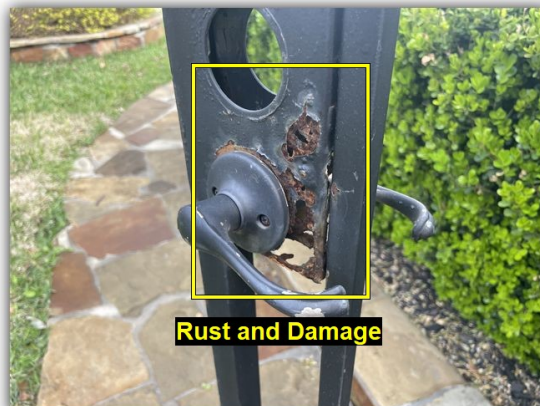
Observed rust and damage to the metal fence in multiple areas.

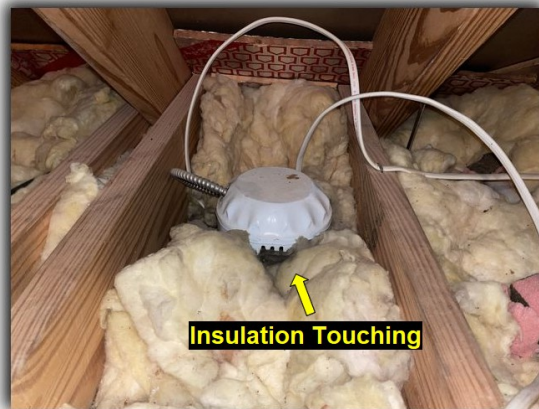
Did not observe an IC (insulation contact) rating for the can lights in the attic. Most can lights require a 3 inch clearance from all combustibles, including insulation. Recommend moving insulation away from the can lights at least 3 inches to reduce the risk of fire.

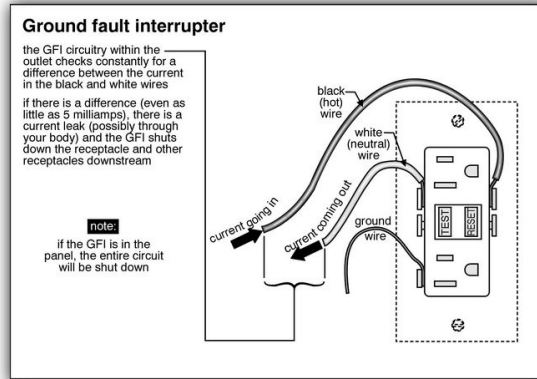
Did not observe GFCI protection for all outlets in required locations including, but not limited to: all laundry, kitchen, bathroom, wet bar, garage and exterior areas. Current standards call for GFCI protection for all outlets in kitchen, bathrooms, laundry room, garage, exterior and any outlet that is within 6 feet of a water source. This is a recognized safety hazard.

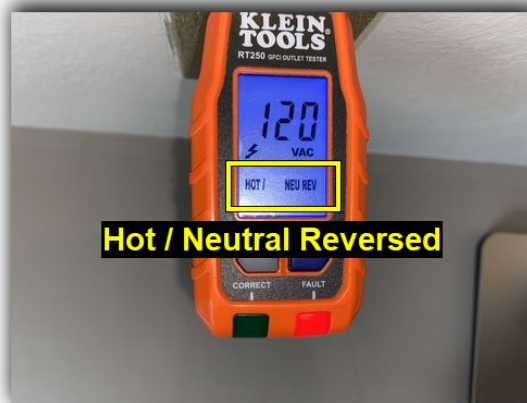
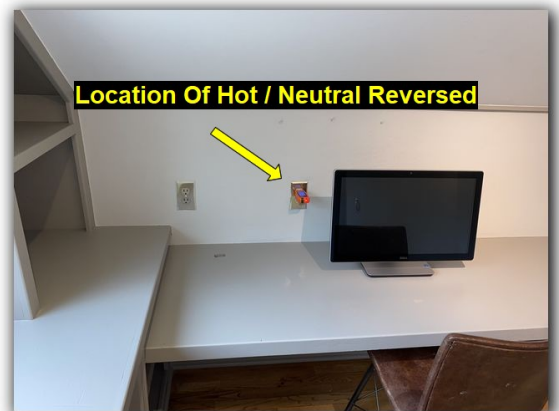
Observed a hot / neutral reversed outlet in the office area behind the media room. Recommend further evaluation by a licensed electrician.

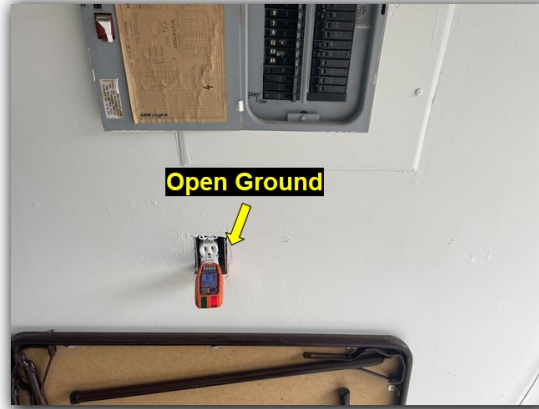
Observed an outlet that was not wired properly in the garage. The outlet has an open ground. Recommend further evaluation by a licensed electrician.

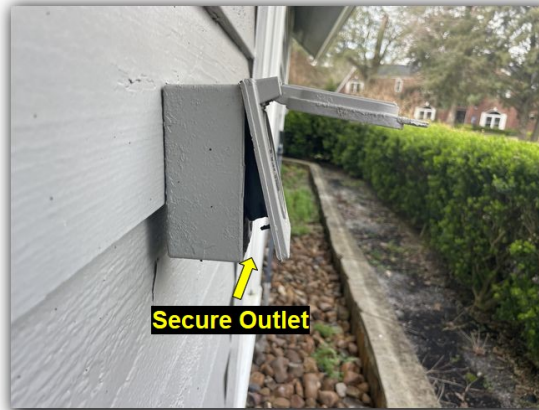
Observed multiple loose outlets on the exterior. Recommend securing the outlets to prevent damage.

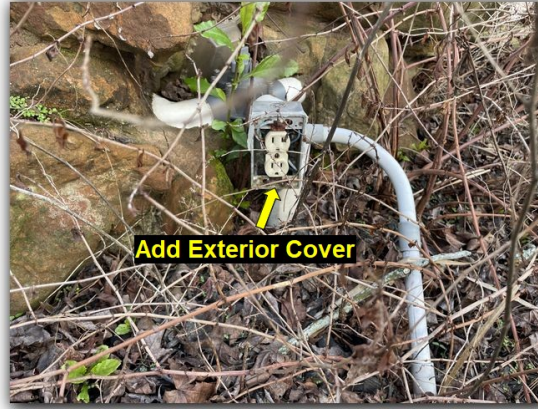
Observed the weather proof cover missing / damaged on one or more exterior outlets. In need of repair.

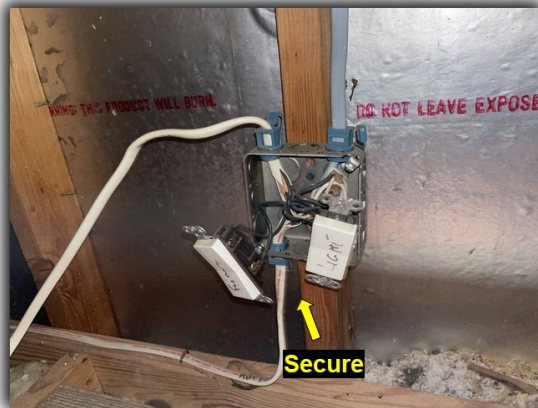
Observed loose switches in the third story upper attic. Recommend securing and covering the switches to prevent damage and access to the live wiring.

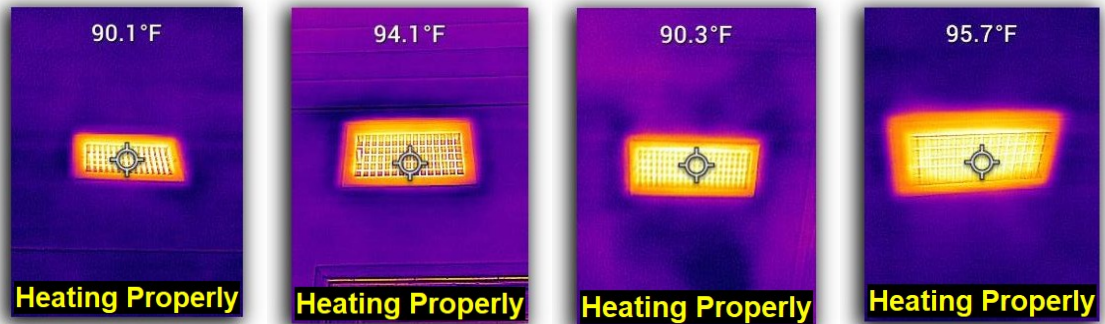
Observed the furnace for the third floor was not operational at the time of inspection. Recommend further evaluation by a licensed HVAC technician.

*A thermal image of the air vents show the other furnace(s) were heating properly at time of inspection.*

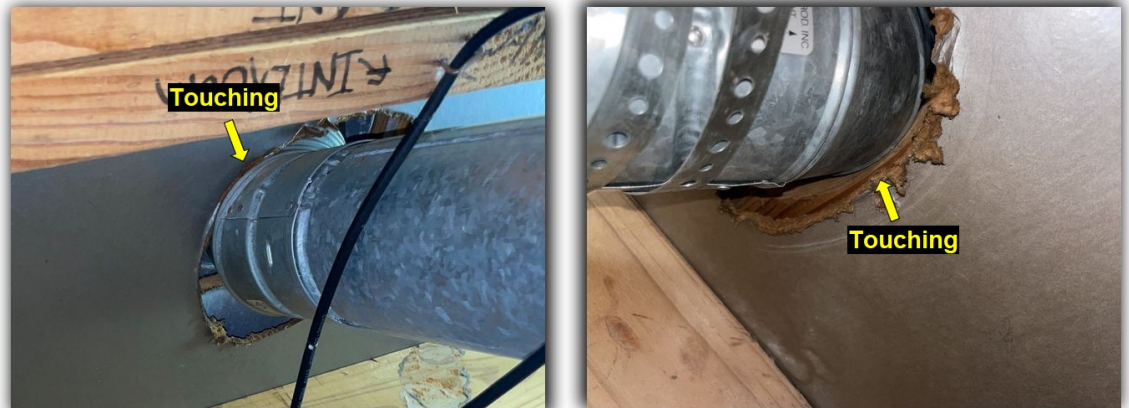
Observed the exhaust duct for multiple furnaces was in contact with combustibles. Current standards call for at least a one inch separation from all combustibles including insulation. This is a fire hazard. In need of repair.

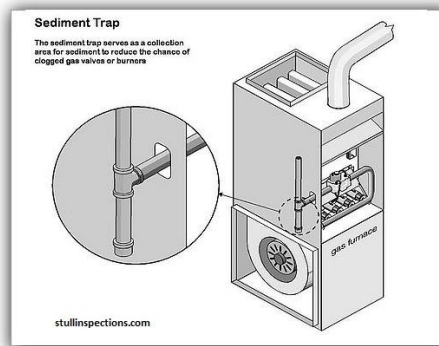
*Did not observe a drip leg (sediment trap) for gas line at furnace(s). Sediment traps are necessary to protect appliance gas controls from the dirt, soil, pipe chips and other debris that can enter the piping during installation or repair and cause damage to the unit. As inspectors we are not required to report this as a deficiency, but you might consider installing drip legs if you ever have repair work performed or replace the furnace(s).*

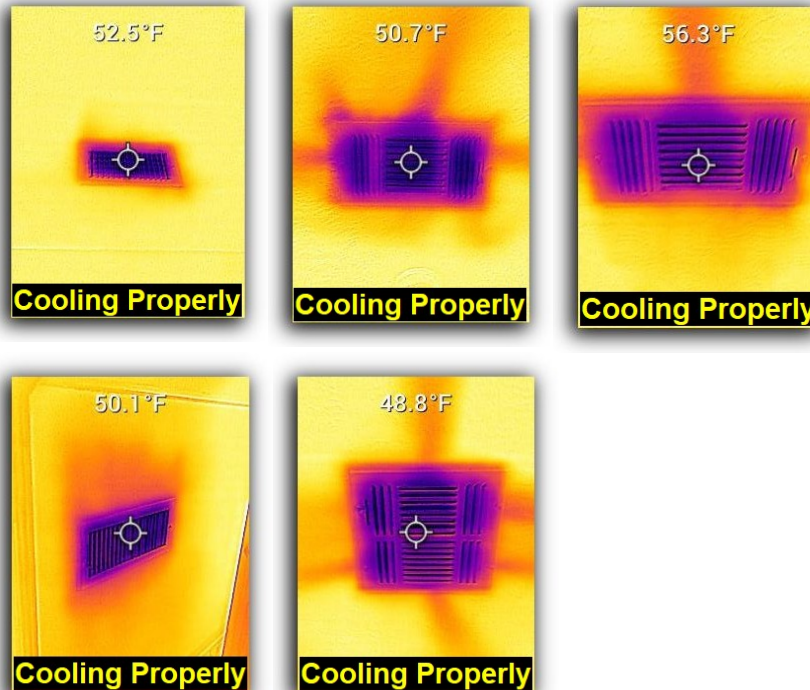
A thermal image of the air vents show the air conditioning unit(s) were cooling properly at time of inspection.

TEMPERATURE DIFFERENTIAL: 18 degrees (70, 52) **GOOD**, 18 degrees (68, 50) **GOOD**  
17 degrees (73, 56) **GOOD**, 19 degrees (69, 50) **GOOD**, 20 degrees (68, 48) **GOOD**

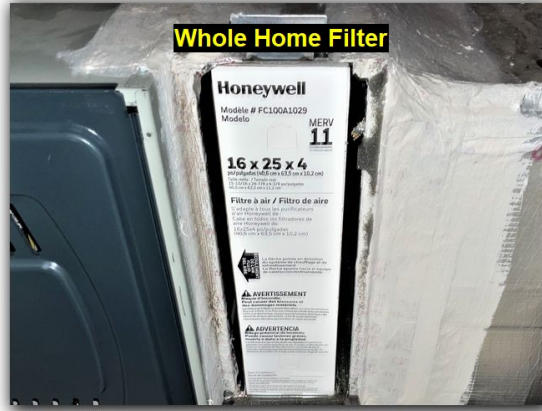
Observed one AC / Heating system is equipped with a whole home filter system. Recommend changing the filter as directed by the manufacturers recommendations.  
Filter Size(s): 20 X 25

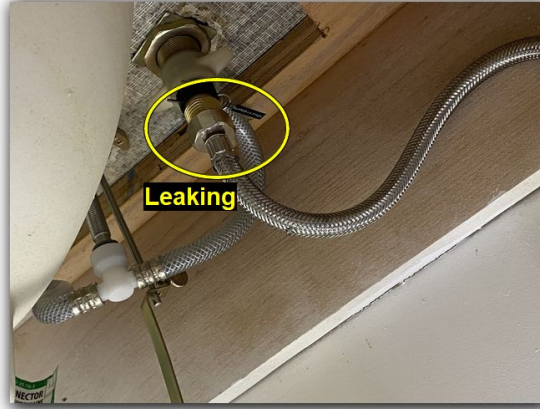
Observed a leak from the plumbing connection under the second floor right bathroom right sink. Recommend further evaluation by a licensed plumber.

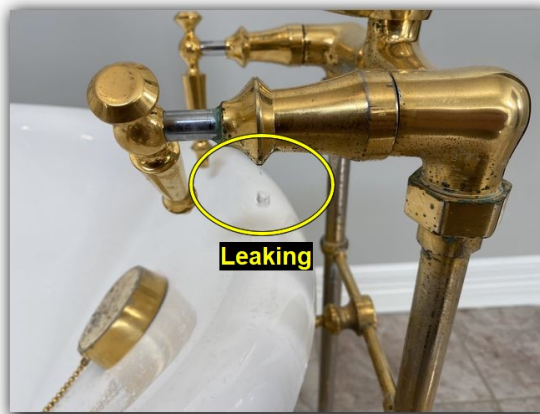
Observed a leak from the cold handle on the tub in the primary bathroom. Recommend further evaluation by a licensed plumber.

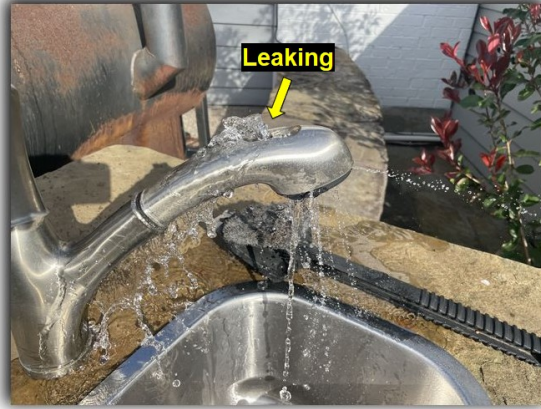
Observed the outdoor sink faucet was damaged and leaking when the water is turned on. Recommend further evaluation by a licensed plumber.

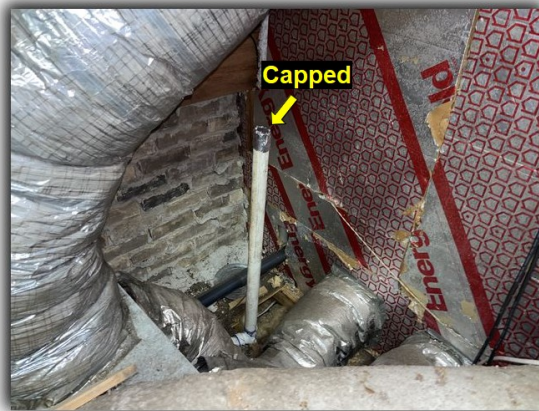
Observed a plumbing vent in the attic above the primary closet was capped with tape. Current standards call for all plumbing vents to vent to the exterior. Recommend further evaluation by a licensed plumber.

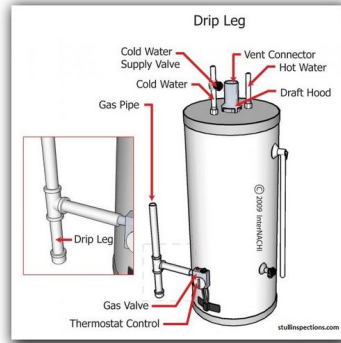
*Did not observe a drip leg (sediment trap) for gas line at water heater(s). Sediment traps are necessary to protect appliance gas controls from the dirt, soil, pipe chips and other debris that can enter the piping during installation or repair and cause damage to the unit. As inspectors we are not required to report this as a deficiency, but you might consider installing drip legs if you every have repair work performed or replace the water heater(s).*

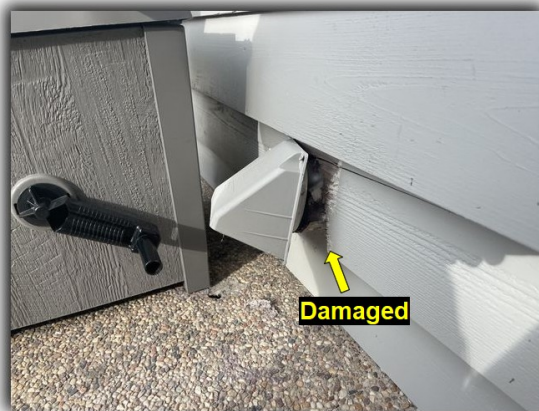
Observed the exterior dryer vent cover is damaged and pulled away from the wall. Recommend securing and sealing the cover to prevent further damage and water penetration.
