HOME INSPECTION REPORT

Prepared For:	Amairani Alanis	
	(Name of Client)	
Concerning:	432 Pecan St, South Houston, TX, 77587	
	(Address or Other Identification of Inspected Property)	
By:	Team One Tyler Holley 24609	9-15-2021
	(Name and License Number of Inspector)	(Date)
	(Name, License Number of Sponsoring Inspector)

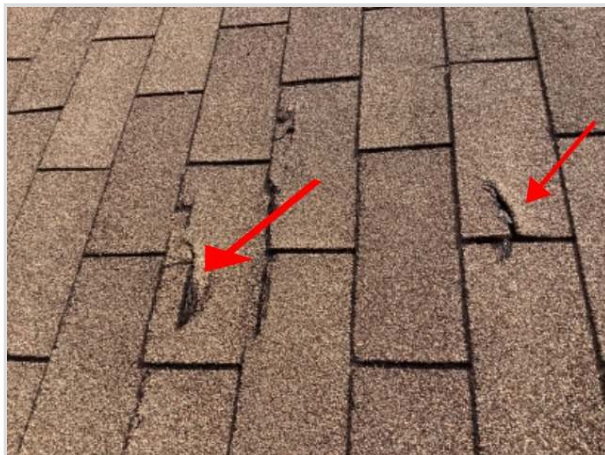
Left side

One or more shingles were damaged at the time of inspection.

There was a hole in the roof covering at the time of inspection. Although it did not allow entry into the home.

An improper repair technique of the roof covering was observed at the time of inspection.

- One or more shingles were damaged at the time of inspection.
- There was a hole in the roof covering at the time of inspection. Although it did not allow entry into the home.
- An improper repair technique of the roof covering was observed at the time of inspection.

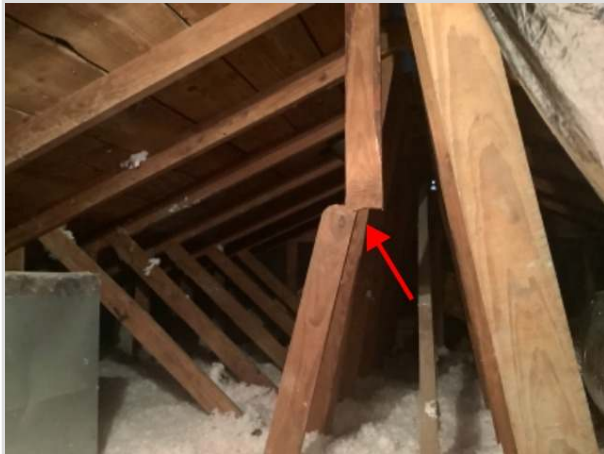
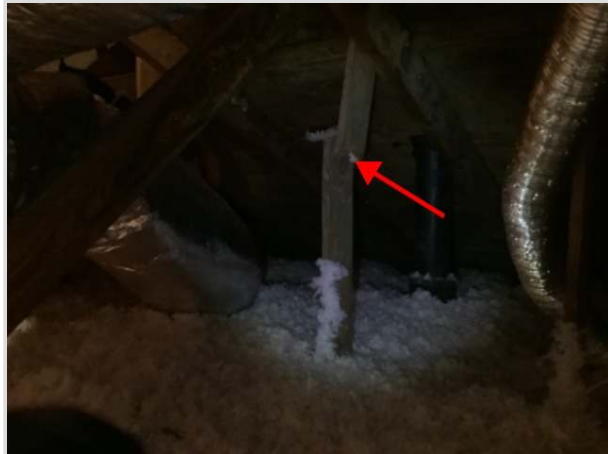
Inside attic space

One or more webs of the engineered truss system were missing/damaged. Significant damage and/or modification to trusses can have negative effects on the structural integrity of the system.

- One or more webs of the engineered truss system were missing/damaged. Significant damage and/or modification to trusses can have negative effects on the structural integrity of the system.

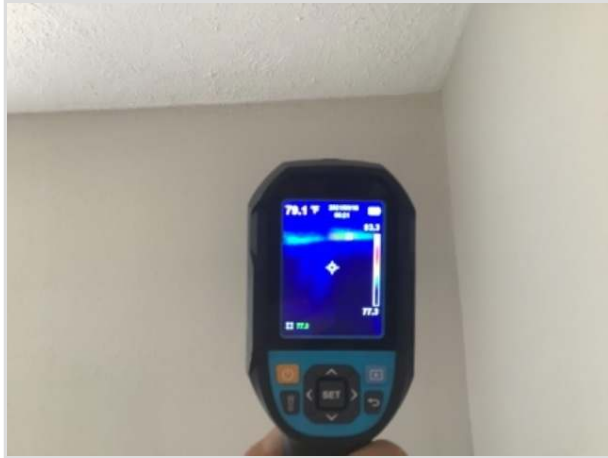
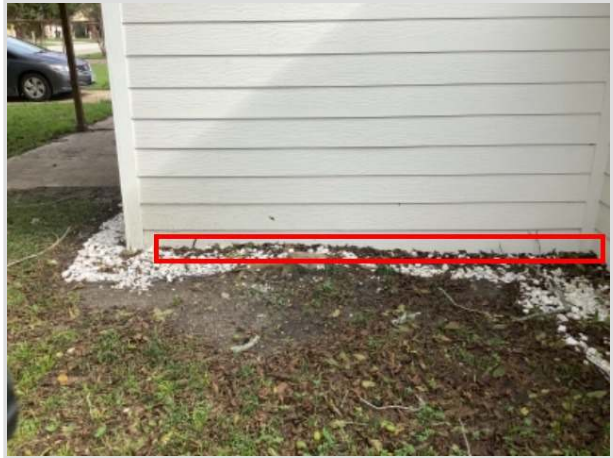
Front right side

One or more walls were leaning at the time of inspection in the following locations. Front side wall, right side wall, left side wall.

Exterior wall covering (brick veneer) was in contact with the soil. Common industry standard calls for brick veneer/masonry to have a four inch clearance above grade (R404.1.6).

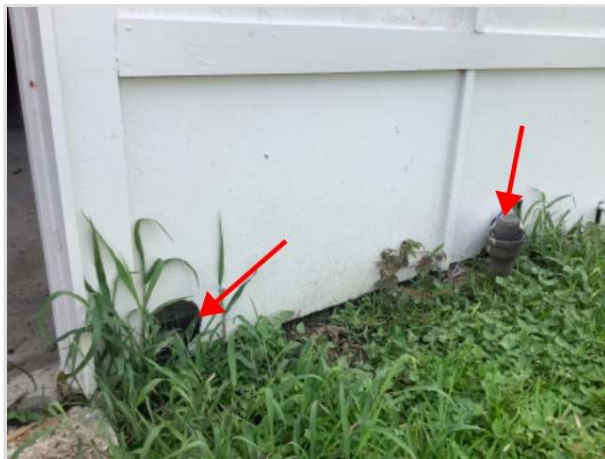
Front of garage

There were holes in the exterior wall covering that allowed access into the garage at the time of inspection.

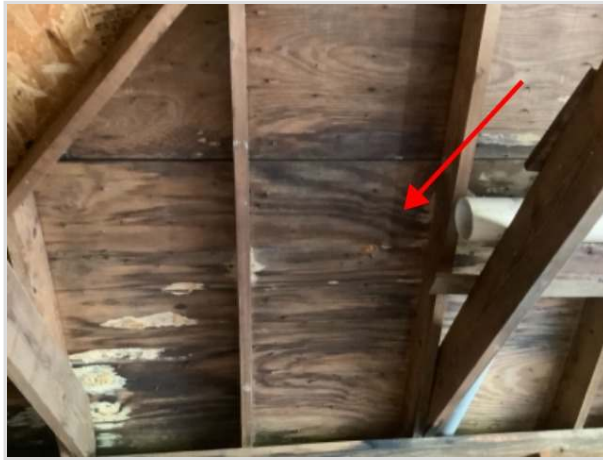
Garage ceiling

There was staining on the garage ceiling indicating possible previous leakage.

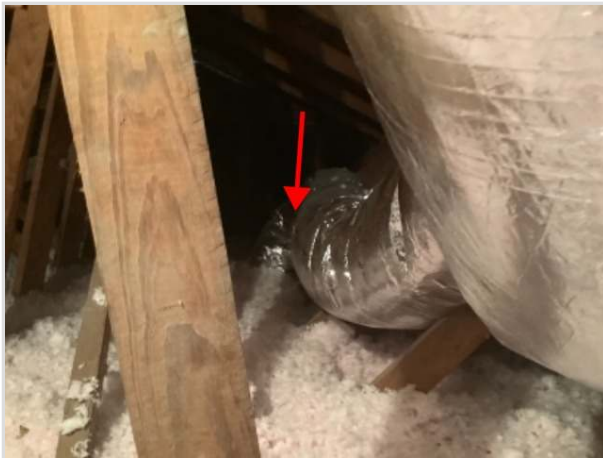
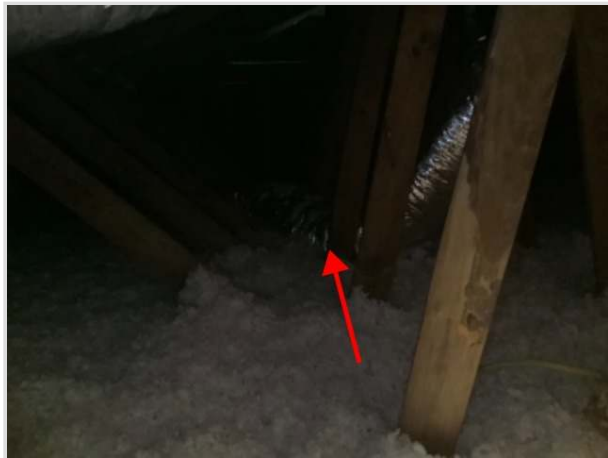
Inside attic space

Portions of the flex duct were improperly installed. Sharp bends around corners, framing and/or other items reduces the airflow of the duct and may affect system performance.

Flex ducts in the attic space were not properly elevated over the insulation, which can cause the bottom of the duct to sweat during the cooling mode.

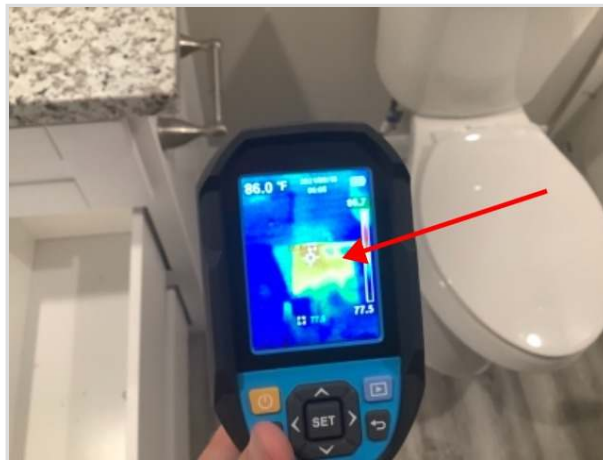
Bathroom

There was water leakage under the floors in the bathroom at the time of inspection. Recommend further evaluation by a plumber.

Fixed.

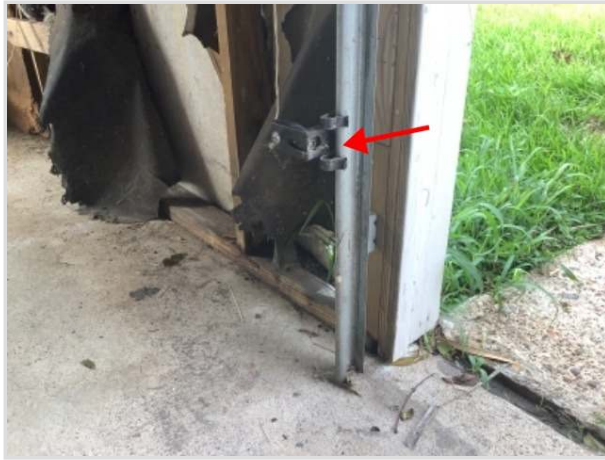
Garage door

Sensors were mounted higher than 6 inches off of the floor. The Texas Real Estate Commission (TREC) considers this to be a deficiency according to the standards of practice (SOP).

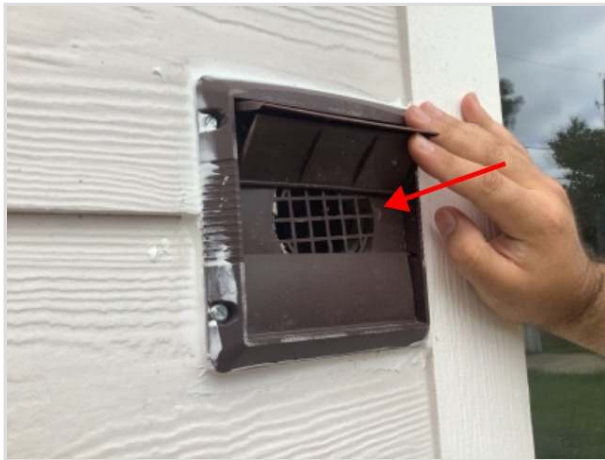
I to the left of the back door

Dryer vent was found to have a screened termination. The Texas Real Estate Commission (TREC) considers this to be a deficiency according to the standards of practice (SOP).
