30410 Beyette Rd  
Magnolia, TX 77355

## PROPERTY INSPECTION REPORT

**Concerning:** 30410 Beyette Rd, Magnolia, TX 77355  
(Address or Other Identification of Inspected Property)

**By:** Joe Budzinski, Lic #23245, 08/12/2020  
(Name and License Number of Inspector) (Date)

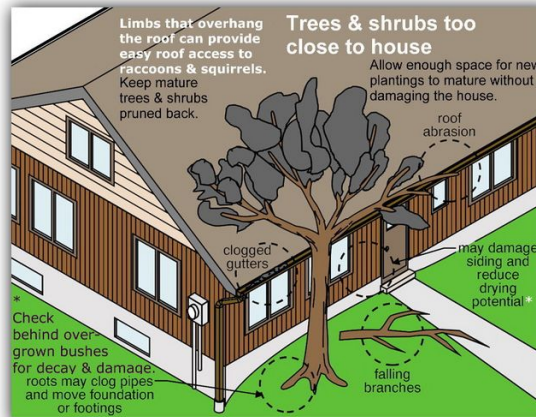
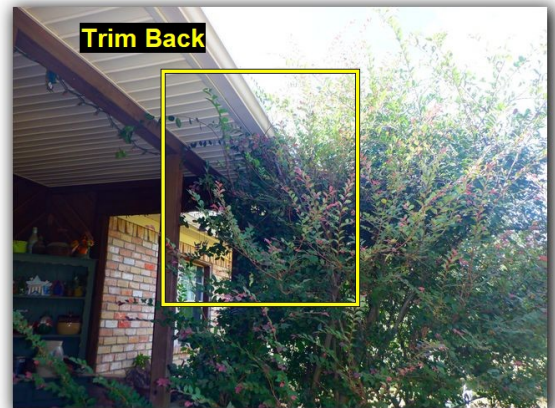
Observed evidence that suggests some movement. Unlevel flooring, soft flooring and improperly joined floor joists observed. Some movement is normal, but I recommend further evaluation by a structural engineer or foundation repair professional to determine if repairs are needed.

Recommend vegetation be cut back away from exterior of home to prevent damage.

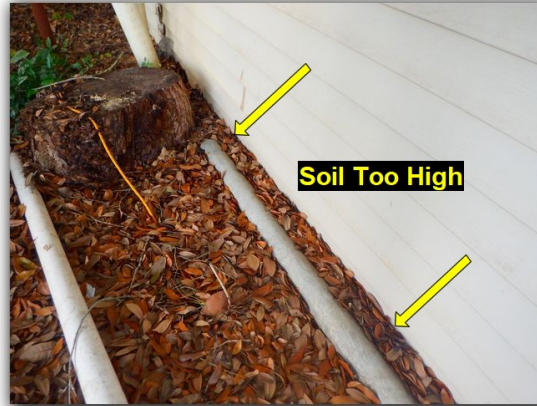
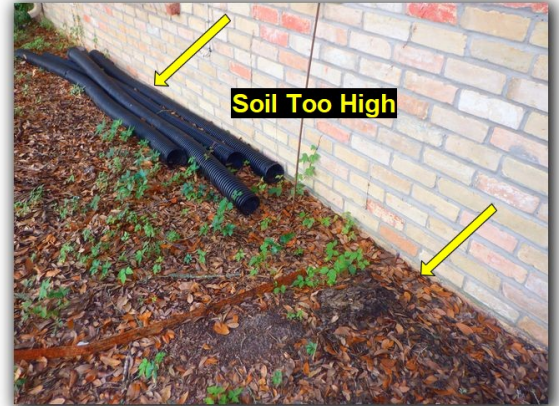
Observed soil levels too high around the foundation in multiple areas. High soil levels are considered a conducive condition to termite activity and water penetration.

*Buyer's note; ensure flower bed soil does not rise above foundation to prevent water and wood destroying insect entry into house.*

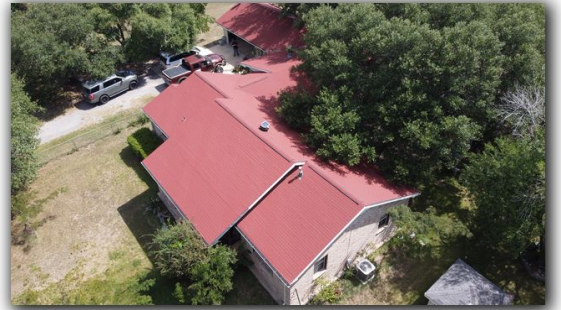
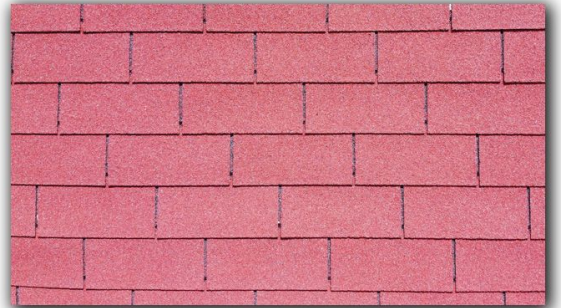
Observed damaged shingles on the surface of the well house roof. Recommend further evaluation by a qualified roofing contractor.

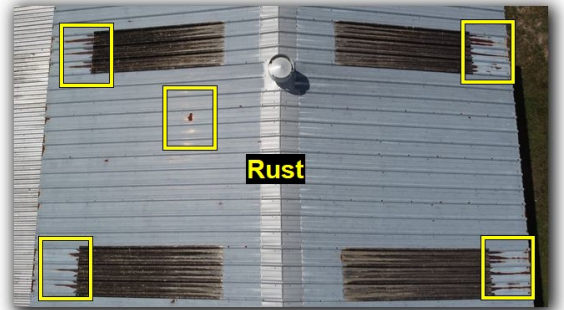
Observed multiple rusted metal roof coverings. Recommend re-coating with a rust resistant coating to slow the oxidation process.

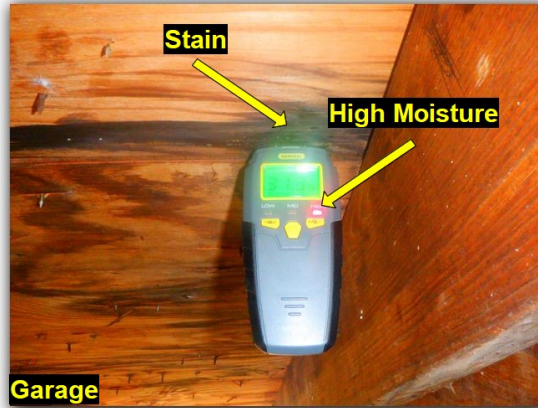
Observed water stains on the roof decking in the garage. Moisture readings were high at time of inspection. Recommend further evaluation by a professional roofing contractor.

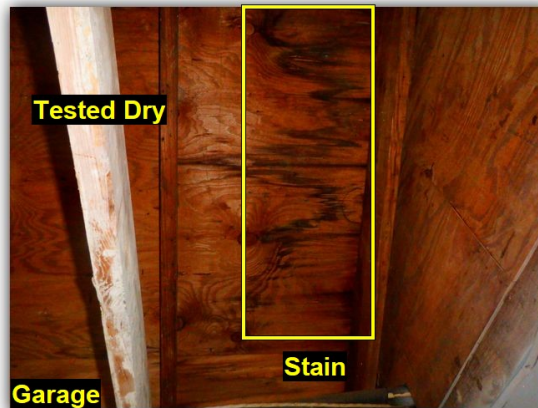
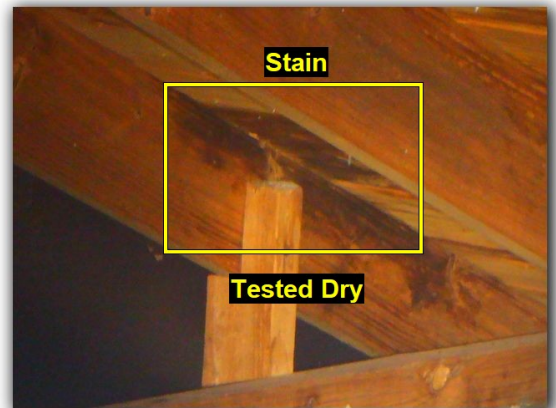
*Observed water stains on the roof decking in the attic and garage in multiple areas. Moisture readings were low at time of inspection which usually indicates the stains are from previous leaks, but I could not be certain. Recommend asking the seller about previous leaks that may have been repaired or having further evaluation by a contractor.*

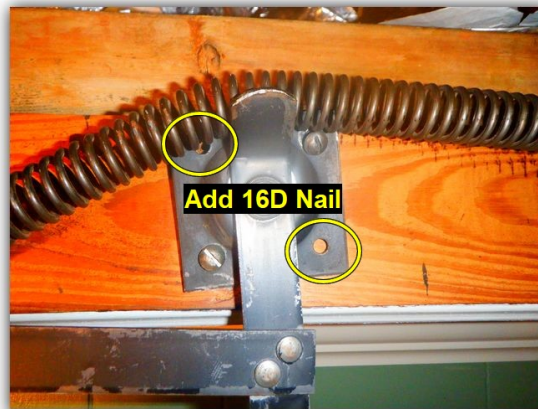
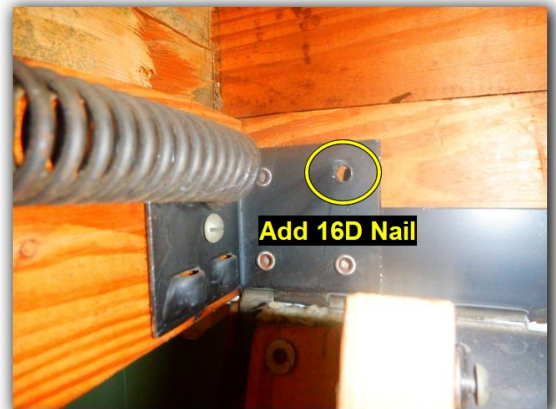
Observed inadequate service walks for moving around the attic safely. Current standards call for at least 24 inch wide solid decking to be installed for servicing attic equipment.

Observed one or more nails missing from attic access ladder frame. Recommend installing a 16d nail or 1/4 inch diameter lag screw to properly secure stairway frame to ceiling.

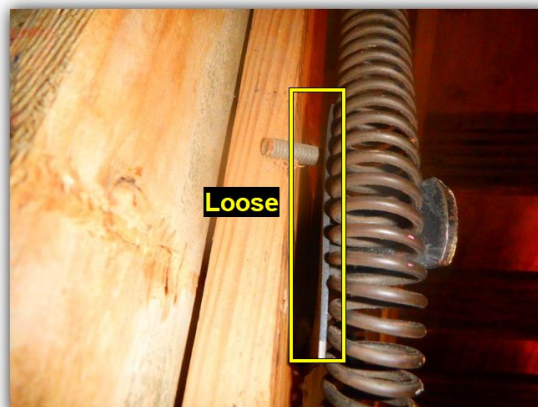
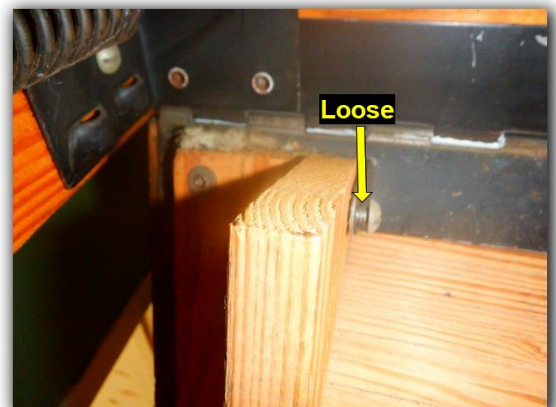
Observed multiple loose fasteners. In need of tightening.

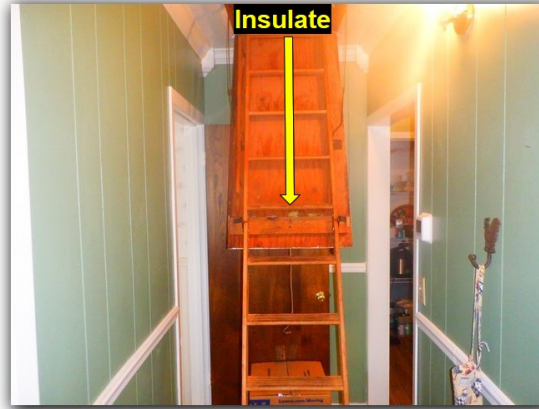
*For optimum energy efficiency, I recommend insulating the pull down attic access.*

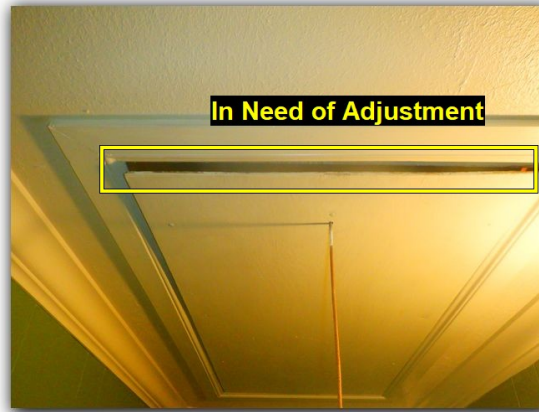
*Observed the pull down attic access is in need of adjustment to fully close.*

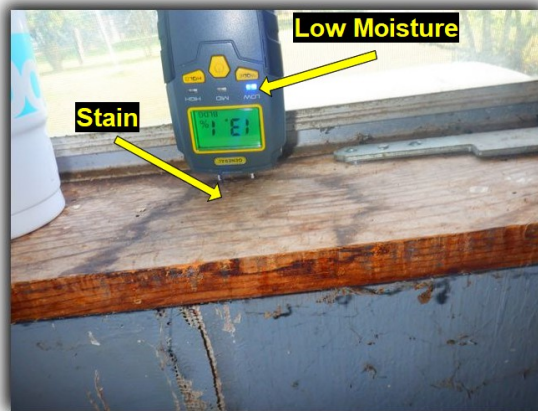
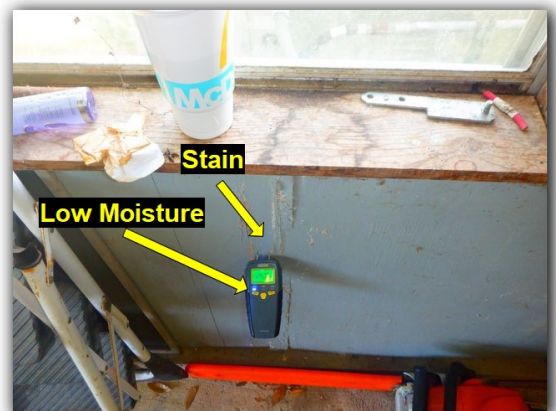
*Observed water stains on the interior wall in the garage. Moisture readings were low at time of inspection which usually indicates the stains are from previous leaks, but I could not be certain. Recommend asking the seller about previous leaks that may have been repaired or having further evaluation by a contractor.*

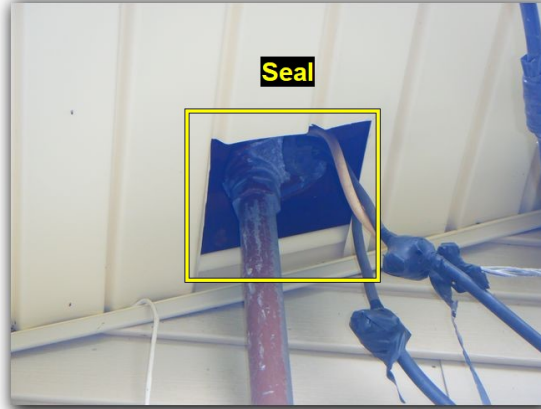
Recommend sealing/caulking around all holes, gaps, cracks and exterior siding penetrations to prevent water / insect entry.

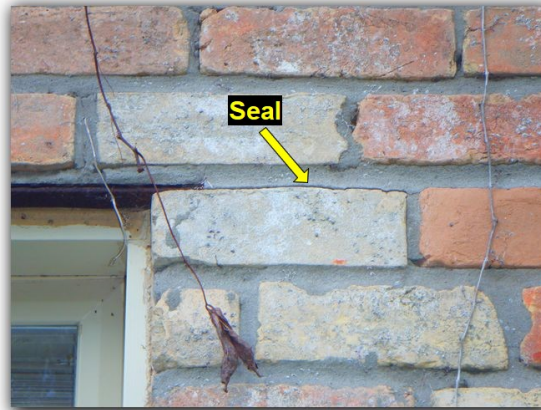
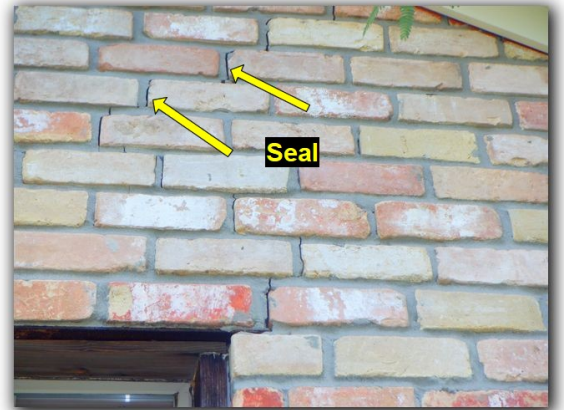
Observed cracks in the brick and mortar around the exterior in one or more areas. Recommend repairing or sealing all cracks to prevent water entry. Recommend sealing/caulking around all holes, gaps, cracks and exterior siding penetrations to prevent water entry.

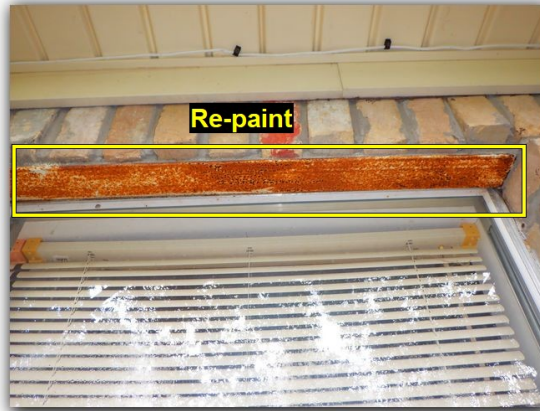
*Recommend coating steel lintels over doors and windows with rust resistant paint or other material to slow the rusting process and preserve the integrity of the lintel.*

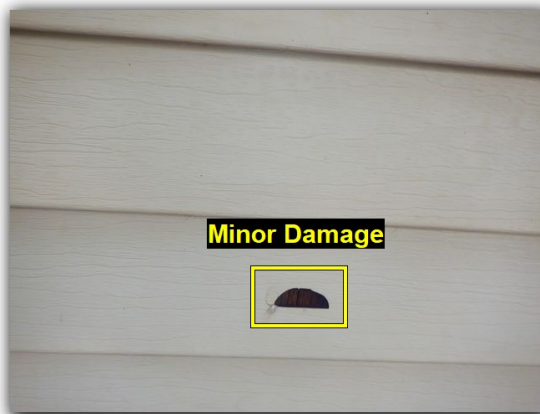
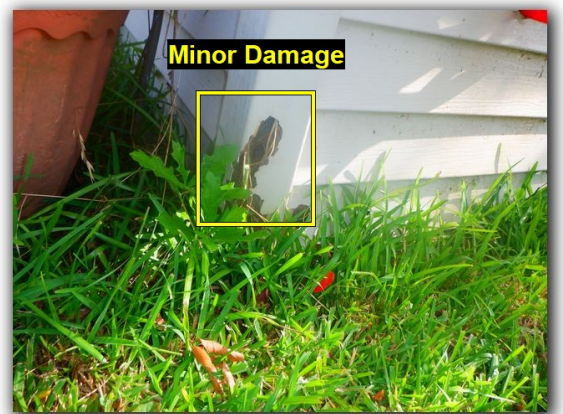
*Observed minor damage to exterior siding in one or more areas.*

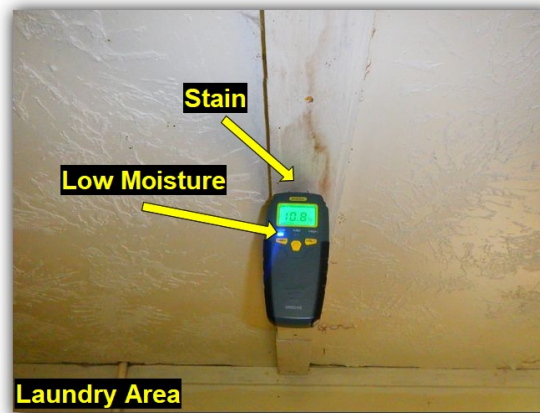
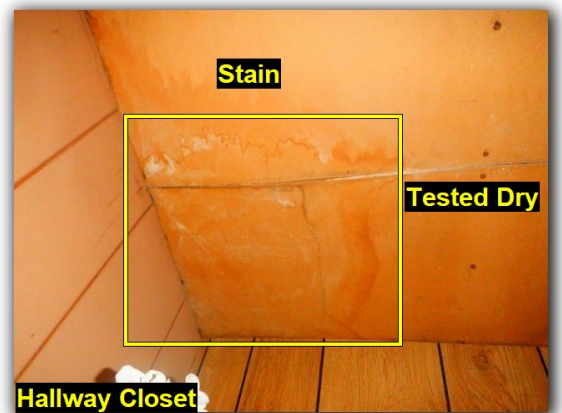
*Observed water stains on the ceiling in the, including but not limited to: Laundry area, right rear bedroom and hallway hall closet. Moisture readings were low at time of inspection which usually indicates the stains are from previous leaks, but I could not be certain. Recommend asking the seller about previous leaks that may have been repaired or having further evaluation by a contractor.*

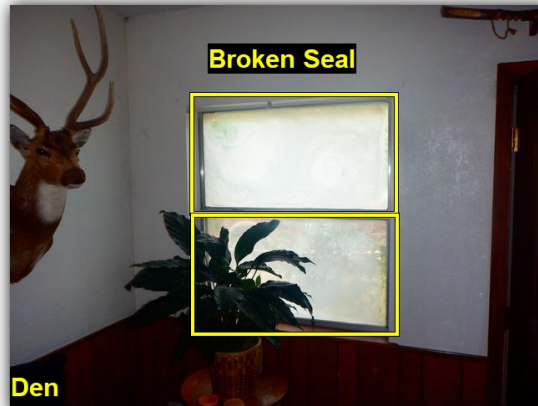
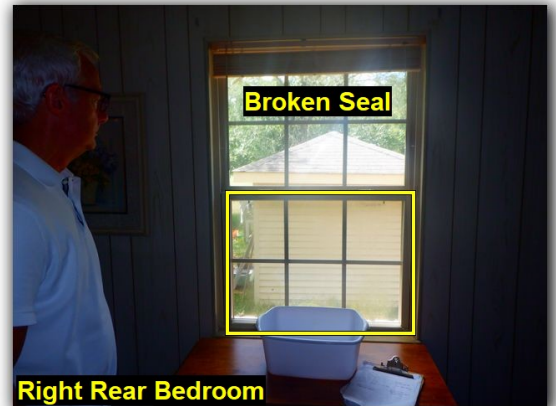
Observed the thermal seal was broken on five or more windows, including but not limited to: Den and right rear bedroom. A broken seal allows condensation to form between the panes which causes a cloudy film to develop. This cloudiness will continue to get worse until it is difficult to see out of the window.

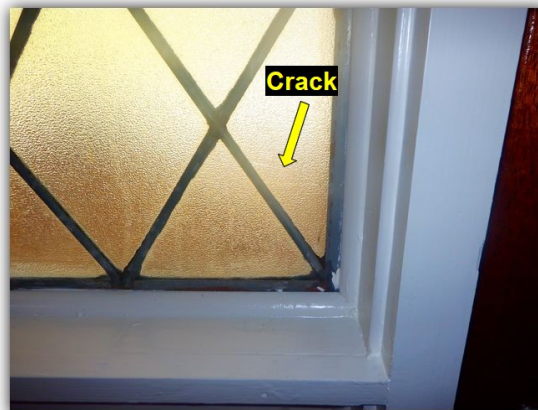
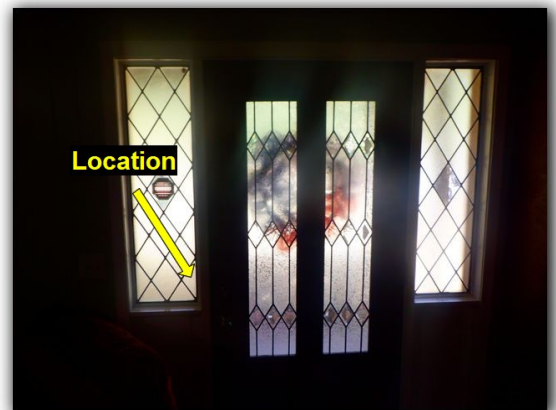
Observed one or more broken window panes.

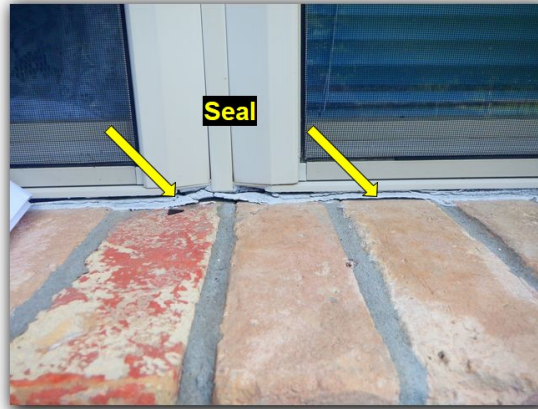
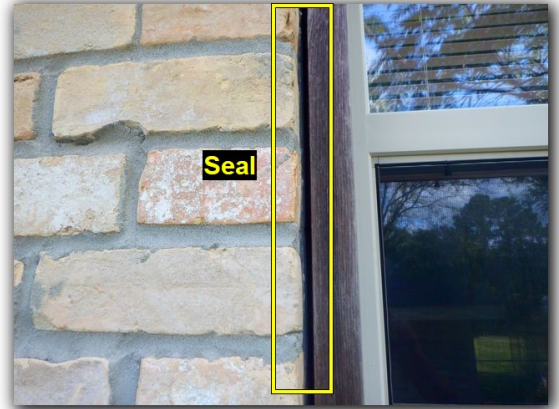
Recommend sealing the exterior of windows.

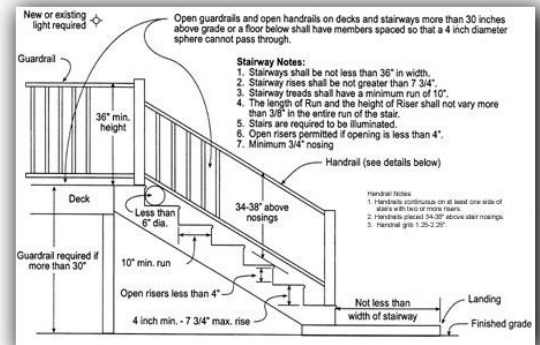
Observed the stairs in the garage and barn were not up to current standards with deficiencies that may include, but are not limited to; riser height, riser variance, improper handrail and baluster spacing. Note: Standards for stairs have changed significantly since time of construction.

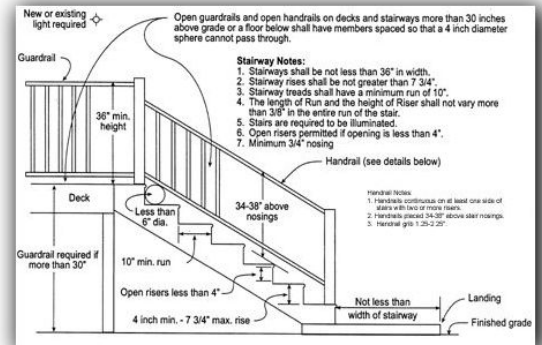
Observed the stairs were not up to current standards with deficiencies that may include, but are not limited to; riser height, riser variance, improper handrail and baluster spacing. Note: Standards for stairs have changed significantly since time of construction.

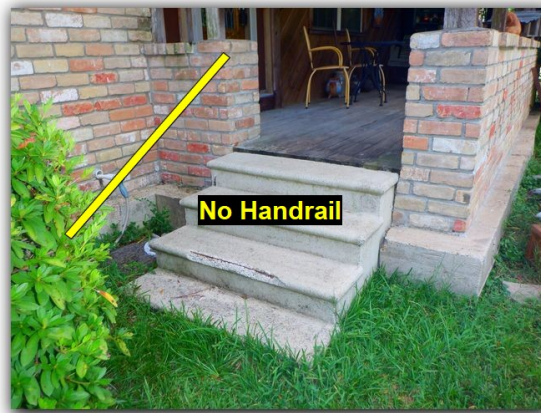
Did not observe a handrail for all exterior stairs. Current standards call for a handrail to be in place whenever there are 4 or more risers.

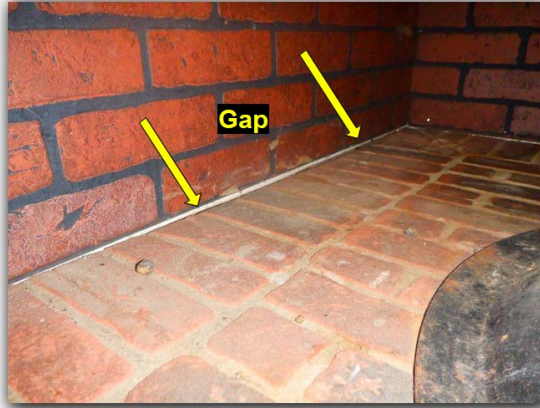
Observed the wood burning stove has gaps between the fire shield (wall) and the hearth (floor). In need of repair.

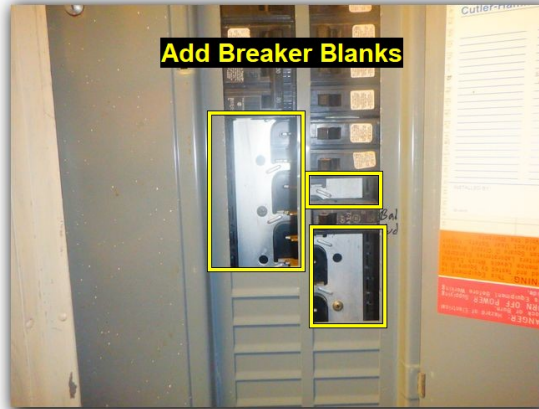
Observed breaker blanks missing from the panel cover. When a breaker is removed, breaker blanks should be installed to properly secure the panel.

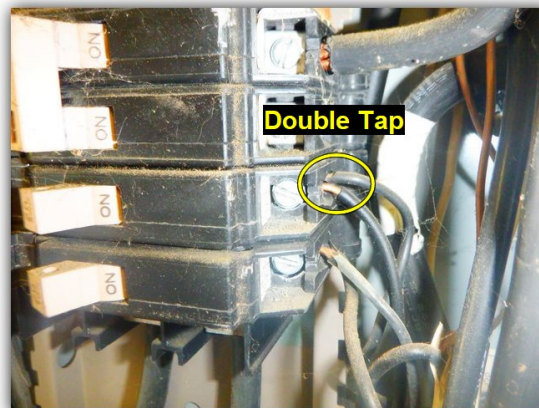
Observed two conductors attached to a single breaker in multiple areas (Double Tap). Current electric codes permit only one conductor to be attached to a single breaker.

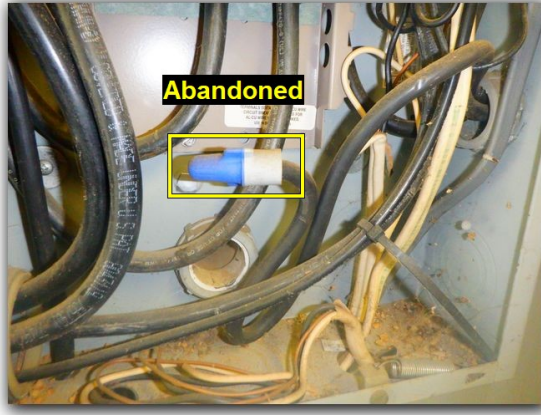
Observed multiple abandoned large electrical conductors in the main service panel and sub panels. Recommend further evaluation by a licensed electrical contractor for further evaluation.

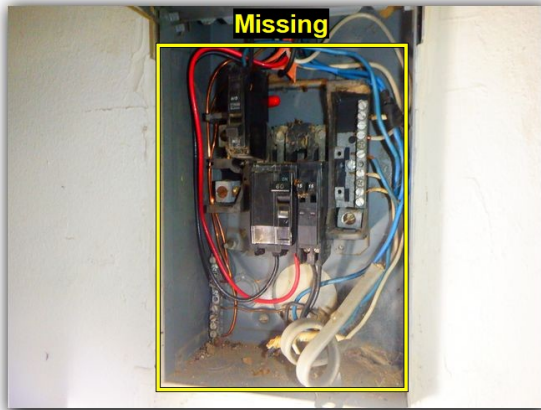
Observed one or more sub panels missing the dead front cover. In need of replacement.

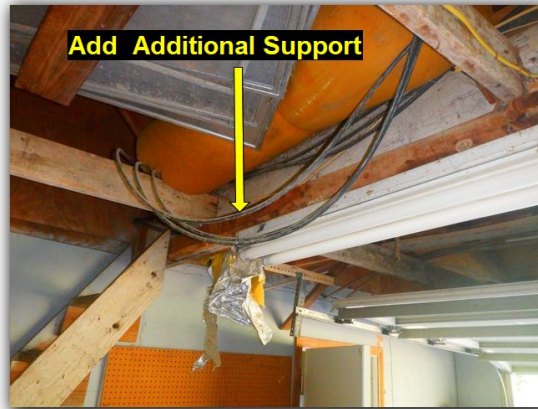
Observed electrical wiring not properly supported in the garage. Current standards call for all electrical wiring to be supported at a 4.5 foot maximum span.

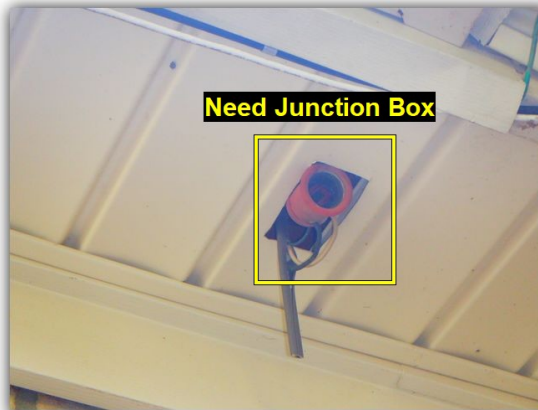
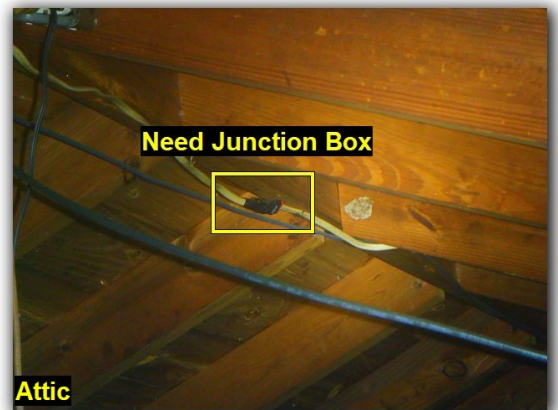
Observed one or more splices in wiring that were not properly secured inside a junction box.

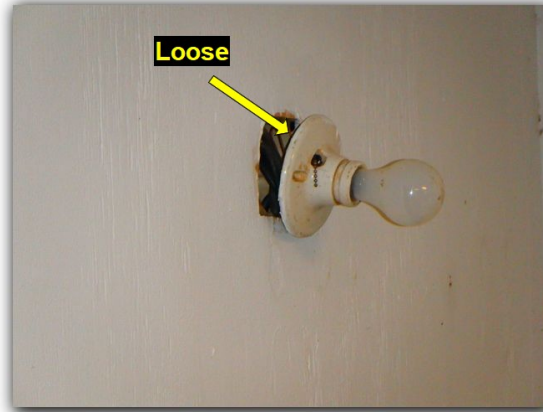
*Observed multiple loose light fixtures. In need of securing.*

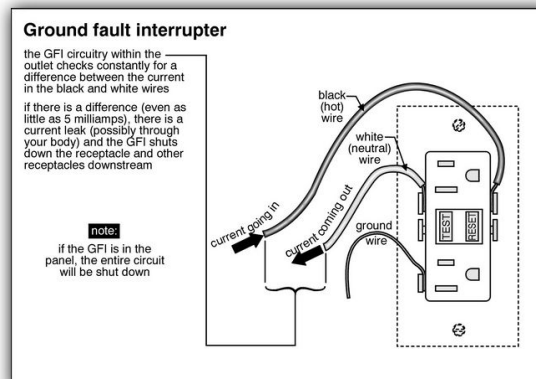
Did not observe GFCI protection for all outlets in required locations including, but not limited to; all kitchen, laundry area, garage, all bathrooms and exterior. Current standards call for GFCI protection for all outlets in kitchen, bathrooms, laundry room, garage, exterior and any outlet that is within 6 feet of a water source. This is a recognized safety hazard.

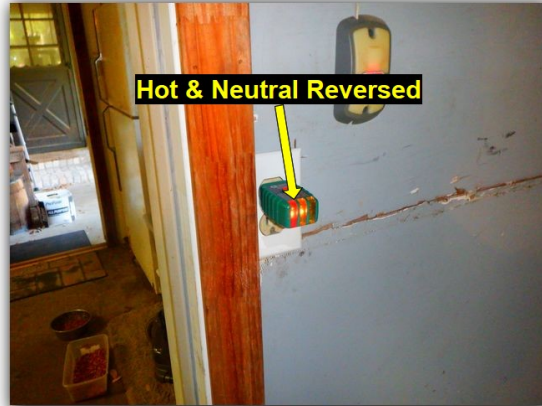
Observed multiple outlets not wired properly. The hot and neutral wires are reversed. Recommend further evaluation by a licensed electrical contractor.

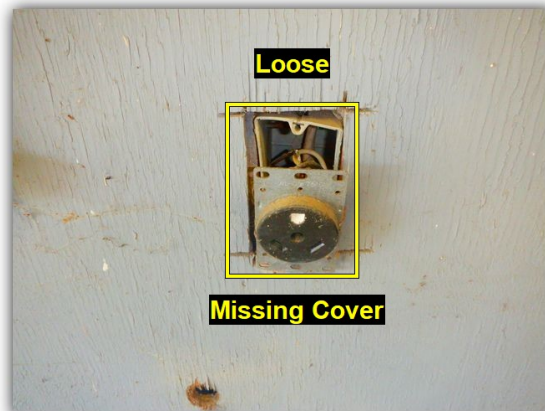
*Observed one or more loose outlets.*

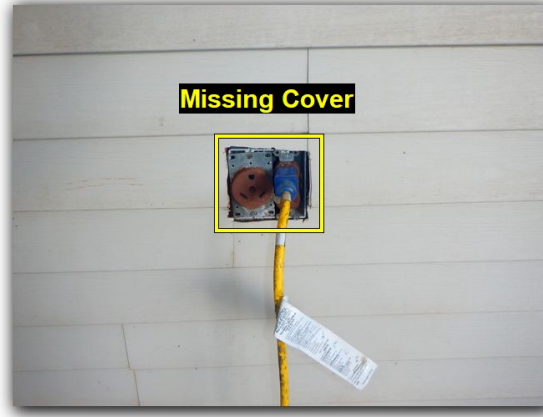
Observed multiple exterior outlet missing the weatherproof cover. In need of repair.

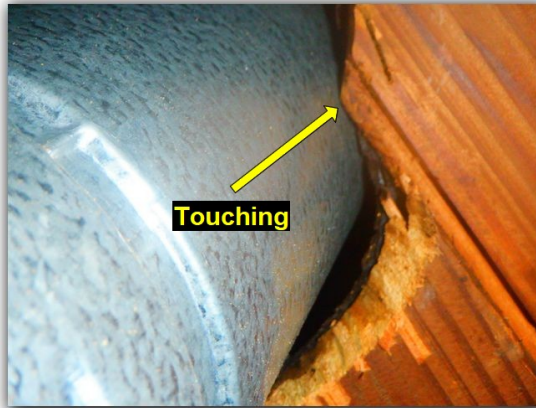
Observed the exhaust duct for the furnace was in contact with the roof decking. Current standards call for at least a one inch separation from all combustibles including insulation. This is a fire hazard. In need of repair.

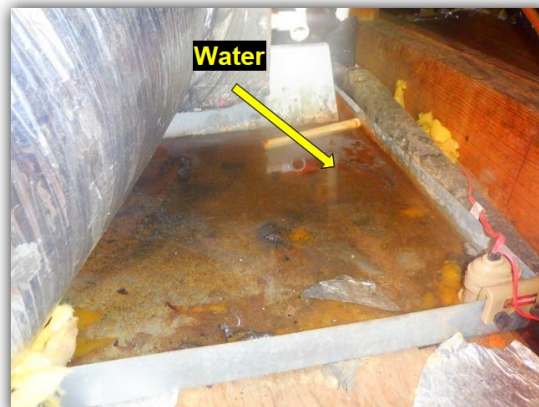
Observed water in the drain pan of the ac unit above the laundry area.. This usually means the primary line has become clogged or blocked. Recommend consulting a licensed HVAC technician.

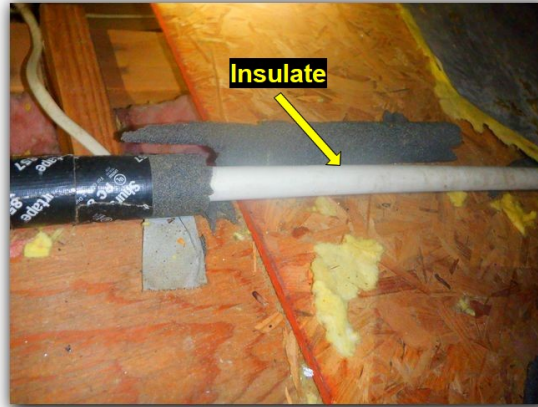
Observed the condensate line was missing insulation in the attic. Condensate lines will sweat and can drip condensation. Recommend insulating exposed areas of condensate line.

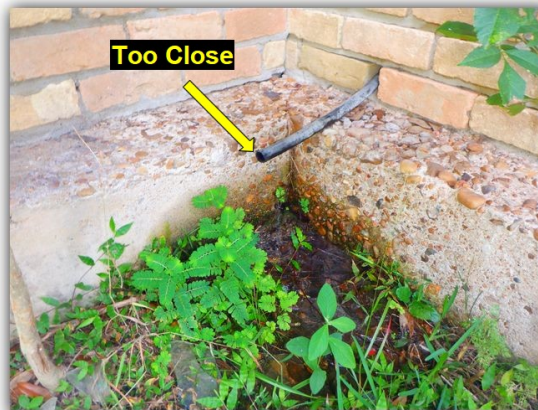
Observed the condensate line for the air conditioner was terminating too close to the home. Recommend adding an extension so the condensation does not drip close to the foundation.

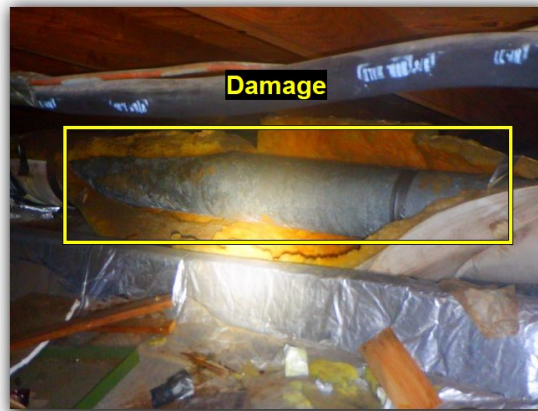
Observed multiple damaged ducts in the attic. Recommend further evaluation by a licensed HVAC technician.

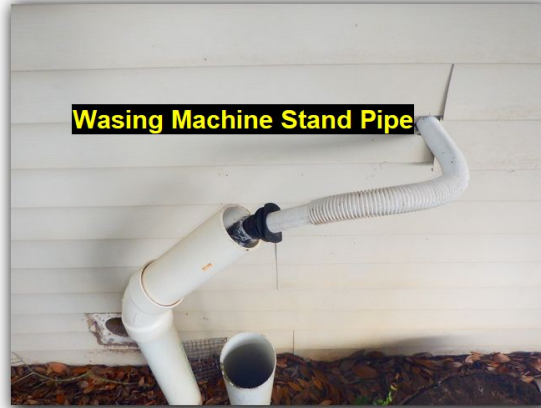
Observed an unconventional standpipe drain for the washing machine. Recommend consulting a licensed plumbing contractor for further evaluation.

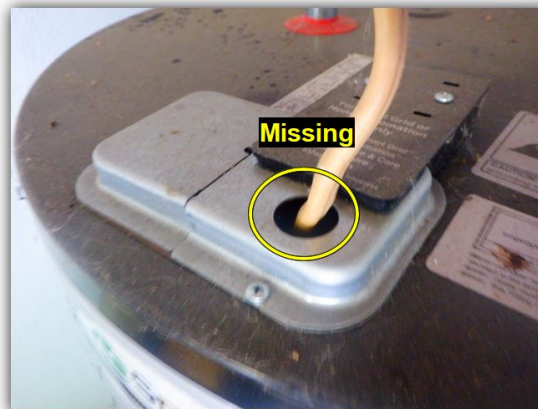
Observed protective grommet(s) missing from water heater top cover panel. The grommet(s) protect the electrical wiring from being damaged by the metal panel.

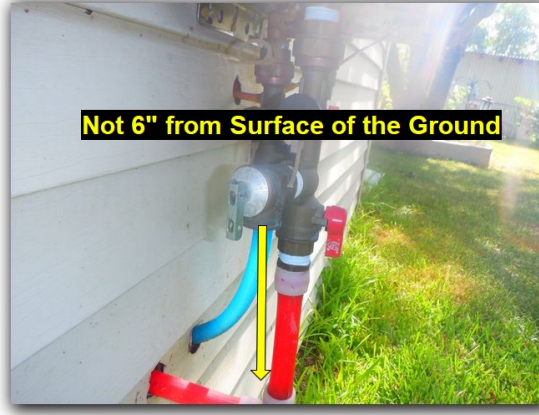
Did not observe a drain line for the TPR valve at tankless water heater. Current standards call for the TPR valve to have a drain line that terminates no higher than 6" from the surface of the ground.

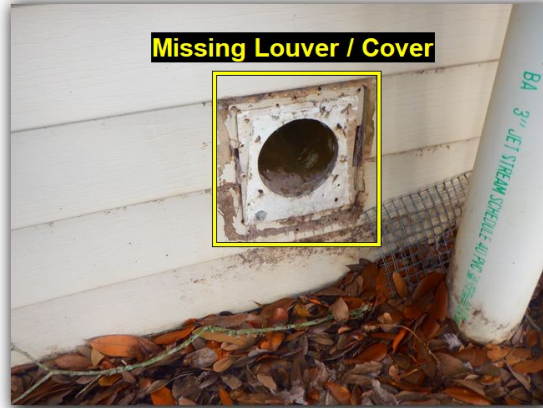
Observed the exterior dryer vent missing the louver and cover. In need of repair.

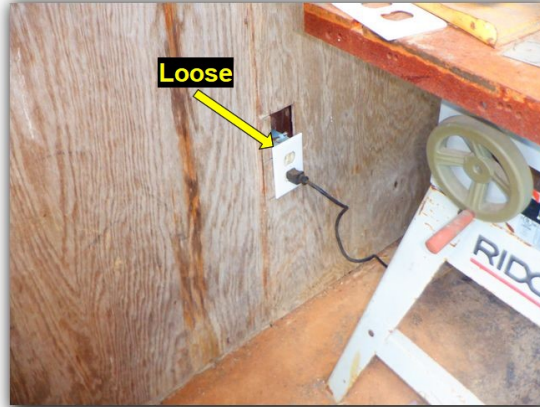
*Observed multiple loose outlets.*

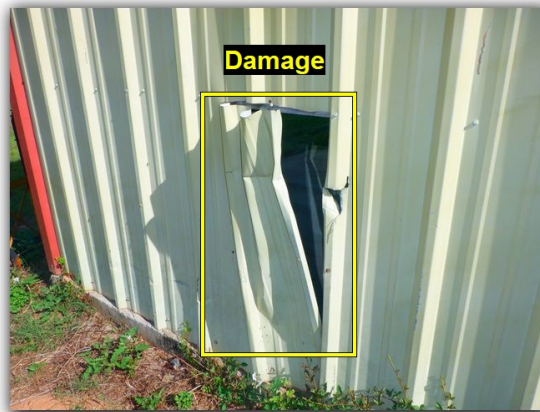
*Observed damage to the exterior siding in one or more areas.*

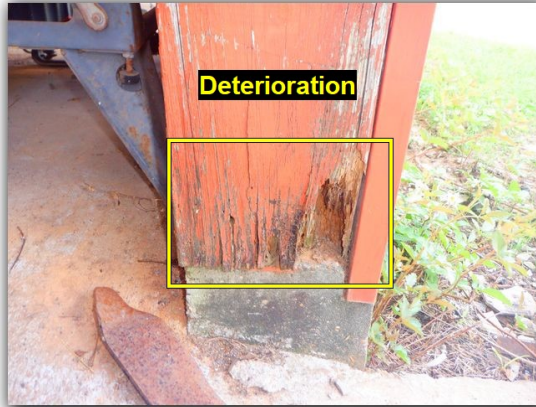
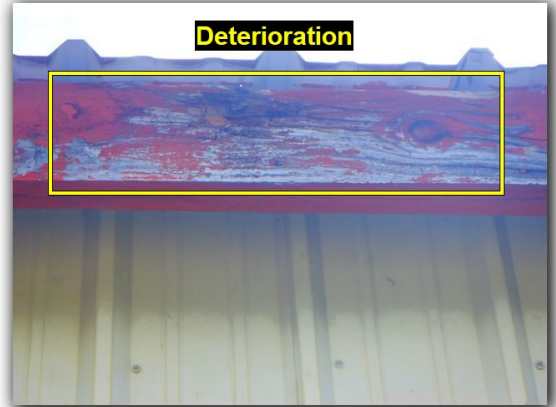
Observed wood deterioration to multiple areas of the fascia and trim boards. Recommend coating with a weather resistant paint to slow the deterioration process.

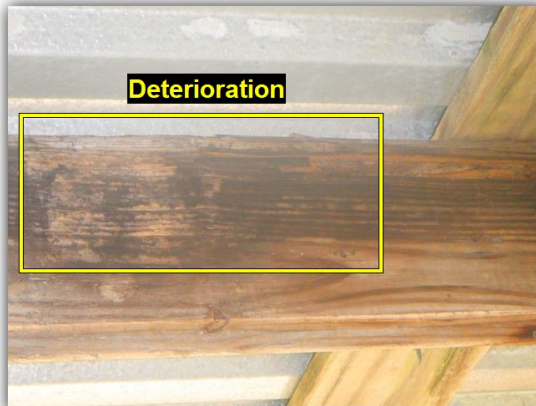
Observed wood deterioration to multiple roof rafters of the carport attached to the back of the barn. Recommend coating with a weather resistant paint to slow the deterioration process.

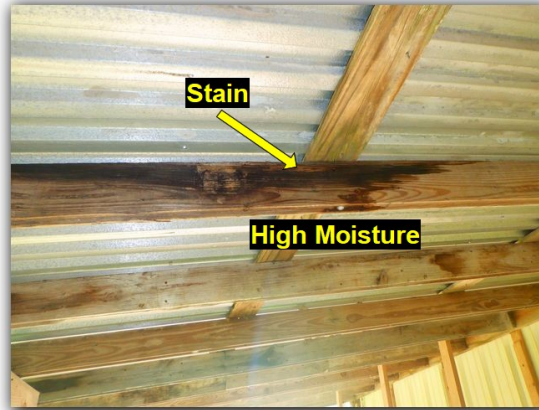
Observed water stains on the roof decking in the carport attached to back of the barn. Moisture readings were high at time of inspection. Recommend further evaluation by a professional roofing contractor.

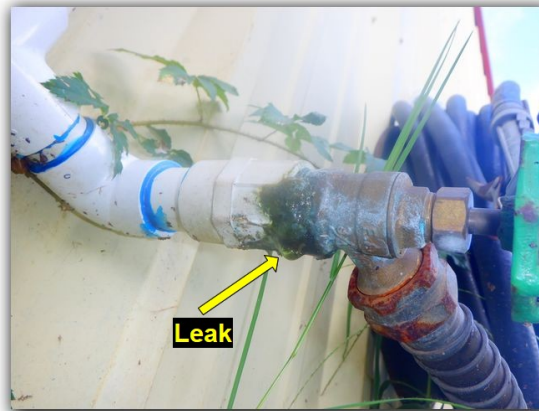
Observed a hose bib leak at the left rear corner of the barn. In need of repair.

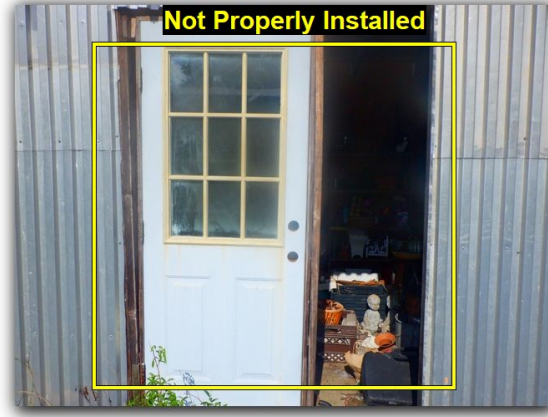
Observed the small storage shed does not have a properly installed door.
