## Property Inspection Report

3923 Laguna Dr, Galveston, TX 77554

Date of Inspection: 5/20/2020 Time: 10:00 AM - 12:30 PM

Inspector: Ruben Vasquez

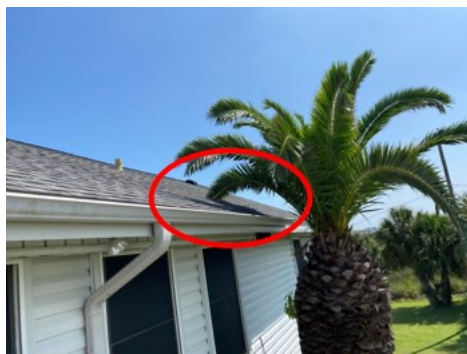
Foliage was noted close to the structure. We recommend trimming all bushes away from structure. Bushes and trees too close to the structure can prevent the wall from drying properly, their roots can affect the foundation, and their branches can damage the structure. This was located on the right.

Right: foliage close to structure

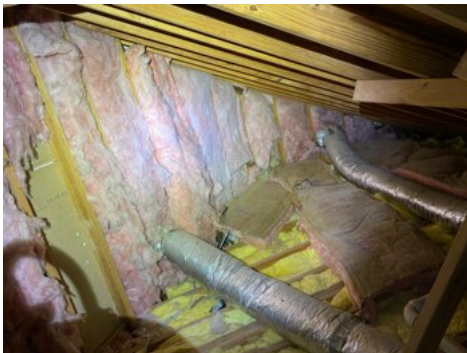
Per today's standards, insufficient insulation was observed in the attic space. Insulation improvements may be cost effective, depending on the anticipated term of ownership.

Insulation needs improvement

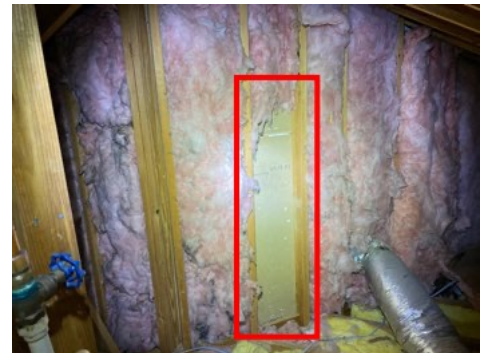
Vertical insulation had fallen in the attic space. We recommend having this replaced to for added energy efficiency.

Front: fallen vertical insulation

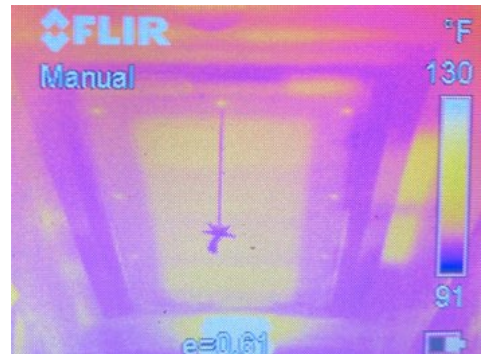
The pull-down stair to the attic was not insulated. We recommend adding insulation for improved energy efficiency.

Pull-down stairs lacked insulation

Thermal image of pull-down stairs lacking insulation

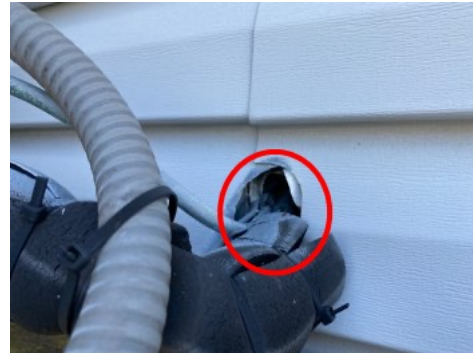
A hole was noted where the air conditioning refrigerant lines entered the structure. We recommend sealing the area with foam insulation to prevent pest intrusion. This was located on the left.

Left: hole in wall at ac lines

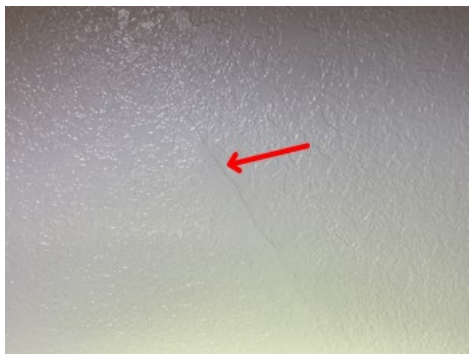
Hairline cracks which were by nature mainly cosmetic were noted on the ceiling. We recommend having these caulked and painted. This was observed in the kitchen.

Kitchen: hairline cracks

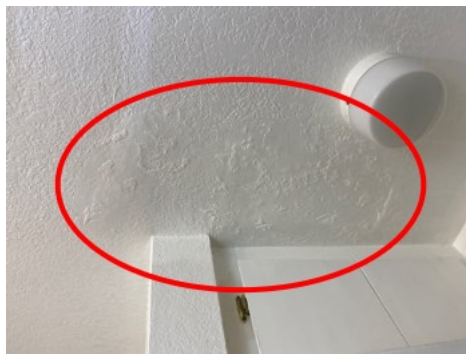
Evidence of patching was detected which indicates previous work performed. We recommend monitoring. This was observed in the bathroom 1.

Bathroom 1: patching

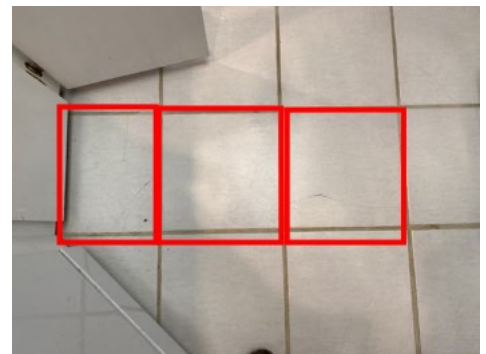
Cracked floor tile was noted in the house. The tile sounded solid when knocked on. We recommend monitoring and replacing if the condition gets worse. This was noted in the kitchen.

Kitchen: cracked tiles

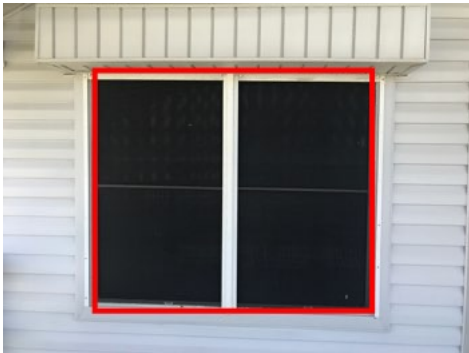
The windows were equipped with solar screens. This limited our visibility of the windows from the exterior. If this is a concern, we recommend having the solar screens removed and the windows further evaluated. This was noted around the house.

Around House: solar screens installed

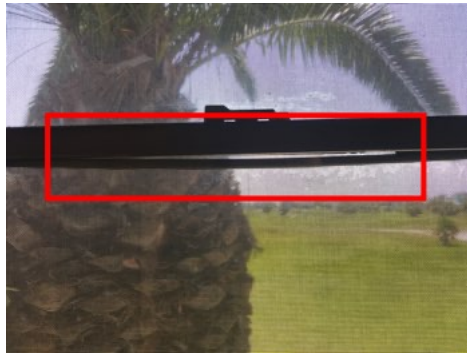
Damaged/loose weather stripping was noted on a few windows in the house. We recommend having these repaired to reduce air infiltration and help keep the pane secure.

Living Room: loose weather stripping

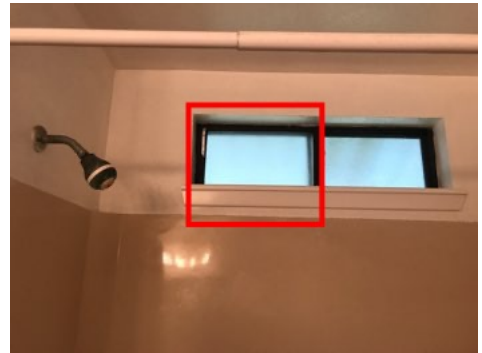
A window was inoperative. We recommend having this repaired/improved to allow proper use as intended and an egress.

Bathroom 2: inoperable window

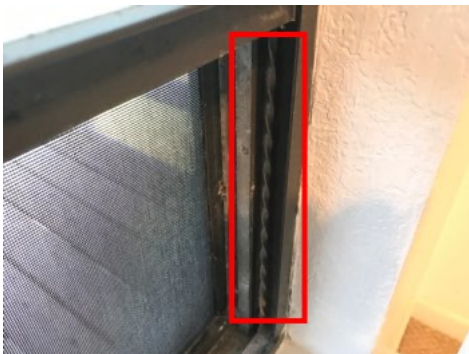
Window hardware was damaged. We recommend repair. This was noted in the dining room, living room.

Dining Room: damaged hardware

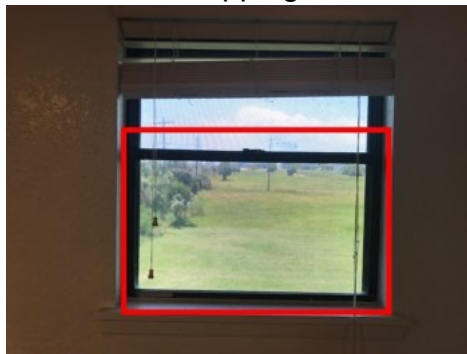
A window would not stay open at the time of inspection. This is a potential safety hazard. We recommend having this repaired. This was found in bedroom 2.

Bedroom 2: window would not stay open

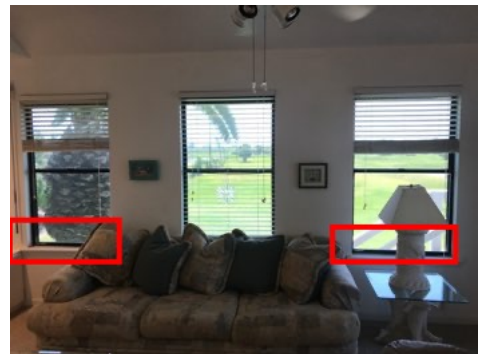
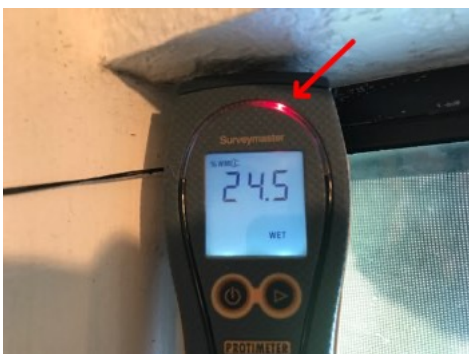
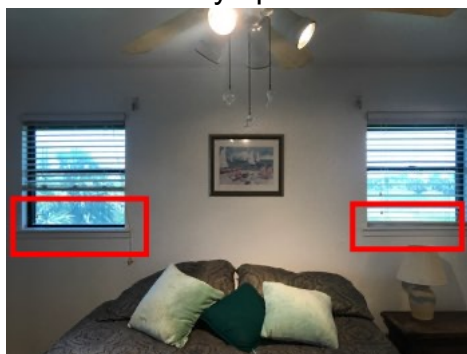
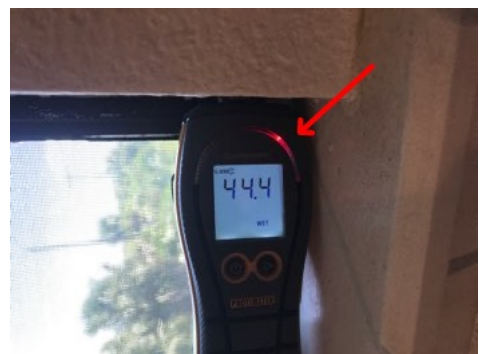
Elevated moisture was noted near or at a sill. The cause for the moisture should

be determined and repairs undertaken, if necessary, to prevent structural damage. This was observed in the living room and bedroom 2.

Living Room: elevated moisture levels at window sills

Living Room: elevated moisture levels at window sills confirmed

Bedroom 2: elevated moisture levels at window sills

Bedroom 2: elevated moisture levels at window sills confirmed

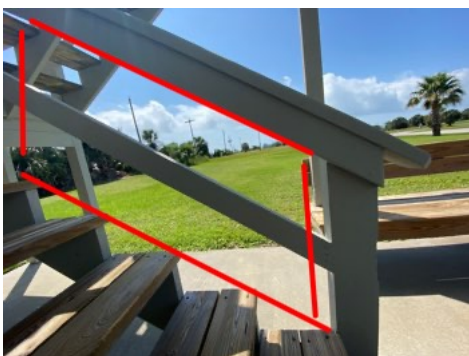
The sloped handrail assembly at the stairway had spaces between the spindles which allowed the passage of a 4 3/8-inch sphere. To improve child safety, we recommend altering the handrail assembly in a manner which will prevent the passage of a 4 3/8-inch sphere.

The sloped handrail in such as way that made it climbable by children. This condition is a potential fall hazard. We recommend that steps be taken to alter the handrail assembly so that it is no longer climbable by children.

Handrail: Spindles more than 4 and 3/8" apart(climbable)

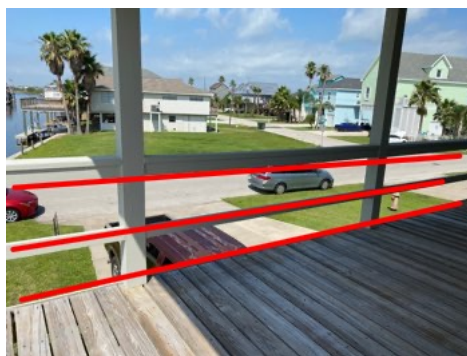
The horizontal guardrail assembly at the stairway had spaces between the spindles which allowed the passage of a 4-inch sphere. To improve child safety and comply with generally-accepted current safety standards, we recommend altering the handrail assembly in a manner which will prevent the passage of a 4-inch sphere. This includes areas beneath and to the sides of the guardrail.

The horizontal guardrail assembly at the stairway had components which made it climbable by children. This condition is a potential fall hazard. We recommend that steps be taken to alter the guardrail assembly so that it is no longer climbable by children.

Guardrail: Spindles more than 4" apart(climbable)

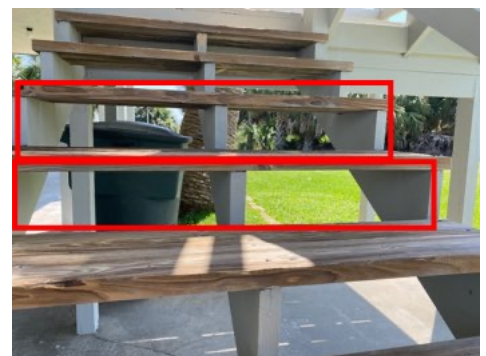
The stairway had open risers in which the space between treads allowed the passage of a 4-inch sphere. In staircases having 4 or more risers, such as this one, the space between treads should be less than 4 inches for child-safety reasons. We recommend correction.

Open risers

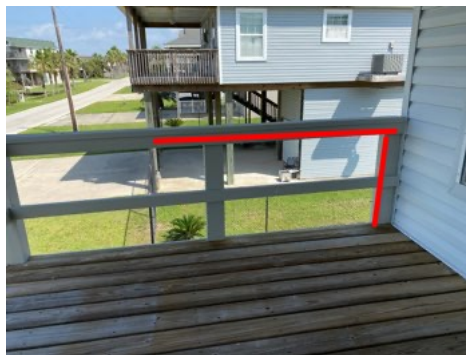
The horizontal guardrail assembly at the balcony was loose which for safety reasons should be securely fastened. We recommend having this improved.

Balcony: guard rail loose

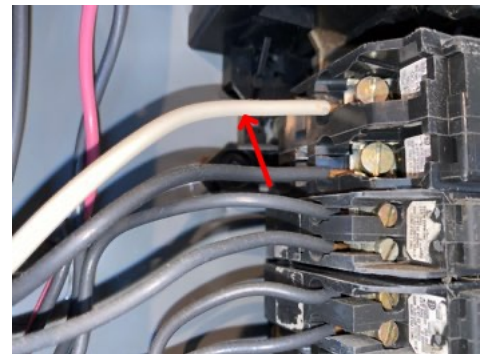
An ungrounded conductor (hot) was improperly identified. We recommend having this permanently re-identified.

Conductor improperly color labeled

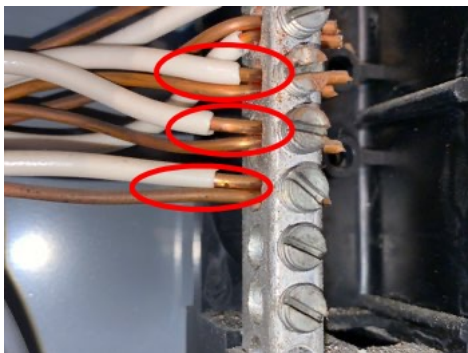
Ground and neutral conductors were under the same terminal. This conditions is improper per today's standards. We recommend repair.

Grounds and neutrals under the same terminal

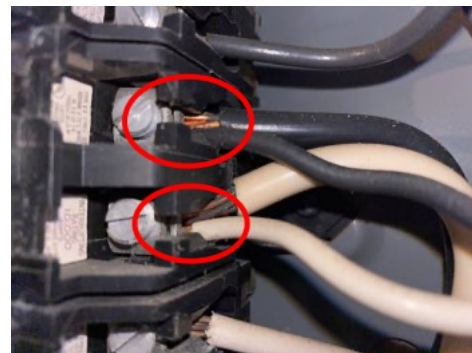
Two wires were connected to a breaker designed for only one wire. This is known as a "double-tap" and is a defective condition. We recommend repair.

Double tapped breakers

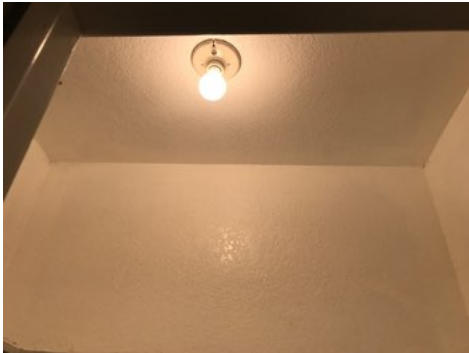
Today's standards require having a globe cover protecting closet light fixtures. We recommend making the upgrade for improved safety.

Closets: Globe missing

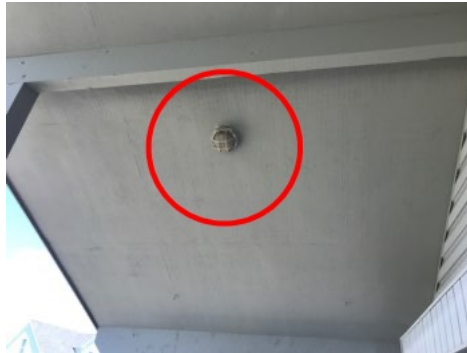
An inoperative light fixture was noted in the house. We recommend replacing the bulb. Should this not resolve the issue, we recommend having the fixture repaired/replaced. This was observed on the front porch, rear garage.

Front: inoperative fixture

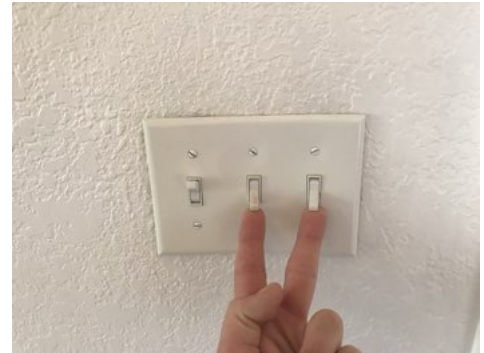
We found an electrical switch and were unable to determine its operation. We recommend consulting with the sellers. This was observed in the living room.

Living Room: unable to determine operation

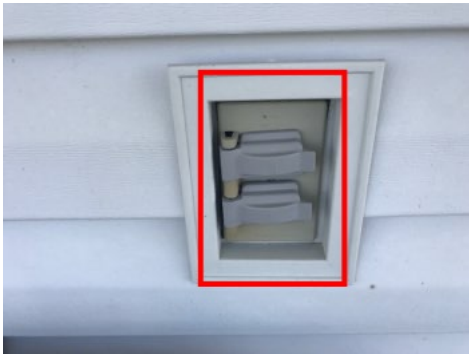
Today's standards require having a bubble cover on all exterior receptacle outlets exposed to the elements. We recommend making the upgrade.

Exterior: Bubble cover recommended

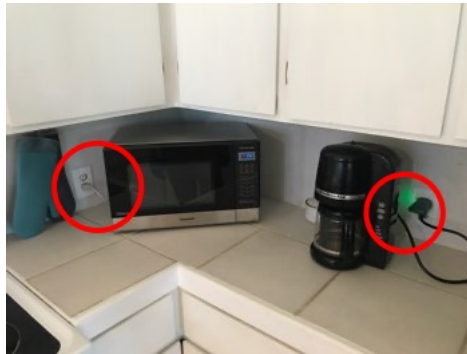
A receptacle outlet was found to not be protected by a Ground Fault Circuit Interrupter (GFCI) receptacle. Today's standards require GFCI protected outlets be installed in basements, crawlspaces, garages, the home exterior and interior receptacles located within 6 feet of a plumbing fixture to avoid potential electric shock or electrocution hazards. We recommend having this repaired per today's standards. This condition was observed in the kitchen, garage.

Kitchen: outlets not GFCI protected

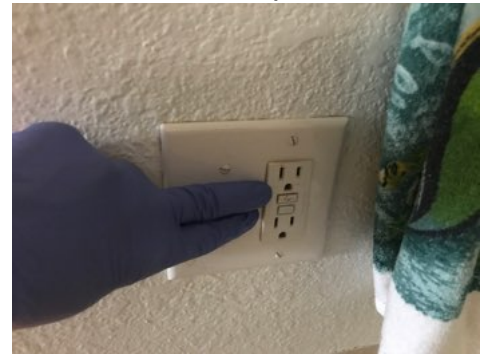
A Ground Fault Circuit Interrupter (GFCI) electrical outlet in the home did not re-set, was slow to re-set or made a buzzing sound when re-set. This is a safety issue. We recommend replacement of this GFCI outlet to ensure that it operates correctly when required. We observed this in bathrooms 1&2.

Bathroom 1: deteriorated GFCI, would not reset

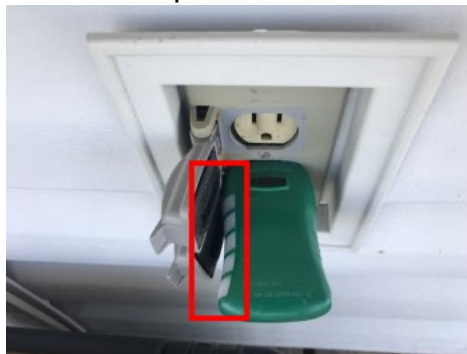
An outlet did not have power at the time of inspection. We recommend having this further investigated to determine the cause and have any necessary repairs made. This was found on the front porch.

Front Porch: no power at outlet

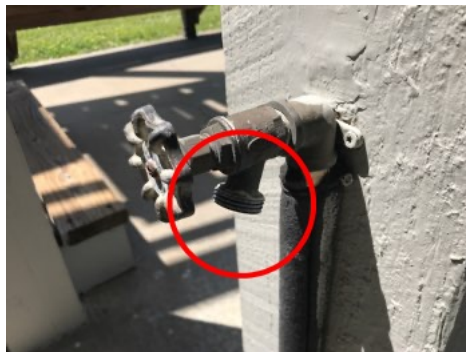
Around house: Back flow preventer recommended

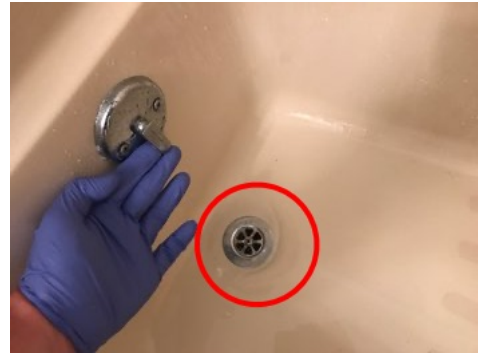
Bathroom 1: inoperable stopper

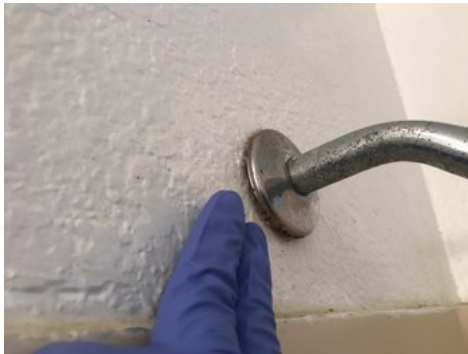
All shower and bathtub handles, faucets, spouts and shower heads should be caulked at the wall. Be sure to caulk any gaps that may appear between the hardware & tile of the fixtures or shower enclosures. Most tile surfaces will have gaps in the grout that can also allow for water penetration past the tile work. A leak in any one of these areas can cause concealed structural damage that would not be obvious in a visual inspection.

Caulk needed at bathroom wall protrusions

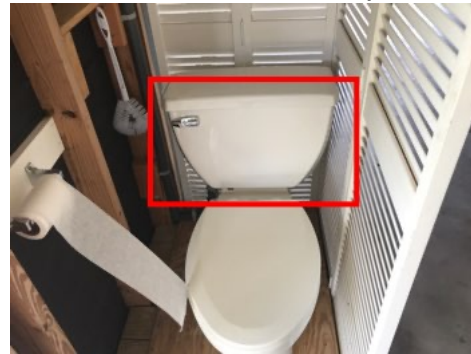
Garage: loose toilet tank

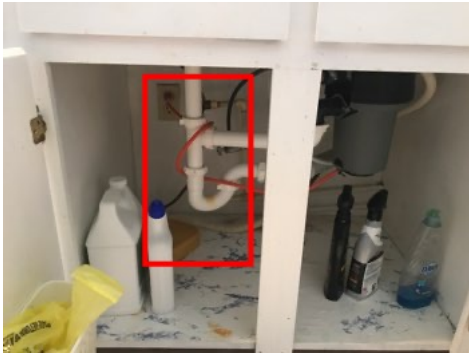
Kitchen: leak at drain

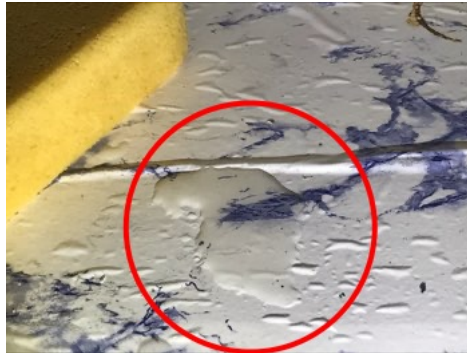
Kitchen: water on cabinet floor from leak at drain

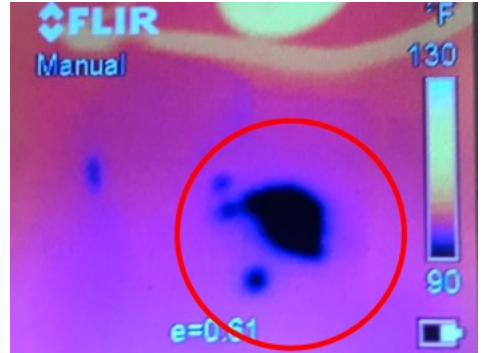
Kitchen: thermal image of water on cabinet floor from leak at drain

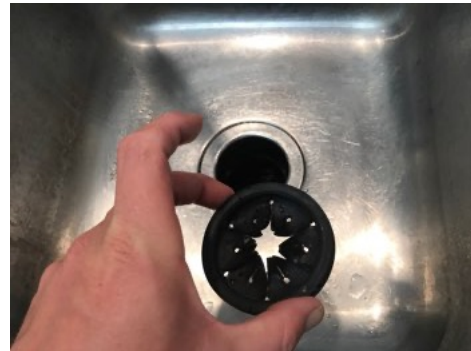
The garbage disposal was missing the splash guard at the time of the inspection. We recommend a new insert be installed to prevent injury from items ejected during disposal operation.

Detached splash guard
