# Acadian Home Inspection LLC

## PROPERTY INSPECTION REPORT

**Concerning:** 24430 Sundance Spring Dr, Porter, TX 77365  
(Address or Other Identification of Inspected Property)

**By:** Thomas Christopher Duhon, Lic #10577 09/11/2019  
(Name and License Number of Inspector) (Date)

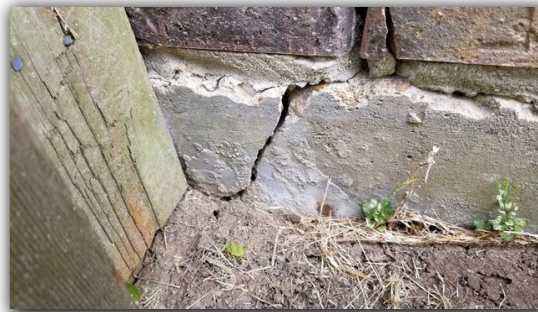
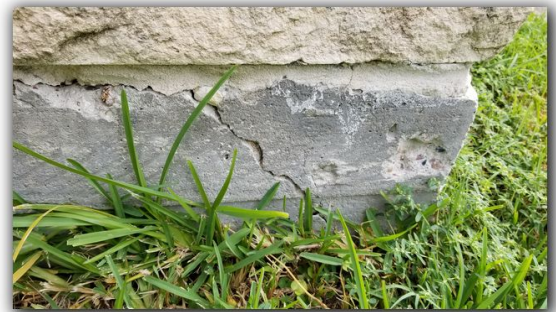
Corner cracks visible at one or more corners of exterior foundation. These are common and usually do not indicate a foundation problem. However, non-repaired corner cracks could lead to brick separations or loosening over time at corner areas.

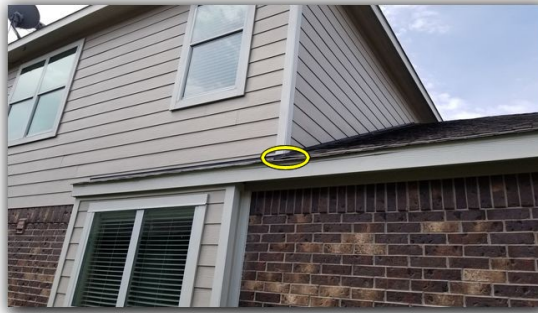
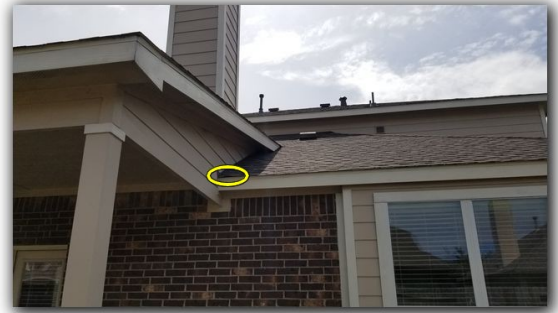
Lifted or wavy flashing noted at lower north east side and lower north side of roof covering. Flashing should be made to lie as flat as possible and all exposed nail heads

should be properly sealed over to prevent moisture penetration.

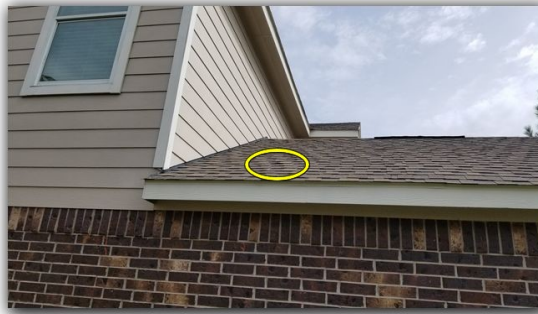
Numerous shingles, at lower south west side roof coverings, have lifting shingles and or lifting corners at shingles. All roof shingles that are lifting or have lifting corners need to be properly re-secured to lie flat, or need to be replaced and rechecked by manufacturer's representative, roofing contractor, or inspector for integrity and warranty.

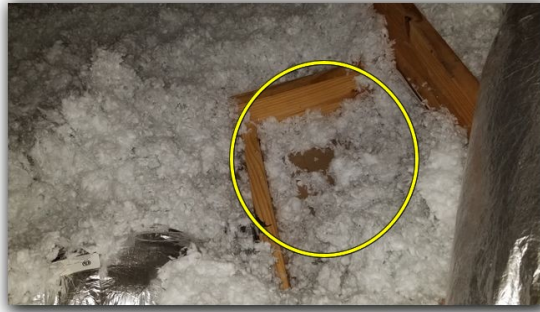
Batt and or blown – approximately R-30, as per builder tag. Insulation appears adequate. Redistribute/install insulation evenly in attic above/beside all air conditioned spaces as needed for better energy efficiency.

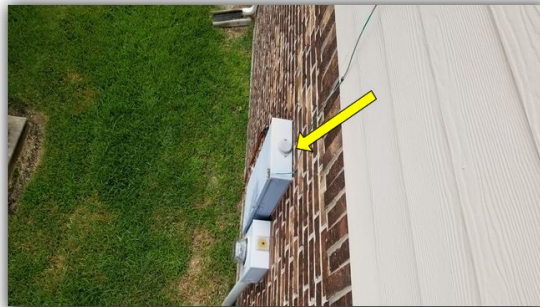
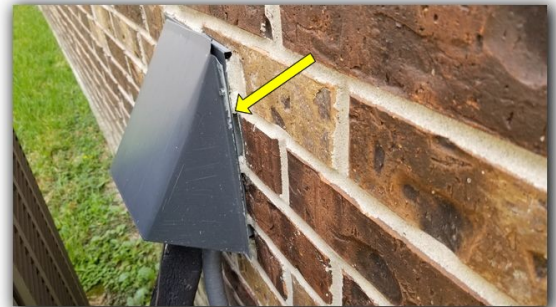
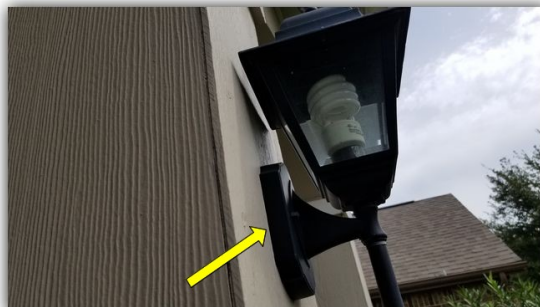
As is standard in new home construction, recheck for and seal around all exterior wall penetrations, as required when home was built or recommend as per current standard around all outlets, conduit, J-boxes, panel box, main panel, electric meter, electric gutter box, A/C disconnect, A/C flashing box, foam spray where A/C lines enter flashing boxes, exhaust vents, CATV / CAT5E cable, doorbell, drain lines, clean-outs coach / jar lights, etc. at exterior siding, brick, stucco, and stone walls.

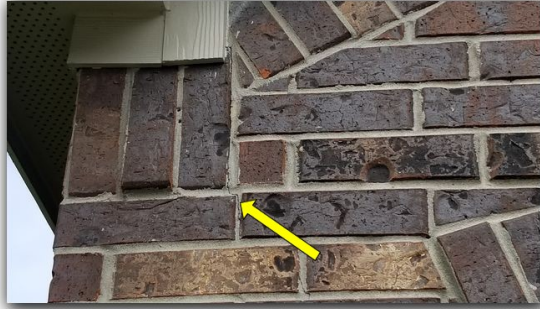
Mortar/stair step cracks noted at multiple areas around brick exterior. Theses appear to

be cosmetic and not structural in nature and can be repointed if buyer desires.

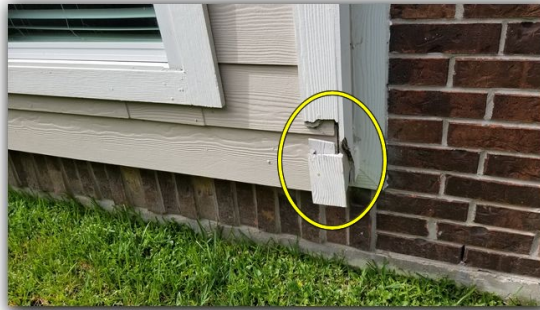
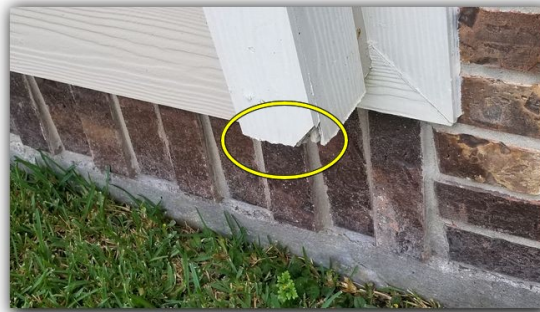
Area of deterioration/damage is noted at north and east sides of exterior siding and/or trim. All deteriorated/damaged areas should be properly repaired and sealed, as needed, to prevent moisture penetration.

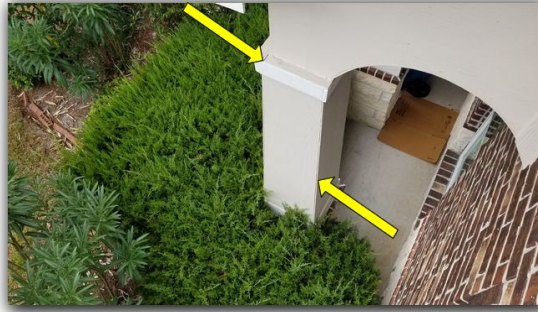
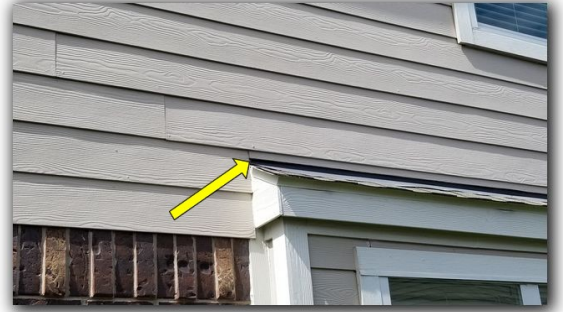
Seal and paint exterior siding/trim at nail heads, overlap edges, butt joints, separations, vertical joints.... etc. to prevent water penetration at dings, scuffs and holes to extend life.

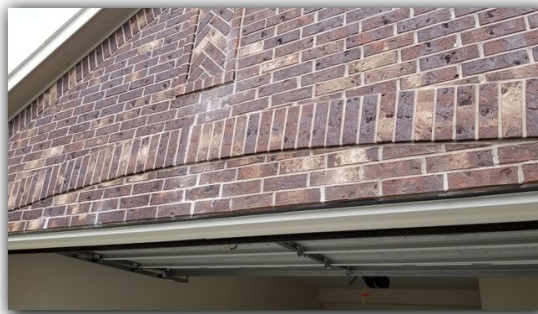
Install weep holes, required since 1992, at brick above lintels at maximum of 33" spacing above windows, entrance / exit jambs, garage overhead door jambs and elsewhere where lintels noted.

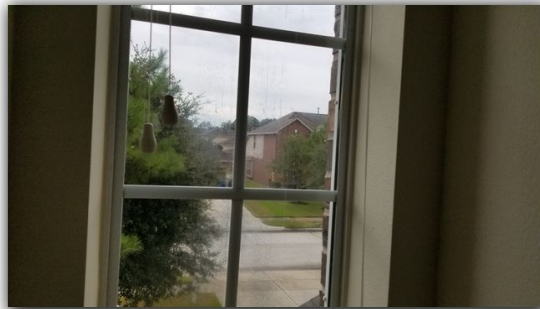
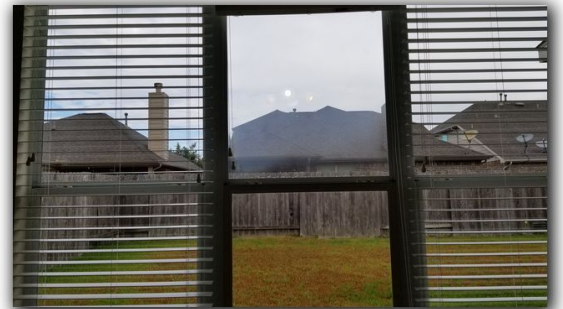
Cloudy or moisture noted at double pane windows could indicate seal failure.

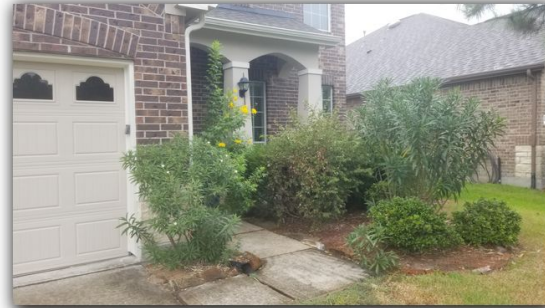
Vegetation, plants, bushes, trees need cut back at least 3' from roof exposures lowered and cut back at least 1' from around house and/or garage including vines for observation of exterior walls / overhang and slab to reduce conducive conditions for wood destroying insects and to protect and extend life of exterior from weathering.

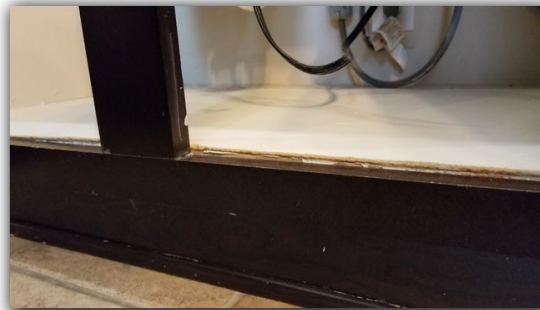
Swelling and/or evidence of moisture exposure noted at bottom panel in cabinets under kitchen sink.

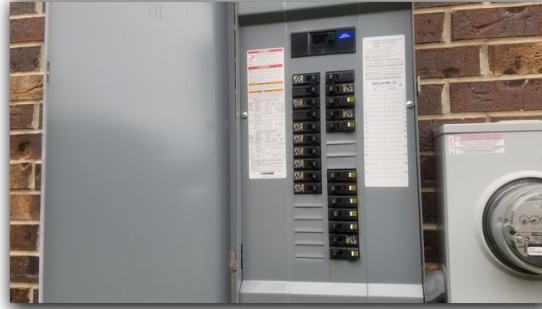
Square D 125 amp main panel box with aluminum feeder wire noted at east exterior.

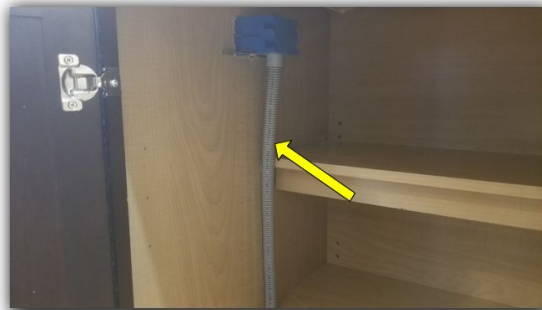
Properly secure flexible cable sheathing within 12" of J-box in kitchen island cabinet.

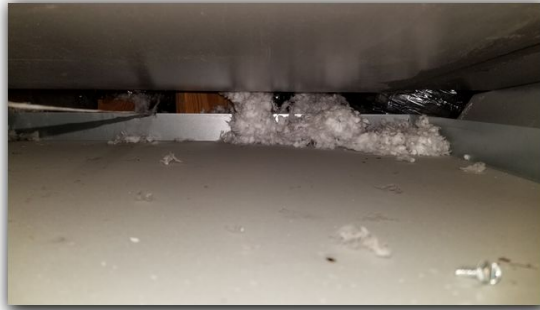
Remove all debris including rust at A/C emergency drain pan(s) to prevent possible restrictions forming at drain line.

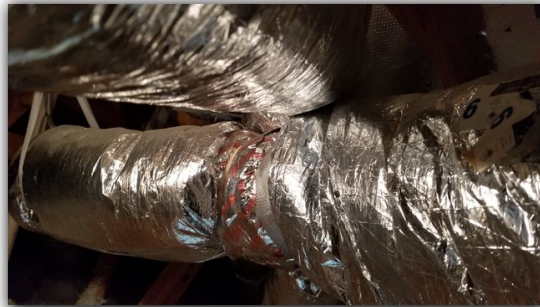
Install insulation or other approved material between ducts coming in contact with one another to prevent possible condensation forming as needed in attic.

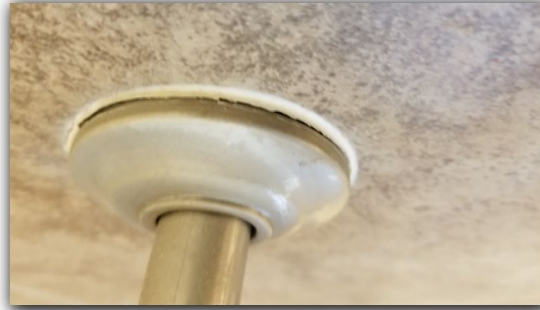
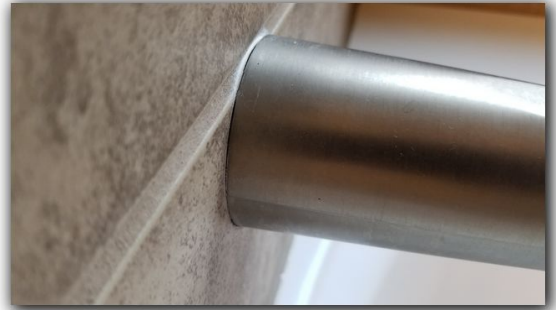
Non-sealed escutcheons at shower walls at all bathrooms should be caulk/sealed to prevent moisture penetration. Such as shower arm escutcheons, tub spouts, faucet controls..etc.

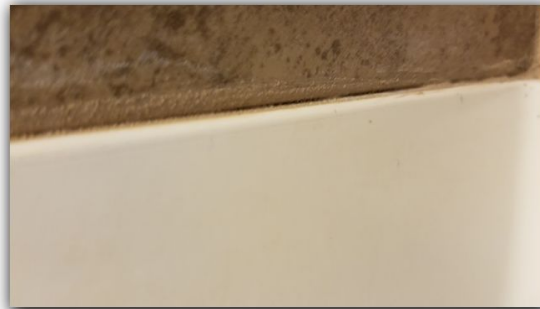
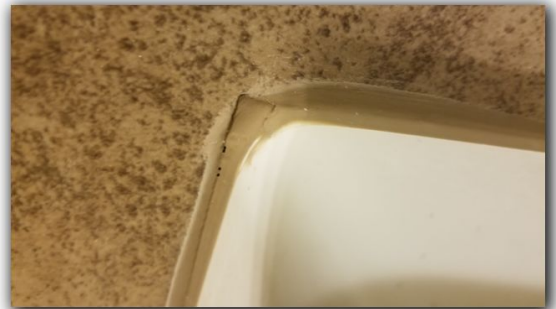
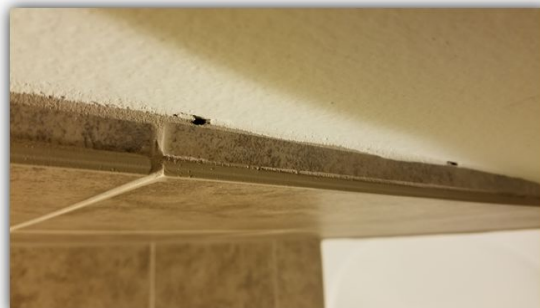
Caulk, grout caulk, or grout, as needed, all cracks at all bathroom shower wall/ tub surround corners, at tub, at ceiling, curbs, steps, and between tiles to prevent moisture penetration.

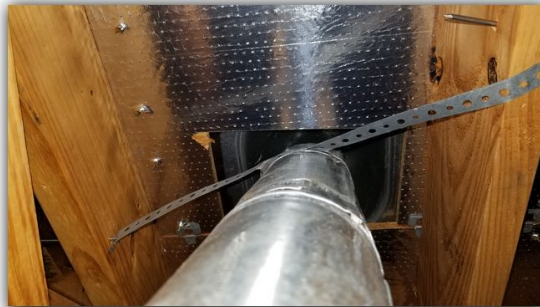
Adjust flue or cut back roof decking for minimum 1" clearance to decking as needed and strap flues between rafters under roof jacks in attic for stability. Be sure flue is at least 1' above roof to maintain a minimum 5' overall length required from unit to termination.

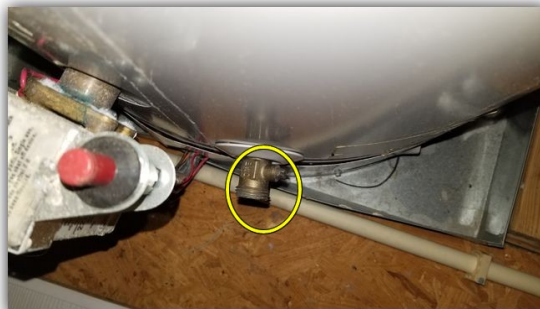
Adjust or increase size of emergency drain pan so that unit's drain cock is positioned over pan.

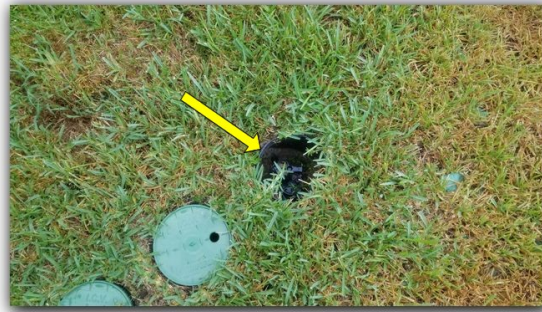
Replace missing solenoid cap noted as missing at backyard.

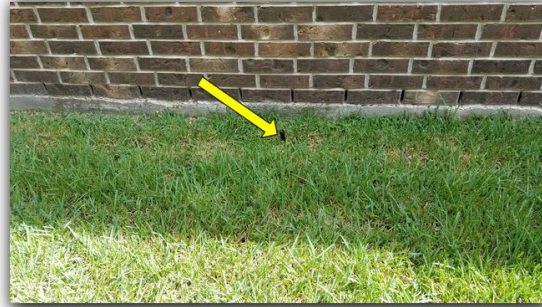
Sprinkler head noted at station 6 is noted as not working and is in need of repair/replacement.
