Property Inspection Report #20220205-01

for property: 7603 Candlegreen Ln
Houston, TX 77071

PROPERTY INSPECTION REPORT FORM

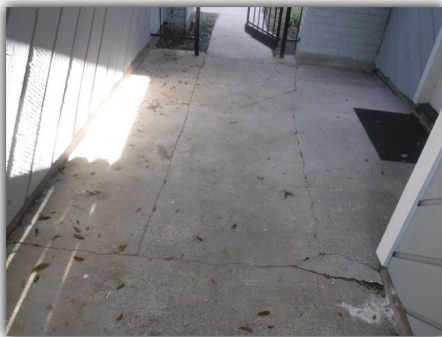
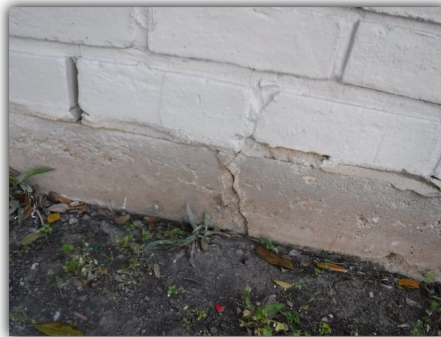
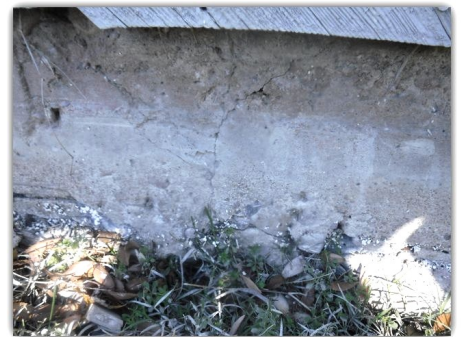
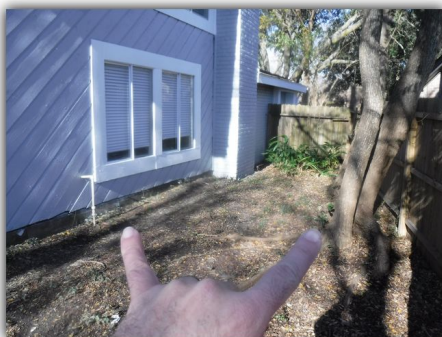
The foundation appears that it has been repaired. If the foundation has been repaired it is recommended to ask for the documentation supporting the repairs, warranty, and elevation data. The inspector also recommends contacting the company that performed the repair work and request an evaluation of the current condition compared with the previous data after the repairs. Keep in mind that the warranty most likely cover only the sections of the foundation repaired and not the entire structure. Get all the details of the warranty.

Large tree(s) near house foundation. Client should consider removal of tree(s) or the installation of root barrier to reduce possibility of damage to house foundation from tree roots and moisture removal.

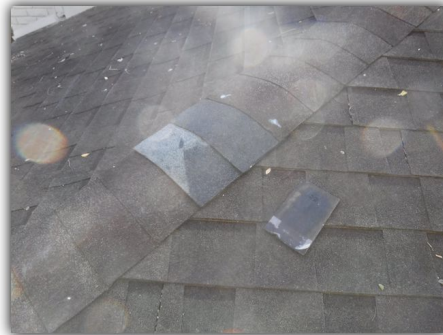
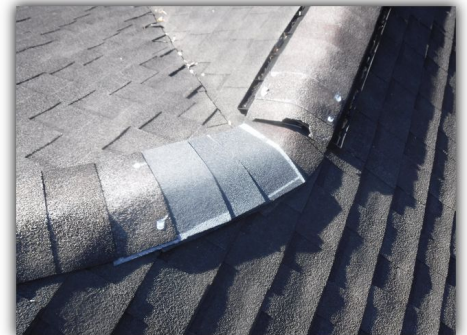
Roof coverings exhibited general damage and repairs that could affect performance. Recommend a qualified roofer evaluate and repair.

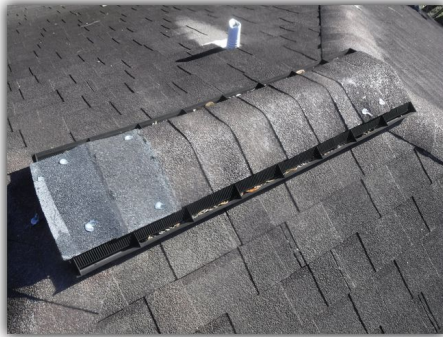
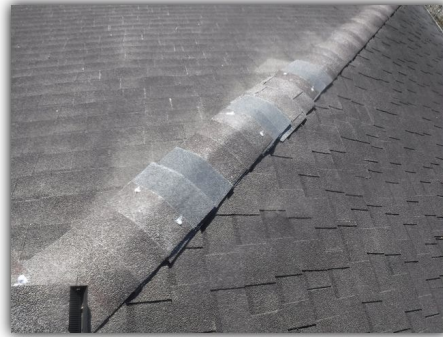
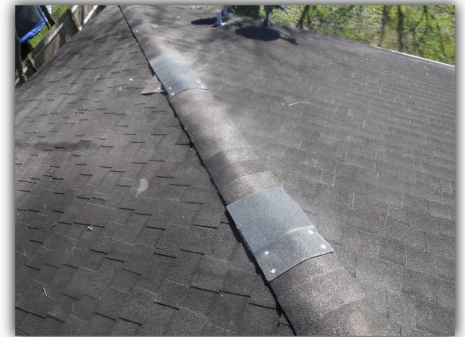
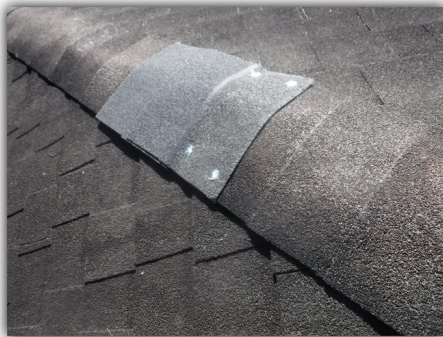
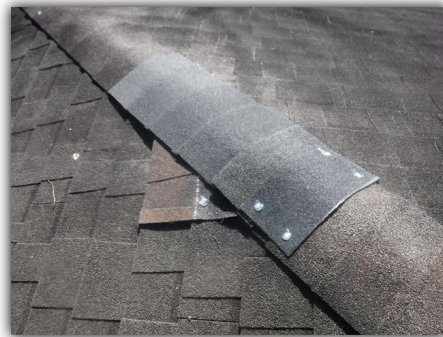
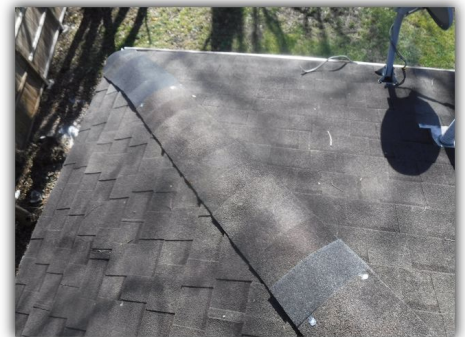
Maintenance Notes: It is recommended that flashing and roof penetrations be reviewed at least annually for damage. Leaks are most commonly found around flashing and roof penetrations, rather than through the shingles, unless the shingles are damaged, or at the end of their life span. Seals around plumbing vents, can deteriorate, metal flashing can lift up, and sealant can dry and crack allowing moisture to enter the attic. Yearly inspections of the flashing and roof penetrations should be performed to detect problems before deterioration and water causes major damage.

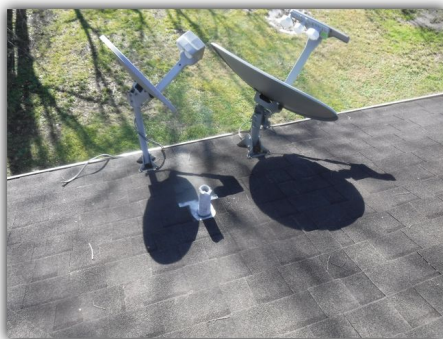
Satellite dishes are not recommended to be mounted on the roof covering. The mounting process may for water intrusion

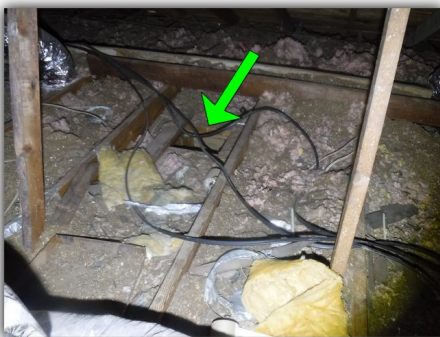
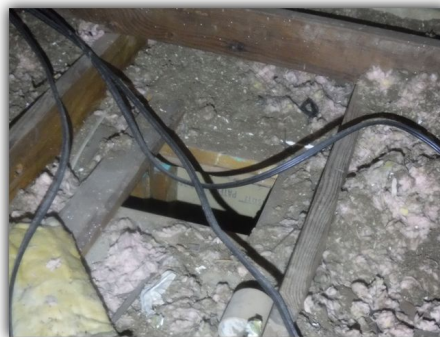
Evidence of previous (possibly current) rodent activity in attic.

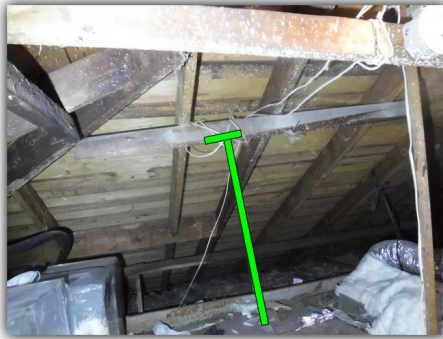
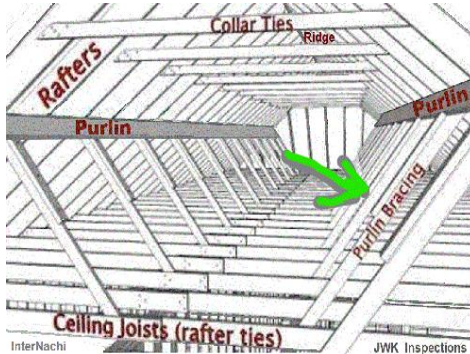
Missing or removed purlin braces

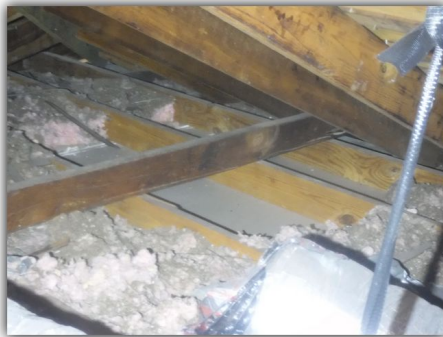
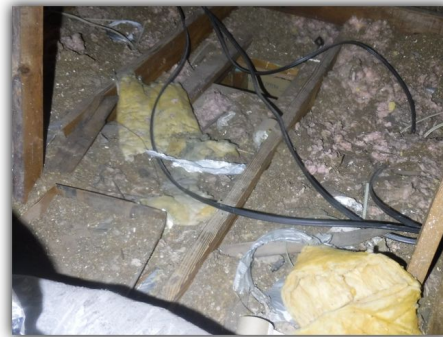
Some of the insulation has been disturbed. It is recommended that the insulation be redistributed, and improved as necessary to ensure consistent comfort levels throughout the home.

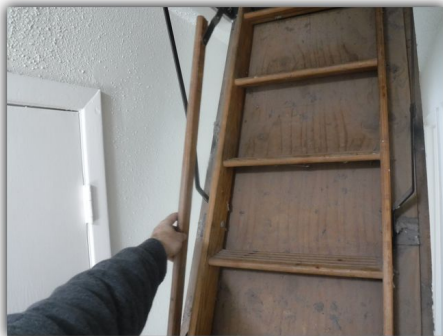
Tighten loose / replace missing nuts and bolts on stairway sections.

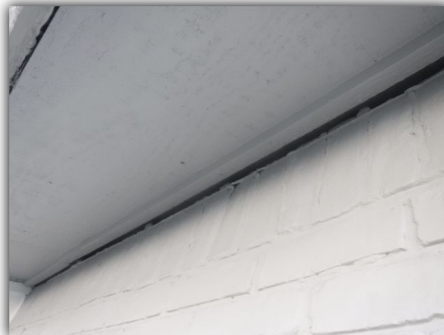
Gaps should be sealed from rodents, also may allow wind driven rain entry. Recommend sealing all gaps to keep the house from rodent and water intrusion.

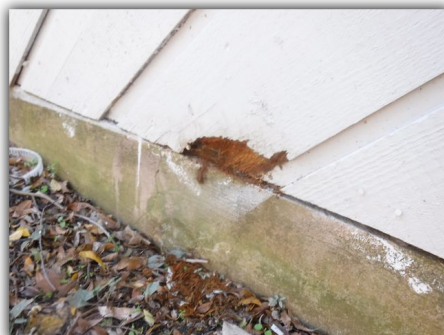
Water damaged was noted in wood siding at one or more location and it is recommended that the damaged wood be repair and/or replaced.

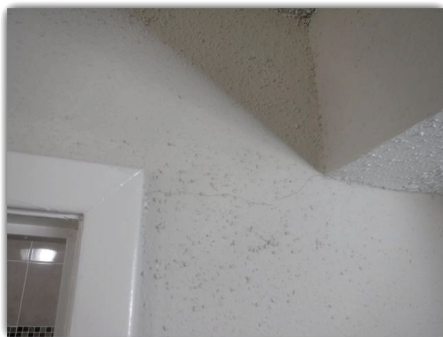
Cosmetic cracks and/or repaired cracks observed in Sheetrock

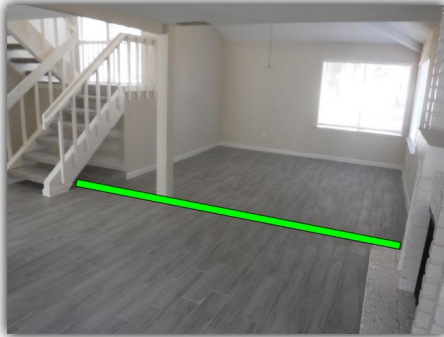
Tripping hazard, there is no contrasting color at raised section of flooring;

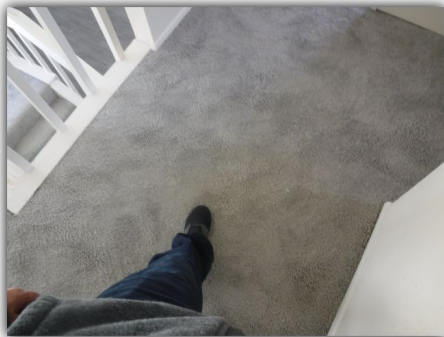
The flooring squeaks when walked in one or more areas.

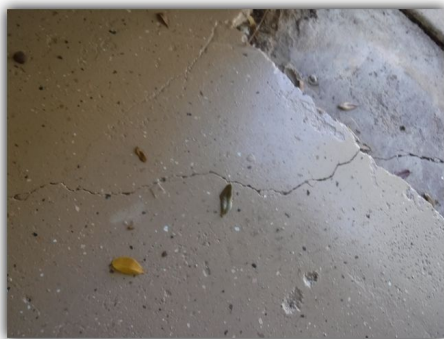
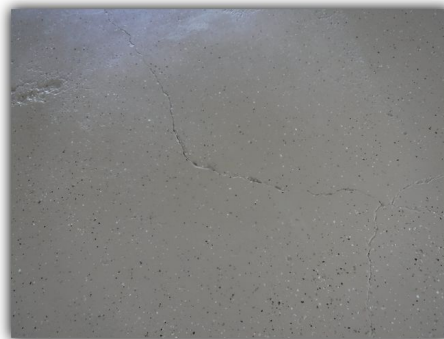
Cracks in a concrete garage floor. Most cracks in garage floors are common and not an indication of serious structural issues, however there are a few that indicate that maintenance is needed or that there may be a structural concern.

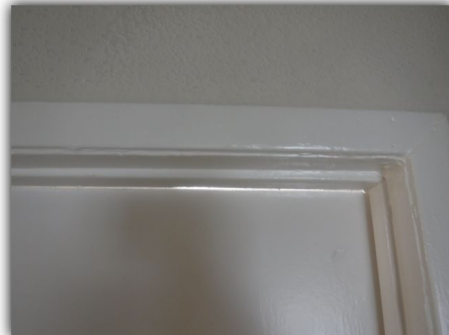
■ The door(s) were sticking and/or out of square at the time of the inspection.

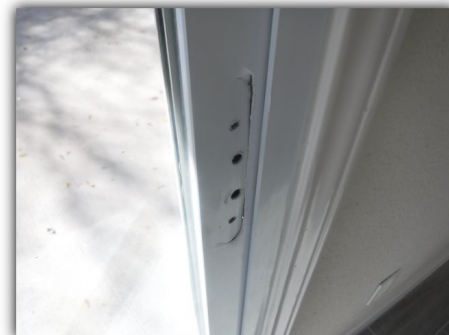
Observed door lock damaged

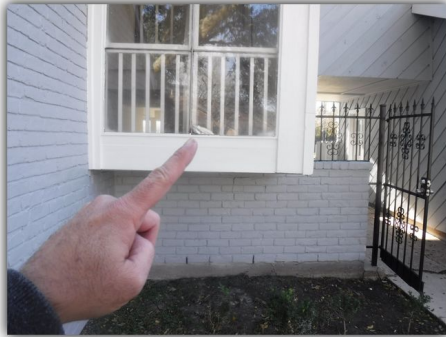
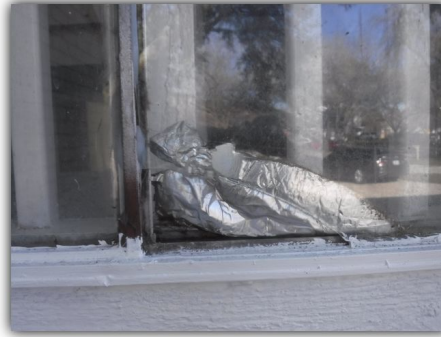
One or more windows had cracked / broken glass pane(s)

Screens were missing and/or damaged in the windows at the time of the inspection.

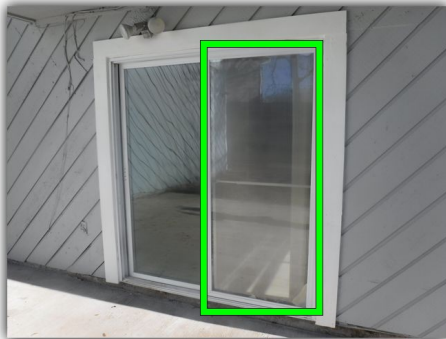
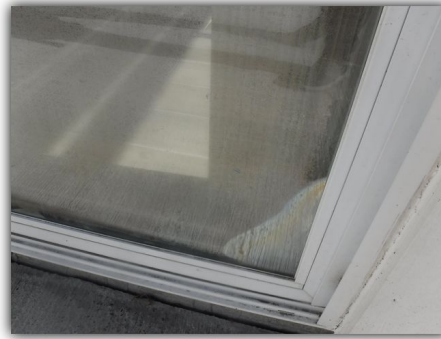
Thermal pane window on sliding door seals have failed, and moisture has penetrated.

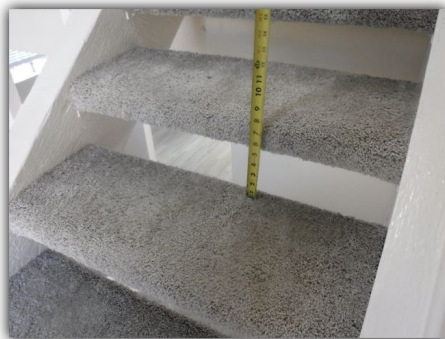
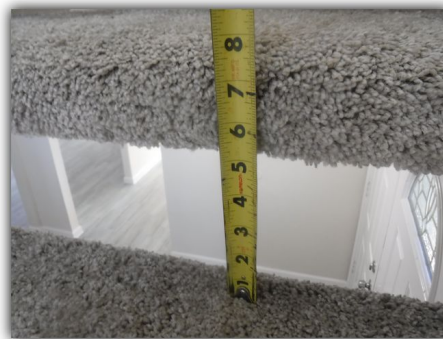
■ The hand railing is not at the proper height, which is 34-38 inches high. The hand railing was measured at 33.inches at the time of the inspection.

Distance between tread openings shall not exceed 4 inches

Deficiencies presented within this section are recommended to be further evaluated by a qualified contractor to access damages and/or costs related to repair and/or replacement.

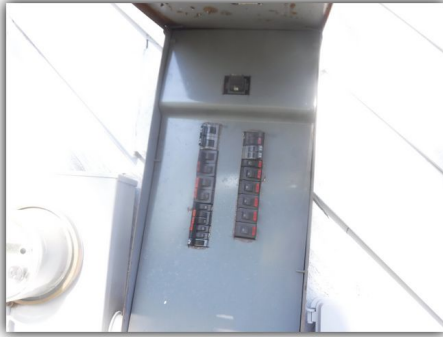
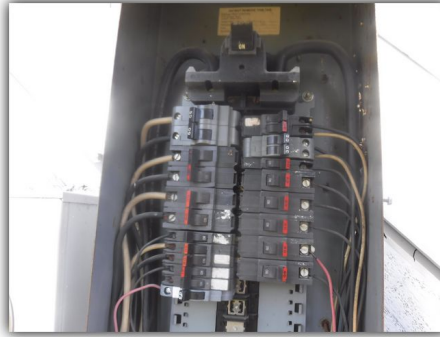
There is a Main service entrance panel(s) located in the Back yard. They were visually inspected with the dead-front covers removed.

Panel loose in wall

Brand of electrical service panel is Federal Pacific. This make of panel is known for difficult to find and more costly to replace breakers. In addition this panel is associated with a higher incidence of failures / safety problems. If additional information is needed, recommend a qualified electrician be consulted. Replacement of panel recommended as an upgrade / safety improvement. For safety reason, the panel was not fully evaluated and recommend full evaluation by a licensed electrical contractor.

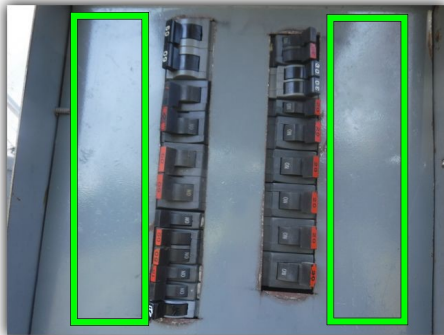
All fuse or breaker panels are required to have an complete, legible, and accurate listing of what the circuits are connected to. This is properly called a legend.

Dead front missing one or more securing screws. Need to ensure screws used do not have sharp / pointed ends that can penetrate live electrical wiring behind dead front and cause shock, fire, serious injury..

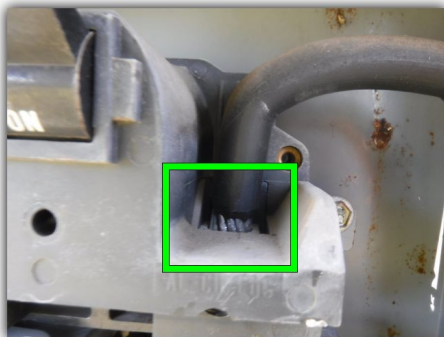
The anti oxidizing mastic should be used on the service wires located in the electrical box. The aluminum conductors should be cleaned and treated with an anti oxidizing compound.

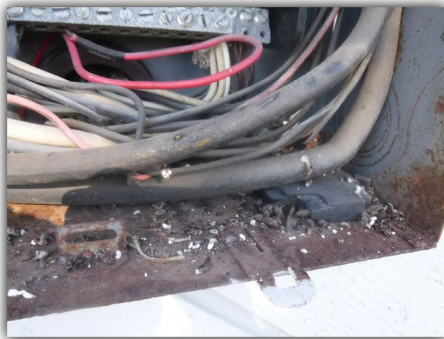
Clean debris from the bottom of the panel box.

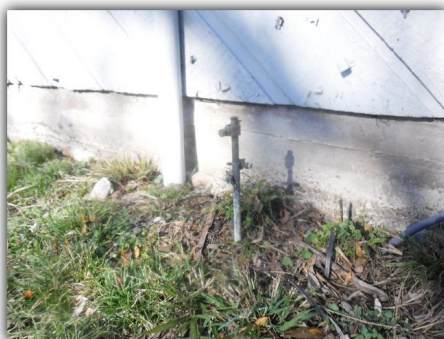
The main electrical service grounding electrode was not visible at the time of the inspection. A grounding electrode conductor was visible exiting the main panel and entering soil, but the inspector was unable to confirm its proper termination or proper grounding of the electrical service. Although this is a common condition, you may wish to have proper grounding conditions confirmed by a qualified electrical contractor for safety reasons.

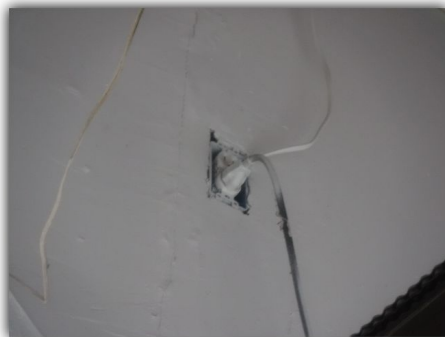
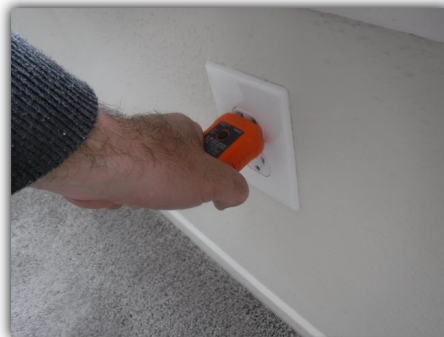
One or more cover plates were either missing or damaged;

Outlet(s) not secured to wall

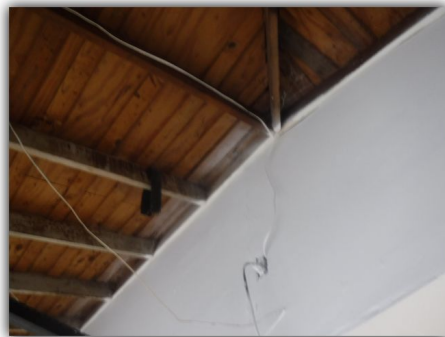
- Garage

Observed improper wiring / Electrical wiring not in protective conduit;

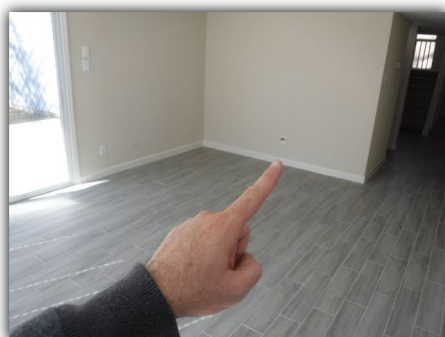
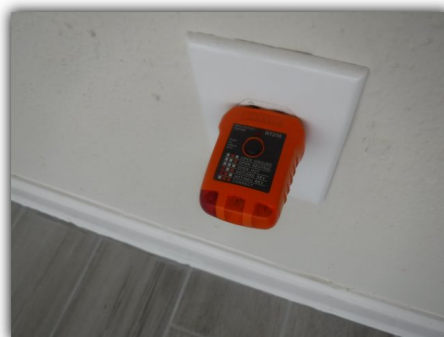
- Breakfast

No power to outlet(s);

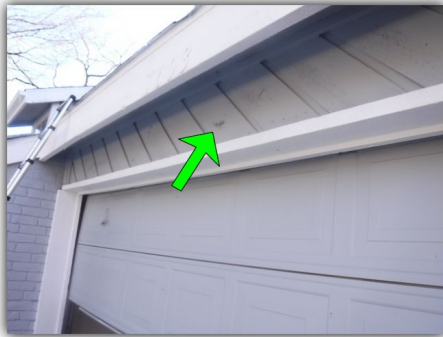
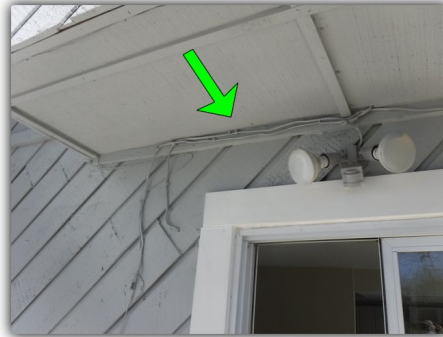
Missing light fixture / exposed wires were noted.

Electrical wiring not in protective conduit;

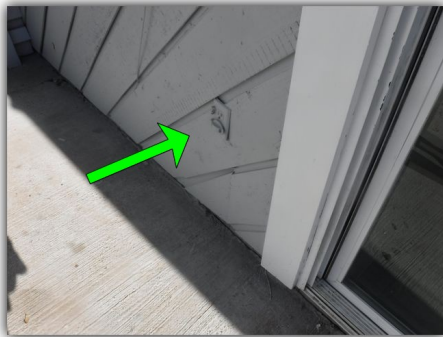
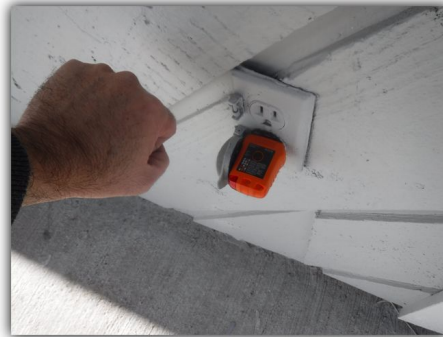
Exterior receptacles are currently required to have a "weatherproof while in use" cover, also known as a plastic "bubble cover" type.

No power to exterior outlet(s);

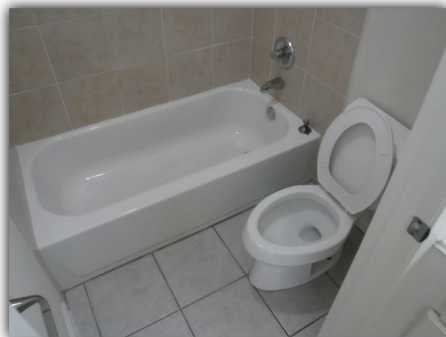
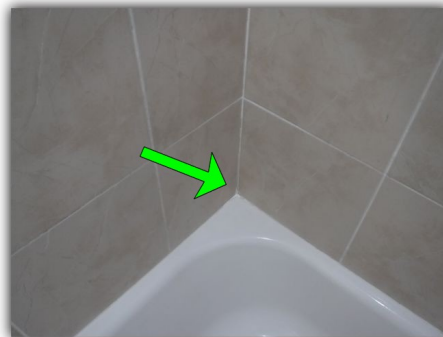
□ The tub enclosure needs to be sealed. Grout / caulking needed at vertical tile corners, cracks in tile and/or mortar between tiles, and where tile meets tub to prevent water entry behind wall.

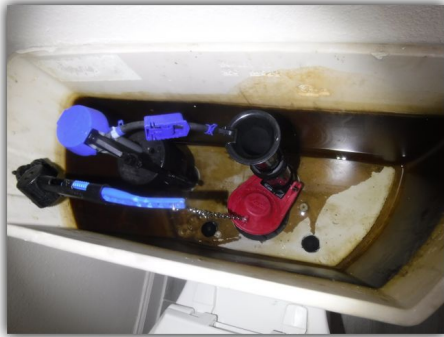
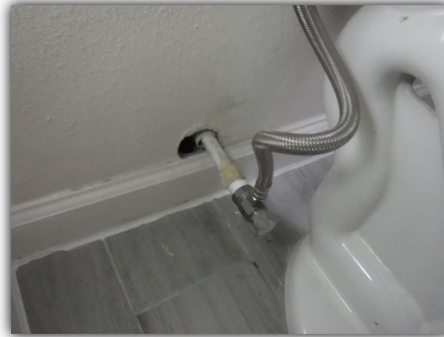
- Guest bathroom

Observed deficient flushing mechanisms. Replacing the commode's flushing mechanisms and water supply hoses as a preventative measure before occupying the house is recommended.

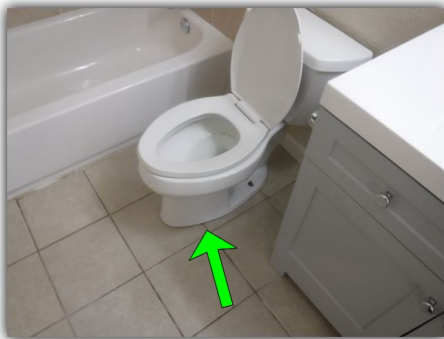
- Upstairs hallway

The floor mounting is loose. The commode(s) needs to be sealed/caulked.

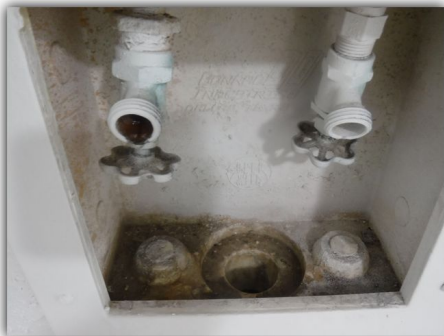
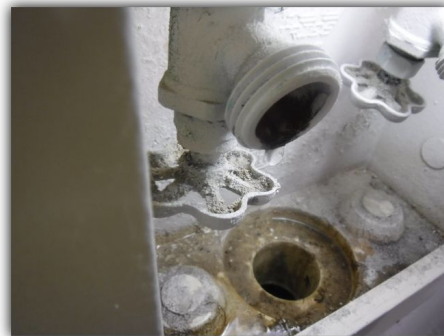
The faucet is leaking

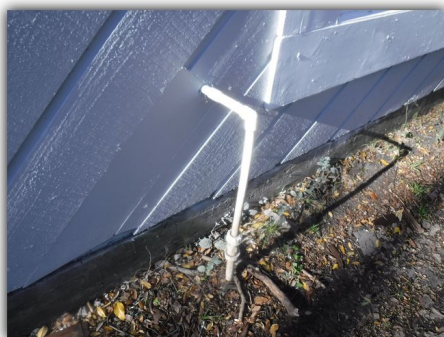
Note: The visible portions of the water pipes in the attic are not insulated. Recommend insulating exterior water line(s) to prevent freeze damage.

One or more exterior hose bibs do not have back-flow prevention.

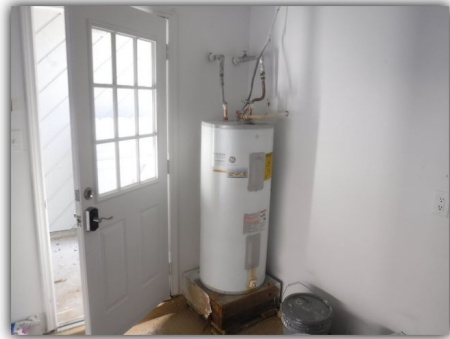
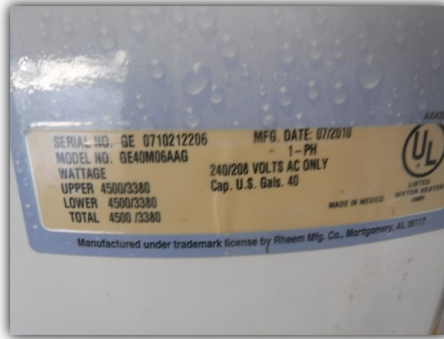
MFG Date: 2010

Older unit, limited service life remaining.

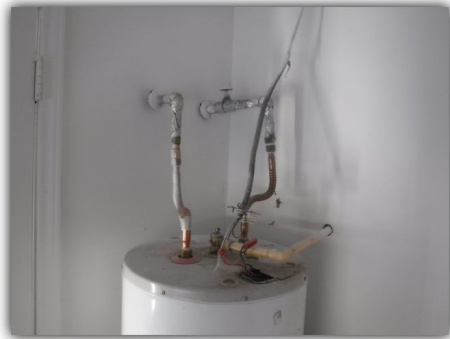
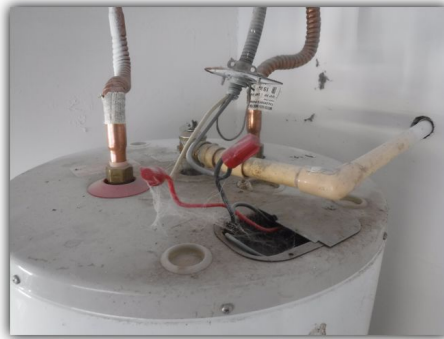
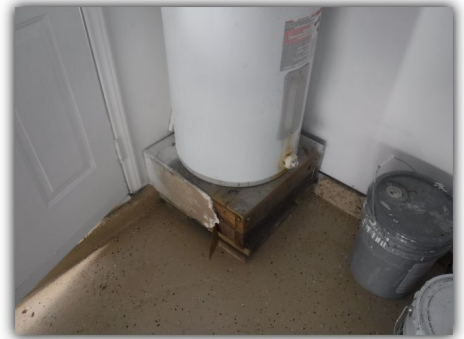
- Service disconnect is missing. Recommend installing electrical disconnect within sight of unit.
- Observed loose / exposed / improper wiring on the unit.
- A water heater drain pan should be installed under the water heater tank in locations in a dwelling where a leak from the tank could cause damage to the structure or property

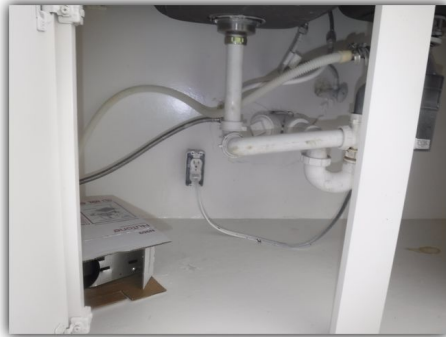
■ The drain line was not raised as high as possible, and secured under the cabinet in order to help prevent possible back-siphoning at the time of the inspection.

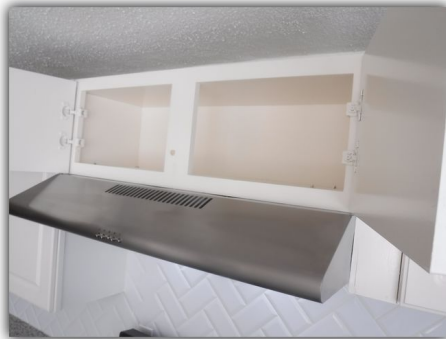
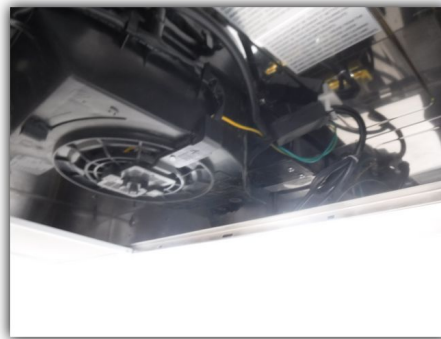
Range hood exhausts is blocked and not to the exterior.

Current codes require all gas and electric stove/ranges to terminate directly to the exterior.

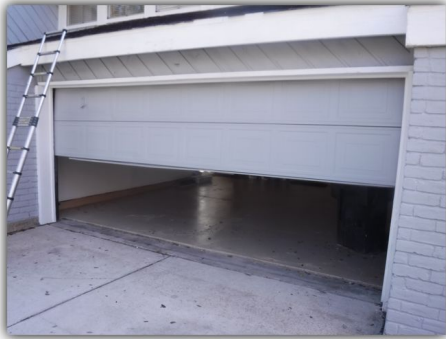
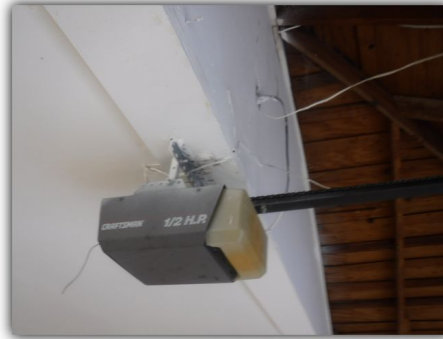
The garage door opener was not working properly at the time of the inspection.

Rust was noted on the door
