HOUSTON METROPOLITAN INSPECTIONS UNLIMITED, LLC

Prepared For:			
	(Name of Client)		_
Concerning:	1823 LEATHERSTEM LANE, KINGWOOD, TEXAS	LOW54-063019	
	(Address or Other Identification of Inspected		_
By:	LINDA MCCRACKEN TREC License #709	JUNE 30 2019	
	(Name and License Number of Inspector)	(Date)

Report Identification: 1823 LEATHERSTEM LANE, KINGWOOD, TEXAS LOW54-063019

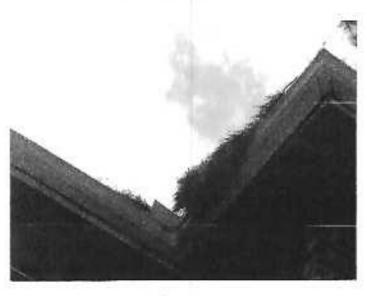
The roof and gutters need cleaned.

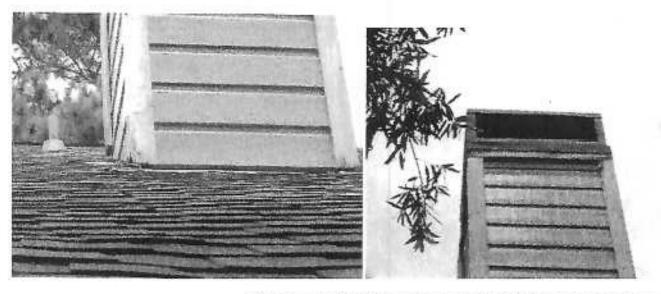
There are deteriorated trim boards on the chimney.

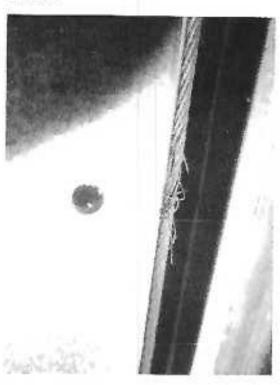
The cable on the overhead garage door is fraying; this needs replaced before it breaks, .

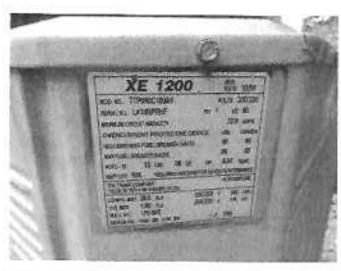
The downstairs upstairs AC unit is a 5 ton, dated 1996. This unit was cooling sufficiently. There was a 19 degree differential between the supply and return air. There is water in the attic pan.
