PROPERTY INSPECTION REPORT FORM

Lucy A. Evei Name of Client	5/26/2022 Date of Inspection
1806 Nantucket Dr, Houston, TX 77057 Address of Inspected Property	
Quinnon Yu Name of Inspector	24428 TREC License #

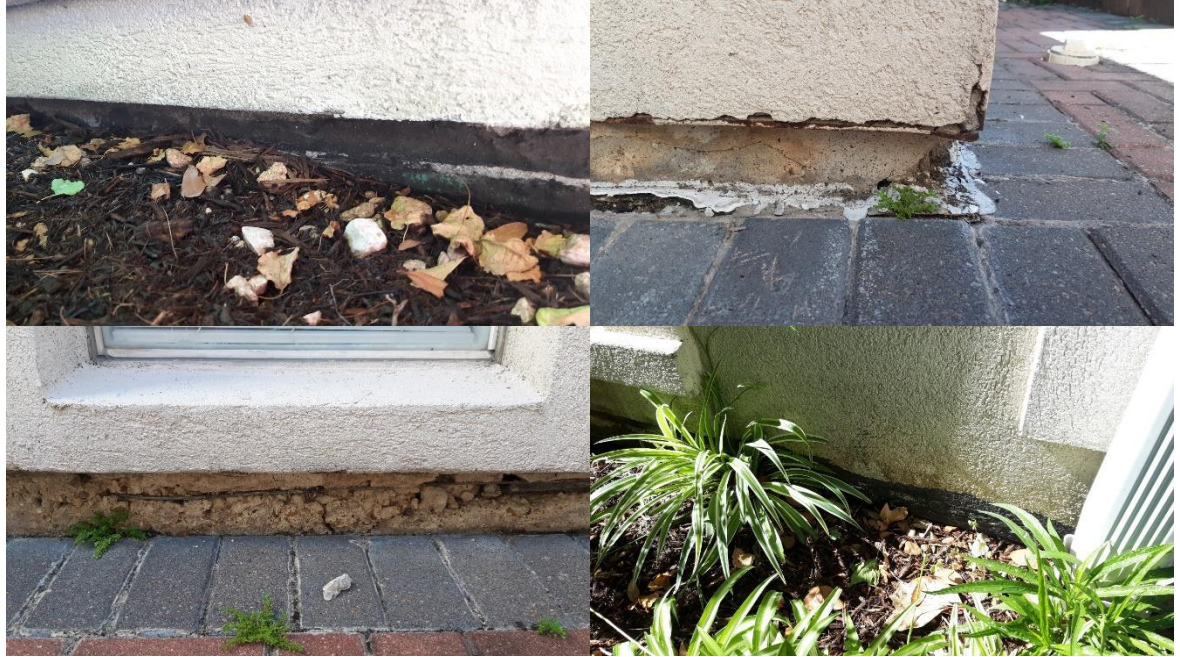
Normal settlement cracks were observed throughout the structure. Corner cracks and chips were also observed. These are typical for homes constructed on slab of almost any time period. Most commonly, the uneven drying process of newly poured concrete and shifting soils are the culprits behind the cracking and chips in the corner of the foundation.

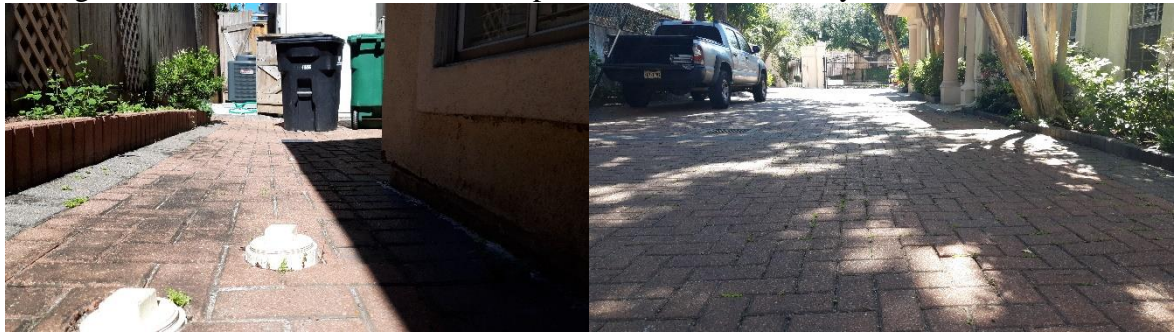
Grading appears to NOT slope away from the structure. A grade that slopes away is important to prevent water from ponding near the structure, increasing the chance of water damage. It is recommended to have a drop of about 6 inches every 10 feet.

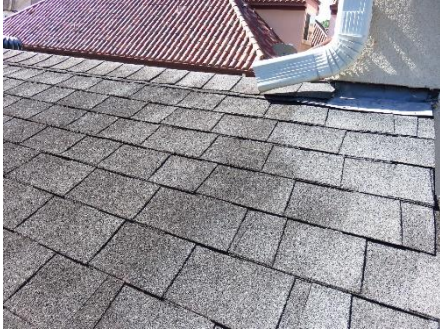
A downspout at the 3rd to 2nd level roof transition of the structure did not terminate properly. Downspouts should terminate with a splash block or assisted tubing in order to divert water away from the structure. Water exiting a downspout has high force and can damage and erode shingles over time.

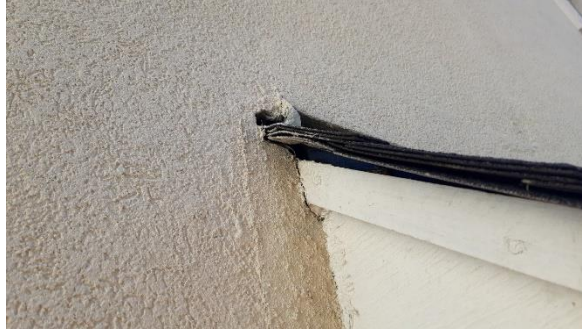
More than 2 layers of shingles were observed at the back roof. It is recommended to have no more than 2 layers of shingle roofing installed. Excessive layers of roof covering put unnatural stress on the structure and can weaken future performance.

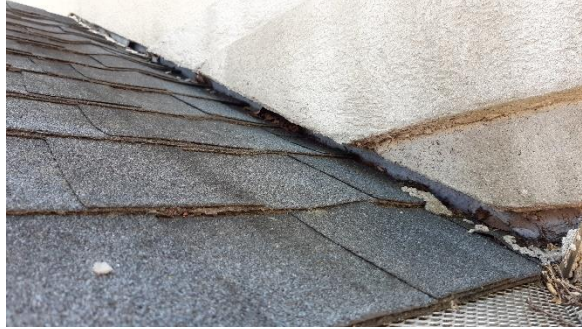
The patio roofing was observed to be cluttered with debris. This should ideally be cleared out as debris can trap moisture against the exterior surface.

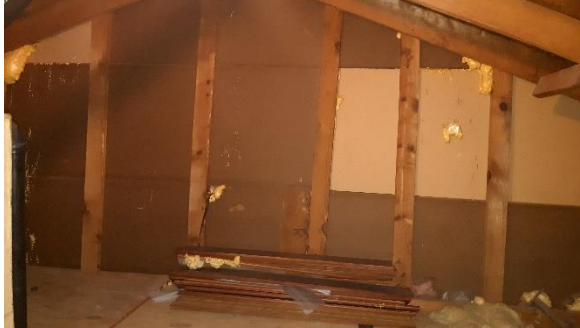
Insufficient fireproofing was observed in the attic between this home and the neighboring unit. Per today's standards, dividing walls between housing units should be protected with fireproof sheathing in order to give occupants of both sides more time to react to fire hazards.

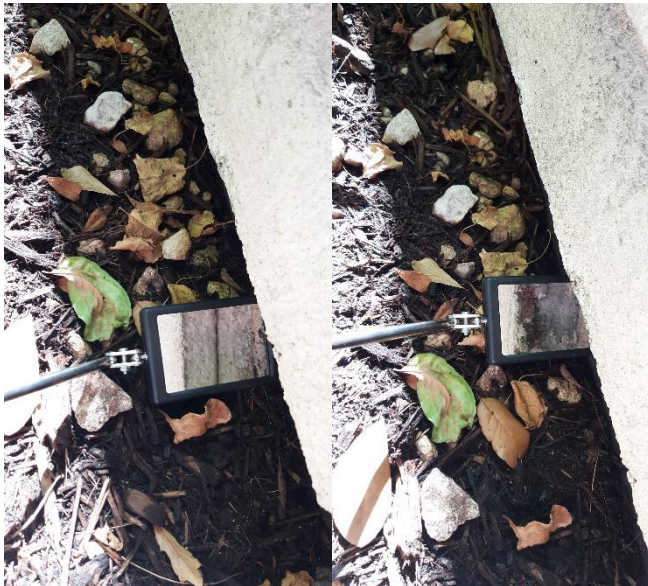
Two types of stucco exterior cladding were identified: Exterior insulation and finishing system (EIFS) and traditional hardcoat. The EIFS was observed in the front and sides of the house through hollow tapping and mirror viewing at the lower edge. The hardcoat was observed at the very rear. EIFS cladding has a relatively known history of water penetration behind the outer surface. During time of inspection, both the EIFS and hardcoat were observed to be dry, even after a recent rain. Recommend to monitor the exterior regularly in order to observe for water penetration.

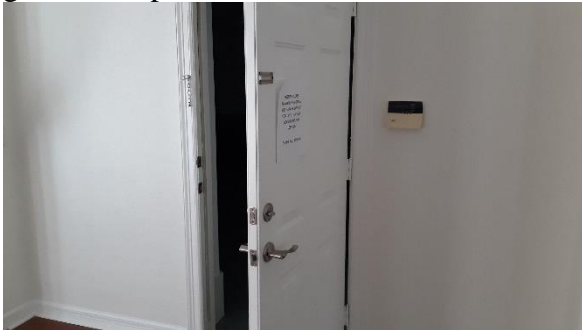
The garage entry door was not self-closing. Doors that open directly into a living space from the garage need to be fire-rated and self-closing. The rationale behind this is to prevent fires from traveling to the living space quickly and to prevent the accidental exposure of exhaust gases from parked vehicles.

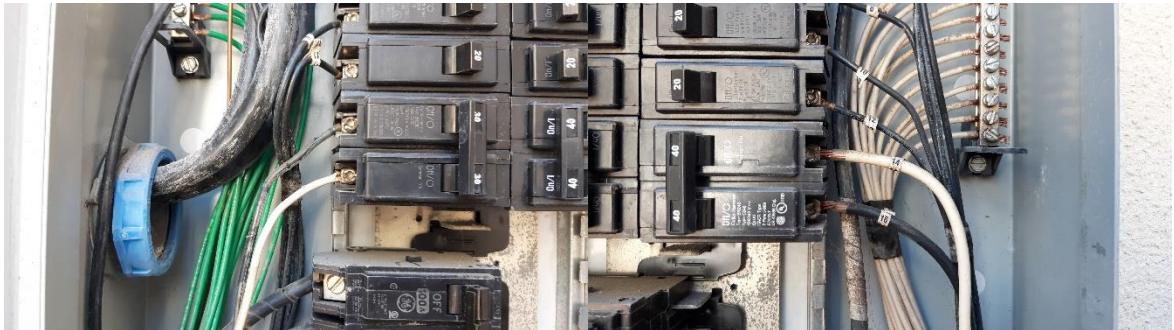
White wires were observed going into the breakers. Per electrical standards, only wires that are covered in red or black colors should be going into the breakers. This reasoning is to properly identify which wires are “hot” or live. White sheathed wires are reserved for neutral conductors.

Recommend an electrician to evaluate and remedy any potential problems as necessary.

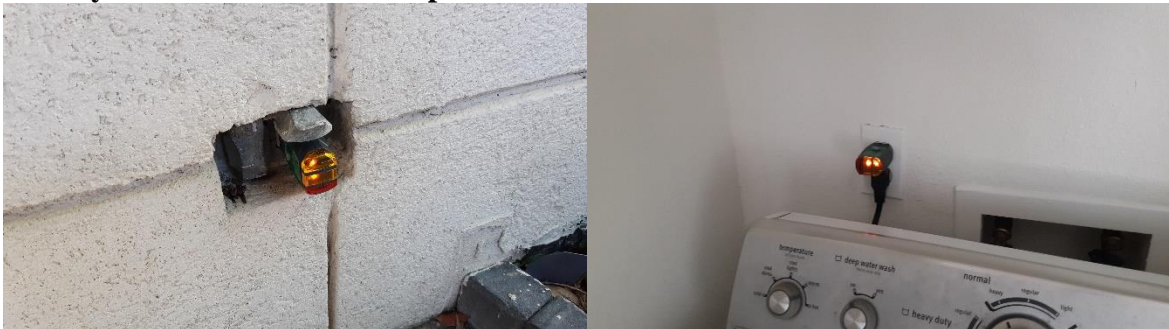
GFCI outlets were NOT appropriately placed throughout the house. The exterior and laundry outlets were not GFCI protected.

Recommend an electrician to evaluate and remedy as necessary.

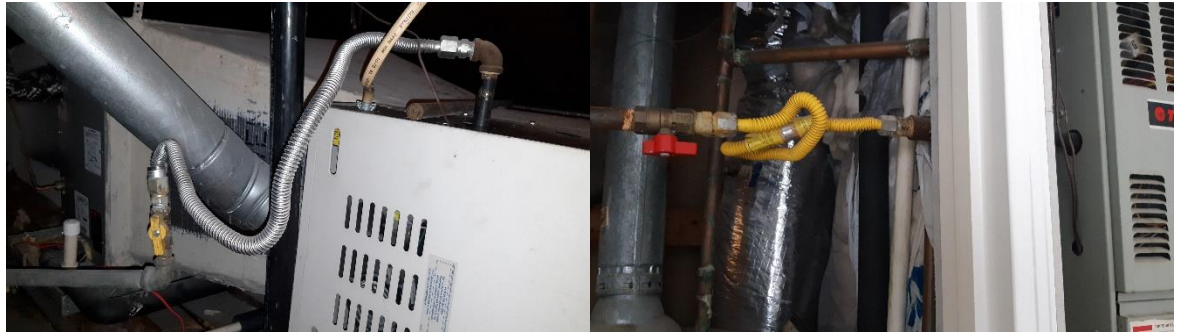
There was an observed lack of a sediment trap in the gas supply line. A sediment trap is a piece of piping that serves to change the direction of flow before the gas reaches the appliance. This acts as a filter for the natural gas. Natural gas can have foreign contaminants that can pollute the appliance. A sediment trap prevents those contaminants from interfering with the appliance. **An example of a sediment trap is provided below.**

Recommend a licensed HVAC professional to evaluate any problems and remedy as necessary.

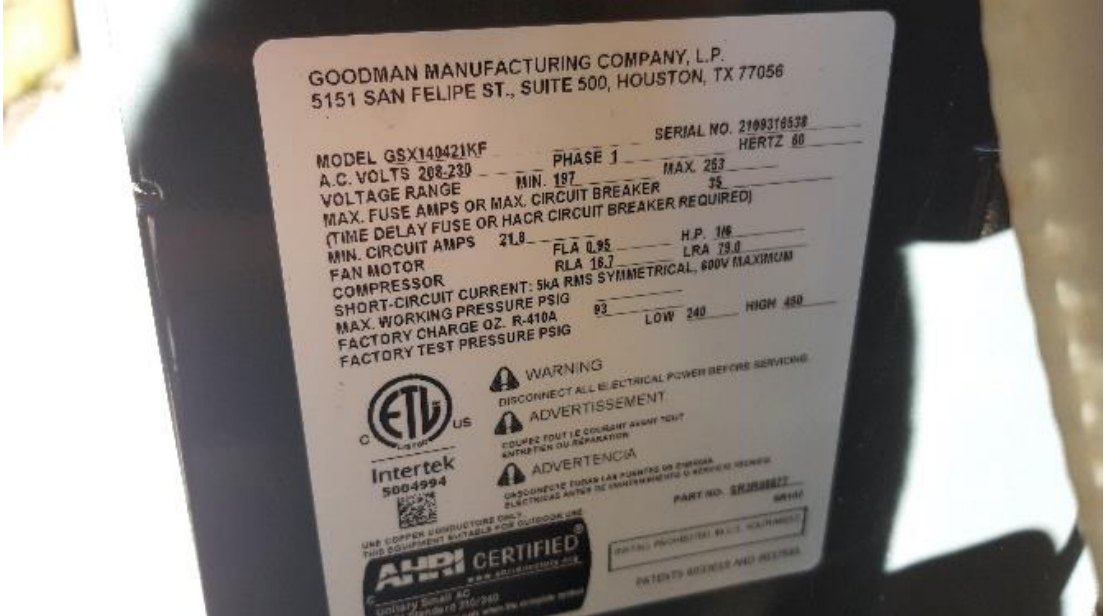
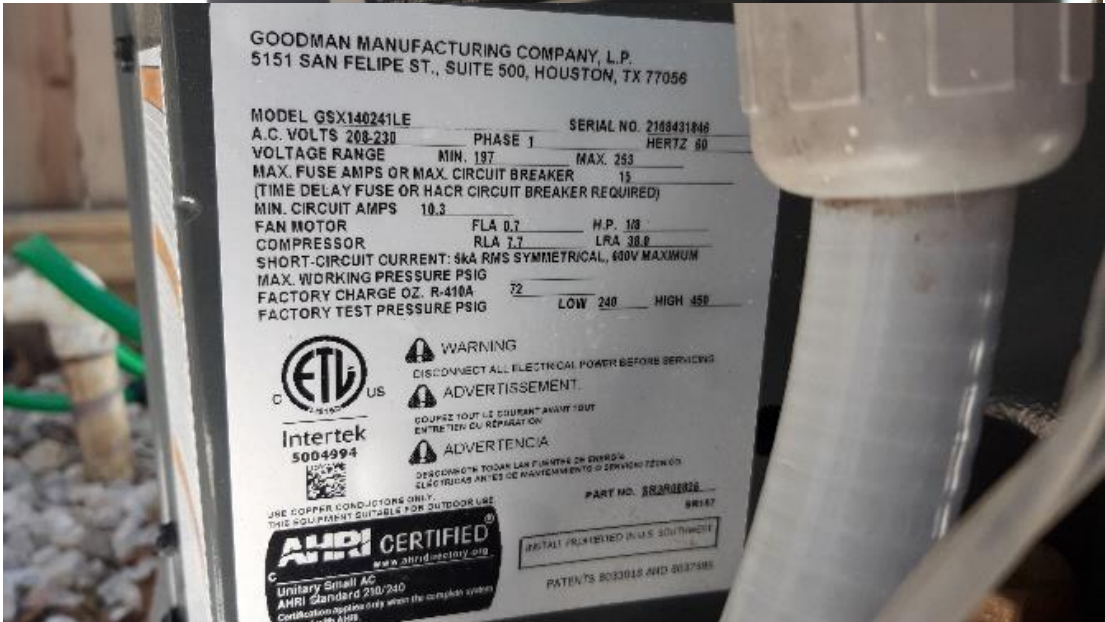
An overfusing situation has been observed. Per the manufacturer's label, the MAXIMUM fuse that can be installed in conjunction with the small and big unit is 15 and 35 amps. The breakers that correspond to the AC units are 40 amp breakers. This means that in the rare case of electrical failure, the service panel's breakers will not catch the situation before a fire risk has manifested.

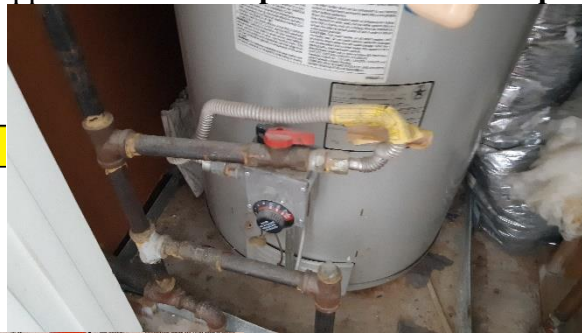
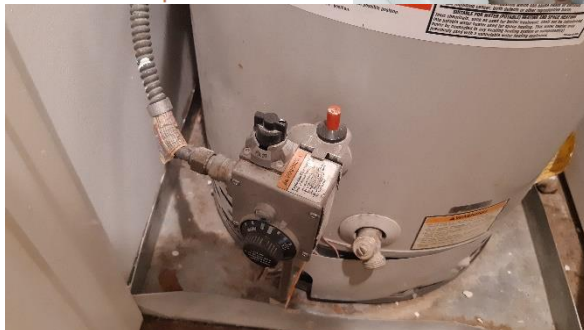
There was an observed lack of a sediment trap in the gas supply line for both units. A sediment trap is a piece of piping that serves to change the direction of flow before the gas reaches the appliance. This acts as a filter for the natural gas. Natural gas can have foreign contaminants that can pollute the appliance. A sediment trap prevents those contaminants from interfering with the appliance. **An example of a sediment trap is provided below.**

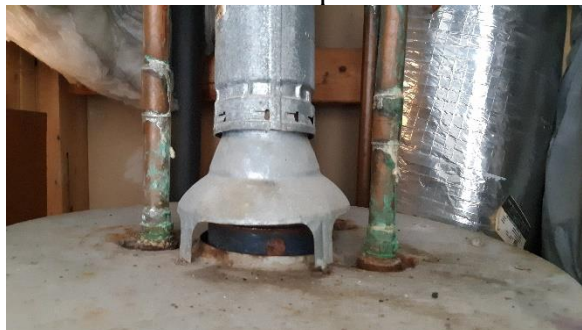
Patina was noticed on the copper piping for the 3rd floor water heater. This is most common on older heaters due to corrosion from age. While not immediately harmful, it is recommended to have a plumber evaluate for any leaks or improper piping.

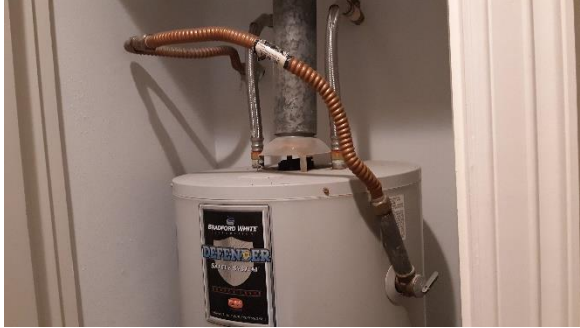
The TPR (temperature pressure relief) valve is not plumbed properly. The temperature and pressure relief (TPR) valve is a safety device that is used to quickly and safely release water within the tank when either temperature or pressure exceeds manufacturer standards. This is done in order to prevent accidental explosions. The valve should ideally be plumbed **DOWNWARDS** to a **READILY VISIBLE** location so that any activation of the valve is immediately noticeable for the building occupant. This allows any issues to quickly be identified and addressed.

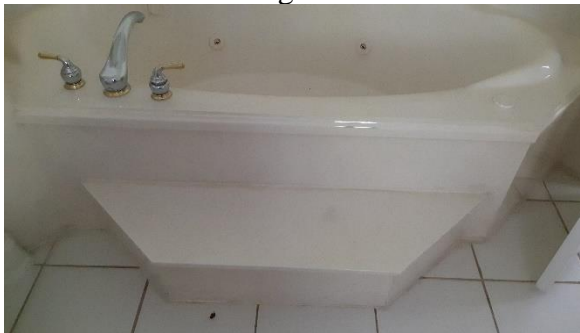
There was no access panel observed. An access panel provides an easy way to fix the mechanics of the system. In order to perform maintenance on the hydro massage equipment, the tub must be damaged.
