PROPERTY INSPECTION REPORT

Concerning: 9322 Eckert, Arcola, TX 77583
(Address or Other Identification of Inspected Property)

By: Riley Rundquist, Lic #24486
(Name and License Number of Inspector)

02/11/2021
(Date)

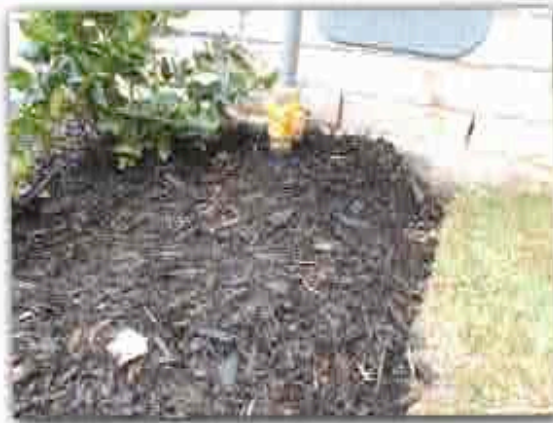
NOTE: The foundation is obstructed from view at the right side where the flower beds are against the slab.

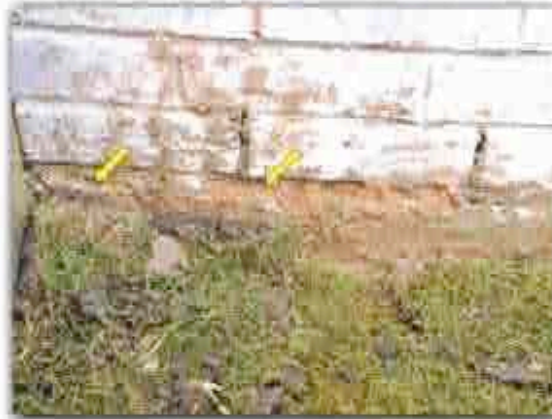
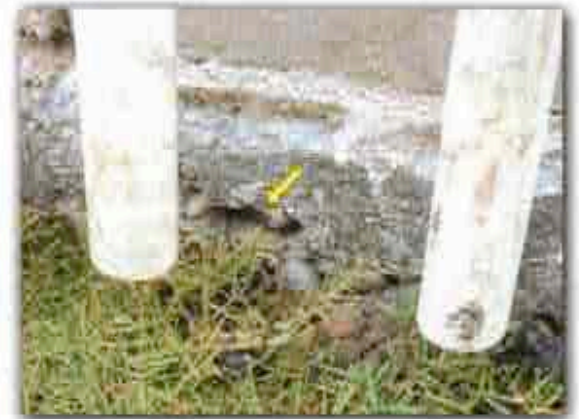
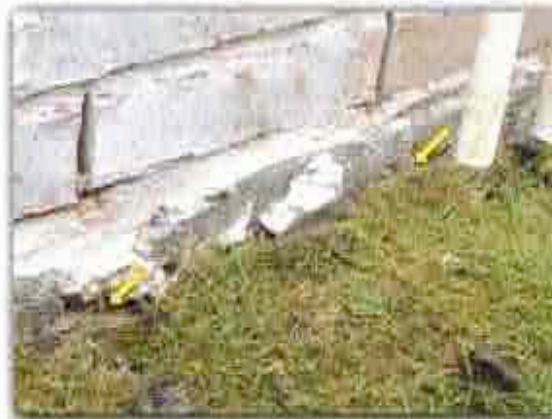
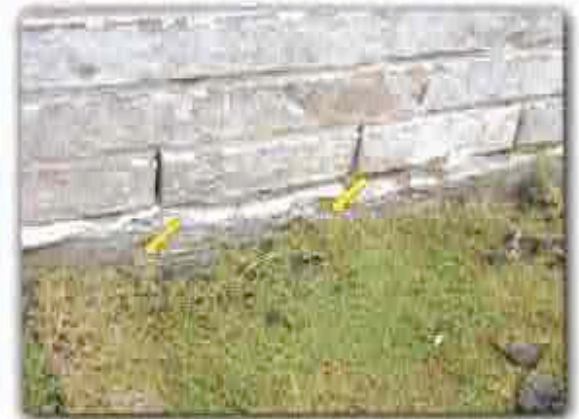
There is exposed aggregate on the right side in multiple locations.

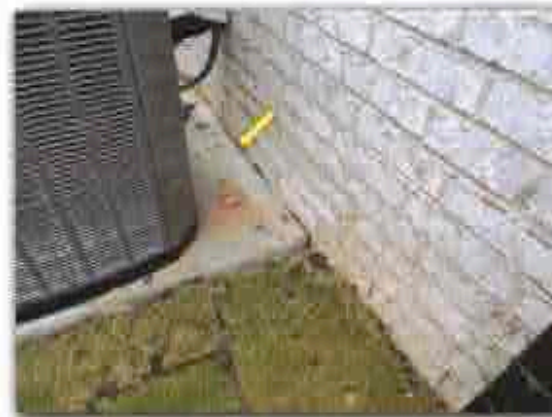
NOTE: The foundation is obstructed from view at the right side where the condenser is located.

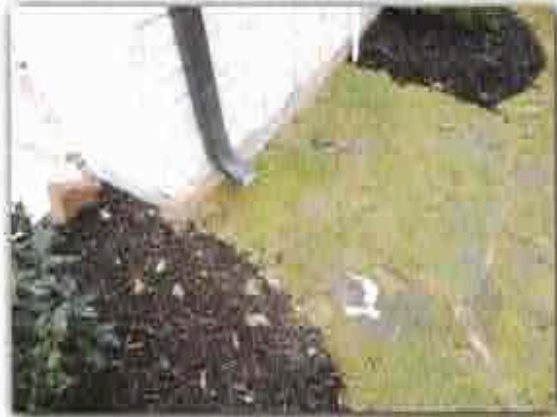
The splash block is missing at the base of the down spout at multiple locations.

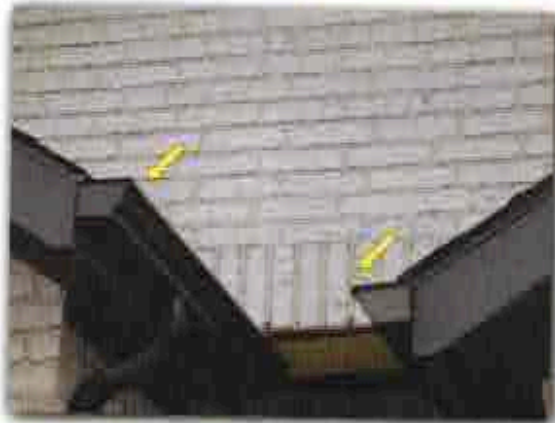
There is flashing missing at the opposite side of the entryway.

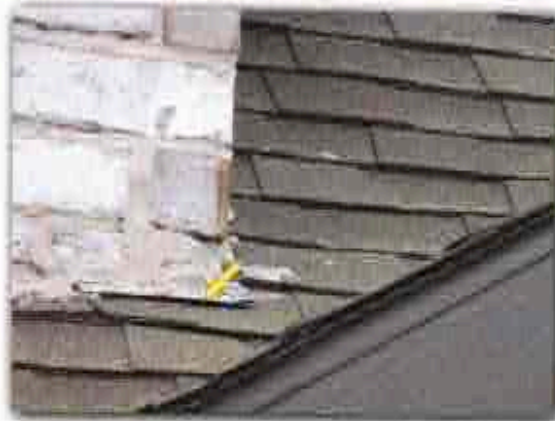
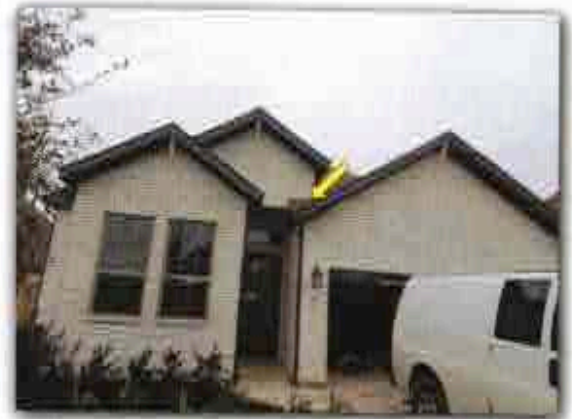
The flashing needs to be sealed on the front right side.

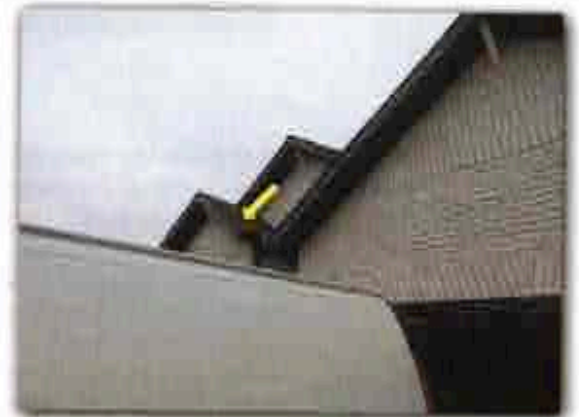
There are shingles lifted at the front.

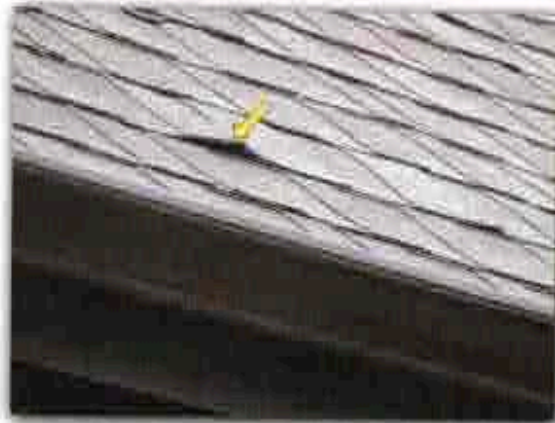
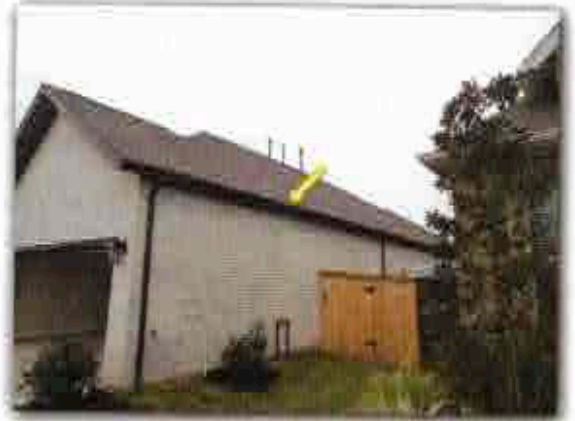
There are shingles lifted at the right side.

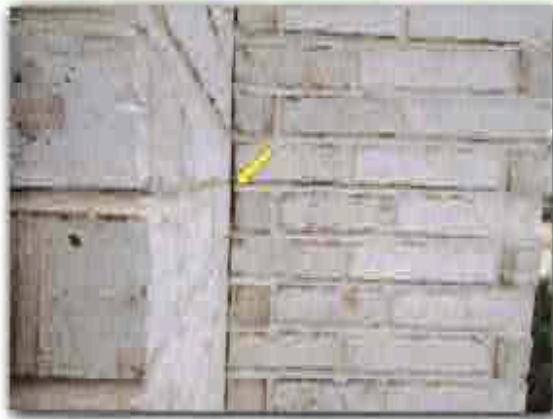
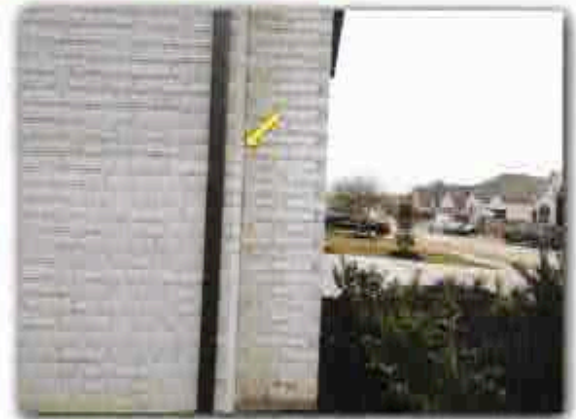
There is no caulking material at the brick corners / intersections at multiple locations around the home. The pictures below are not exhaustive of all locations.

All wall penetrations and exposed openings should be sealed to help prevent pest and moisture penetration into the wall cavity including areas such as electrical outlets, exterior light fixtures, window and door frames, and water and gas supply lines.

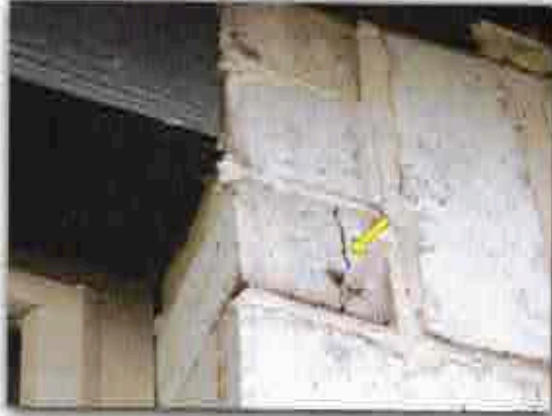
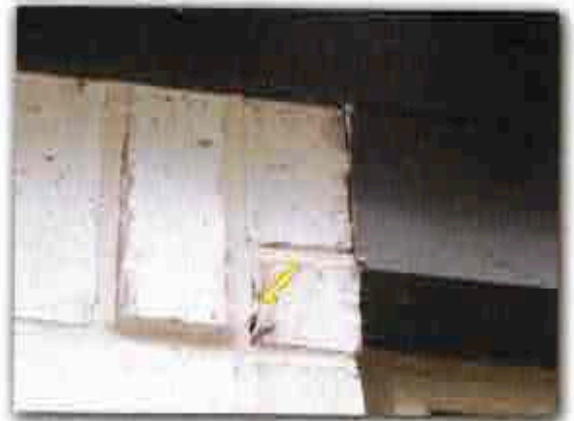
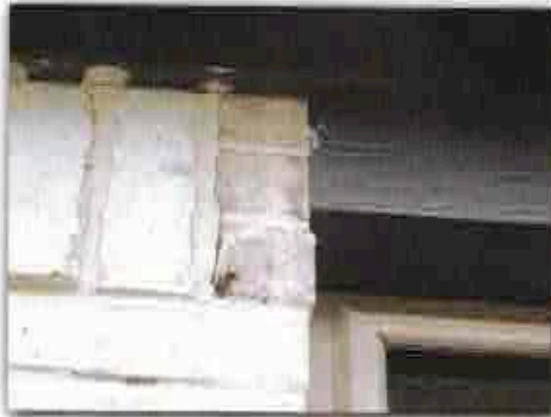
The fasteners for the window shutters are installed. There are multiple locations where this fastener has cracked the brick/mortar.

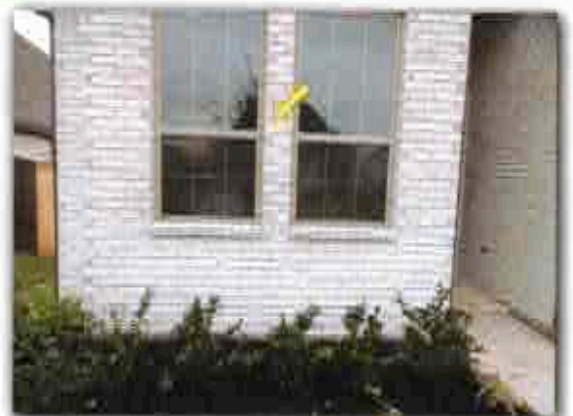
There is a gap in the mortar at the front left side.

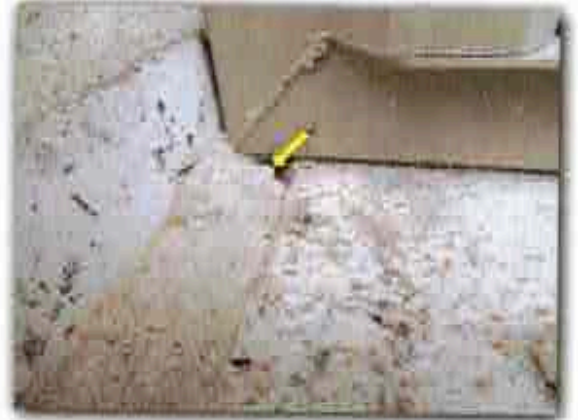
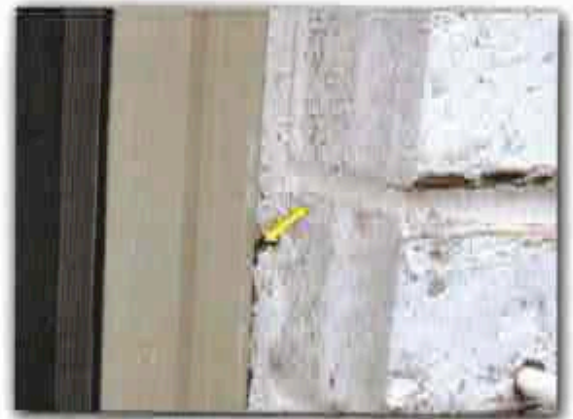
There are gaps in the mortar around windows in multiple locations.

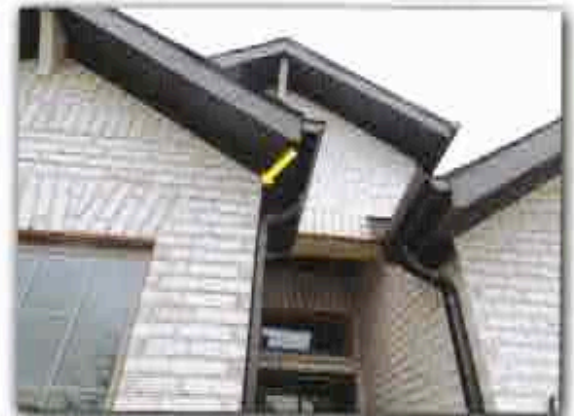
There is a gap where the fascia board meets the wall near entryway.

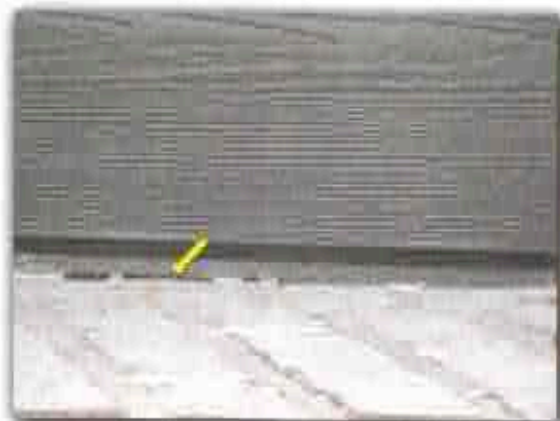
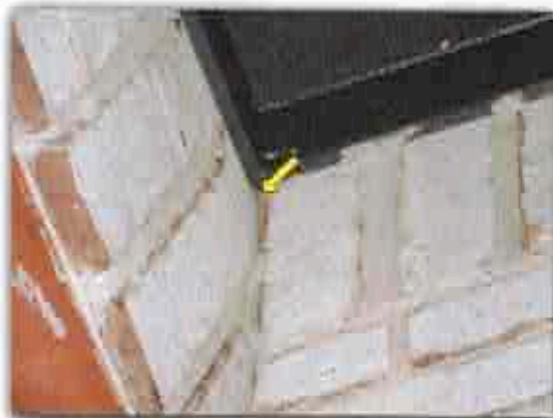
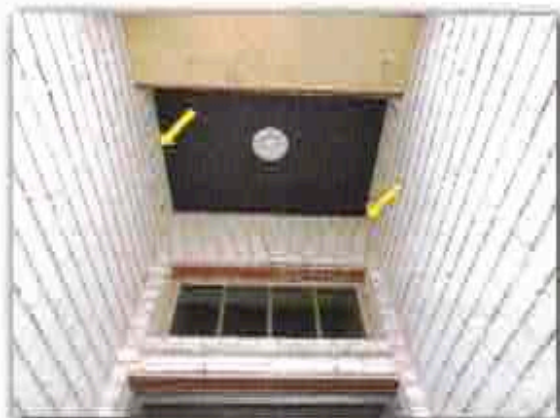
The ceiling material over the entryway has gaps where it meets the sidewall and shows some framing members. This can be conducive to pest penetration.

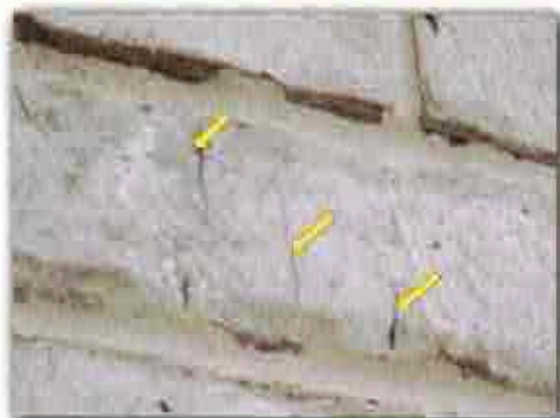
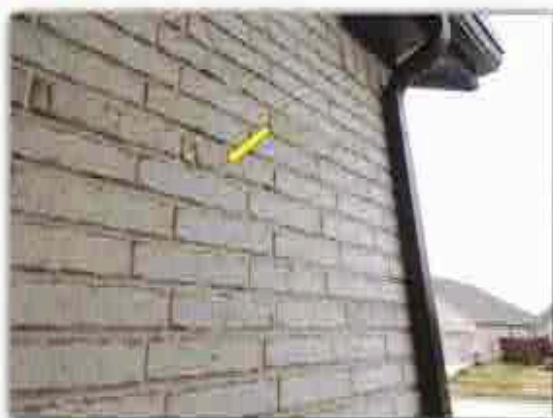
There is a crack on the brick at the front middle side.

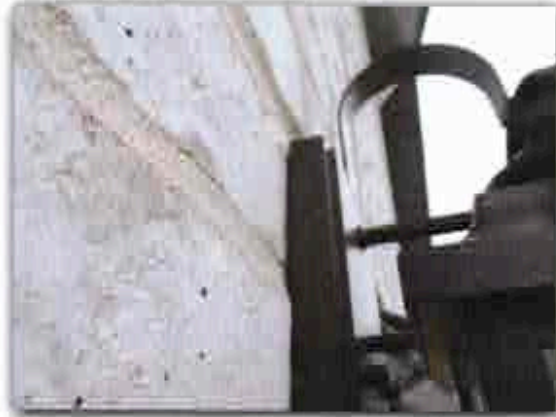
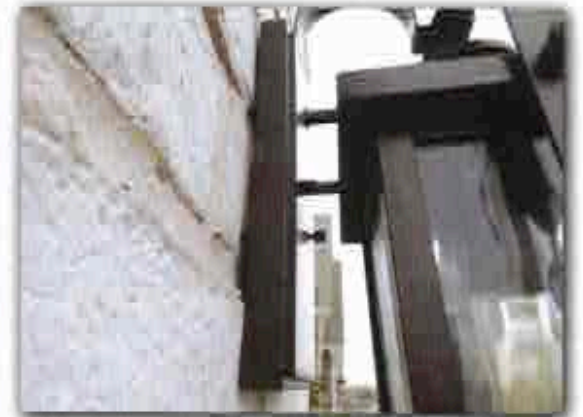
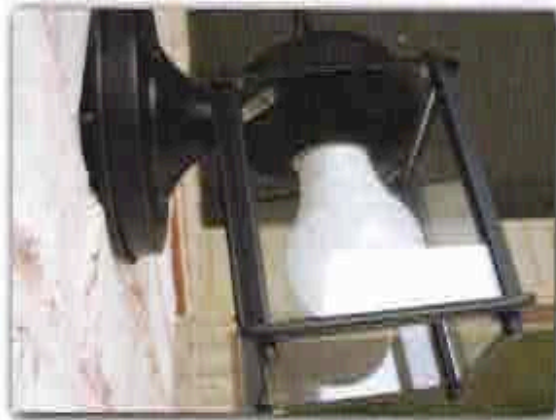
The exterior light fixtures are not properly sealed/caulked or secured to the wall. This is a potential moisture penetration point.

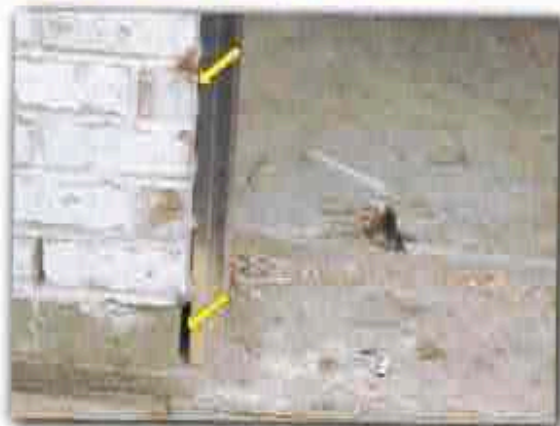
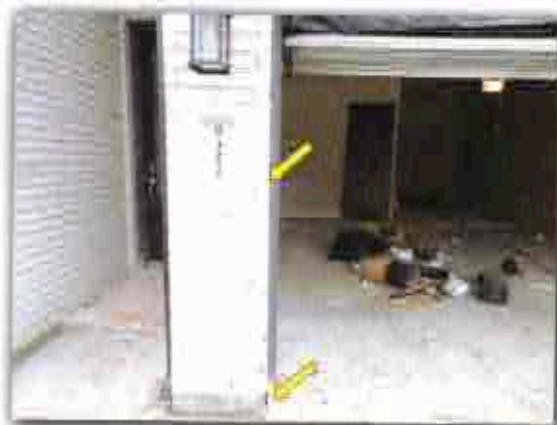
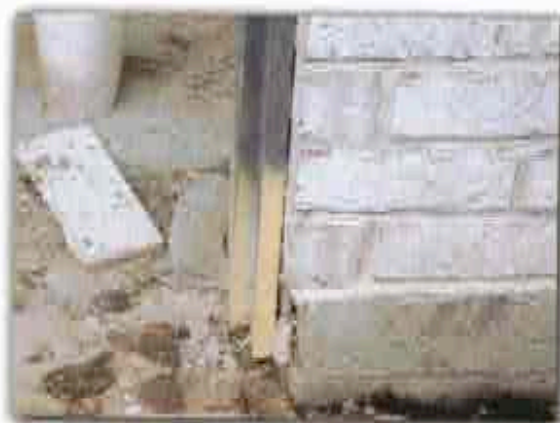
The garage door siding is not sealed.

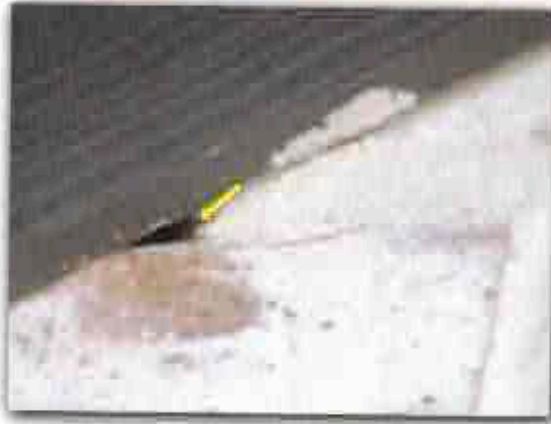
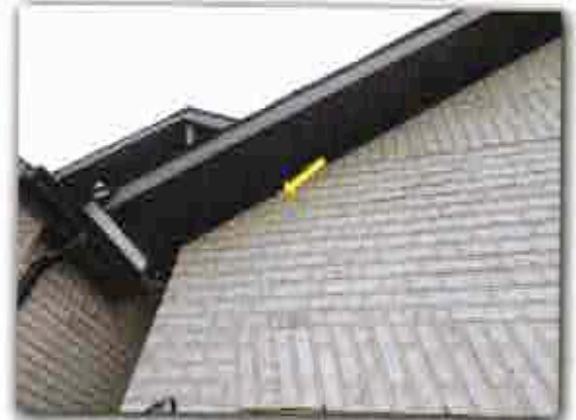
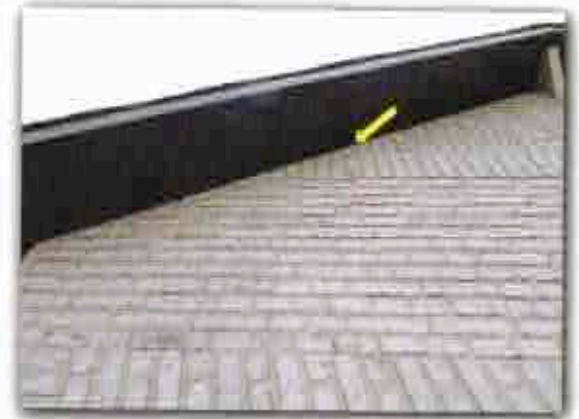
There are gaps in the mortar above the garage.

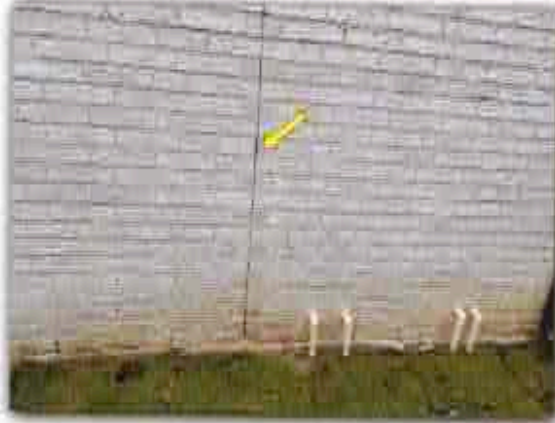
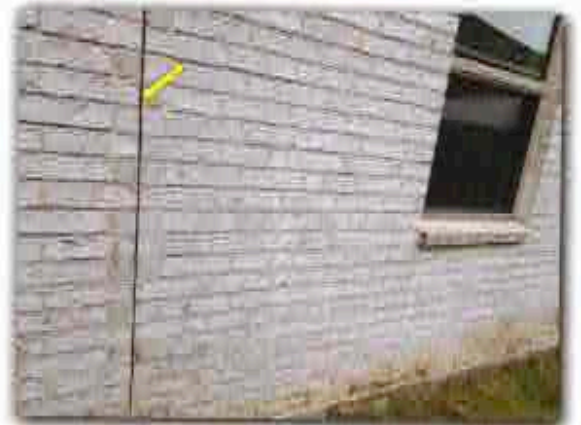
There is missing caulking material in the expansion joint at multiple locations.

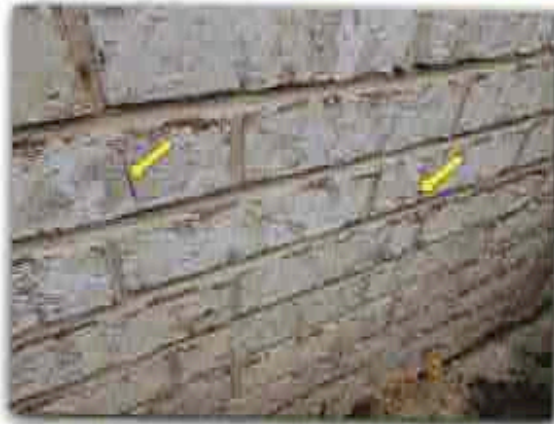
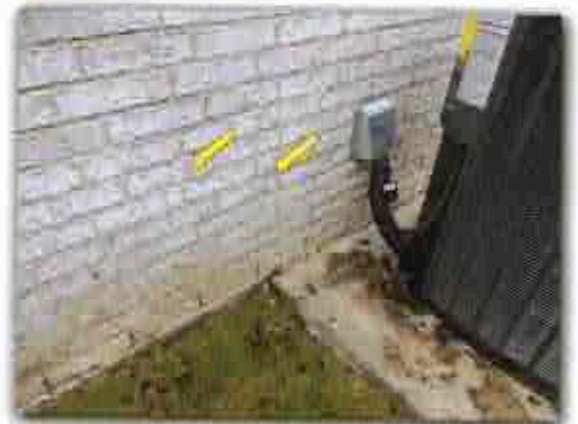
There is a crack on the brick at the back right side.

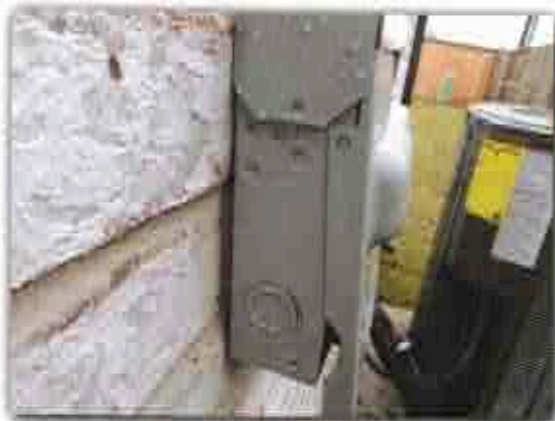
The A/C emergency shut off switch boxes are not properly weather sealed/caulked at the exterior wall.

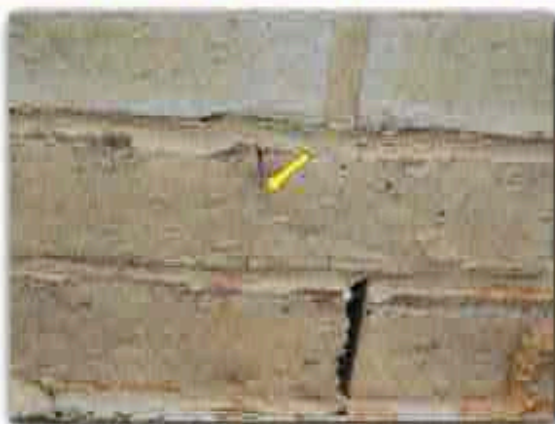
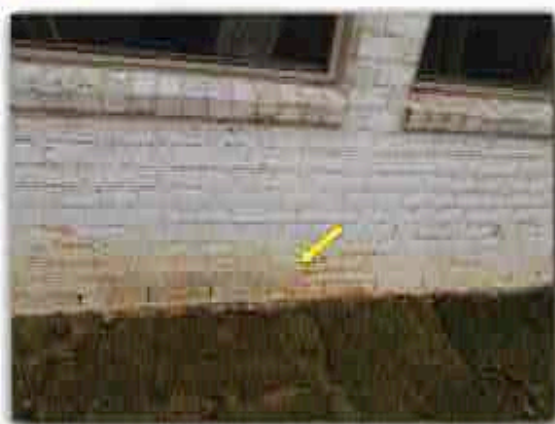
There is a crack on the brick at the back middle-side.

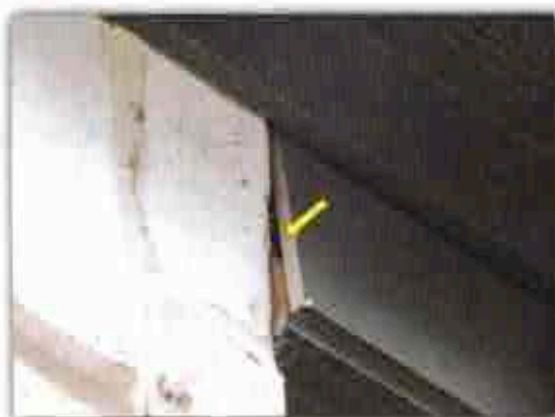
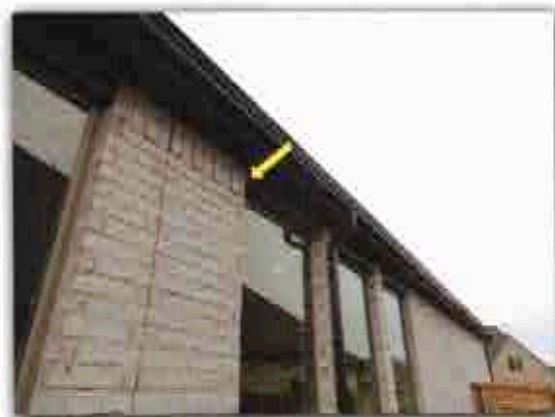
There is a gap where the board above window meets the wall at the left side.

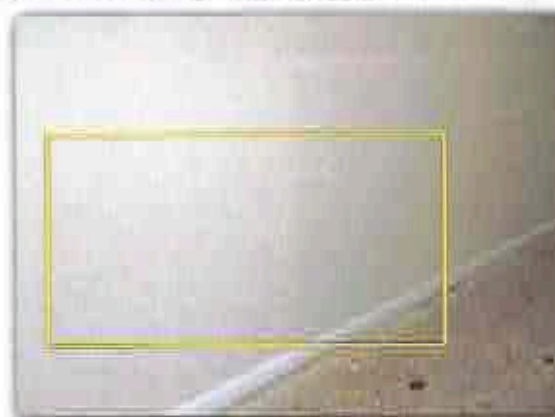
There is a stain on the sheetrock on the left side garage wall.

NOTE: I recommend further investigation at areas where moisture stains are present as I cannot see into the wall or behind the sheet rock. I cannot determine what may be present inside the wall.

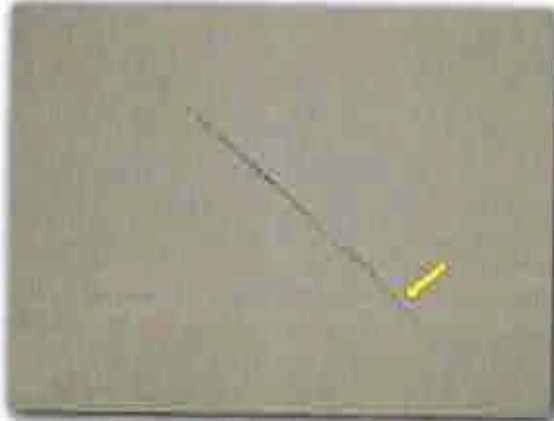
There is a sheetrock crack in the ceiling in the garage.

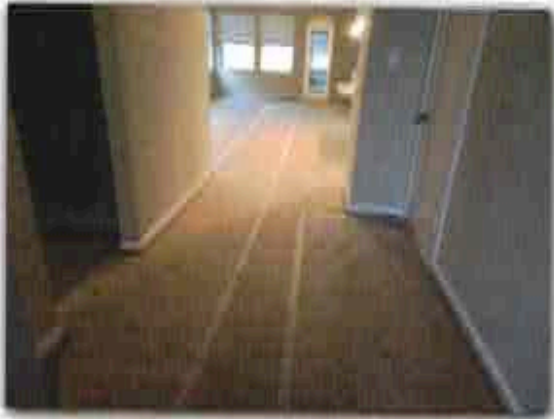
NOTE: The flooring is obstructed and not all of the flooring is visible for inspection.

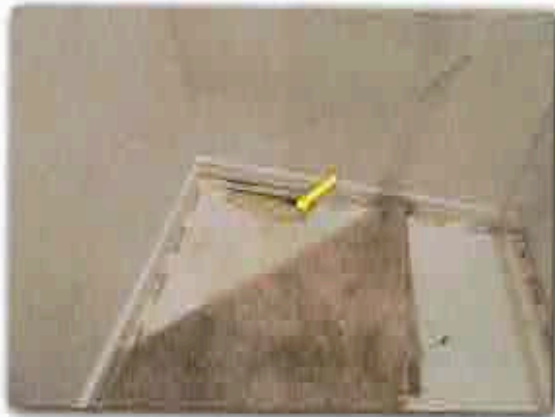
The left side bedroom closet floor is damaged.

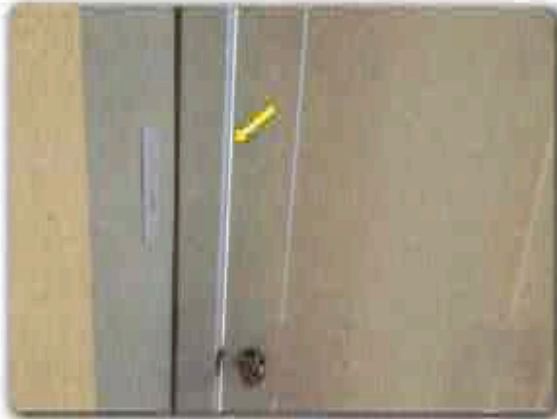
There is daylight showing through the jamb of the garage door. This is indicative that the door is not fully weather sealed.

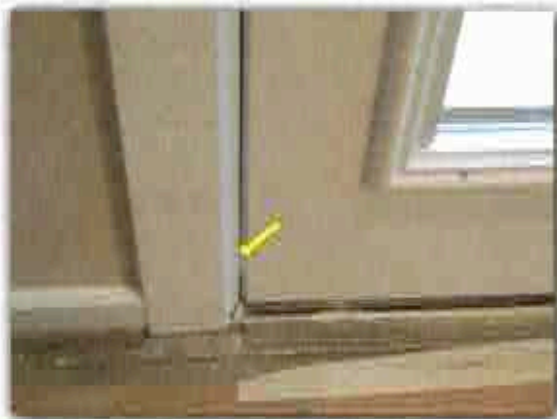
There is daylight showing through the backyard door jamb. This is indicative that the door is not fully weather sealed.

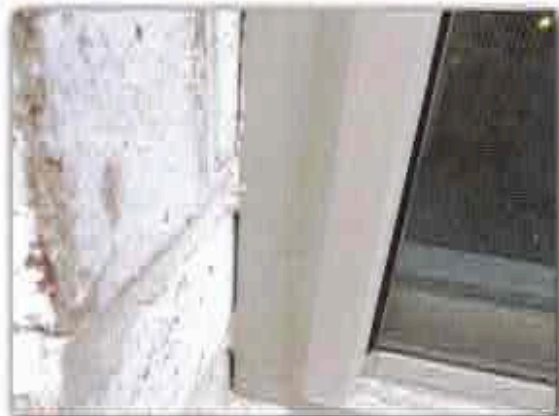
The caulking around the windows is missing in multiple locations. The picture below is representative.

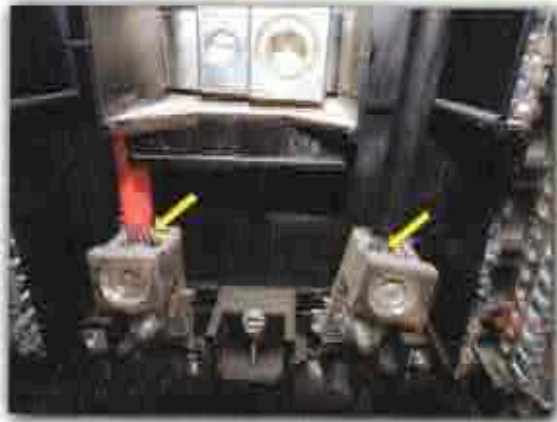
There is no anti oxidant paste on the aluminum service wires at the main lugs.

Due to defects observed, recommend service and complete system check by licensed electrician.

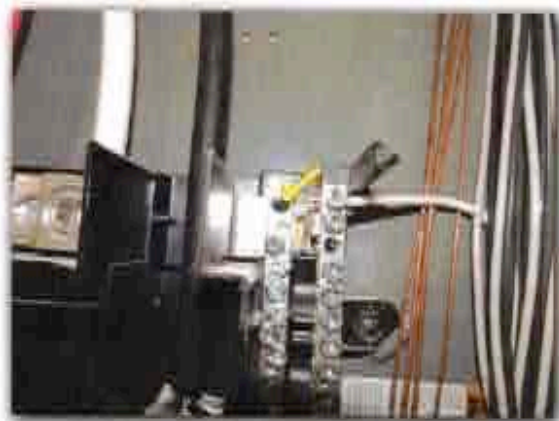
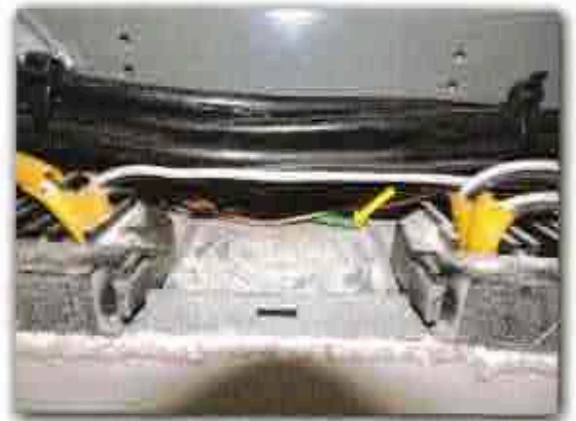
The bonding screw is not installed in the main panel. This is required to ensure that the neutral bar is secured to the panel. I was able to locate it sitting at the bottom of the panel. This needs to be installed.

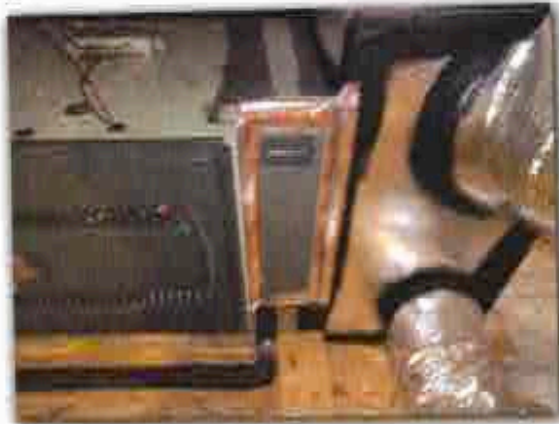
Filter Type: Media Filter
filter should be checked.

Condition: Door was taped shut and the

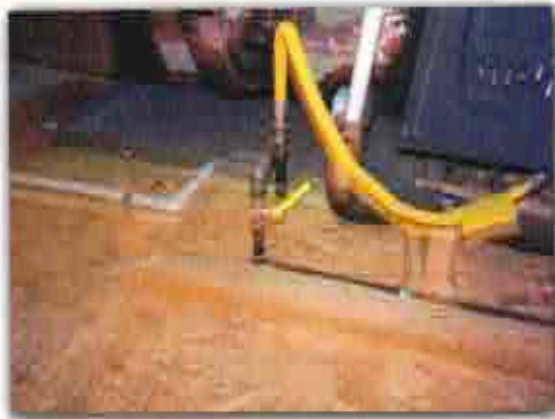
The gas supply was shut off to the home at the time of the inspection. I was not able to turn the unit on to test it.

NOTE: As a preventive/maintenance measure, I recommend the heating and cooling systems be serviced by a licensed HVAC technician prior to each heating and cooling season.

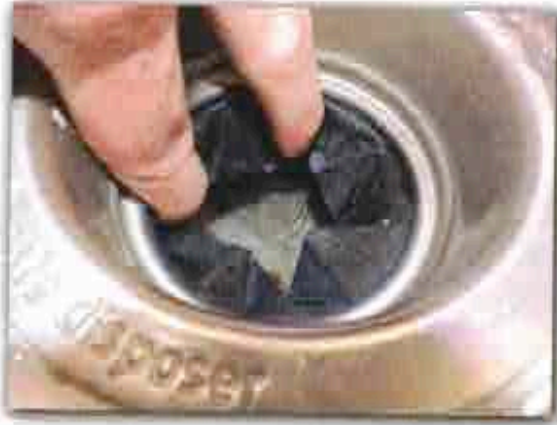
There is debris inside the unit.

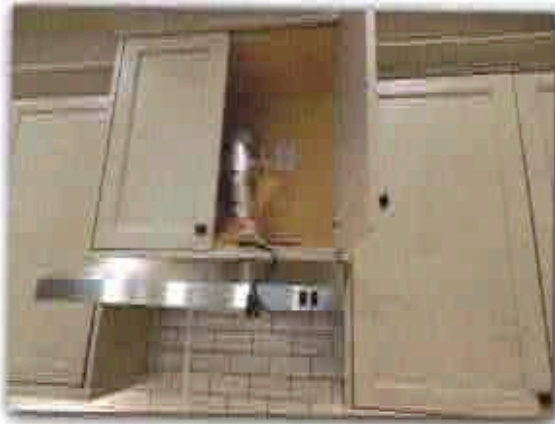
The Range Hood is installed but not plugged in. I was unable to operate at time of inspection. Plug in and test.

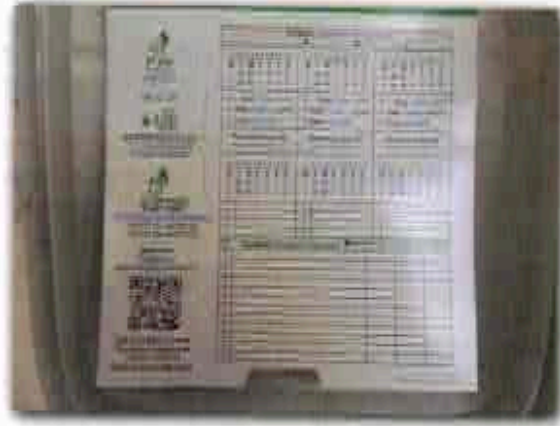
The control panel is missing labeling.
