# **House To Home Inspection**

## **Inspection Report**

161 West Breezy Way Unit 5C Spring Texas 77380

## PROPERTY INSPECTION REPORT

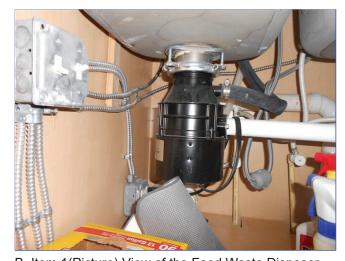
There were no deficiencies detected concerning the function of the food waste disposer at the time of the inspection. The food waste disposer was turned on and the grinding hammers were inspected for freedom of movement. The disposer was also inspected for the proper wiring and plumbing as well as for any possible water leaks.

B. Item 1(Picture) View of the Food Waste Disposer
