Inspection for Property located at 20960 Young Meadows Way
05/20/2020
Prepared for : Donna Dukes

PROPERTY INSPECTION REPORT

Concerning: 20960 Young Meadows Way, Katy, TX 77449
(Address or Other Identification of Inspected Property)

By: Robert Hughes, Lic #20949 TPCL 787224 05/20/2020
(Name and License Number of Inspector) (Date)
Anthony Hughes Lic #21356
(Name and License Number of Inspector)
Gregory Hughes Lic #22420
(Name and License Number of Inspector)

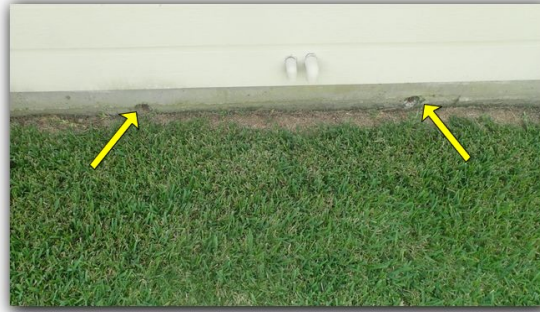
Post tension cable live ends are exposed. Recommend repair before more extensive repairs become needed.

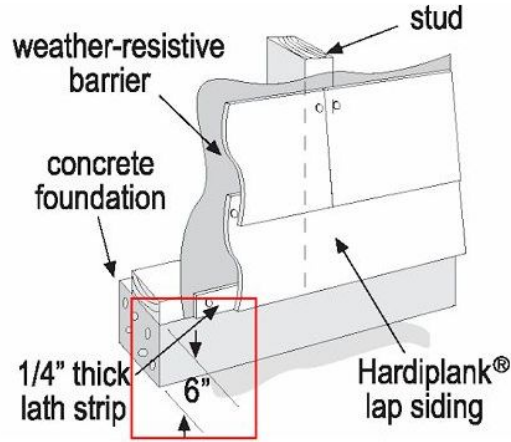
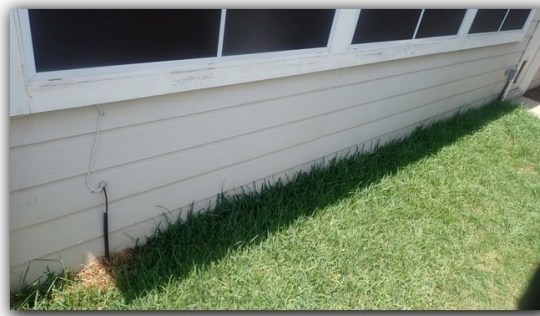
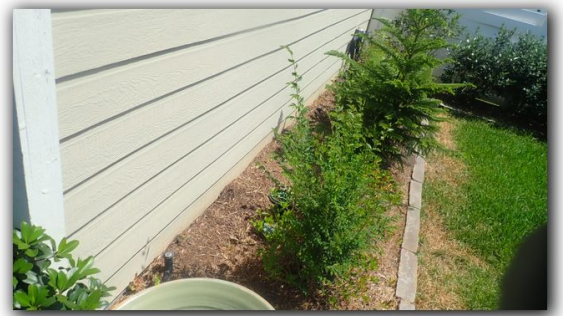
Soil level too high, or close to cement board siding, promotes wood rot and is considered a conducive condition to termite activity at one or more locations around house/garage.

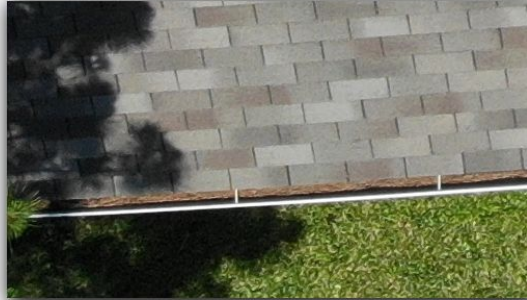
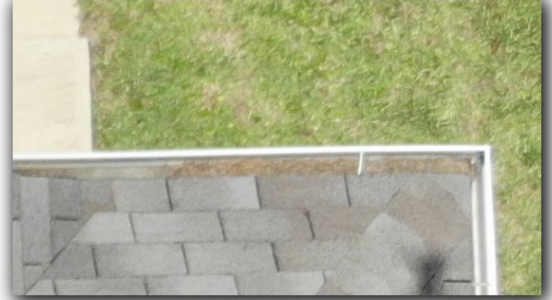
Comments: The gutters have areas full of debris and/or holds standing water. Needs to be cleared and possibly re-hung to slope toward downspout drains.

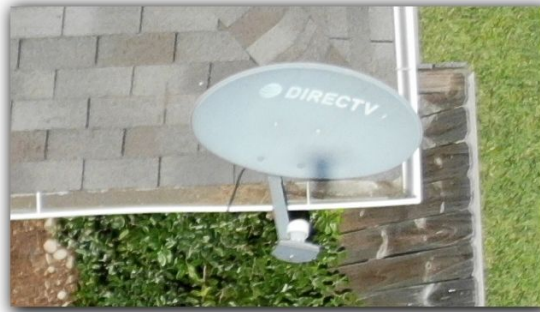
Note: Roof penetrations such as Satellite dishes, cables, etc. should be monitored for possible leaks.

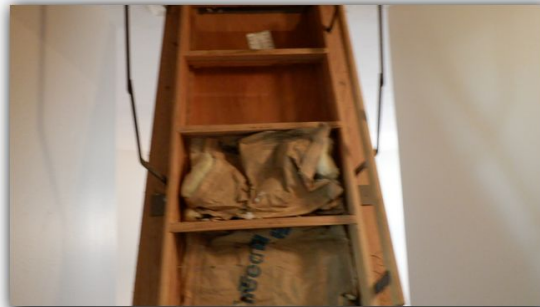
Comments: The stairway has fiberglass batt insulation. This type of insulation is be a tripping hazard because it is thick and loose. Suggest obtaining foam board insulation, cut to fit space behind stairs, then taping or glueing into place.

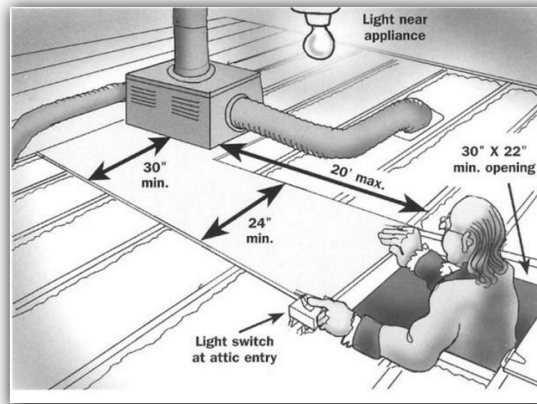
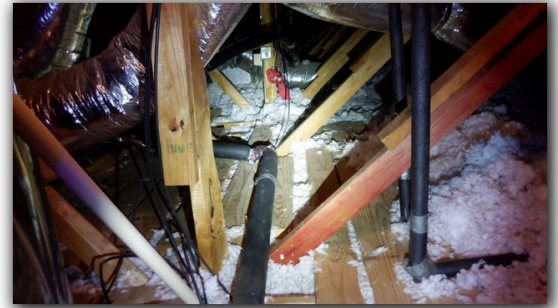
Inadequate attic walkway and/or platform to mechanical equipment in attic. According to IRC M1305.1.3, attic passages require a minimum 30 inch head clearance and a minimum 24 inch wide SOLID (no gaps or obstructions), floor to equipment for servicing and a 30 inch deep solid platform in front of equipment.

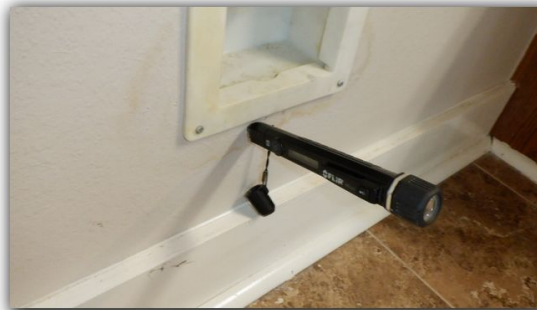
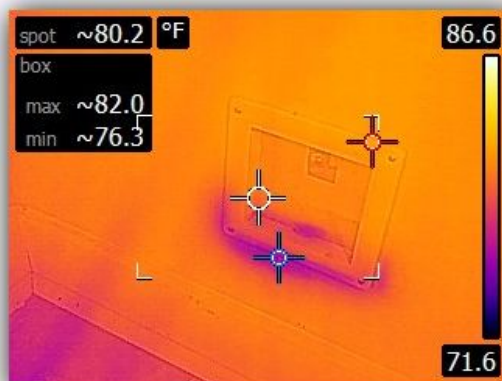
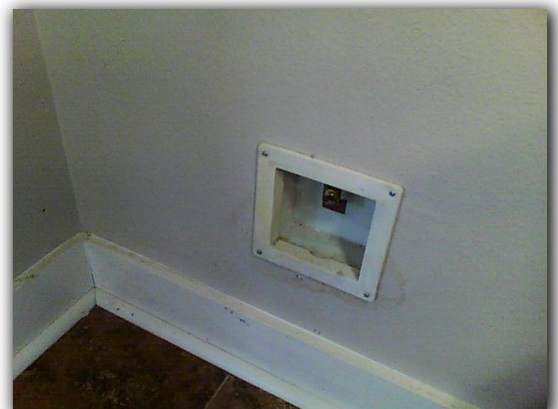
Comments: Active leak at refrigerator supply valve.

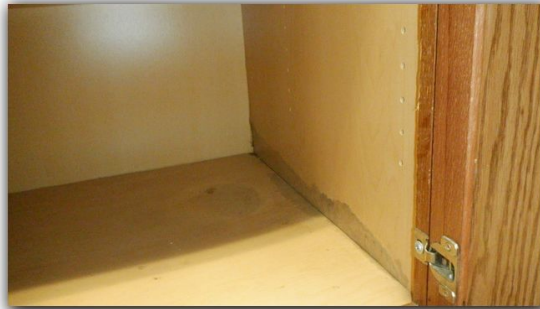
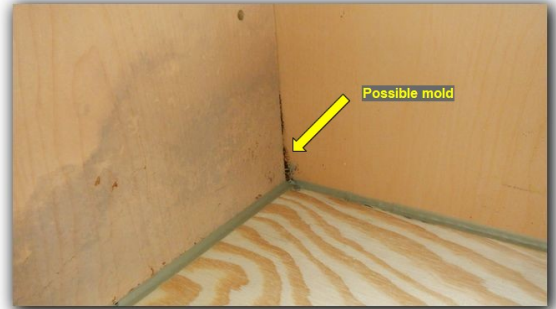
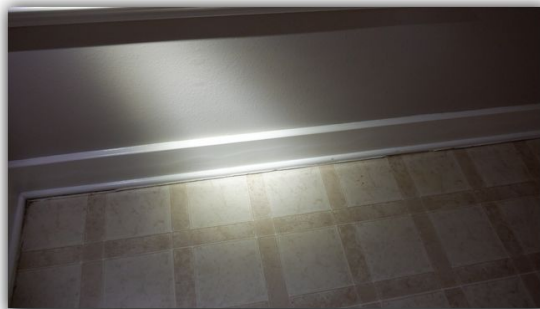
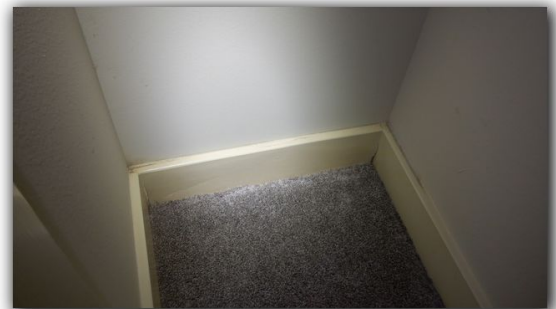
Previous water damage to Kitchen sink cabinet, Laundry room trim and front bed closet.

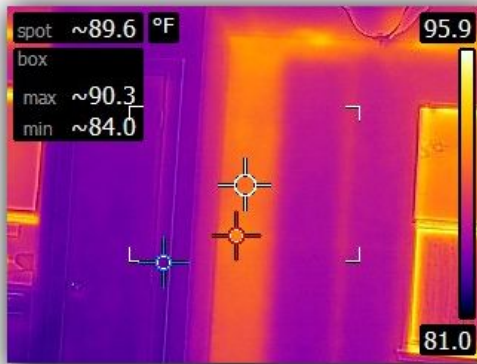
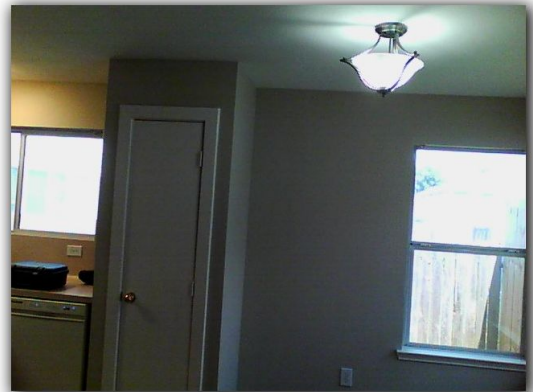
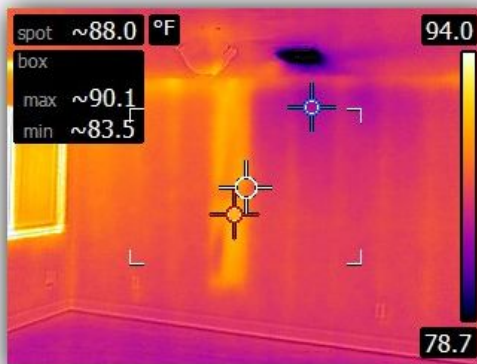
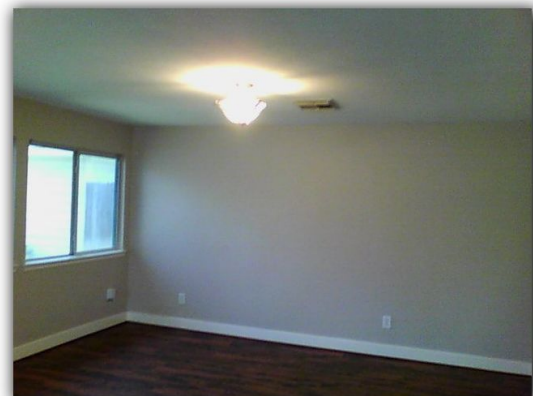
Thermal imaging detects some missing and/or inadequate insulation.

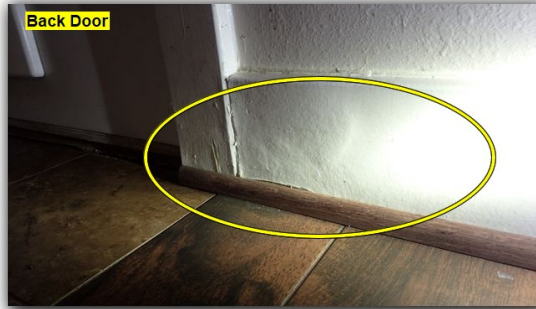
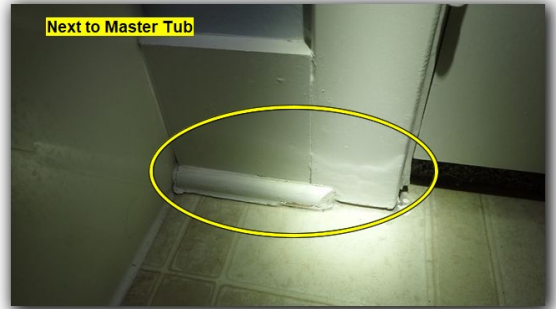
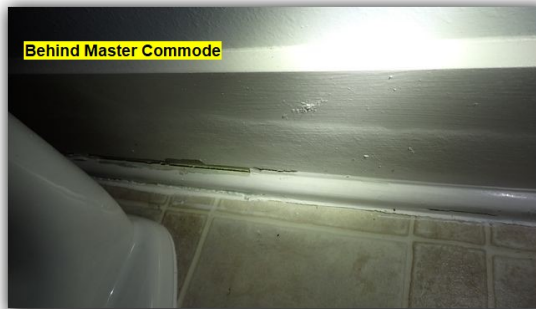
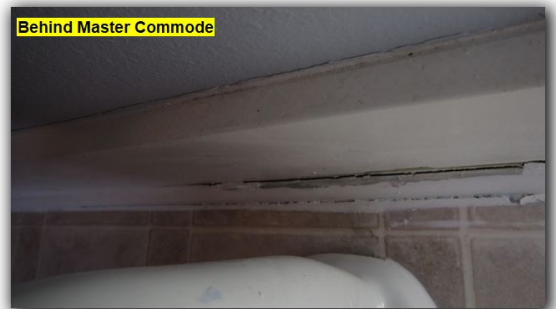
Water stains / damage or repairs observed:

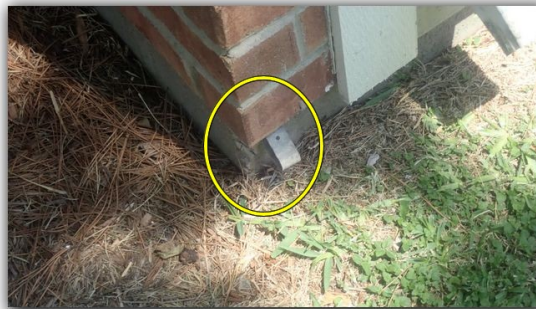
One or more brick veneer wall ties exposed. Remove exposed ties.

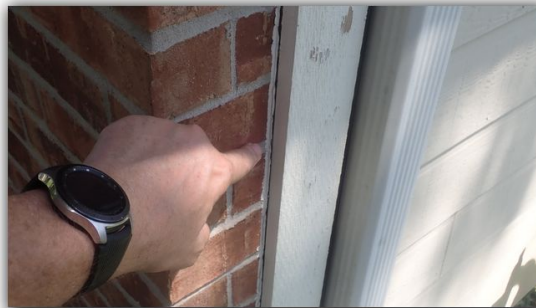
Caulking missing and/or deficient around trim boards may allow wind driven rain entry.

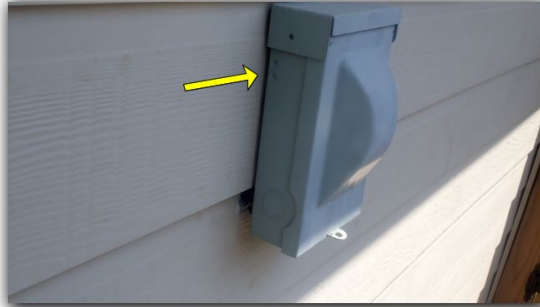
Recommend caulking around electrical service panels and disconnect boxes of A/C units to prevent water entry behind disconnects. Caulk top and sides, leave bottom un-caulked to allow moisture escape.

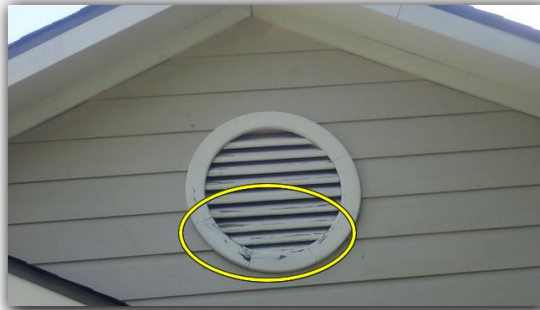
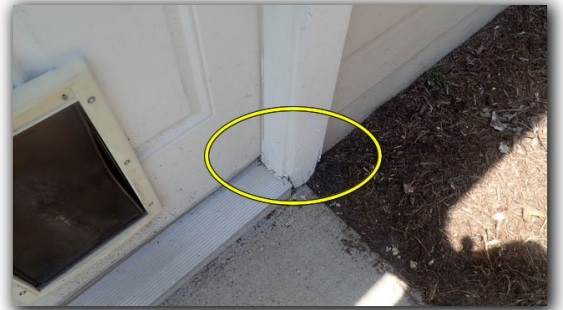
Wood rot observed on areas of house / garage.

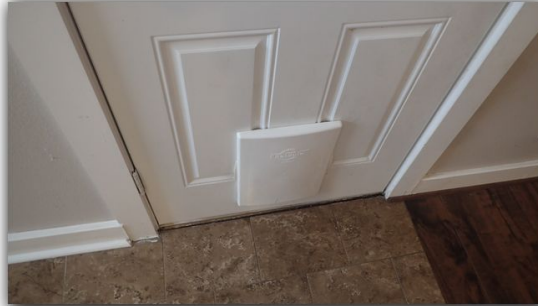
Security consideration, dog access door to exterior.

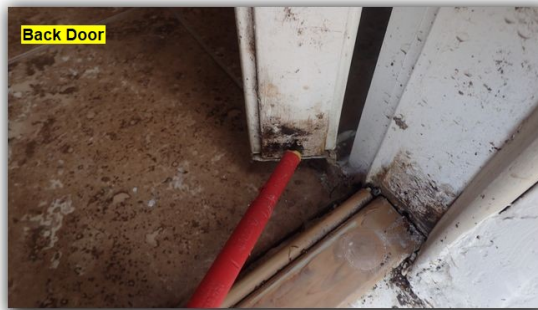
Wood rot of lower door and/or jamb.

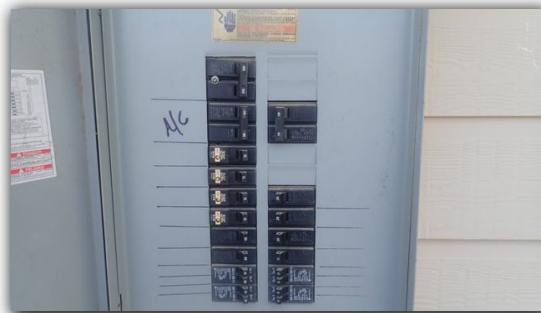
Not all breakers are properly identified.

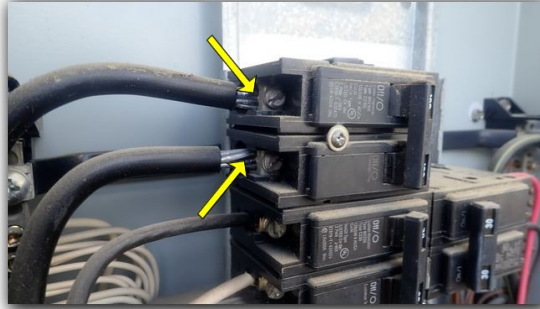
There is no anti-oxidant compound (grease) on the exposed aluminum wiring.

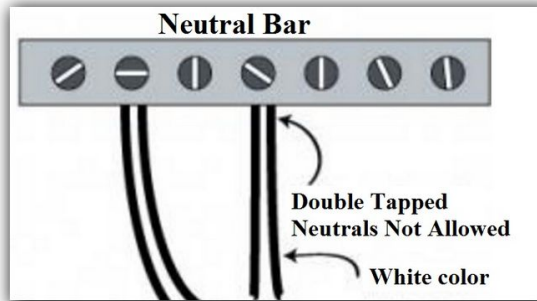
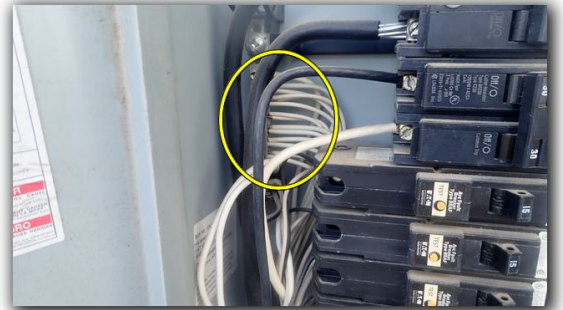
Observed two or more neutral conductors under one screw lug on the neutral bus.

Current industry standards and National Electric Code permit one neutral conductor per screw lug.

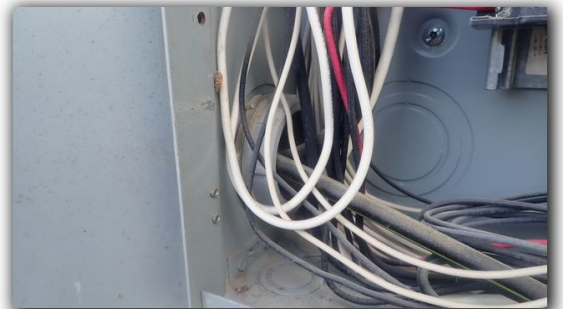
No grounding lug with bonding conductor to case on incoming service conduit at concentric knockout. IRC 3609.4.4

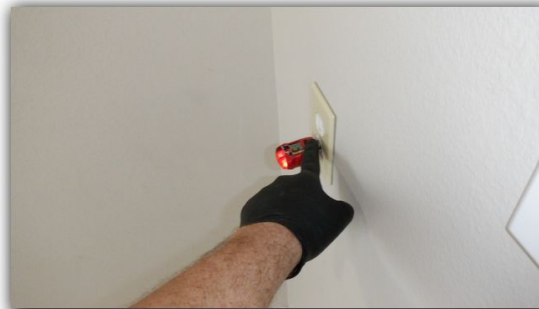
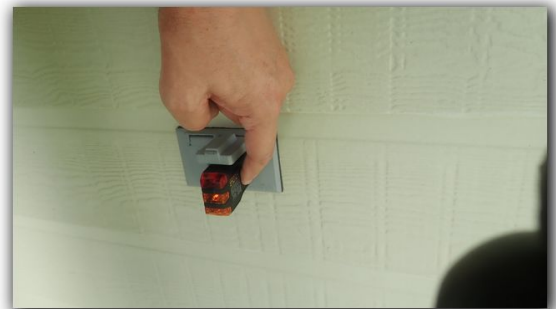
Comments: Did not observe GFCI protection of all outlets in required locations, including but not limited to the location marked below. This condition is a recognized safety hazard and is in need of repair.

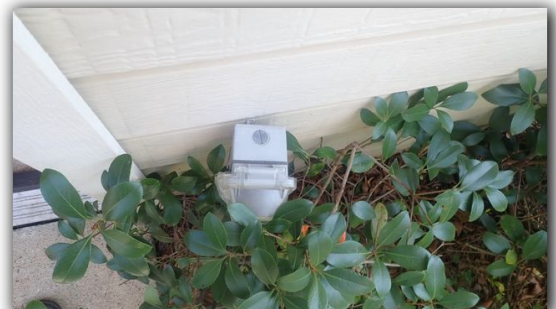
One or more outlets are not secured well in wall.

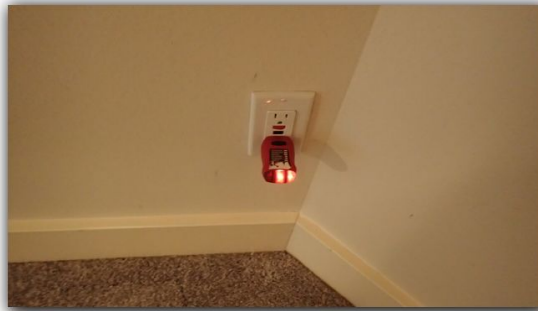
Second GFCI outlet in the far end of the master closet was not functional.

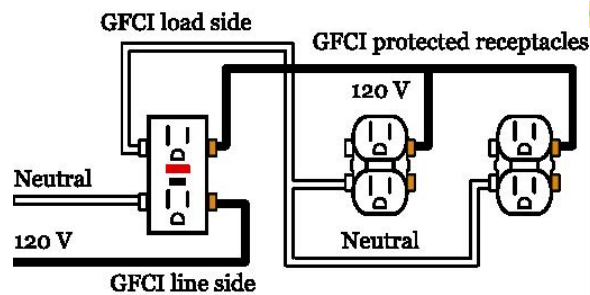
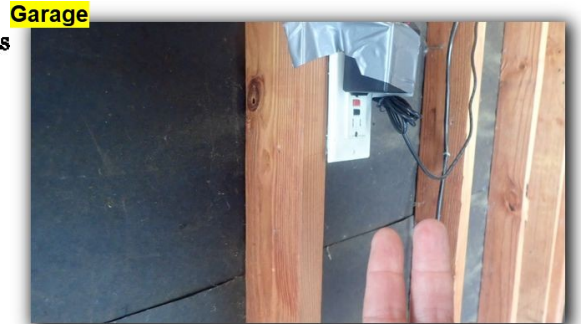
Multiple GFCI resets on the same circuit. This condition is un-necessary and creates confusion for the homeowner. There should only be 1 GFCI reset per circuit.

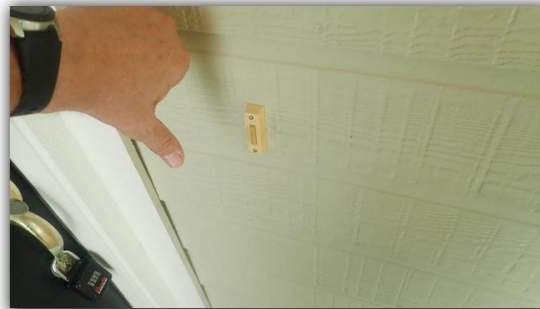
The Doorbell is non-functional.

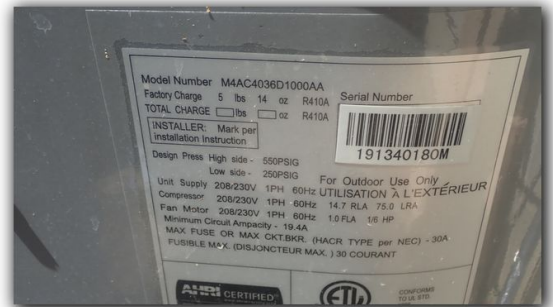
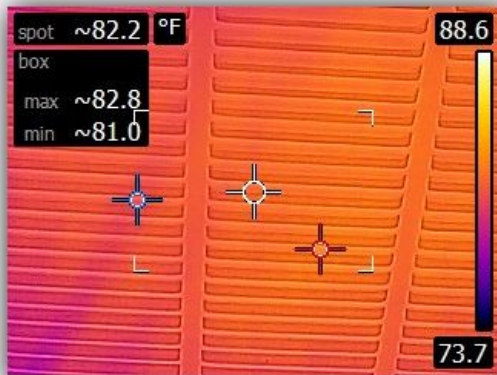
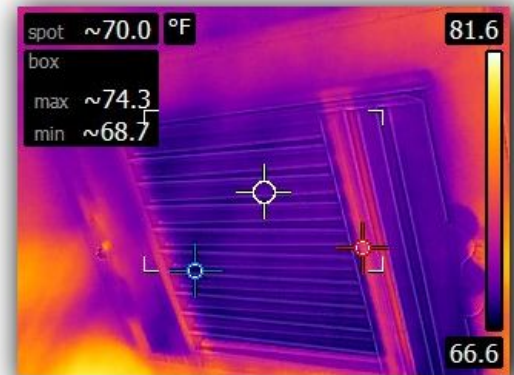
The A/C unit is producing a low temperature differential when measured at the return and supply registers. According to the Texas Real Estate Commission, the temperature differential is deficient if it is below 15 degrees or above 20 degrees. Because of this condition Texas House Check recommends that the Air Conditioning systems be serviced by an HVAC contractor when the temperature differential is below 15 Degrees F.

The air conditioner produces a differential temperature of 14.4 degrees F.

The condenser has a 3 ton cooling capacity and was manufactured in 2019.

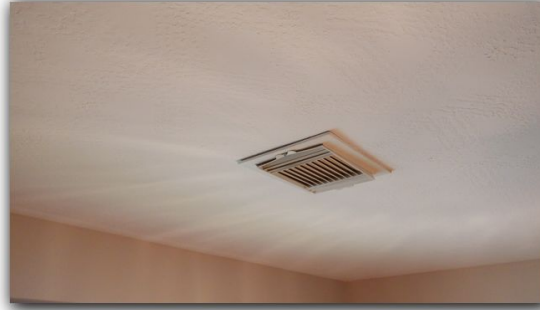
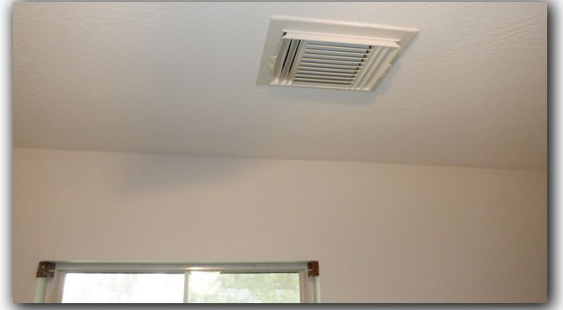
Comments: One or more air registers are facing a direction that may not promote good airflow and temperature comfort. Consider facing the primary flow of the registers towards the exterior walls if the room feels uncomfortable.

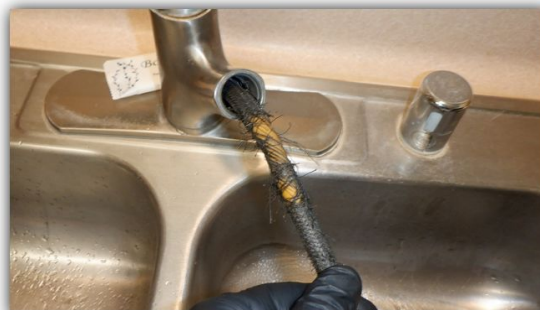
Comments: Kitchen faucet line is frayed.

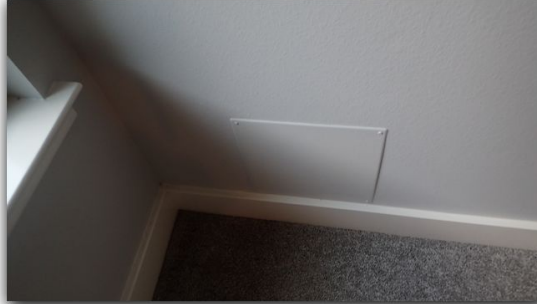
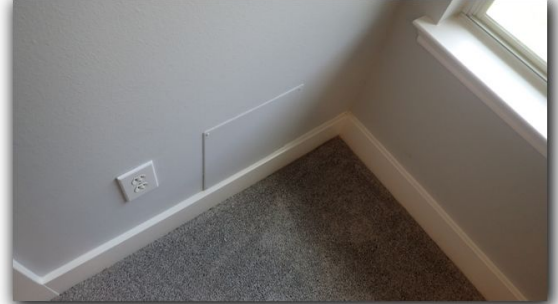
Access covers that are painted to the walls were not removed for inspection because removing the cover may damage the wall finish.

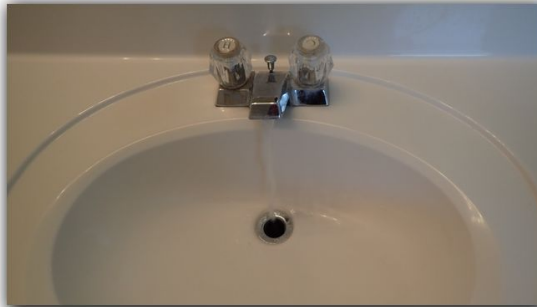
Weak faucet pressure located in Master Bath. This can simply be a water supply valve problem or it could be a problem with the supply lines to the bathroom. Because a supply valve may leak when adjusted it is out of the scope of this inspection to adjust any valves.

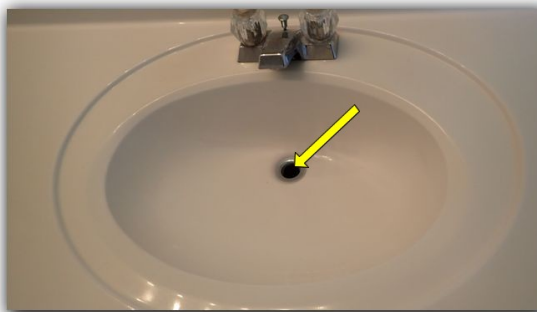
Drain stopper or pop-up lever assembly of one or more sinks is missing, damaged or needs adjustment.

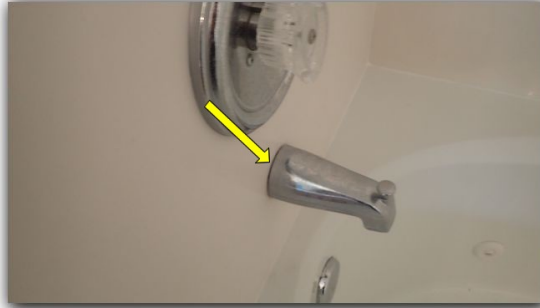
Recommend caulking around all tub/shower faucets and spouts to prevent water entry behind wall.

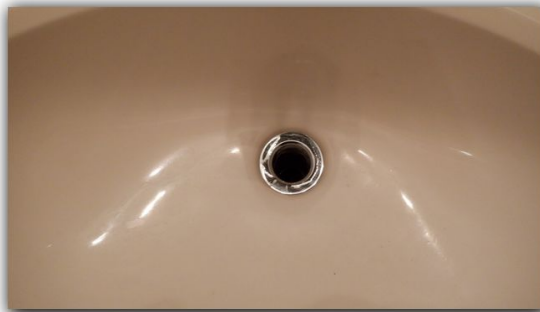
Comments: Drain stopper missing.

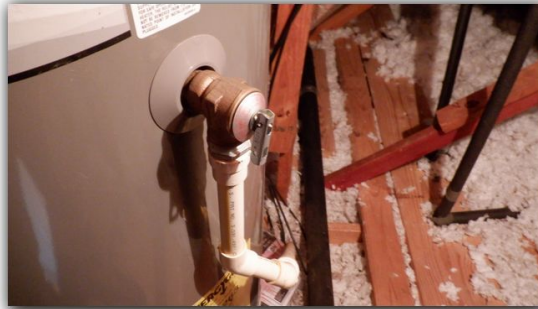
T&P valve difficult to operate, needs repair.

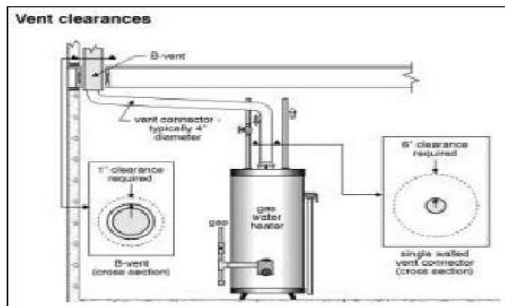
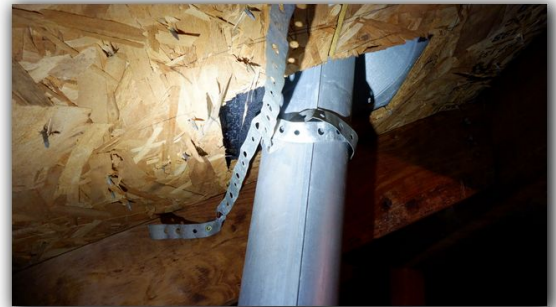
Exhaust vent pipe is in contact or does not have required minimum 1" clearance from combustible material, [wood roof decking].

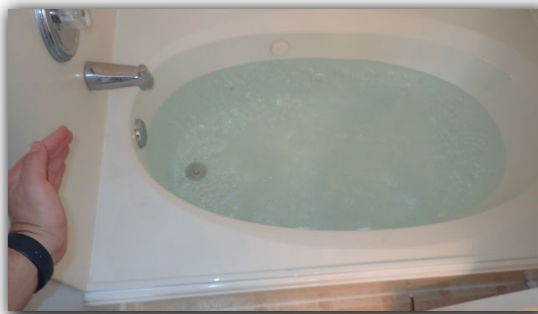
Comments: Excessive noise when operating the spa tub. Recommend further evaluation/repair by a qualified plumber.

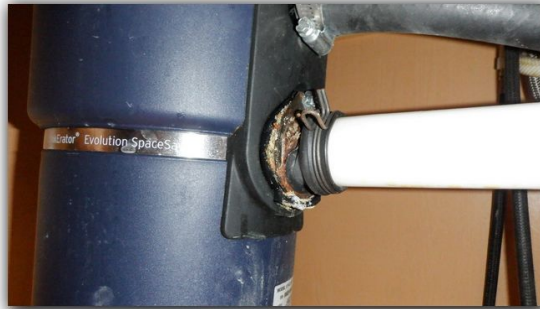
Comments: Corrosion, possible previous leak.

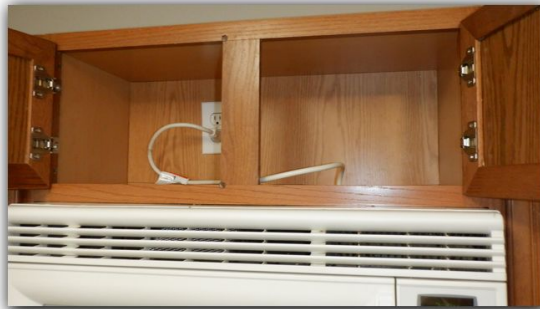
Comments: The range hood is integrated in the microwave oven mounted above the range. The hood relies on filter screens to remove particles and grease from the cooking fumes. **IT DOES NOT VENT OUTSIDE.** Regular cleaning and/or replacement of the filter screens is necessary for proper and effective operation.

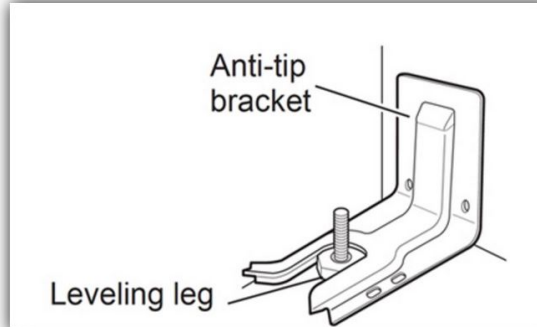
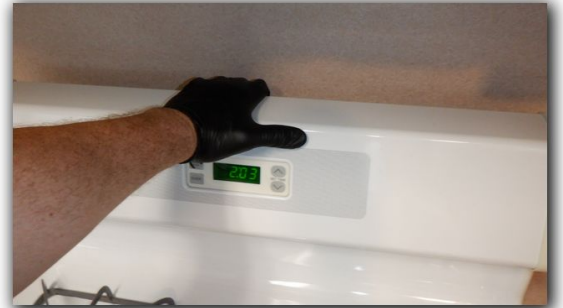
Comments: Does not have recommended anti-tip bracket on back side of unit.

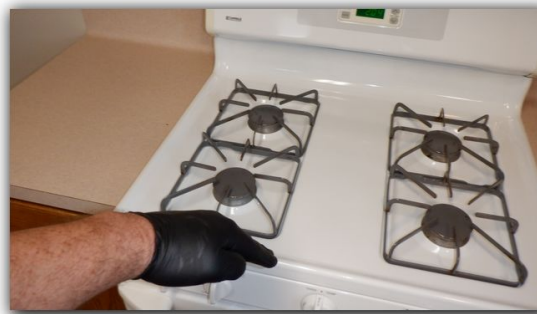
Unit not level.

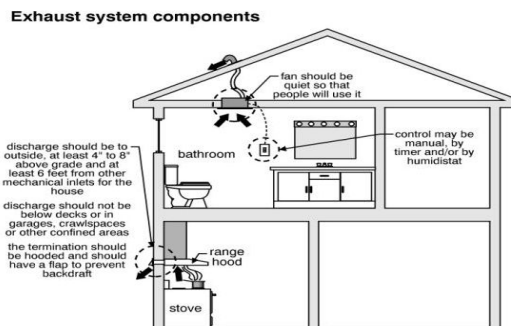
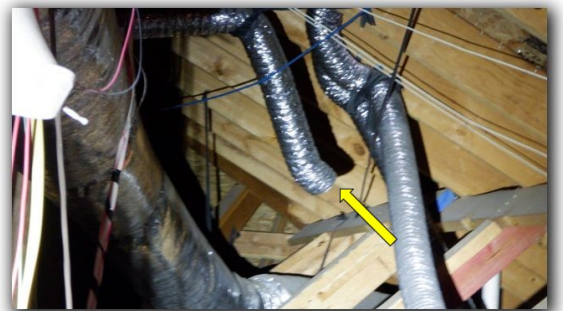
Comments: Improperly vents into attic. Should vent to exterior.
