PROPERTY INSPECTION REPORT

BUYERS EYE HOME INSPECTION

Concerning: **13120 John Reynolds Road Galveston, Texas 77554**

By: **Kimble Nobles Lic. No. 6139 Revision 1**

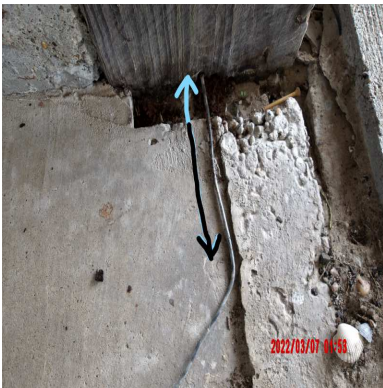
Type of foundation: Buried Wood Pilings with a Concrete Grade Cap. Many TDI certificates of compliance (7) WPI-8's was issued beginning 08/27/1990 to 04/27/2021. Appears the home was built in 1974. After inspection of visible edges of the grade cap for cracks or the lack of, corresponding cracks or tares in the cement based siding, level or un-level floors, square and plumb doorjambs or the lack of, wall conditions, and structural condition. In this inspectors "opinion" the foundation appears to be functioning partially as intended for the inspection period. As a note the depth of the pilings is unknown. **There are several pilings that have eroded at the grade cap (penetrations as deep as 50% into the wood). Deficient.** There is a slight amount of settlement near the center of the building as well as the north center (there is also some added bracing). **Deficient.** **A qualified piling company should inspect these areas and make necessary repairs.** The concrete grade cap may develop small cracks in it. These cracks are caused by the racking of the home in the wind. This is a common regular and normal occurrence. The downstairs garage walls are the breakaway type and one flow through vent.

Piling erosion.

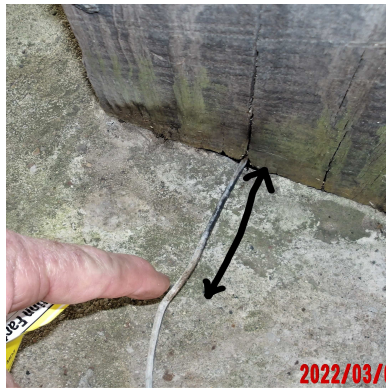
Piling erosion.

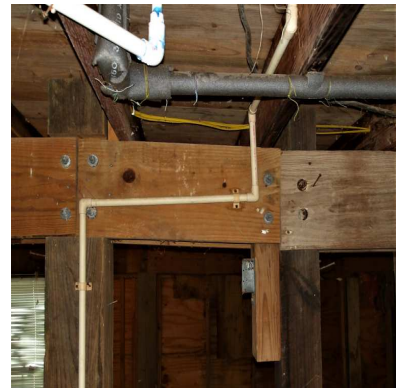
Piling bracing.

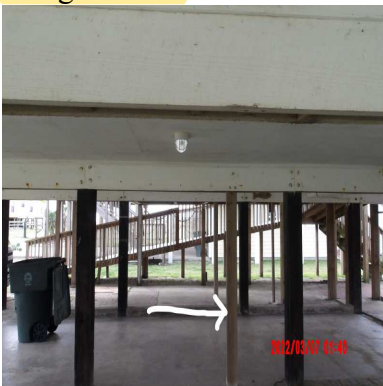
Extra bracing.

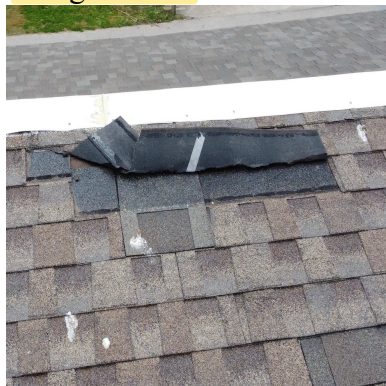
Not functioning as intended for the inspection period. **Deficient.** A TDI certificate of compliance WPI-8 was issued for the entire re-roof covering 04/27/2021 (the dates conflict the disclosure). The composition shingle roof was inspected by drone. There is some gravel loss and no spider cracking at this time. The roof covering has several torn and missing shingles mostly in the north section. **Deficient.** There is also rusting edge shingles. **Deficient.** A qualified roofer should inspect these areas and make necessary repairs. An average composition shingle covering last approximately 15 to 23 years in the gulf coast area. It appears this covering is aging normally. The method of shingle attachment is unknown. It would require pulling up of a shingle and destroying the adhesive bond. The fascia and soffit material are wood and cement based.

Damaged roofing.

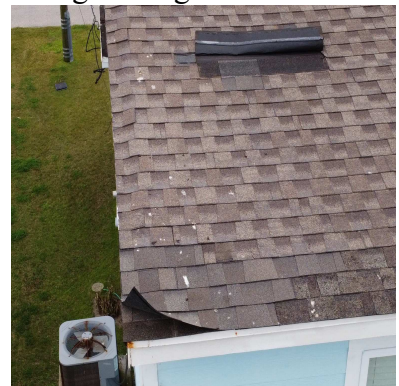
Damaged roofing.

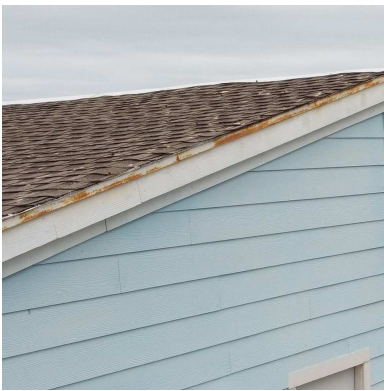
Rusted edge flashing.

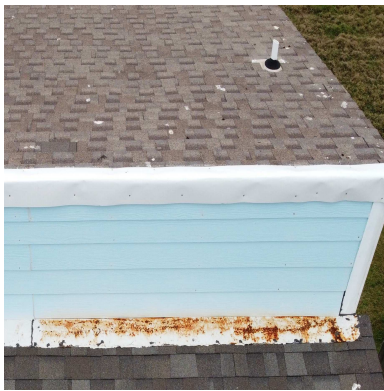
Rusting flashing.

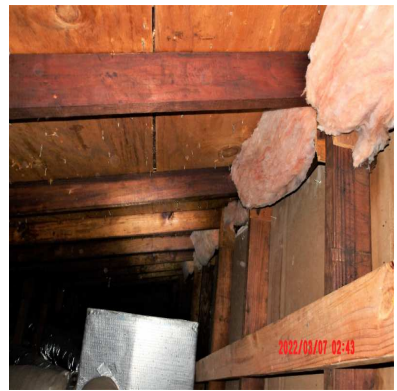
No insulated attic vertical walls.

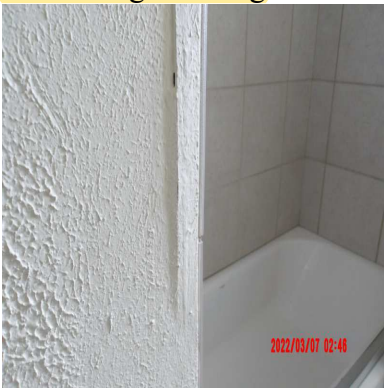
Sample texture repair.

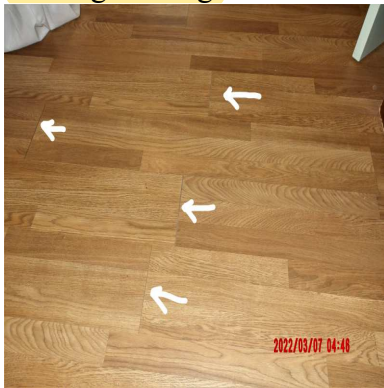
Appears to be functioning as intended for the inspection period. There are several ceiling texture repairs over the years. There are no water stains at this time. There are is normal wear of the laminate flooring. There is some butt joint gaps, seam gap separation, and small amount of cupping of the wood laminate. **Deficient**. The sub flooring has some un-levelness.

Flooring gaps sample.

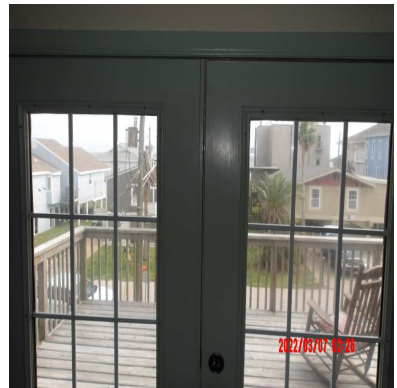
Appears to be functioning as intended for the inspection period. The exterior patio doors (both levels) on the south side are in poor condition and need repair. **Deficient**. The first level utility closet door is damaged. **Deficient**. The 2nd level east bedroom closet door is damaged. **Deficient**.

Patio doors in poor and needing repair.

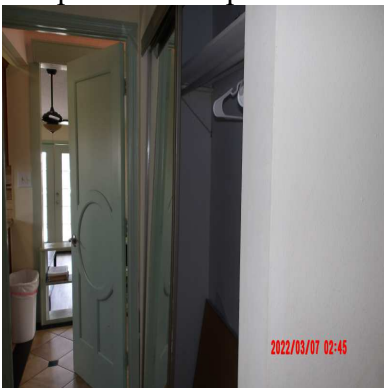
Damage closet door.

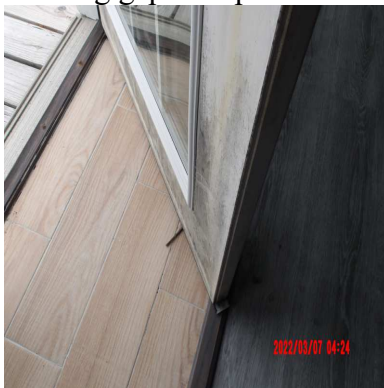
Damaged patio doors.

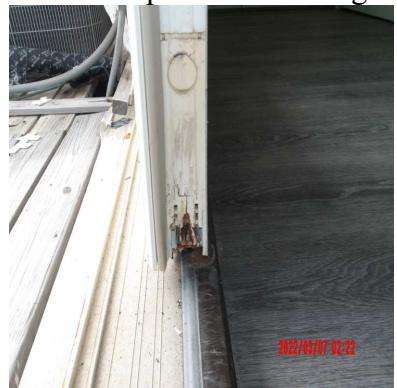
Damaged patio doors.

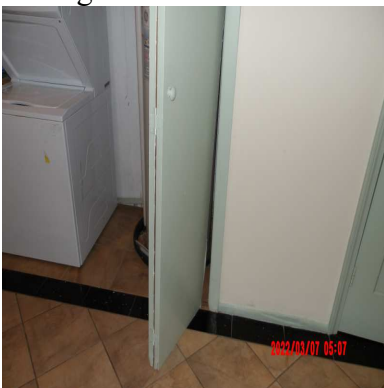
Broken door.

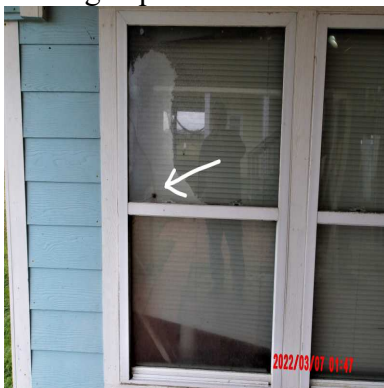
Broken window.

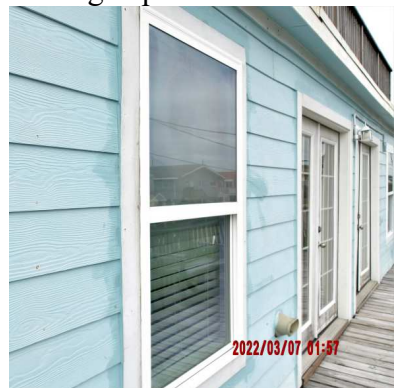
Appears to be functioning as intended for the inspection period. A TDI certificate of compliance WPI-8 was issued for the windows replacements 03/16/2006. The home is equipped with double pane glass. The bedroom windows are operational for the inspection period. The bedroom windows may be the only means of emergency egress. Check the windows at least once a year. The guides can be cleaned and lubed with a dry lubricant to keep them operating smoothly. **There is a broken window downstairs westside north, and 1st living level west bathroom. Deficient. A damaged guide at the 2nd level east side window. Deficient. There are two windows fogged on the south deck. Deficient.**

Fogged window.

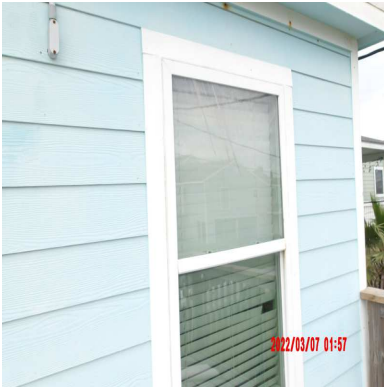
Fogged glass.

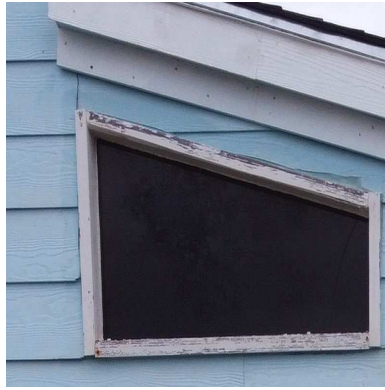
Broken glass.

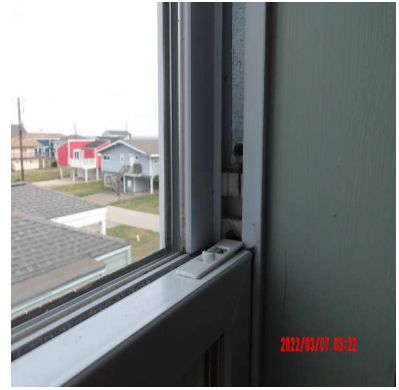
Broken guide.

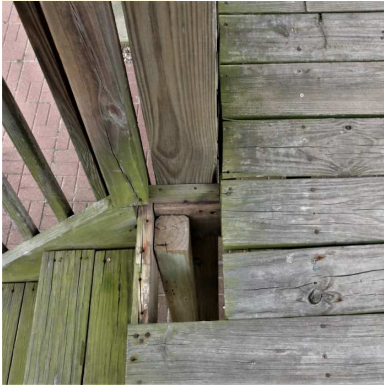
Appears to be functioning as intended for the inspection period. There is a decking board missing at the top of the long ramp. **Deficient**. There is a missing baluster at the top of the top stairway. **Deficient**. There are several curled deck boards on the large ramp. **Deficient**. There are two steps made in the top level. These steps are 10 inch tall. **Deficient**. Step height should not be more than 7 1/4 inches.

Missing deck step board.

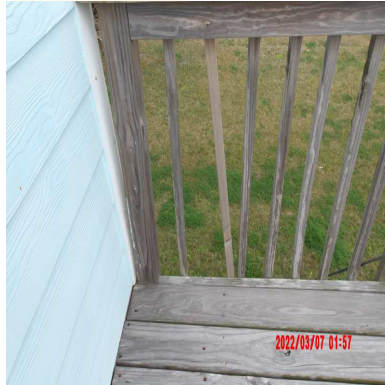
Broken baluster.

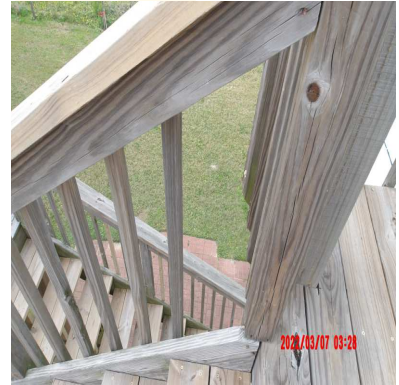
Missing baluster.

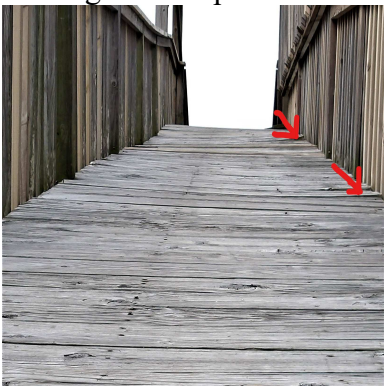
Un-level decking.

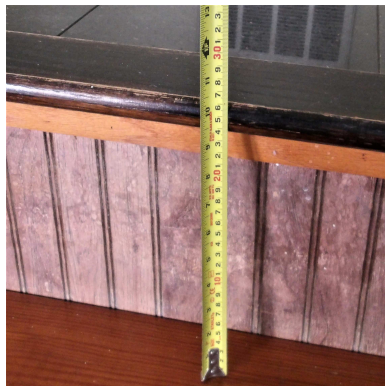
Hazardous riser height steps.

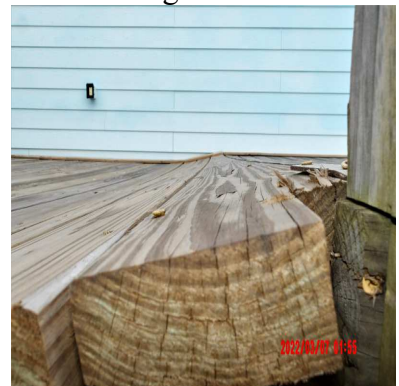
Un-level deck.

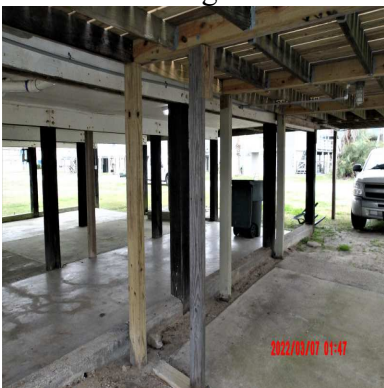
Temporary bracing under the deck.

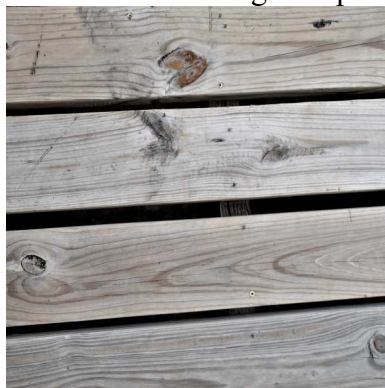
Appears to be functioning as intended for the inspection period. Wooden decks should be treated with a water sealer as needed to preserve and prolong their life. All exterior cellulose materials (wood) are subject to age, pest, and weather. Damage of this type should be anticipated. The wood decking has several replaced boards and heavily weathered boards. **Deficient**. Repair or replace as needed. A regular cleaning and painting of all exterior surfaces will extend the life of these materials. The 1st level deck has several un-level areas. **Deficient**. There are some temporary braces where the newer and older decks meet on the west side. There are several gaps between deck boards greater than 1/4 inch. **Deficient**.

Wide gaps between of deck boards.

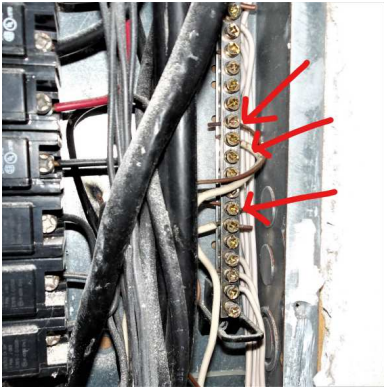
The electrical service panel is a Cutler Hammer 200-amp panel with disconnect in the panel and an General Electric 100-amp sub panel in the 2nd level. Copper wiring, correct breaker and wire sizing are present in the main panel. There are several neutral and ground wires are connected to the wrong buzz strips. **Deficient.** Appears to be functioning as intended for the inspection period. AFCI breakers are not installed. **Deficient.** This home was constructed well before this code was established. See note below. The sub panel was not opened as it was sealed shut with caulk and paint. **Deficient.** There are two knockout covers missing at the General Electric sub panel. **Deficient.** The main J-box at the meter is heavily rusted and the top conduit is broken and leaks rain water in it. **Deficient.** The conduit from the main J-box is not connected into the wall. **Deficient.** A qualified electrician should trouble shoot this system and make necessary repairs.

Incorrect wires on buzz bar.

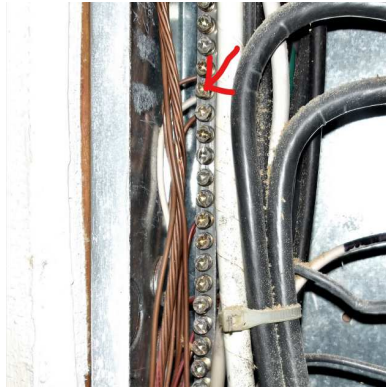
Incorrect wires on buzz bar.

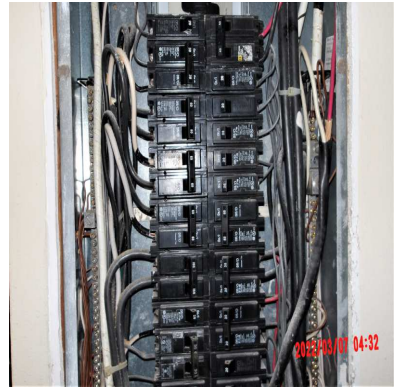
No AFCI breakers.

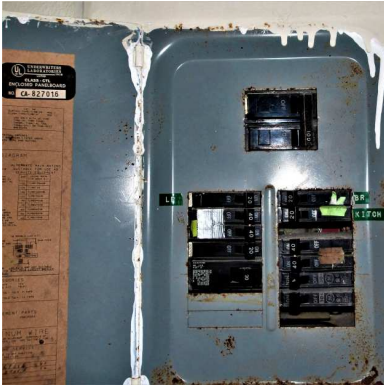
Sub panel stuck to the wall.

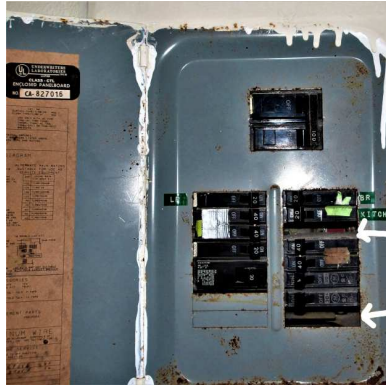
Missing knockouts.

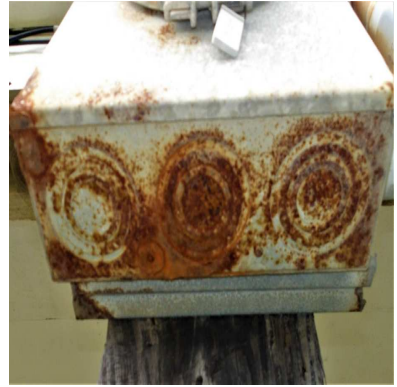
Heavy rust a meter panel.

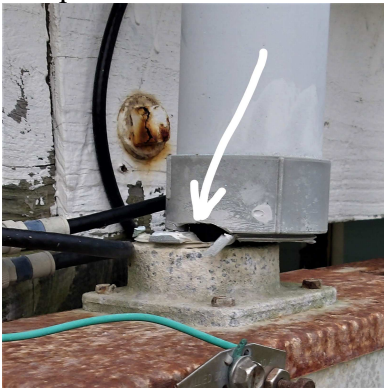
Broken conduit.

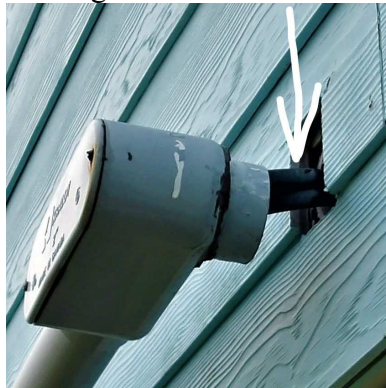
Conduit loose at the wall.

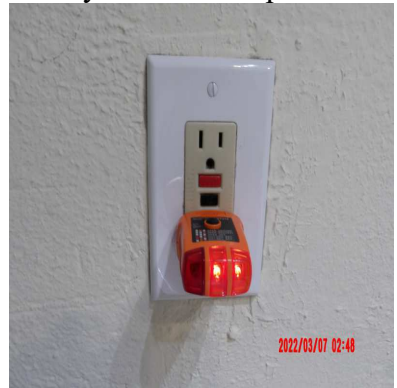
Not all of the required GFCI protection is in place and functioning as intended. **Deficient.** The kitchen counter tops (up and down) are not GFCI protected correctly. **Deficient.** The downstairs GFCI receptacles are loose in the wall and no GFCI in the work bench. **Deficient.** There is a receptacle of the wall at the 1st level west bedroom. **Deficient.** A qualified electrician should trouble shoot this system and make necessary repairs. See note below for the correct location of GFCI protection.

GFCI receptacle not tripping.

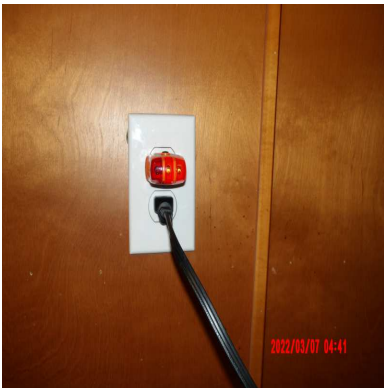
No GFCI protection.

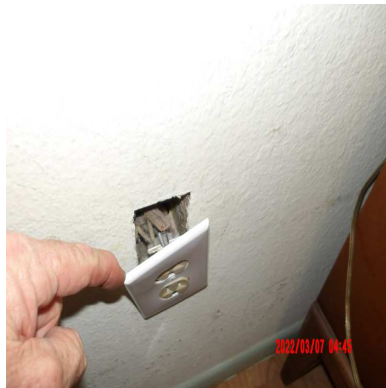
Loose receptacle in the wall.

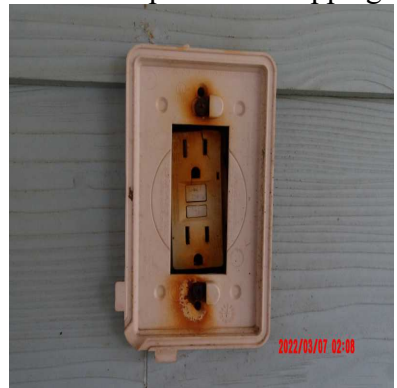
Loose GFCI receptacle in the wall.

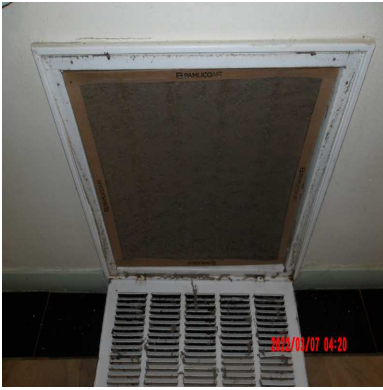
Both of the filters bypassing.

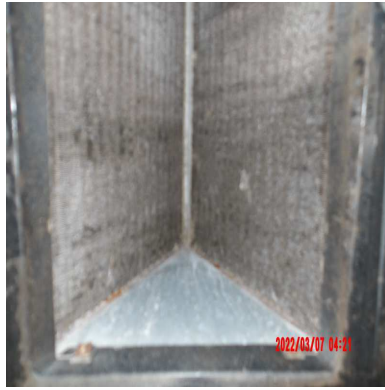
Evaporator coils dirty.

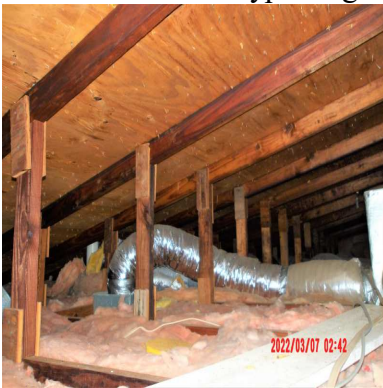
Appears to be functioning as intended for the inspection period. This home is equipped with ridged pipe ductwork covered with insulation
This home is equipped with flex ductwork. This ductwork is resting on top of the ceiling joist in the attic. This is not the preferred method. **Deficient**. Ductwork that is not hung can have flow and condensate problems.

Ductwork not tied to the structure.

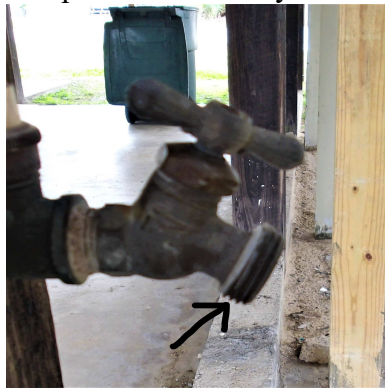
Appears to be functioning as intended for the inspection period. Water pressure appears normal. All fixtures operated correctly. The exterior faucets are not equipped with back flow devices. **Deficient**. Simply install backflow devices for exterior hose bibs. The home is equipped with plastic CPVC pipe. The location of the water meter is front. The location of the main water shut off is piling on the east side. The static water pressure is 48 psig., on the day of inspection. The 1st level bathroom plumbing fixture pulls out the wall. **Deficient**.

Missing back flow devices.

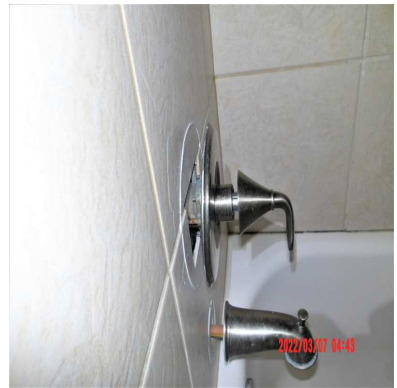
Fixture piping loose in the wall.

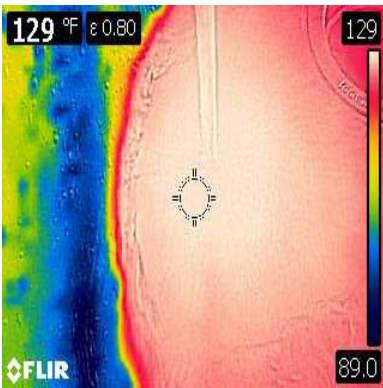
An electric 50-gallon water heater (mfg 4/2008). Functioning as intended for the inspection period. The unit recorded a 129-degree temperature at the kitchen sink. **Deficient**. **Water temperatures over 125°F can cause severe burns instantly or death from scalds.** Children, the disabled and the elderly are at the highest risk of being scalded. See the instruction manual before setting the temperature on the water heater. Feel the water before bathing or showering. Temperature limiting valves are available. Monitor temperature and **Adjust water heater thermostat accordingly**. Check your owner's manual for information. The safety valve piping not connected. **Deficient**.

Very hot water.

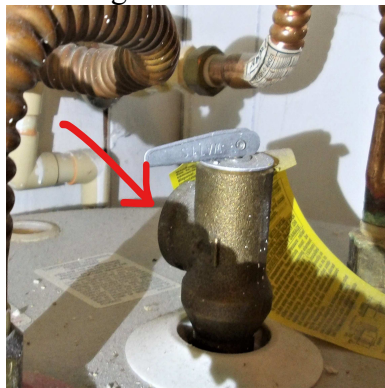
Missing safety valve piping.

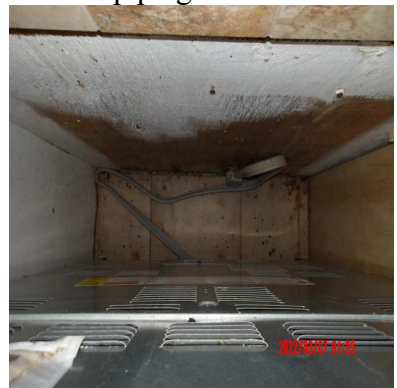
Both ranges appear to be functioning as intended for the inspection period. The electric ranges operated within limits. One of the upstairs burners is not functioning. **Deficient**. The units are not equipped with an anti-tip device. **Deficient**. This devices keep the range from tipping over when the door is down.

Not anti-tip device.

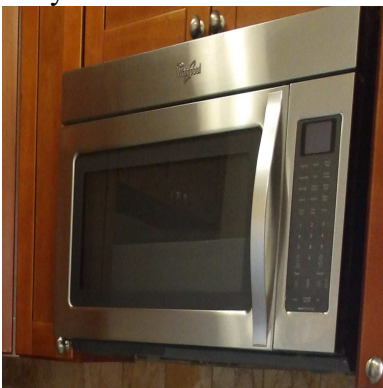
Not functioning.

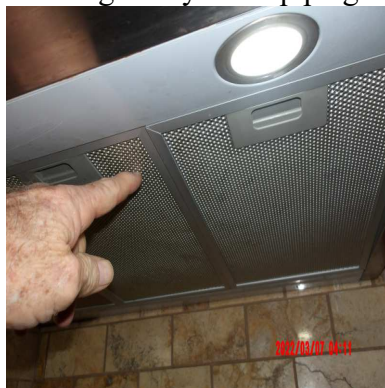
External vent.

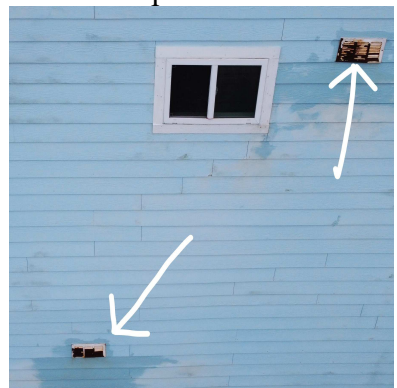
The upstairs range hood is not functioning as the microwave is not functioning. **Deficient**. The downstairs vent hood is an external air vent. Both of the metal vent covers are heavily rusted and are the wrong cover. **Deficient**.

Vents rusting.

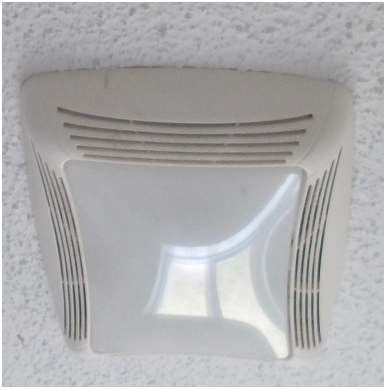
The upstairs and downstairs on the north side are not functioning as intended for the inspection period. Deficient.

Bath vents not functioning.
