Property Inspection Report #20210805-01

for property: 3902 Fernglade Dr
Houston, TX 77068

PROPERTY INSPECTION REPORT

By: Enzo Ricci, Lic #23551 08/05/2021
(Name and License Number of Inspector) (Date)

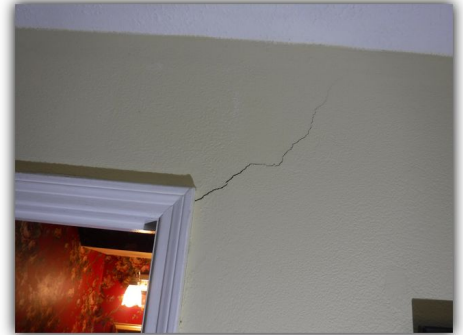
On 08/05/2021 at 9:00 am Inspector Enzo Ricci's opinion was that the foundation appeared to be in questionable condition. At this time, I did observe visible evidence that I would consider as being indications of movement and/or settlement. The areas inspected were, but may not be limited to the accessible foundation walls, ceilings, floors, doors & windows which indicated major signs of movement and/or settlement.

Large tree(s) near house foundation. Client should consider removal of tree(s) or the installation of root barrier to reduce possibility of damage to house foundation from tree roots and moisture removal.

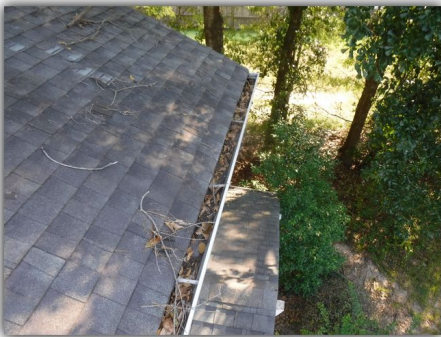
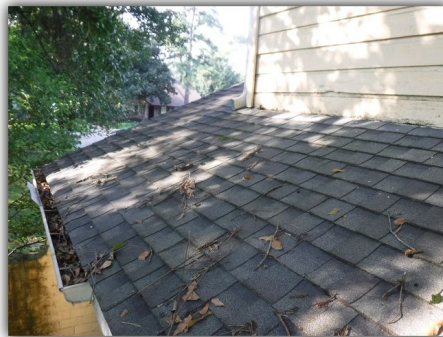
Recommend addition of a full rain gutter system to help improve drainage and/or prevent wood rot. While roof overhangs and porch roofs protect building walls from impinging rain, gutters serve to protect building walls and foundations from roof water runoff. Roof gutters, downspouts and leaders or diverters form the initial components of a drainage system for the building and site.

- Debris visible in the gutters at the time of the inspection should be removed to encourage proper drainage.
- Observed one or more clogged downspout

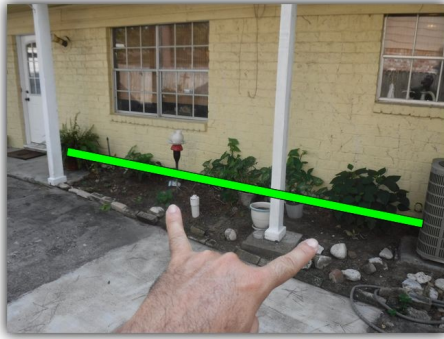
■ High soil levels were observed at the foundation walls. A minimum of **four** inches of foundation wall should be exposed under the brick veneer. High soil levels are conducive to wood destroying insect infestation, and possible water penetration into the home.

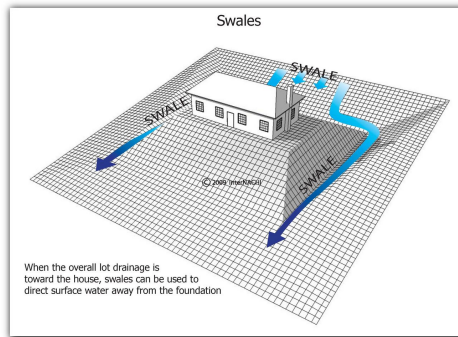
■ The drainage and grading around this home is inadequate. In order for the drainage to be effective, the landscaping must be configured so that the yard is sloped away from the foundation by at least 6 inches in the first 10 feet and/or adding additional gutters/downspouts to the house is another option to improve drainage and/or in- ground drains should be designed and added to divert rainwater and runoff away from the house as appropriate and/or drainage swale should be improved/installed.

Poor soil and grading conditions are conducive to wood destroying insect infestation, and water penetration into the home if not corrected. The means should be provided to catch and channel the water away from the house and foundation. Improvements should be undertaken by professional landscaper and/or gutter company.

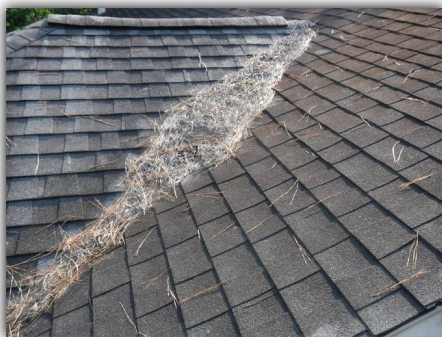
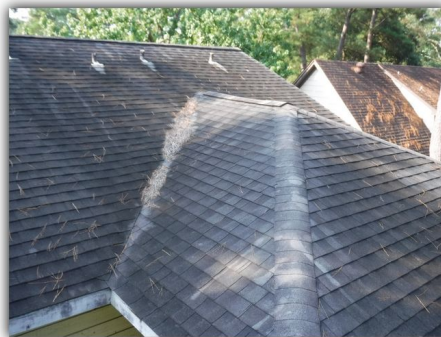
- rear left

Observed damaged section of the roof

Remove all loose debris off roof (clean sweep) to prevent damage / puncture(s) to roof surface.

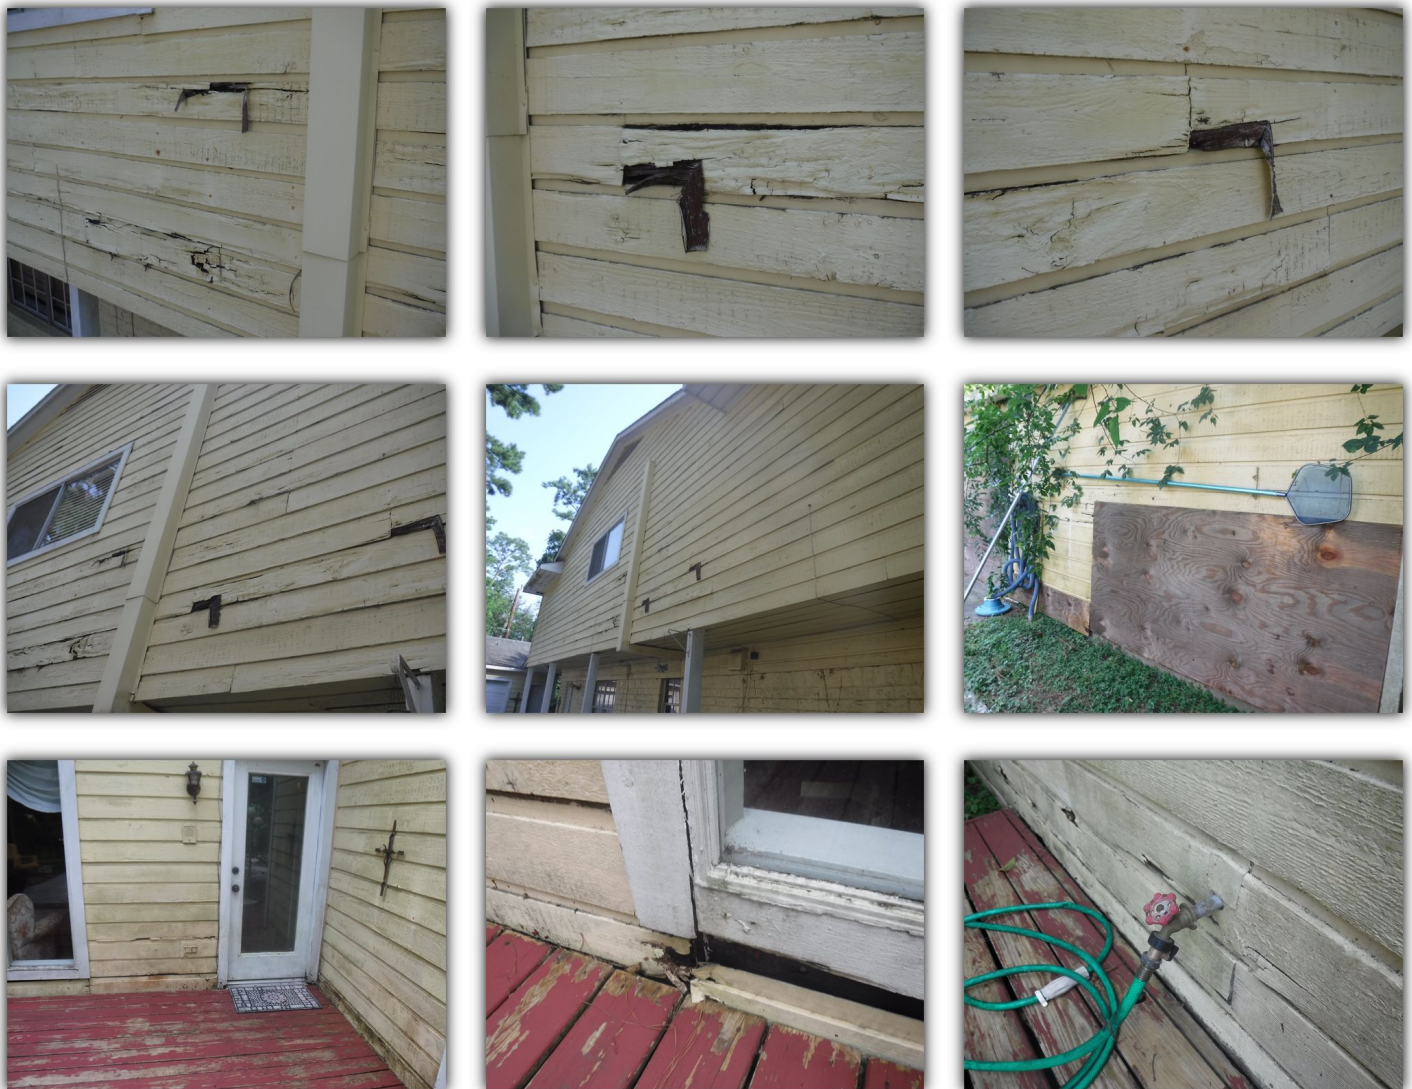
■ Wood rot was observed at one or more location and it is recommended that the damaged wood be replaced. It is pointed out that additional damage could be present under the rotted material that will not be visible until the outer rotted materials are removed. Have a service company determine the entire scope of wood rot throughout the house, and provide a cost estimate to replace all rotted wood.

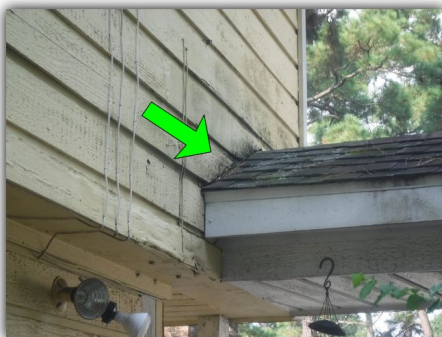
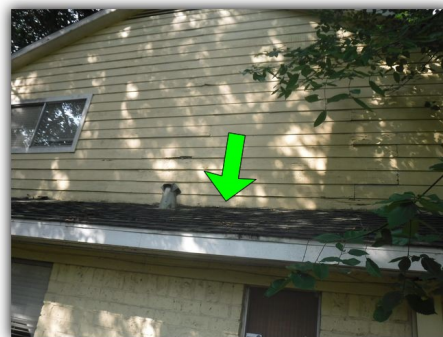
■ Damaged soffit and/or fascia boards were observed in one or more locations of the house. Repairs should be under taken to prevent water and rodent intrusions.

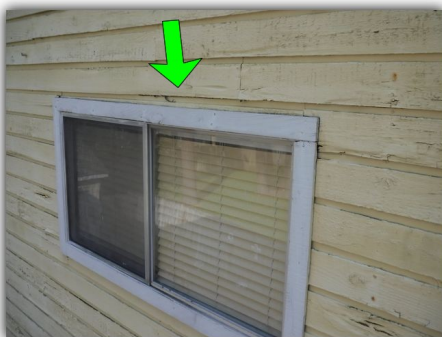
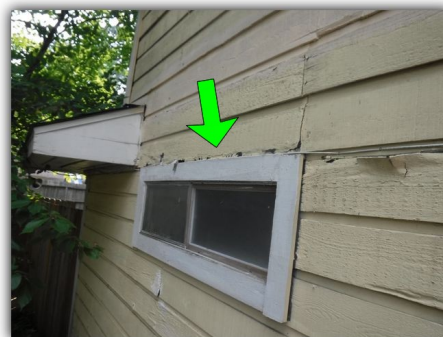
■ When the bottom of the siding is not separated from the roof it is susceptible to: deterioration and water infiltration. The bottom of the siding should be a minimum of 1 - 2 inches above the finished roof. The space helps prevent debris from accumulating between the roof and the wall.

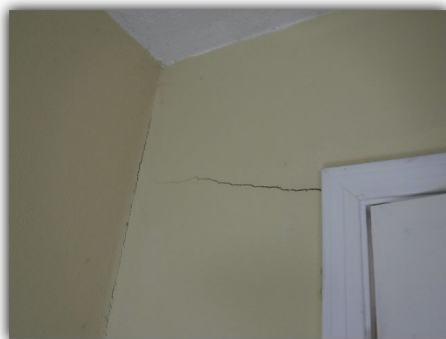
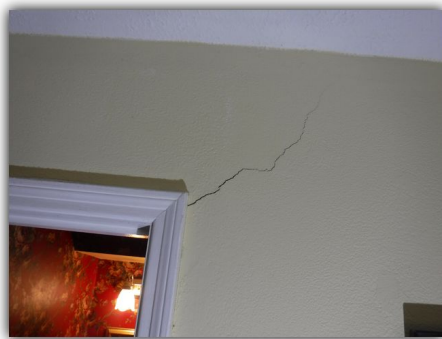
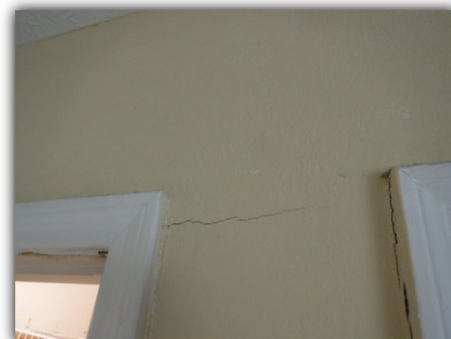
Cosmetic cracks and/or repaired cracks in sheetrock observed over some / many doors, windows, and/or corners. Here are some examples but not limited to:

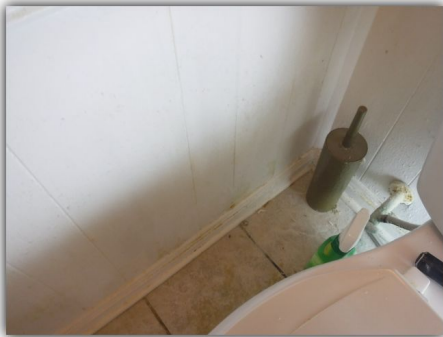
- Master bathroom adjacent to the toilet

■ Elevated moisture readings was present at the time of the inspection in / on the wall

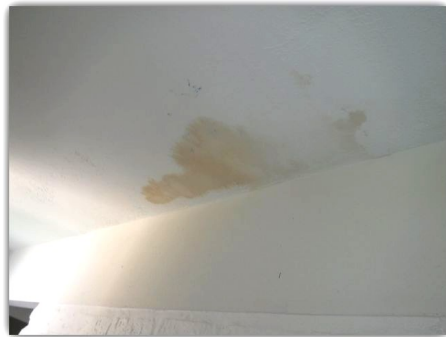
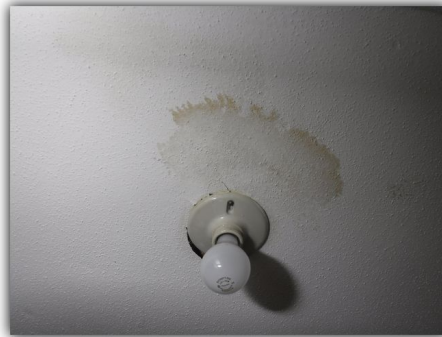
- Upstairs front hallway/chimney
- Master bathroom
- Laundry room
- Master closet

Water stains, damage or repairs observed, moisture detection equipment indicated that stains are not active (wet) at time of inspection;

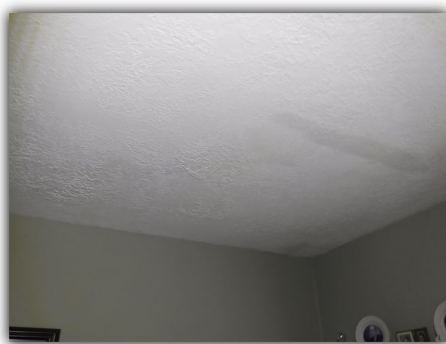
- Rear left bedroom

Observed signs of previous repairs in one or more places;

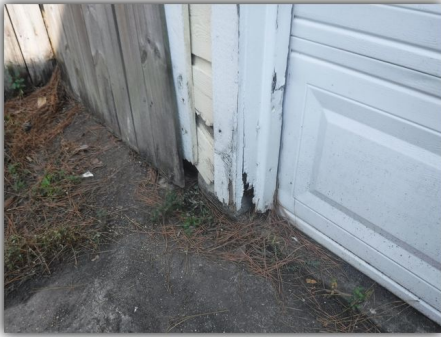
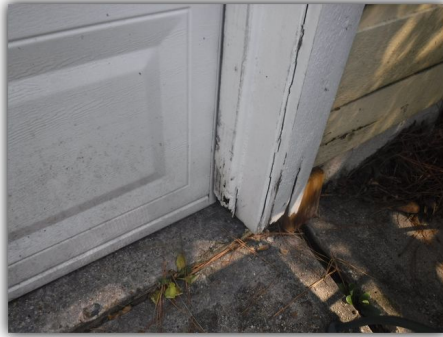
■ Wood rot, lower section of garage door vertical 2x6 trim board(s).

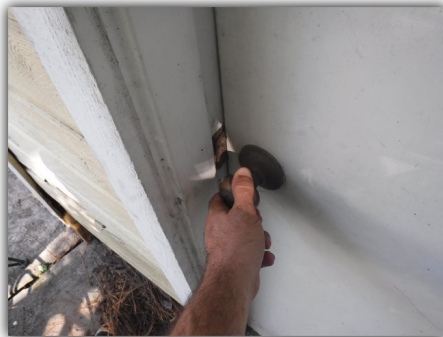
- Garage

■ Damaged door. The door(s) were not latching properly at the time of the inspection.

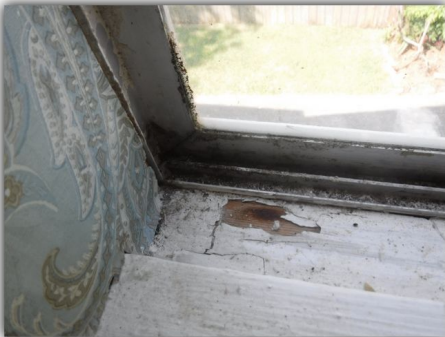
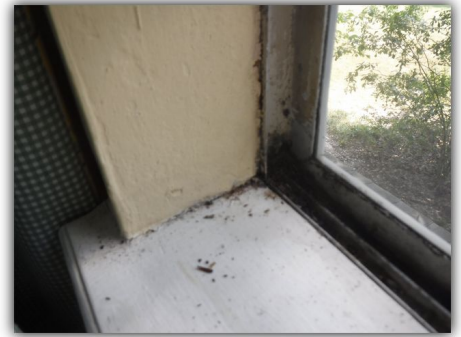
■ Signs of moisture penetration were present on one or more windowsills at the time of the inspection. The windows inspected were in need of caulking. Here are some examples but not limited to:

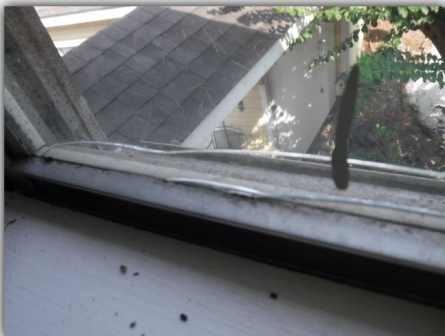
■ One or more windows had cracked / broken glass pane(s).
● Rear left bedroom

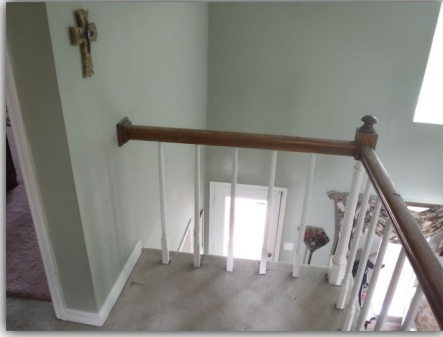
Space between railings does not comply with current industry standard, (code) UBC 421.1.1 & CABO D105.2.1. Requires spacing between intermediate rails do not allow passage of an object four inches in diameter. Recommend covering large openings in stair rails with temporary type nylon netting if small children are present in house to prevent injury.

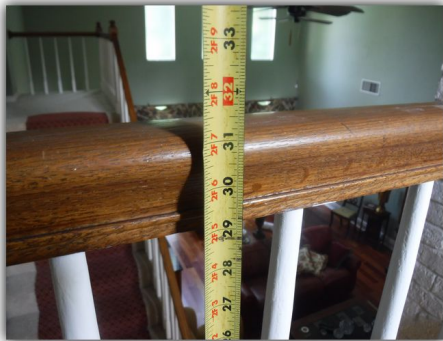
Guardrail too low for safety, current industry standards requires minimum guardrail height of 36 inches. (Code reference, IRC R316.1).

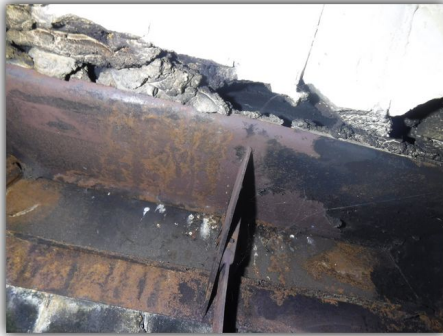
■ The front portion of the firebox appears to be cracked and/or loose mortar and/or unsealed. It is recommended that the unsealed areas be sealed to inhibit hot exhaust gases from migrating into areas where combustible materials may be present.

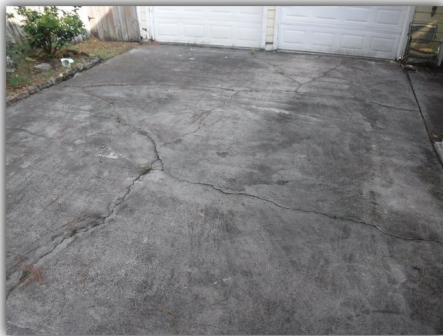
The driveway and/or walkway is cracked and appears to have some movement in the elevation of the concrete. The elevation differences can be a trip hazard as well as contribute to the deterioration of the driveway. I recommend having a qualified contractor evaluate and repair as needed.

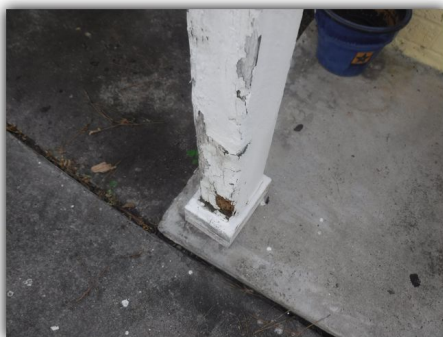
Observed wood rot at columns support. No slab pedestal or metal chairs in column were noted.

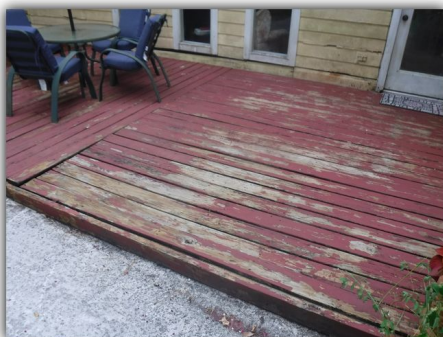
Observed wood damaged at rear wood decking. Trip hazard.

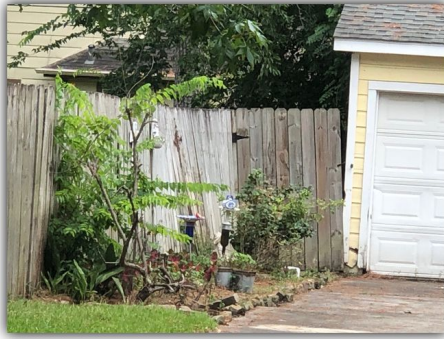
Observed damage section of the fence at one or more locations

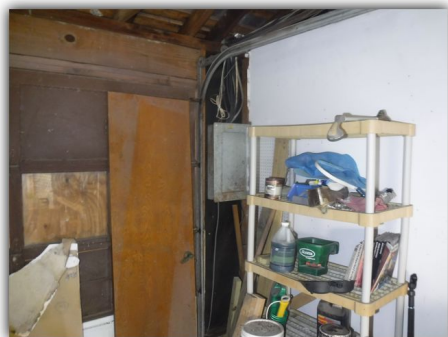
Code requires minimum clearance to electrical service panels to be 36" in front of and 30" from side to side.

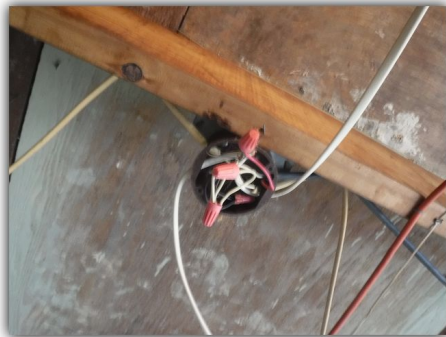
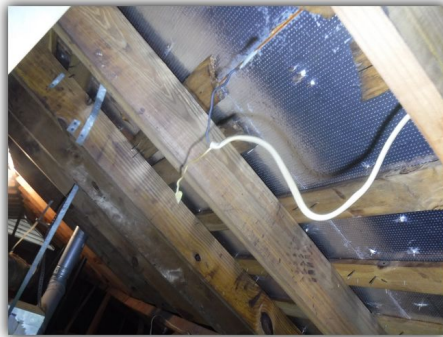
■ Wire connections are not enclosed in proper electrical junction box(s), or electrical junction box(s) do not have covers in place, including but not limited to the following:

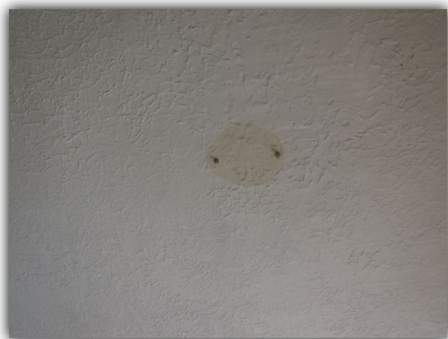
■ There are not detectors located in all the locations (Hallways - Bedrooms) required by today's code. Recommend installation of detectors that are all interconnected so that when one detector goes off they all go off.

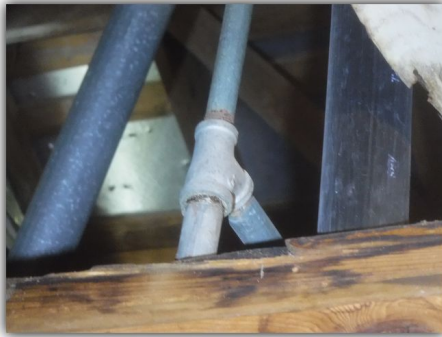
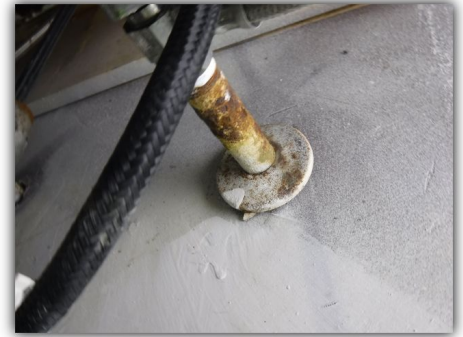
Galvanized steel pipe

Water supply piping observed to be predominantly galvanized. This is an outdated material and as corrosion reduces the diameter of the pipe interior, water flow will be increasingly restricted. All galvanized pipe in the home may need to be replaced soon.

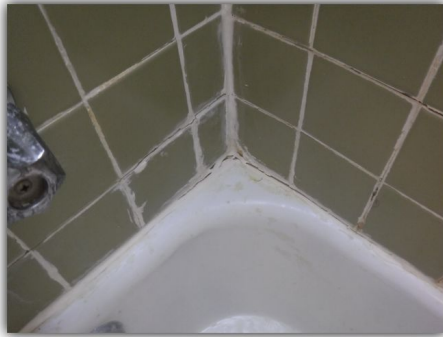
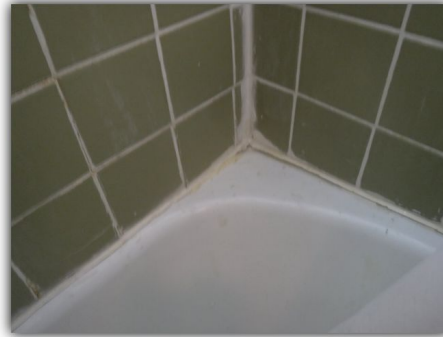
■ The tub enclosure needs to be sealed. Grout / caulking needed at vertical tile corners, cracks in tile and/or mortar between tiles, and where tile meets tub to prevent water entry behind wall.

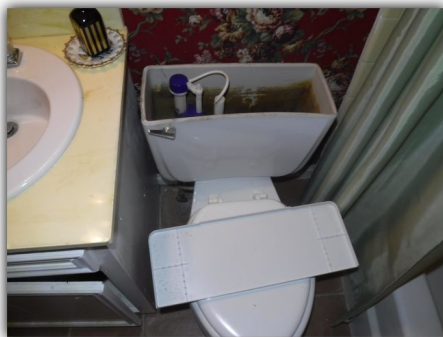
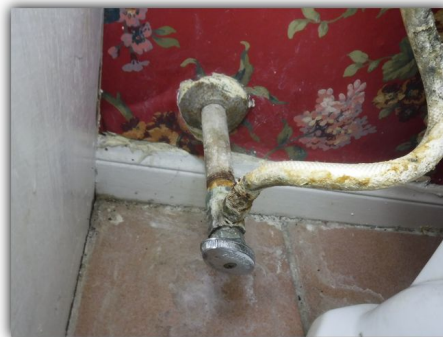
- upstairs right bathroom

No water was present in toilet. The water supply pipe exhibited corrosion which will eventually cause leakage or is already leaking.

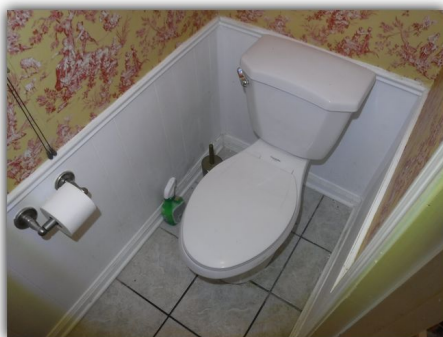
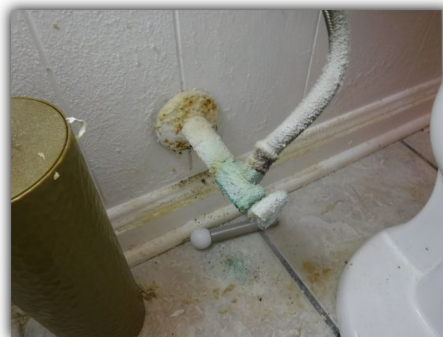
- Master bathroom

The water supply pipe exhibited corrosion which will eventually cause leakage.

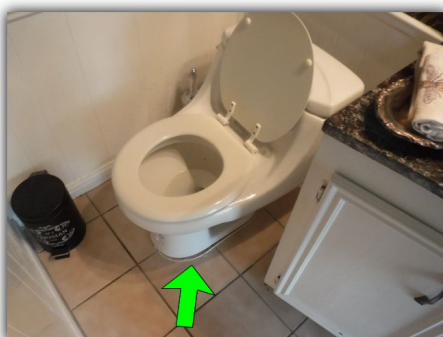
■ The floor mounting is loose. The commode(s) needs to be sealed/caulked.

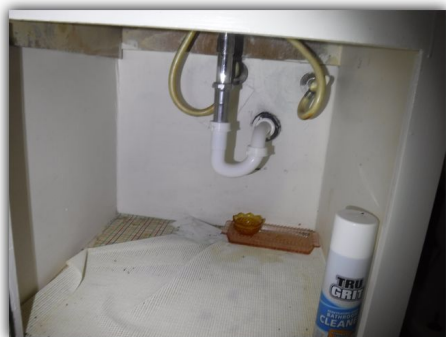
■ Signs of water stain or previous water leak were noted under the sink (lavatory).

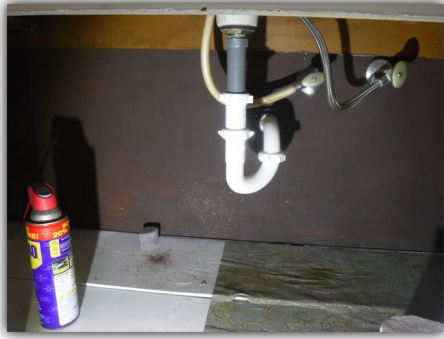
- Active water leak was noted under the sink (lavatory).
- Jack & Jill

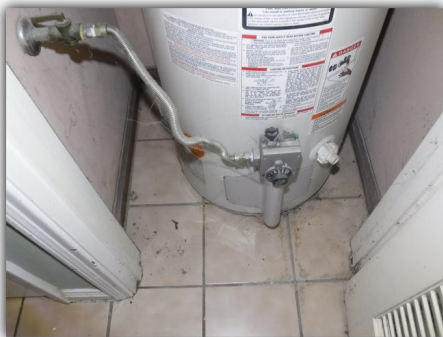
■ There were no sediment traps installed on the natural gas distribution pipes prior to the connections to the appliances.

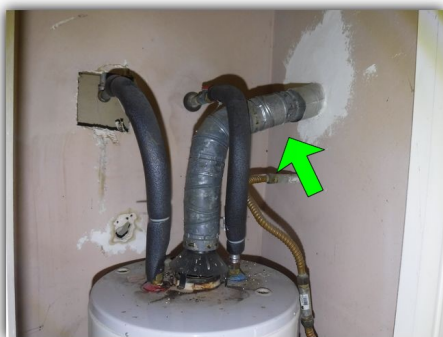
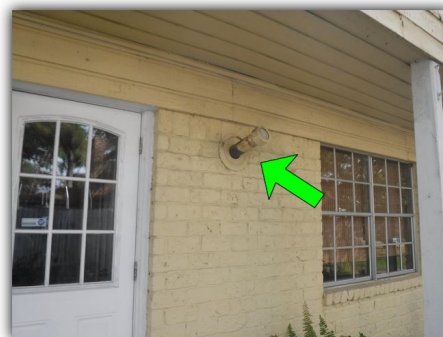
■ Improper exhaust termination was noted.

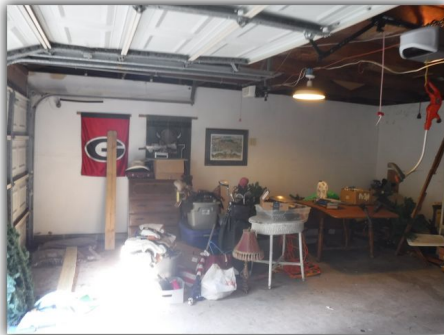
Left garage door opener is damaged.
