PROPERTY INSPECTION REPORT

Concerning: 8507 Hatton St, Houston, TX 77025

01/17/2022 1:00 pm

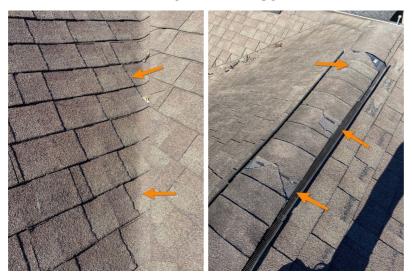
1: Damaged Coverings

Roof coverings exhibited general damage that could affect performance. Recommend a qualified roofer evaluate and repair.

Recommendation: Contact a qualified roofing professional.

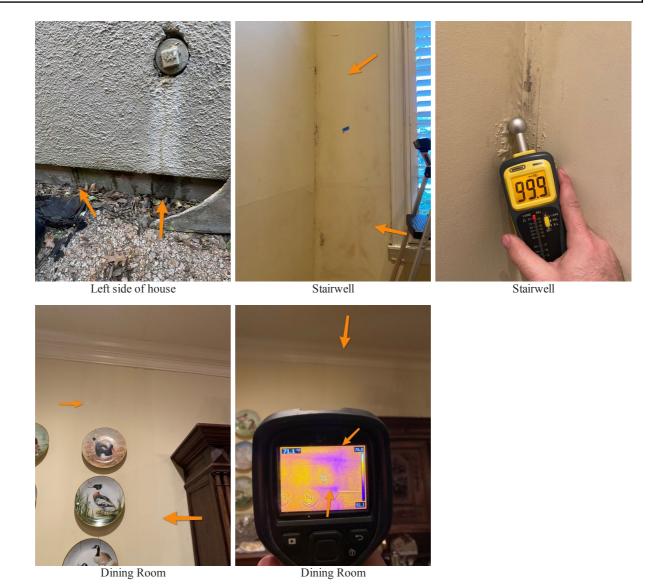
Wall structure showed signs of water intrusion, which could lead to more serious structural damage. Recommend a qualified contractor identify source of moisture and remedy.

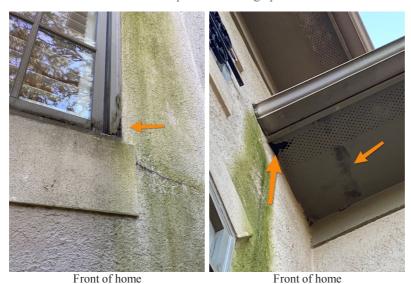
5: Siding or trim is damaged or deteriorated

Damaged or deteriorated siding and trim can allow access to water and insects into the home. Have damaged or deteriorated areas replaced.

Recommendation: Contact a qualified siding specialist.

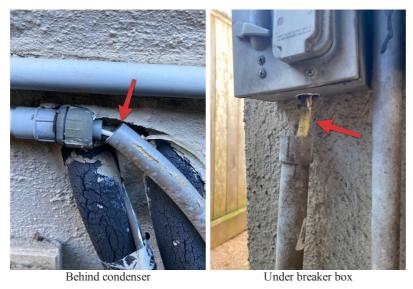
1: Conduit is loose, missing, or damaged

The conduit is meant to protect the wire from becoming damaged and posing a hazard.

Recommendation: Contact a qualified professional.

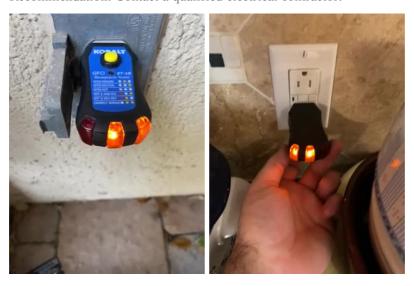
7: Missing GFCI protection where required

No GFCI protection. Recommend licensed electrician upgrade by installing ground fault receptacles. Here is a link to read about how GFCI receptacles keep you safe.

Recommendation: Contact a qualified electrical contractor.
