PROPERTY INSPECTION REPORT

2568 Bering Drive Houston, Texas 77057

Scott R. Arnold TREC. # 5468

08/09/21

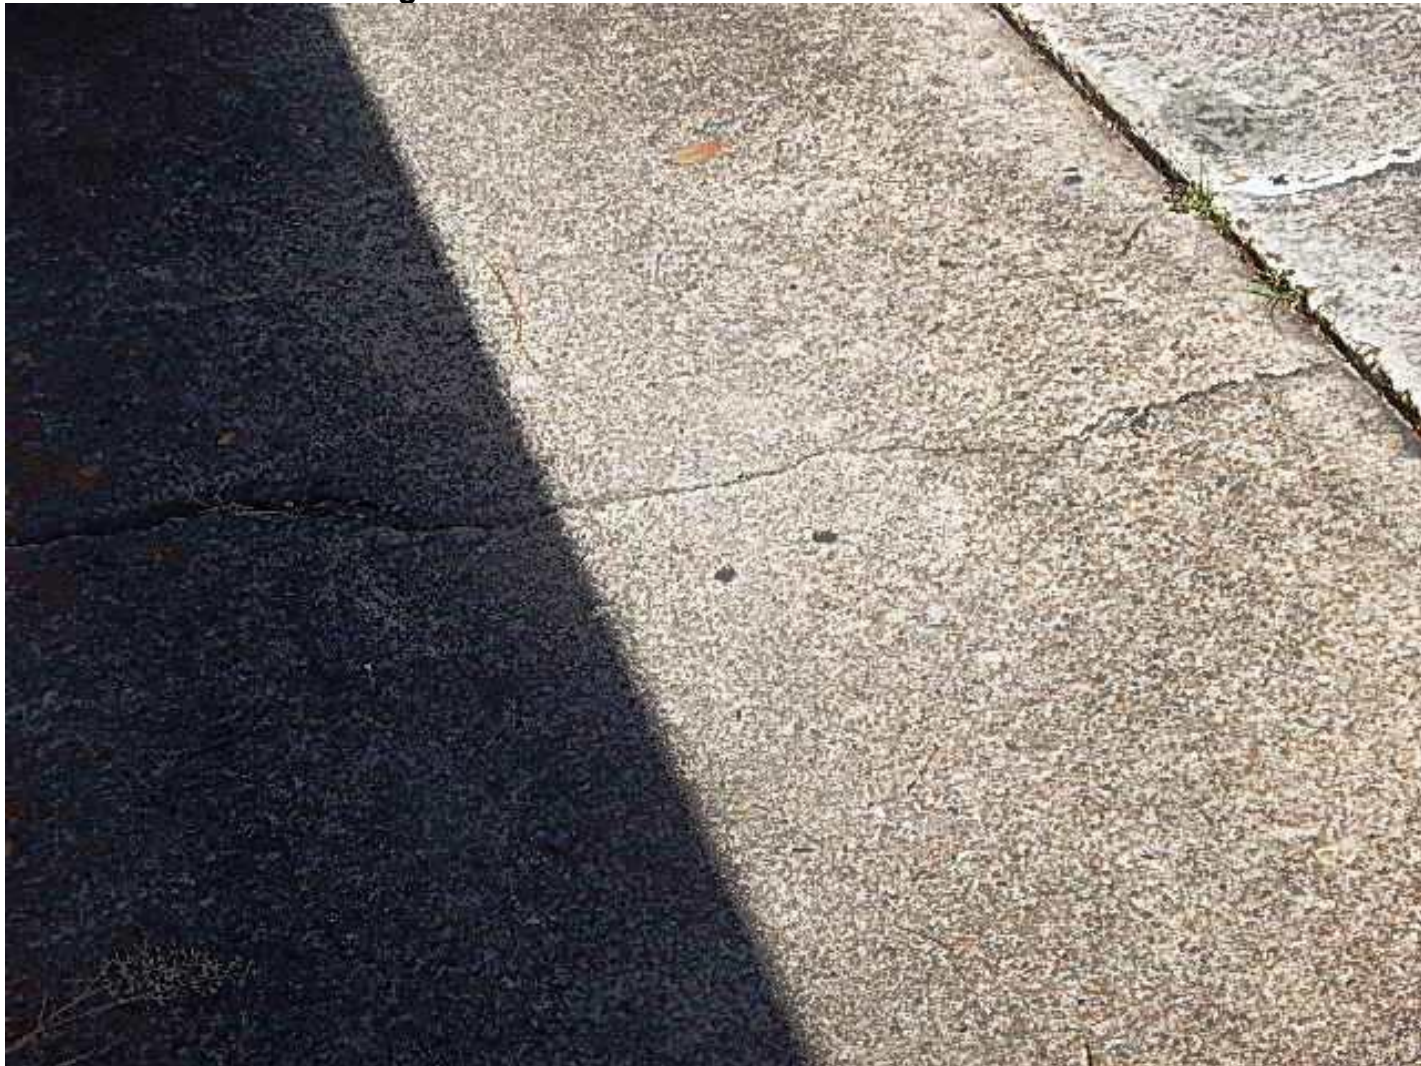
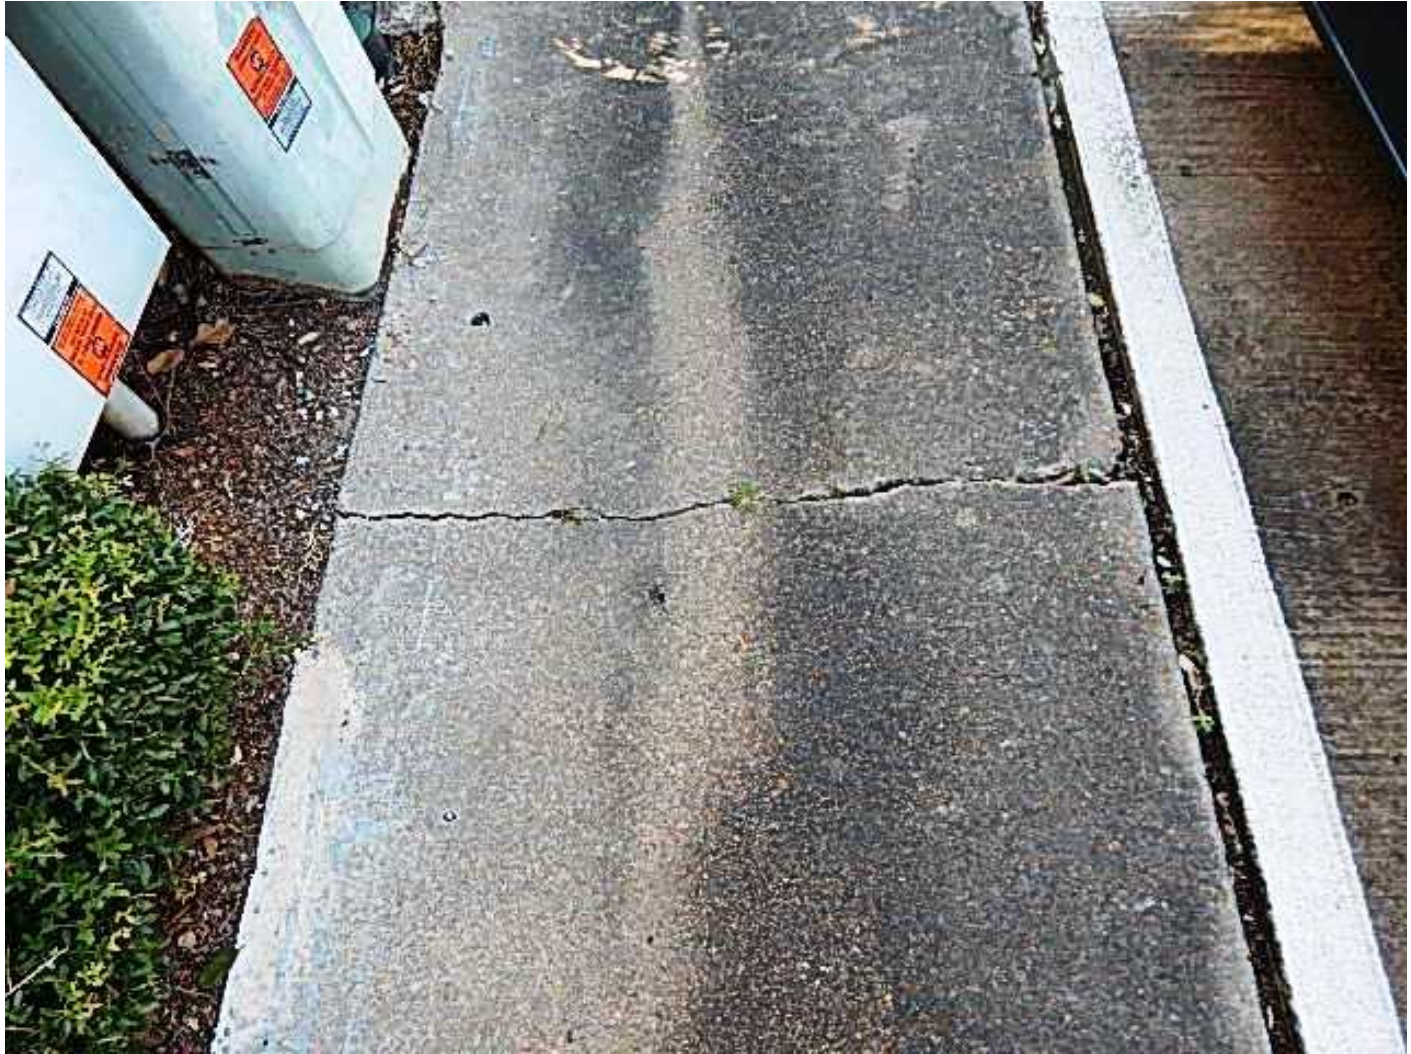
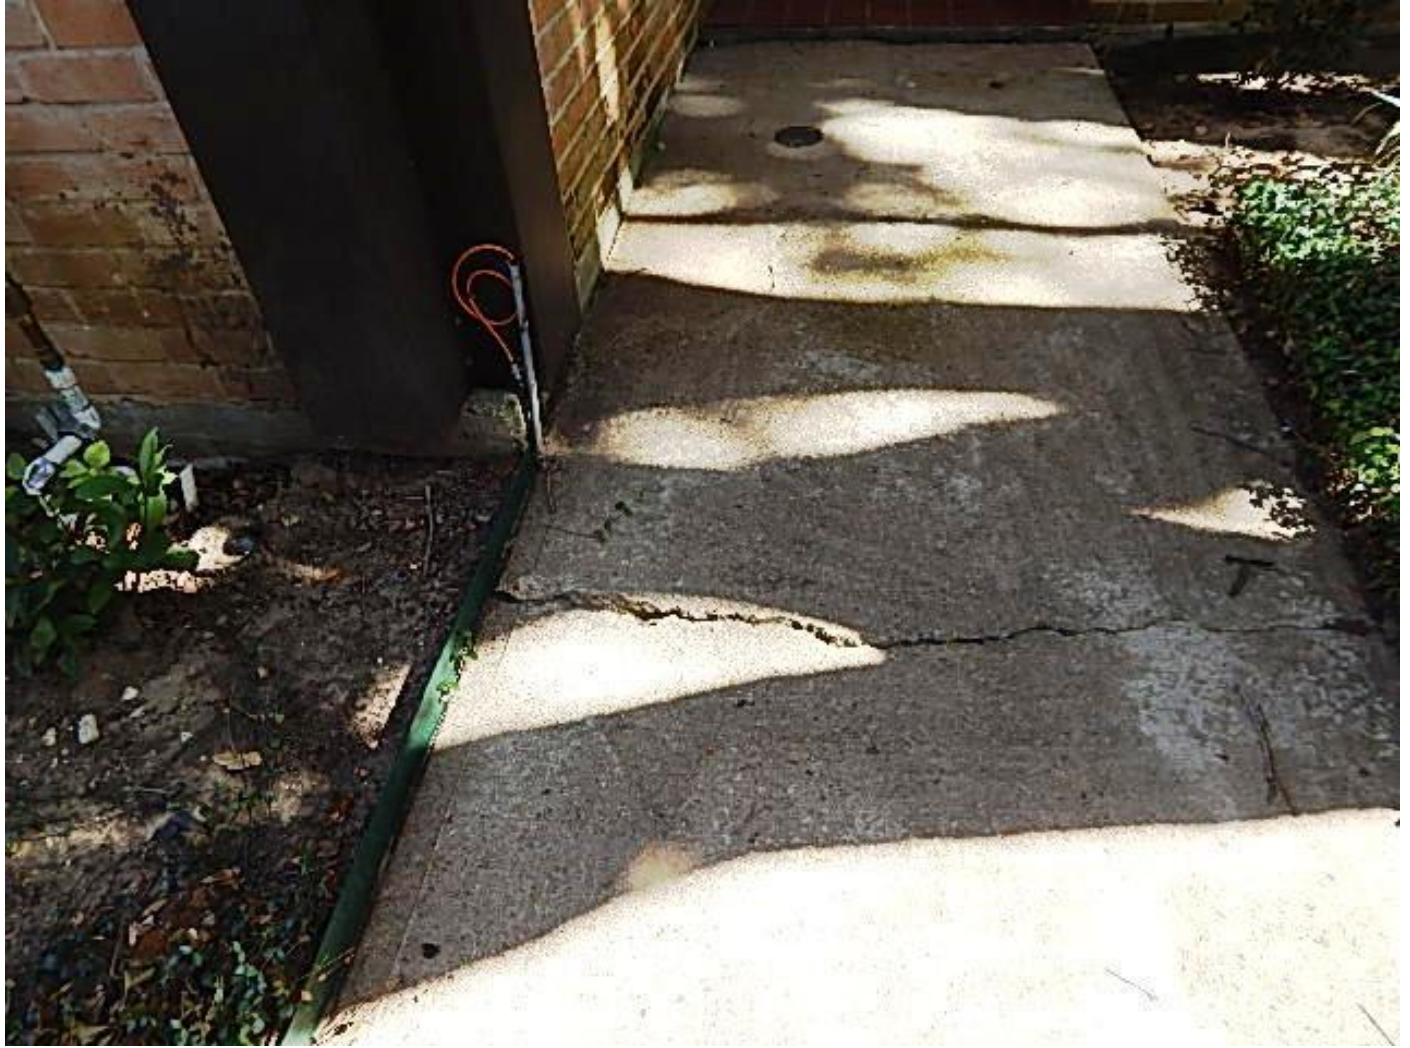
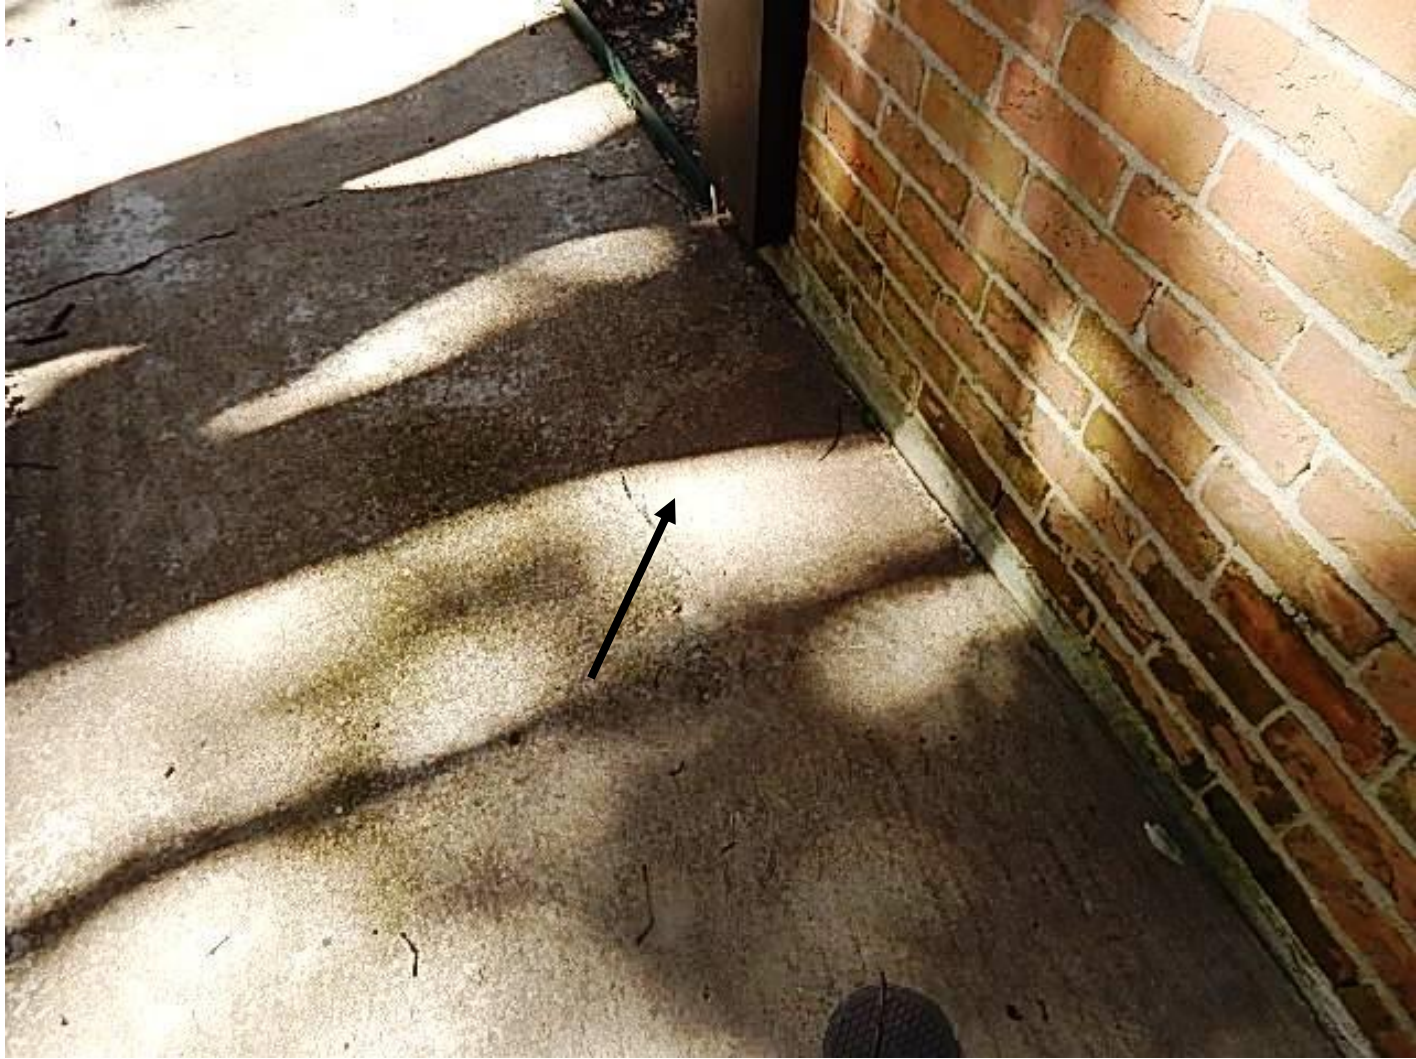
Comments: Recommend requesting disclosures as to any prior foundation repairs as to what has been performed previously and any related Engineering documentation as well. some of the foundation was obstructed visually by the siding being all the way to the ground. There were cracks observed in the concrete in the garage and walkways. No significant phenomena appeared to be visible at the time of inspection that would tend to be suggestive of significant differential movement of the foundation. There was evidence of prior pier installs.

Evidence of prior pier installs.

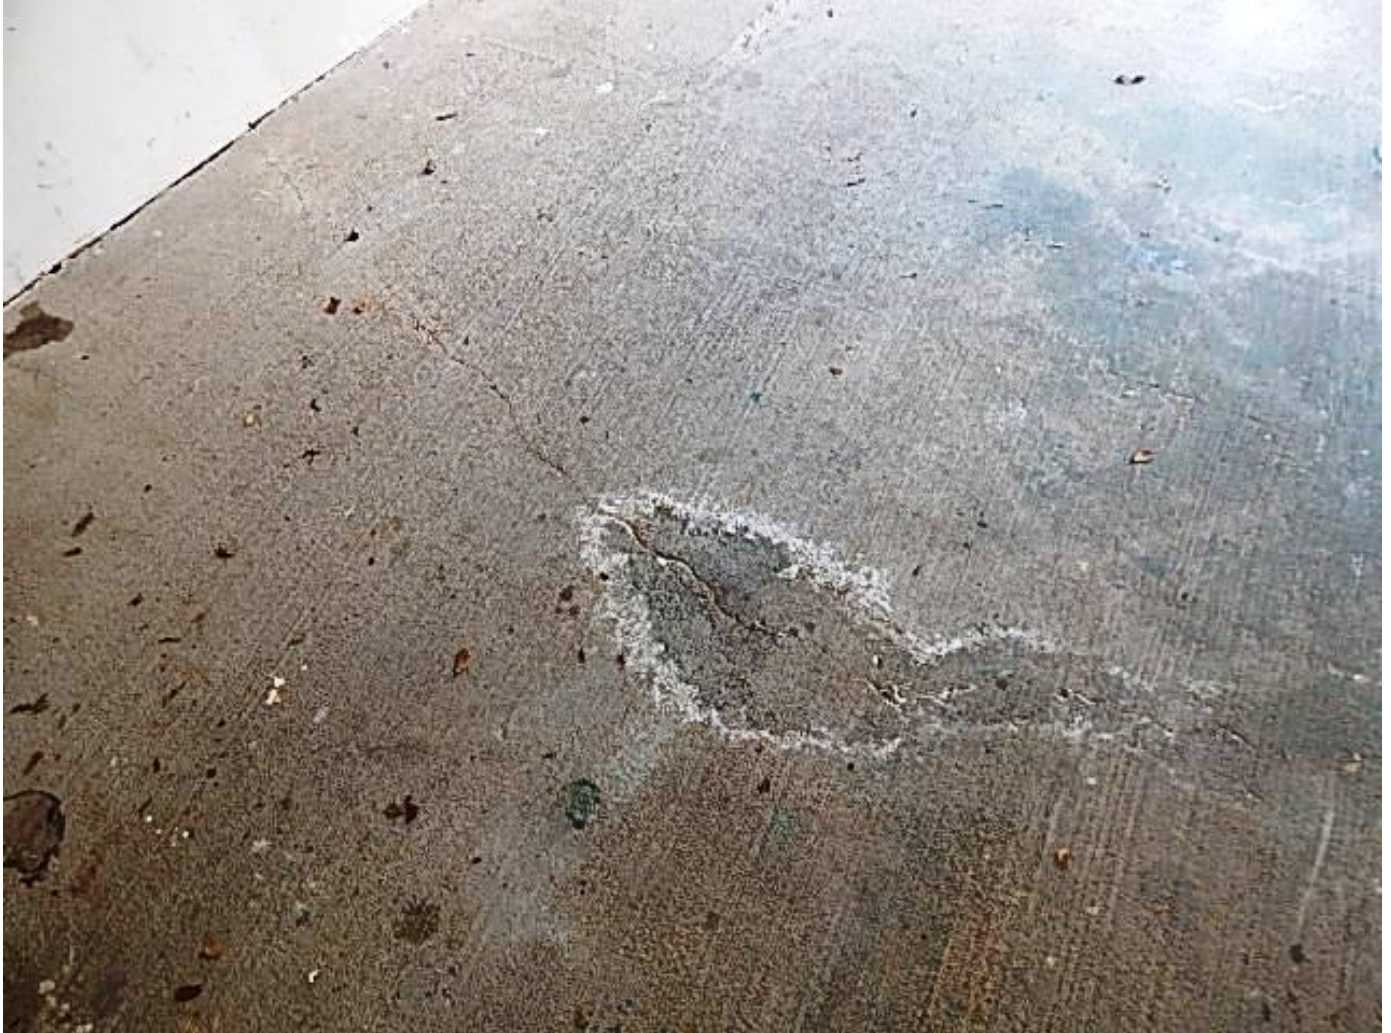
Cracks in the garage concrete.

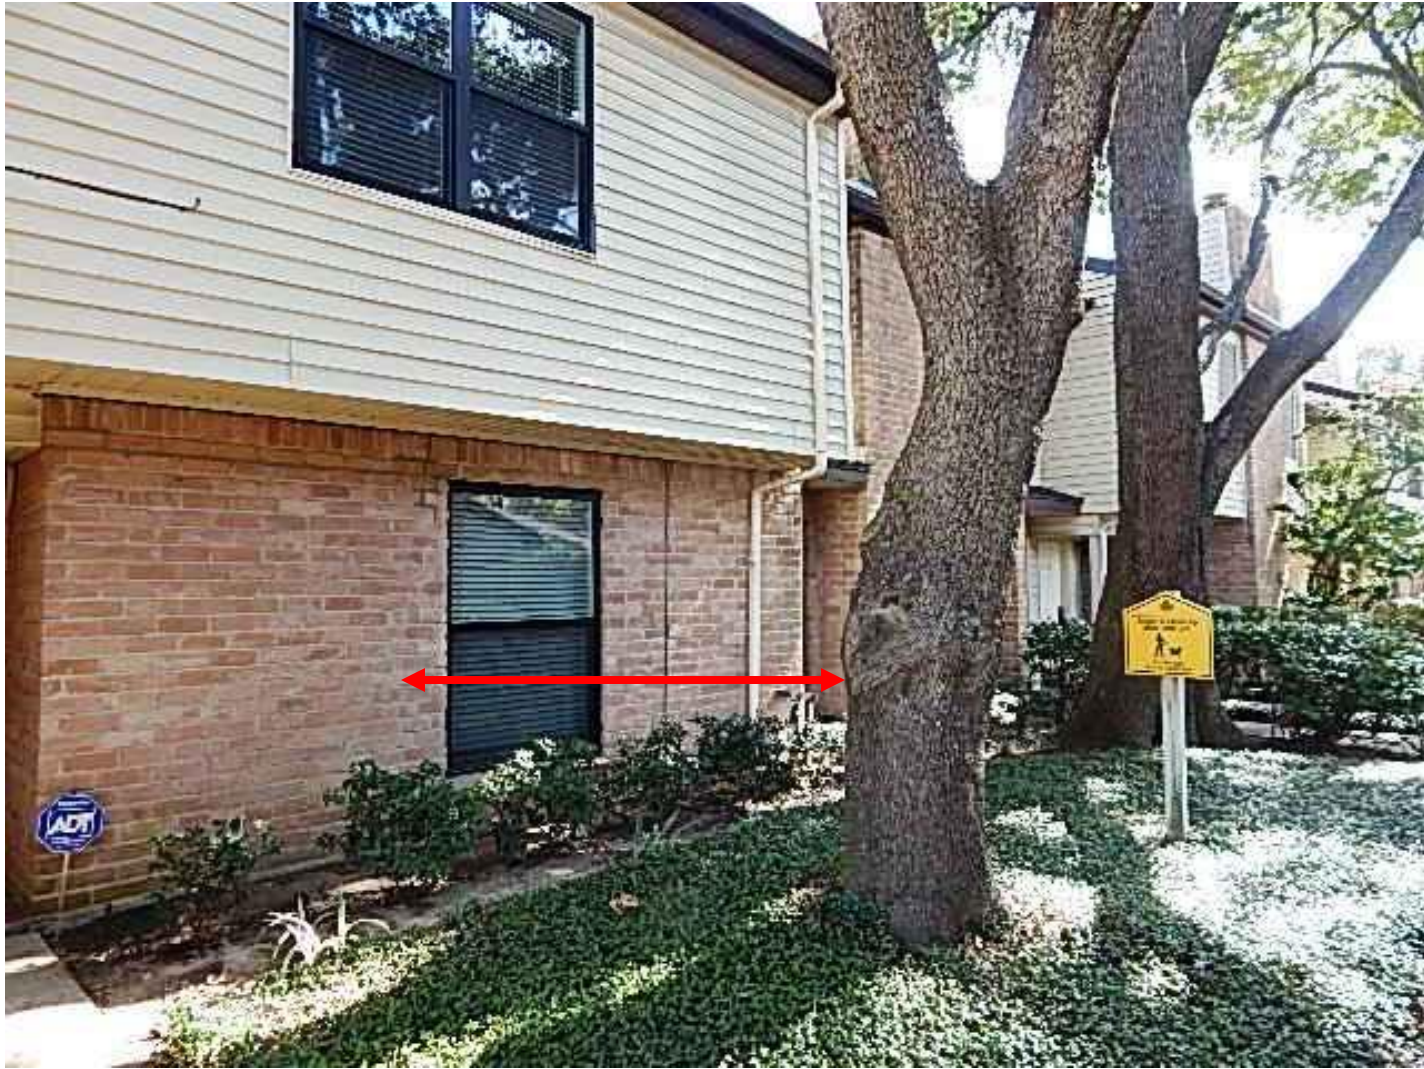
Comments: Recommend maintaining a minimum of 3-5 inches of slab exposure and grading the soil at a five-degree angle away from the structure and out towards the street or a drop of six inches in ten foot of soil. If planting any future trees maintain a minimum 15 feet from the structure preferably 20. There was a large hardwood off the exterior s/wall that was too close to the structure. Elsewhere there were areas that the siding was obstructing visual access to the foundation as it was installed flush to the concrete and ground.

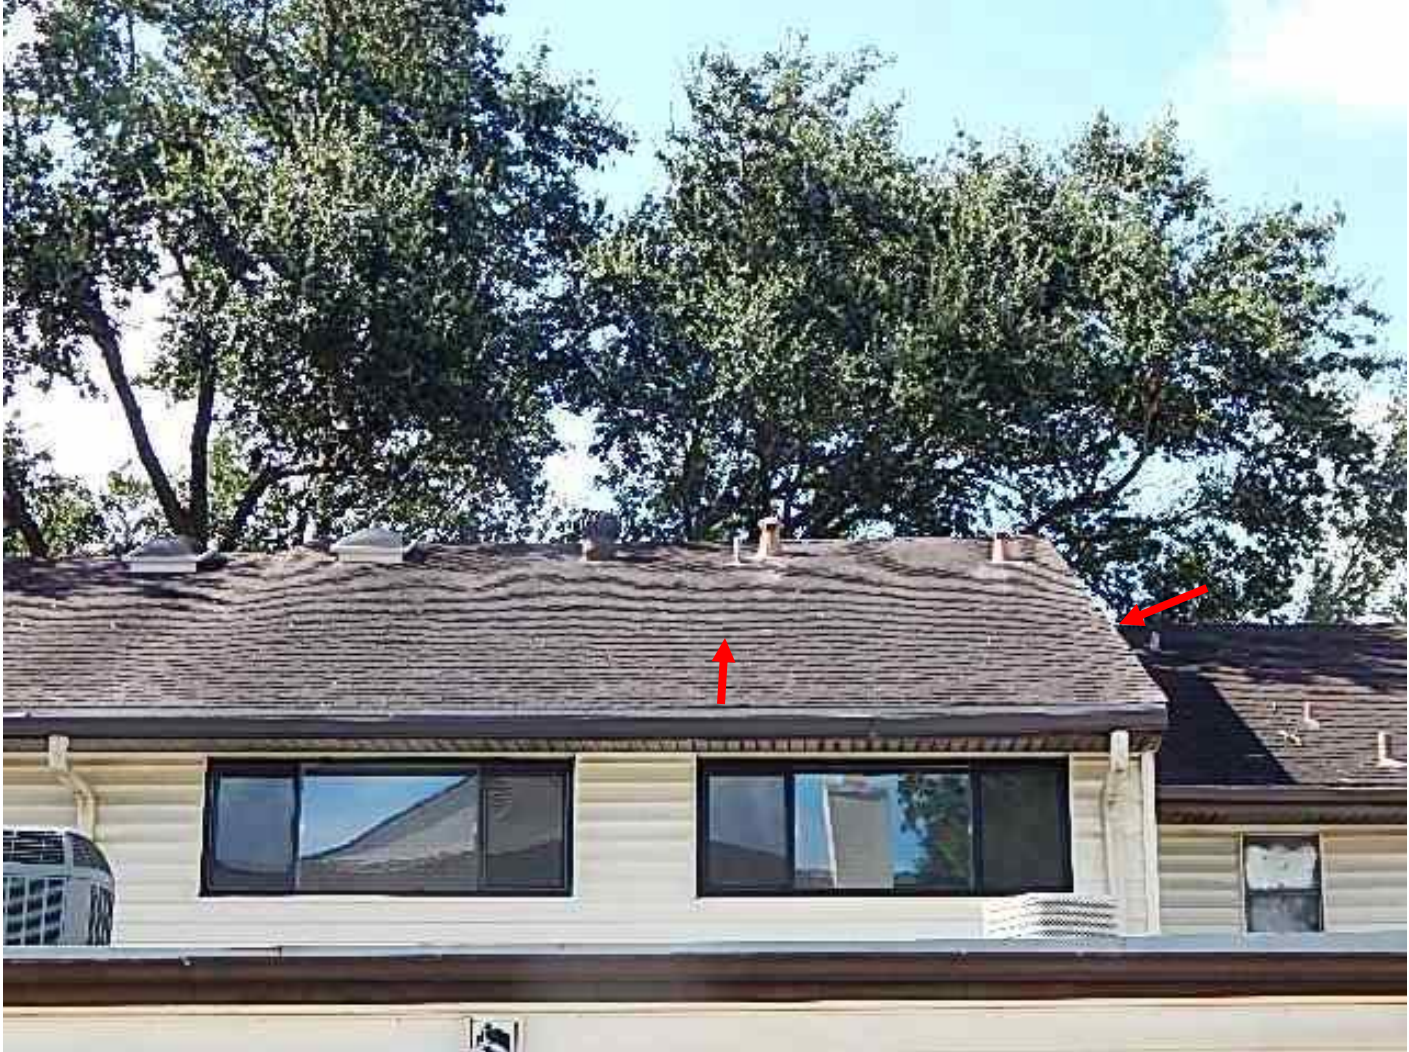
Comments: "See" sellers/CAM/HOA, in re: age/warranty. There were lifting up shingles along the drip edge and main upper roof off the north exposure side.

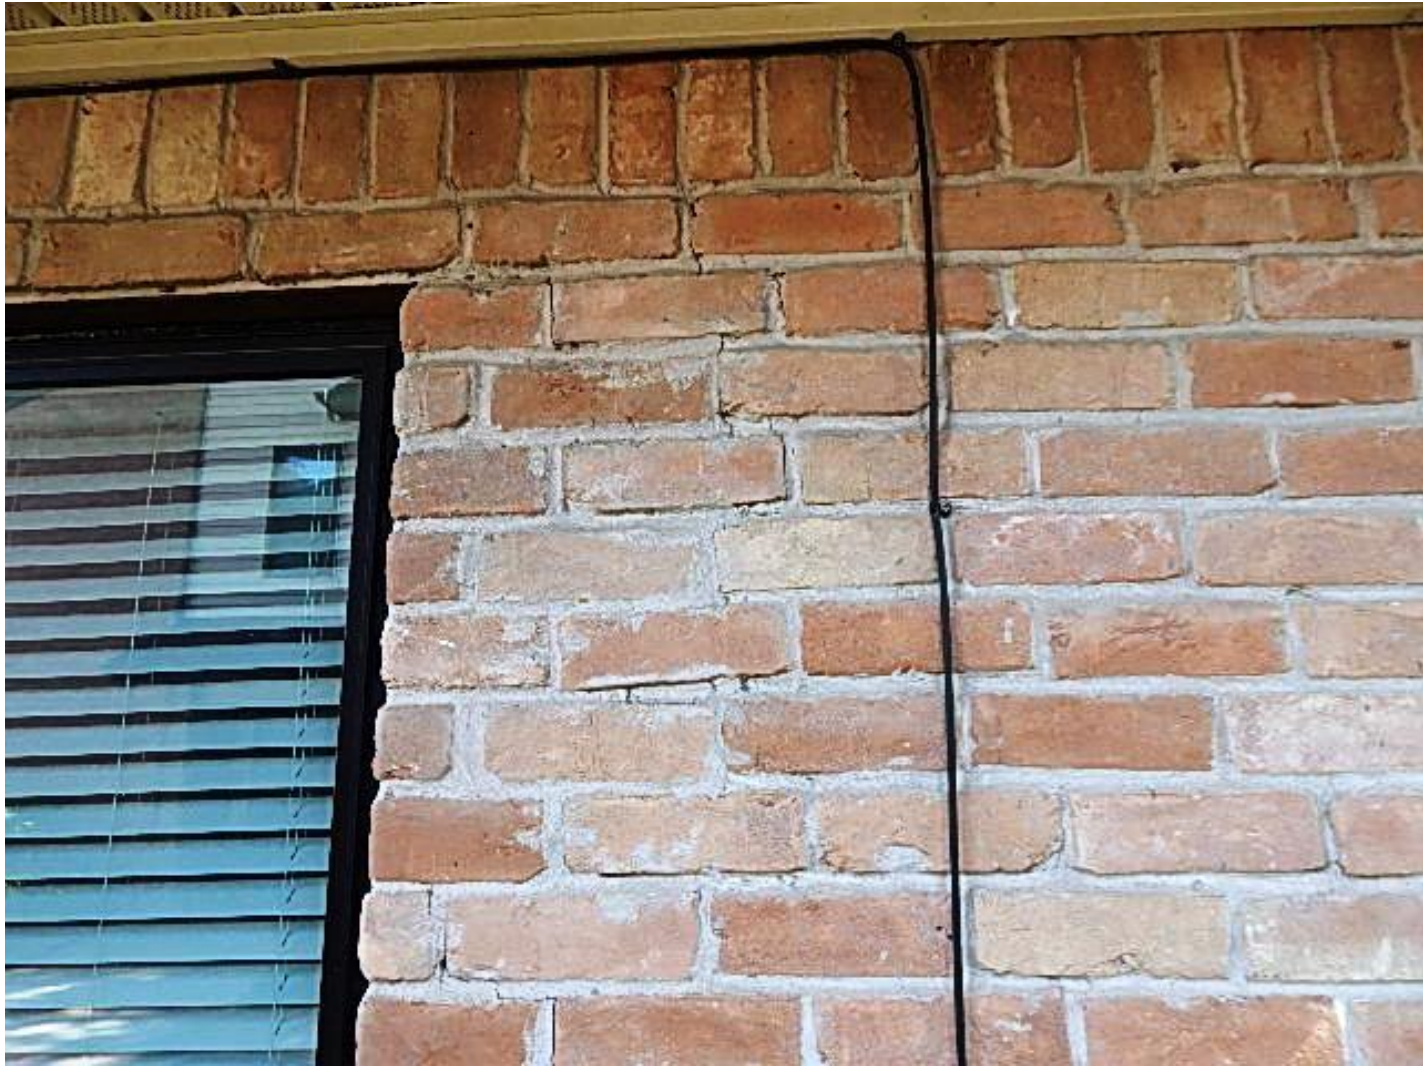
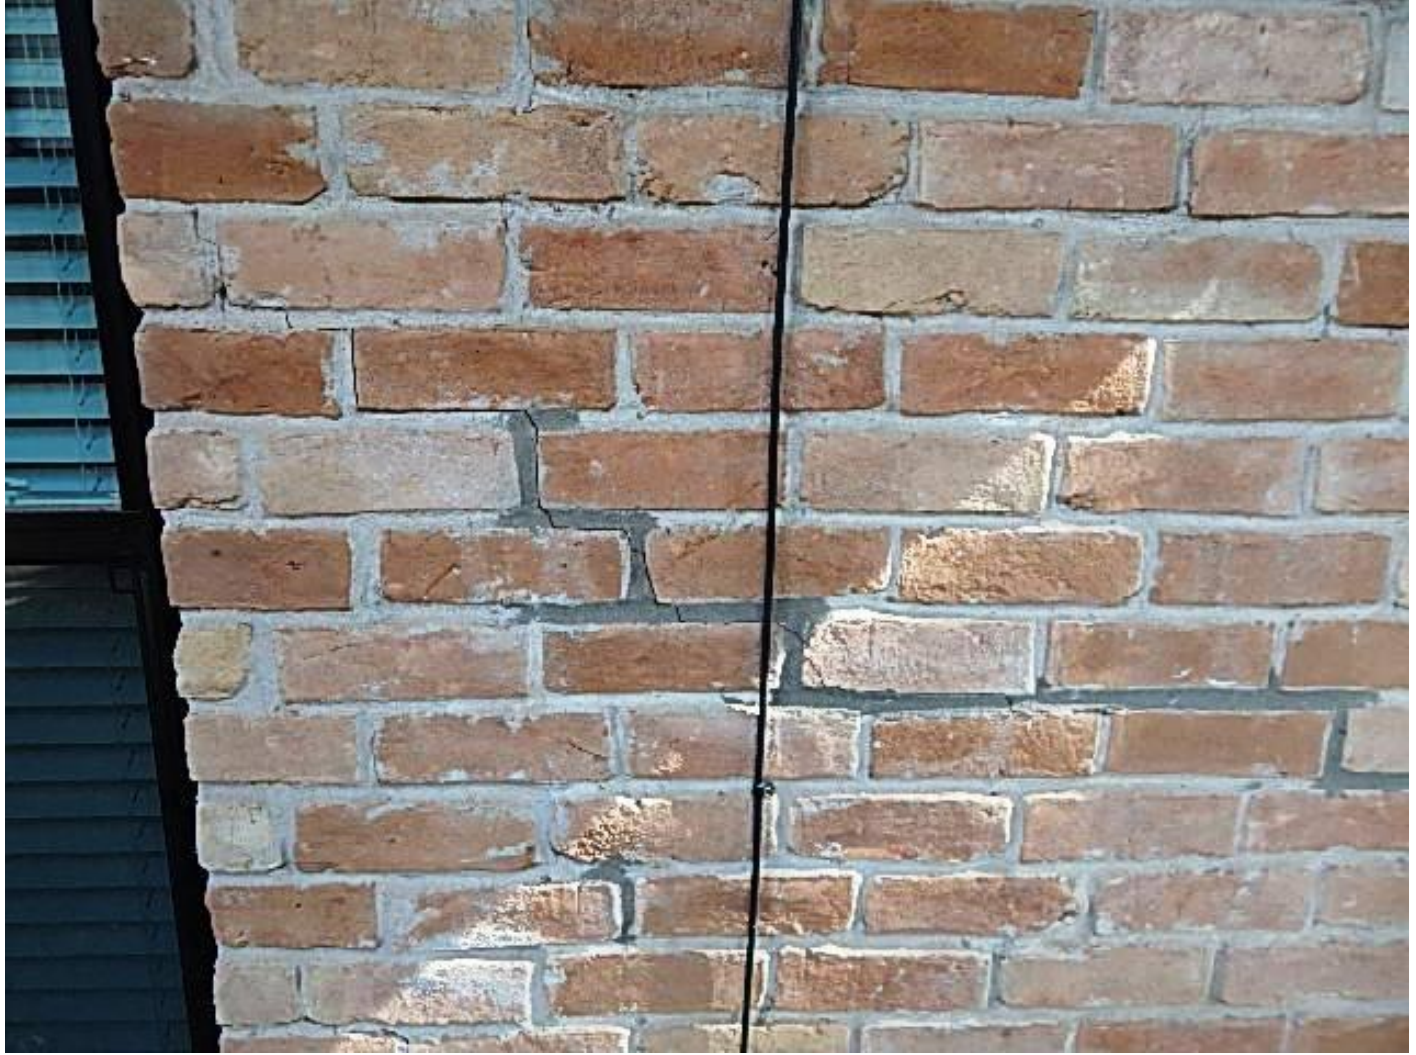
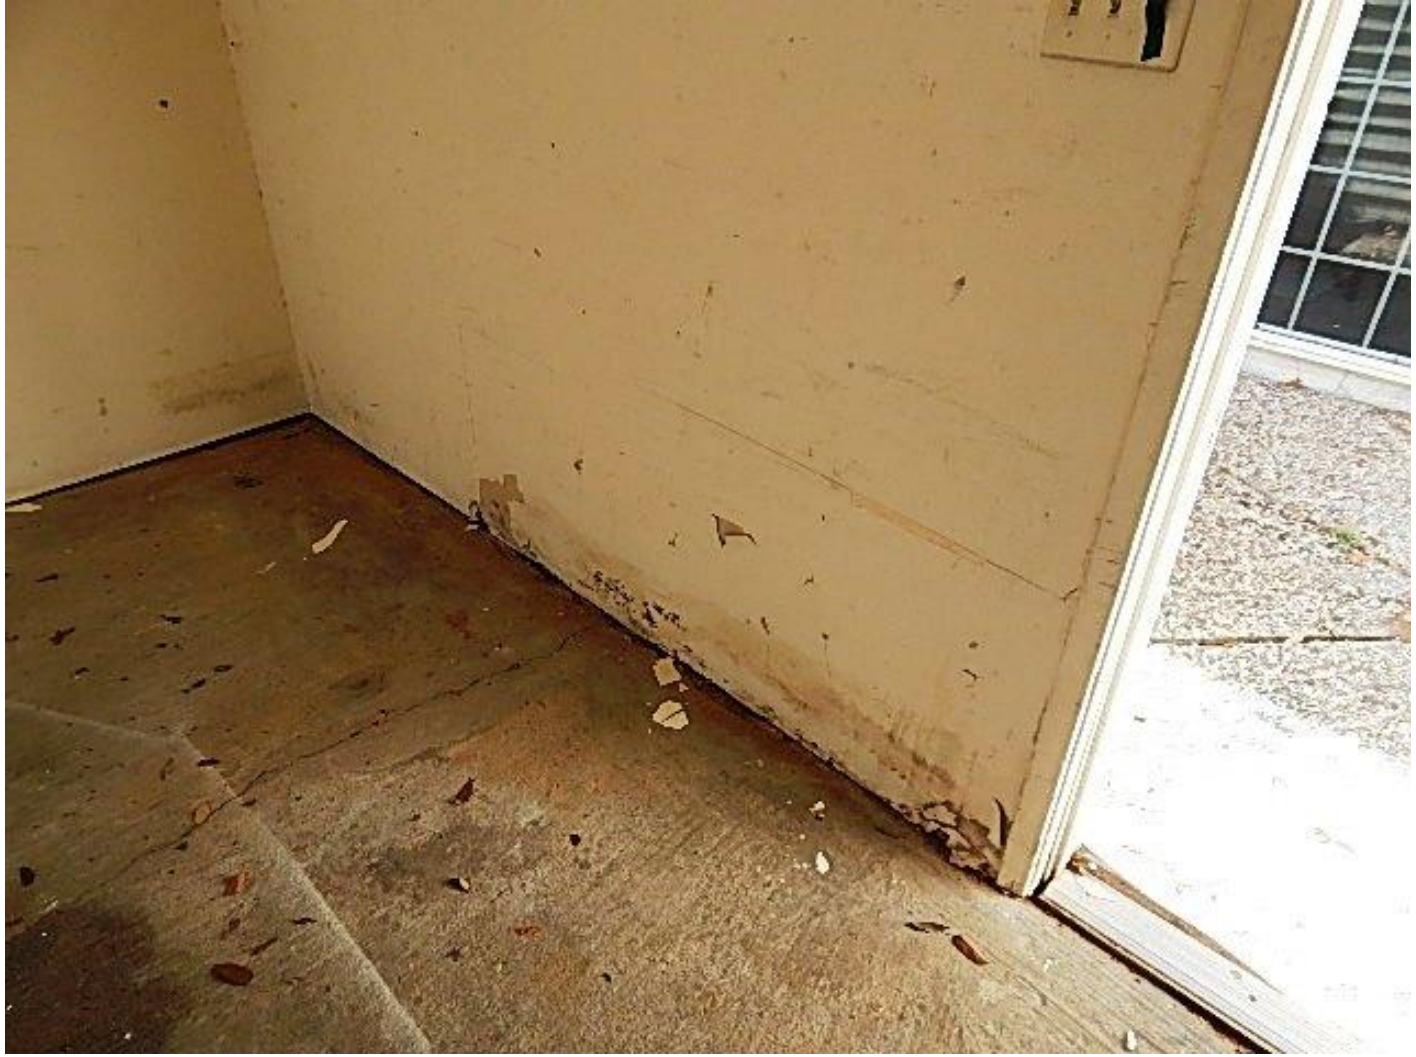
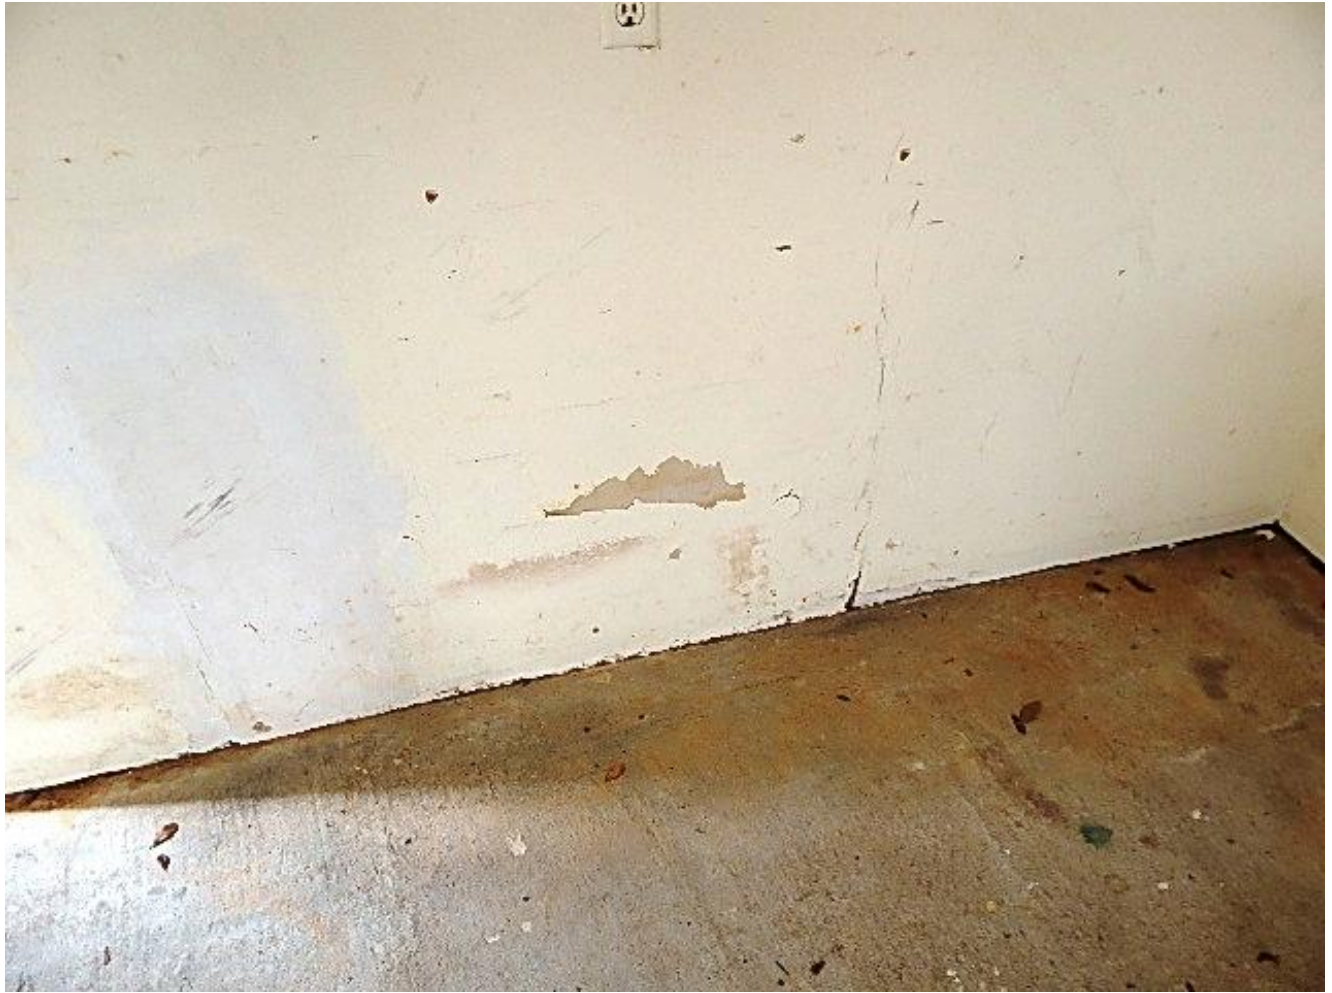
Comments: There were some brick settling cracks and repairs observed around the various sides of the home more predominately off the s/exp/side. There was sheet rock cracks repairs and damage in several walls of the garage.

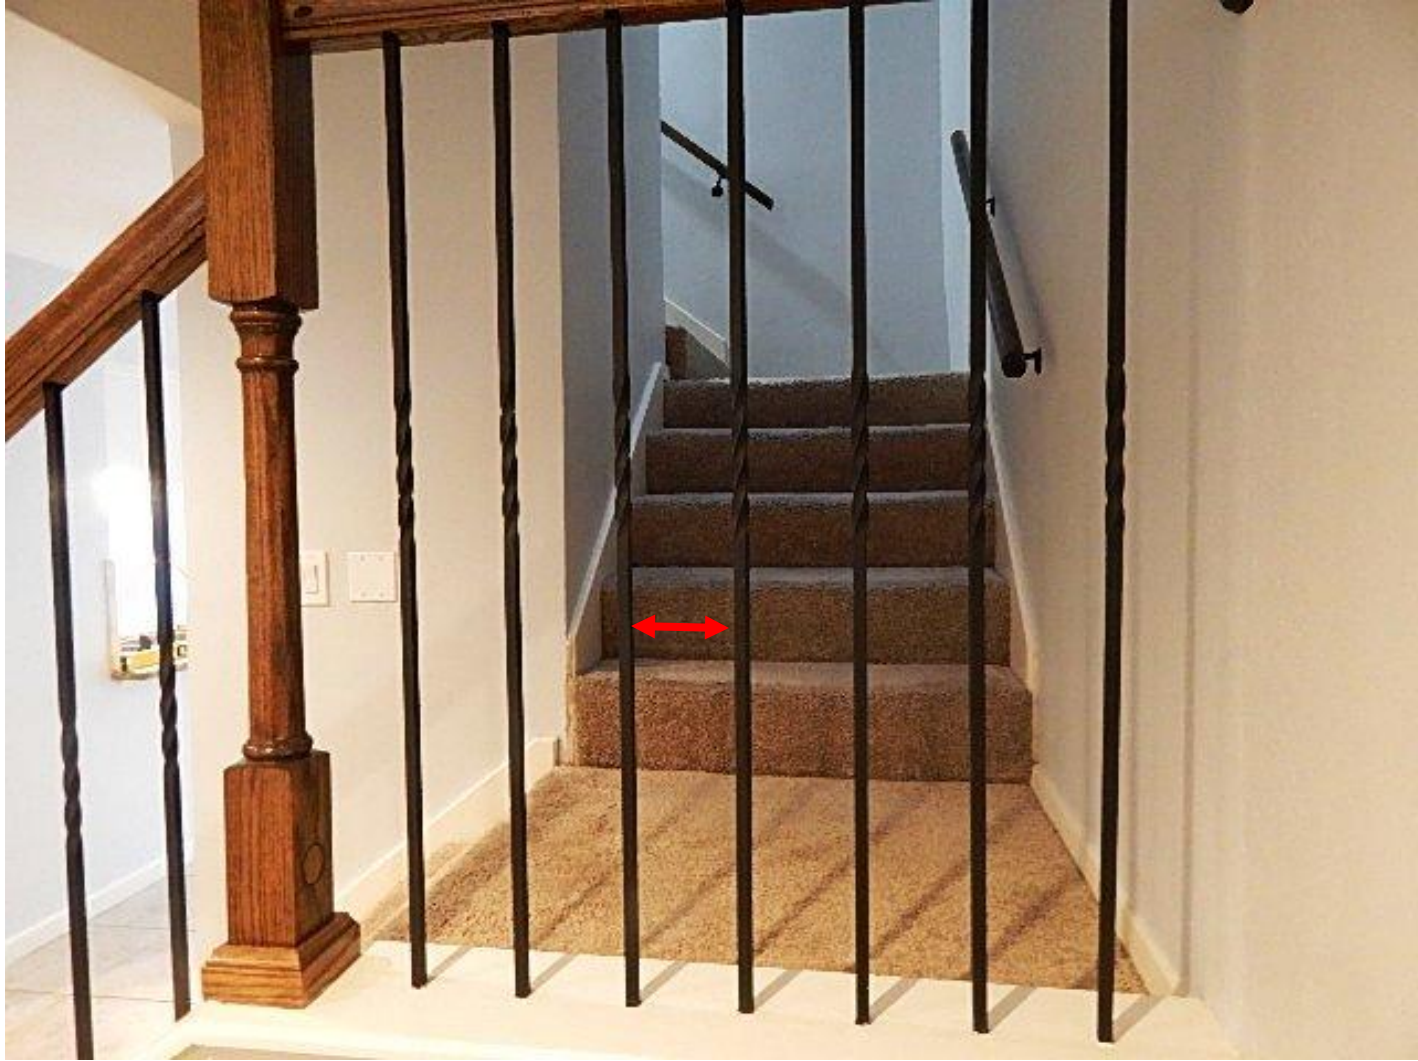
Comments: The vertical metal balusters were spaced > the max allowable 4 inches a child safety issue. Childproof.

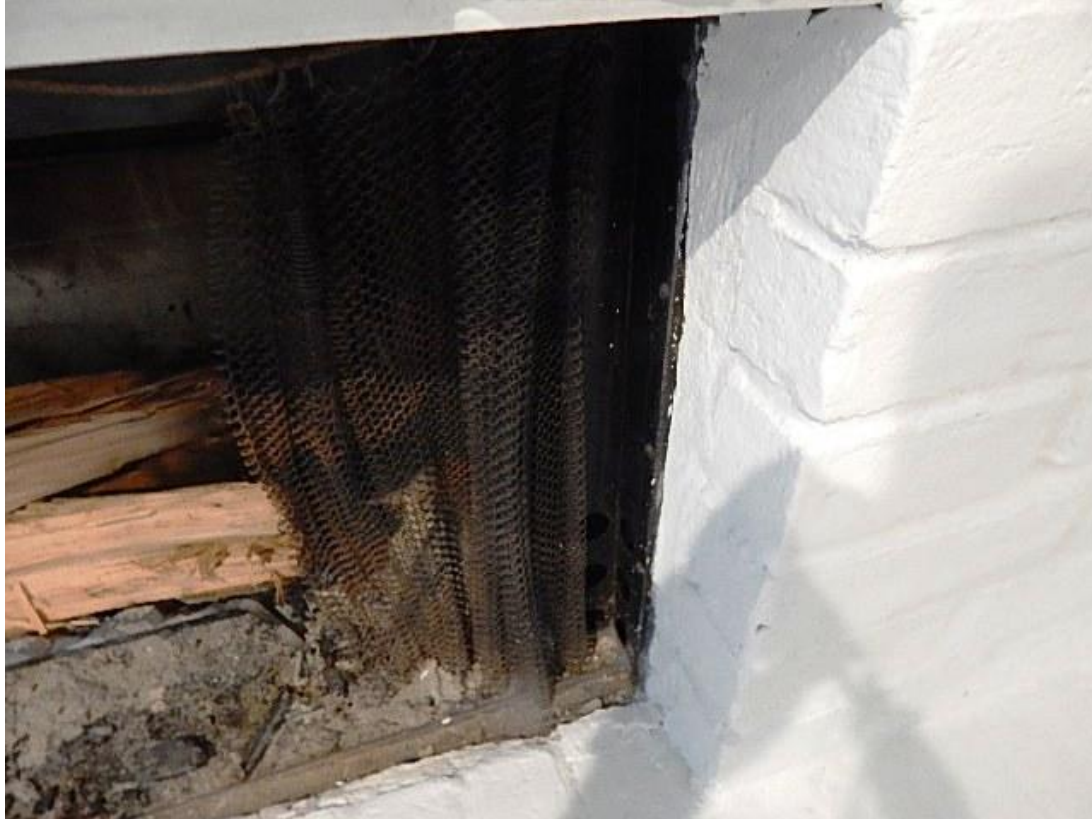
Comments: The wood burning fire box lacks the side screens safety clips.

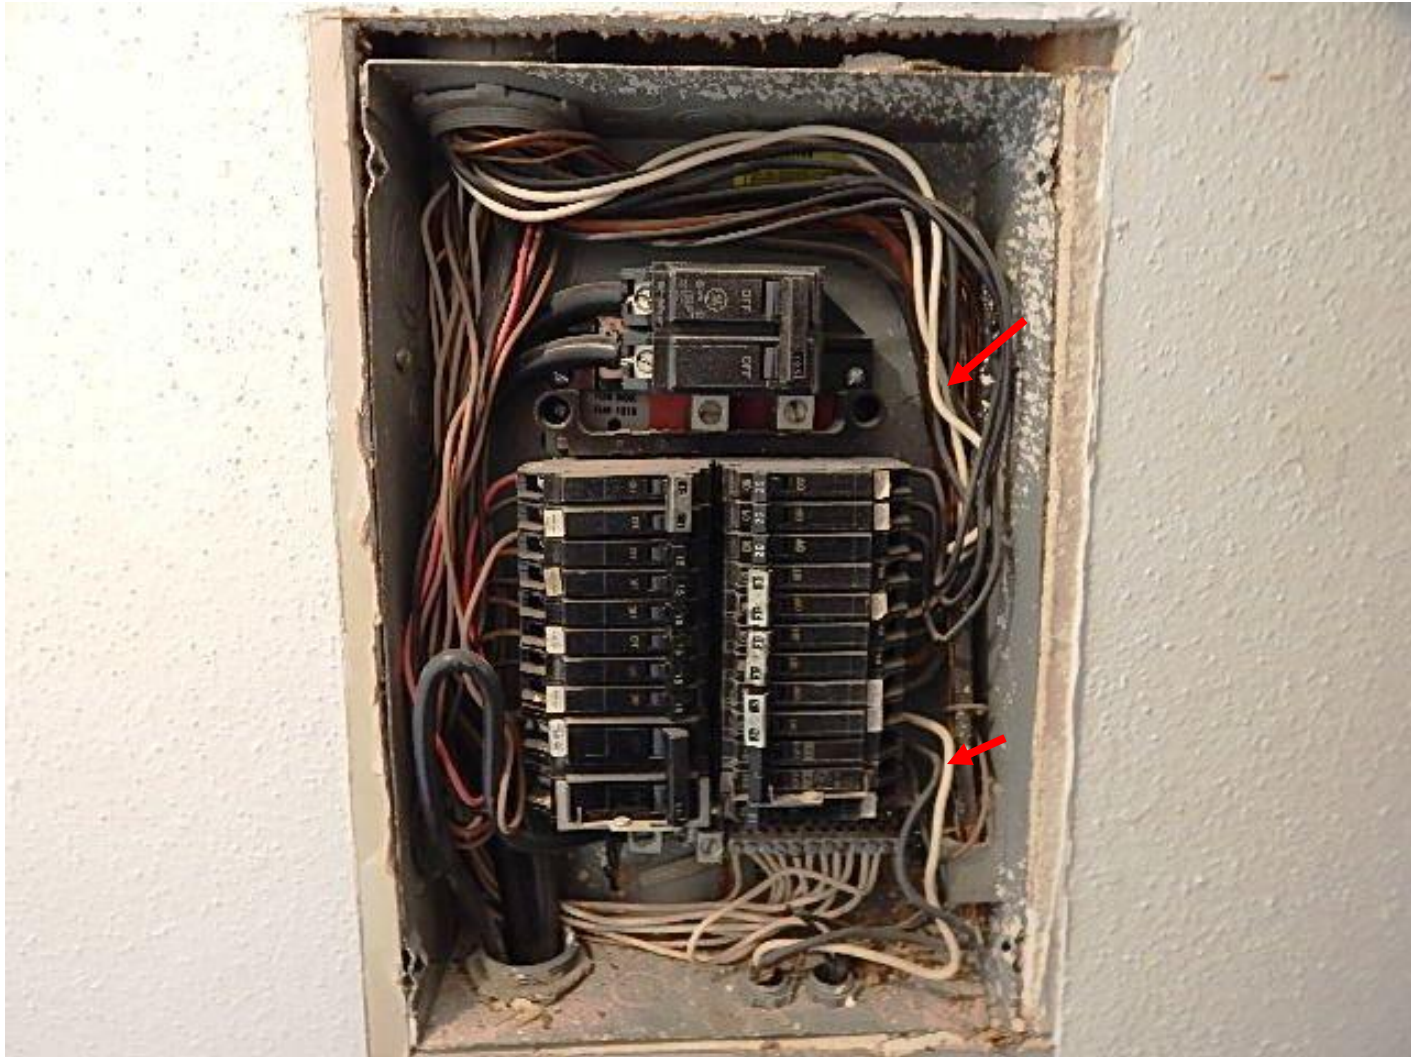
Recommend a qualified, professional, and licensed, electrician verifies ampacities, grounding, polarity, over-current protection, and ground-fault protection and arc-fault so as to otherwise meet the current standards and repairs any found deficiencies. There was a complete lack of arc-fault protection and GFCI protection inside and outside of the home (outside only as far as GFCI protection goes). White wires that are hot should be black tape wrapped.

Red arrows indicate hot wires that should be black electricians tape wrapped to indicate that they are “hot” not neutral as they appear.

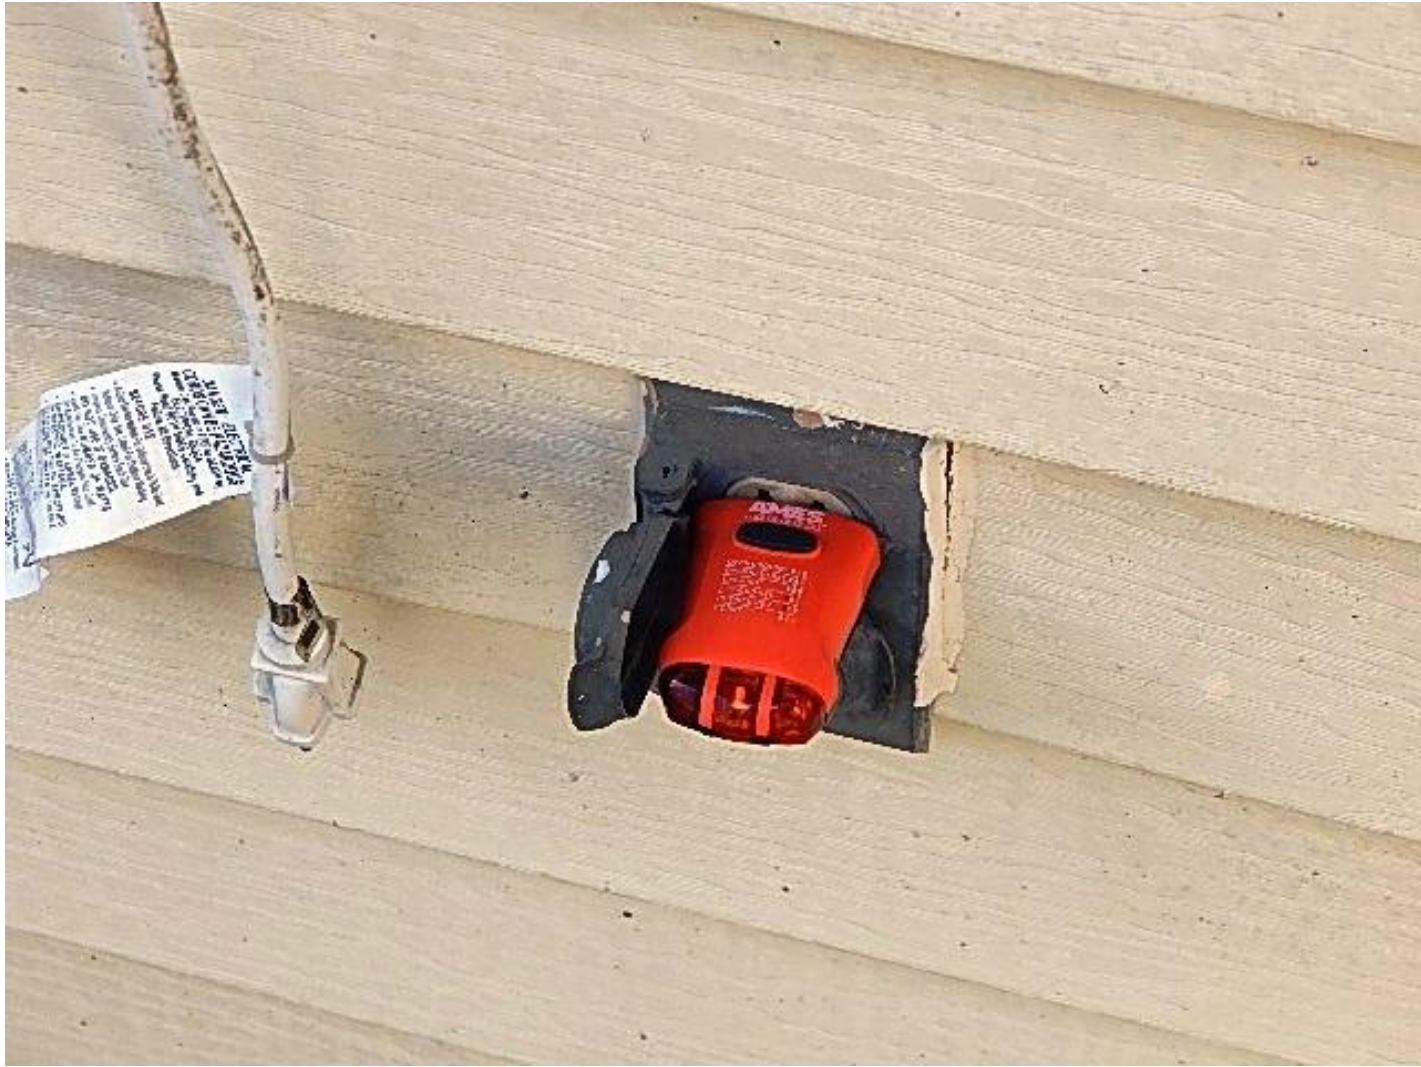
Not GFCI protected.

Comments: Recommend a qualified, professional, licensed, electrician, verifies/installs arc-fault protection, ampacities, grounding, polarity, over-current protection, and ground-fault protection so as to otherwise meet the current standards. There was a lack of arc-fault protection inside and outside of the home as well GFCI protection on the exterior of the home. Some of the closet light bulbs lack globe covers which can be a fire hazard. Several of the closet and laundry room light fixtures (DNI) and some lack globe covers. The attic light
