PROPERTY INSPECTION REPORT

2568 Bering Drive Houston, Texas 77057

Scott R. Arnold TREC. # 5468

08/09/21

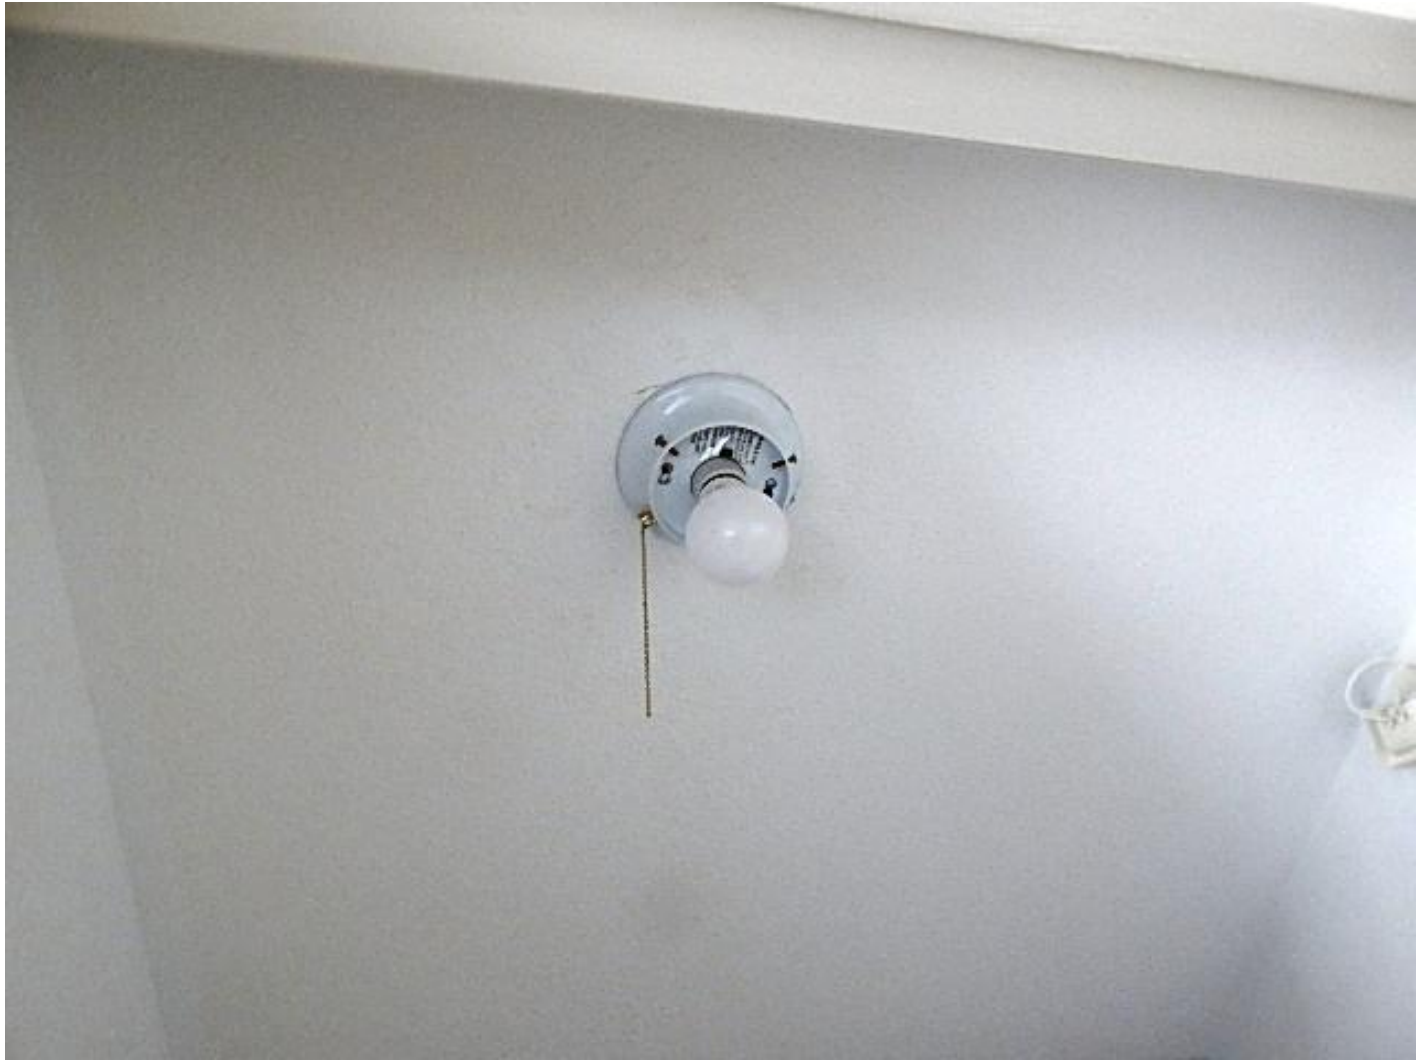
Missing globe cover.

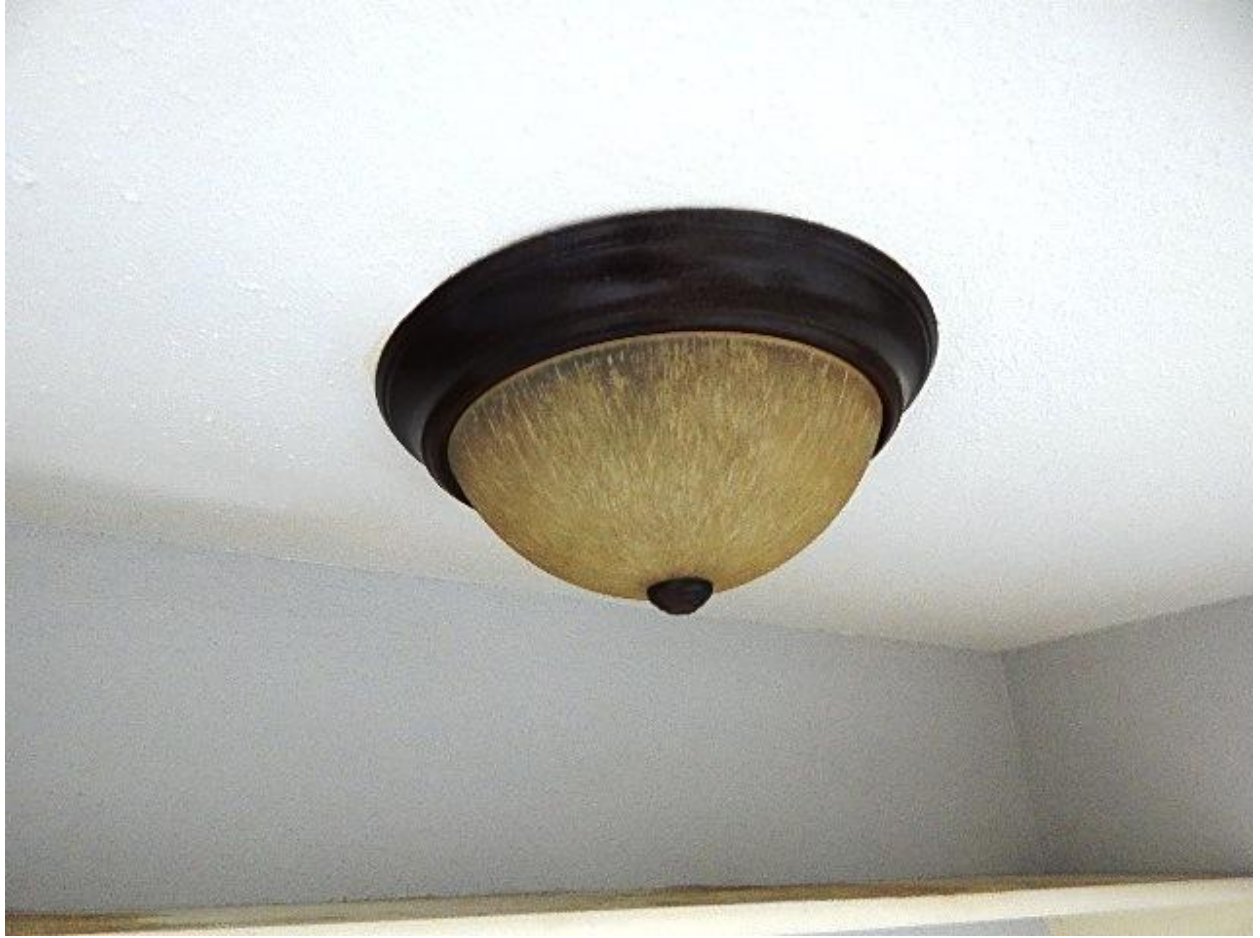
DNI.

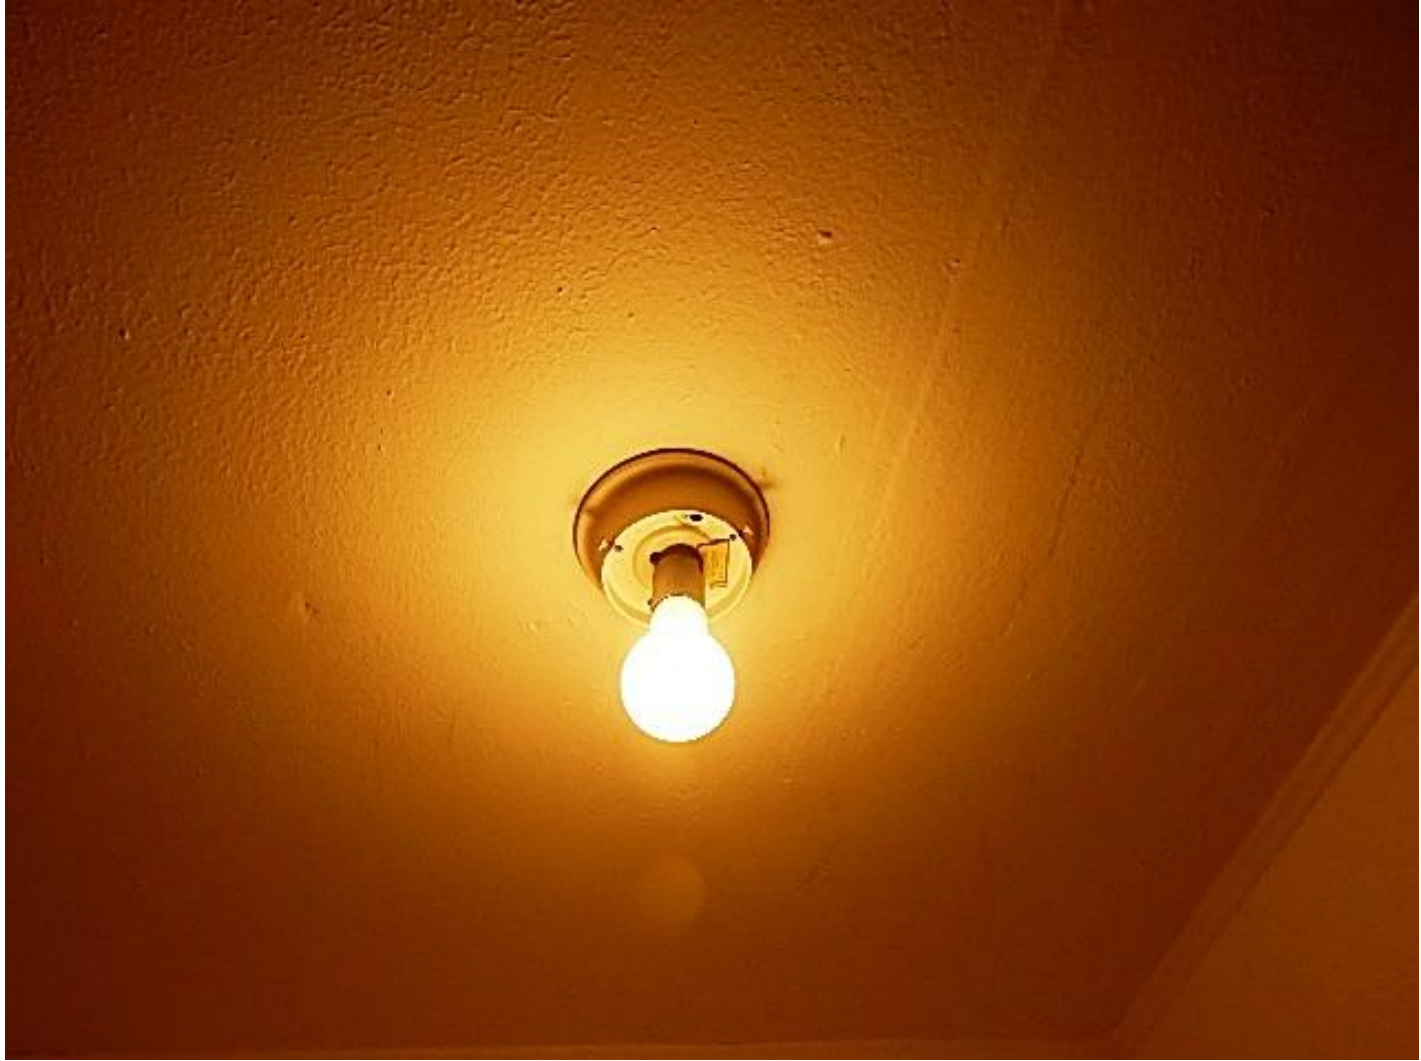
And another.

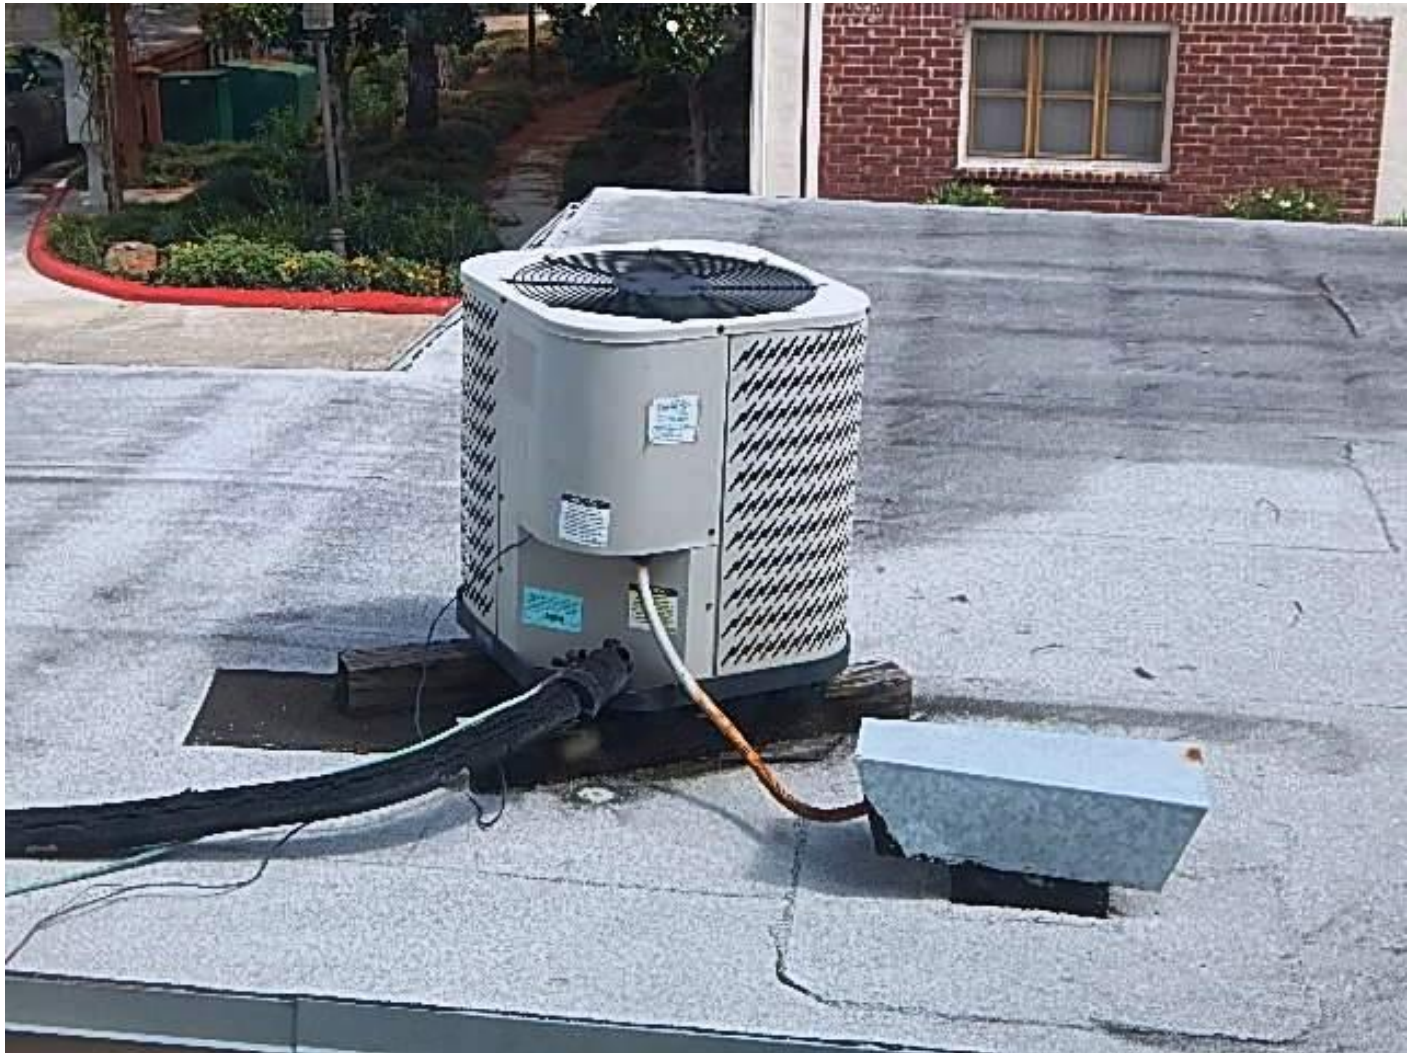
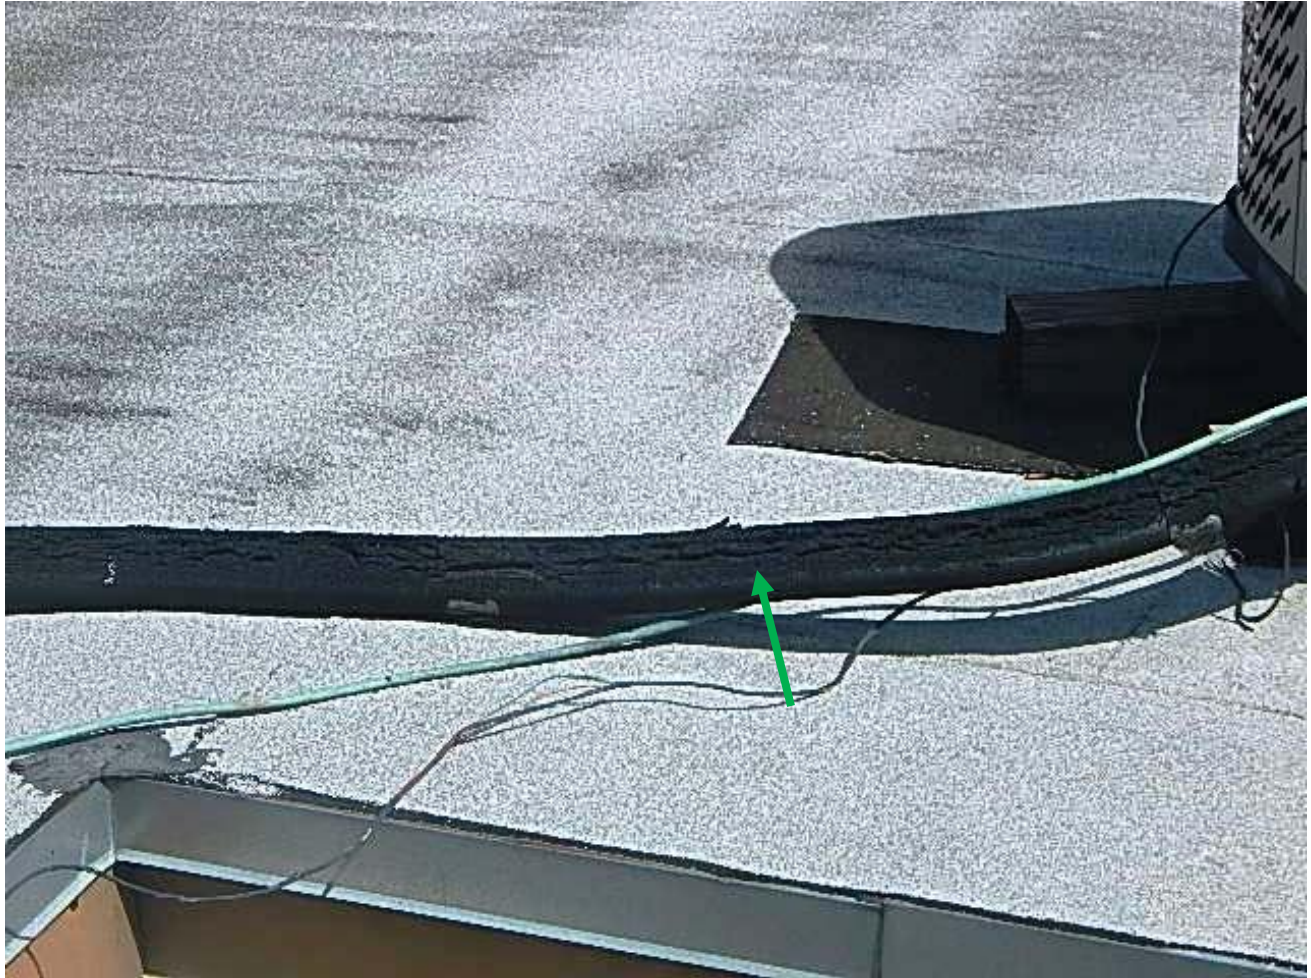
Comments: At the return air the temp read 73 deg. F. and at the various supply sides they read 50-55 deg. which is acceptable Delta T drops across the coil. Not knowing the maintenance histories of the HVAC systems I would recommend a thorough cleaning and servicing of the systems as well as any needed repairs to both HVAC systems by a qualified, licensed, professional HAVC person. The suction line insulation was weather rotted and needs replacing.

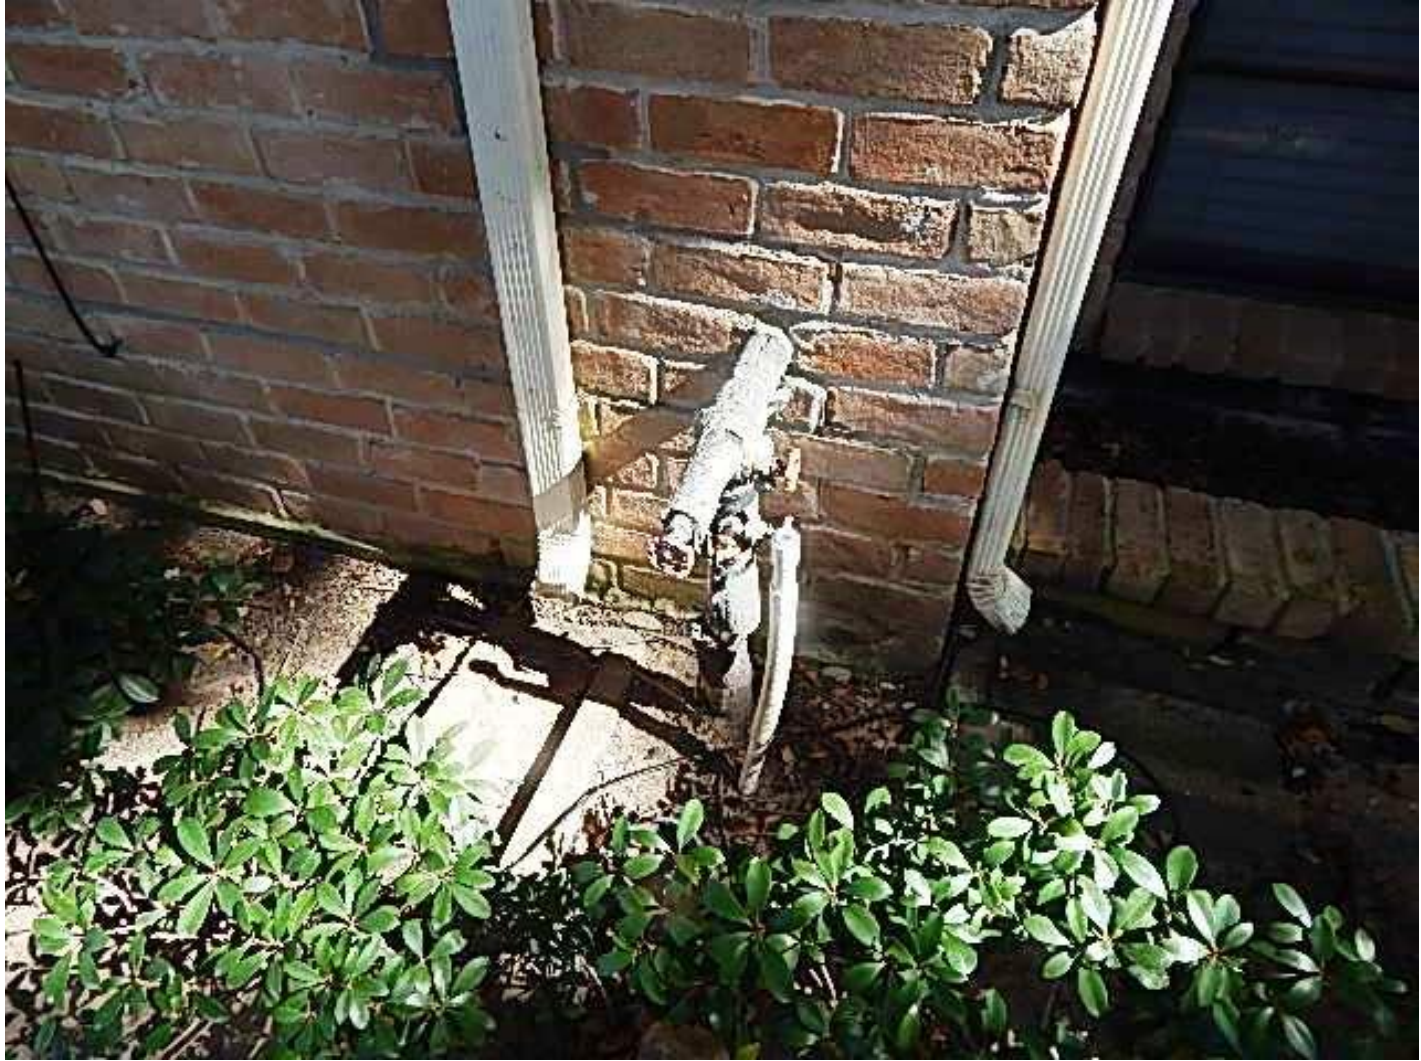
Main shut off.

Location of main water supply valve: Ext/s/wall, needs to be re-insulated.

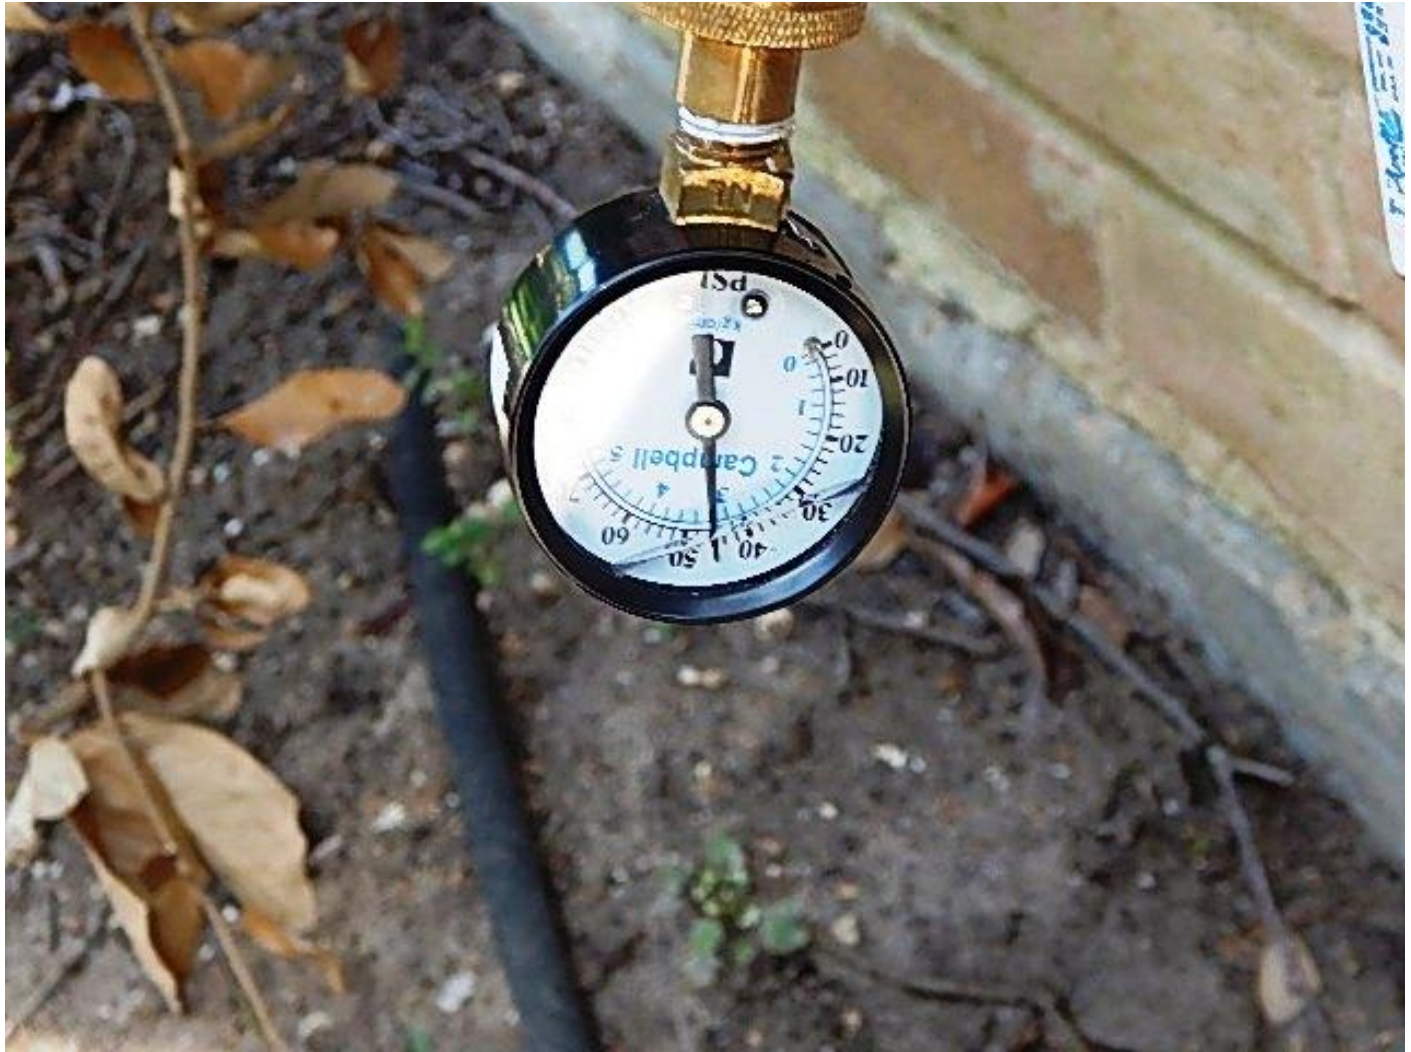
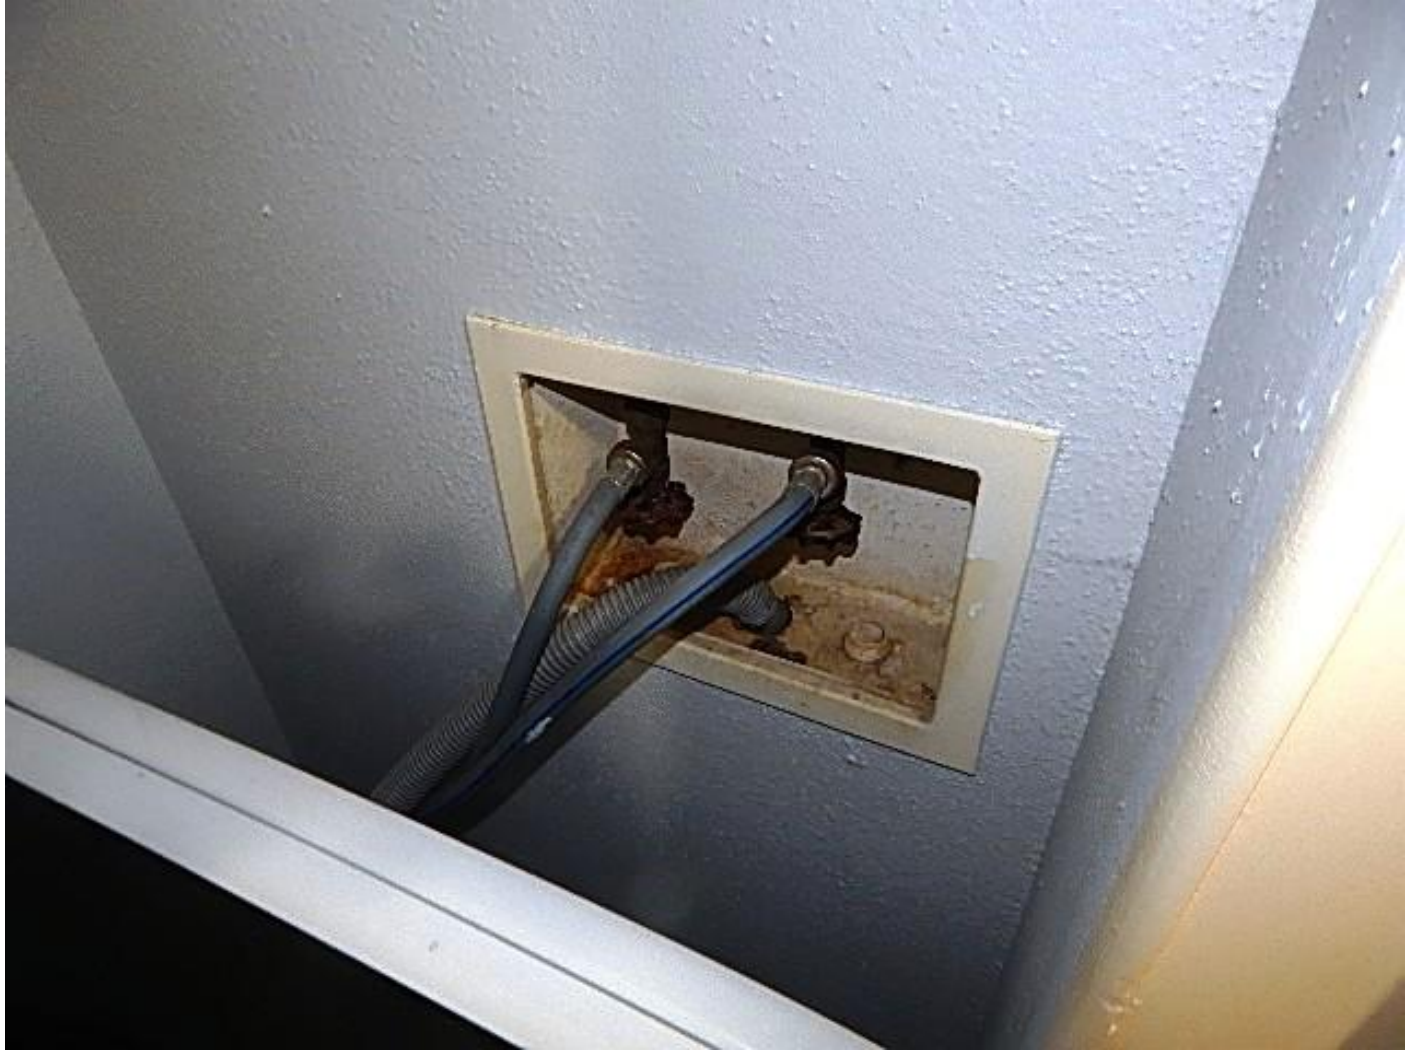
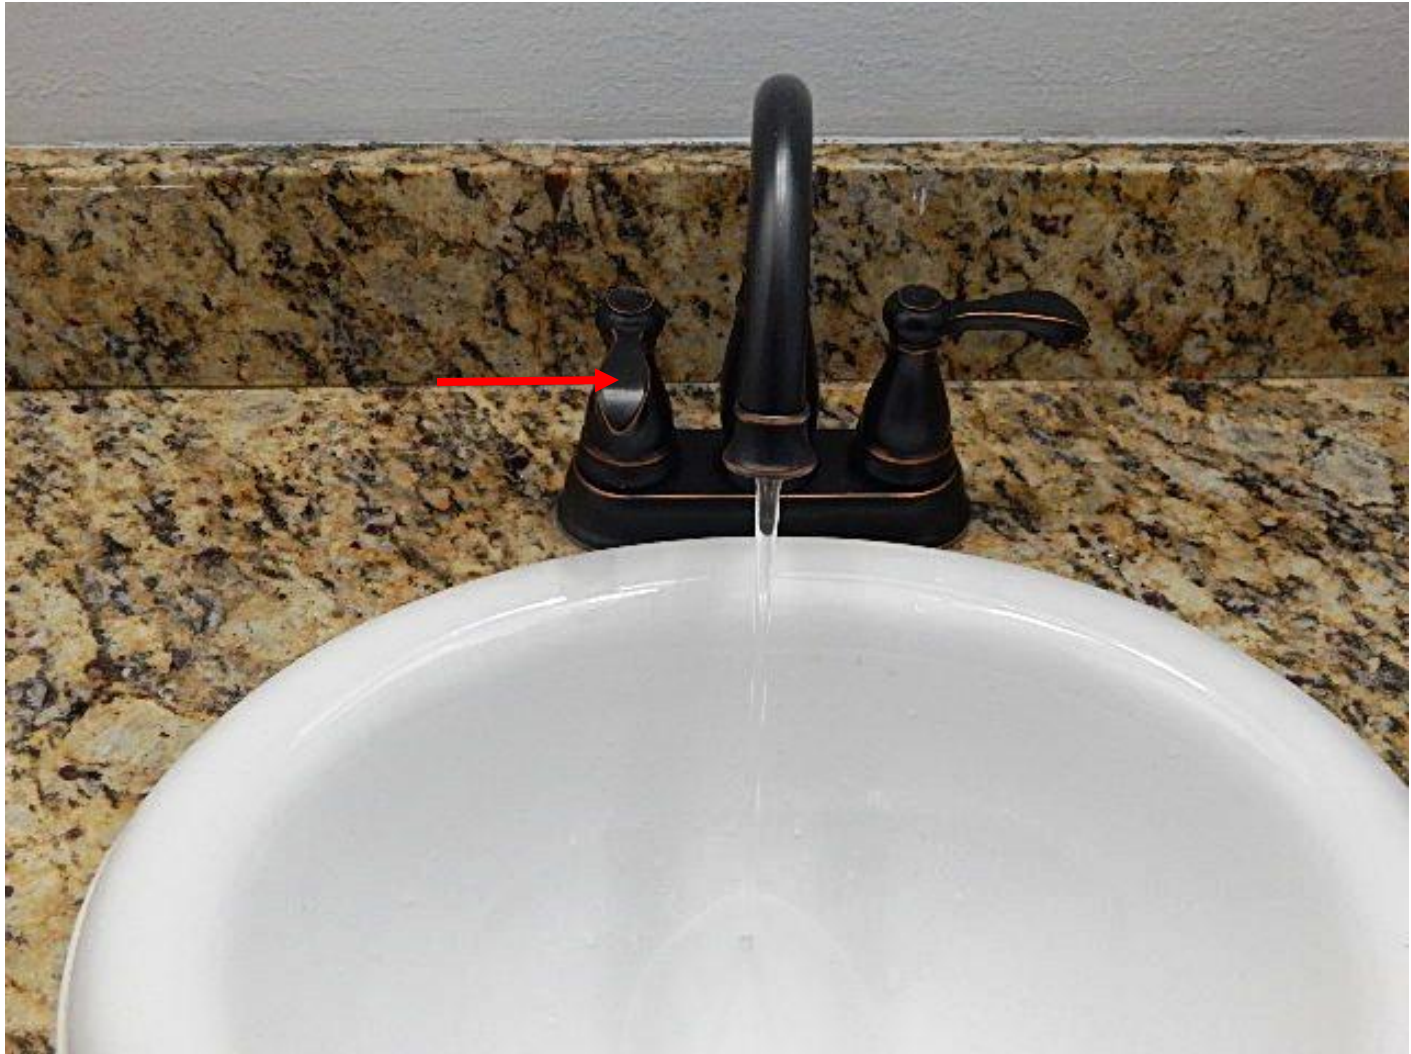
Comments: Most of the plumbing pipes were galvanized where visible others were CPVC. The following deficiencies were observed: The exterior plumbing supply pipes from the walls outward were not insulation wrapped. The clothes washer hose bib connects appear to be leaking. The hot water side pressure for the downstairs ½ bathroom was low. Recommend a qualified, licensed, professional plumber, hydrostatic tests the plumbing system for leaks and checks for obstructions with a camera scope. Note: the shower and tub pans were not leak tested.

Low water pressure hot side.

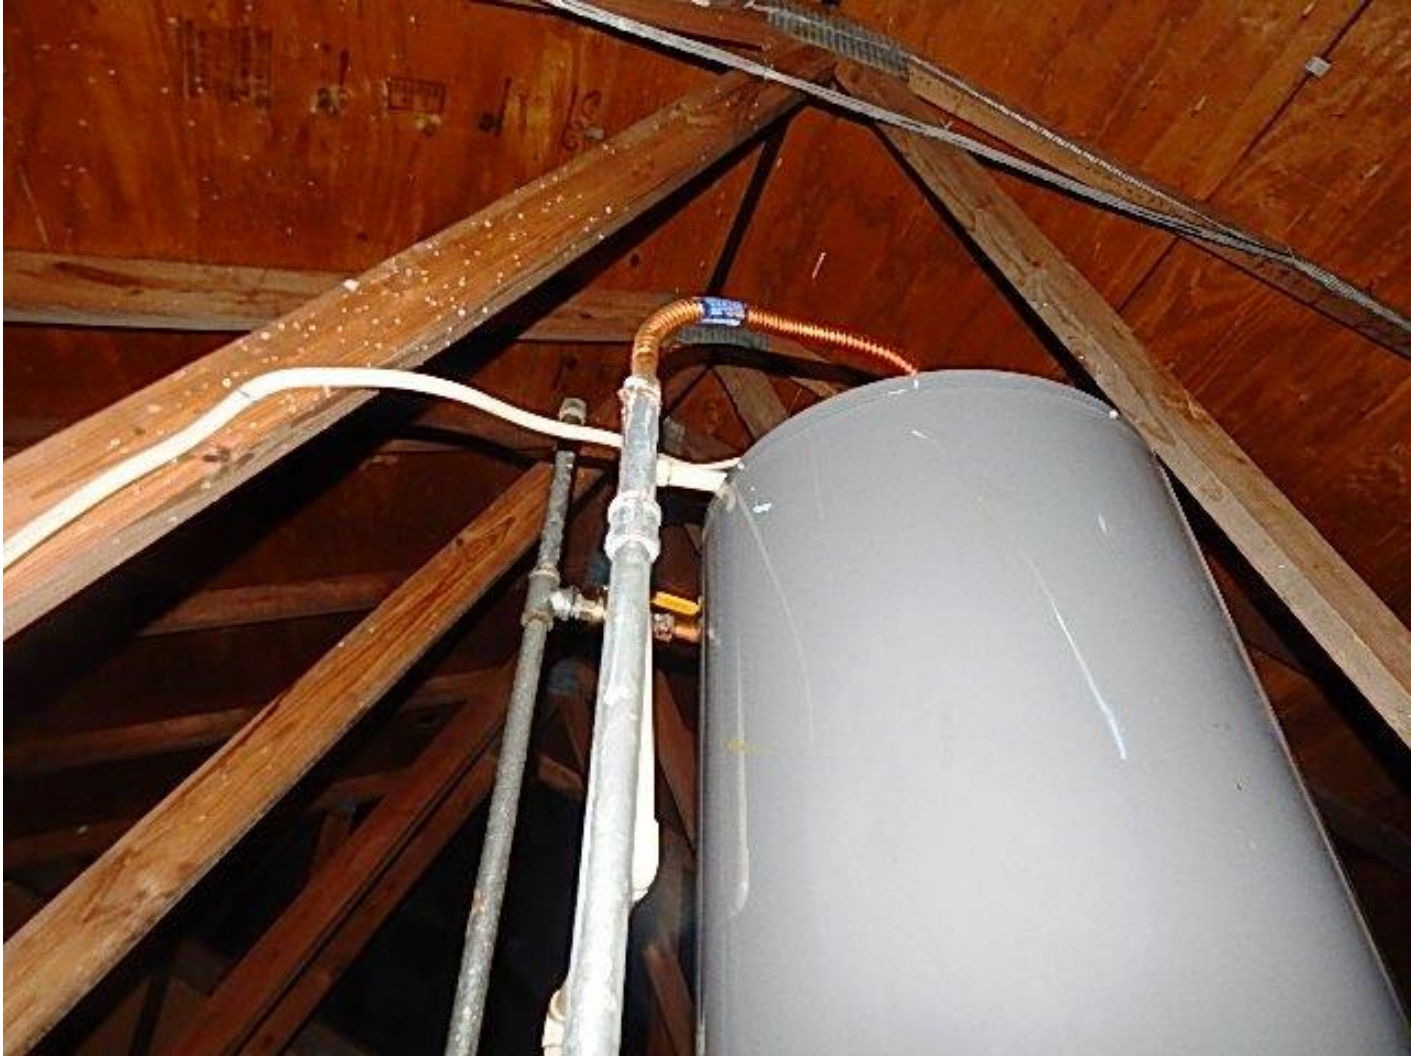
Comments: Rheem. 2018. The following deficiencies were observed: There was a lack of a power disconnect at the unit (hardwired). The water lines were not insulated at the tank top. The water lines were not bonded and at least (2) of the connection fittings were badly corroded.

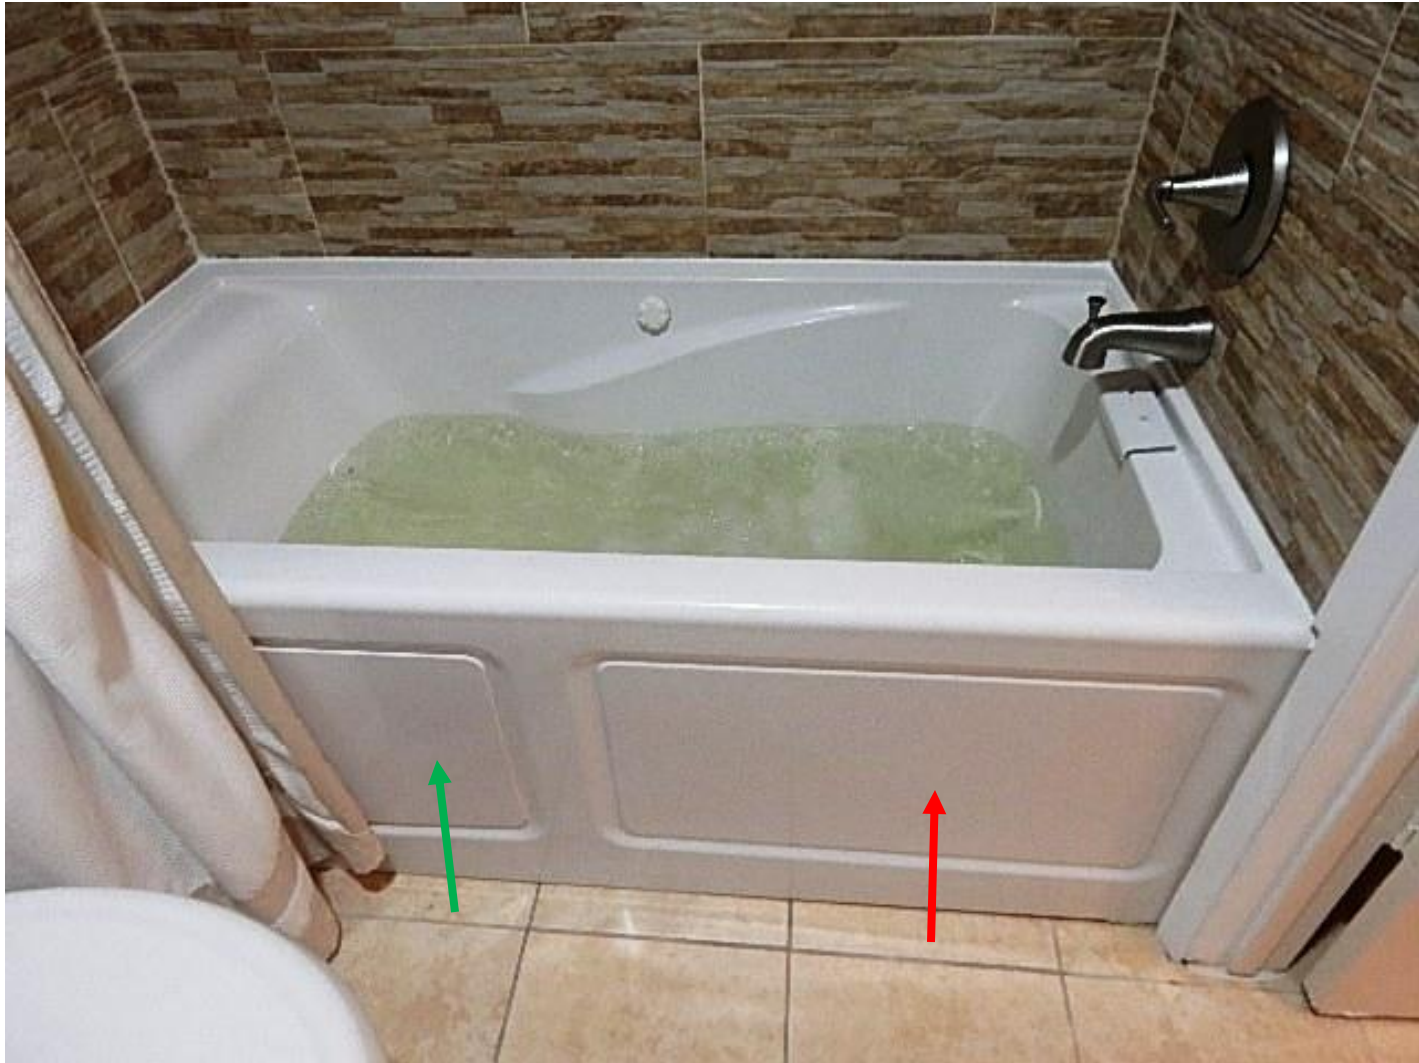
Comments: The left side door was the only accessible one. There was no GFCI on/off switch for the system.

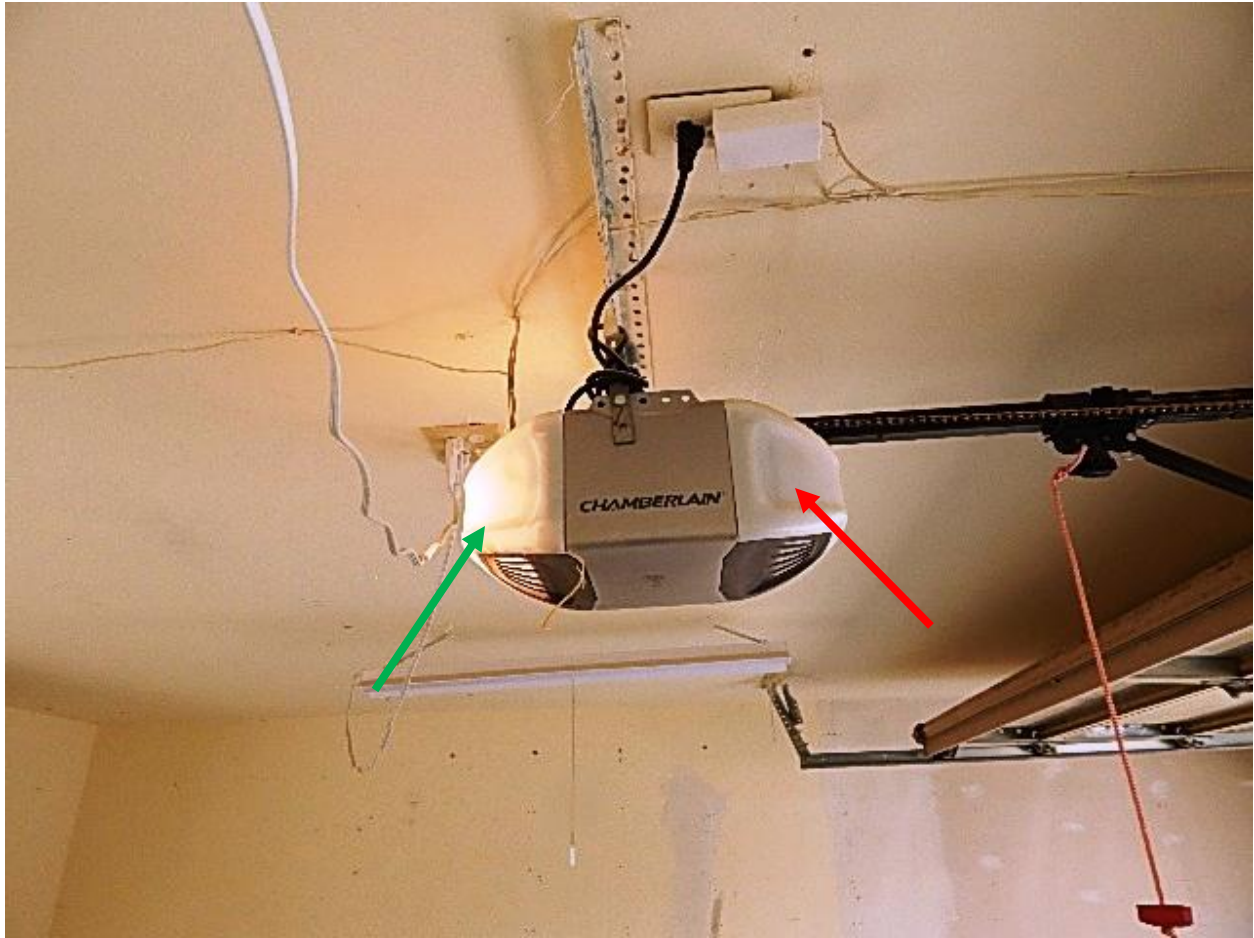
Comments: Chamberlain chain driven system. The n/half of the motor head DNI/DNF when tested the s/half worked as it should.

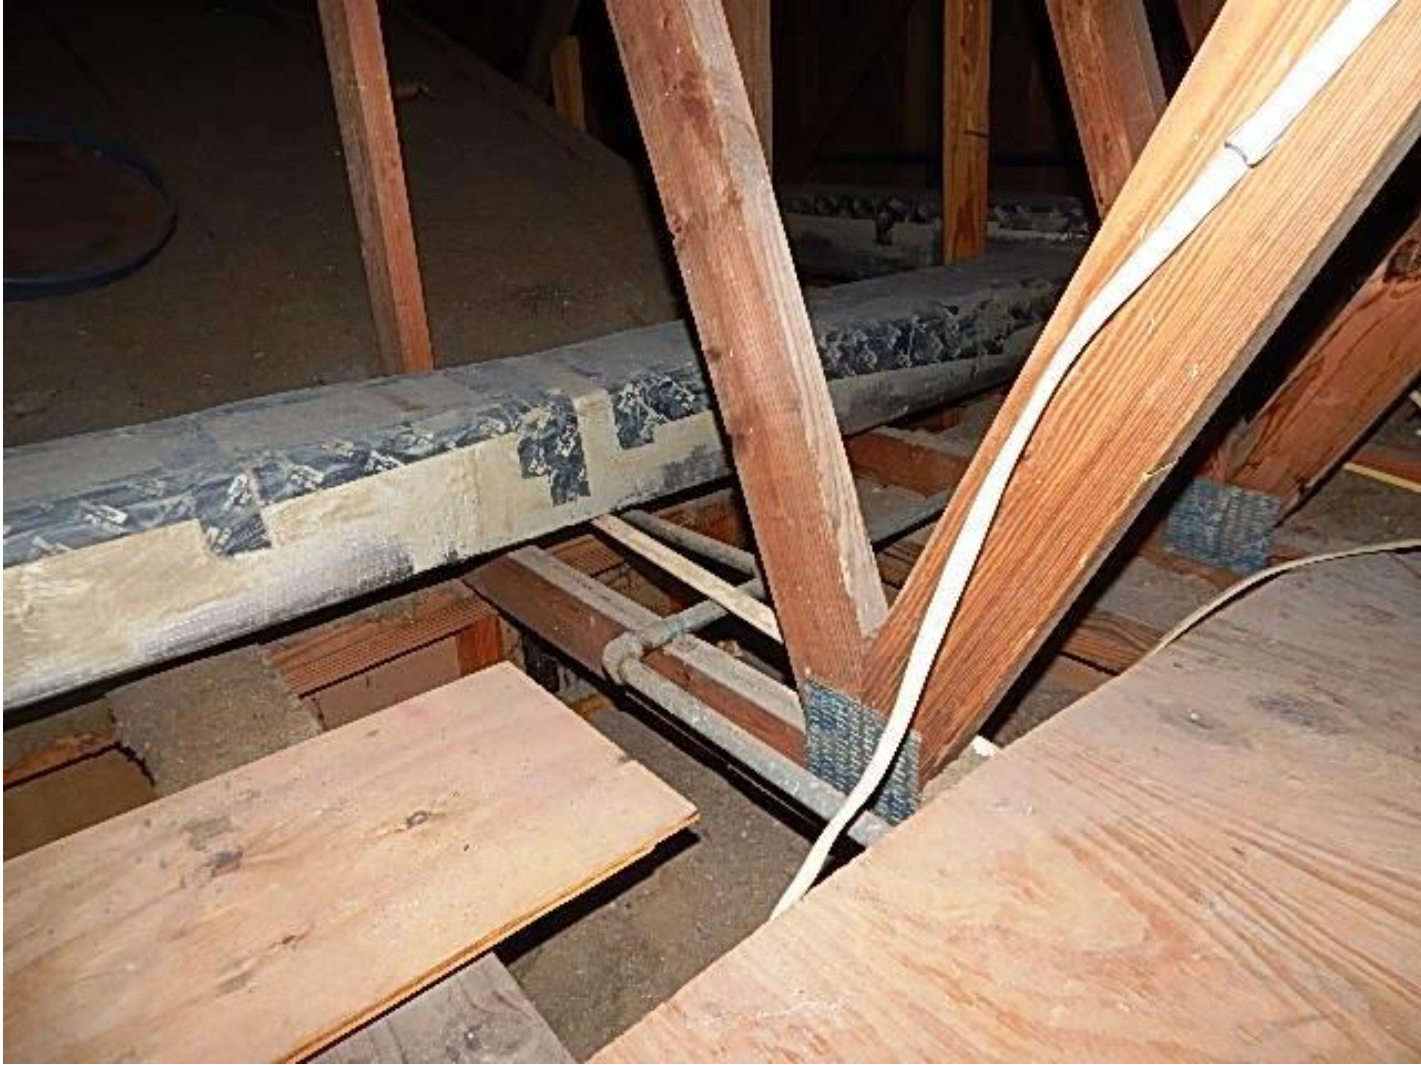
Comments: The attic plumbing pipes were not insulated.
