**September 16, 2020**

## PROPERTY INSPECTION REPORT

**Concerning:** 106 Emory Birch, Montgomery, TX 77316  
(Address or Other Identification of Inspected Property)

**By:** Brendan Andrew Hirshey, Lic #22135 09/16/2020  
(Name and License Number of Inspector) (Date)

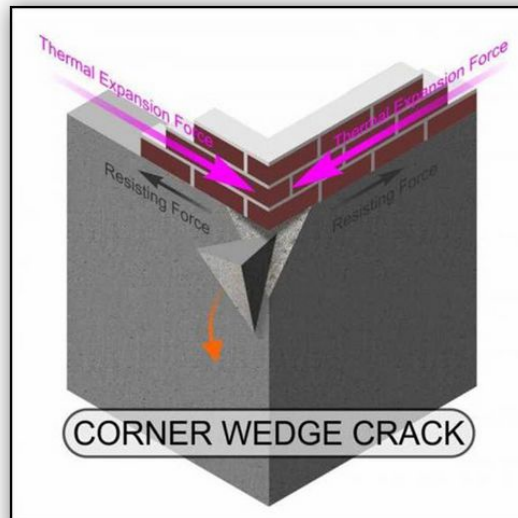
- One or more of the foundation perimeter beam corners were observed to be sheared off (corner pop). This is a common condition to observe and is due to thermal expansion and contraction of the different building materials. This condition does not adversely affect the foundation performance. However, in some cases, some cosmetic improvements may be necessary.

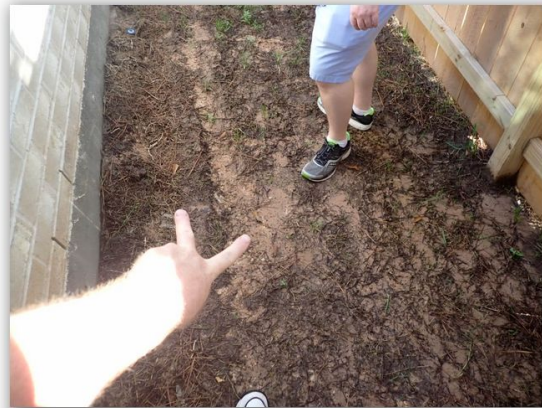
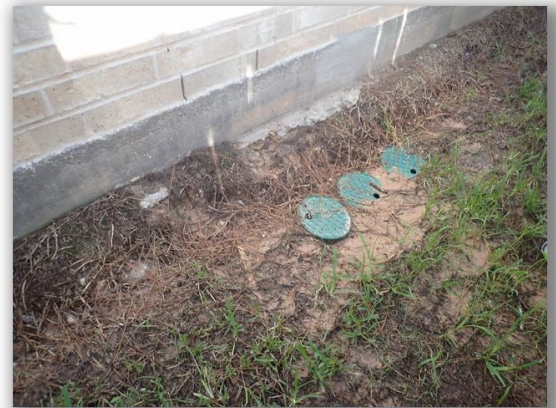
- Fill dirt is needed on the east side, west side of the structure. The low spots in the finished grade (ground) adjacent to the foundation perimeter wall need to be filled in to help prevent water from standing and/or ponding next to the foundation area.
- **Poor to negative site drainage** was observed on the east side, west side of the structure. Proper drainage is needed to help prevent water from standing and/or pooling next to the foundation beam. Corrective measures may be needed if the water stands within 10-feet of the foundation perimeter beam for more than 24-hours.

**Notice:** There is sod/dirt covering missing on the east/west side of the house.

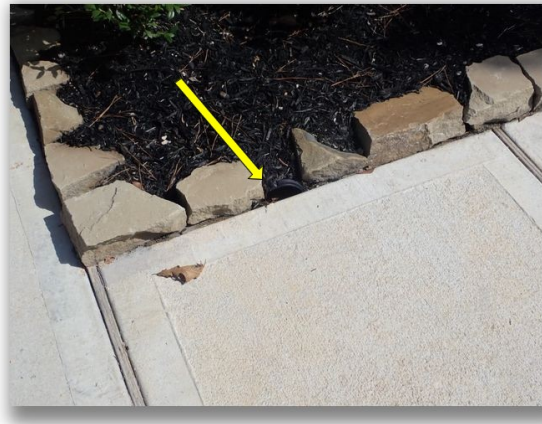
- The gutters termination needs to be improved in the south yard.

**Note:** The gutter downspouts should discharge water at least thirty-six inches (36") away from the foundation perimeter beam. Storm water should be encouraged to flow away from the structure at the points of discharge.

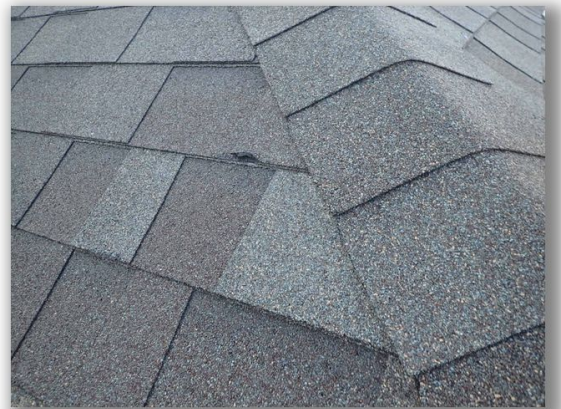
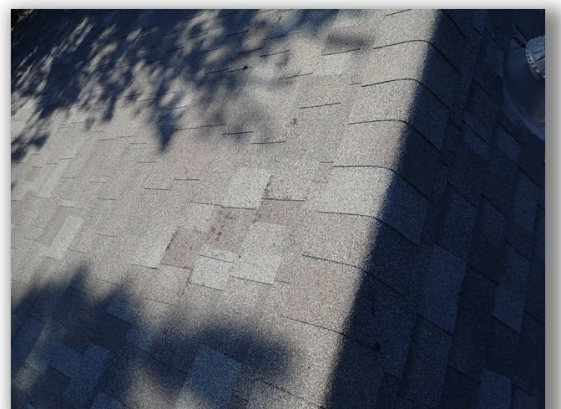
- Damaged shingles were observed on the north side, east side, west side of the roof structure.
- Some cracking and cupping of the roofing material was observed.
- There is a lot of foot traffic bruising and/or damage to the roofing material on the east side, west side, south side, north side of the roof structure.
- One or more of the shingles were observed to be lifting on the west side, north side of the roof structure.

You are strongly encouraged to have a properly certified roofing contractor to physically inspect the roof, prior to the expiration of any time limitations such as option or warranty periods, to fully evaluate the condition of the roofing material. The observation made to support the rendering of this opinion are listed but not limited to the following:

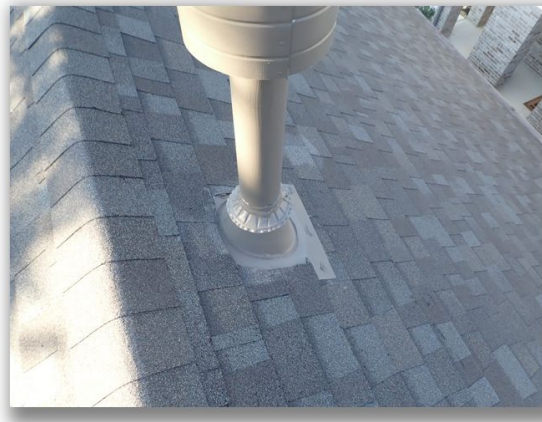
- The flashing is not properly installed on the south side of the roof structure. This condition could allow water intrusion at this location.

The flashing details needs to be checked, reset or repaired as necessary. The observations made to support the rendering of this opinion are listed but may not be limited to:

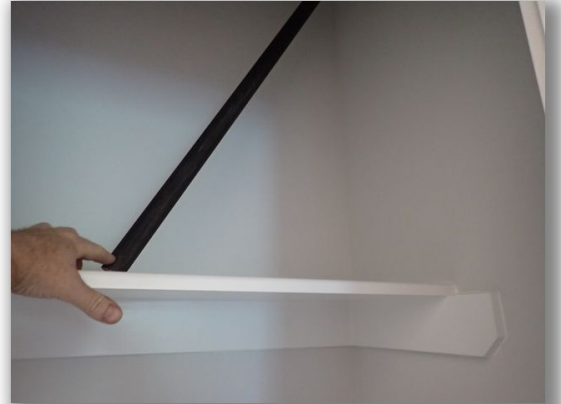
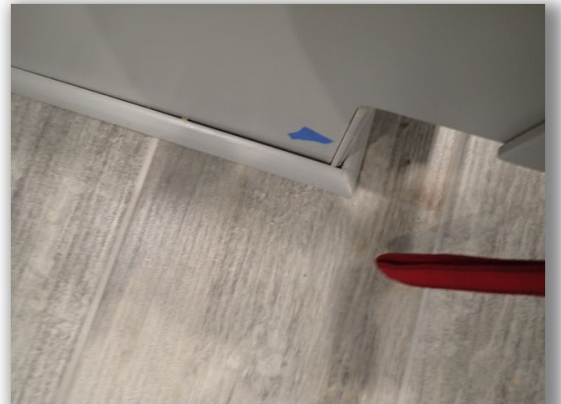
- Cabinet surface damage was observed in the kitchen, primary bathroom, hall bathroom.
- The closet rod was observed to be improperly installed in the front entry hallway.

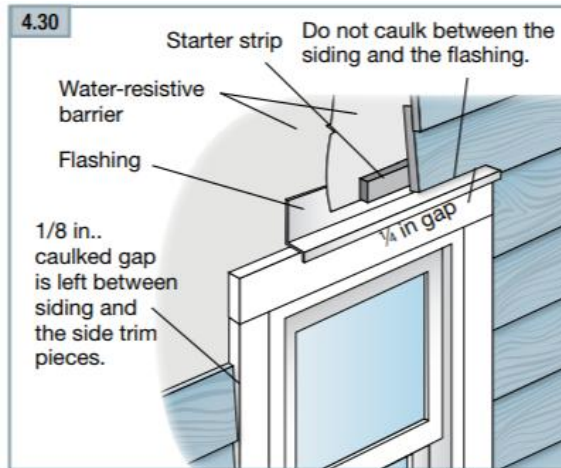
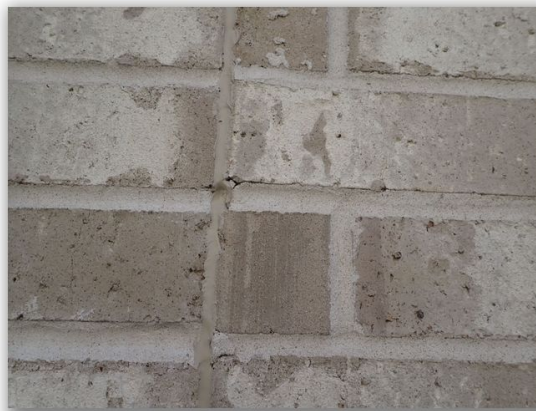
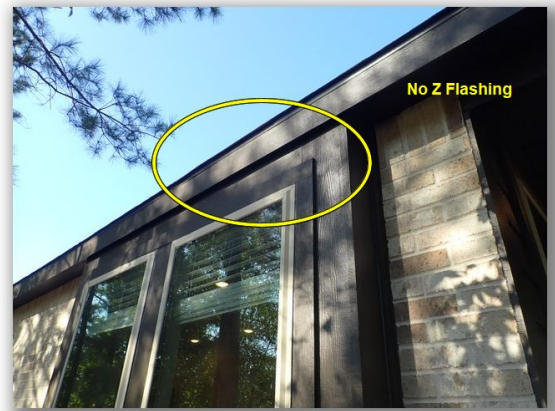
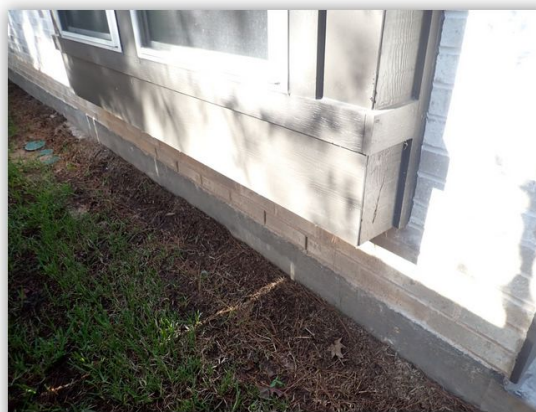
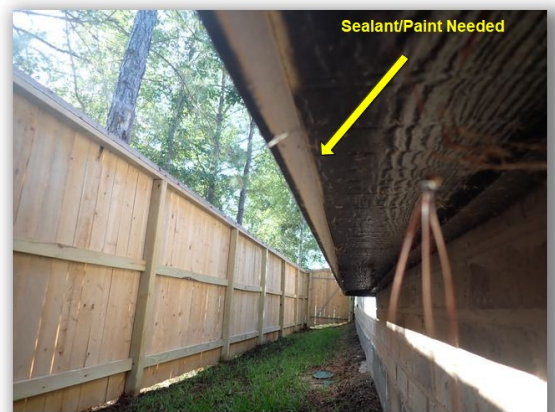
- The area between the exterior cladding / veneer and all of the wall penetrations / openings need to be properly sealed. Areas such as utility connections, downspouts, hose bibbs, lighting fixtures, receptacles etc. It is recommended to use an elastomeric caulking / sealant.
- The wall expansion joint(s) need to be properly sealed on the east side, west side of the structure. It is recommended to use an elastomeric caulking.
- Mortar improvements are recommended for the exterior masonry veneer on the south side, east side of the structure.
- There is no visible through wall flashing (head flashing) above the windows. Under current building installation standards, there should be through wall flashing continuously above all windows penetrations to help prevent water intrusion at these locations.
- All of the exterior wood type surfaces need a fresh coat of paint.

**Note:** Minor mortar and/or brick cracks were observed in the exterior veneer.

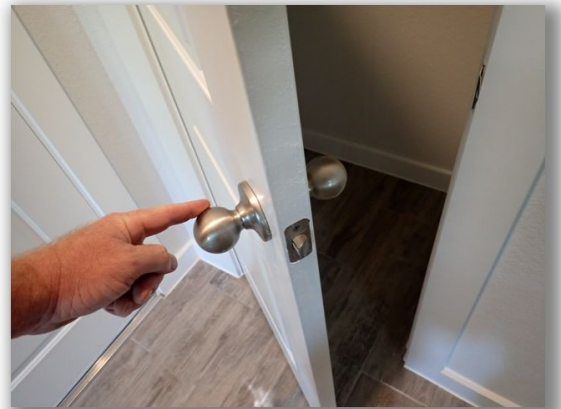
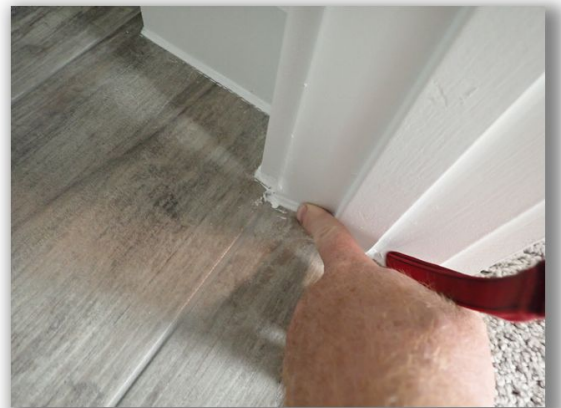
- The door is not latching properly to the pantry, hallway closet.
- The door has some surface damage to the laundry room.
- The door hardware is missing to the laundry room.
- The door hardware is loose to the various locations throughout the house.
- The door has some surface damage to the laundry room.
- The door frame has some damage to the laundry room, front corner bedroom.

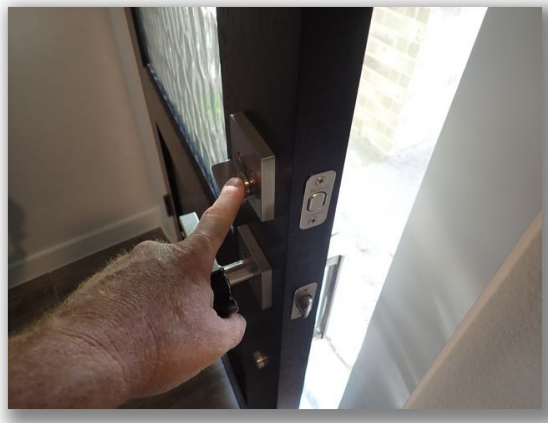
- The door hardware does not function properly to the front entry door.

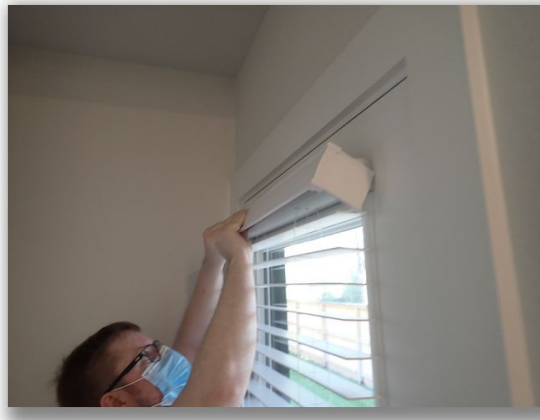
**Note:** Some of the blinds were damaged/or not operating properly.

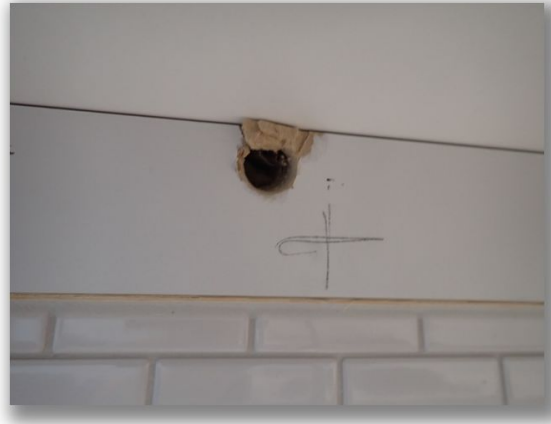
- Open end wires were observed in the kitchen. Open end wires should be enclosed in a junction box for reasons of safety.

The buyer should have the electrical system checked by a Qualified Licensed Electrician. The observations made to support the rendering of this opinion are listed but not limited to the following:

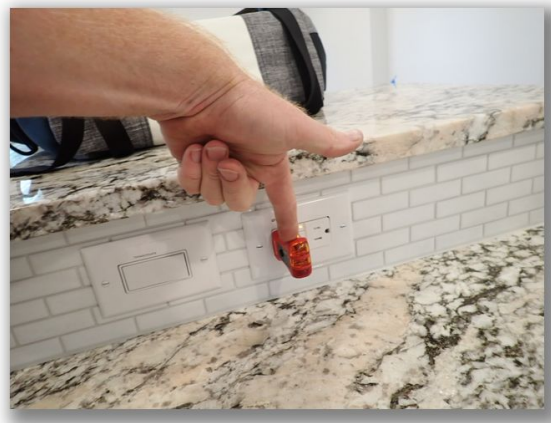
- One of the ground fault circuit interrupter (GFCI) devices does not appear to be functioning properly at the time of this inspection. The device in question is located in the kitchen area.
- One or more of the receptacles appears to be inoperative. This receptacle(s) and circuit should be investigated and corrected as necessary. Receptacle(s) were located in the kitchen.
- One or more of the receptacles were observed to be loose at the wall mount in the various locations throughout the house.

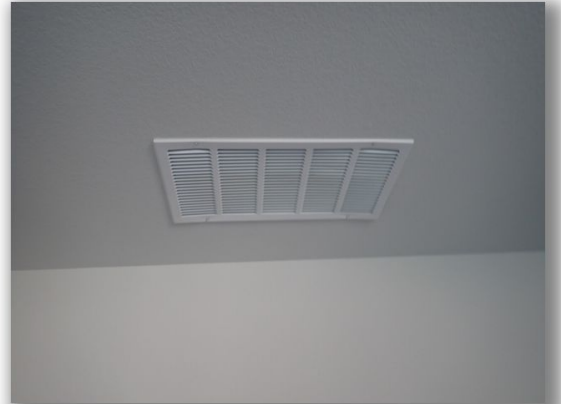
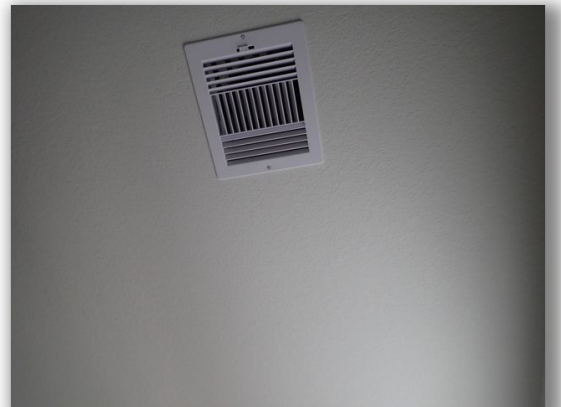
- The air register has poor air flow in the side middle bedroom, laundry room.
- The return register in the primary bedroom was observed to be damaged and/or crushed. This condition should be further evaluated and corrected as necessary.
- The duct work in the attic area does not appear to be properly suspended and separated to help prevent condensation from developing. It is recommended to separate and suspend the duct work with supports in minimum intervals of 4-feet that have a minimum width of 1.5-inches.

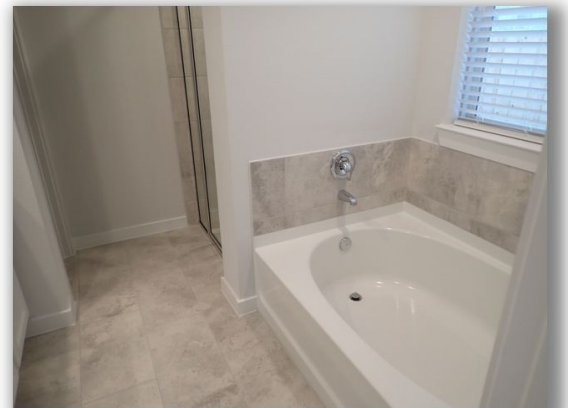
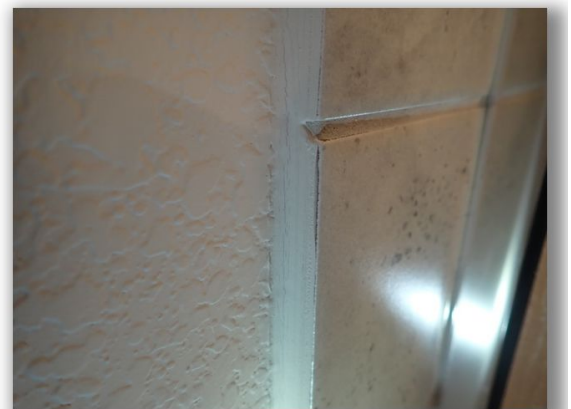
- Cracked, deteriorated and/or missing shower stall grout and/or caulking should be repaired or replaced as necessary.
- The shower spout is leaking at the neck connection.

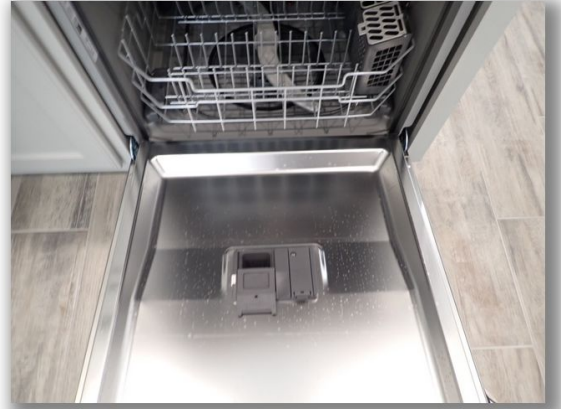
- The dishwasher is loose at the cabinetry and should be better secured.

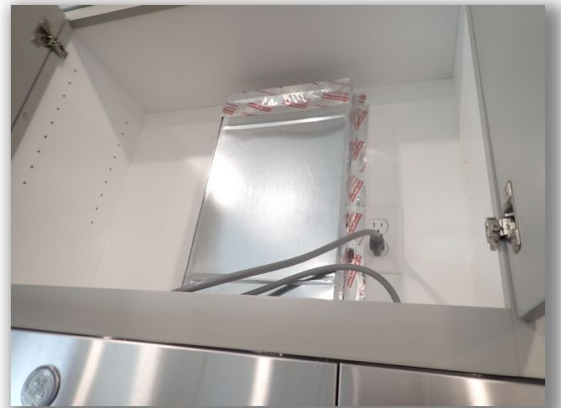
- The range exhaust vent is leaking into the cabinet area. Range exhaust vents should vent to the exterior of the house.

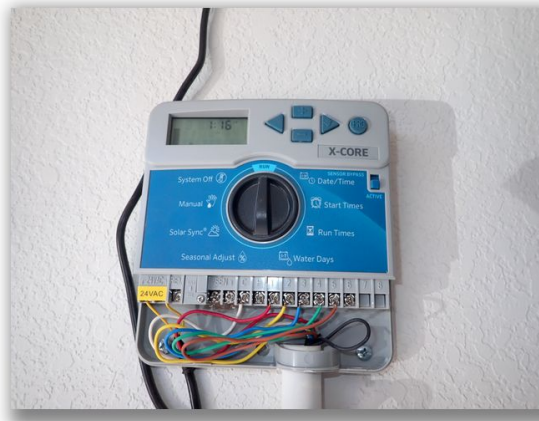
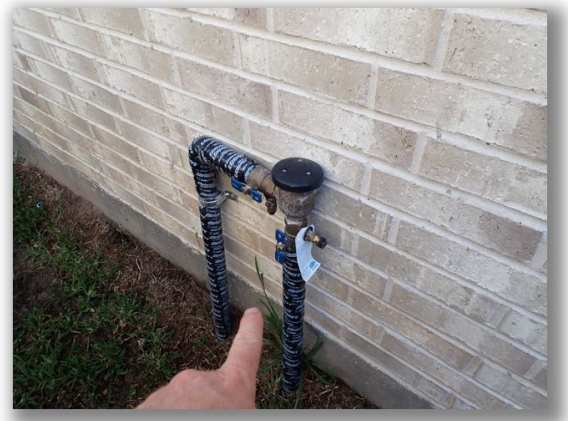
- One or more of the sprinkler heads need to be adjusted so not to disperse water onto concrete flatwork (such as; roadways, sidewalks, fences, porches, patios or driveways) in station(s); **1, 5, 3, 2.**
- One or more of the sprinkler heads need to be adjusted so not to spray water onto the exterior walls, surfaces or windows in stations; **3,4, 5.**
- There appears to be a sub-surface leak or damaged water lines in station(s); **1.** The cause and remedy should be further evaluated and corrected as necessary.
- One or more of the sprinkler heads appear to be leaking at the base of the head in station(s); **1.** The cause and remedy should be further evaluated and corrected as necessary.
- One or more of the sprinkler heads do not pop-up high enough to disperse water properly in station(s); **5.**

The sprinkler system and associated components should be further evaluated and/or serviced by a Licensed Irrigation Technician. The observations made to support the rendering of this opinion are listed but not limited to the following:

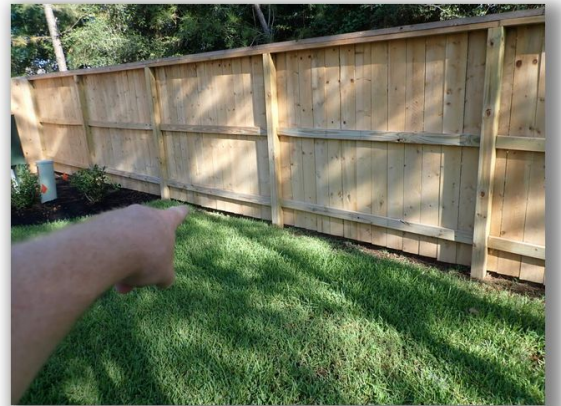
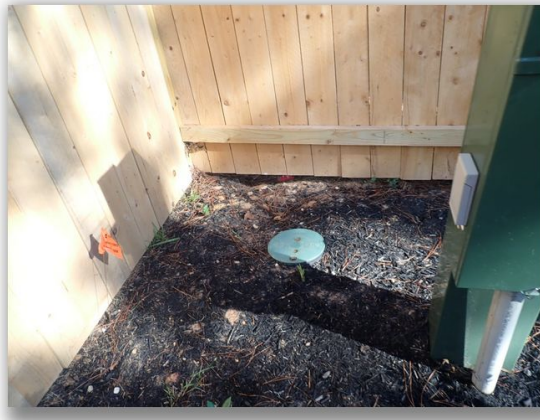
- There are large gaps under the fence and repairs are recommended.

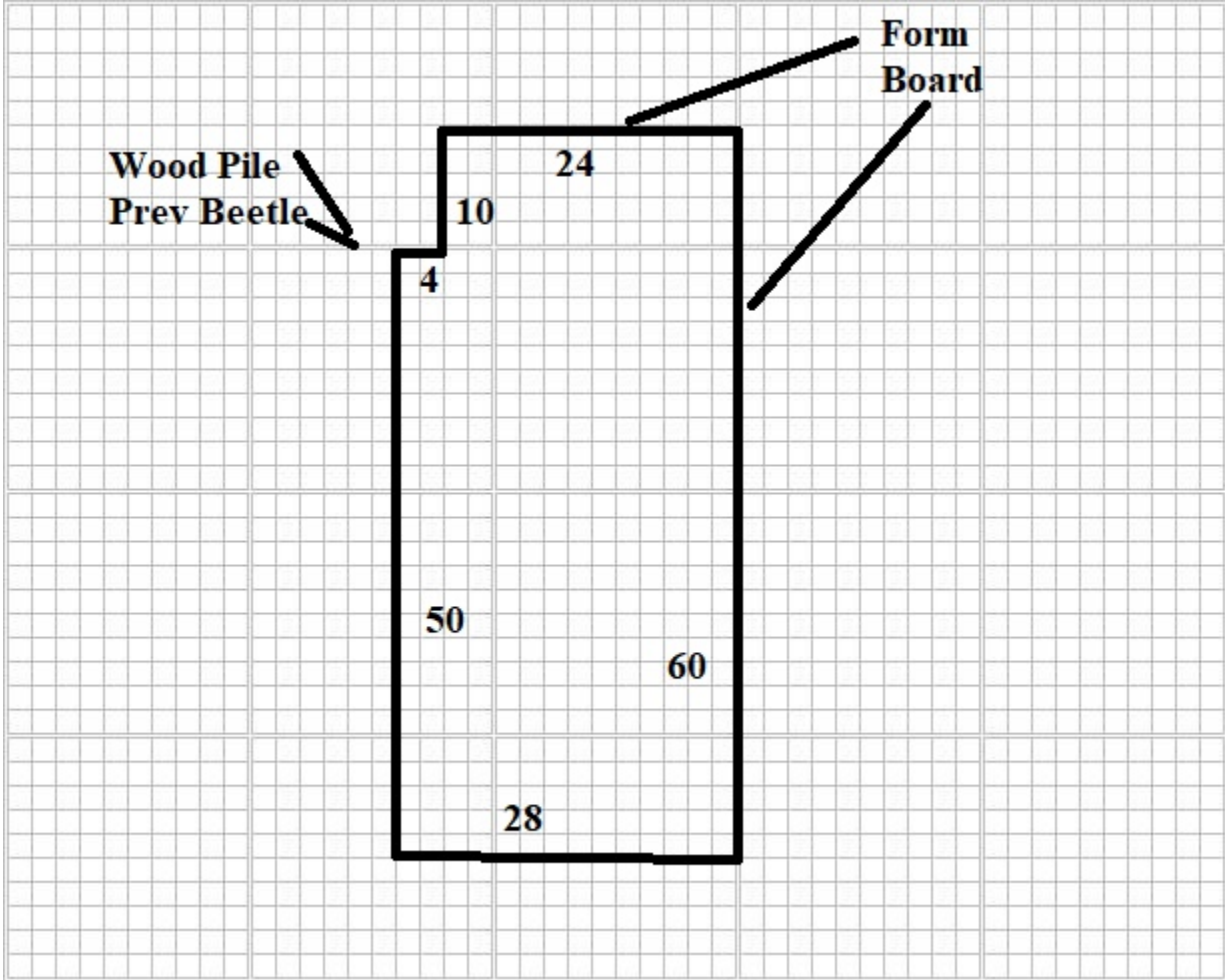
Additional Comments There is visible evidence of a previous termite infestation at the time of this inspection without signs of previous treatment or records of previous treatment. Treatment is recommended at this time. See diagram for location(s).
