Discovery Home Inspection Services, LLC

Property Inspection Report

612 So 1 1/2 St, NEDERLAND, TX 77627 Inspection prepared for: GRANT ROWLAND Real Estate Agent: Mozelle Cobb -

Date of Inspection: 2/22/2022 Time: 11:30AM Age of Home: 31+ years Size: 1400+ SF

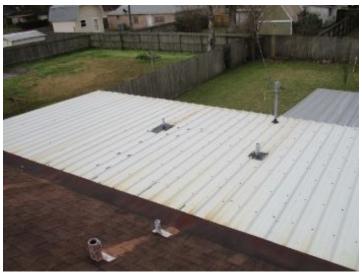
Inadequate attic ventilation. No lower vents at home and no roof top vents at addition.

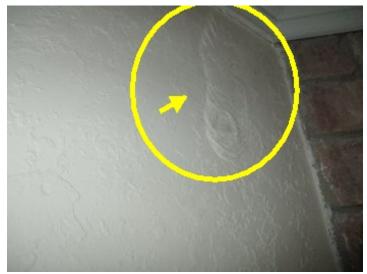
Observed what appears to be water damage to interior wall in the addition den on wall to the left of fireplace.

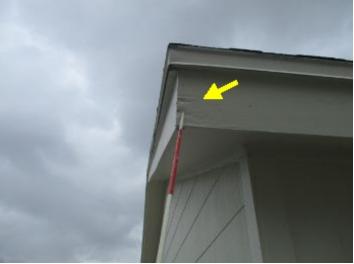
Rot to rear right corner eave fascia trim board.

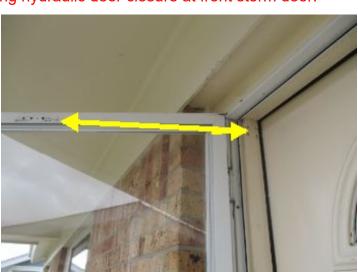
Missing hydraulic door closure at front storm door.

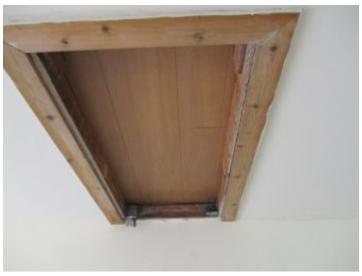
Pull down attic stairs have been removed.

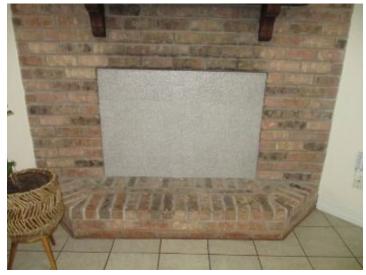
Unable to remove large tiles covering at ft of firebox to view firebox.

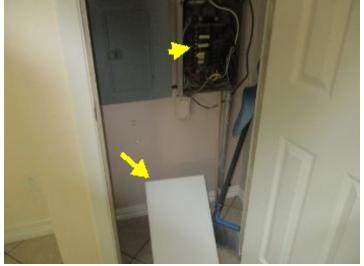
Incorrect cover plate used at right panel in addition closet. Original cover plate is removed and hinges are damaged.

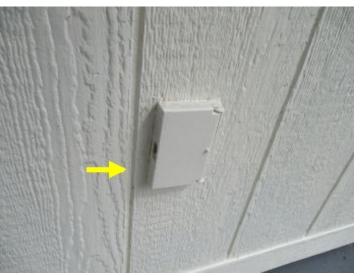
Rear porch receptacle cover is painted shut, unable to open.

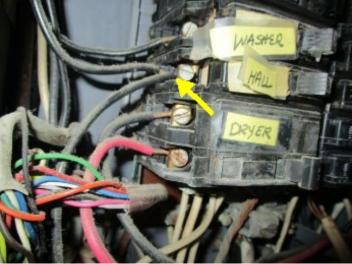
Double tapping (more than one wire pre breaker) observed at left side breaker in right interior closet panel.

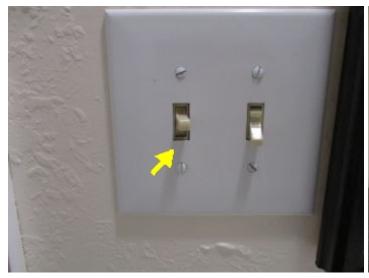
Worn and loose wall switch in rear addition bathroom.

- worn insulation on romex to receptacle in cabinet above microwave.
- Recommend further evaluation by a qualified electrician.

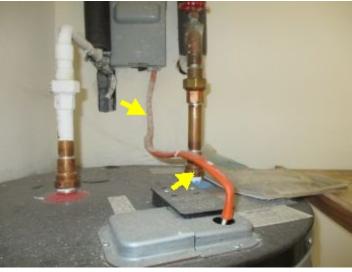
The exposed romex (electrical wire) atop water heater is required to be in protective conduit for safety reasons.

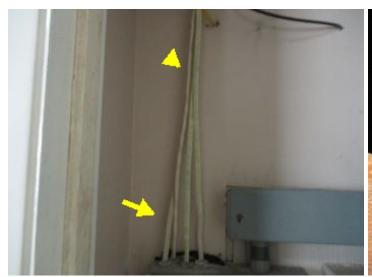
of rear addition above panel is required to be in protective conduit for safety reasons.

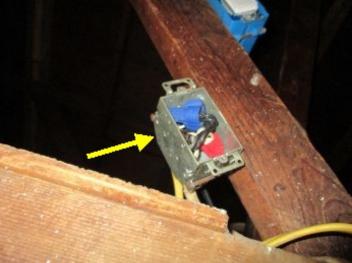
The exposed romex (electrical wire) in the closet Replace missing cover plates at receptacles and or junction boxes.

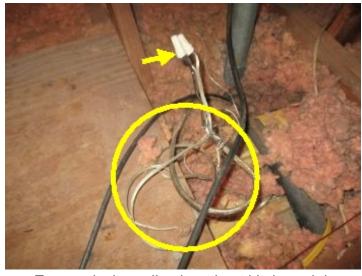
Exposed wire splice in attic at kitchen sink pendant light is required be in protected junction box for safety reasons. Note us e of extension cord for permenanat wiring to this light.

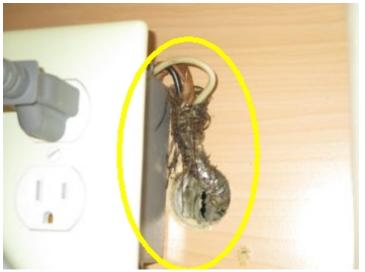
worn insulation on romex to receptacle in cabinet above microwave.

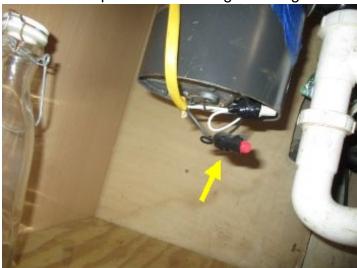
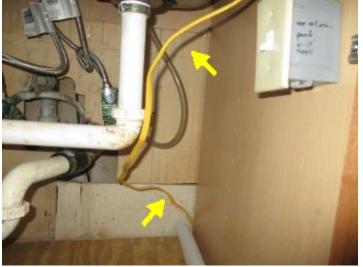
Exposed wire splice at disposal is required be in protected junction box for safety reasons. The exposed romex (electrical wire) under kitchen sink is required to be in protective conduit for safety reasons.

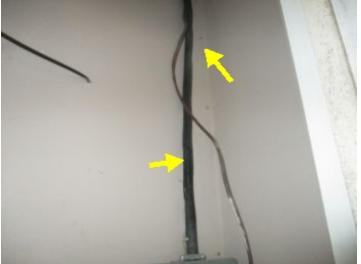
The exposed romex (electrical wire) in the closet of rear addition above panel is required to be in protective conduit for safety reasons.

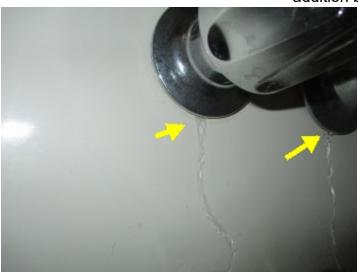
Leak at tub / shower fixtures in addition bathroom.

Recommend plumber to further evaluate.

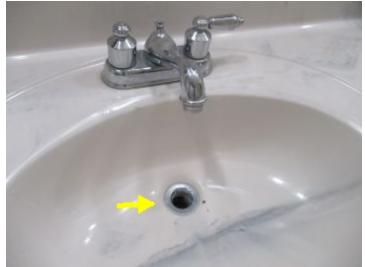
Missing drain stop at at left sink in addition bathroom.

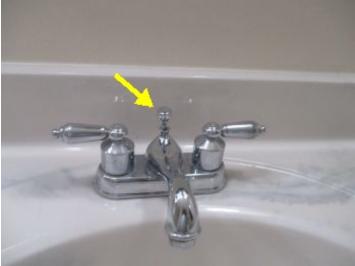
Non functioning drain stop pull lever at right sink in addition bathroom.

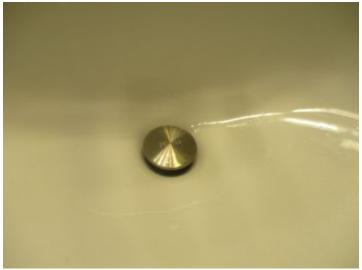
Non functioning drain stop at sink and tub in hallway bathroom.

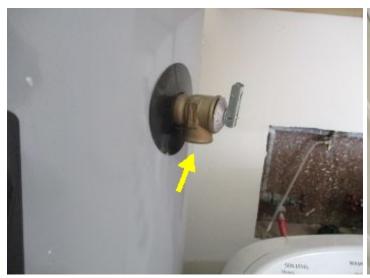
There is no drain line (drip line) at the Temperature and Pressure relief valve.

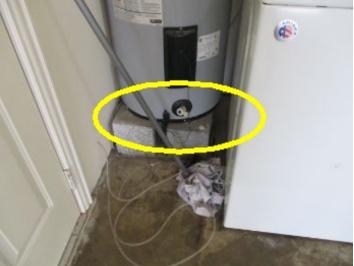
There is no drain pan under water heater, does not meet current industry standards.

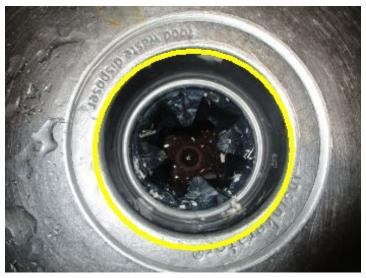
- Garbage disposal did not operate. Motor hums.Splash guard is worn

Splash guard is worn

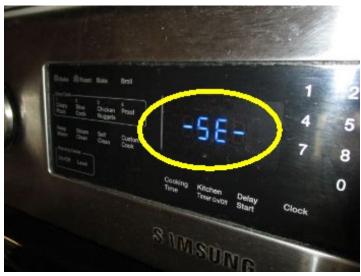
Did not function, display error "-SE-" is flashing, unable to reset.
