Residence is a two-story wood frame structure.
For the purpose of this report, residence faces north.
Residence was occupied at the time of the inspection.

PROPERTY INSPECTION REPORT

Concerning: 22615 Arbor Stream Dr, Katy, TX 77450
(Address or Other Identification of Inspected Property)

By: David Terry, Lic #10562 05/14/2018
(Name and License Number of Inspector) (Date)

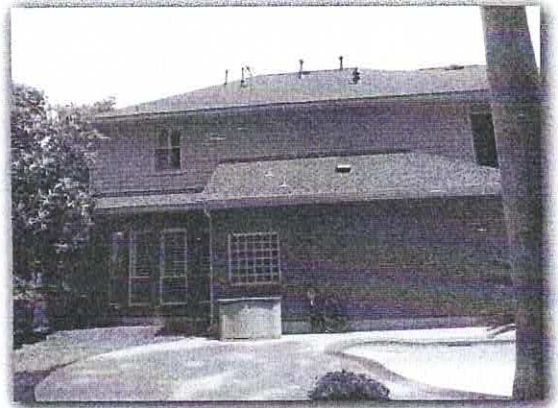
The residence was observed as having a concrete post-tension slab on grade foundation. The foundation appears to be functioning as designed and intended at this time. The structure did not exhibit visible indications of excessive shifting or settlement damage typically associated with foundation problems. No structural shifting cracks on interior or exterior walls were observed or visible at the time of the inspection. The structural members and load bearing walls appeared unremarkable at this time. The foundation appears to be reasonably level.

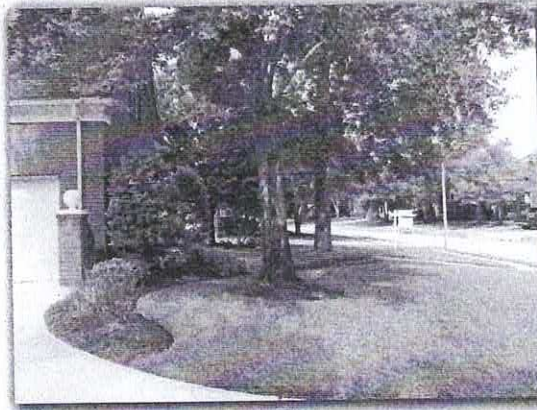
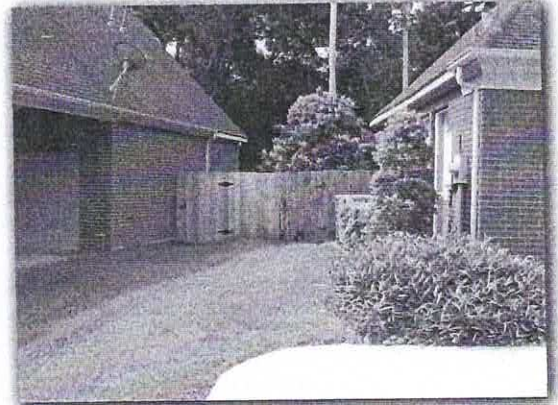
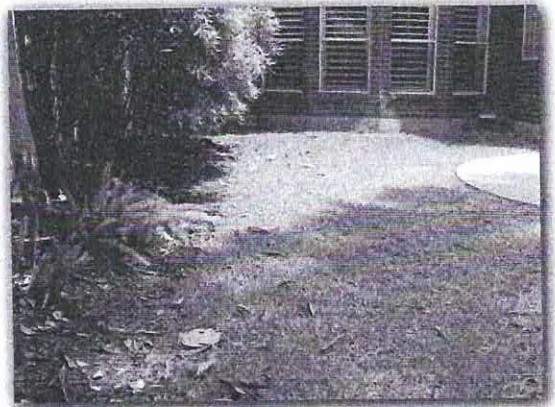
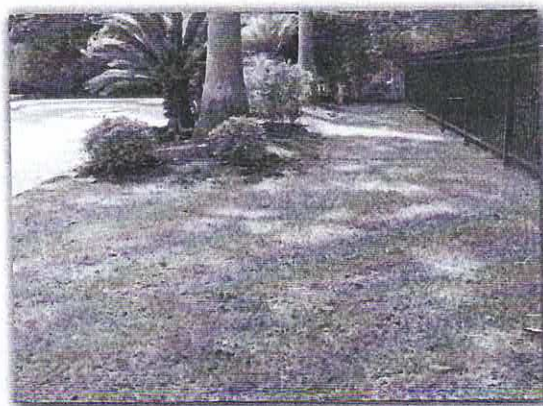
The grading on the property appears satisfactory at this time. The slope and drainage was considered typical and normal. It is recommended that 3-5" of foundation exposure be kept around the perimeter of the foundation and that a consistent moisture content be maintained. Improper grading and moisture control can lead to possible foundation problems.

It is recommended to lower the soil level of the flower beds along the perimeter of the foundation, as needed, to expose 3-5" of the foundation wall and provide proper drainage away from the foundation.

Recommend installing splash blocks or other means of erosion control at gutter downspouts as needed.

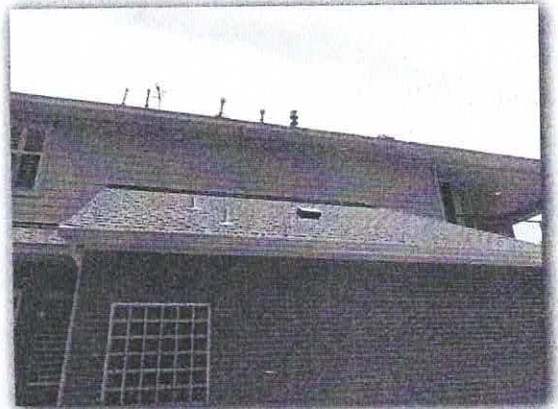
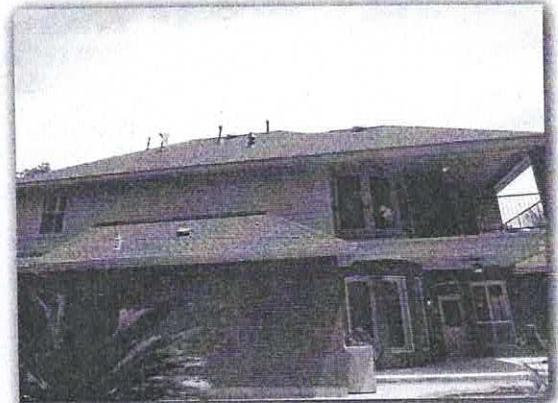
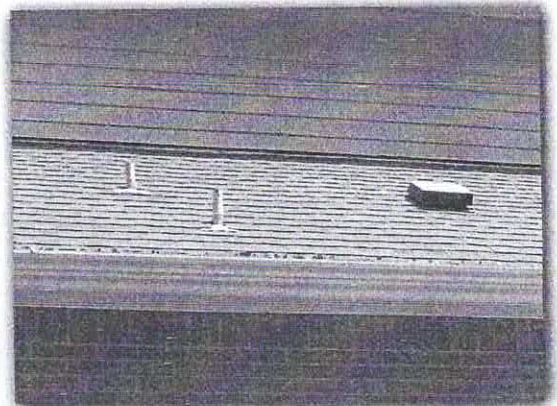
The residence was observed as having a hip and gable framed roof with a composition shingle cover. The roof was observed and inspected from ground level using visual aids. The overall visible shingle cover, associated flashing, and roof venting jacks appeared in satisfactory condition at this time with no physical damage noted. No water penetration was observed from the visible areas of the interior roof or interior ceilings. The typical life expectancy for a similar shingle roof system is approximately 15-20 years.

Recommend necessary repairs be made to secure and seal the base flashing above the lower roof on the northeast and southeast areas of the residence.

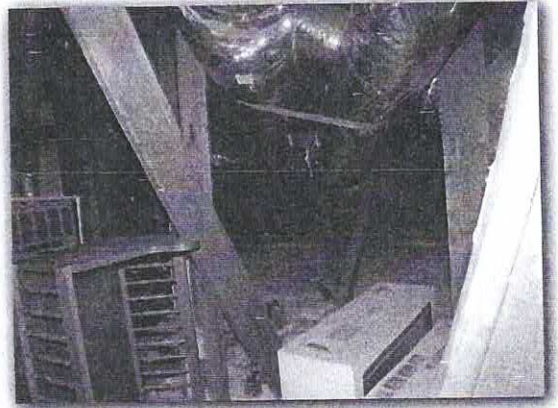
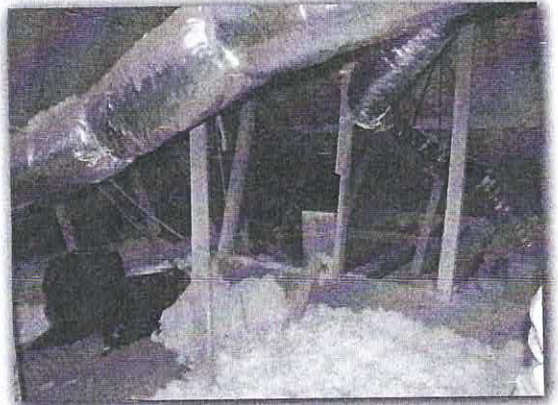
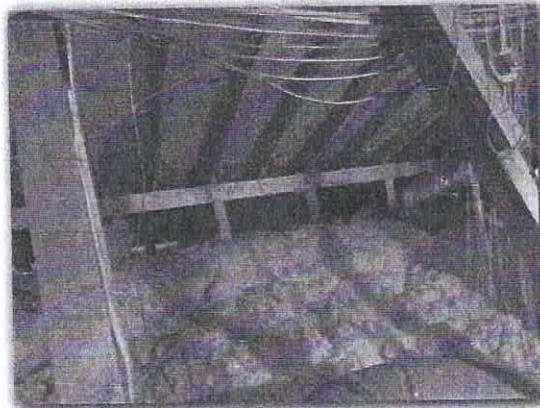
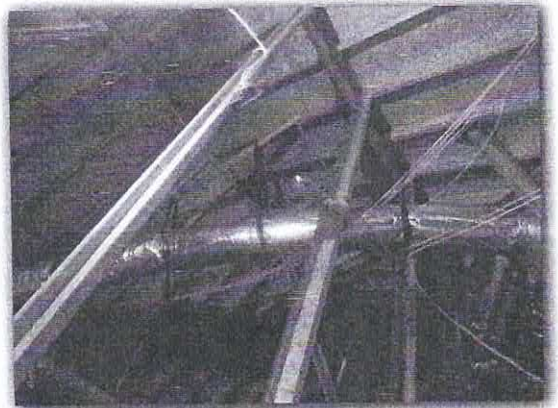
The accessible portions of the attic area of the residence was visually inspected. The overall condition of the visible interior rafters, framing, supports and radiant barrier painted decking appear sound at this time. Insulation in the attic area was observed at a depth of approx. 10-12". Attic ventilation was observed to be soffit vents at the roof edge with power and ridge vents at the ridge. Attic ventilation appears to be adequate at this time.

The power vents were not in operation at the time of the inspection. Recommend further investigation and any necessary repairs be performed by a licensed HVAC contractor.

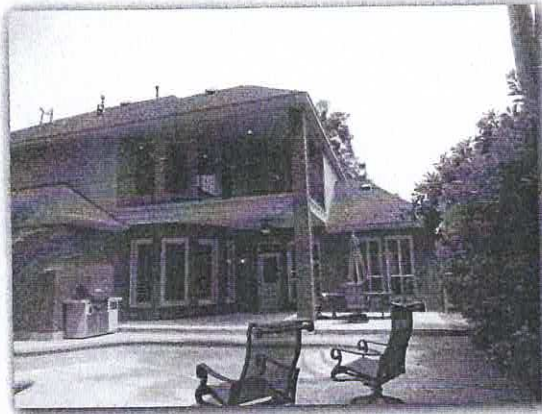
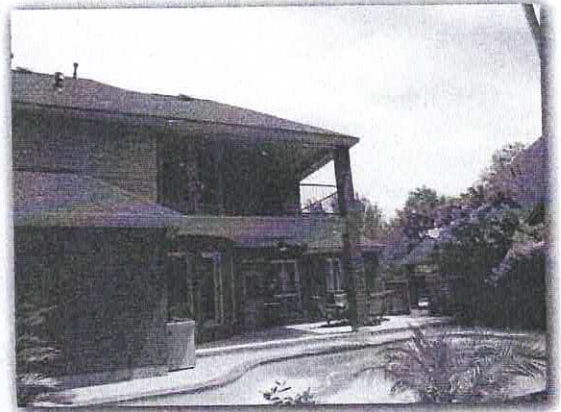
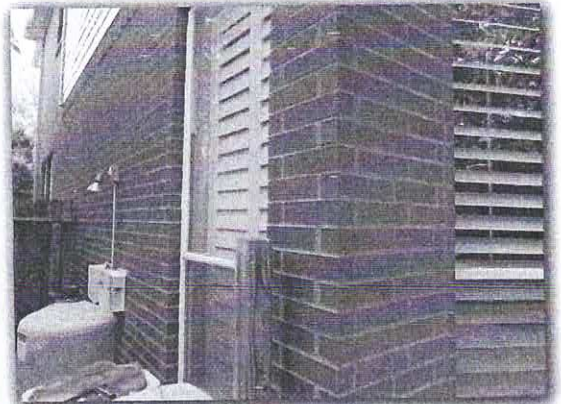
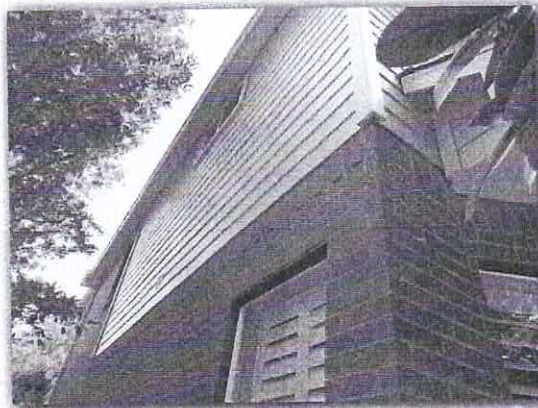
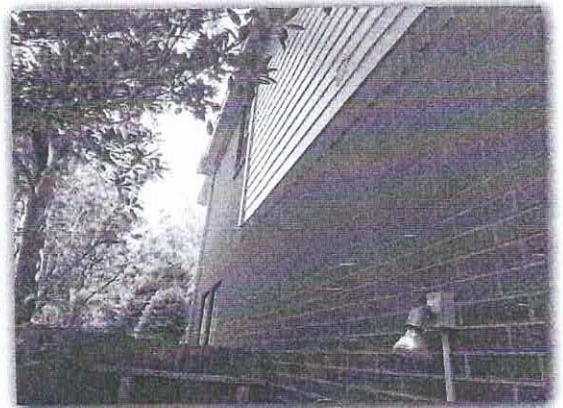
The masonry wall areas with stucco, composition wood and fiber cement sided walls on frame construction were observed to be in overall good condition at this time. Interior and exterior walls showed no indication of shifting and no settlement cracks to wall areas were observed at this time.

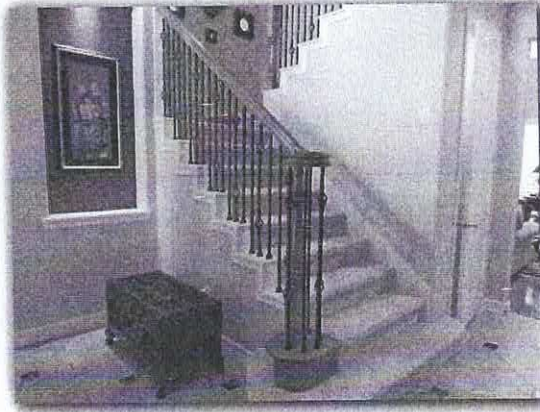
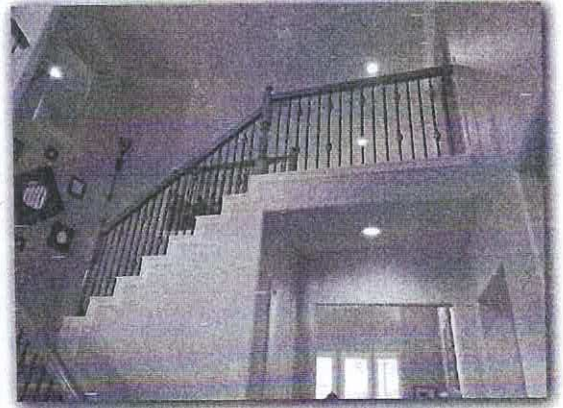
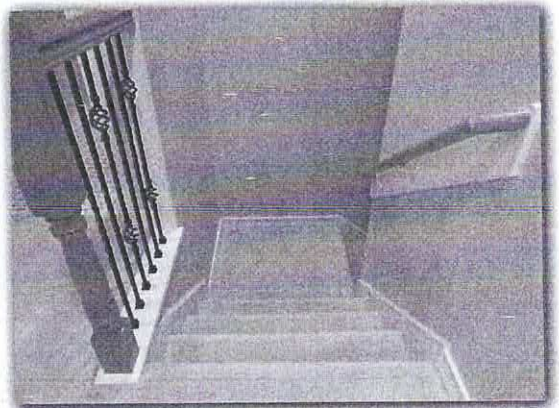
The carpeted stairways and handrails were observed to be in good condition and compliant with stair construction regulations.

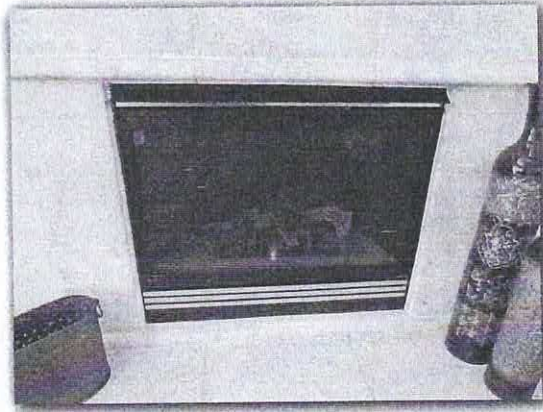
The gas assisted sealed fireplace failed to ignite using manual controls. Recommend necessary repairs be performed by a qualified contractor to restore normal operations.

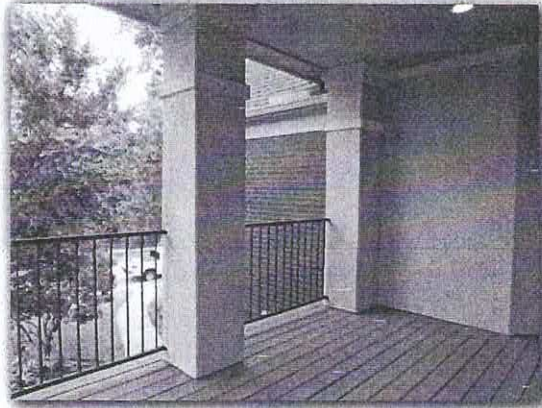
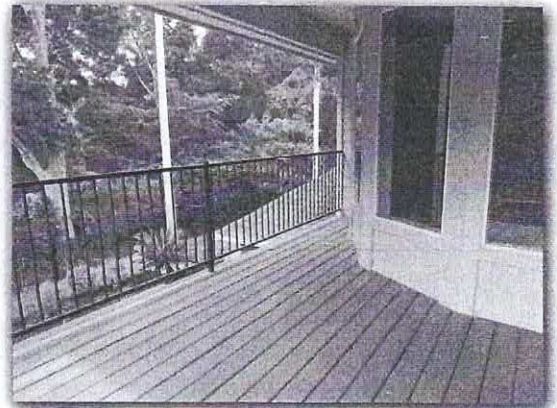
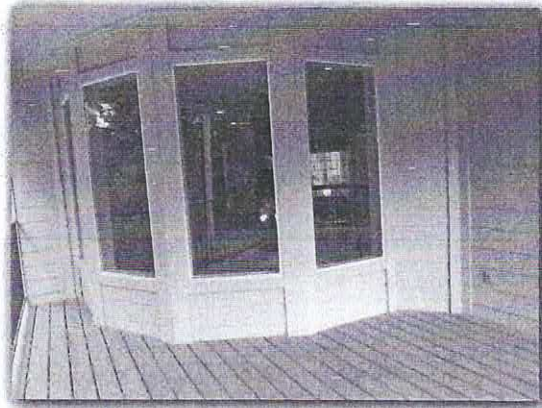
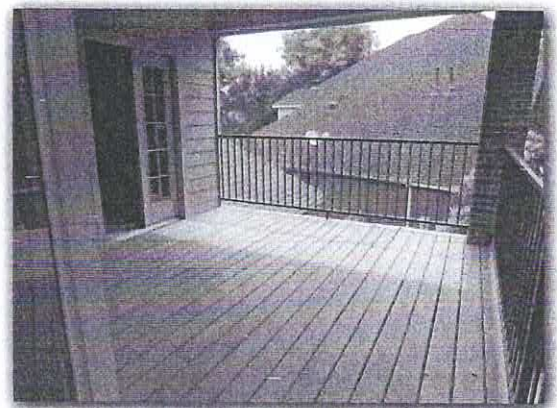
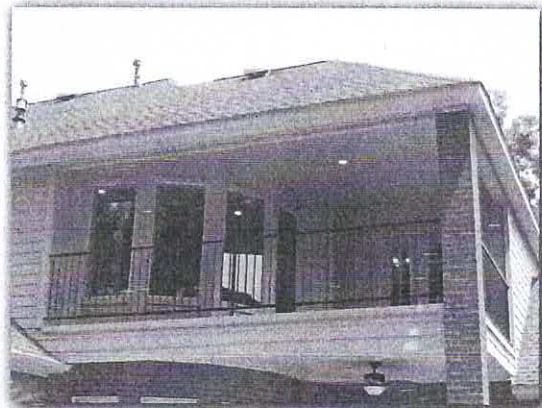
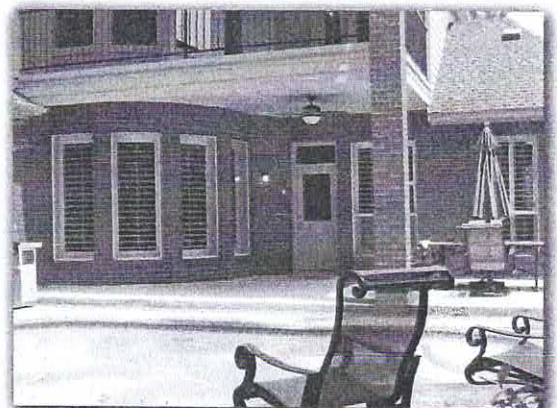
The front porch, patio and balcony areas looked unremarkable at this time.

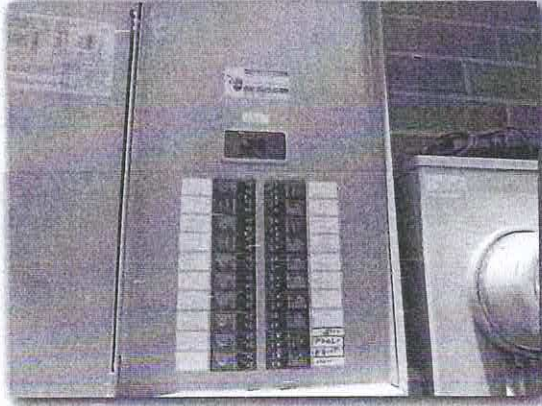
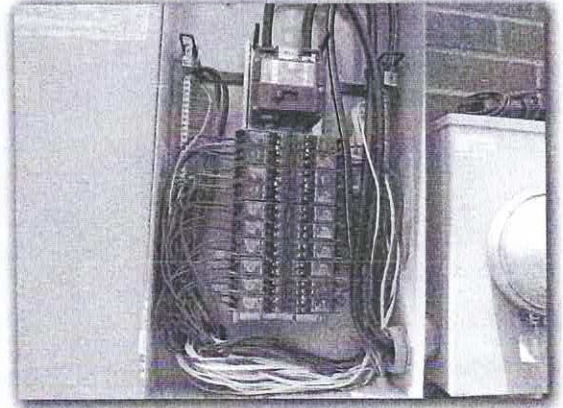
200amp service panel-150amp main- 120/240v copper wired breaker service. Breaker wiring, buss bar shields and breakers showed no indications of over heating or arcing and were observed to be in good condition at this time.

Voltage readings of 120+v were measured on all breaker lugs at the service panel and were considered normal.

The aluminum main leads and ground wire in the service panel are required to be protected with an anti-oxidant inhibitor per the electrical code. The electrical grease is not present and should be installed on the leads connected to the main breaker and buss bar.

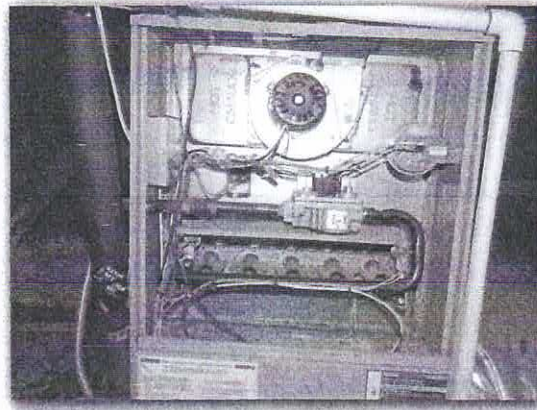
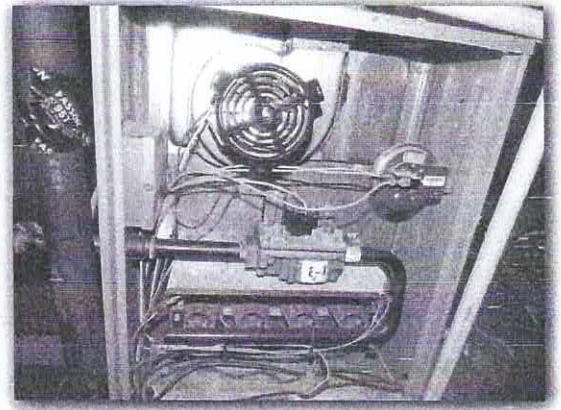
Dual 2014 model TRANE gas fired forced air furnaces with electric ignition. The lower zone is controlled by a 100,000 BTU furnace MOD.# TUE100A960K2, the upper zone is controlled by a 80,000 BTU furnace MOD.# TUE080A948K2. Both of the furnace systems were operated using the standard manual controls, the furnace operations were deemed satisfactory. Burner compartments were relatively free of rust or scale deposits and the flame color was consistent, furnace installation was also considered satisfactory at this time.

The mechanical gas piping code (2608.2.2) requires a sediment trap (drip leg) be incorporated into the gas line downstream of the gas valve. The sediment trap shall be either a tee fitting with a capped nipple in the bottom outlet or other device recognized as an effective sediment trap. The trap or drip leg is not present on the gas piping at this time and is recommended to be installed.

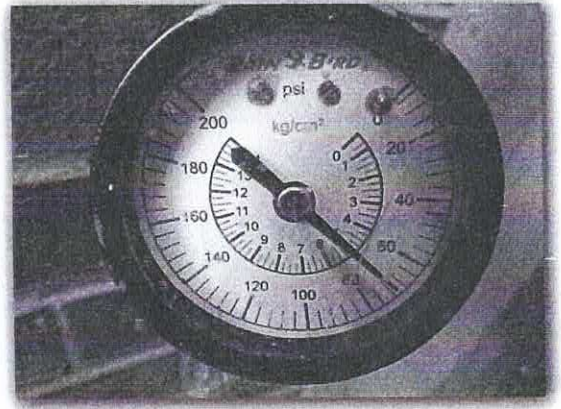
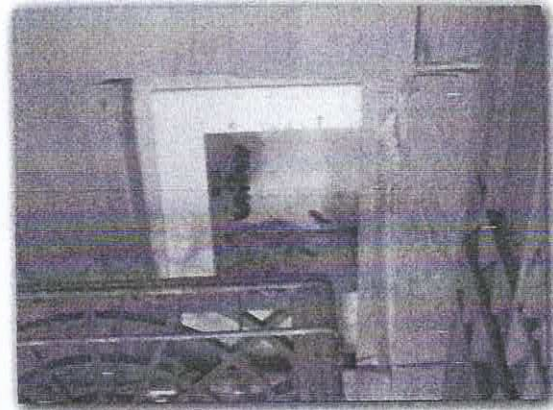
The plumbing in the residence appears to be constructed of COPPER piping. No plumbing leakage from the visible or accessible piping was observed at this time. While no piping leakage was observed, it should be noted that the majority of the piping is concealed by interior walls and insulation in the attic and is not visible.

Recommend installing backflow prevention on the exterior hose bibbs as needed.

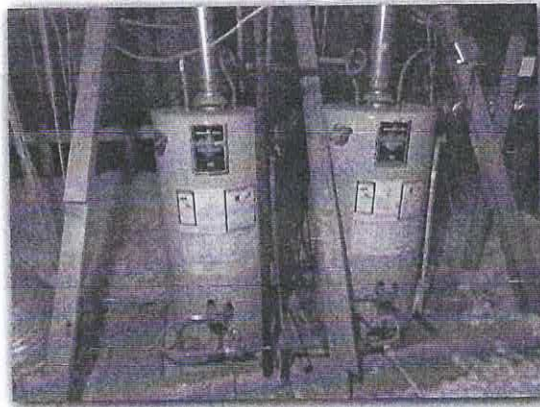
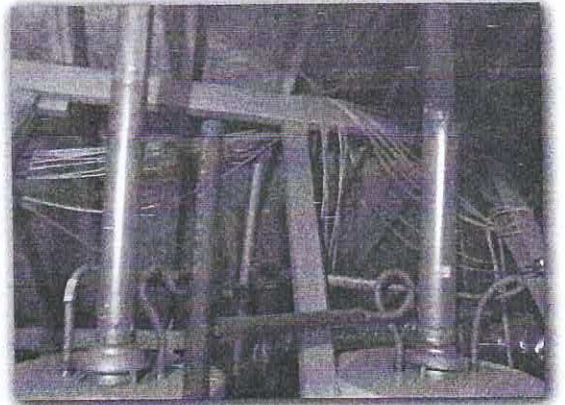
Dual BRADFORD-WHITE 40 gallon gas fired water heaters MOD. #M4403S6FBN, both units were observed to be functional and properly installed at this time. Water temperature was measured at 122 degrees, temperature controls on the water heaters can be adjusted for comfort levels.

The mechanical gas piping code (2608.2.2) requires a sediment trap (drip leg) be incorporated into the gas line downstream of the gas valve. The sediment trap shall be either a tee fitting with a capped nipple in the bottom outlet or other device recognized as an effective sediment trap. The trap or drip leg is not present on the gas piping at this time and is recommended to be installed.

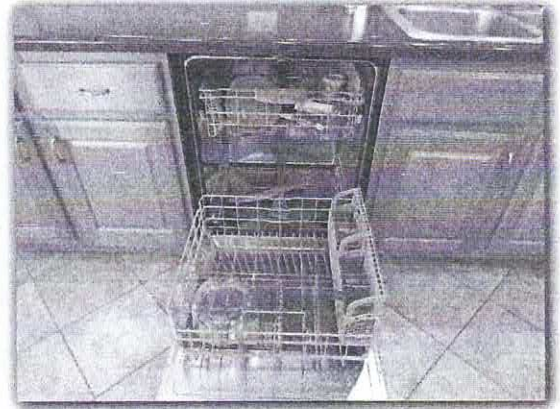
The BOSCH dishwashing unit was found to be operational, no leakage or cycling problems were observed at this time.

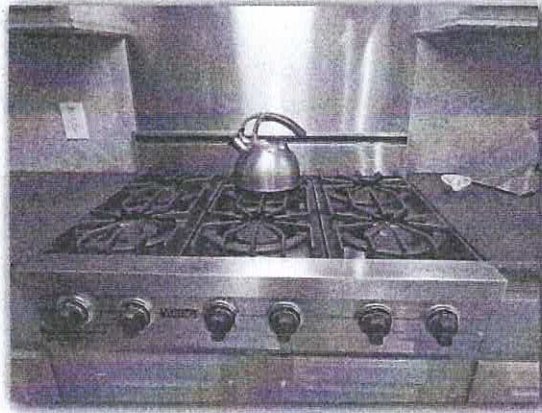
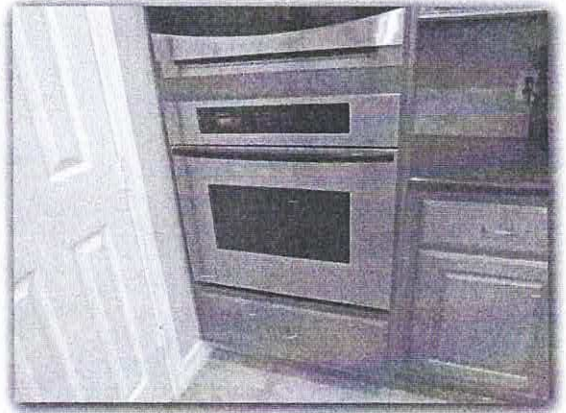
The VIKING gas cooktop was observed to be operational. The THERMADOR electric oven was also observed to be operational. Oven temperature was consistent with oven settings.

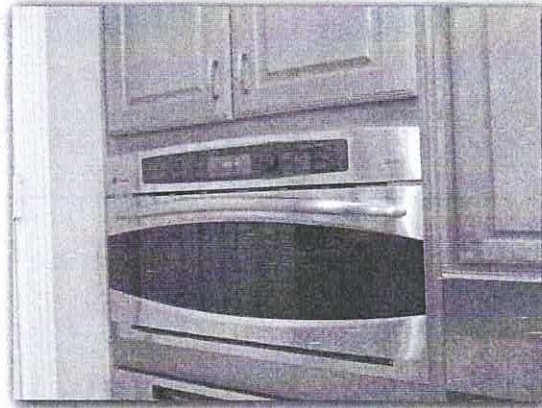
The GE microwave oven was observed to be operating properly. No microwave leakage was detected at the time of the inspection.

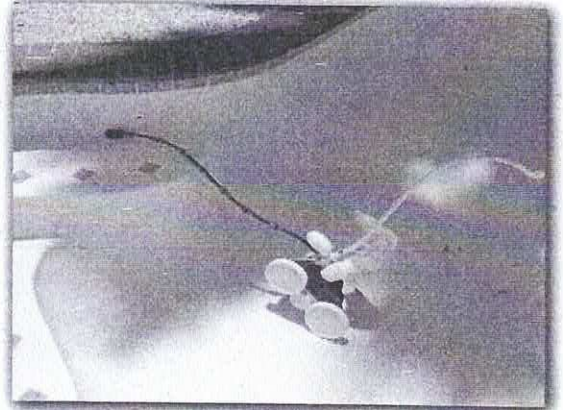
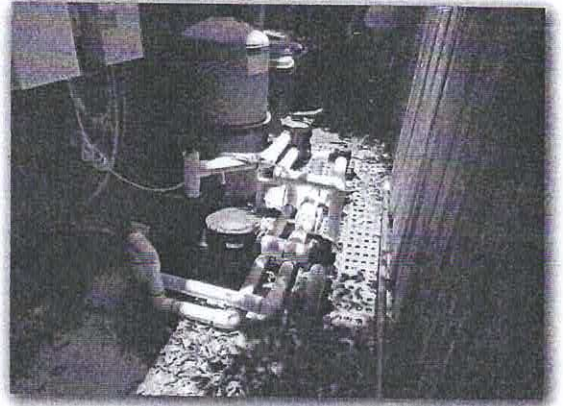
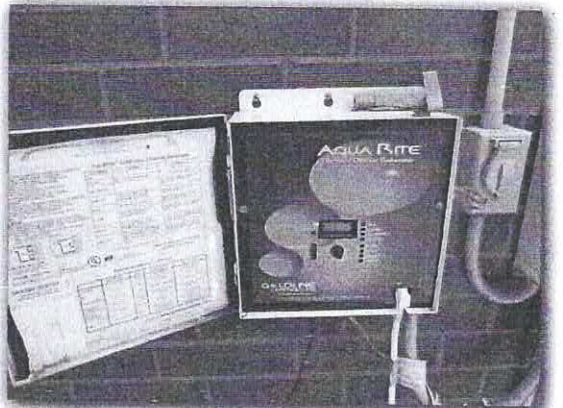
In-ground gunite constructed pool was observed to be structurally sound, no visible cracks in the surfacing or tiling was present at this time. The pool equipment was operated using the timer controller at the equipment area.

The 2HP main pump appeared to be seized and inoperable at the time of the inspection. Repairs are called for to replace the pump.
