RESIDENTIAL INSPECTION REPORT

2 Regency Point
Conroe TX 77356

Ben Morris & Margaret Morris
JUNE 3, 2021

PROPERTY INSPECTION REPORT

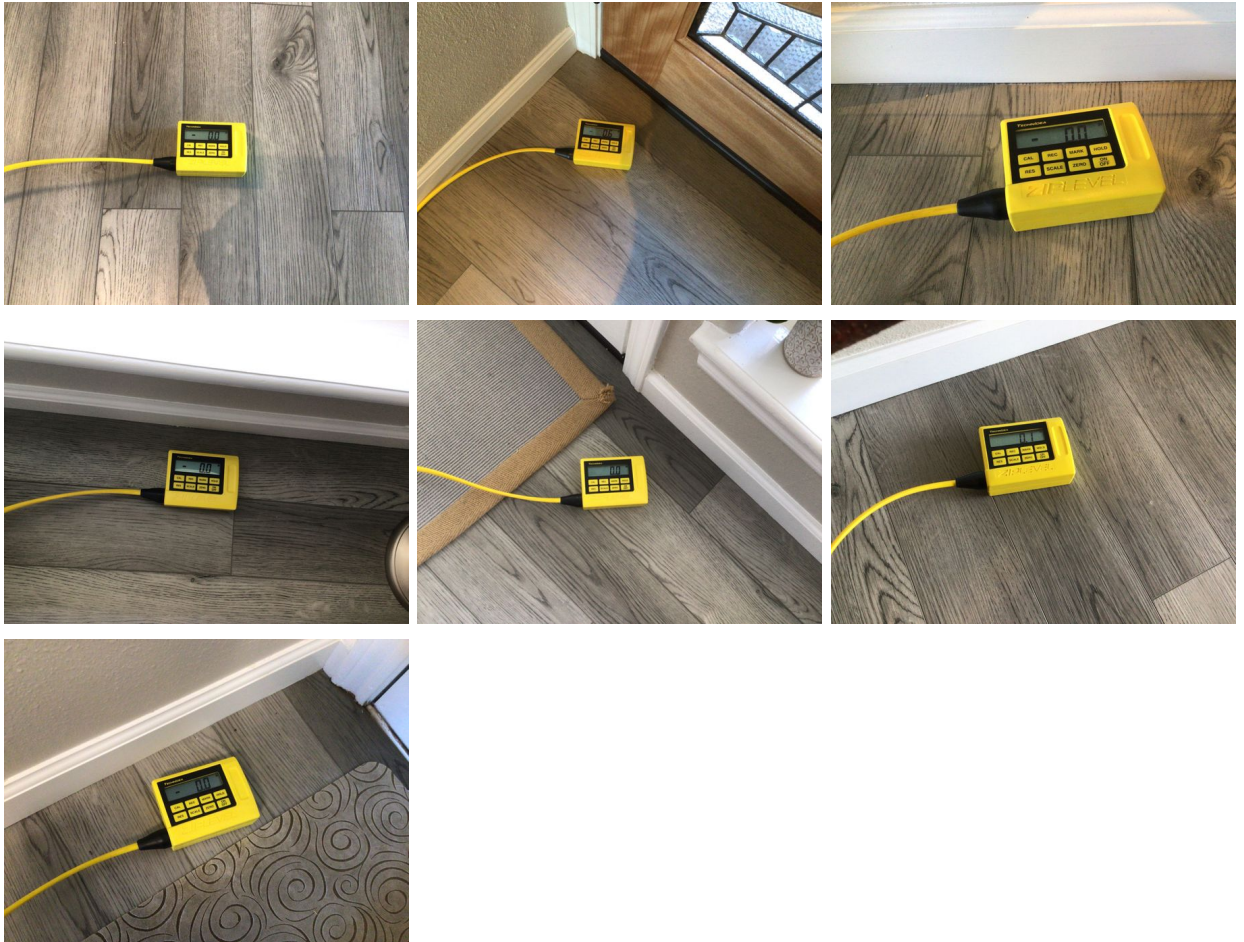
No deficiencies were noted at the time of inspection. The foundation appeared to be functioning as intended.

This foundation was measured with the use of an electronic digital measurement tool. Multiple elevation points were registered on the foundation throughout the property to determine if there were elevation variations that indicated excessive movement of the foundation. At the time of this inspection the measured areas did not indicate any variations that, in this inspector's OPINION, indicated any need for invasive repairs to the foundation.

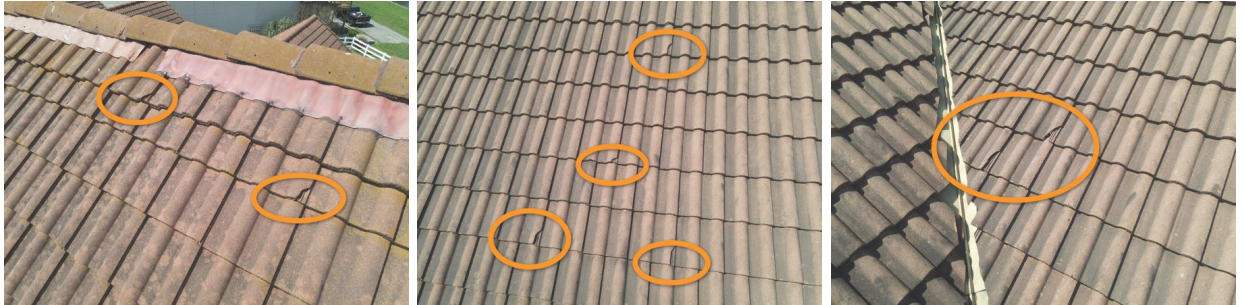
1: Tiles Cracked/Broken

Multiple Locations

Roof had cracked/broken tiles. Evaluation and/or repair by a qualified roofing professional is recommended.

Recommendation: Contact a qualified roofing professional.

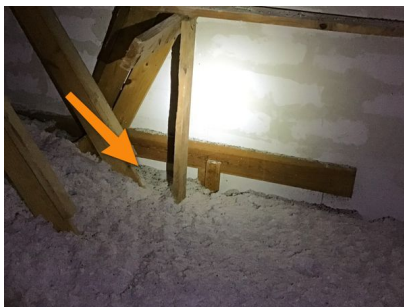
1: Note: Rodent activity

There was evidence of prior and/or current rodent activity in one or more areas of the home. Pest control services are available through our sister company, Green Team Pest, and can be scheduled through our office. If you have any concerns regarding rodent infestation we strongly recommend you schedule this service.

Recommendation: Contact a qualified pest control specialist.

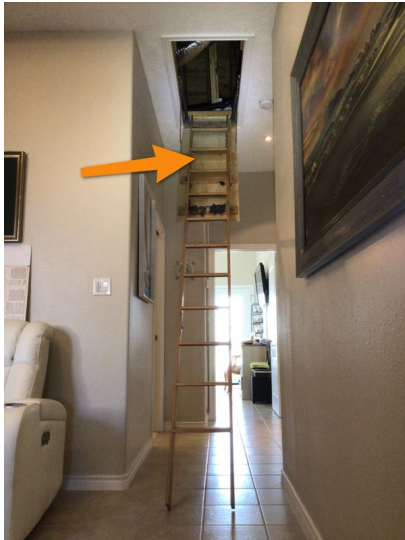
2: Pulldown stairs/ladder: Not insulated or weatherstripped

The ladder door was not insulated or weatherstripped. This can lead to increased energy loss. Remedy as needed.

Recommendation: Contact a qualified professional.

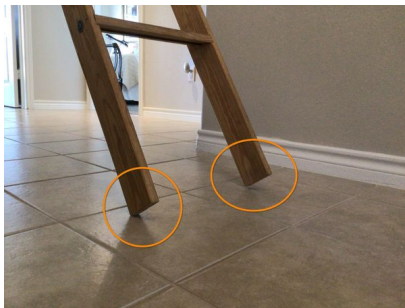
3: Pulldown stairs/ladder: Improper slope

Attic stairs were not properly cut at bottom giving improper slope. This puts improper stress on the side rails and hinges. Remedy as needed.

Recommendation: Contact a qualified professional.

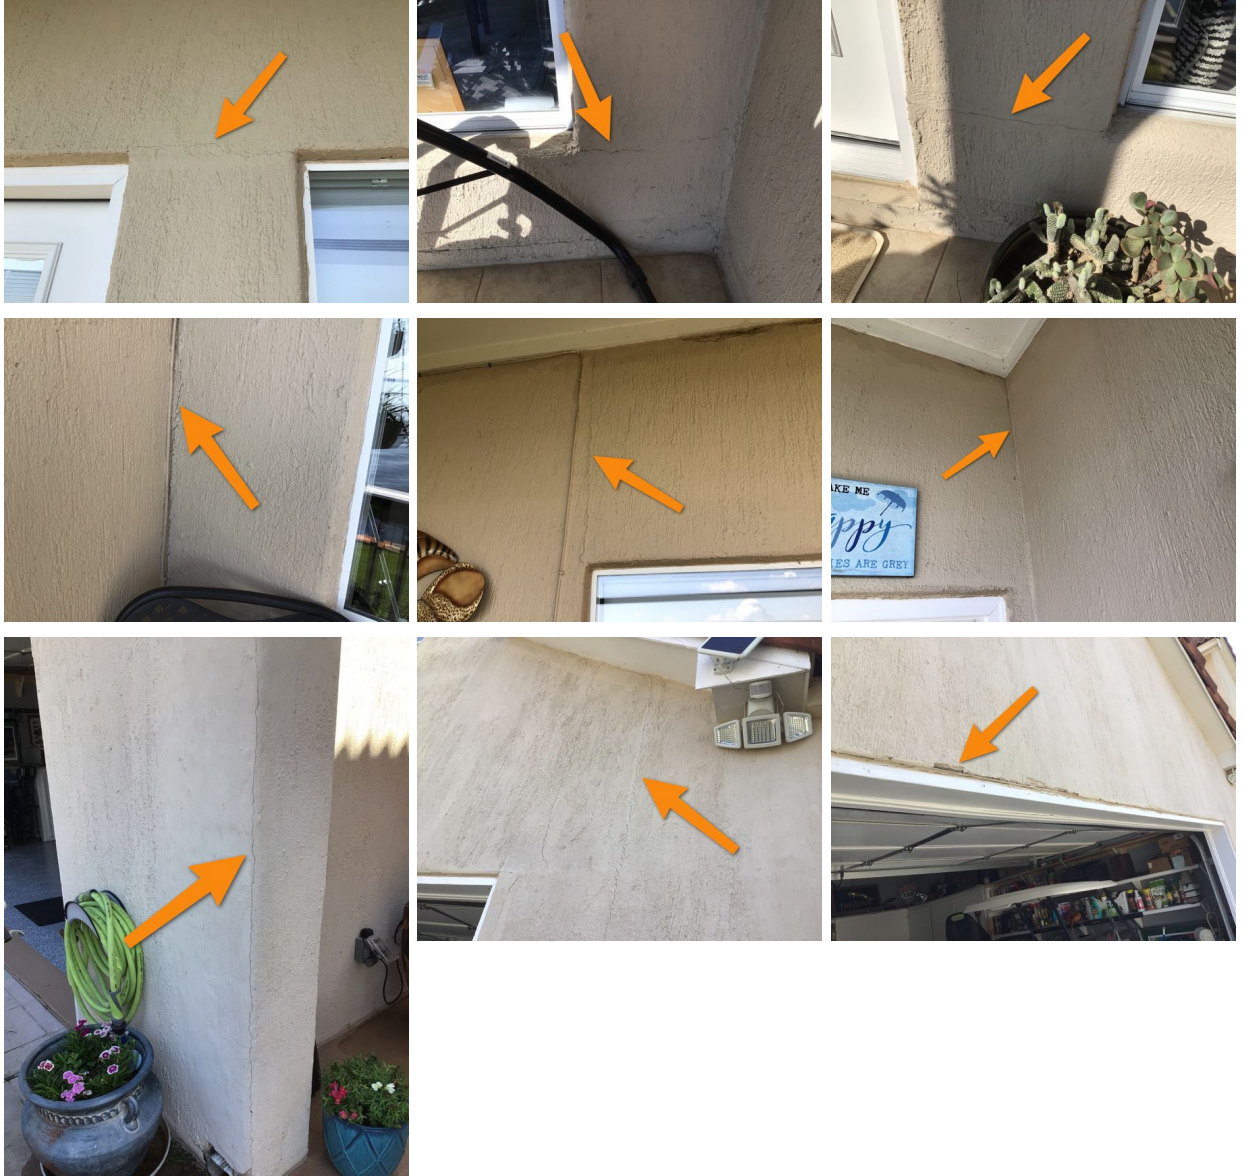
1: Stucco: Cracked or Damaged Surface

Multiple Locations

Cracked or damaged Stucco/EIFS was observed. Evaluation by a qualified contractor is recommended to determine the best method of remedy.

Recommendation: Contact a stucco repair contractor

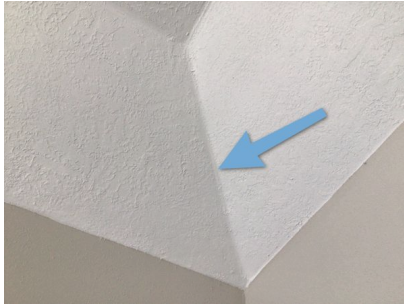
1: Ceiling: Texture Cracks

Texture cracks were observed in ceiling joints and appear cosmetic in nature. These are not typically caused by structural defects.

Recommendation: Contact a handyman or DIY project

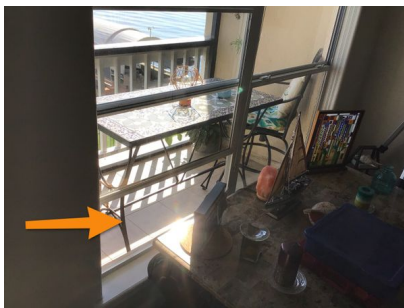
1: Missing/Damaged Screen(s)

One or more windows are missing a screen or had a damaged screen. Replacement of screens is recommended.

Recommendation: Contact a qualified window repair/installation contractor.

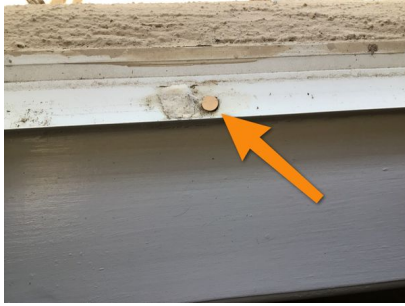
2: Drill holes in frames

The majority of the homes windows have drill holes in the frame for installation of the security system window contacts. Written confirmation from the builder or the window manufacturer stating that these drill holes will not affect the warranty is recommended.

Recommendation: Contact your builder.

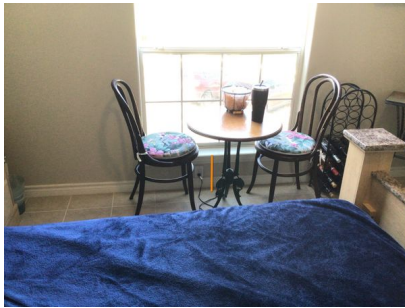
3: Sill Height: Too Low

Current building standards require any window with an exterior sill height of 72 inches or more to have a minimum interior sill height of 24 inches.

Recommendation: Contact a qualified professional.

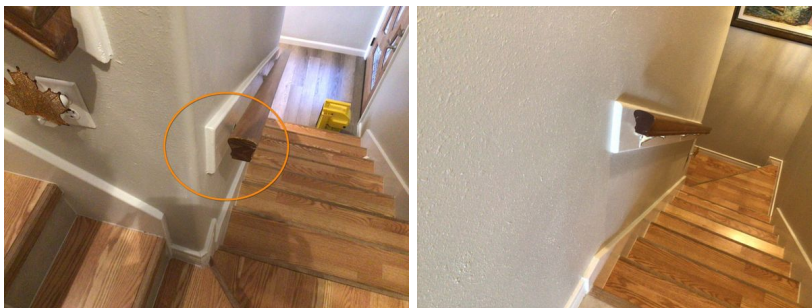
1: Handrails/Guardrails: Doesn't turn into wall

Stairway handrail does not turn in towards the wall at the upper end

Note: This is a safety measure to prevent an individual's clothing from getting caught on the open end of the handrail

Recommendation: Contact a qualified professional.

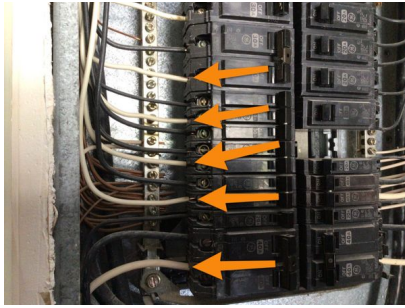
1: White Wires Not Marked

White wires connected to breakers are not marked with black or red electrical tape to indicate that they are "hot". Remedy as needed.

Recommendation: Contact a qualified electrical contractor.

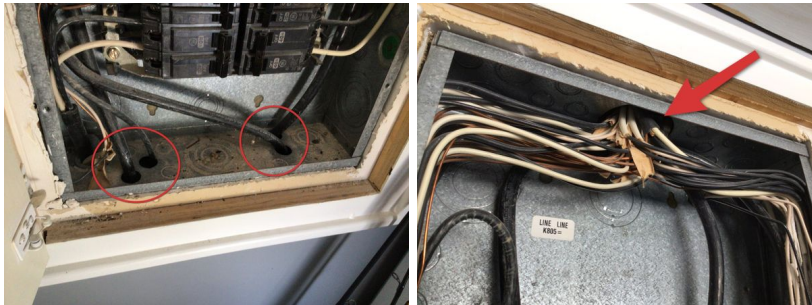
2: Missing Wire Bushing

▲ Safety Hazard

There was no bushing around wires that pass through the panel into the wall to protect them from abrasion. Evaluation and/or remediation by a licensed electrician is recommended.

Recommendation: Contact a qualified electrical contractor.

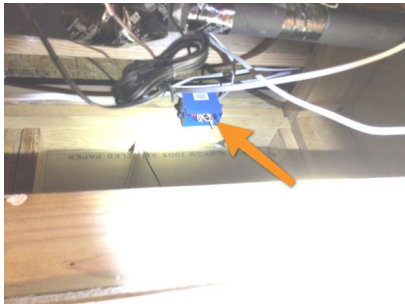
1: Wiring: Open Junction Box

HVAC Cabinet

An open junction box was present. Remedy as needed.

Recommendation: Recommended DIY Project

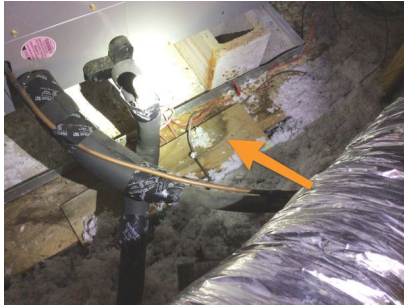
1: Condensate System: Discoloration Under or Around HVAC Equipment

Discoloration under or around HVAC equipment indicates prior moisture contact. Cause was not determined.

Recommendation: Contact a qualified HVAC professional.

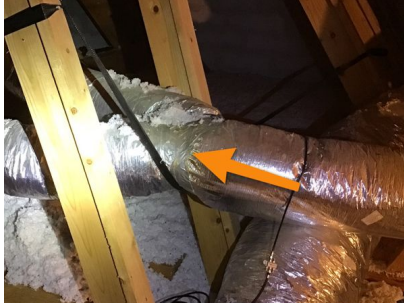
2: Ducts: Duct Tape Used (improper)

Duct tape had been used on sections of ducting. Despite the name, duct tape is not an approved material for HVAC ducts. Remedy as needed.

Recommendation: Contact a qualified professional.

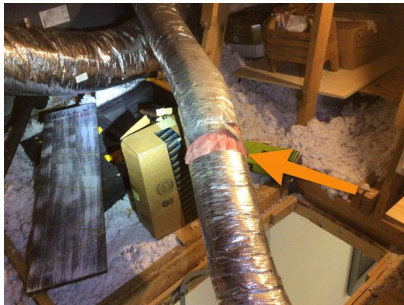
3: Ducts: Damaged

The air supply duct was damaged. Evaluation and remediation by a licensed HVAC contractor is recommended.

Recommendation: Contact a qualified HVAC professional.

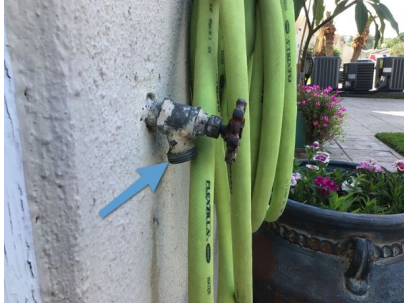
1: Hose bibb (outdoor faucet): Backflow Prevention Missing

A hose bibb was missing a backflow preventer. These devices are inexpensive and easily installed, and help to prevent contamination of potable water. Remedy as needed.

Recommendation: Contact a handyman or DIY project

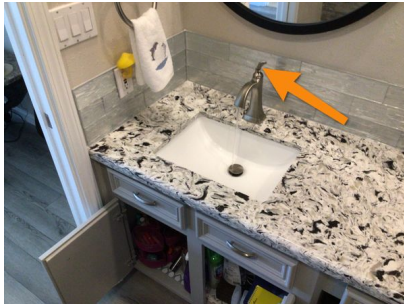
2: Fixtures: Hot and Cold Reversed

Primary Bathroom

Hot should always be on the left.

Recommendation: Contact a qualified professional.

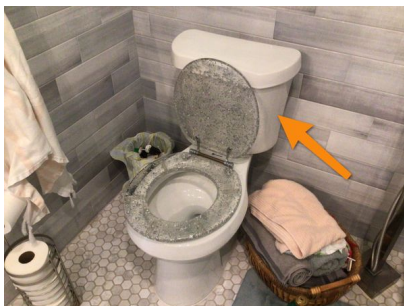
3: Toilet: Tank is loose

2nd Floor

The tank was loose. Remedy as needed.

Recommendation: Contact a qualified plumbing contractor.

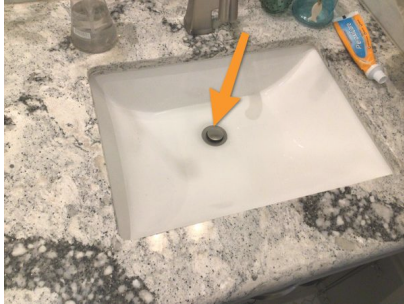
1: Drain piping: Slow Drains

2nd Floor

Poor/slow drainage was observed at time of inspection. Evaluation and/or remediation by a licensed plumber is recommended.

Recommendation: Contact a qualified plumbing contractor.

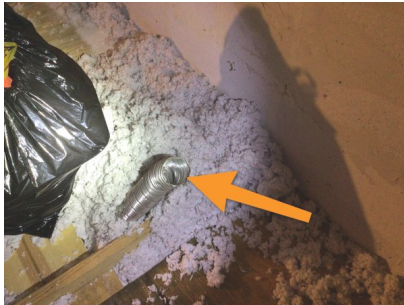
1: Vent Duct Terminates in the Attic

The exhaust fan discharges into the attic. Bathroom exhaust fans should terminate to the exterior of the structure. Remedy as needed.

Recommendation: Contact a qualified professional.
