7126 Kings Dr
Baytown, TX 77521

PROPERTY INSPECTION REPORT FORM

James Manuel <i>Name of Client</i>	04/05/2022 <i>Date of Inspection</i>
7126 Kings Dr, Baytown, TX 77521 <i>Address of Inspected Property</i>	
Arturo Marquez <i>Name of Inspector</i>	TREC 2685 <i>TREC License #</i>
 <i>Name of Sponsor (if applicable)</i>	 <i>TREC License #</i>

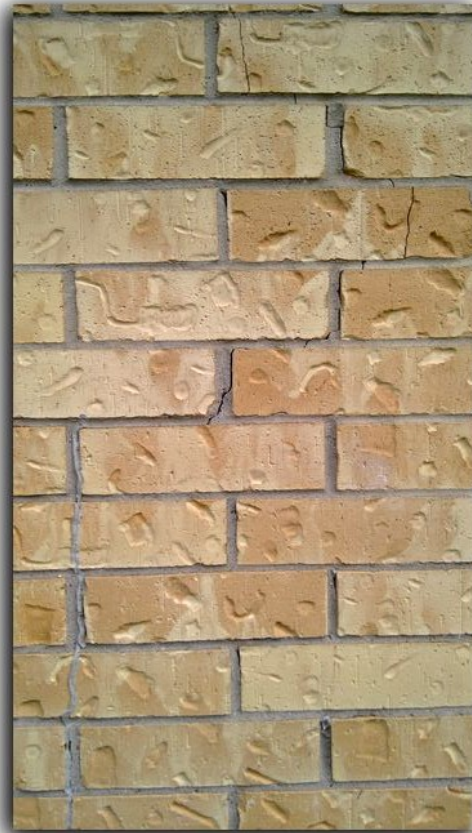
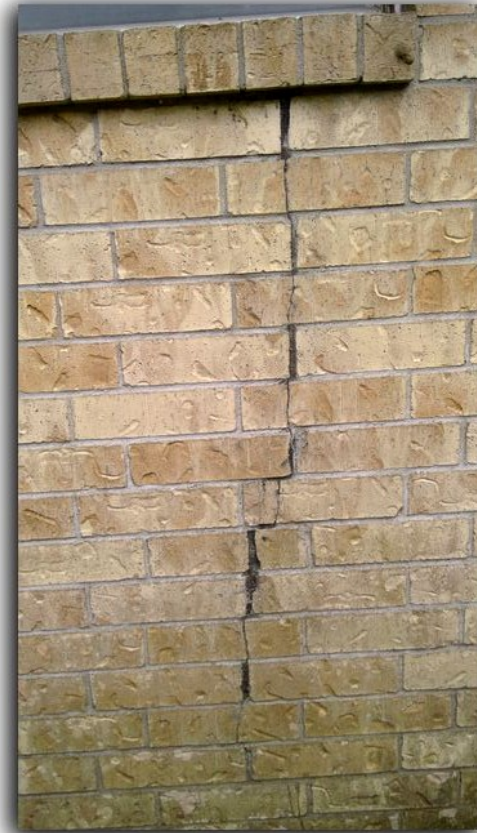
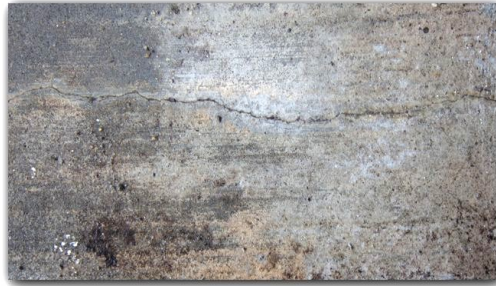
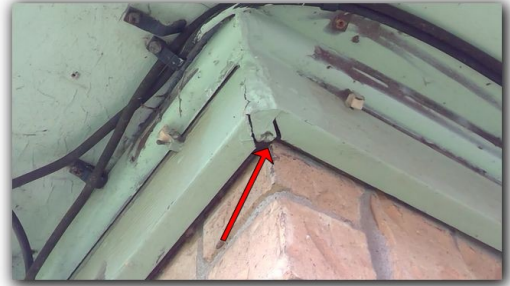
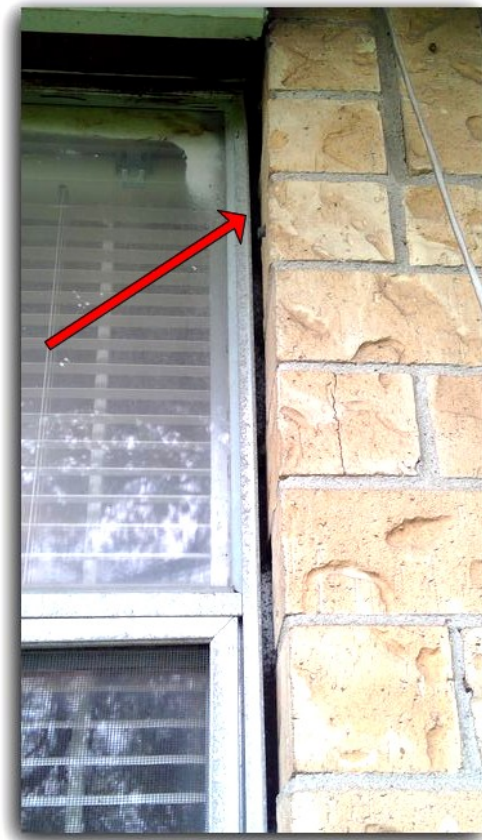
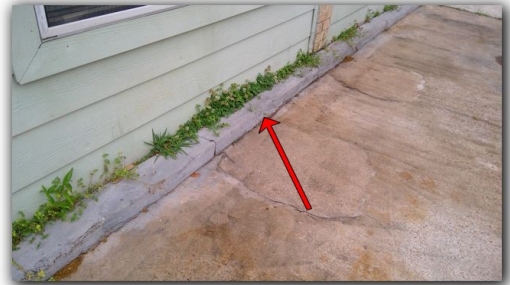
Comments: Cracks were observed on right, rear, and left brick veneers, and on front porch slab, [see sample pictures](#). The rear left corner brick Frieze board was observed pushed outwards, [see sample picture](#). Separation was observed Rear left window frame brick veneer junction , [see sample picture](#). Deflections were observed along the rear and left brick rows.

The concrete patches on flat work indicate previous foundation repairs may have already been performed on this home, [see sample picture](#). Need to contact homeowner regarding extent of any foundation repairs and warranty.

It is recommended that a monitoring and maintenance program be initiated in an effort to minimize possible future differential movement.

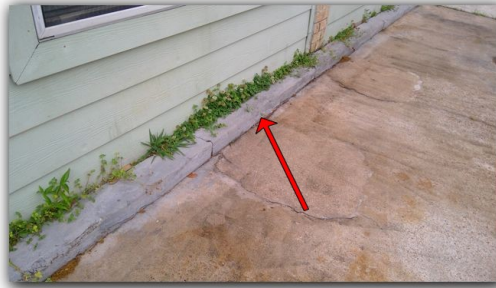
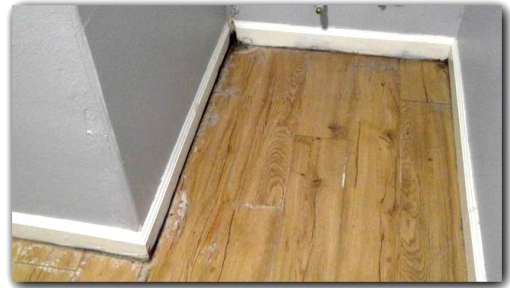
Comments: The concrete dams along the front and ride grade beams of the garage conversion indicate an attempt to prevent moisture intrusion, see sample picture. Evidence of potential moisture intrusion causing some stains and some damage were observed in the utility room, see sample picture.

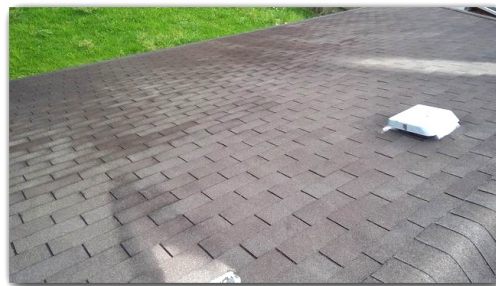
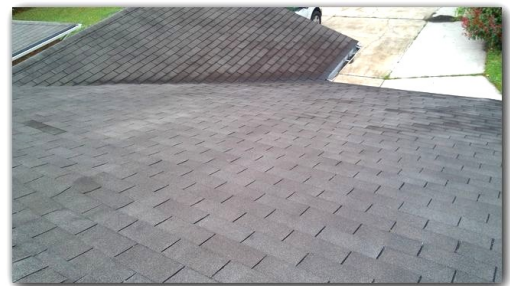
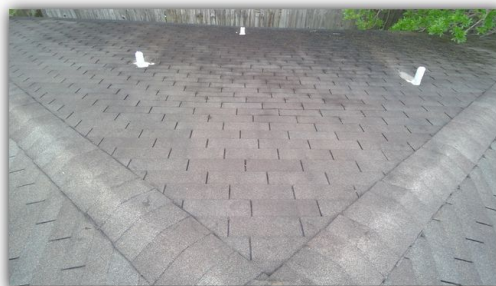
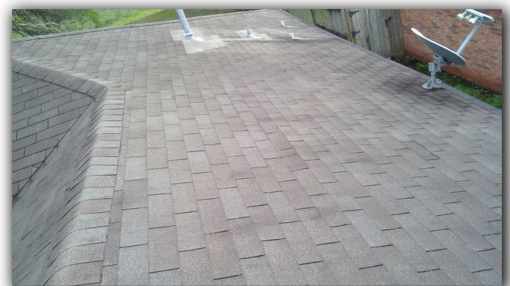
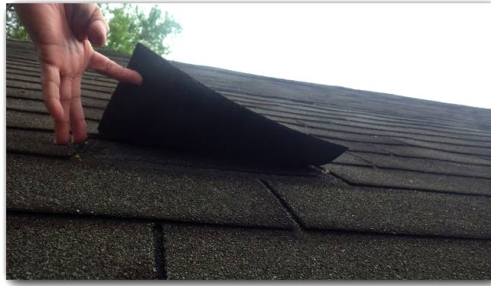
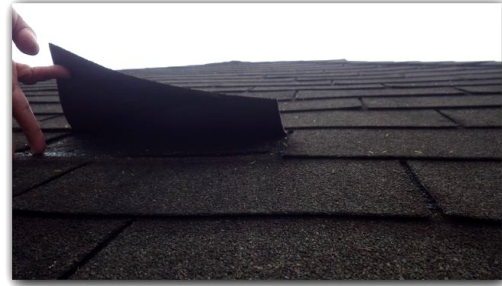
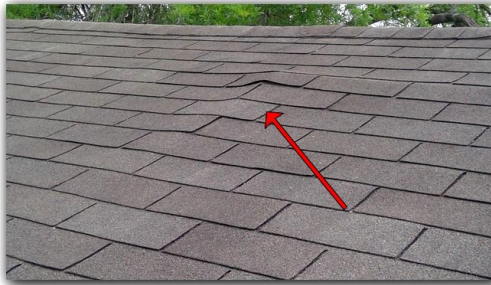
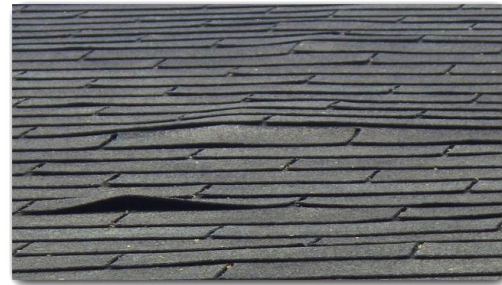
Comments: The overall condition of this roof covering was observed currently functional, see sample pictures.

However, numerous inadequately adhered and easily lifted tab ends, and several uplifted tab ends were observed, see sample pictures.

It is this inspector's opinion this roof covering to be in its last quarter of expected useful lifespan.

Need to contact a qualified roofer for further evaluation regarding any necessary corrections.

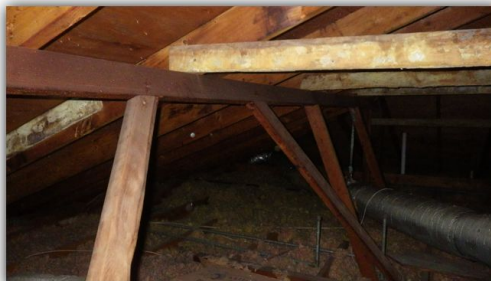
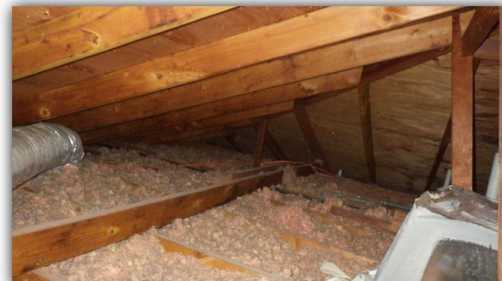
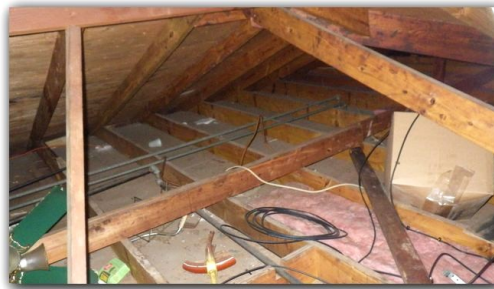
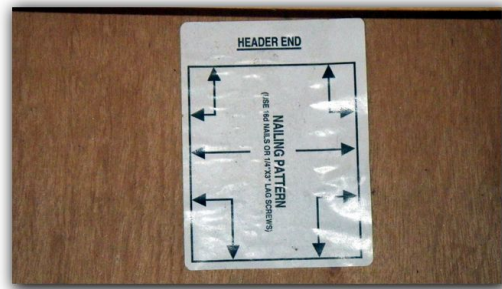
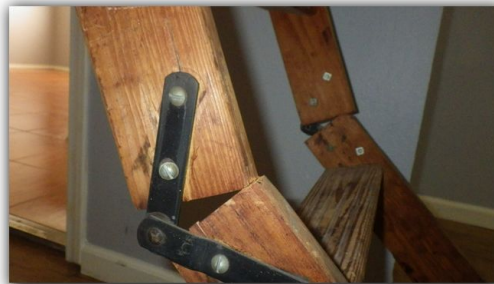
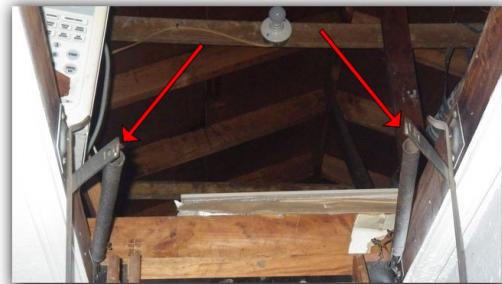
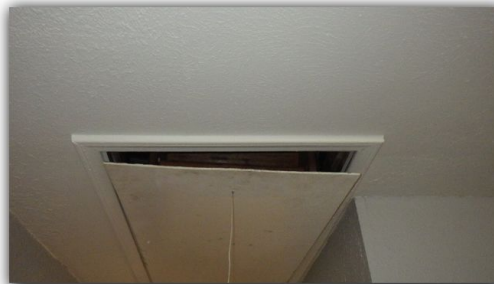
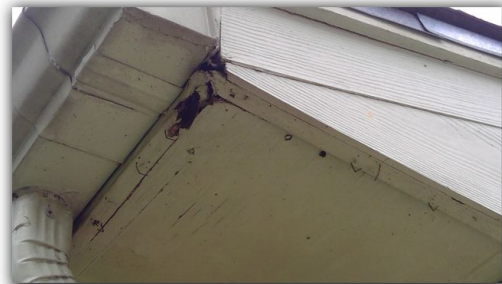
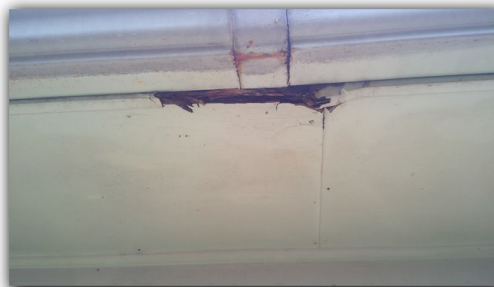
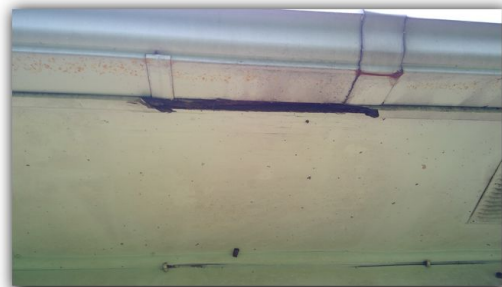
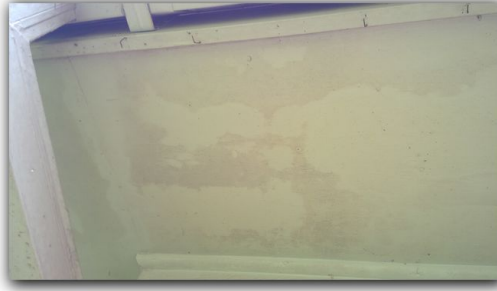
Comments: Visible components were observed currently operable, [see sample pictures](#).

However, need additional insulation to provide a uniform minimum R-30 rating; and, the garage conversion area lacks any insulation, [see sample picture](#).

Inadequate nails/screws and/or nailing pattern were observed at hallway attic drop ladder, [see sample picture](#). Drop ladder did not rest flush when fully extended, [see sample picture](#). The drop ladder hinges are bowing inwards indicating potential for popping loose, [see sample picture](#). Drop ladder does not close adequately creating points for air-loss/air-infiltration, [see sample picture](#). And, need to insulate drop ladder panel.

Discoloration/moisture stains were observed at numerous spots around the soffit panels; and, some moisture damage was already observed on front, right and rear soffit and fascia boards, [see sample pictures](#). This may indicate possible roof and/or gutter leaks.

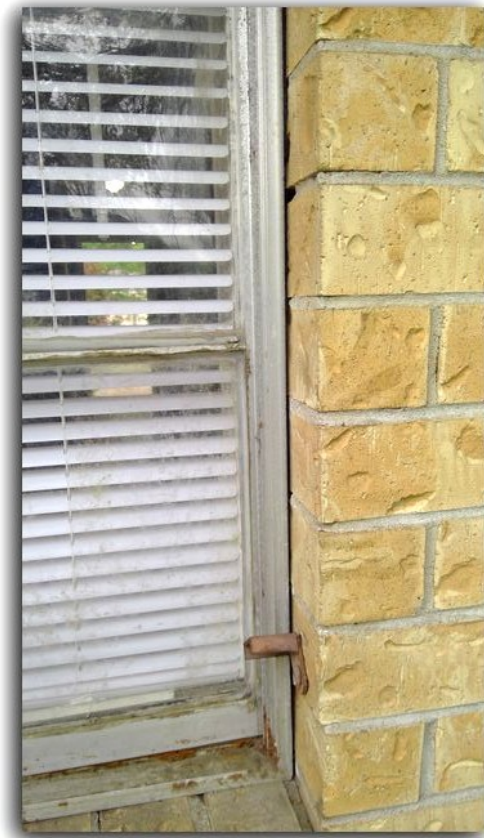
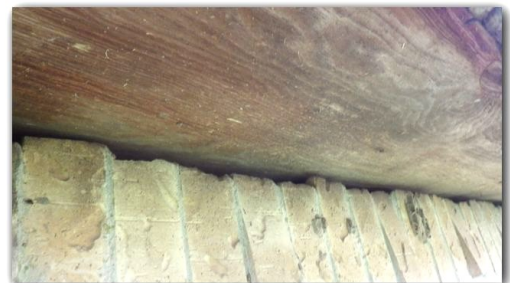
However, need additional sealant at window frame/brick veneer junctions and along front window box underside/brick veneer junction, see sample pictures.

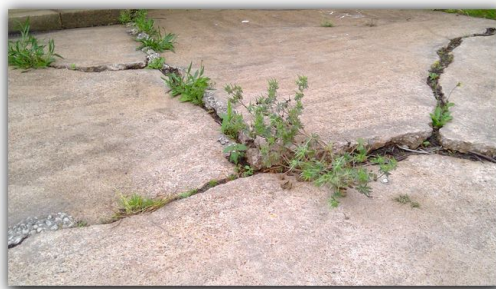
Comments: Broken and uneven concrete was observed creating tripping hazards at rear patio, see sample picture.

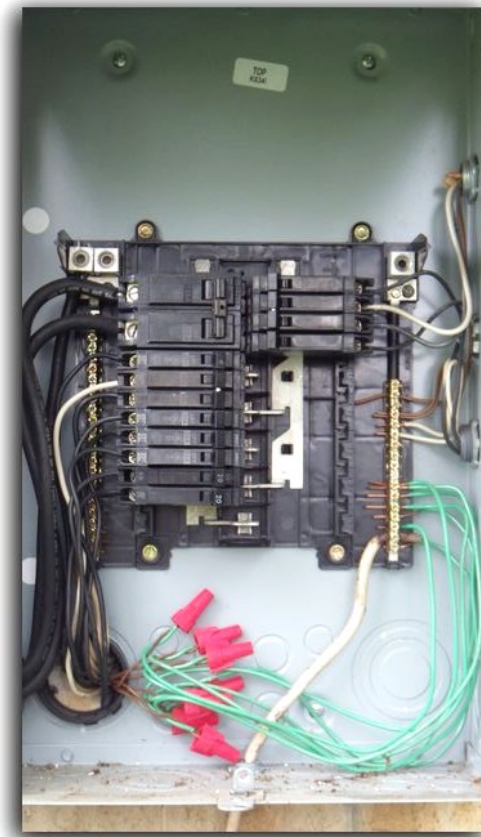
Comments: Load calculations were not performed. This is a GE panel box with a 125 amp main breaker, see [sample picture](#). System was observed currently operable.

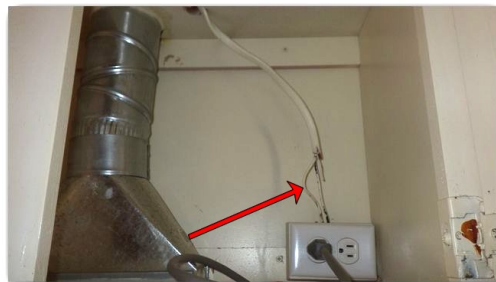
Exposed/inadequately protected electrical cables observed in cabinet over microwave, [see sample picture](#).

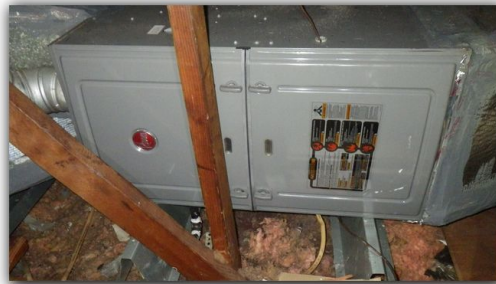
Comments: Furnace was observed in good physical condition, see sample picture. No inspection was performed to check for possible heat exchanger cracks as this would involve dismantling of unit, which is beyond the scope of this inspection. Gas was locked/closed at the meter valve preventing a proper operational status inspection of furnace. Furnace should be properly evaluated when gas is made readily available.

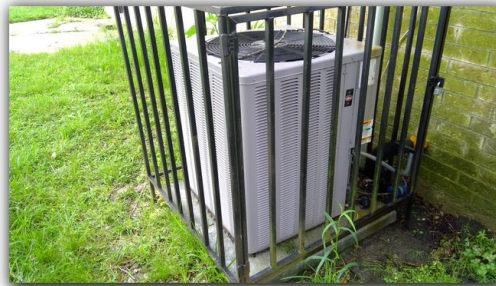
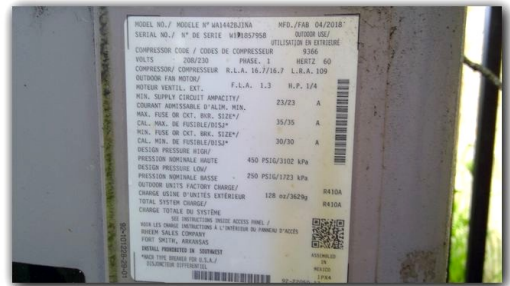
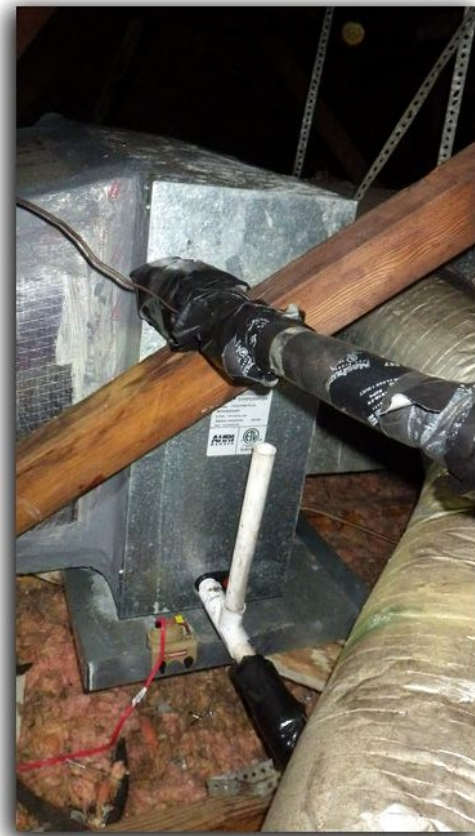
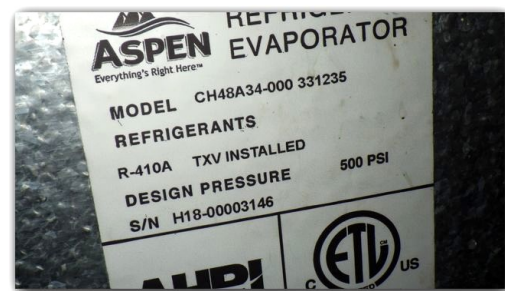
A 17 degree temperature differential reading (49F.-66F.) was detected between the supply and return. System was observed currently operable.

However, the manufacturers ID requires a maximum circuit breaker rating of 35 amps; this condenser was connected to a 40 amp breaker at panel box.

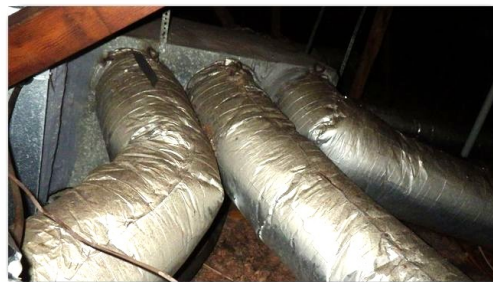
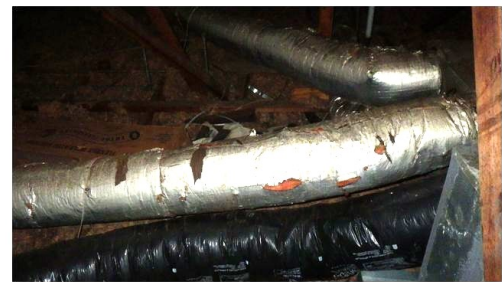
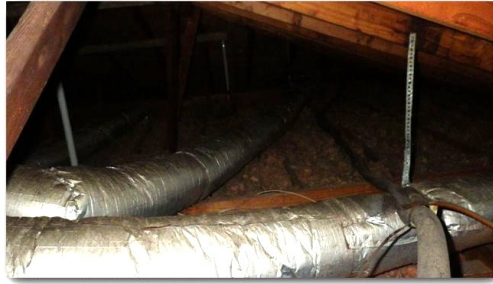
Comments: Visible components were observed currently operable; no inspection was performed on duct interiors, see duct sample pictures.

However, in humid climates ducts should be suspended to allow better air-flow; ducts buried or lying on attic insulation, see sample picture, can create condensation around duct where it touches the insulation.

Some of the duct wrapping was observed with small tears.

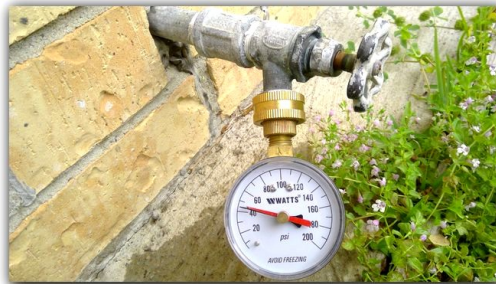
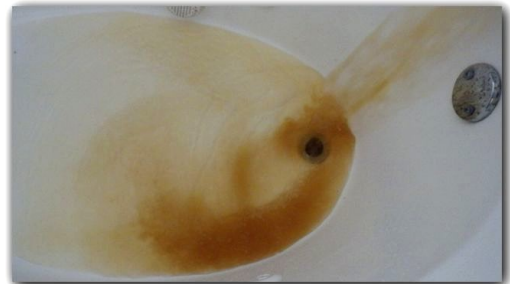
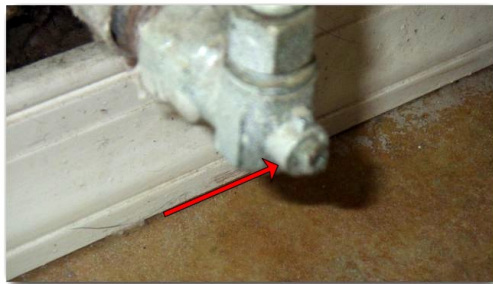
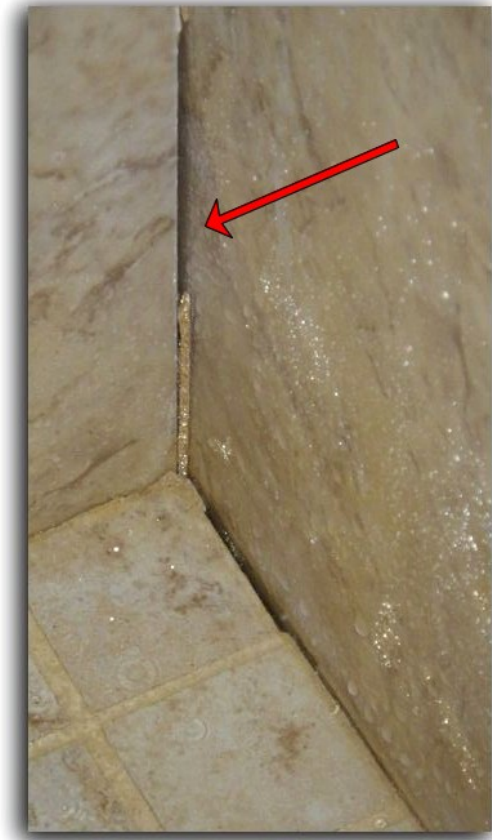
Comments: System and fixtures were operated and observed currently operable, [see pressure sample picture](#).

However, brownish/rust colored water was observed at spare bathtub during operation of faucets [see sample picture](#); water supply system may need to be flushed.

The master bathroom toilet water shutoff valve handle was broken/missing, [see sample picture](#).

Missing/deteriorated grout was observed at master shower stall wall and floor joints, [see sample picture](#).

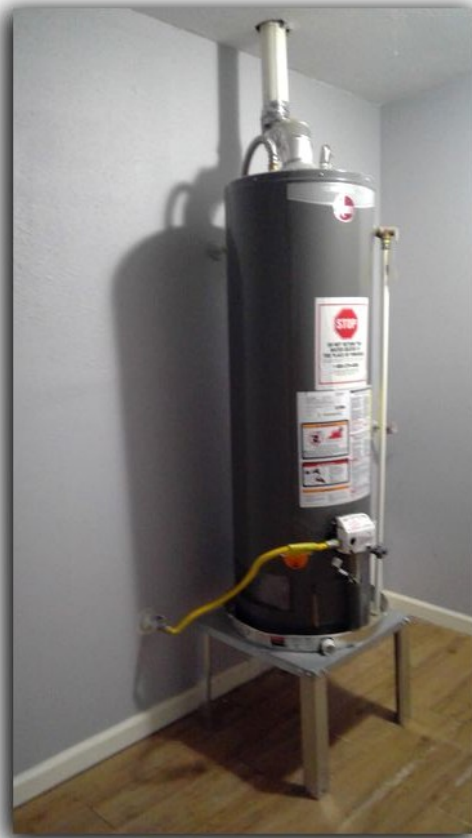
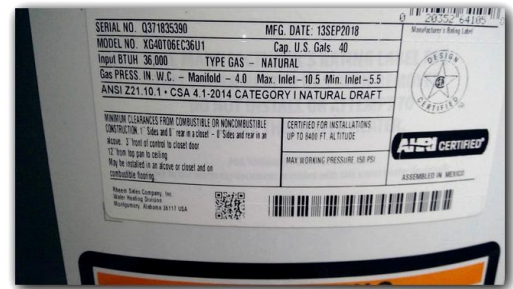
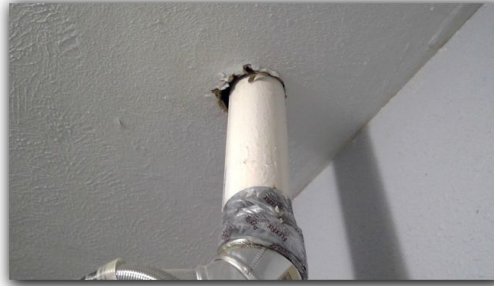
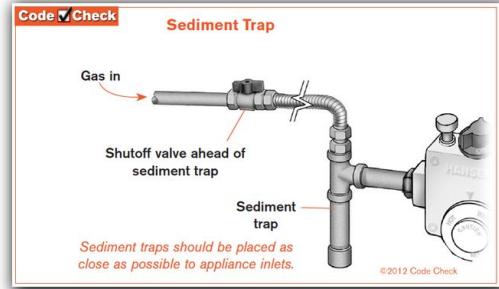
Comments: The I.D. plate on unit indicates it to be a 2018 model, see sample pictures. Unit was observed currently in good physical condition. Gas was locked/closed at the meter valve preventing a proper operational status inspection of water heater. Water heater should be properly evaluated when gas is made readily available.

Water heater drain pan lacks a drain line properly discharging into a proper drain system or to the exterior of structure.

Water heater lacks a sediment trap at gas line connection, see sample illustration.

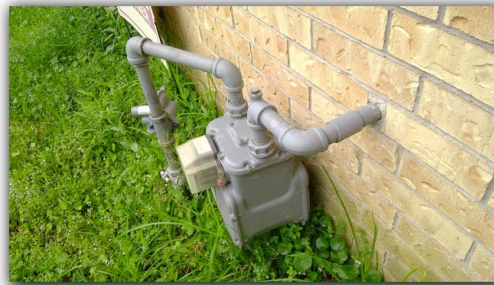
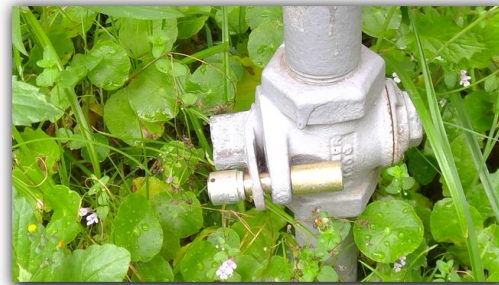
Type of gas distribution piping material: black iron, see sample picture

Comments: Gas was locked/closed at the meter valve preventing a proper operational status inspection of gas distribution system; system should be properly evaluated when gas is made readily available.
